## Evaluation of W-Beam Guardrail Terminal Post in Sleeve

**Prepared by:** Texas A&M Transportation Institute  
Texas A&M University System  
College Station, TX 77843

**Date:** October 2019

**Report #:** 4000(183) (TTI Report No. 611011-1)

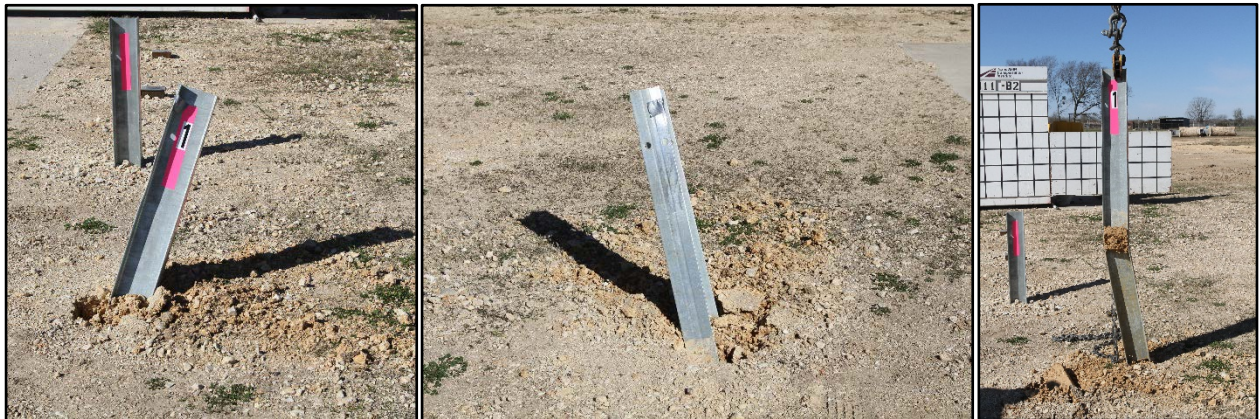
**Figure 3.5. Direct Embedded Post after Test No. 611011-B1.**

The bogie impacted the direct embedded post at 90° while traveling at a speed of 20.9 mi/h. The direct embedded post was pushed toward the field side 5.0 inches at grade and was leaning 73° toward the field side. Maximum stroke on the honeycomb nose was 6.5 inches. Figures 3.5 and 3.6 show the post and bogie, respectively, after the test. Acceleration-time, force-time, and force-displacement curves are provided in Figures 3.7 through 3.9, respectively.

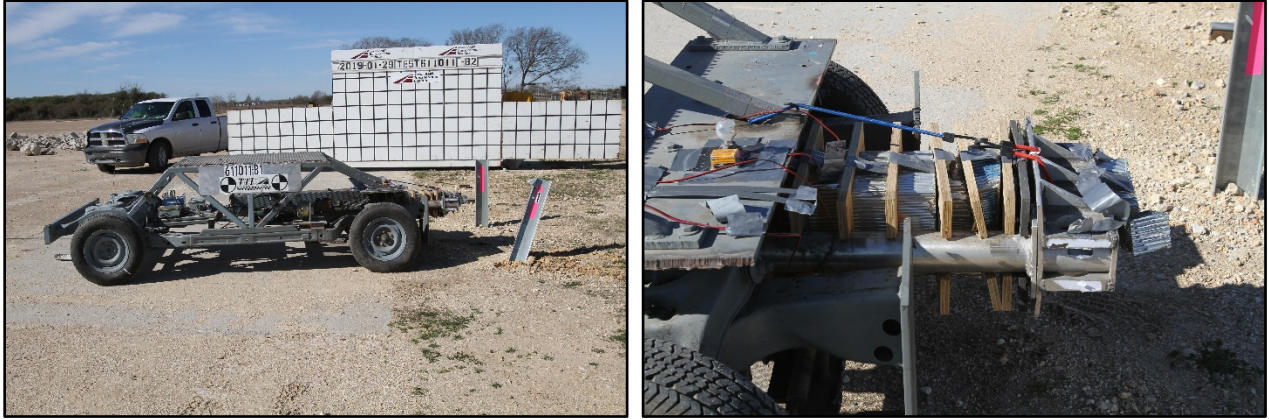
**Figure 3.6. Bogie Test Vehicle after Test No. 611011-B1.**

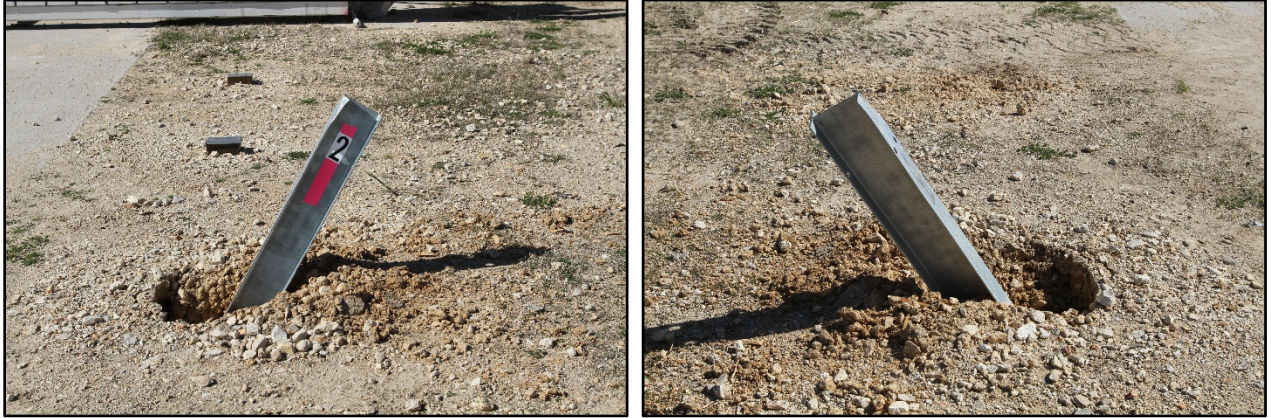
**Figure 3.10. Direct Embedded Post after Test No. 611011-B2.**

The bogie impacted the direct embedded post at 90° while traveling at a speed of 26.0 mi/h. The direct embedded post was pushed toward the field side 12.5 inches at grade and was leaning 59° toward the field side. Maximum stroke on the honeycomb nose was 5.5 inches. Figures 3.10 and 3.11 show the post and bogie, respectively, after the test. Acceleration-time, force-time, and force-displacement curves are provided in Figures 3.12 through 3.14.

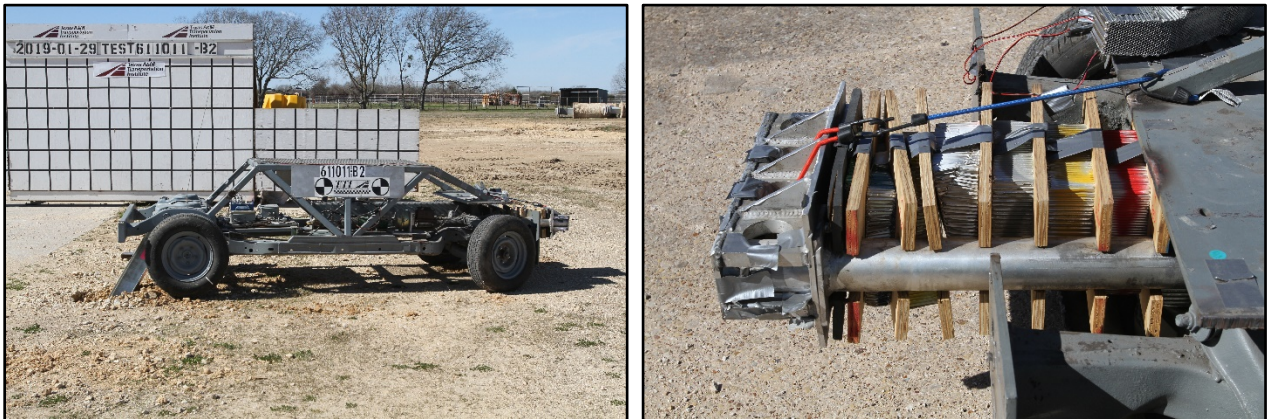
**Figure 3.11. Bogie Test Vehicle after Test No. 611011-B2.**

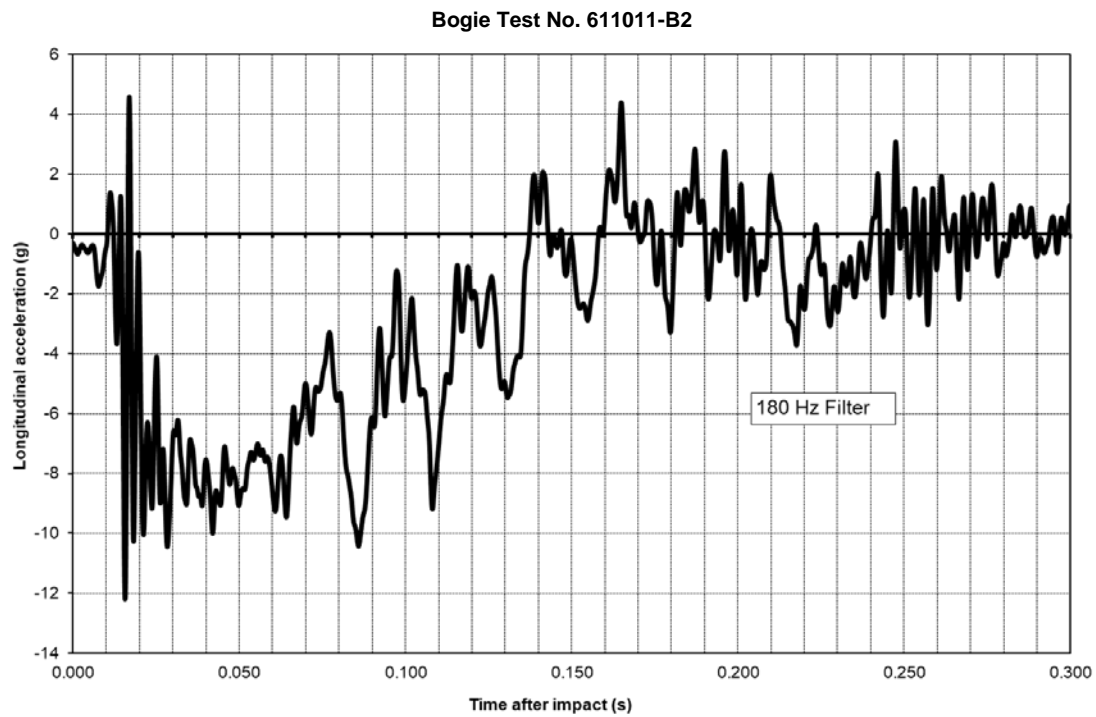
**Figure 3.12. Longitudinal Acceleration for Test No. 611011-B2.**

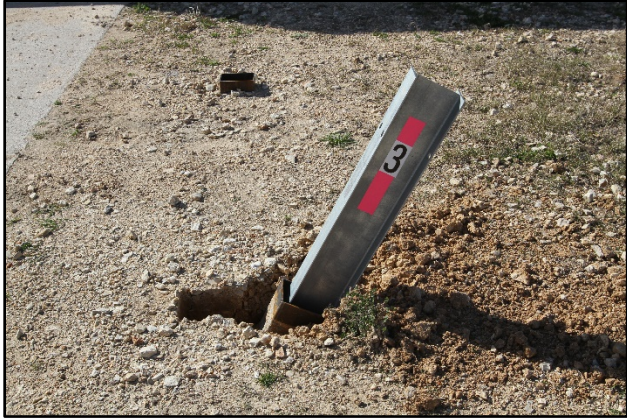
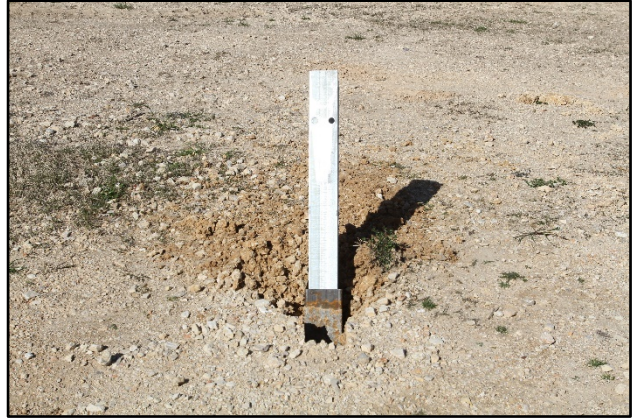
**Figure 3.15. Post in Steel Sleeve after Test No. 611011-B3.**

The bogie impacted the post installed in a sleeve at 90° while traveling at a speed of 20.9 mi/h. The direct embedded post (and sleeve) was pushed toward the field side 13.0 inches at grade and was leaning 63° toward the field side. Maximum stroke on the honeycomb nose was 5.25 inches. Figures 3.15 and 3.16 show the post and bogie, respectively, after the test. Acceleration-time, force-time, and force-displacement curves are provided in Figures 3.17 through 3.19.

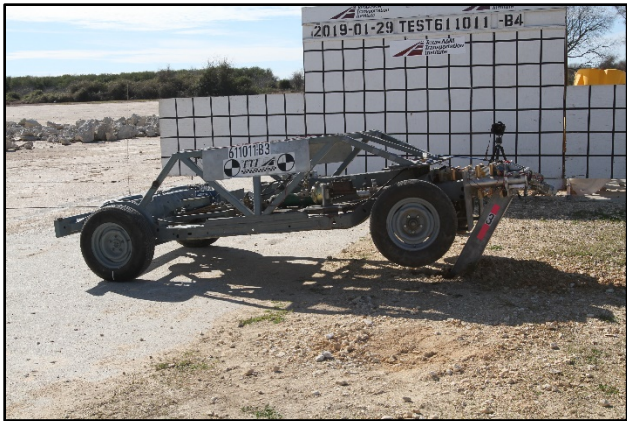
**Figure 3.16. Bogie Test Vehicle after Test No. 611011-B3.**

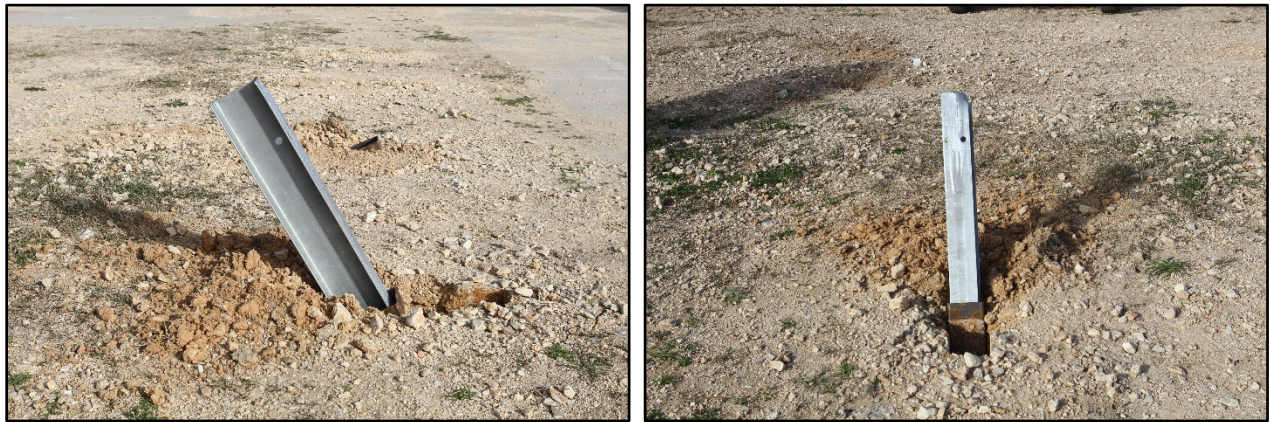
**Figure 3.20. Post in Steel Sleeve after Test No. 611011-B4.**

The bogie impacted the post installed in a sleeve at 90° while traveling at a speed of 25.1 mi/h. The direct embedded post (and sleeve) was pushed toward the field side 3.0 inches at grade and was leaning 60° toward the field side. Maximum stroke on the honeycomb nose was 6.0 inches. Figures 3.20 and 3.21 show the post and bogie, respectively, after the test. Acceleration-time, force-time, and force-displacement curves are provided in Figures 3.22 through 3.24.

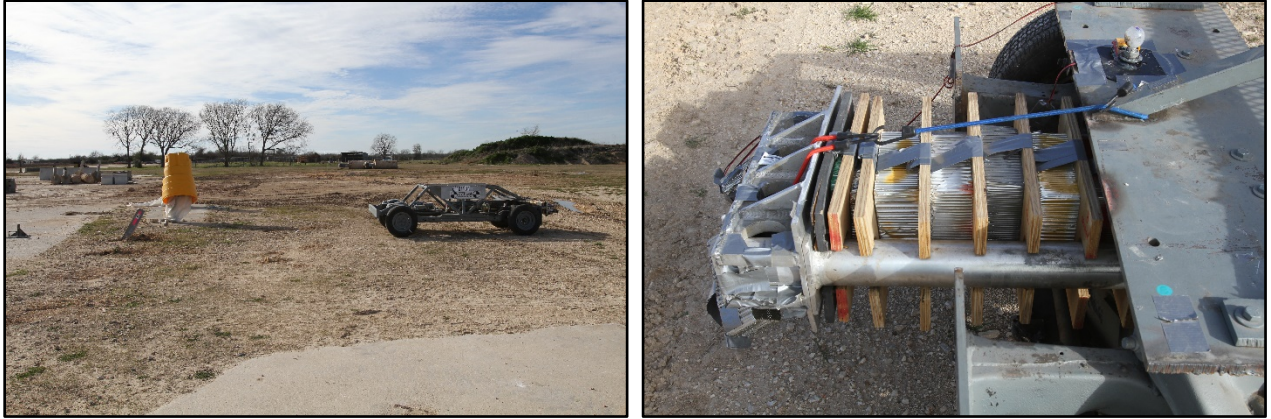
**Figure 3.21. Bogie Test Vehicle after Test No. 611011-B4.**

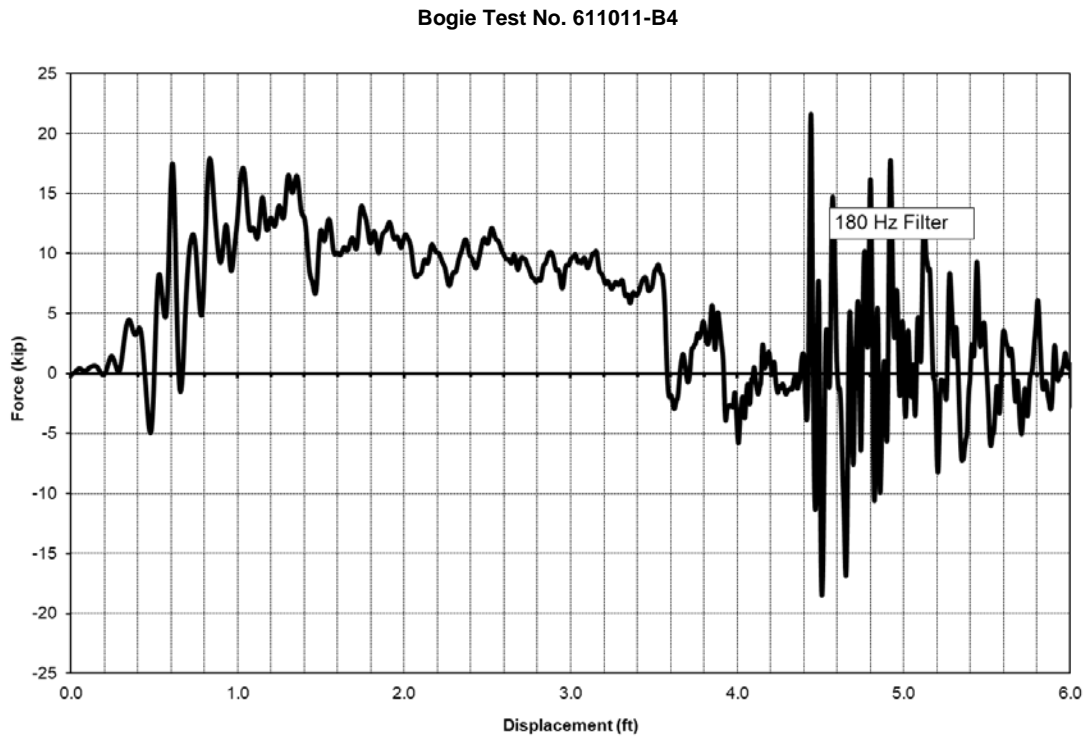
**Figure 3.24. Force vs Displacement for Test No. 611011-B4.**

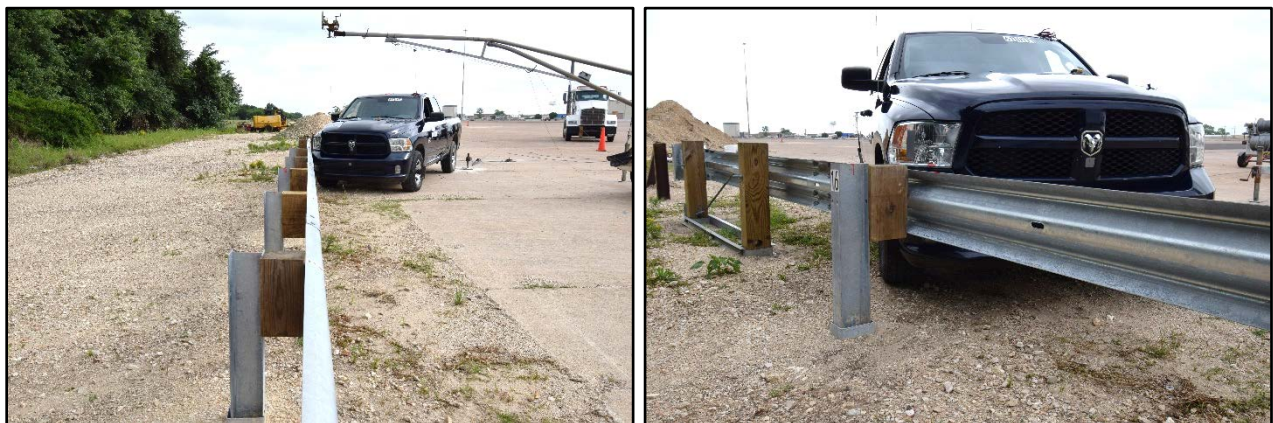
**Figure 7.1. Terminal/Test Vehicle Geometrics for Test No. 611011-1.**

Figures 7.1 and 7.2 show the 2015 RAM 1500 pickup truck used for the crash test. The vehicle's test inertia weight was 5024 lb, and its gross static weight was 5024 lb. The height to the lower edge of the vehicle bumper was 11.75 inches, and height to the upper edge of the bumper was 27.0 inches. The height to the vehicle's center of gravity was 28.0 inches. Tables E.1 and E.2 in Appendix E1 give additional dimensions and information on the vehicle. The vehicle was directed into the installation using the cable reverse tow and guidance system, and was released to be freewheeling and unrestrained just prior to impact.

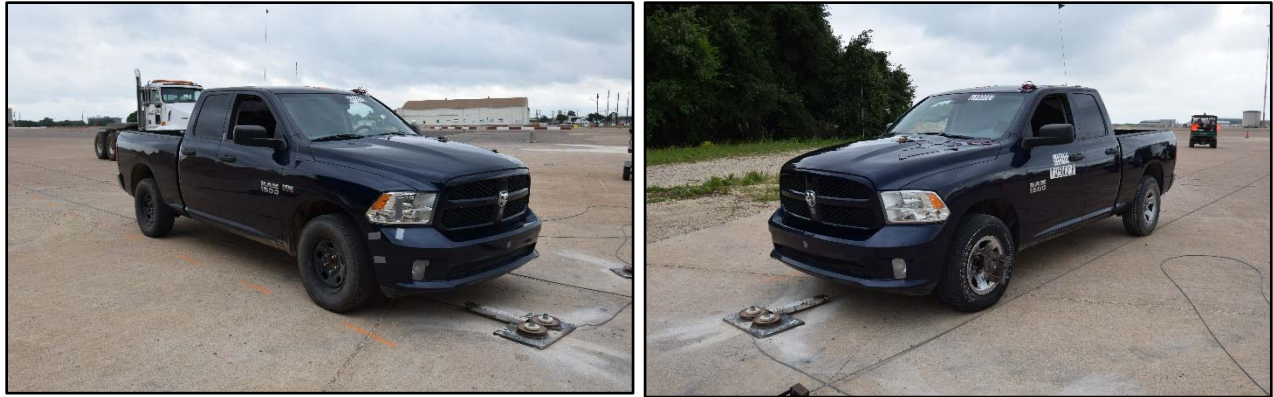
**Figure 7.2. Test Vehicle before Test No. 611011-1.**

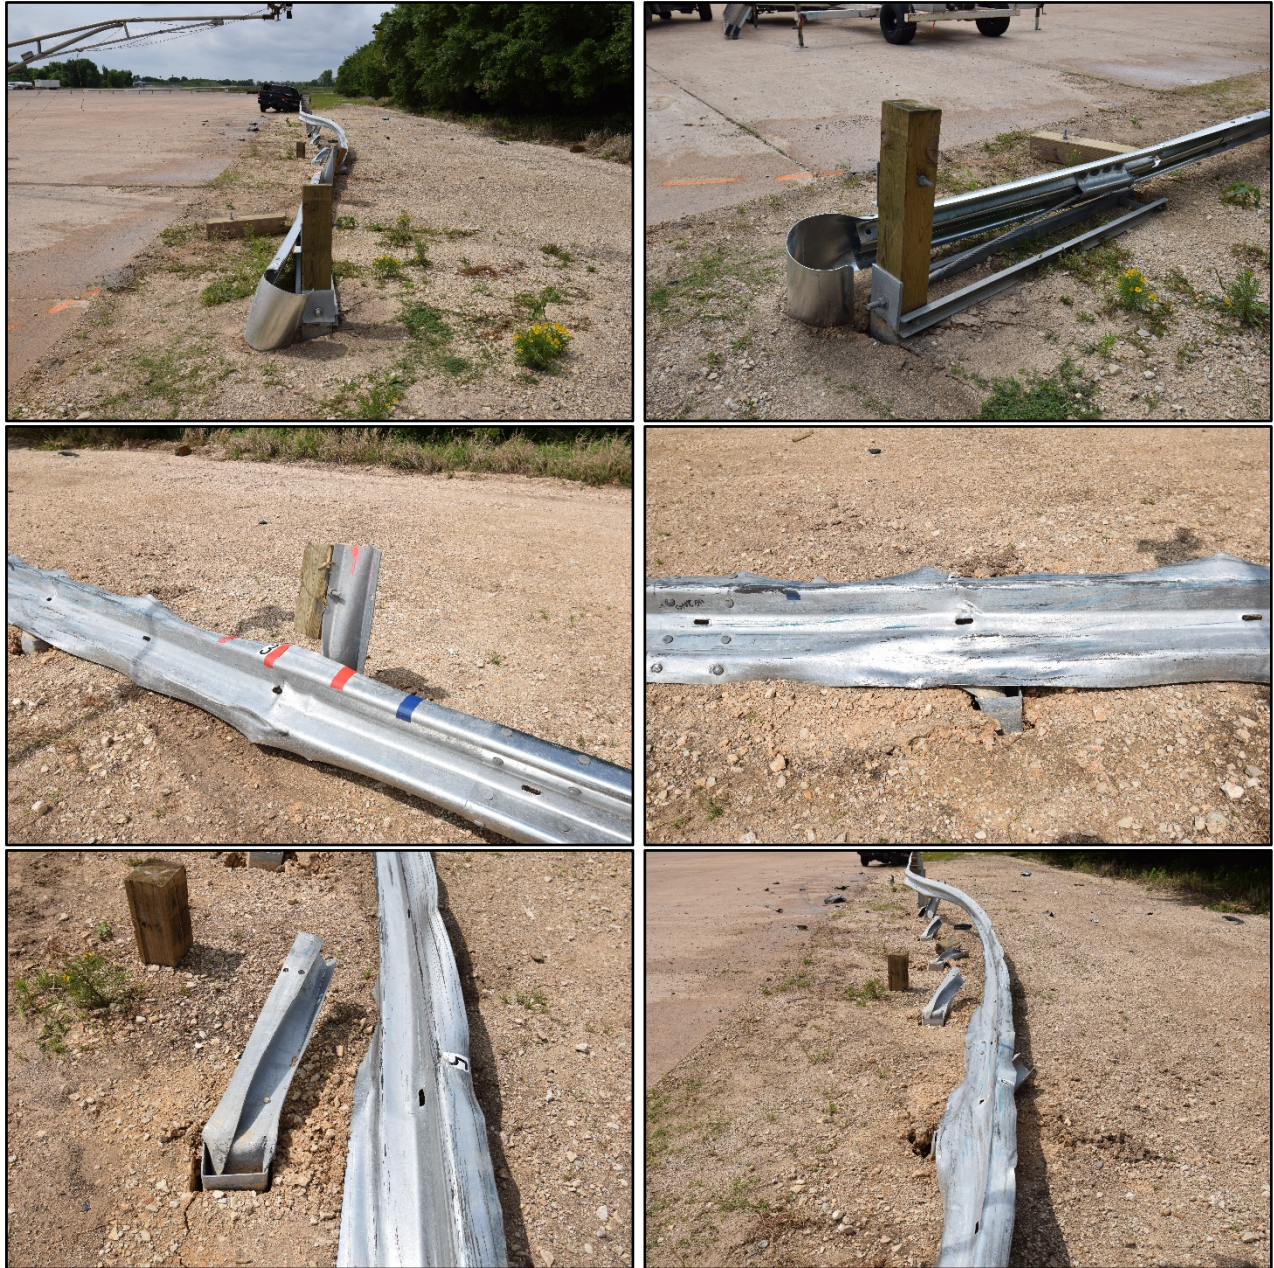
**Figure 7.3. Terminal after Test No. 611011-1.**

Figure 7.3 shows the damage to the guardrail and the DAT terminal. Post 1 was leaning downstream at 85°. Post 2 broke off at grade. Post 3 rotated 95° clockwise and was leaning

toward the field side at 85°. Posts 4 through 7 were leaning back at approximately 0-10°, and post 8 was leaning downstream at 53°. The blockouts were missing from posts 4, 5, 7, and 8, and the rail released from posts 1 through 9. Figure 7.4 shows movement of some of the sleeves. Working width\* was 54.9 inches, and height of working width was 54.0 inches. Maximum dynamic deflection during the test was 48.5 inches. The maximum permanent deflection was 41.1 inches, located 2 feet downstream of the original post 6 location.

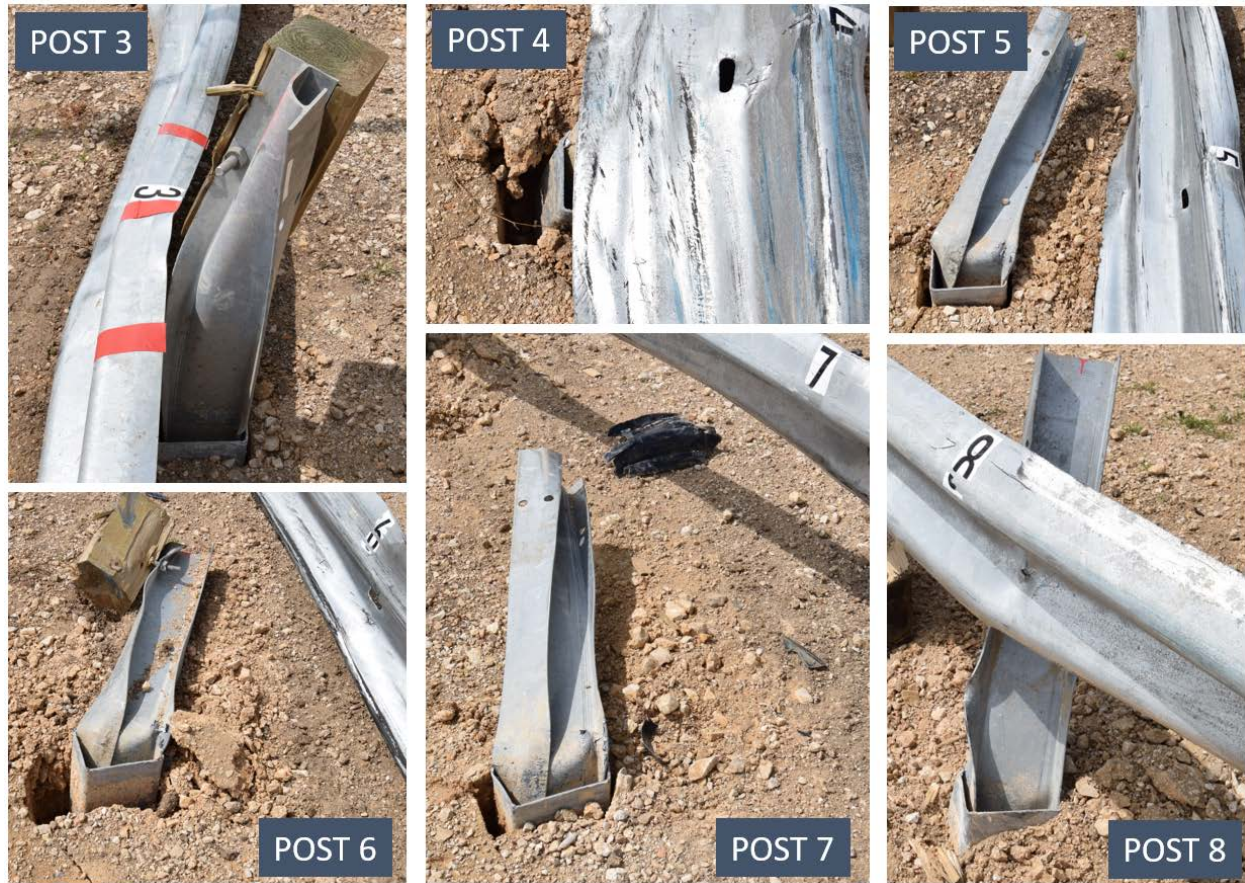
**Figure 7.4. Movement of Some of the Sleeves after Test No. 611011-1.**

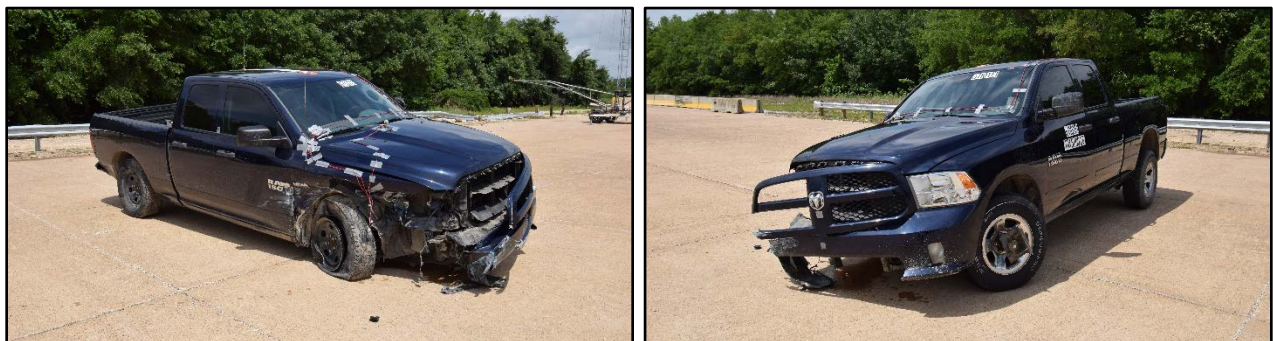
**Figure 7.5. Test Vehicle after Test No. 611011-1.**

Figure 7.5 shows the damage sustained by the vehicle. The front bumper, grill, right front tire and rim, right lower A-arm, right front fender, right front door, right rear exterior bed, and rear bumper were damaged. Maximum exterior crush to the vehicle was 7.0 inches in the side plane at the right front corner at bumper height. No occupant compartment deformation or intrusion was observed. Figure 7.6 shows the interior of the vehicle. Tables E.3 and E.4 in Appendix E1 provide exterior crush and occupant compartment measurements.

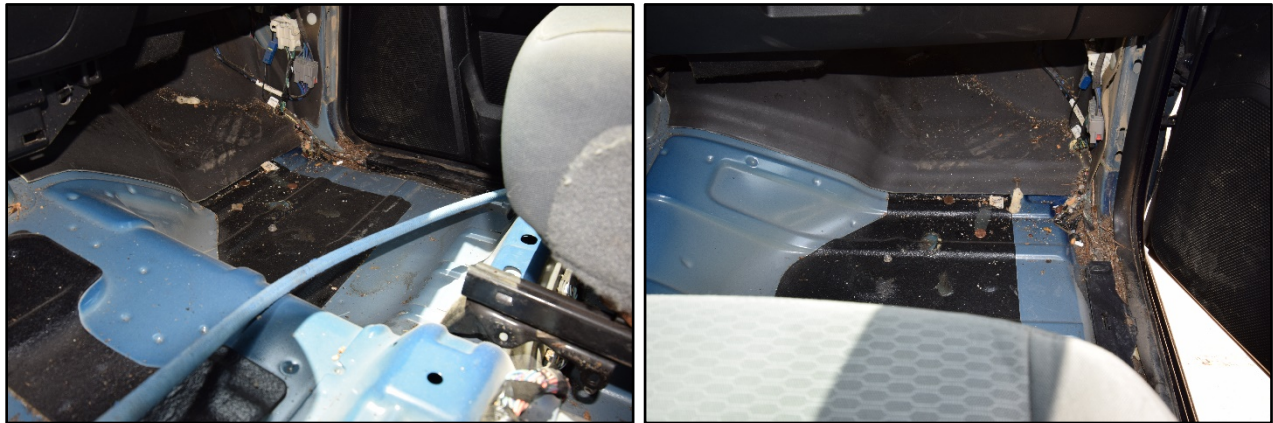
**Figure 7.6. Front Impact-Side Interior of Test Vehicle after Test No. 611011-1.**
