**Texas A&M
Transportation
Institute**
Proving Ground

Test Report No. 612831-01
Test Report Date: May 2020

***MASH* EVALUATION OF F-SHAPE
AND SINGLE-SLOPE CONCRETE
BARRIERS WITH DRAINAGE
SCUPPERS**

Test No.: 612831-01-1 / -2 / -3

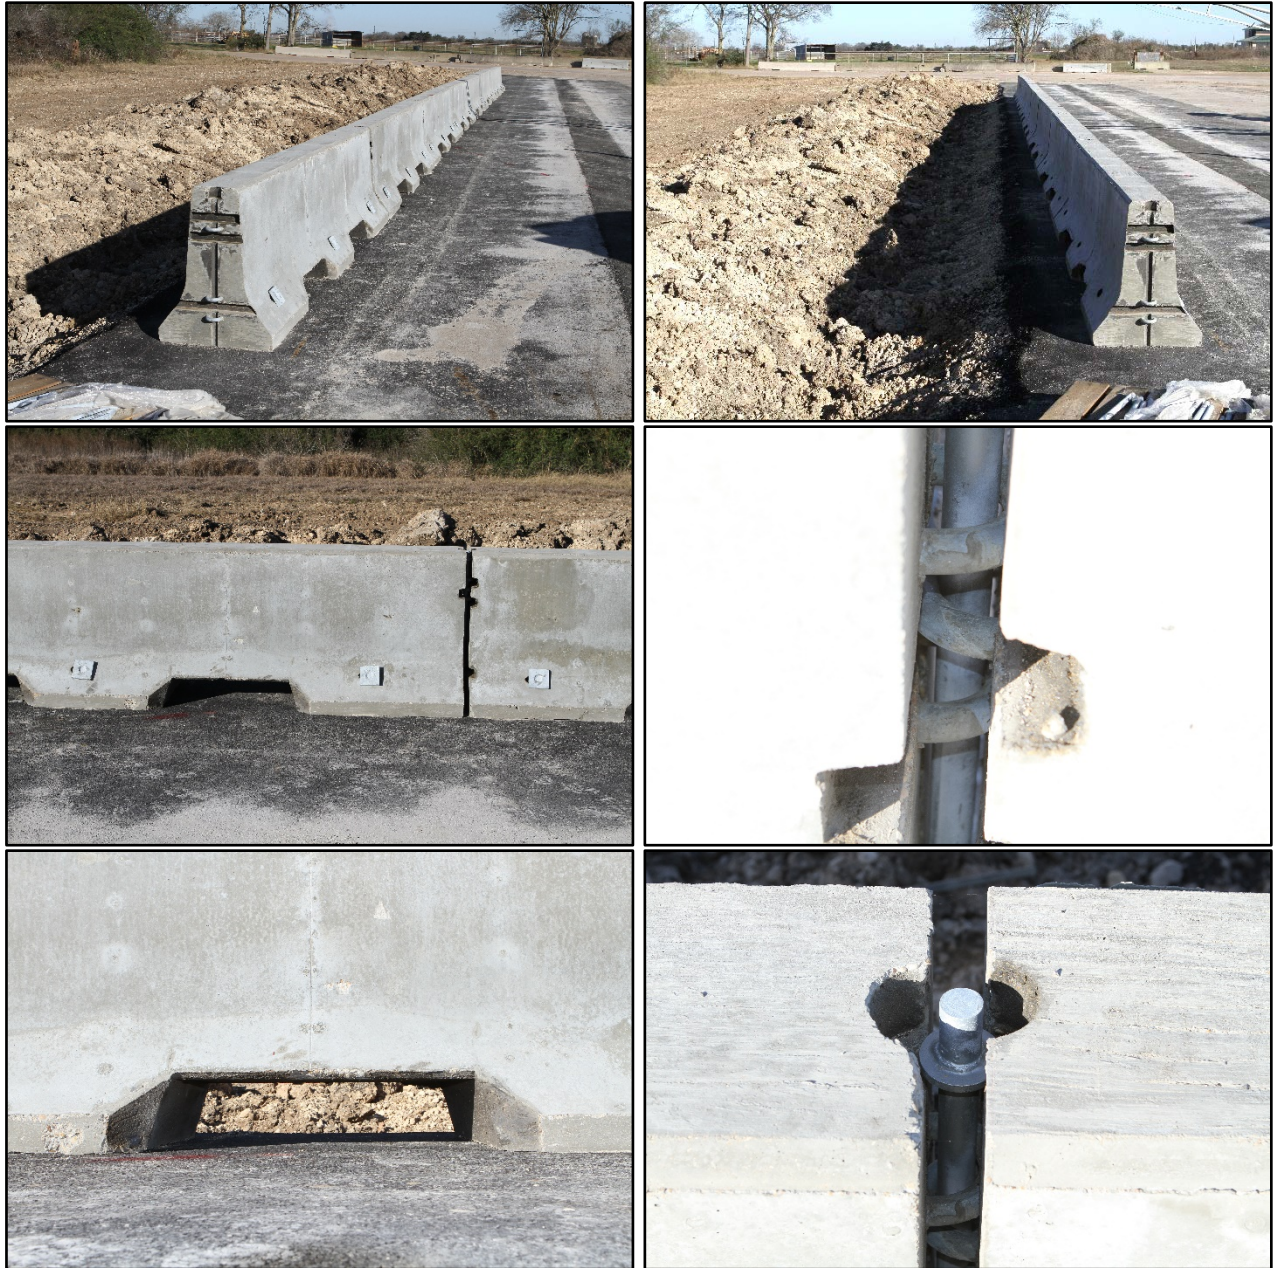
Figure 4.2. Pinned F-Shape Barrier with Drainage Scuppers prior to Testing.

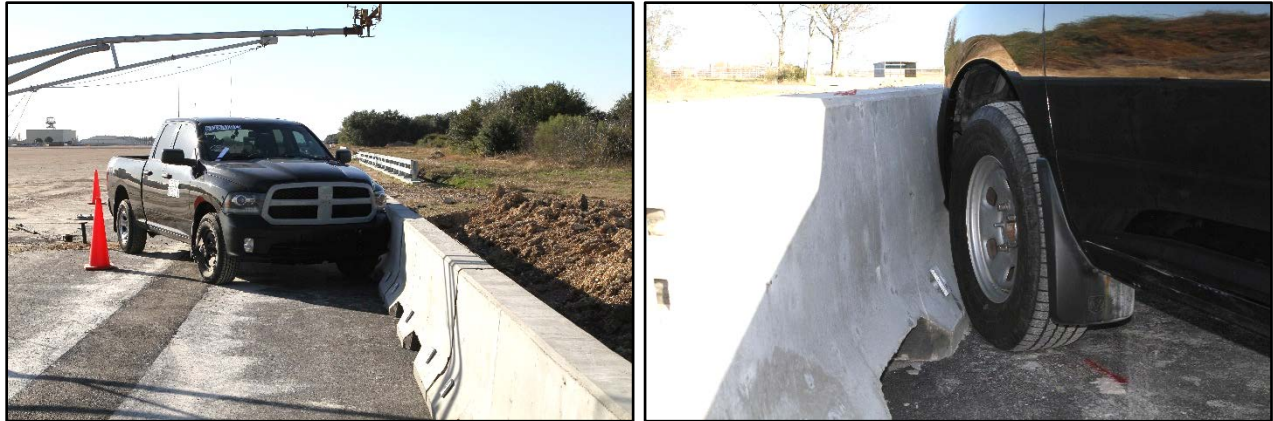
Figure 4.3. Barrier/Test Vehicle Geometrics for Test No. 612831-01-1.

MASH Test 3-11 involves a 2270P vehicle weighing 5000 lb \pm 110 lb impacting the target critical impact point (CIP) of the barrier at an impact speed of 62 mi/h \pm 2.5 mi/h and an angle of 25° \pm 1.5°. The CIP for *MASH* Test 3-11 on the pinned F-shape barrier was 4.3 ft \pm 1 ft upstream of the center of the joint between segments 3 and 4. Figure 4.3 depicts the target impact setup.

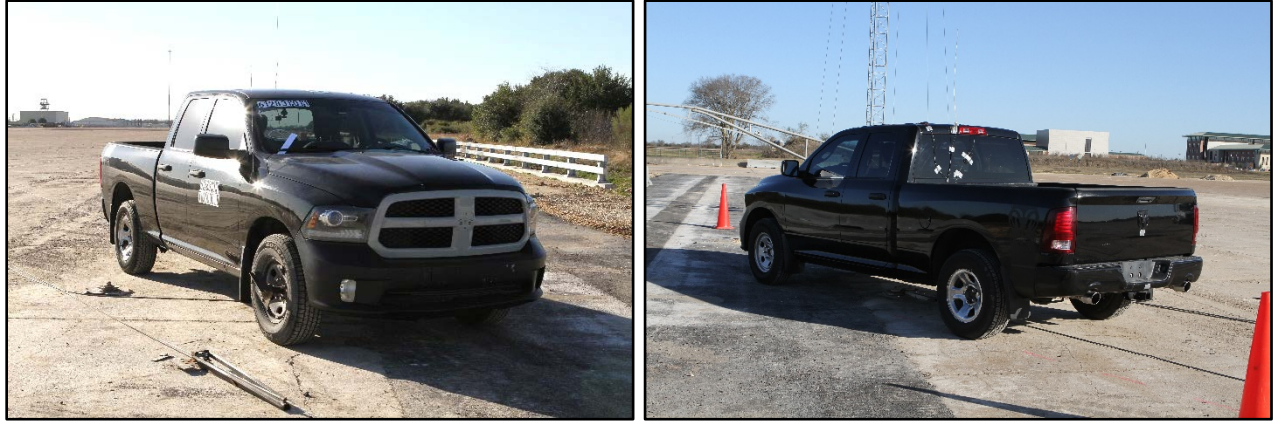
Figure 4.4. Test Vehicle before Test No. 612831-01-1.

Figure 4.4 shows the 2014 RAM 1500 pickup truck used for the crash test. The vehicle's test inertia weight was 5000 lb, and its gross static weight was 5000 lb. The height to the lower edge of the vehicle bumper was 11.75 inches, and height to the upper edge of the bumper was 27.00 inches. The height to the vehicle's center of gravity was 28.5 inches. Tables C.1 and C.2 in Appendix C1 give additional dimensions and information on the vehicle. The vehicle was directed into the installation using a cable reverse tow and guidance system. It was released to be freewheeling and unrestrained just prior to impact.

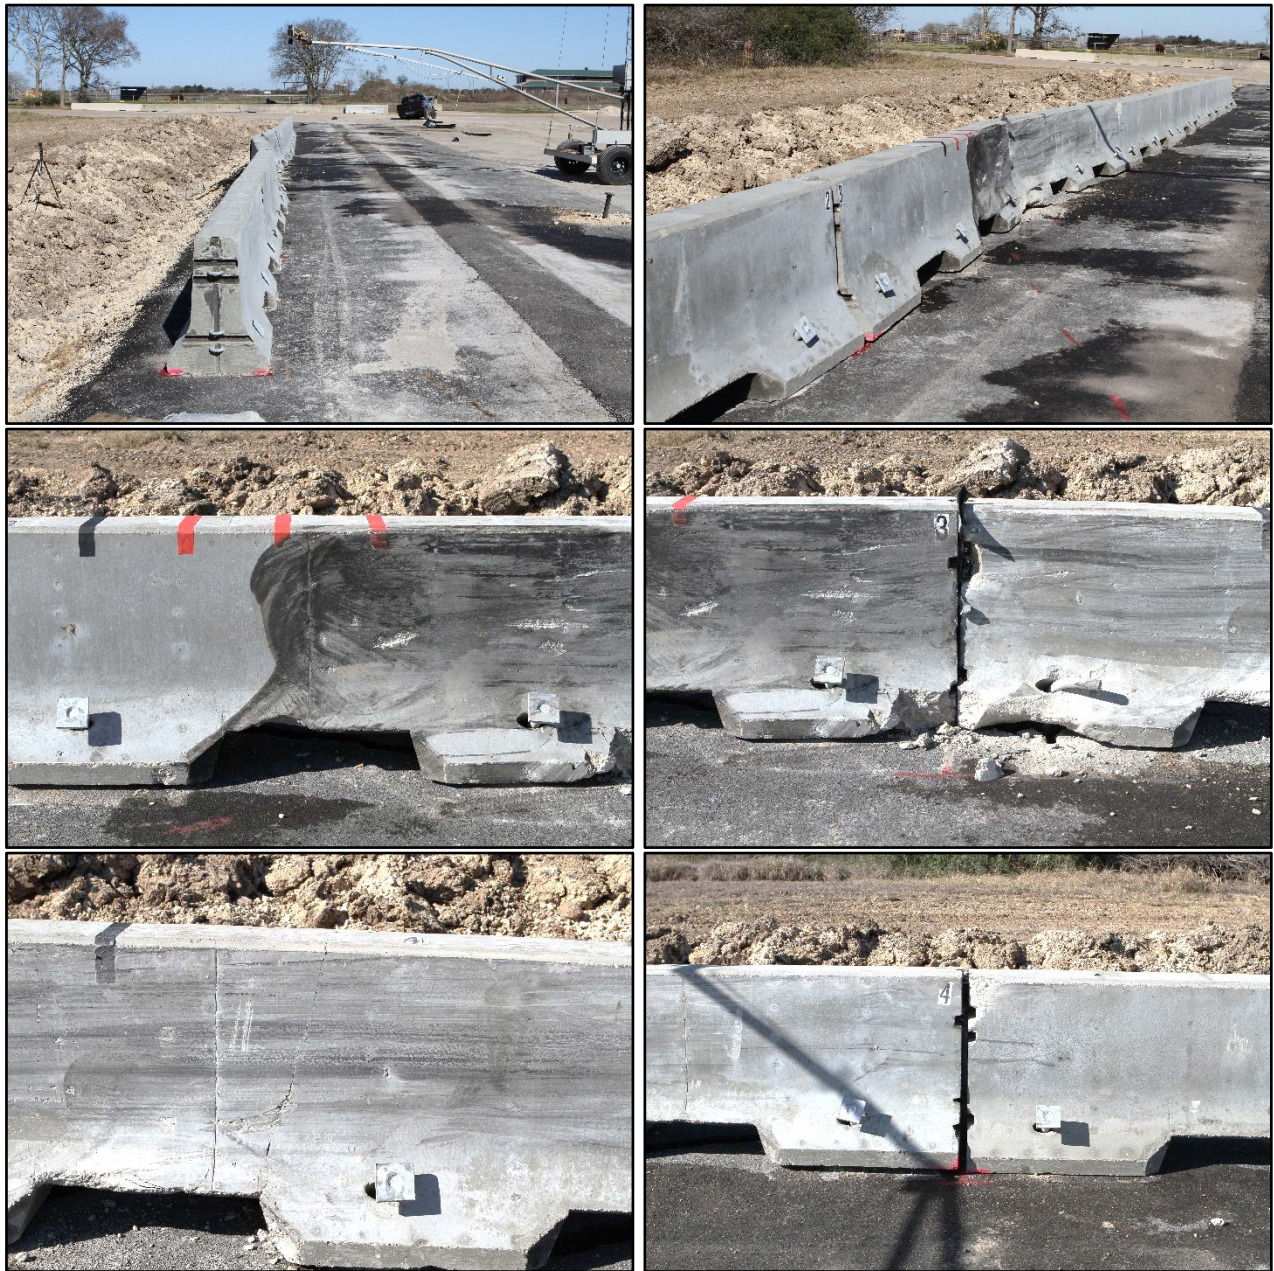
Figure 4.5 shows the damage to the barrier. Table 4.2 shows transverse barrier movement at the joints, and Table 4.3 shows how much the anchoring pins protruded after the test. Barriers 1 through 3 each moved downstream 1½-inches. No movement was noted at barriers 6 through 8. There was some spalling at the downstream scupper of barrier 3, and there was some damage to the toes of barriers 3 and 4 on the traffic side. There was a crack running approximately vertical radiating from the corner of the upstream scupper on barrier 4, and the upper field side upstream corner of barrier 5 was broken off approximately 4 inches down from the top of barrier and 4 inches downstream barrier.

Working width* was 39.6 inches, and height of working width was 32.0 inches. Maximum dynamic deflection during the test was 21.7 inches, and maximum permanent deformation was 10.0 inches.

Figure 4.5. Barrier after Test No. 612831-01-1.

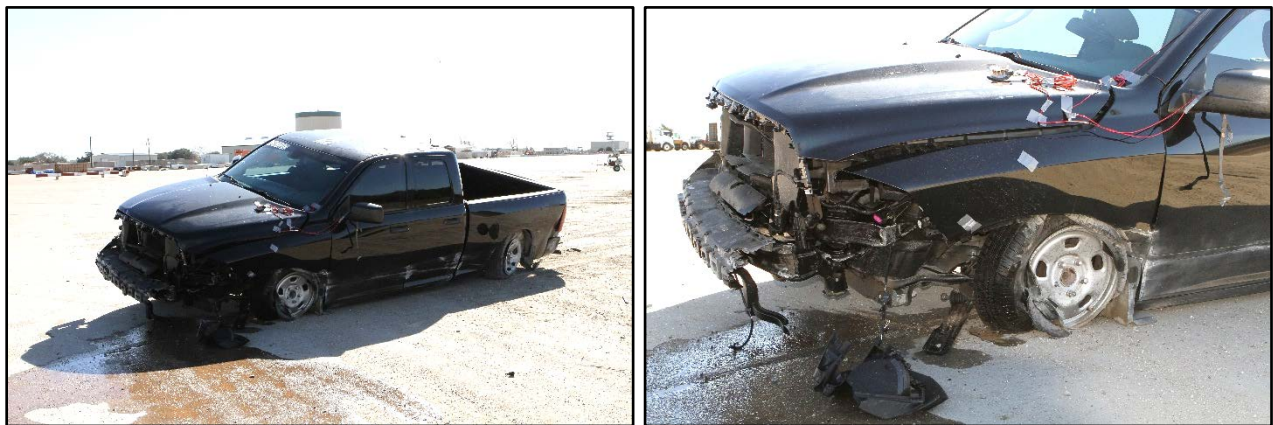
Figure 4.6 shows the damage sustained by the vehicle. The front bumper, hood, radiator and support, grill, left front fender, left front tire and rim, left frame rail, left front control arm, sway bar, tie rod, left front floor pan, left front door, left rear tire and rim, and rear bumper were damaged. Maximum exterior crush to the vehicle was 14.0 inches in the side plane at the left front corner at bumper height. Maximum occupant compartment deformation was 3.0 inches in the left front firewall. Figure 4.7 shows the interior of the vehicle. Tables C.3 and C.4 in Appendix C1 provide exterior crush and occupant compartment measurements.

Figure 4.6. Test Vehicle after Test No. 612831-01-1.

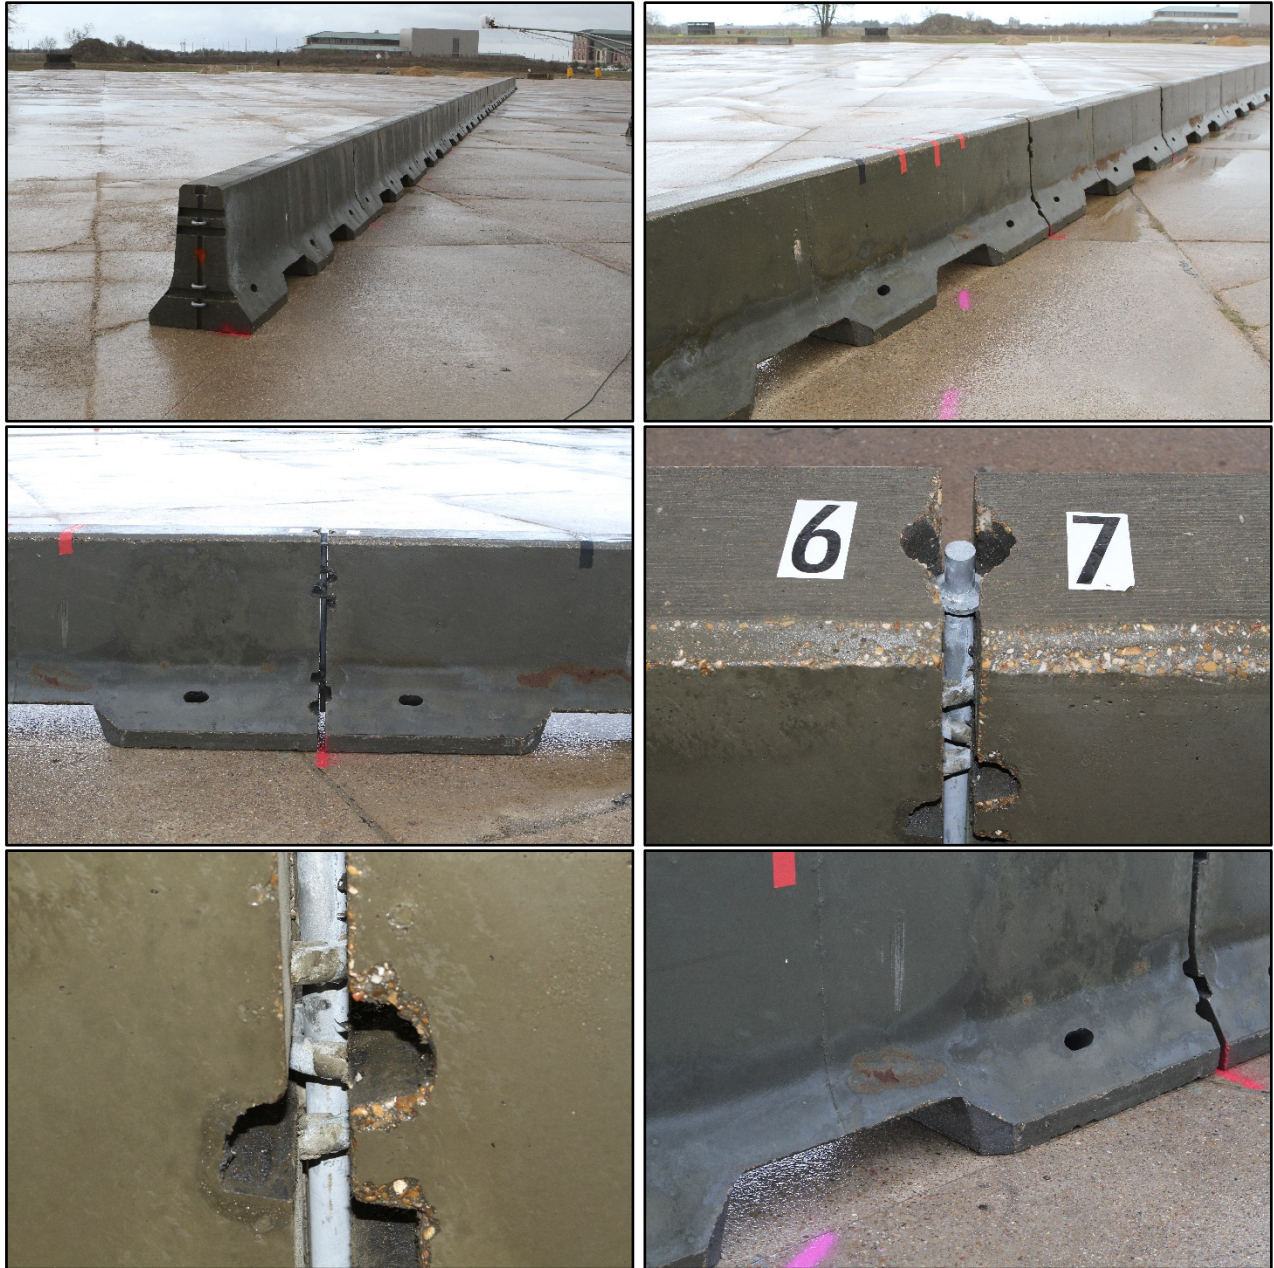
Figure 5.2. Free-Standing F-Shape Barrier with Drainage Scuppers Prior to Testing.

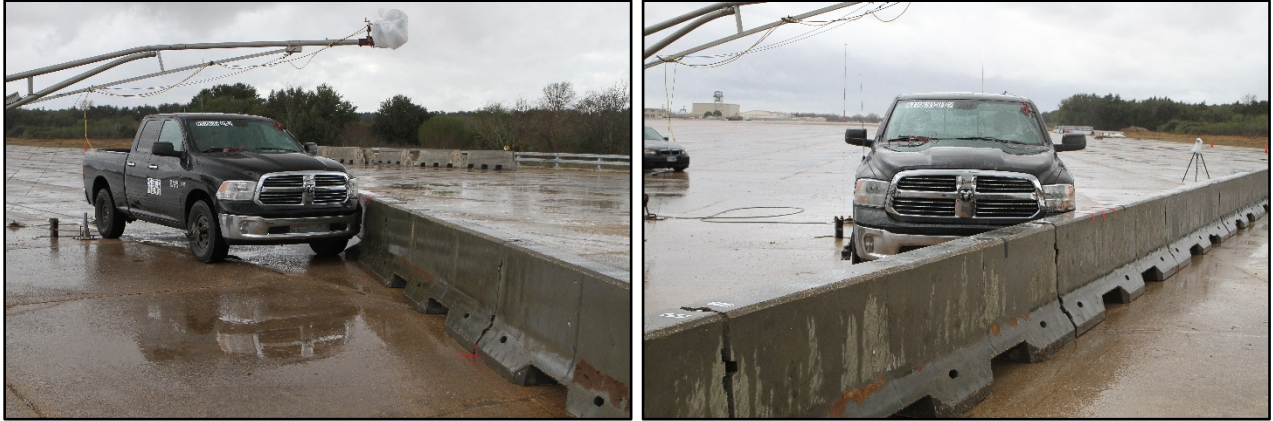
Figure 5.3. Barrier/Test Vehicle Geometrics for Test No. 612831-01-2.

MASH Test 3-11 involves a 2270P vehicle weighing 5000 lb ±110 lb impacting the target CIP of the barrier at an impact speed of 62 mi/h ±2.5 mi/h and an angle of 25° ±1.5°. The CIP for *MASH* Test 3-11 on the free-standing F-shape barrier with drainage scuppers was 4.3 ft ±1 ft upstream of the center of the joint between segments 6 and 7. Figure 5.3 depicts the target impact setup.

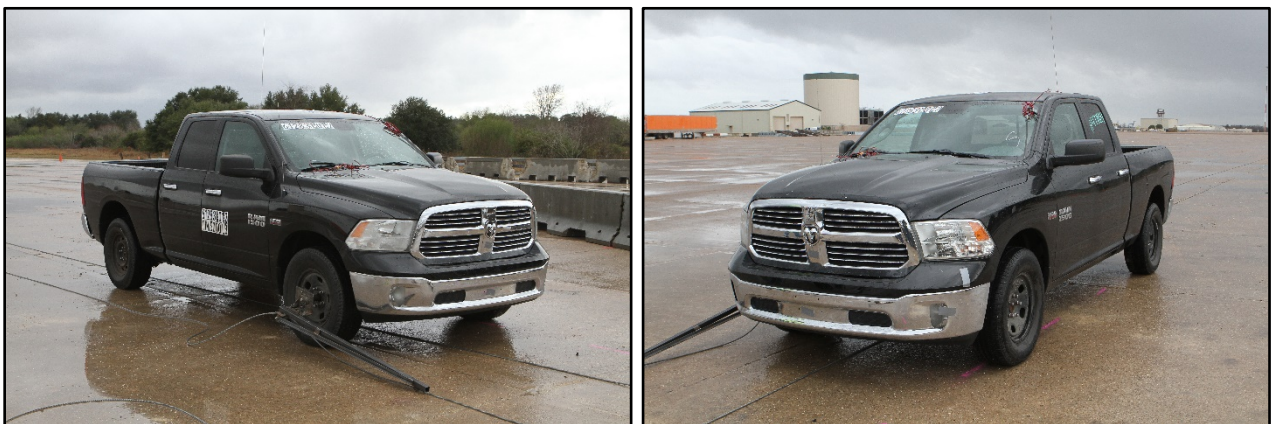
Figure 5.4. Test Vehicle before Test No. 612831-01-2.

Figure 5.4 shows the 2014 RAM 1500 pickup truck used for the crash test. The vehicle's test inertia weight was 5054 lb, and its gross static weight was 5054 lb. The height to the lower edge of the vehicle bumper was 11.75 inches, and height to the upper edge of the bumper was 27.00 inches. The height to the vehicle's center of gravity was 28.75 inches. Tables D.1 and D.2 in Appendix D1 give additional dimensions and information on the vehicle. The vehicle was directed into the installation using a cable reverse tow and guidance system. The vehicle was released to be freewheeling and unrestrained just prior to impact.

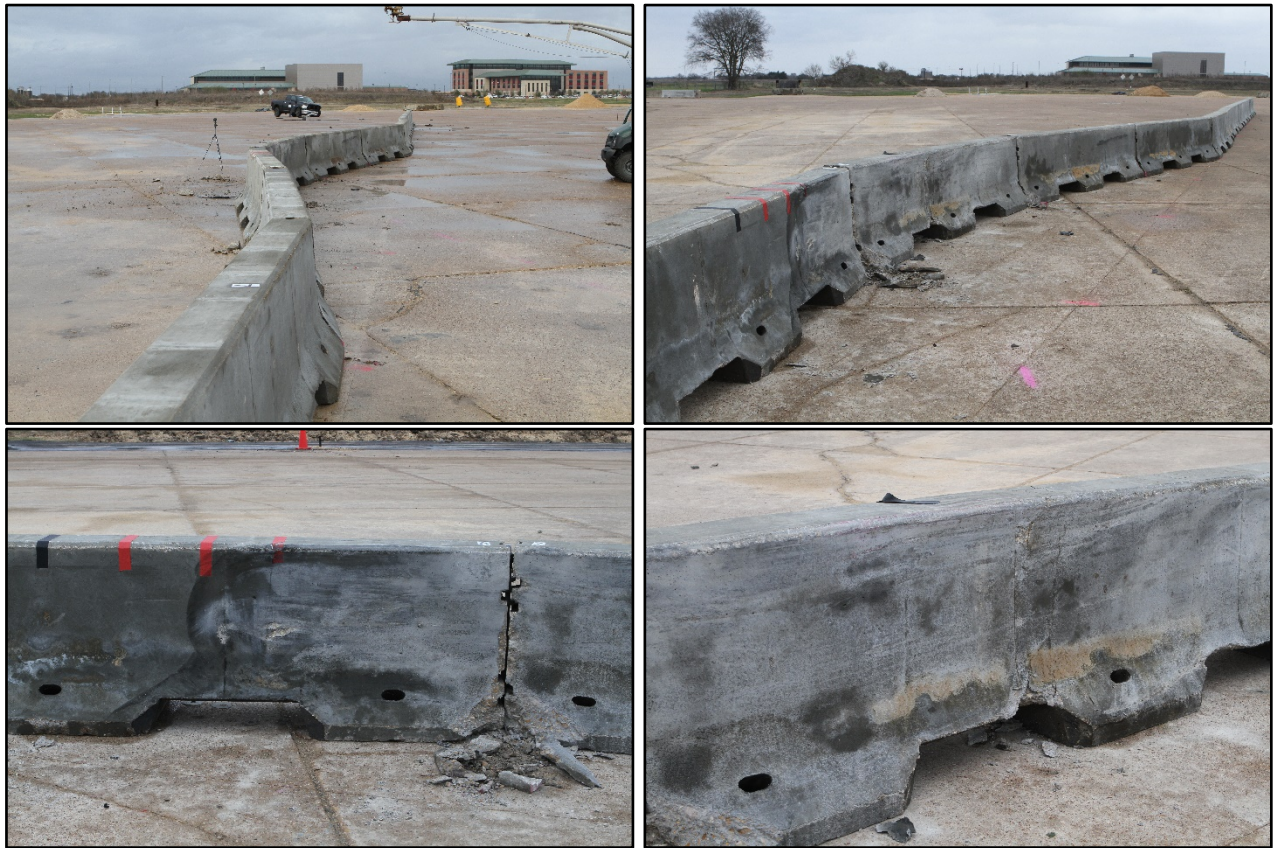
Figures 5.5 and 5.6 show the damage to the barrier. Barriers 1 and 2 moved downstream 7 inches, and barrier 3 moved downstream 7½ inches. Barrier 4 moved downstream 8 inches, and its upstream end moved 2 inches toward the field side. Barriers 10 and 11 moved upstream 2 inches, barrier 12 moved upstream 1½ inches, barrier 13 moved upstream 1 inch, and barriers 14 and 15 moved upstream ½ inch. Barrier 16 did not move. Table 5.2 shows transverse movement at the joints.

There were multiple cracks in barrier 7, but it remained intact. There was minor damage to the lower corners of both barriers on the field side at joint 4-5. There was significant damage to both corners of both barriers on the traffic side at joint 6-7, and joint 7-8. There was also significant damage to the field side corners of both barriers at joints, 5-6, 7-8, 8-9 and 9-10. Barriers 1-3 and 11-16 were not damaged during this test (barriers 15 and 16 had minor damage from use in a previous test).

Working width* was 86.9 inches, and height of working width was 3 inches. Maximum dynamic deflection during the test was 63.0 inches, and maximum permanent deformation was 63.0 inches.

Figure 5.5. Barrier after Test No. 612831-01-2.

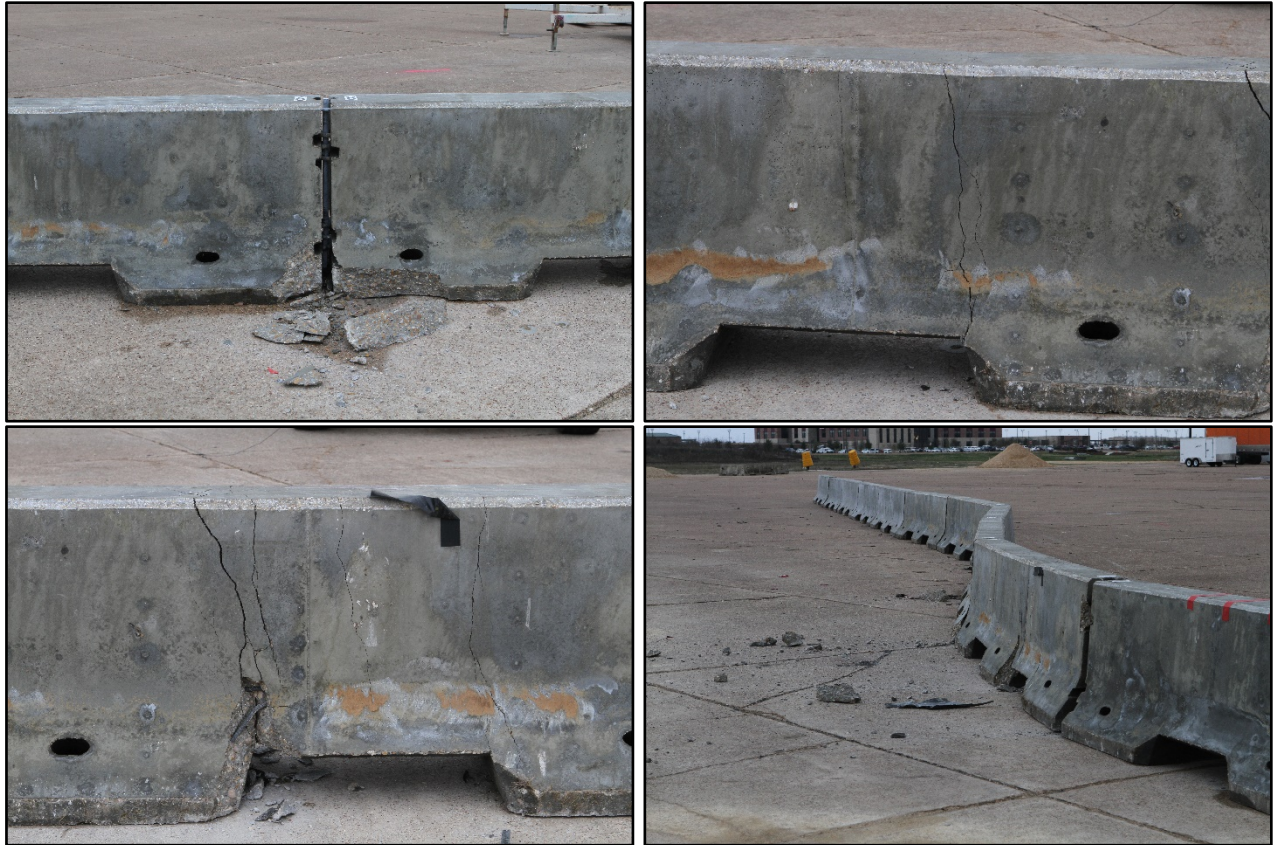
Figure 5.6. Field Side of Barrier after Test No. 612831-01-2.

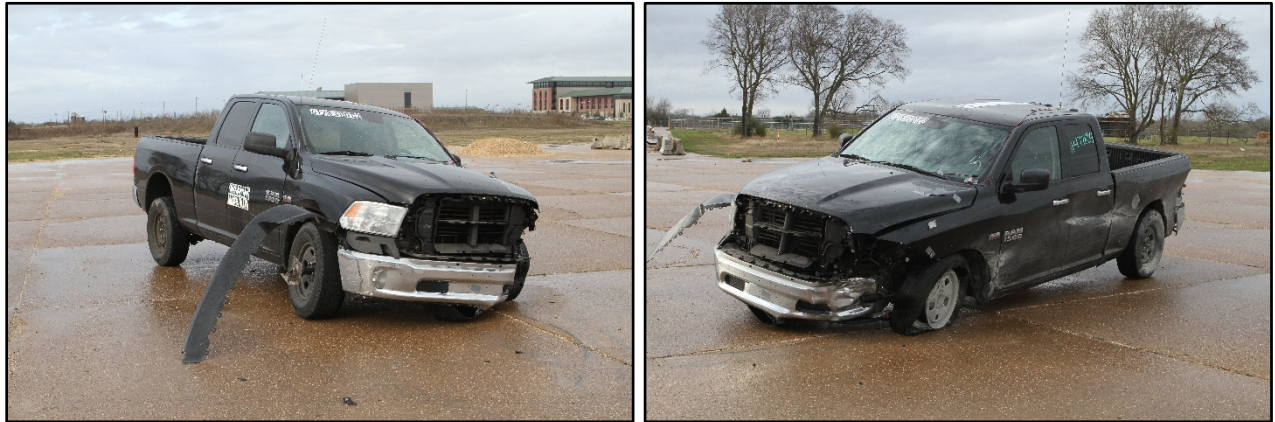
Figure 5.7 shows the damage sustained by the vehicle. The front bumper, hood, grill, left front fender, left front tire and rim, left upper and lower control arms, left frame rail, left front floor pan, left front and rear doors, left rear cab corner, left rear exterior bed, and rear bumper were damaged. Maximum exterior crush to the vehicle was 15.0 inches in the side plane at the left front corner at bumper height. Maximum occupant compartment deformation was 1.5 inches

in the left front fire wall. Figure 5.8 shows the interior of the vehicle. Tables D.3 and D.4 in Appendix D1 provide exterior crush and occupant compartment measurements.

Figure 5.7. Test Vehicle after Test No. 612831-01-2.

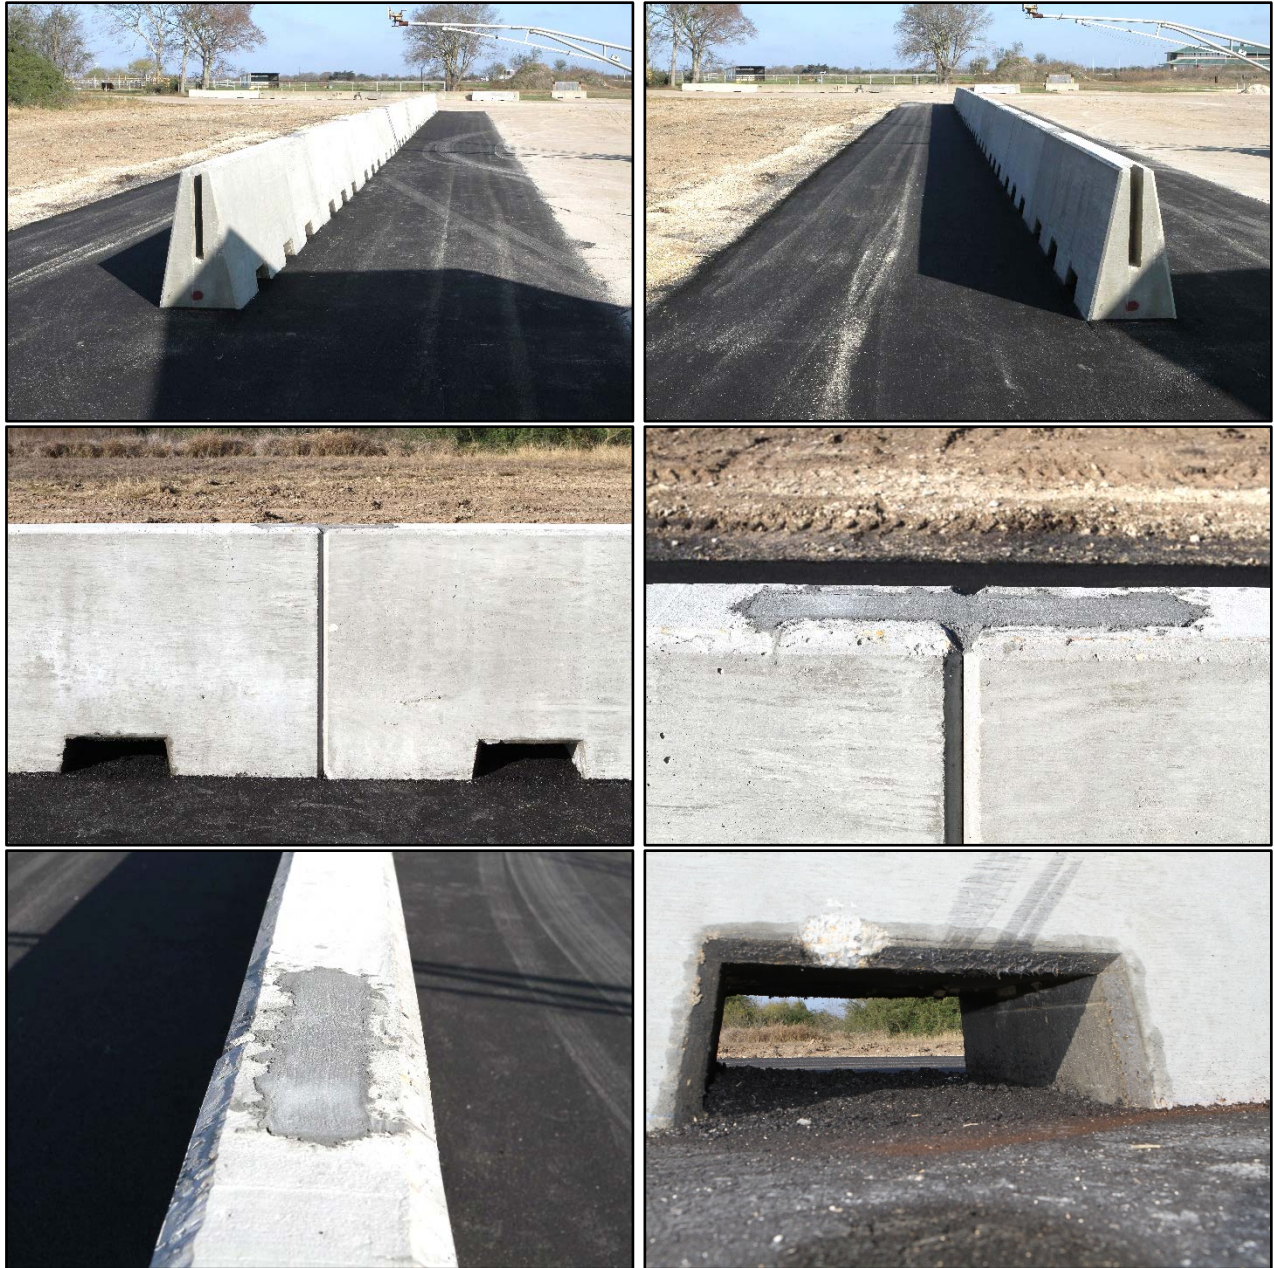
Figure 6.2. Embedded Single-Slope Barrier with Drainage Scuppers Prior to Testing.

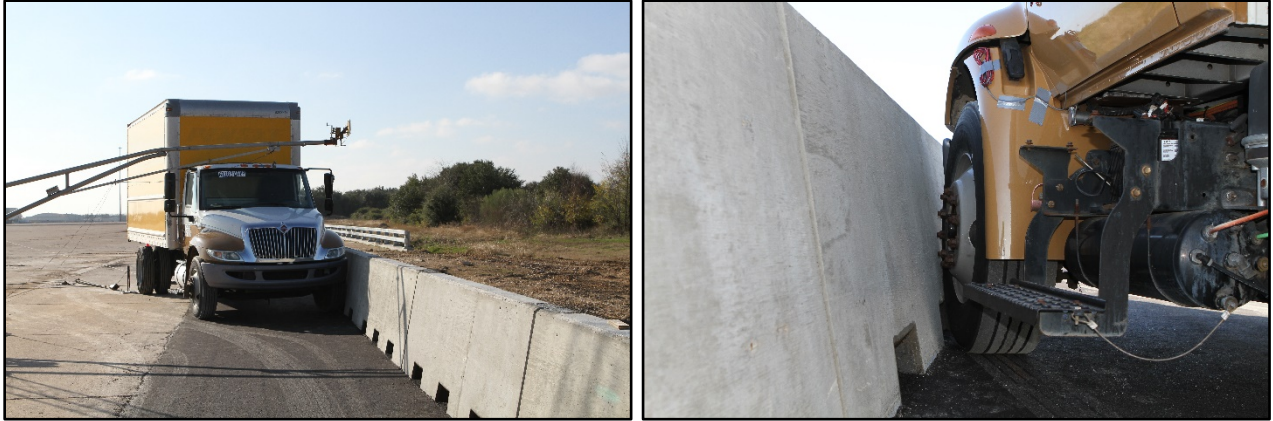
Figure 6.3. Embedded Single-Slope Barrier with Drainage Scuppers/Test Vehicle Geometrics for Test No. 612831-01-3.

MASH Test 4-12 involves a 10000S vehicle weighing 22,000 lb \pm 660 lb impacting the CIP of the barrier at an impact speed of 56 mi/h \pm 2.5 mi/h and an angle of 15° \pm 1.5°. The CIP for this test was 5 ft \pm 1 ft upstream of the center of the joint between barrier segments 3 and 4. Figure 6.3 depicts the target impact setup.

The 2012 International 4300 single-unit truck used in the test weighed 22,370 lb, and the actual impact speed and angle were 57.7 mi/h and 16.7°. The actual impact point was 6.5 ft upstream of the center of the joint between barriers 3 and 4. Minimum target IS was 142 kip-ft, and actual IS was 206 kip-ft.

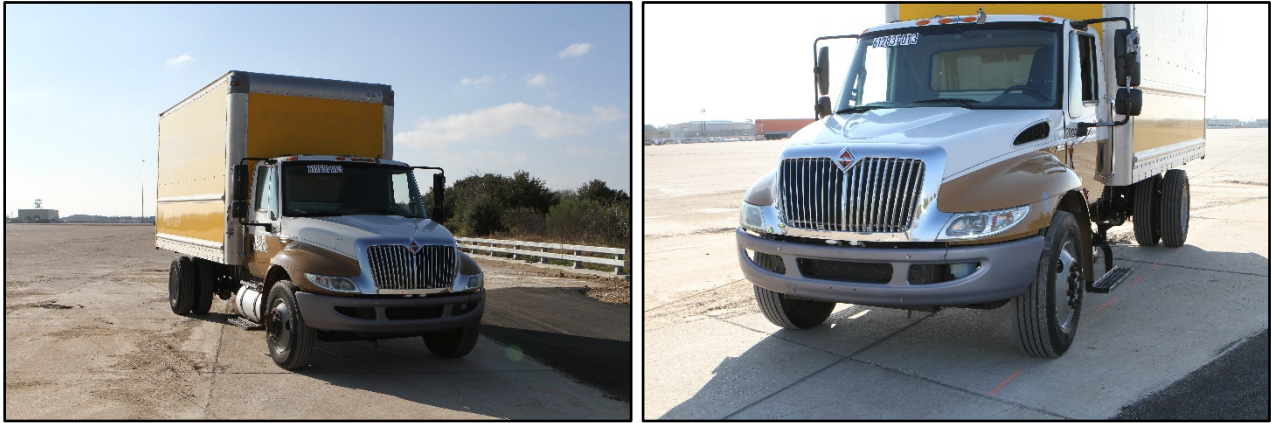
Figure 6.4. Test Vehicle before Test No. 612831-01-3.

Figure 6.4 shows the 2012 International 4300 single-unit truck used for the crash test. The vehicle's test inertia weight was 22,370 lb and its gross static weight was 22,370 lb. The height to the lower edge of the vehicle bumper was 18.25 inches, and height to the upper edge of the bumper was 33.25 inches. The height to the vehicle's ballast center of gravity was 62.0 inches. Table E.1 in Appendix E1 gives additional dimensions and information on the vehicle. The vehicle was directed into the installation using a cable reverse tow and guidance system and was released to be freewheeling and unrestrained just prior to impact.

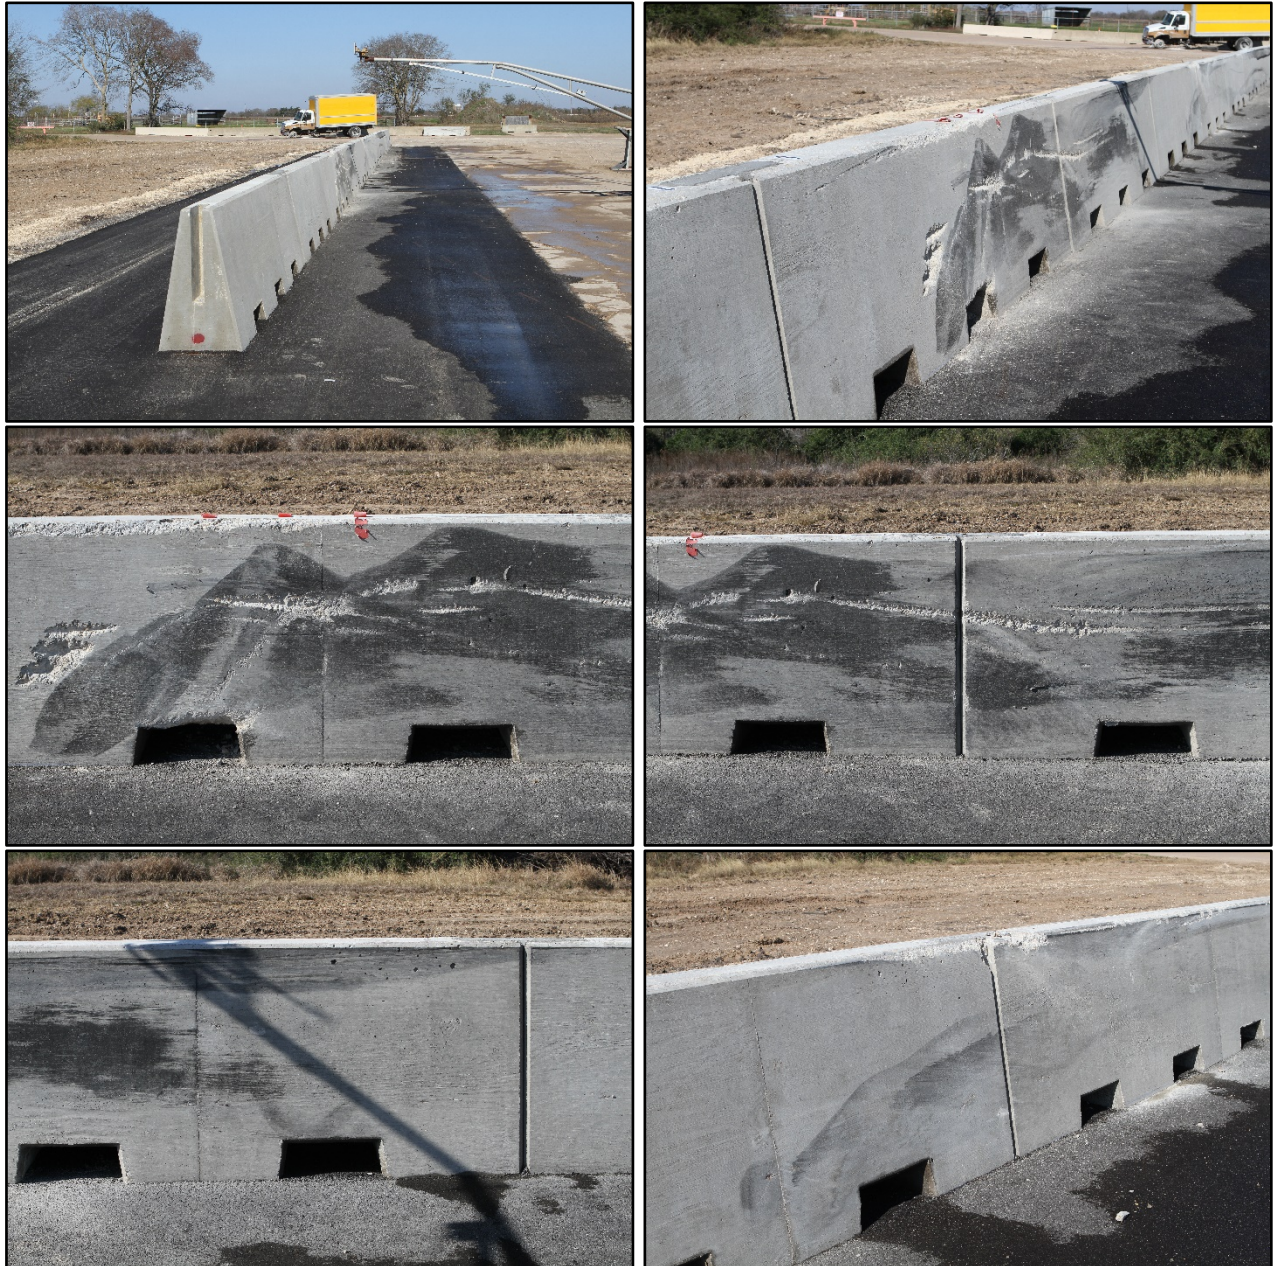
Figure 6.5 shows the damage to the barrier. Barrier segment 3 had a crack on the traffic side at top near each end, and there were scrapes and gouges up to one inch deep on barrier segments 3 and 4. There was no visible movement in the asphalt, and no measurable static deflection.

Working width* was 70.8 inches, and height of working width was 153.0 inches. Maximum dynamic deflection during the test was 1.8 inches, and no permanent deformation was observed. Maximum lateral intrusion of the passenger cab, measured from the pre-impact traffic-side face of the barrier was 26.3 inches at a height of 87.8 inches.

Figure 6.5. Embedded Single-Slope Barrier with Scuppers after Test No. 612831-01-3.

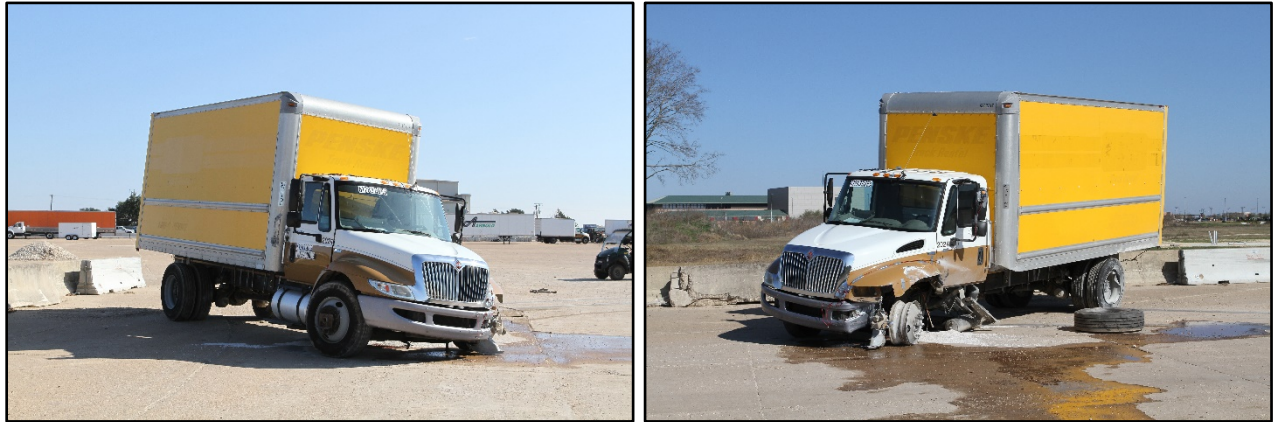
Figure 6.6 shows the damage sustained by the vehicle. The front bumper, hood, left front tire and rim, left door, left side steps, left front springs left floor pan, left front corner of box, left rear outer tire, and left rear lower corner of box were damaged. Maximum exterior crush to the vehicle was 12.0 inches in the side plane at the left front corner at bumper height. Maximum occupant compartment deformation was 5.0 inches in the left center floor pan. Figure 6.7 shows the interior of the vehicle.

Figure 6.6. Test Vehicle after Test No. 612831-01-3.

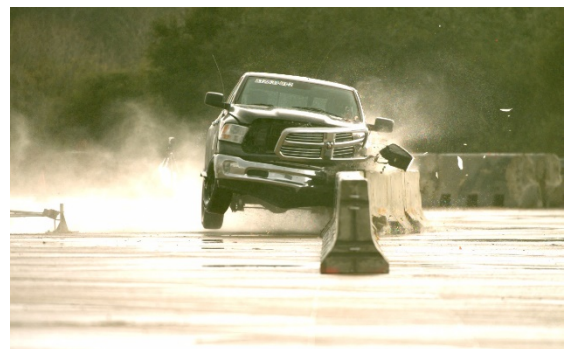
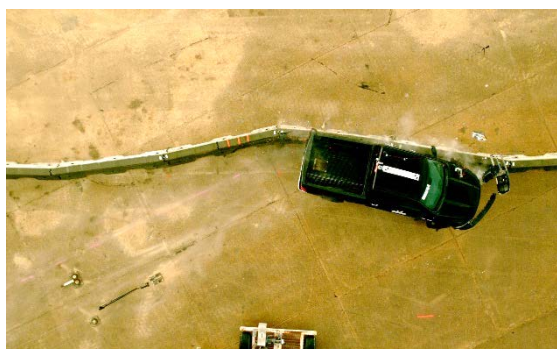
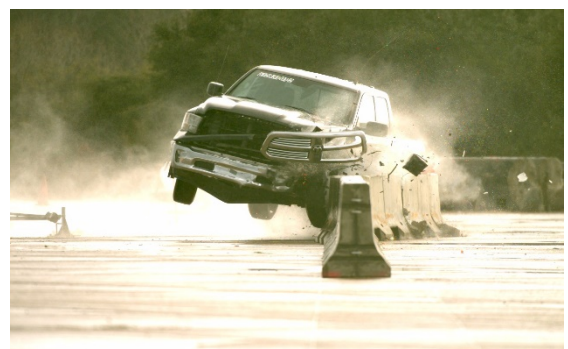
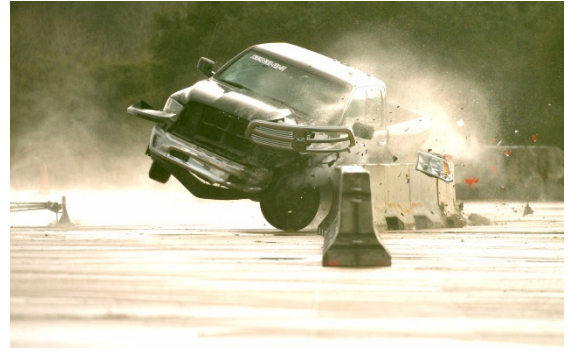
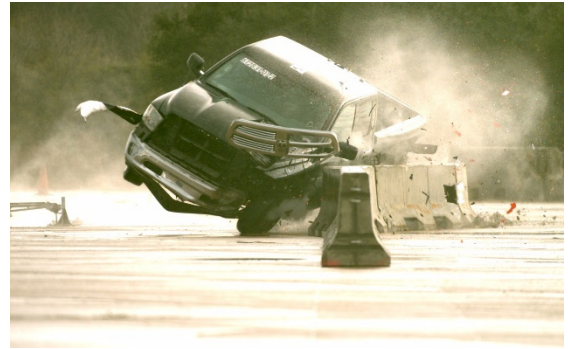
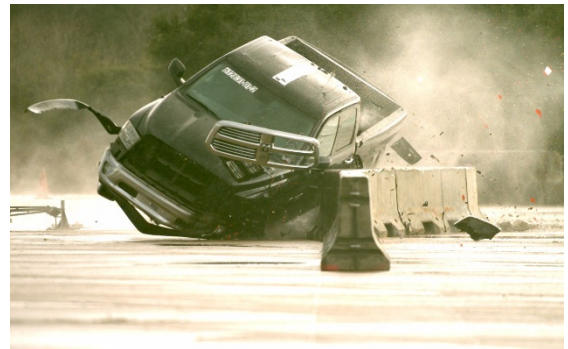
Figure D.1. Sequential Photographs for Test No. 612831-01-2 (Overhead and Frontal Views).

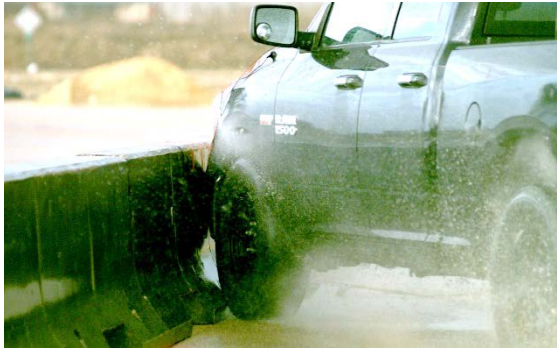
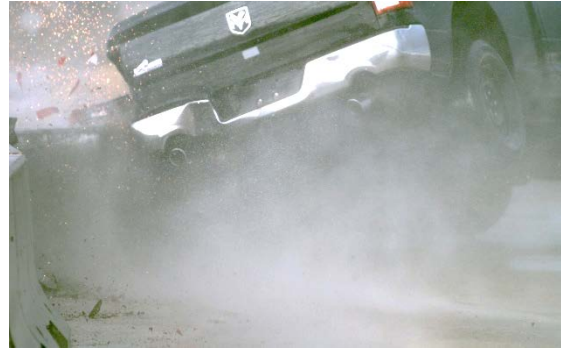
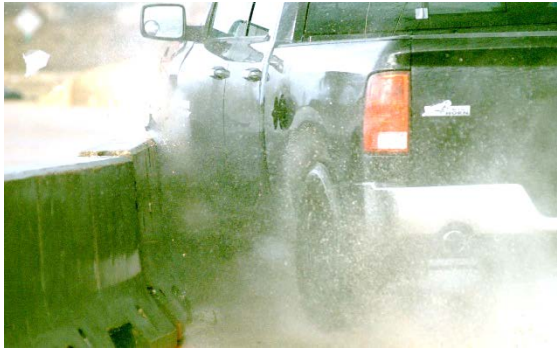
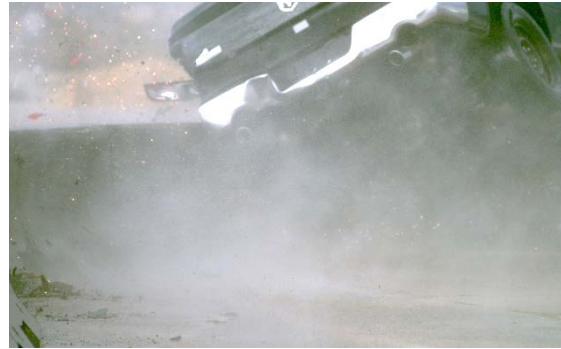
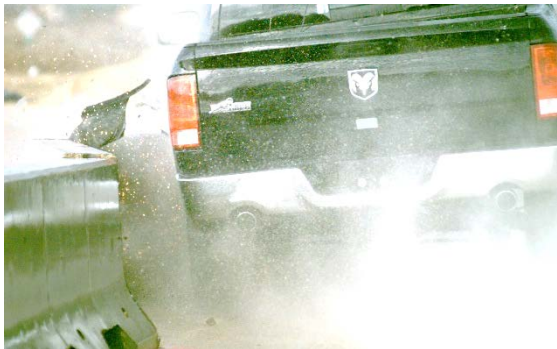
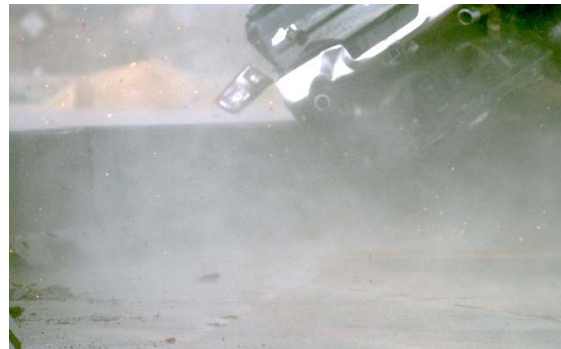
Figure D.2. Sequential Photographs for Test No. 612831-01-2 (Rear View).

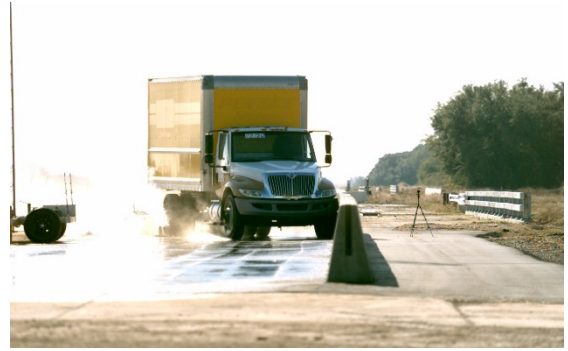
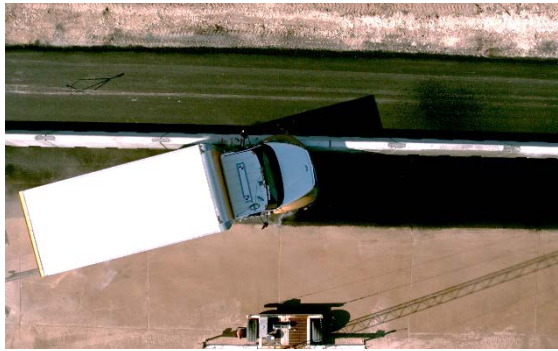
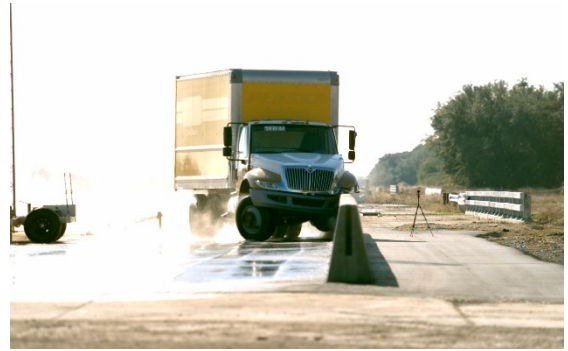
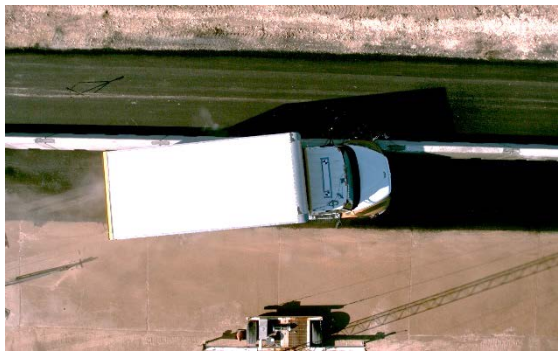
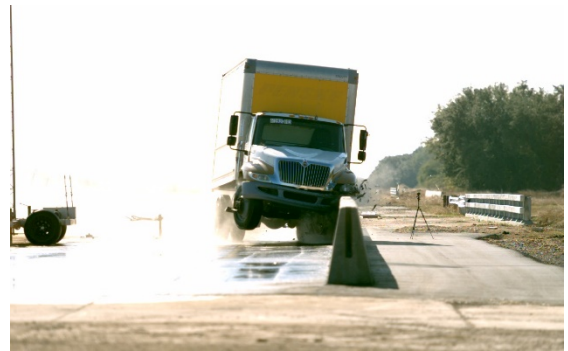
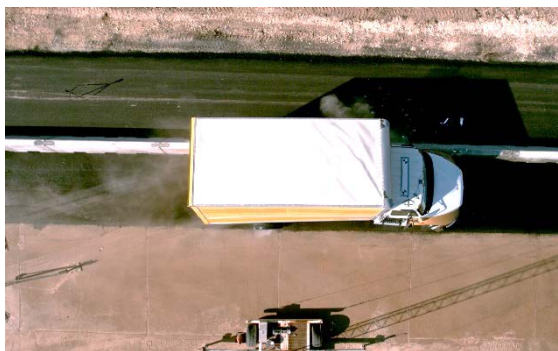
Figure E.1. Sequential Photographs for Test No. 612831-01-3 (Overhead and Frontal Views).

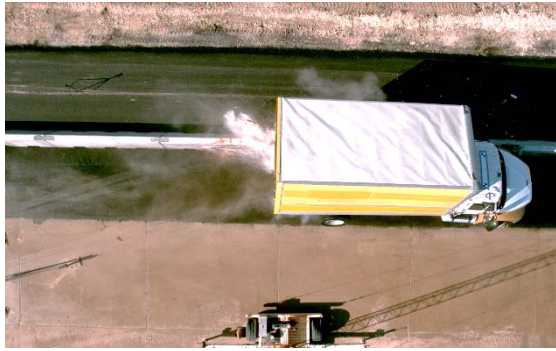
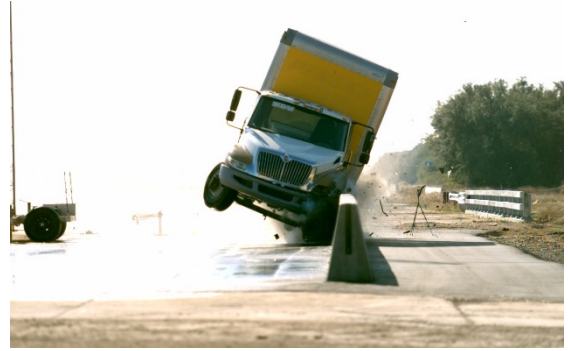
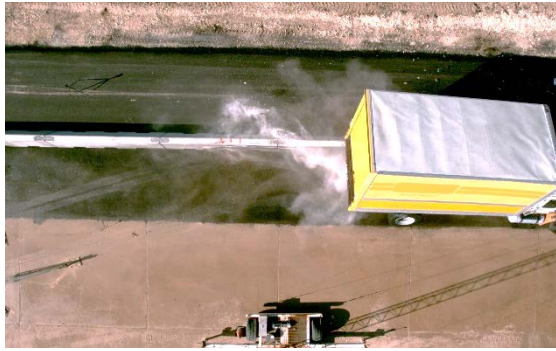
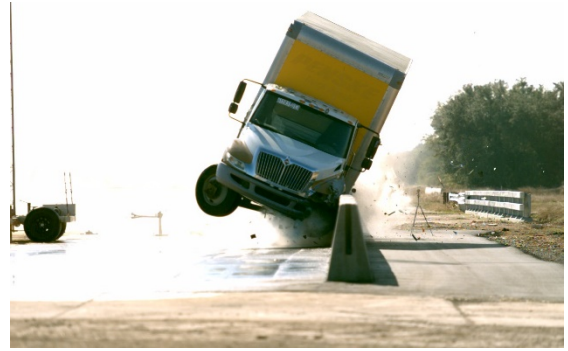
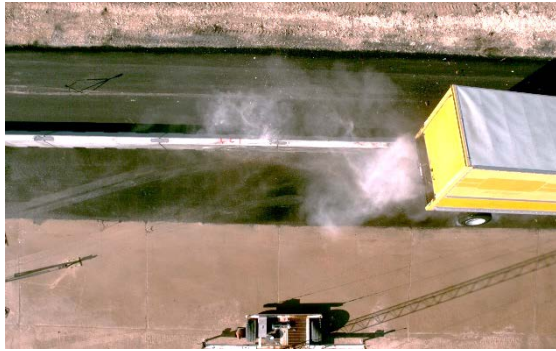
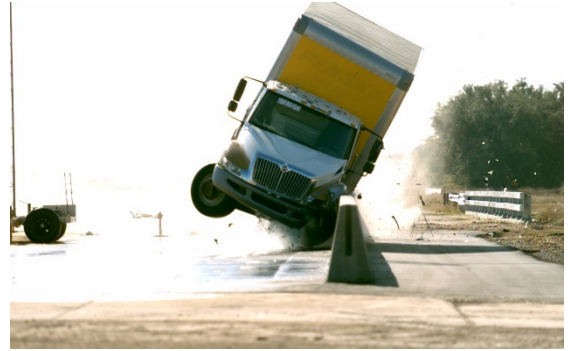
Figure E.1. Sequential Photographs for Test No. 612831-01-3 (Overhead and Frontal Views) (Continued).
