**Texas A&M
Transportation
Institute**
Proving Ground

Test Report No. 612831-01
Test Report Date: May 2020

***MASH* EVALUATION OF F-SHAPE
AND SINGLE-SLOPE CONCRETE
BARRIERS WITH DRAINAGE
SCUPPERS**

Test No.: 612831-01-1 / -2 / -3

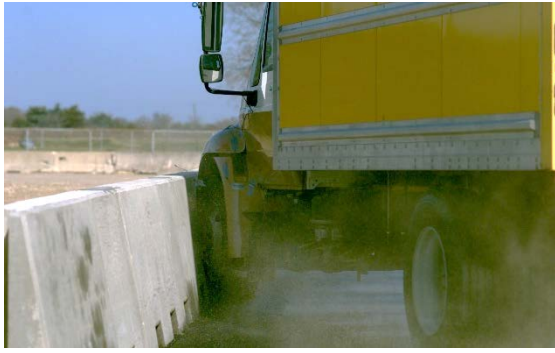
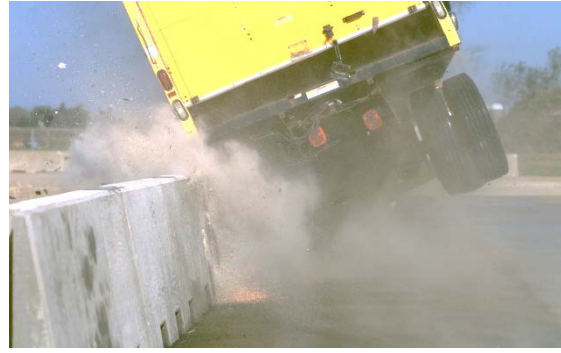
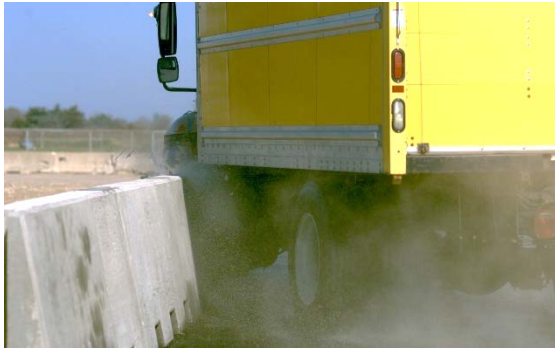
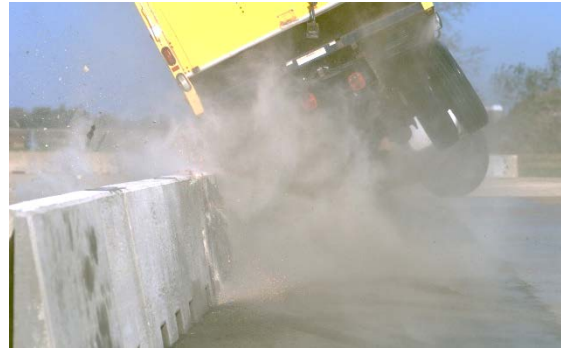
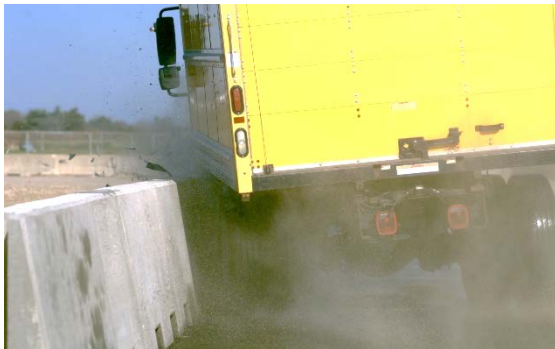
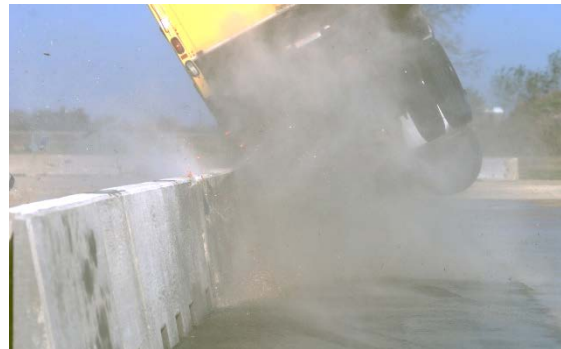
Figure E.2. Sequential Photographs for Test No. 612831-01-3 (Rear View).
