## ***MASH TEST 3-21 ON TL-3 THRIE BEAM TRANSITION WITHOUT CURB***

**Test Report 9-1002-12-3**

**Cooperative Research Program**

**TEXAS A&M TRANSPORTATION INSTITUTE  
COLLEGE STATION, TEXAS**

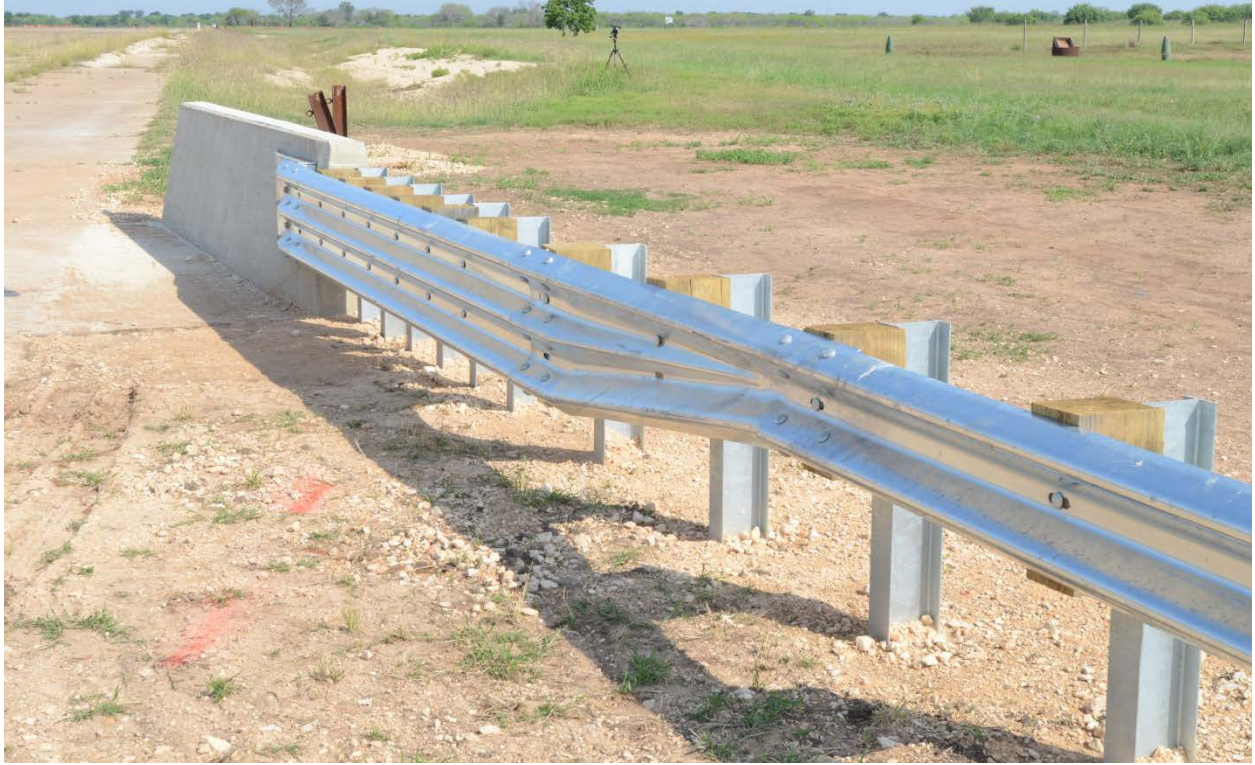
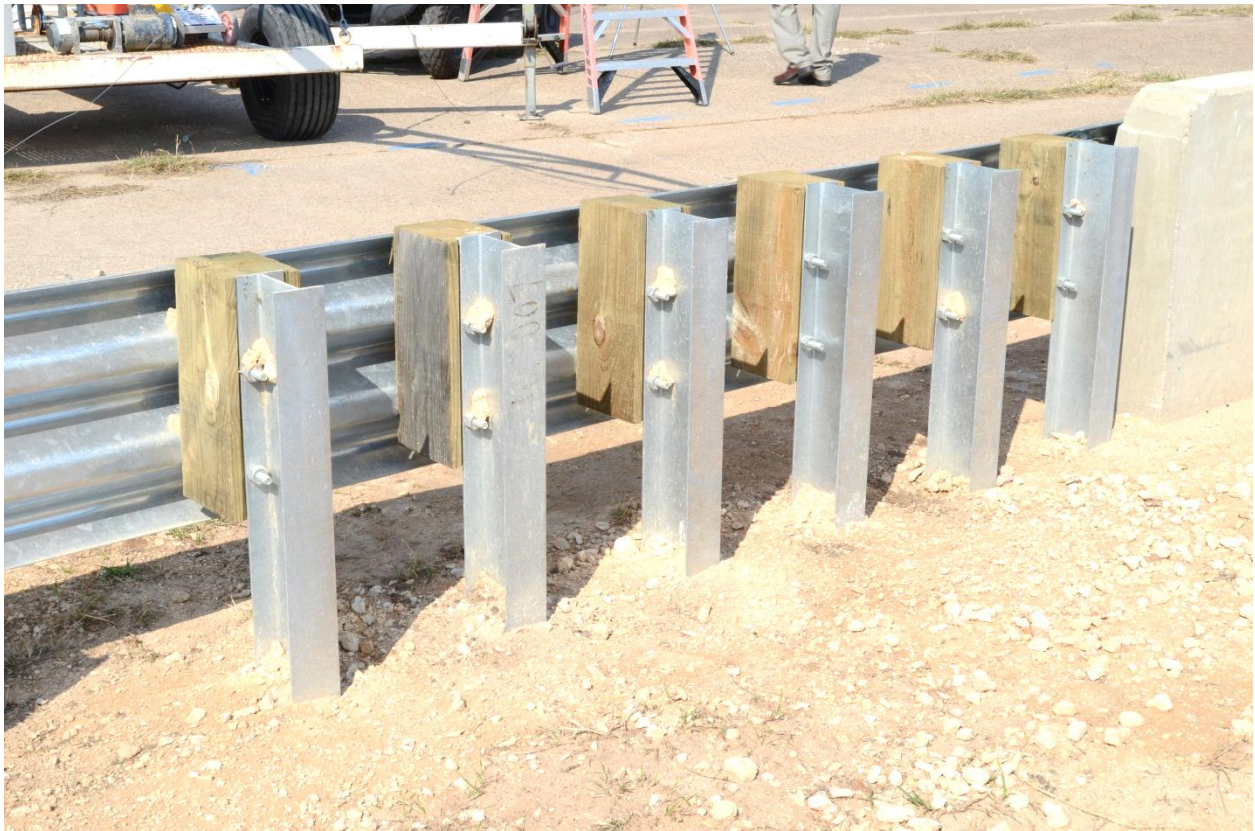
**Figure 2.3. TxDOT TL-3 Transition Installation before Test No. 490022-4.**

The adapter plate is constructed using ¼-inch steel plate. The adapter is 21 inches tall and 40 inches wide. The adapter plate allows for a 4-inch blockout at the top of the plate and tapers down to a 0-inch blockout distance. Quarter-inch thick stiffener plates are then welded to the back of the plate to stiffen the plate.

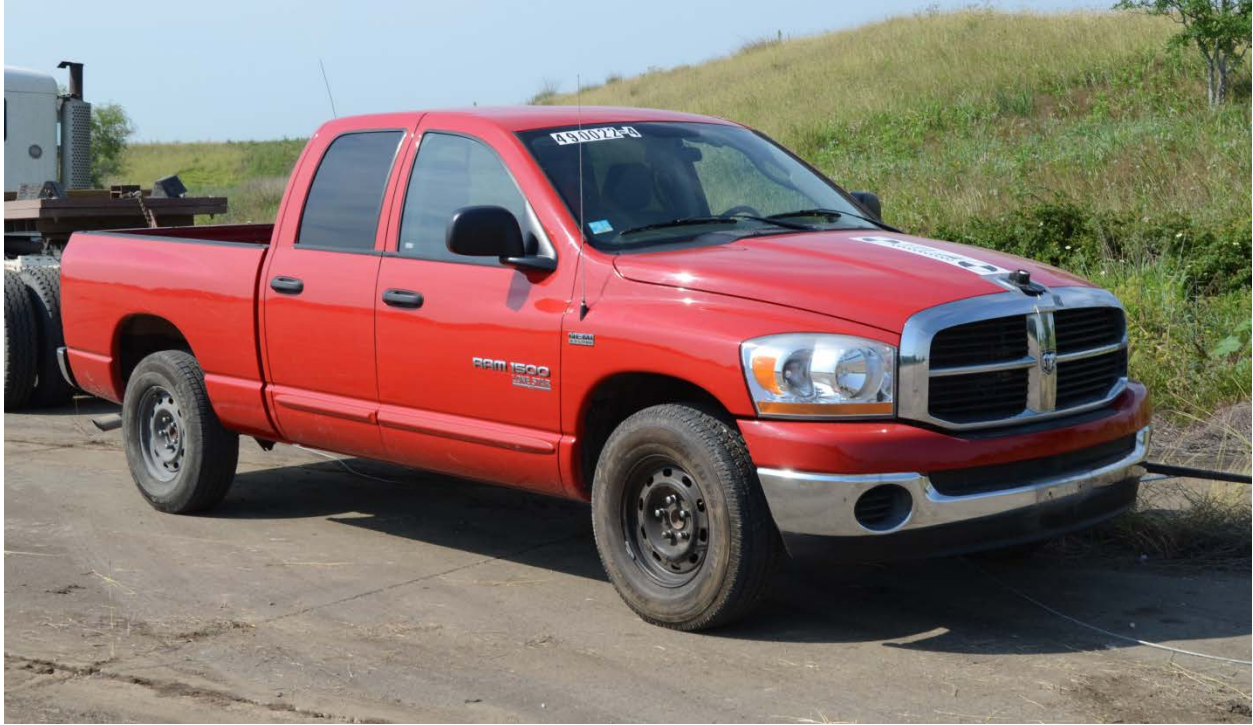
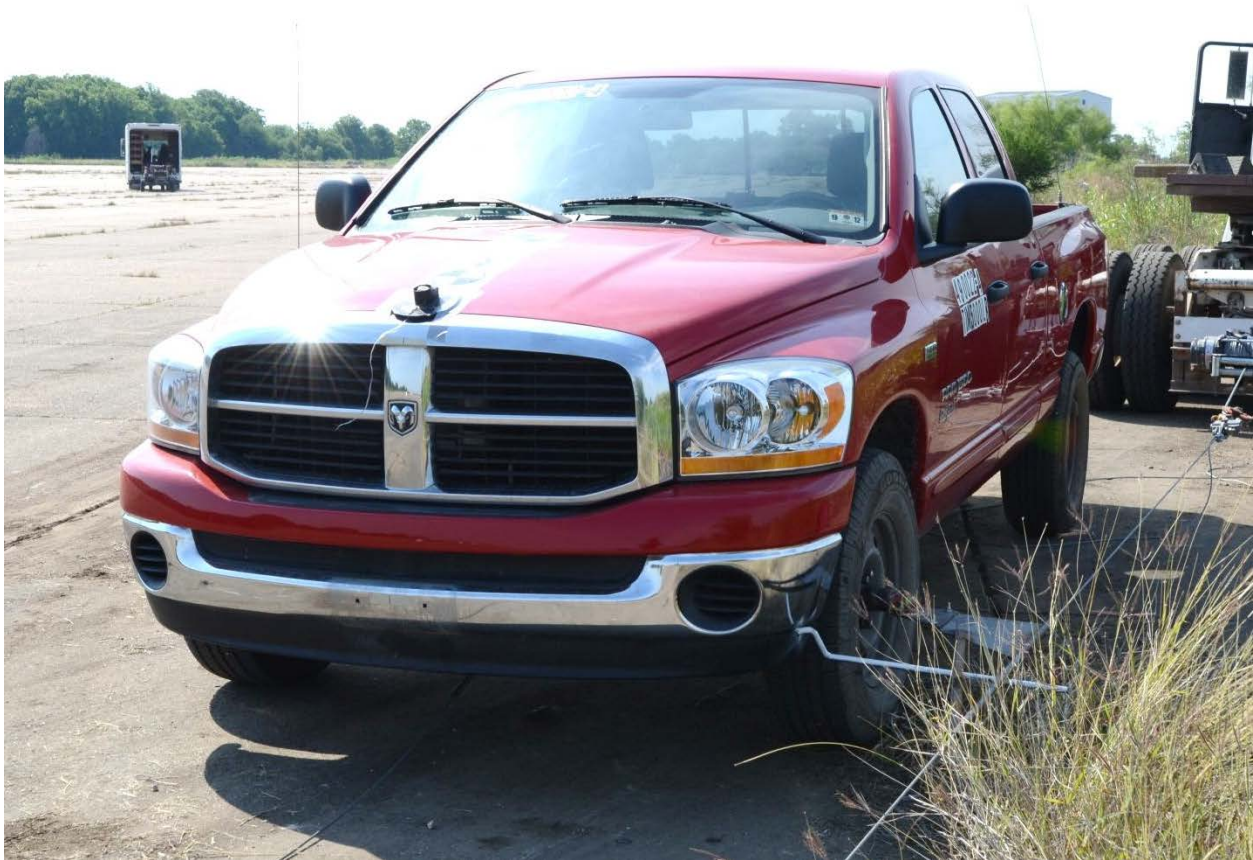
**Figure 5.1. Vehicle before Test No. 490022-4.**

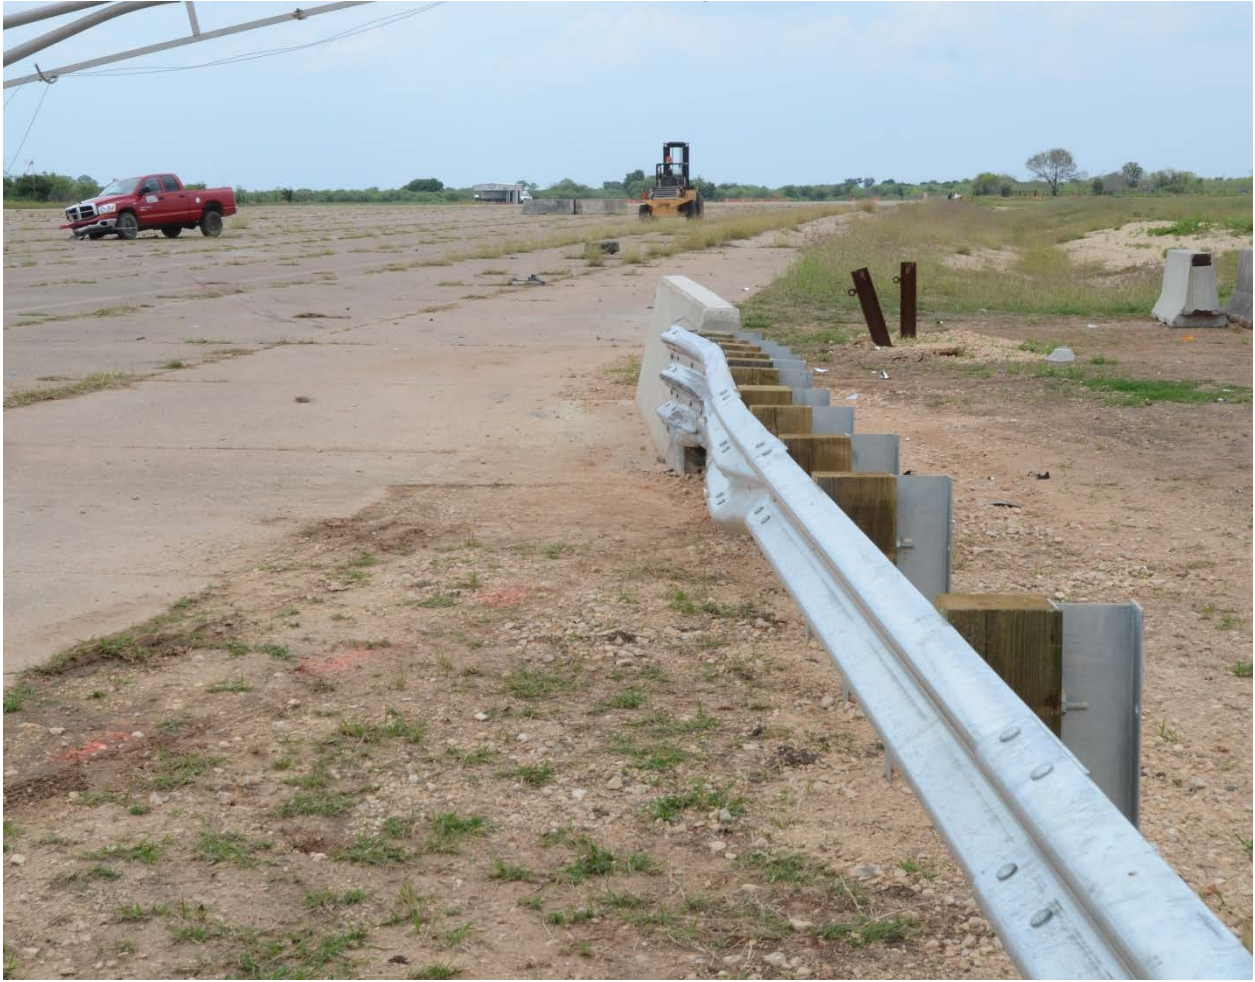
**Figure 5.2. TxDOT TL-3 Transition/Vehicle after Test No. 490022-4.**

Figures 5.2 and 5.3 show damage to the TxDOT TL-3 Transition. The soil was disturbed around post 1 and posts 10 through 12. Post 13 was leaning toward the field side and downstream 0.5 degree (from upright), and there was a gap of 0.25 inch between the edge of the soil and the traffic side of the post. Post 14 was deflected toward the field side 1.12 inches and was leaning 6 degrees toward the field side and 1 degree downstream. Post 15 was deflected toward the field side 1.62 inches and leaning toward field side 6 degrees and downstream 3 degrees. Post 16 was deflected toward the field side 2.0 inches and leaning toward the field side 5 degrees and downstream 7 degrees. Post 17 was deflected toward the field side 1.9 inches and was leaning toward the field side 4 degree and downstream 4 degrees. Post 18 was deflected toward the field side 1.5 inches and leaning toward the field side 5 degrees and downstream 3 degrees. Post 19 was deflected toward the field side 1.4 inches and leaning toward the field side 7 degrees and downstream 6 degrees. Maximum permanent deformation of the thrie beam rail element was 4.5 inches at the top ridge, 3.9 inches at the middle ridge, and 6.5 inches at the bottom ridge. Total length of contact of the vehicle with the thrie beam rail element was 149.0 inches. Working width was 22.8 inches and maximum dynamic deflection of the top of the rail element was 5.9 inches.

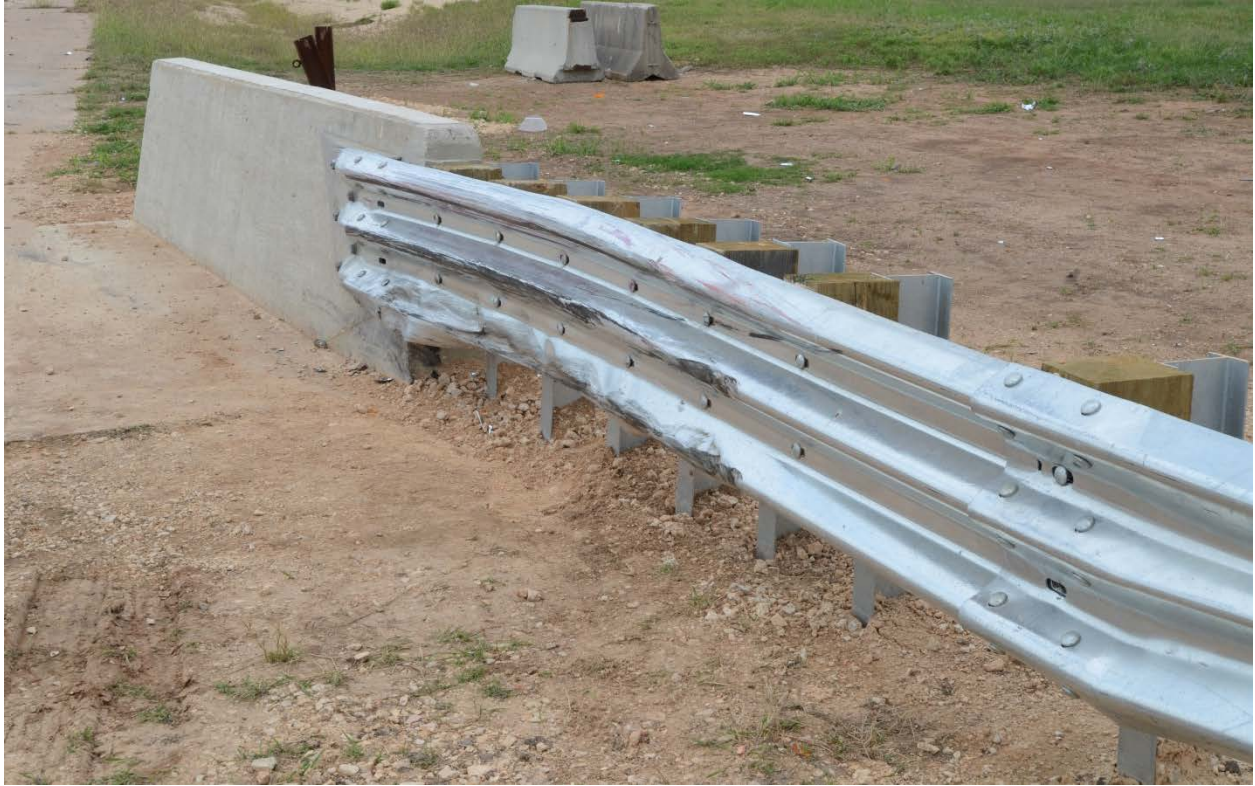
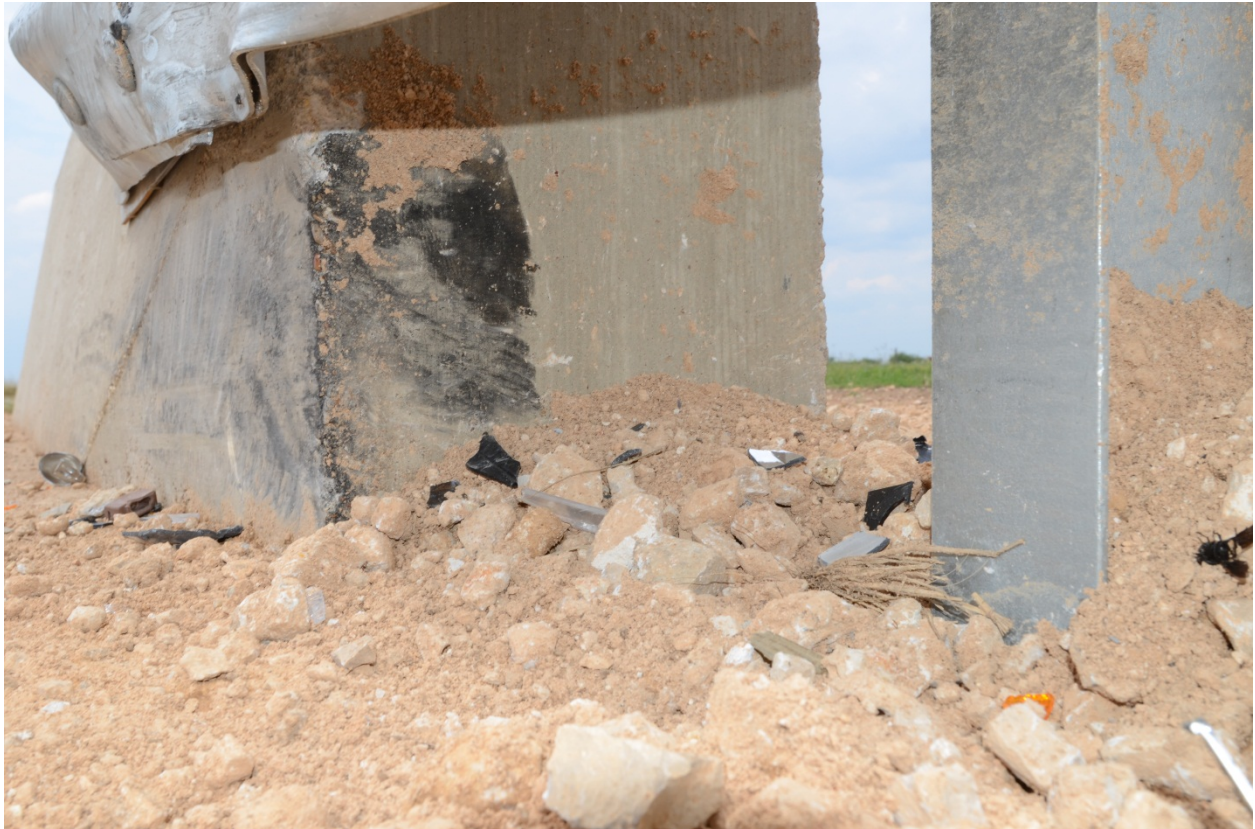
**Figure 5.3. TxDOT TL-3 Transition after Test No. 490022-4.**

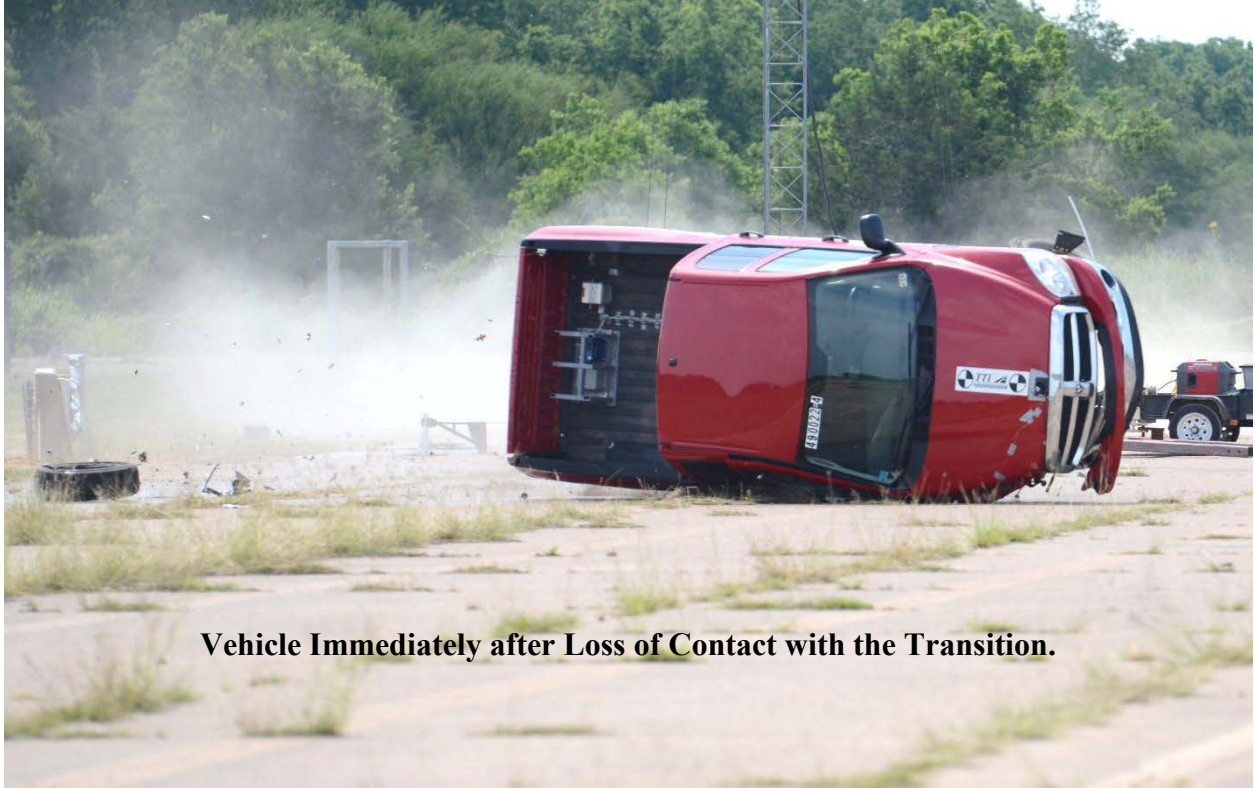
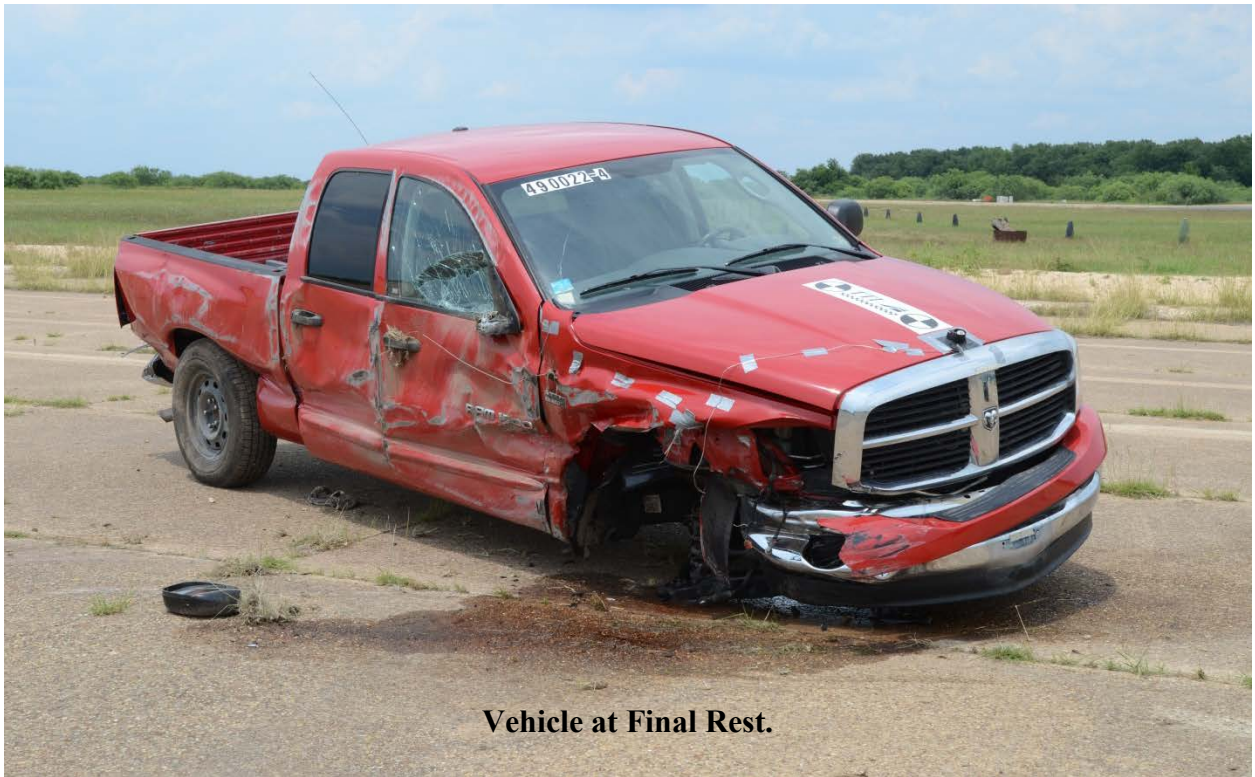
**Vehicle Immediately after Loss of Contact with the Transition.**

**Vehicle at Final Rest.**

**Figure 5.4. Vehicle after Test No. 490022-4.**

As shown in Figure 5.4, the 2270P vehicle was damaged in the right front and right side. The right frame rail, right front upper and lower A-arms, right front upper and lower ball joints, and right outer tie rods were deformed. Also damaged were the front bumper, hood, grill, right front fender, right front tire and wheel rim, right front door and door glass, right rear door, right exterior bed, rear bumper, tailgate, and right rear wheel rim. Maximum exterior crush to the vehicle was 170.0 inches in the front plane at the right front corner at bumper height. Maximum occupant compartment deformation was 3.75 inches in the lateral area across the occupant compartment in the kickpanel area near the front passenger's feet. Figure 5.5 shows the occupant compartment before and after the test. Tables D3 and D4 of Appendix D present the exterior and interior crush measurement.

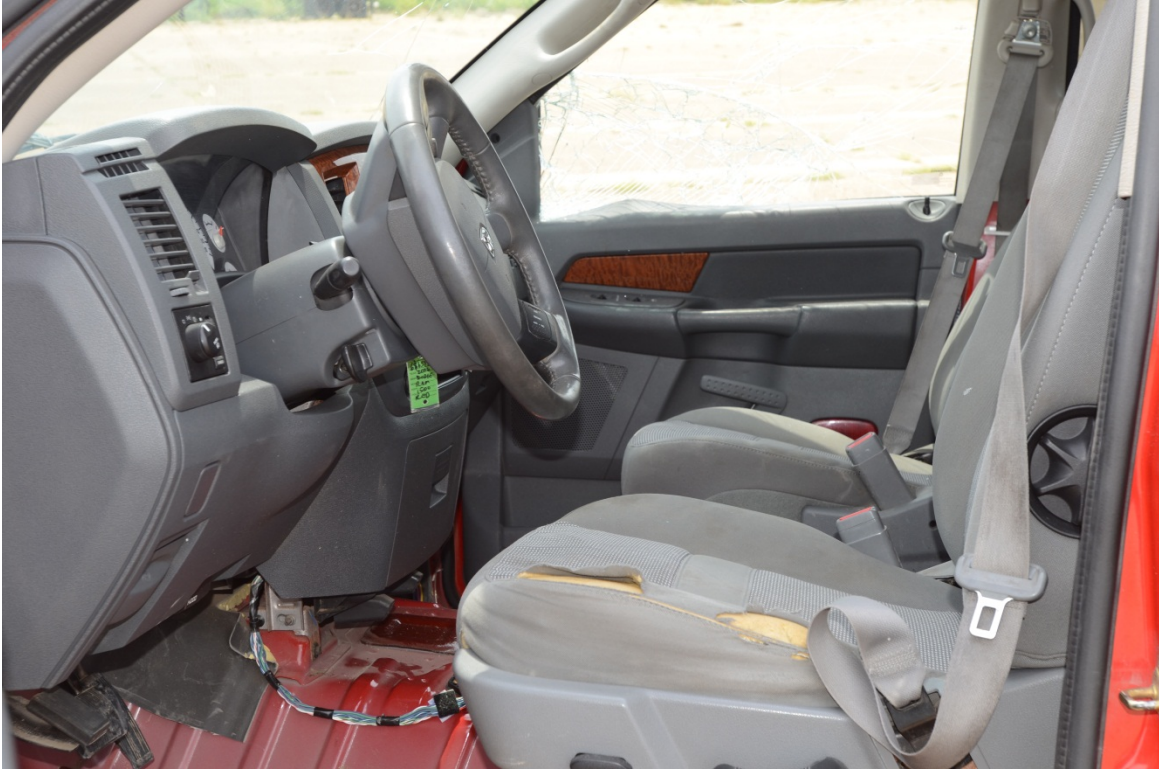
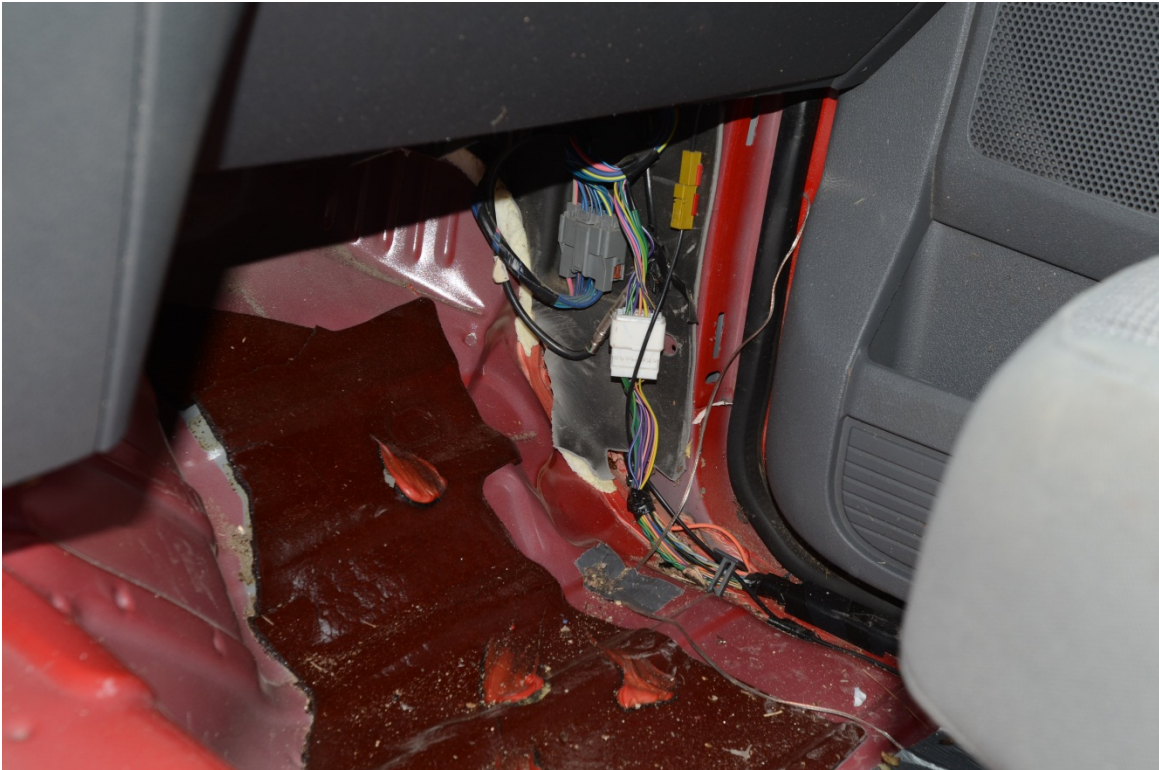
**Figure 5.5. Interior of Vehicle after Test No. 490022-4.**

Results: No detached elements, fragments, or other debris was present to penetrate or show potential for penetrating the occupant compartment, or to present hazard to others in the area. (PASS)  
Maximum occupant compartment deformation was 3.75 inches in the lateral area across the occupant compartment in the kickpanel area near the front passenger's feet. (PASS)

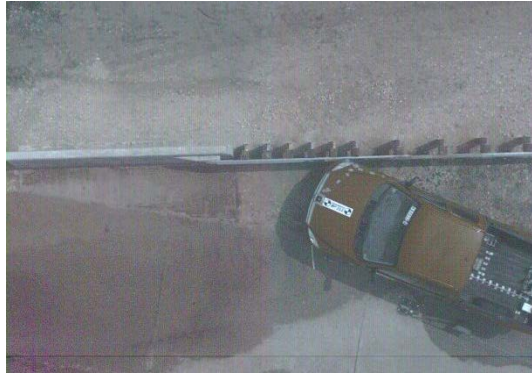
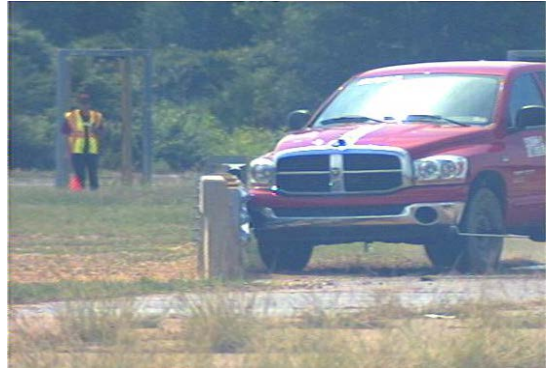
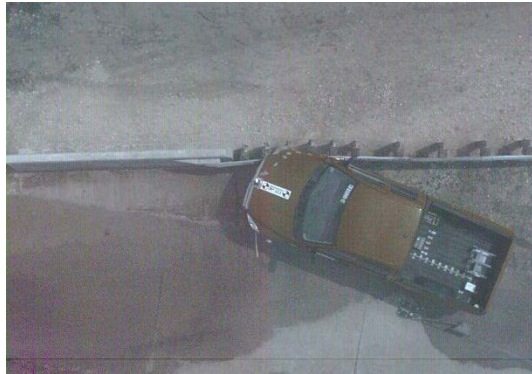
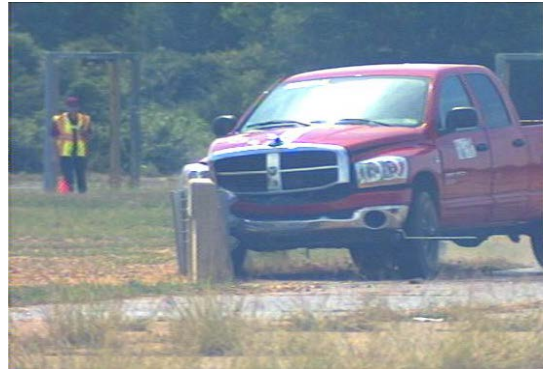
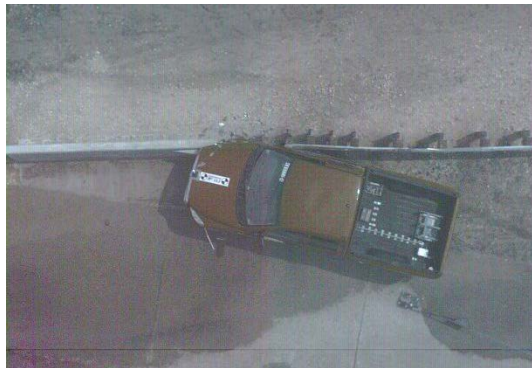
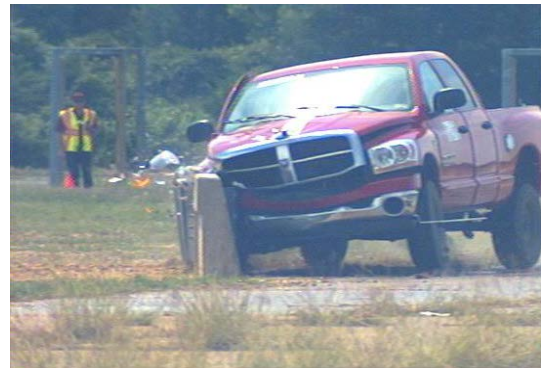
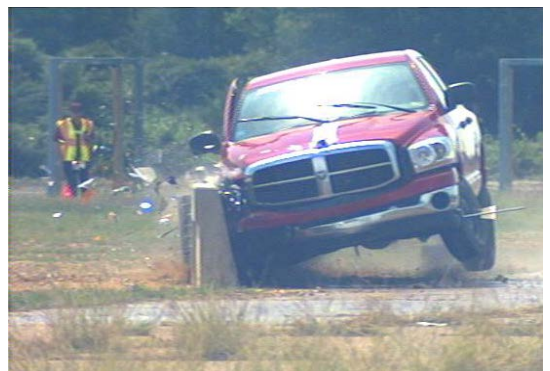
**Figure E1. Sequential Photographs for Test No. 490022-4  
(Overhead and Frontal Views).**

The 2006 Dodge Ram 1500 pickup truck, traveling at an impact speed of 62.6 mi/h, impacted the TxDOT TL-3 Transition 89.0 inches upstream of the concrete parapet at an impact angle of 23.9 degrees. At 0.010 s after impact, the vehicle began to redirect, and at 0.012 s, the three-beam guardrail and posts on either side of impact began to deflect toward the field side. The right front tire contacted the concrete parapet at 0.101 s, and the right front tire and wheel rim separated from the vehicle. At 0.168 s, the vehicle was traveling parallel with the transition at a speed of 52.7 mi/h. The rear of the vehicle contacted the transition at 0.176 s. At 0.316 s, the vehicle lost contact with the transition and was traveling at an exit speed and angle of 52.3 mi/h and 16.2 degrees. As the vehicle exited the transition, it rolled onto its right side and came to rest 208.4 ft downstream of impact and 75.0 ft toward traffic lanes. [Figures E1](#) and [E2](#) in [Appendix E](#) show sequential photographs of the test period.

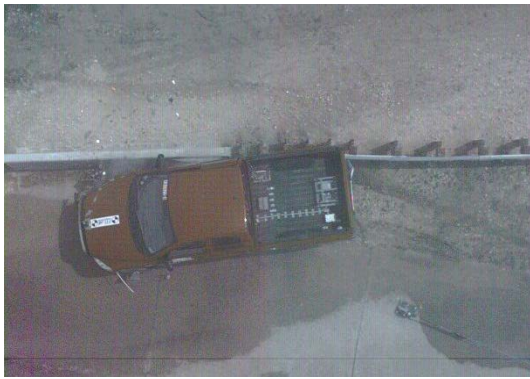
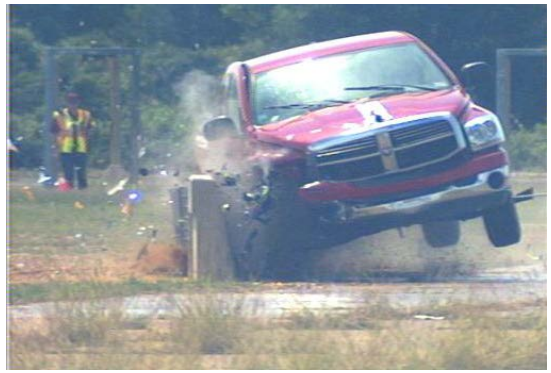
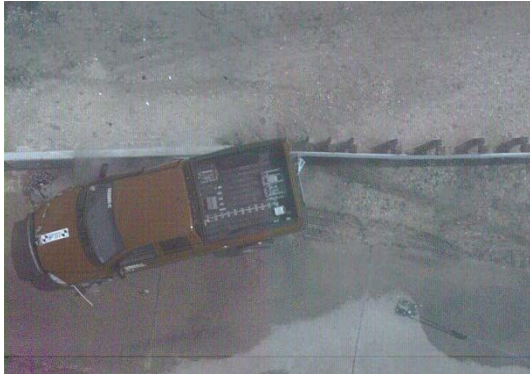
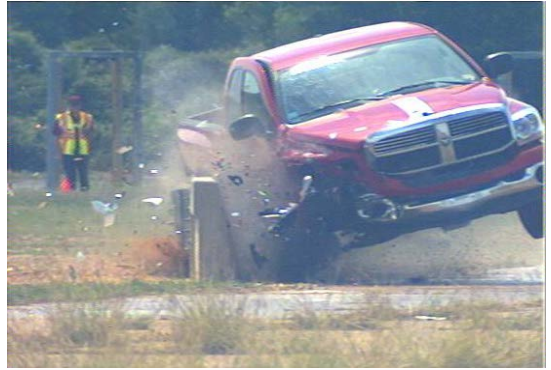
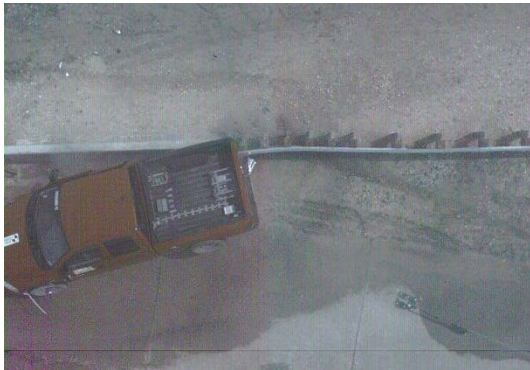
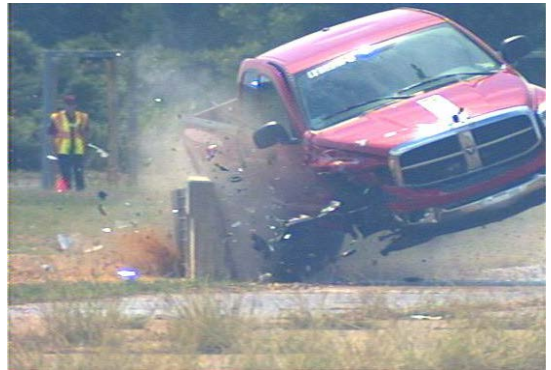
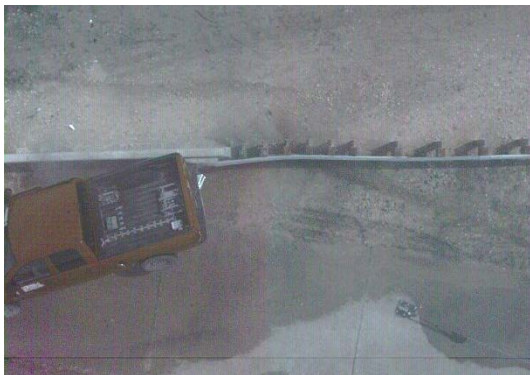
**Figure E1. Sequential Photographs for Test No. 490022-4 (Overhead and Frontal Views) (continued).**

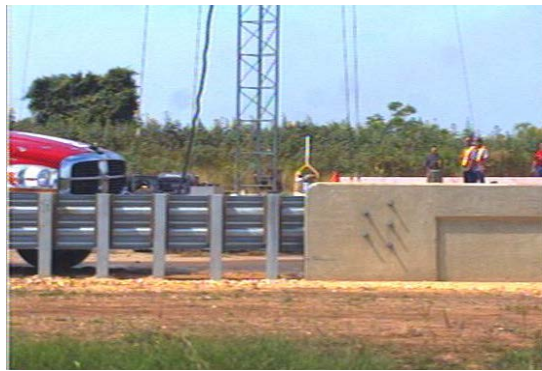
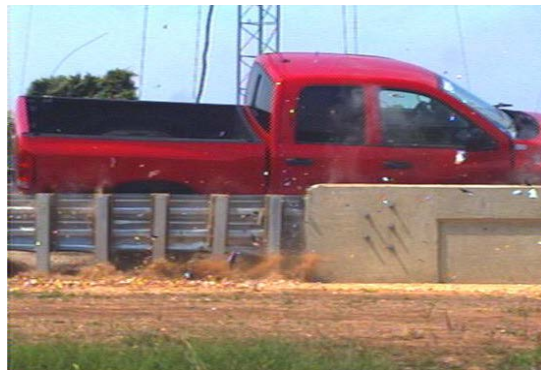
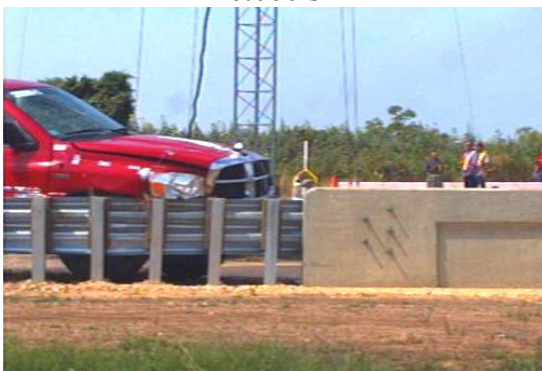
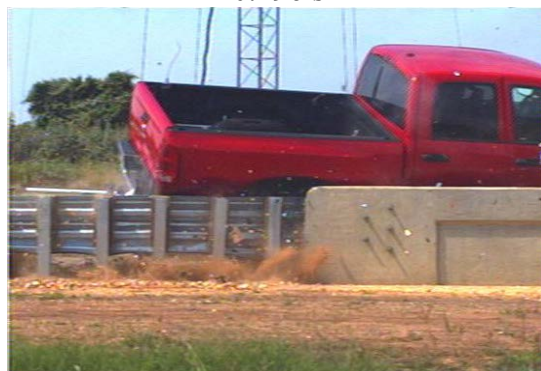
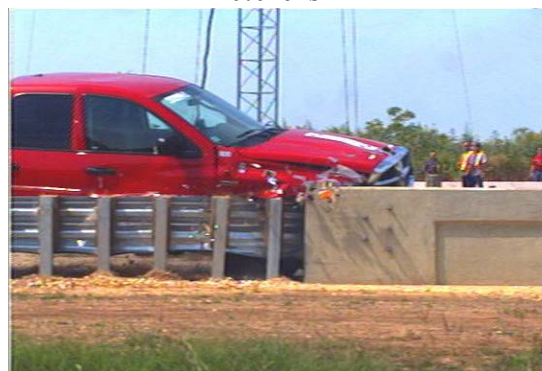
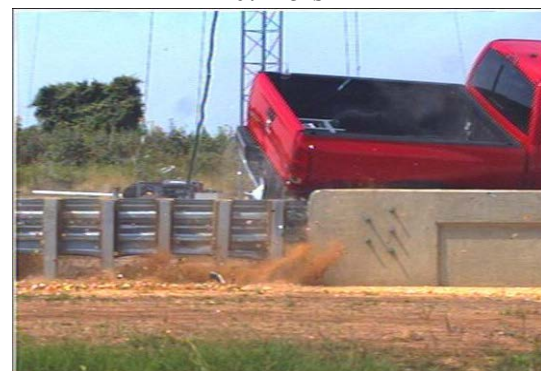
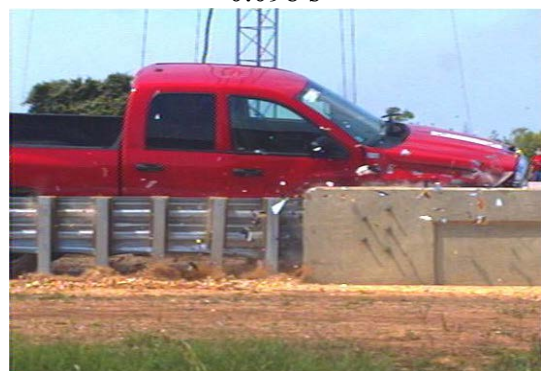
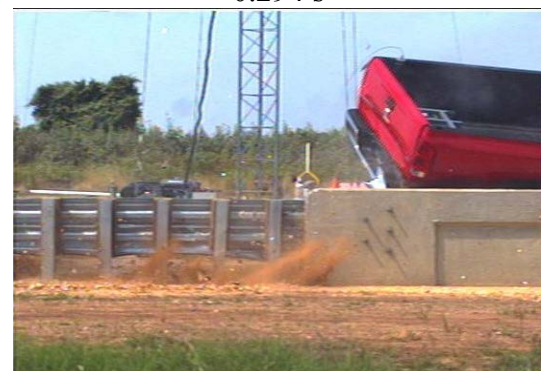
**Figure E2. Sequential Photographs for Test No. 490022-4 (Rear View).**

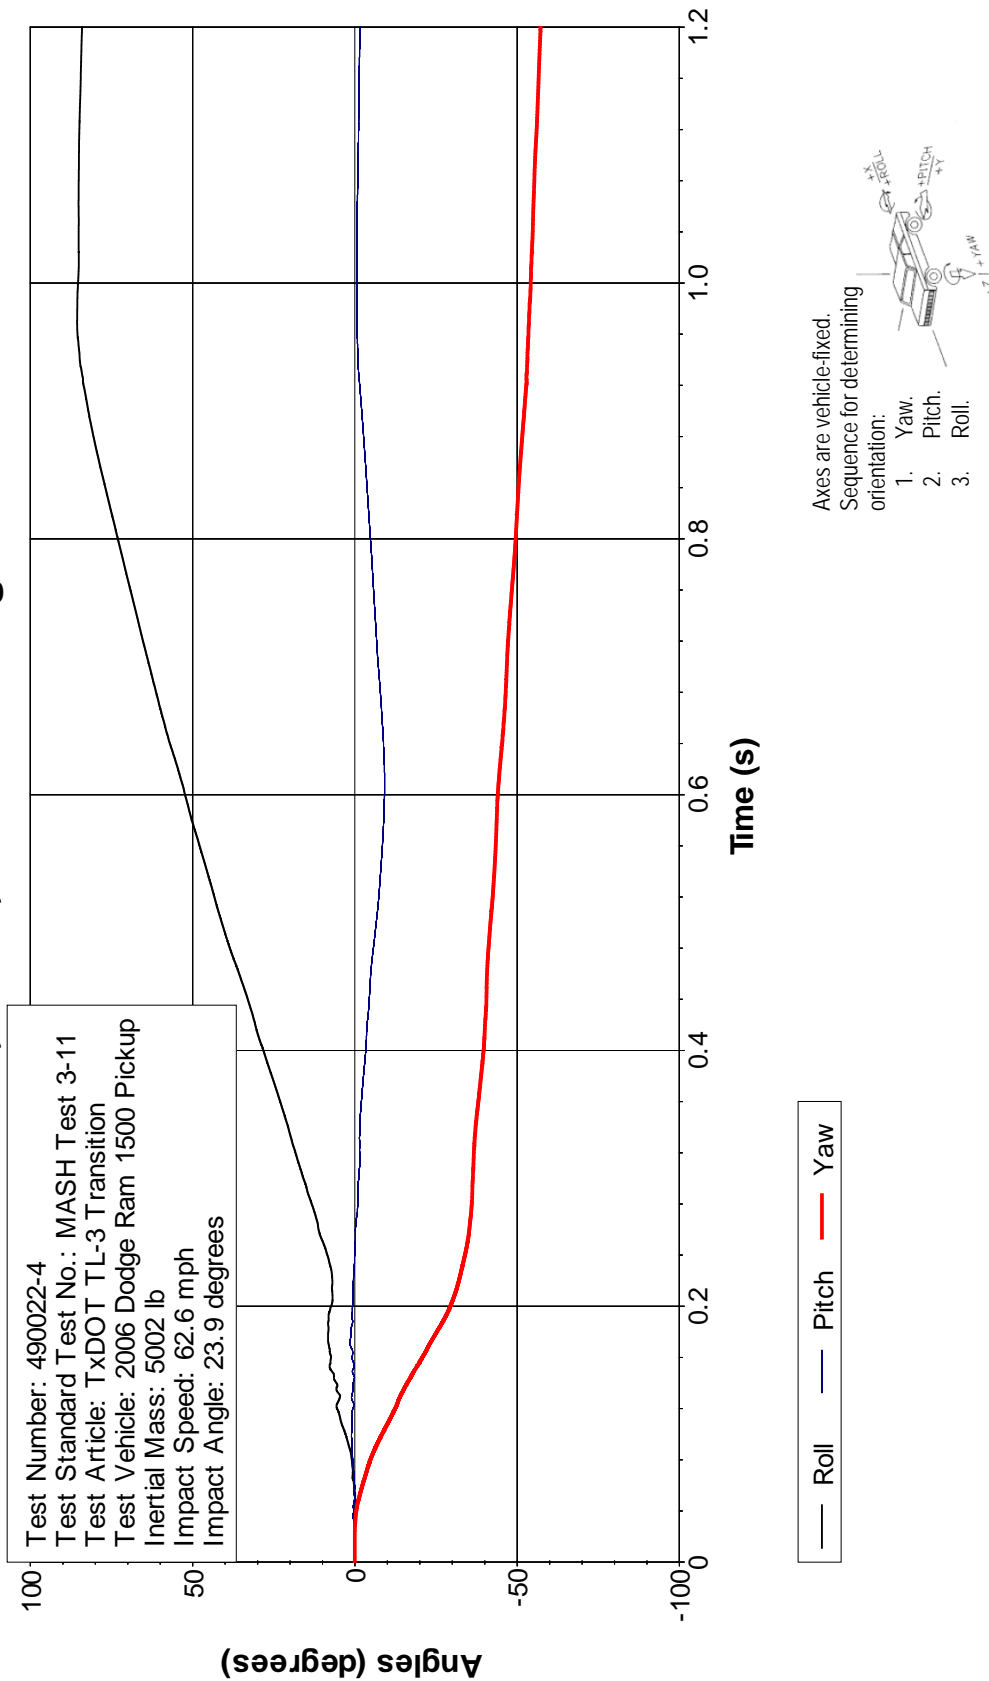
Figure F1. Vehicle Angular Displacements for Test No. 490022-4.
