• Bronx Whitestone Median Barrier Extension Bridge Rail

Name of system: Bronx Whitestone Median Barrier Extension Bridge Rail

Type of system: Longitudinal Barrier Test Level: MASH Test Level 4 (TL4)

# CONTRACT NO.PSC-16-2991 MEDIAN BARRIER EXTENSION CRASH TEST AND FABRICATION FOR THE BRONX WHITESTONE BRIDGE AS-BUILT DRAWINGS

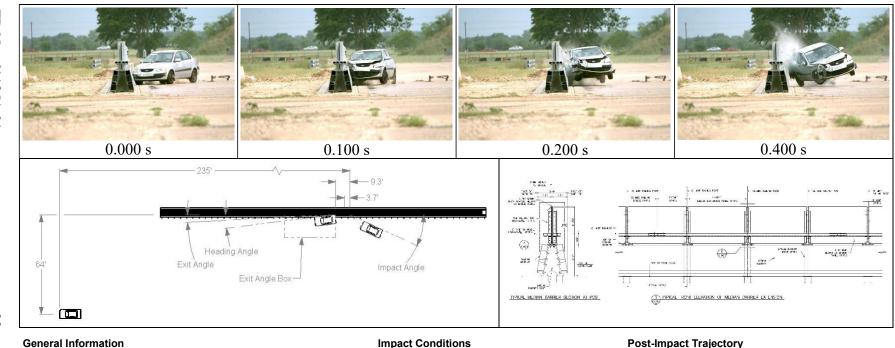
Figure 5.6. Summary of Results for MASH Test 4-10 on Bronx Whitestone Bridge Rail.

General Information		Impact Conditions		Post-Impact Trajectory	
Test Agency	Texas A&M Transportation Institute (TTI)	Speed	. 62.7 mi/h	Stopping Distance	235 ft downstream
Test Standard Test No	MASH Test 4-10	Angle	25.1°		64 ft twd traffic lanes
TTI Test No	611351-3	Location/Orientation	. 3.7 ft upstream of	Vehicle Stability	
Test Date	2019-04-30		joint 6-7	Maximum Yaw Angle	97°
Test Article		Impact Severity	. 58 kip-ft	Maximum Pitch Angle	
Type	Longitudinal Barrier – Bridge Rail	Exit Conditions		Maximum Roll Angle	27°
	Bronx Whitestone Bridge Rail	Speed	53.9 mi/h	Vehicle Snagging	No
Installation Length	210 ft	Trajectory/Heading Angle	. 3.9° / 8.1°	Vehicle Pocketing	No
Material or Key Elements	Steel plate posts, steel parapet covering	Occupant Risk Values		Test Article Deflections

-	steel beams secured to posts, fabricated	Longitudinal OIV	. 18.4 ft/s	Dynamic	None
	steel rail above the parapet, acrylic	Lateral OIV	33.8 ft/s	Permanent	None
	windscreen above parapet and rail	Longitudinal Ridedown	. 6.0 g	Working Width	30.0 inches
	supported by posts	Lateral Ridedown	. 10.2 g	Height of Working Width	6.0 inches
Soil Type and Condition	Reinforced concrete foundation, damp	THIV	. 41.7 km/h		
Test Vehicle		PHD	. 10.4 g	Vehicle Damage	
Type/Designation	1100C	ASI	. 2.61	VDS	01RFQ5
Make and Model	2008 Kia Rio	Max. 0.050-s Average		CDC	01FREW4
Curb	2430 lb	Longitudinal	<b>-</b> 10.3 g	Max. Exterior Deformation	8.0 inches
Test Inertial	2455 lb	Lateral	<b>-</b> 20.2 g	OCDI	RF0102100
Dummy	. 165 lb	Vertical	<b>-</b> 4.2 g	Max. Occupant Compartment	
Gross Static				Deformation	1.5 inches

+	Page 3 01 7
RequiredTest	Narrative	Evaluation
Number	Description	Results
	Test 4-10 involves an 1100C vehicle	
	impacting the test article at a target impact	
	speed of 62 mi/h and target angle of 25°.	
	The target CIP for the right corner of the	
	front bumper was 3.6 ft upstream of the	
	joint between segments 6 & 7.	
	The results of the test conducted on April	
	30, 2019, are found in TTI Test Report No.	
	611351-01.The 2008 Kia Rio test vehicle was	
	traveling at an impact speed of 62.7 mi/h as	
	it made contact with the Bronx Whitestone	
	Median Barrier Extension Bridge Rail 3.7 ft	
	upstream of the joint between segments 6	
	& 7and at an impact angle of 25.1°. After	
	loss of contact with the barrier, the vehicle	
	came to rest 235 ft downstream of the	
	impact point and 64 ft toward the traffic	
	lanes.	
	The Bronx Whitestone Median Barrier	
	Extension Bridge Rail contained and	
	redirected the 1100C vehicle. The vehicle

did not penetrate, underride, or override	
	the installation. No dynamic deflection or permanent deformation was observed. No	
	<b>!</b>	
4 40 (4400C)	detached elements, fragments, or other	DACC
4-10 (1100C)	debris were present to penetrate or show potential for penetrating the occupant	PASS
	compartment, or to present hazard to	
	others in the area. The 1100C vehicle	
	remained upright during and after the	
	collision event. Maximum roll and pitch	
	angles were 27° and 8°, respectively.	
	angles were 27 and 6, respectively.	
	Langitudinal OlV (was 40.4 ft/s and lateral	
	Longitudinal OIV was 18.4 ft/s and lateral	
	OIV was 33.8 ft/s. Maximum longitudinal	
	occupant ridedown acceleration was 6.0 g,	
	and maximum lateral occupant ridedown	
	acceleration was 10.2 g. Occupant risk	
	factors were within the maximum limits	
	specified in MASH.	
	Maximum exterior crush to the vehicle was

8.0 inches in the side plane at the right front	
	corner at bumper height. Maximum	
	occupant compartment deformation was	
	1.5 inches in the right front floor pan.	
	The Drawy Whitestone Marking Drawing	
	The Bronx Whitestone Median Barrier	
	ExtensionBridge Rail performed acceptably	
	forMASH test 4-10.

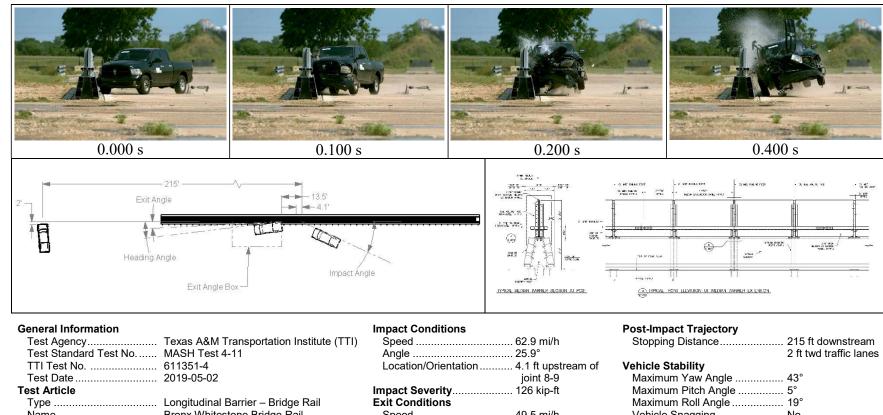
Figure 6.6. Summary of Results for MASH Test 4-11 on Bronx Whitestone Bridge Rail.

General Information		impact Conditions		Post-Impact Trajectory	
Test Agency	Texas A&M Transportation Institute (TTI)	Speed	62.9 mi/h	Stopping Distance	215 ft downst
Test Standard Test No	MASH Test 4-11	Angle		•	2 ft twd traffic
TTI Test No	611351-4	Location/Orientation	4.1 ft upstream of	Vehicle Stability	
Test Date	2019-05-02		joint 8-9	Maximum Yaw Angle	43°
Test Article		Impact Severity	126 kip-ft	Maximum Pitch Angle	5°
Type	Longitudinal Barrier – Bridge Rail	Exit Conditions		Maximum Roll Angle	19°
Name	Bronx Whitestone Bridge Rail	Speed	49.5 mi/h	Vehicle Snagging	No
Installation Length	210 ft	Trajectory/Heading Angle	3.9° / 2.1°	Vehicle Pocketing	No
Material or Key Elements	Steel plate posts, steel parapet covering	Occupant Risk Values		Test Article Deflections	
	steel beams secured to posts, fabricated	Longitudinal OIV	20.3 ft/s	Dynamic	0.7 inch
	steel rail above the parapet, acrylic	Lateral OIV	29.5 ft/s	Permanent	None

windscreen above parapet and rail	Longitudinal Ridedown	5.3 g	Working Width	30.7 inches
	supported by posts	Lateral Ridedown	9.7 g	Height of Working Width	6.0 inches
Soil Type and Condition	Reinforced concrete foundation, damp	THIV	39.2 km/h		
Test Vehicle		PHD			
Type/Designation	2270P	ASI	2.17	Vehicle Damage	
Make and Model	2014 RAM 1500 Pickup	Max. 0.050-s Average		VDS	
Curb		Longitudinal	<b>-</b> 9.5 g	CDC	
Test Inertial		Lateral		Max. Exterior Deformation	11.0 inches
Dummy	165 lb	Vertical	<b>-</b> 4.2 g	OCDI	RF0020000
Gross Static	5175 lb			Max. Occupant Compartme	nt

Page 4 of 7
RequiredTest	Narrative	Evaluation
Number	Description	Results
	Test 4-11 involves a 2270P vehicle	
	impacting the test article at a target impact	
	speed of 62 mi/h and target angle of 25°.	
	The target CIP for the right corner of the	
	front bumper was 4.3 ft upstream of the	
	joint between segments 8 & 9.	
	John between segments o & 3.	
	The results of the test conducted on May 2,	
	2019, are found in TTITest Report No.	
	611351-01.The 2014 RAM 1500 test vehicle	
	was traveling at an impact speed of 62.9 mi/	
	h as it made contact with the Bronx	
	Whitestone Median Barrier Extension Bridge	
	Rail 4.1 ft upstream of the joint between	
	segments 8 & 9 and at an impact angle of

25.9°. After loss of contact with the barrier,	
	the vehicle came to rest 215 ft downstream	
	of the impact point and 2 ft toward the	
	traffic lanes.	
	u amo la los.	
	The Bronx Whitestone Median Barrier	
	Extension Bridge Rail contained and	
	redirected the 2270P vehicle. The vehicle	
	did not penetrate, underride, or override	
	the installation. Maximum dynamic	
	deflection was 0.7 inches, and no	
	permanent deformation was observed. No	
4-11 (2270P)	detached elements, fragments, or other	PASS
, , (==, ,,	debris were present to penetrate or show	
	potential for penetrating the occupant	
	compartment, or to present hazard to	
	others in the area. The 2270P vehicle	
	remained upright during and after the	
	collision event. Maximum roll and pitch	
	angles were 19° and 5°, respectively.	
	angles were to and s prospessively.	
	Longitudinal OIV was 20.3 ft/s and lateral	
	OIV was 29.5 ft/s. Maximum longitudinal

occupant ridedown acceleration was 5.3 g,	
	and maximum lateral occupant ridedown	
	acceleration was 9.7 g. Occupant risk factors	
	were within the preferred limitsspecified in	
	MASH.	
	Maximum exterior crush to the vehicle was

11.0 inches in the side plane at the right	
	front corner at bumper height. Maximum	
	occupant compartment deformation was	
	4.5 inches in the right front firewall area.	
	34	
	The Bronx Whitestone Median Barrier	
ı	Extension Bridge Rail performed acceptably	
	forMASH test 4-11.

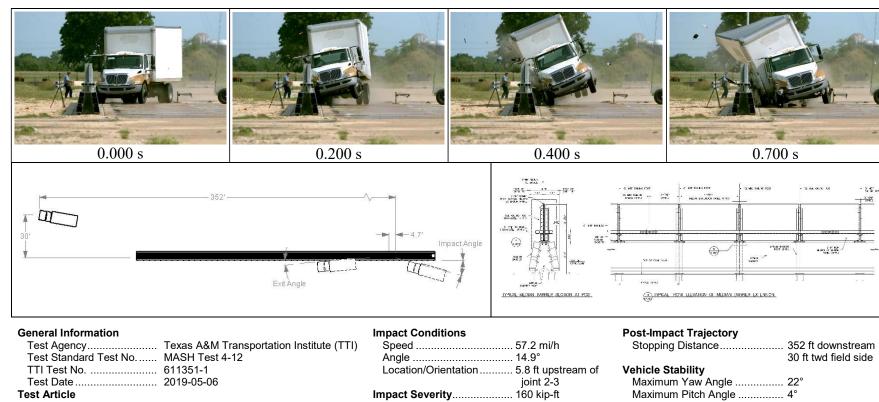
Figure 7.6. Summary of Results for MASH Test 4-12 on Bronx Whitestone Bridge Rail.

Test Agency	Texas A&M Transportation Institute (TTI)	Speed	. 57.2 mi/h
Test Standard Test No	MASH Test 4-12	Angle	
TTI Test No	611351-1	Location/Orientation	. 5.8 ft upstre
Test Date	2019-05-06		joint 2-3
Test Article		Impact Severity	. 160 kip-ft
Type	Longitudinal Barrier – Bridge Rail	Exit Conditions	•
Name	Bronx Whitestone Bridge Rail	Speed	. 50.4 mi/h
Installation Length	210 ft	Trajectory/Heading Angle	. 0.6° / 0°
Material or Key Elements	Steel plate posts, steel parapet covering	Occupant Risk Values	
	steel beams secured to posts, fabricated	Longitudinal OIV	. 7.5 ft/s
	steel rail above the parapet, acrylic	Lateral OIV	. 16.1 ft/s
	windscreen above parapet and rail	Longitudinal Ridedown	. 2.0 g
	supported by posts	Lateral Ridedown	. 4.5 g
Soil Type and Condition	Reinforced concrete foundation, damp	THIV	. 19.9 km/h
Test Vehicle		PHD	. 4.6 g
Type/Designation	10000S	ASI	. 0.84
Make and Model	2012 International 4300 Single-Unit Truck	Max. 0.050-s Average

Curb	14,070 lb	Longitudinal	. <b>-</b> 1.9 g
Test Inertial	22,110 lb	Lateral	. <b>-</b> 7.0 g
Dummy	No dummy	Vertical	3.3 g
Gross Static			_

Post-impact Trajectory	
Stopping Distance	352 ft downstream
	30 ft twd field side
Vehicle Stability	
Maximum Yaw Angle	22°
Maximum Pitch Angle	4°
Maximum Roll Angle	
Vehicle Snagging	
Vehicle Pocketing	No
Test Article Deflections	
Dynamic	Not Obtainable
Permanent	0 inches
Working Width	73.3 inches
Height of Working Width	123.8 inches
Vehicle Damage	
VDS	NA
CDC	01FREW3
Max. Exterior Deformation	10.0 inches
OCDI	NA
Max. Occupant Compartment	
Deformation	3.0 inches

### TEST611351-1:

The target CIP for the right corner of the front bumper was 5.0 ft upstream of the joint between segments 2 & 3.

The results of the test conducted on May 6, 2019, are found in TTITest Report No. 611351-01. The 2012 International 4300 SUT test vehicle was traveling at an impact speed of 57.2 mi/h as it made contact with the Bronx Whitestone Median Barrier Extension Bridge Rail 5.8 ft upstream of the joint between segments 2 & 3, and at an impact angle of 14.9°. After loss of contact with the barrier, the vehicle came to rest 352 ft downstream of the impact point and 30 ft toward the field side.

The Bronx Whitestone Median Barrier Extension Bridge Rail contained and redirected the 10000Svehicle. The vehicle did not penetrate, underride, or override the installation. Any dynamic deflection was obscured in the camera views, but no permanent deformation was observed. No detached elements, fragments, or other debris were present to penetrate or show potential for penetrating the occupant compartment, or to present hazard to others in the area. The 10000S vehicle remained upright during and after the collision event. Maximum roll and pitch angles were 25° and 4°, respectively.

Longitudinal OIV was 7.5 ft/s, and lateral OIV was 16.1 ft/s.

Maximum longitudinal occupant ridedown acceleration was 2.0 g, and maximum lateral occupant ridedown acceleration was 4.5 g.

Maximum exterior crush to the vehicle was 10.0 inchesat the right front corner at bumper height. Maximum occupant compartment deformation was 3.0 inches in the right floor pan area.
