IN-SERVICE PERFORMANCE EVALUATION OF KDOT'S CABLE MEDIAN BARRIER

MIDWEST ROADSIDE SAFETY FACILITY

MwRSF Research Report No. TRP-03-436-20

September 4, 2020

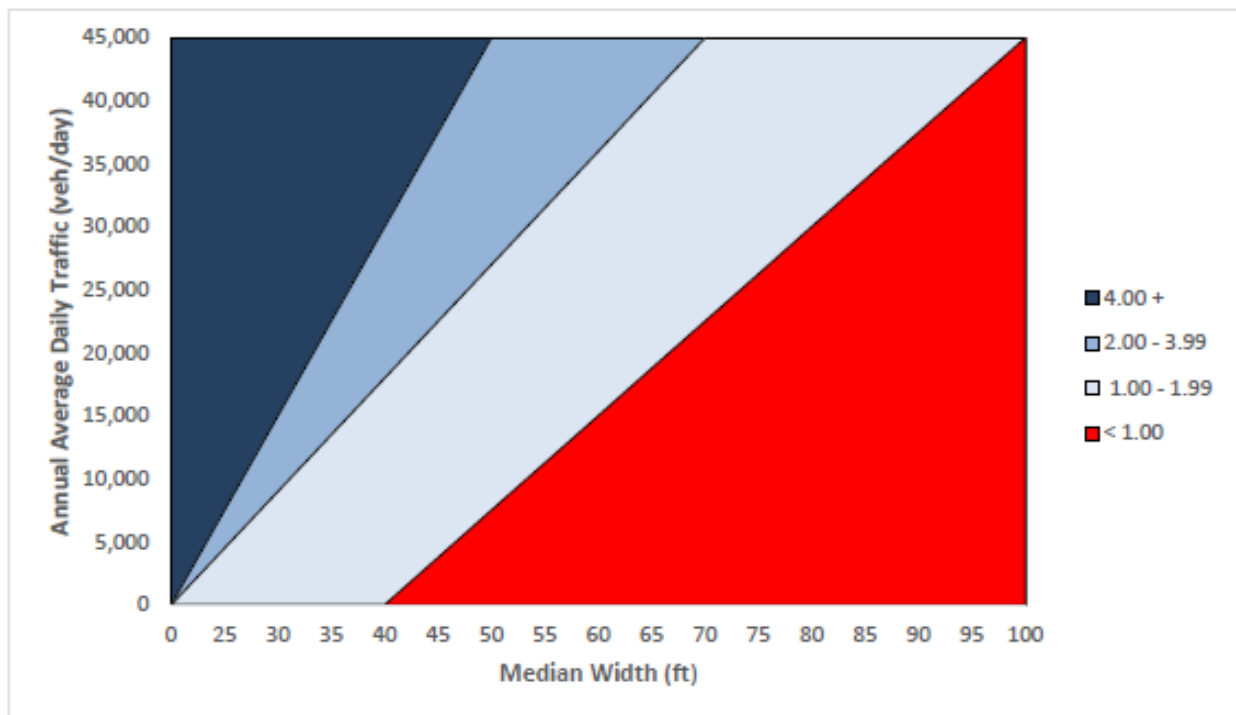
Figure 2. Benefit-to-Cost Ratio for Installing CMB in Iowa Based on AADT and Median Width [16]

CCTRE researchers also investigated the cost-effectiveness of installing CMB based on AADT and median width. Negative binomial regression modeling was used resulting in natural logarithmic distributions of crash rates and injury outcomes correlated to ADT and median widths. Statistical model results indicated relatively low cost-effectiveness for installing CMB in narrow medians or at low traffic volumes, but diminishing return as median widths increased beyond 50 ft. Using the assumed distribution of injuries in before-and-after CMB impact analysis, researchers identified the benefit-to-cost ratios of installing CMB based on median width and ADT. Results are shown in Figure 2. The assumed distribution of crash rate by median width is shown in Figure 3.

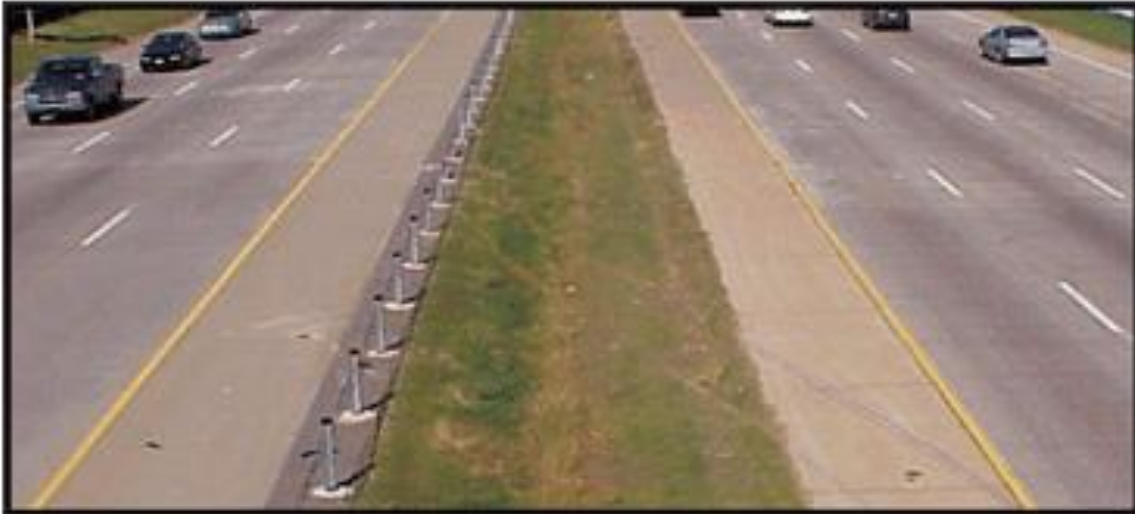
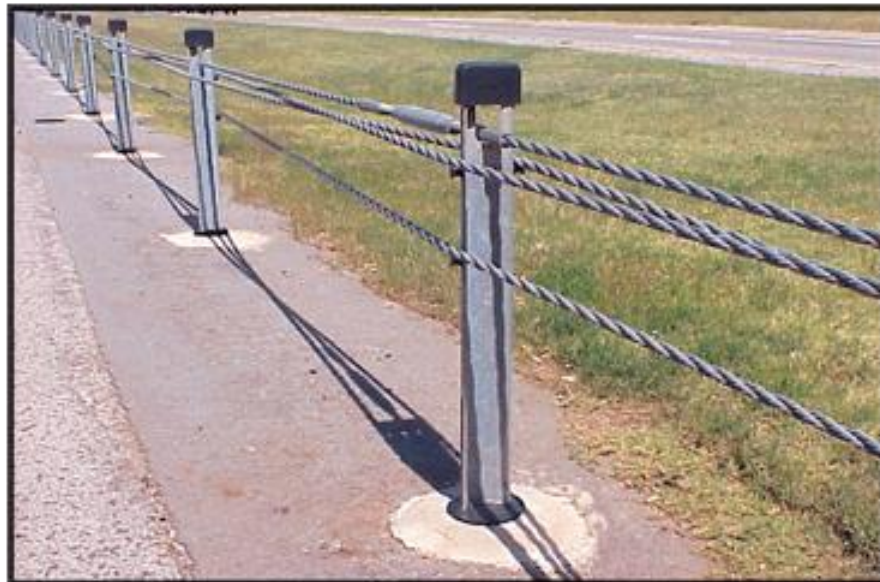
Figure 4. ODOT's CMB [20]

Oklahoma installed approximately 7.2 miles of Brifen CMB in 2000 and 2001 [20], as shown in Figure 4. CMB installations were placed in narrow, flat, divided medians. The Oklahoma DOT (ODOT) noted a decrease in fatal crashes after installing CMBs from 6 fatal crashes in 2001 to 1 in 2006. The average barrier damage during the impacts was approximately 5 posts. ODOT reported good success overall with the CMB performance, with 430 impacts with the CMBs identified through 2006. Overall maintenance, repairs, and installation were noted to be relatively easy and inexpensive. One particular crash resulted in a large truck being captured in the median, which was potentially above the design conditions for this median barrier system, as shown in Figure 5. However, no statistics were available to conclusively analyze the effectiveness of preventing cross-median crashes or the likelihood of other undesirable outcomes (barrier penetration, rollover, or barrier-related severe injuries or fatalities).

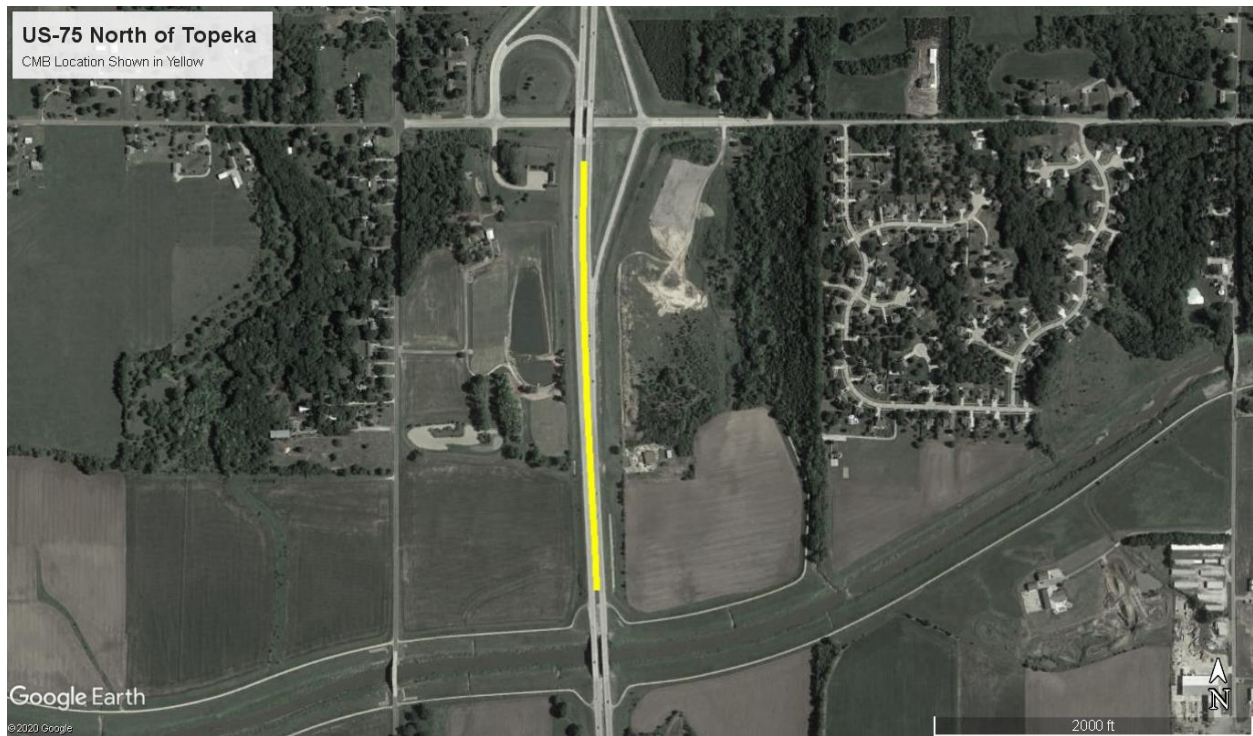
Figure 9. CMB Installation: US-75 (0.51 mi)

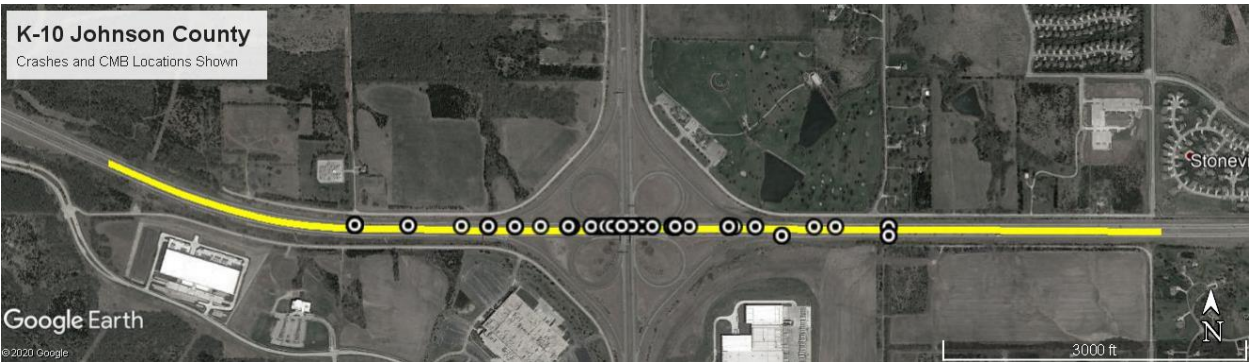
Figure 13. CMB Crashes on Kansas K-10 Roadway in Johnson County

Each crash had an associated “crash location” denoted using GNSS coordinates in latitude and longitude assigned by KDOT. However, crashes occur over broad longitudinal areas; it was unclear whether this geospatial position indicated start of vehicle instability, point of impact, approximate “centerpoint” of vehicle trajectory, vehicle final rest, or a different reference point. As such, the crash locations are considered as approximations of the locations of the crashes. A graphical summary of CMB crashes shown with respect to CMBs are provided in Figures 12 through 15.

The concentration of crashes appeared to be associated with two features: (a) roadway curves and (b) urban interchanges. Both K-10 in Douglas County and US-75 were primarily suburban/rural routes with few interchanges; approximately half of the crashes on K-10 in Douglas County occurred on the north-most curve, as in Figure 12. In comparison, crashes on K-96 (urban with many interchanges) and K-10 in Johnson County at the interchange of K-10 and K-7 interstates were disproportionately high. The highest crash rates per HVMT occurred in conjunction with K-10 in Johnson County and K-96.

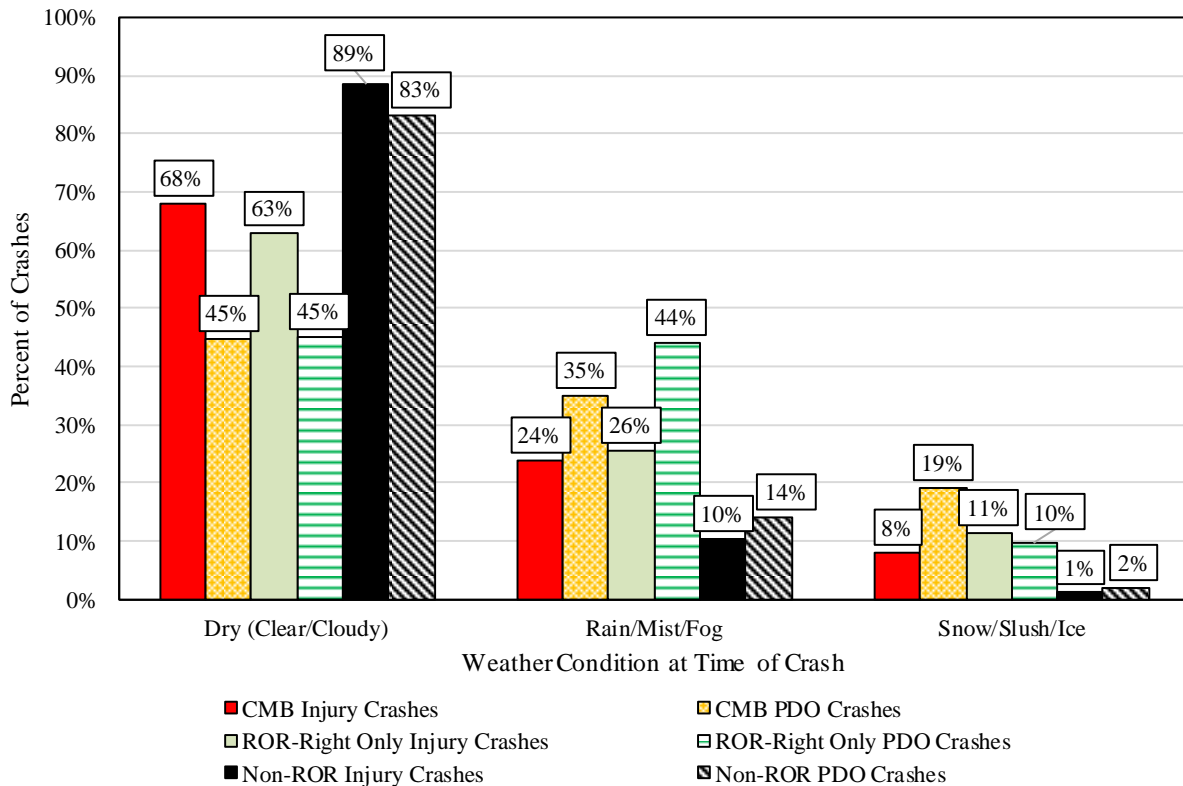
Figure 28. Comparison of Distribution of Injury Outcomes (2013-2018)

The distribution of crash outcomes for injury and PDO crashes was plotted based on weather conditions for CMB, right-side-only ROR, and non-ROR crashes, as shown in Figure 28. Injury crashes were disproportionately associated with dry, clear weather conditions, which is consistent with crash observations in literature [4,5,9,12]. However, a surprisingly high percentage of non-roadside departure PDO crashes were also associated with dry, clear weather conditions. In general, fewer injury crashes were observed during adverse weather conditions, both as a percentage of all injury crashes and as a percentage of all crashes with adverse weather. Only CMB crashes associated with wintery conditions (snow, slush, sleet, or icy conditions) incurred a higher proportion of injury crashes than PDO crashes in non-optimal driving conditions. Moreover, the composition ratio of PDO-to-injury crashes rose (up to twice as much) during adverse weather for other crash types indicating the benefit of reduced travel speeds on preventing injuries.

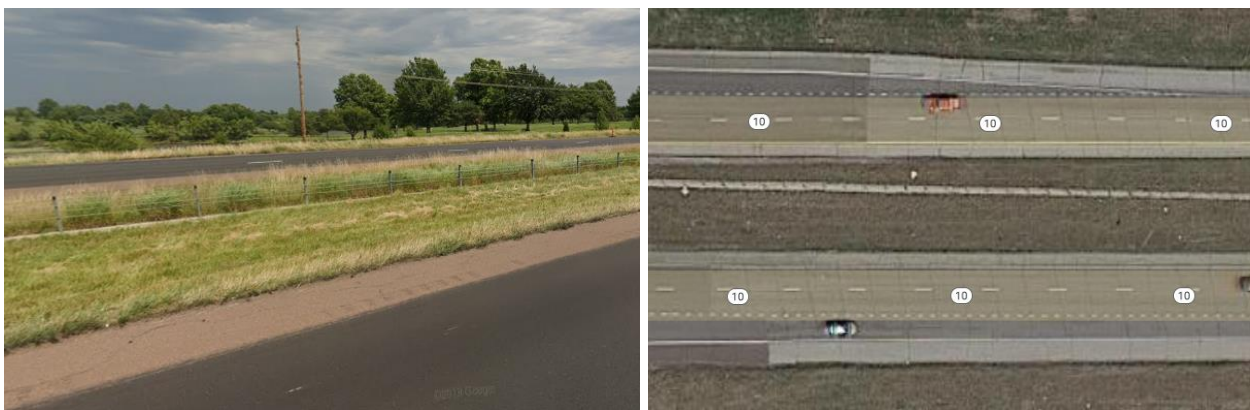
Figure 33. Location of CMB Rollover Crash [25]

The median at the point of the crash was relatively flat (<10:1) and grassy. The CMB system utilized a narrow mow strip with posts located in sockets. At the point of impact, the CMB was flaring and tapered toward the impacting vehicle's lanes, but the taper appeared to be more gradual than 50:1. The approximate location of the rollover crash is shown in Figure 33. Researchers believed that excessive steering associated with an avoidance maneuver contributed to the rollover.

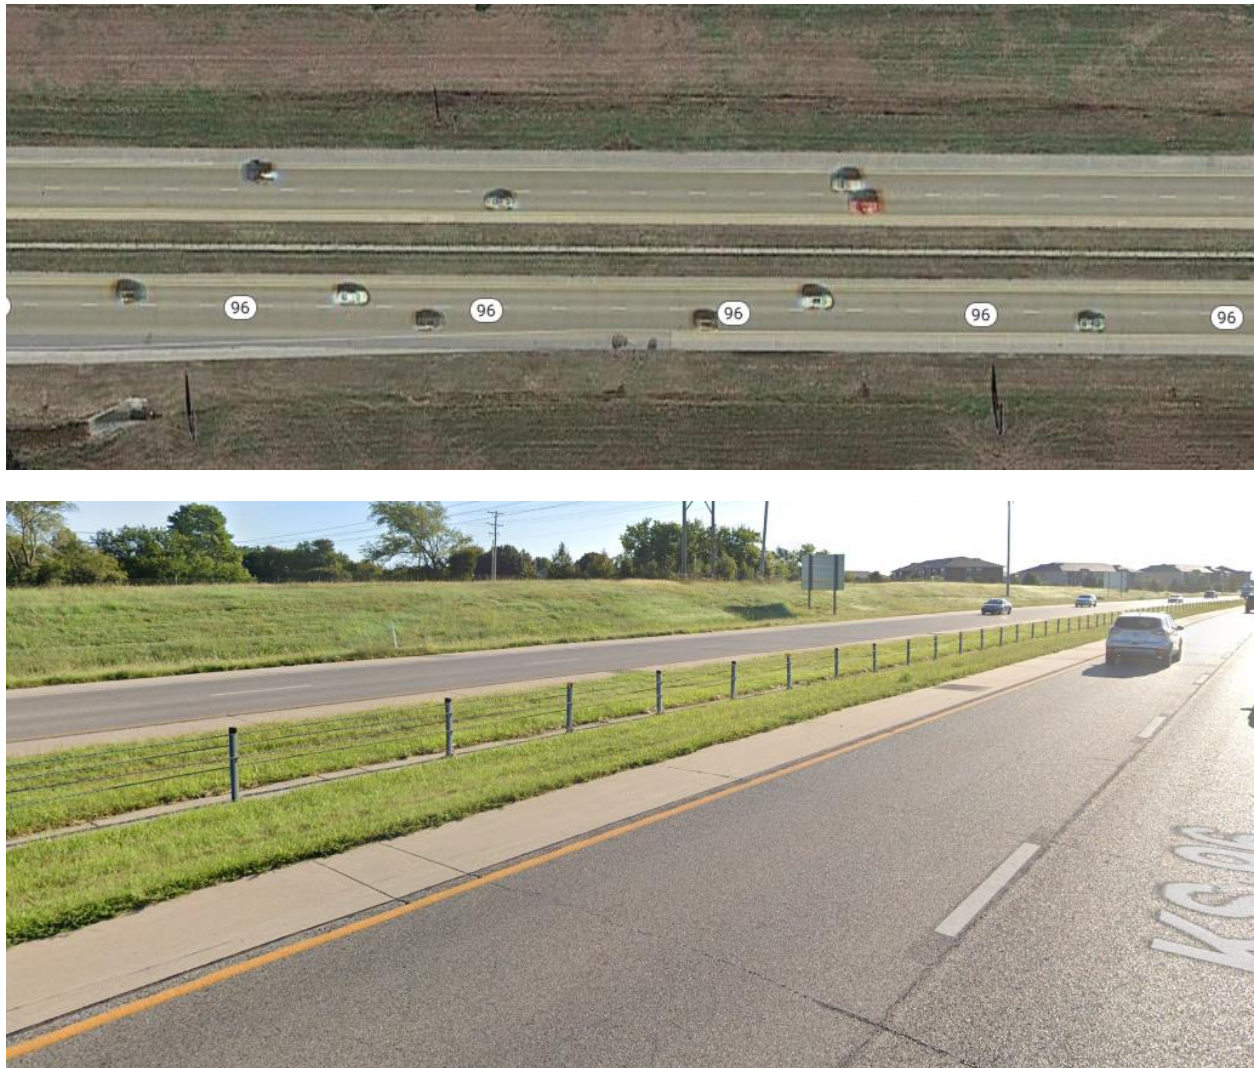
Figure 34. Severe Outcome Crash Location [25]

One severe crash outcome (fatality) was identified in the CMB results and included multiple non-contact vehicles. A Ford F-350 pickup truck carrying cargo in the bed abruptly lost part of the cargo in the roadway, and several adjacent trailing vehicles abruptly stopped and swerved to avoid the lost cargo. Some of the occupants of those vehicles exited the vehicles and intended to clean up the lost cargo to prevent subsequent crashes on K-96. A tractor-trailer vehicle came upon the lost cargo and stopped vehicles and made an avoidance maneuver to the left, toward the shoulder and median, striking one stopped vehicle and the cable median barrier. While slowing to a stop, the tractor-trailer also contacted and killed a pedestrian of a separate stopped vehicle. The crash location is shown in Figure 34, and the scene diagram is shown in Figure 35.
