DEVELOPMENT AND TESTING OF AN OPTIMIZED MASH TL-4 CONCRETE BRIDGE RAIL

MwRSF Research Report No. TRP-03-415-21
March 26, 2021

16. Abstract A new concrete bridge rail was developed and optimized using recently updated <i>Manual for Assessing Safety Hardware</i> (MASH) Test-Level 4 (TL-4) design loads. The rail was optimized to maximize vehicle stability, minimize installation costs, and mitigate the potential for deck damage by minimizing loads transferred to the deck. Additionally, the bridge rail was designed with a 39-in. installation height so that it would remain crashworthy after future roadway overlays up to 3 in. thick. The barrier had a front face with a 3-degree slope (i.e., batter) away from vertical to promote vehicle stability during impacts while also providing some slope to allow for slipforming real-world installations. Yield-line theory was utilized to design both interior and end regions of the barrier. Further, minimum deck strengths were determined and a deck overhang design procedure was provided for users desiring to modify their existing deck details. Finally, MASH test designation no. 4-12 was conducted on the new bridge rail to evaluate its safety performa

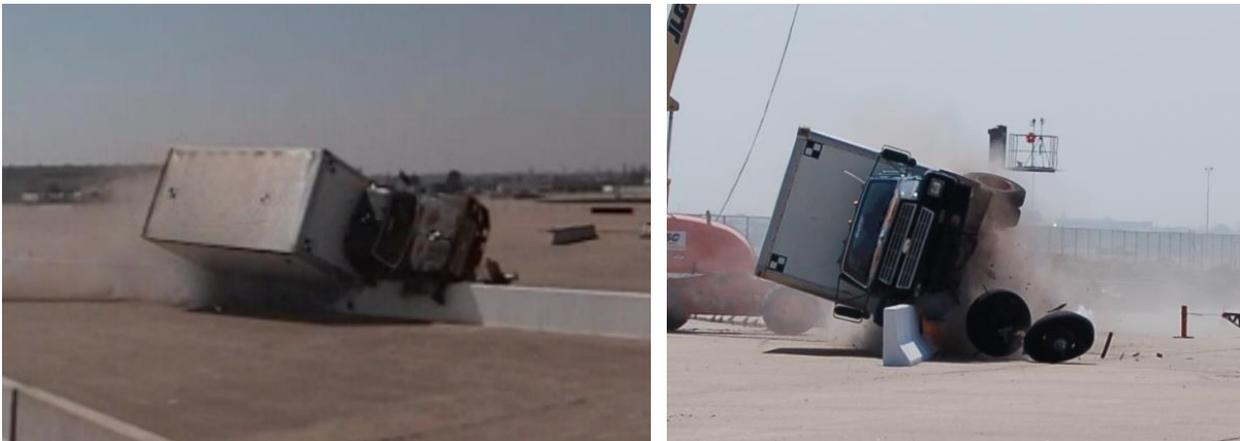
Figure 1. SUT Rollover in MwRSF TL-4 Test with 32-in. Tall Barrier [4]

In 2006, MwRSF conducted a full-scale crash test according to the proposed impact conditions MASH test designation no. 4-12 on a 32-in. tall New Jersey safety shape barrier [4]. Note, MASH had not yet been finalized and published at the time of the crash test. While the 32-in. test article was proven adequate for TL-4 conditions under NCHRP Report 350, it failed to redirect the impacting vehicle, and the SUT rolled over the barrier, as shown in Figure 1.

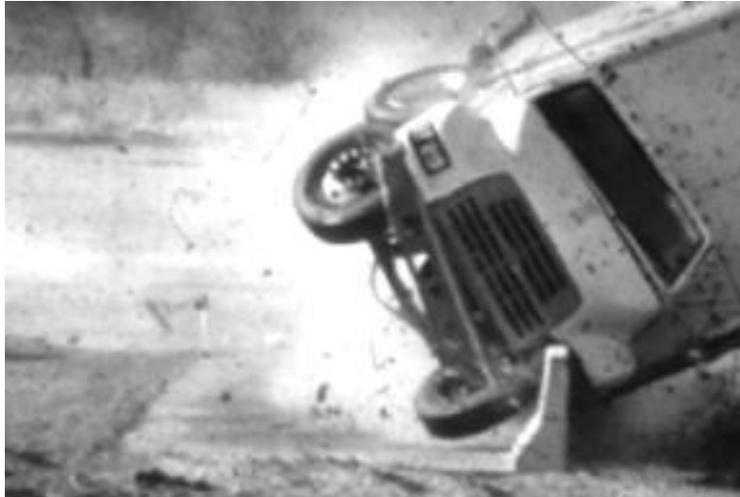
Figure 2. SUT Rollover in TTI TL-4 Test with 32-in. Tall Barrier [5]

In a similar study, Texas A&M Transportation Institute (TTI) conducted a MASH test designation no. 4-12 crash test on another 32-in. tall New Jersey safety shape bridge rail [5]. In this 2010 test, the SUT rolled 101 degrees, traversed past the end of the test installation, and ultimately came to rest upright. Researchers determined that the vehicle would have rolled over the barrier had the test installation length been longer. The roll angle experienced near the end of the barrier installation is shown in Figure 2. Both of these studies illustrated that 32-in. tall barriers were no longer sufficient to contain the TL-4 SUT according to MASH impact conditions.

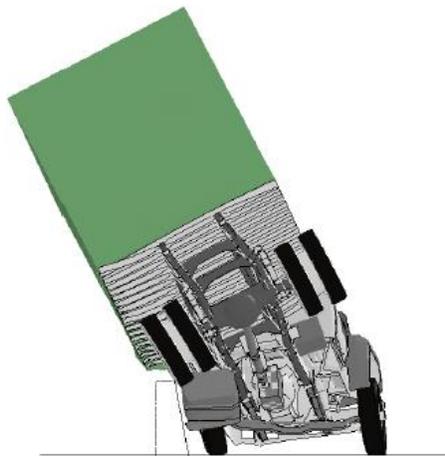
Figure 3. SUT Critical Scenario in Simulated TL-4 Test with 36-in. Tall Barrier [9]

Multiple studies were performed to establish a new minimum height for MASH TL-4 barriers. In 2011, researchers at TTI conducted a parametric simulation study using a nonlinear finite element analysis software called LS-DYNA [8] to investigate the effect of barrier height on vehicle stability [9]. Rigid, single-slope barriers of varying height were impacted in a series of simulated tests consistent with MASH test designation no. 4-12. Beginning with a barrier height of 42 in., the height was incrementally reduced until a critical vehicle roll angle was observed at a barrier height of 36 in., as shown in Figure 3. As a result, a minimum height requirement of 36 in. was proposed for further evaluation in that study.

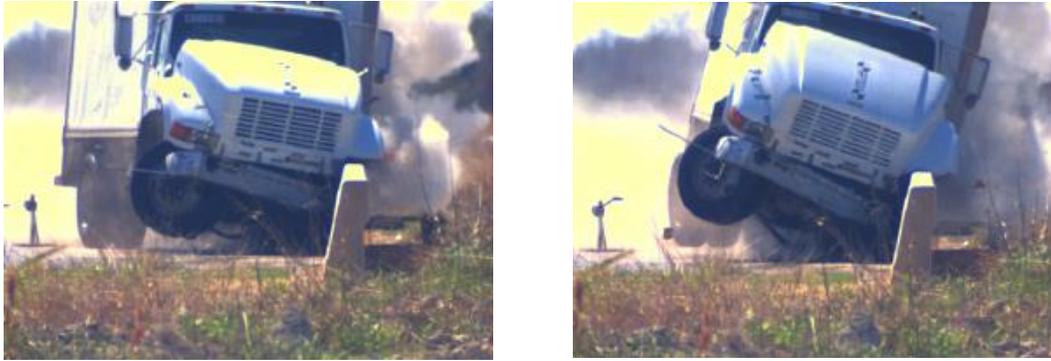
Figure 4. SUT Stability in TL-4 Test with 36-in. Tall Barrier [9]

Subsequently, a full-scale crash test conforming to MASH test designation no. 4-12 was performed on a 36-in. tall single-slope concrete barrier. The results of the test were consistent with the simulation study, and the SUT was contained and redirected while maintaining its stability, as shown in Figure 4. To date, the minimum rigid barrier height (including all concrete barrier shapes and steel bridge rails) to satisfy MASH TL-4 criteria has been 36 in.

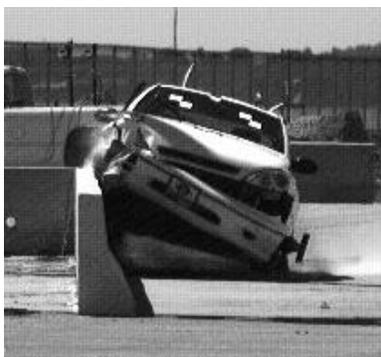
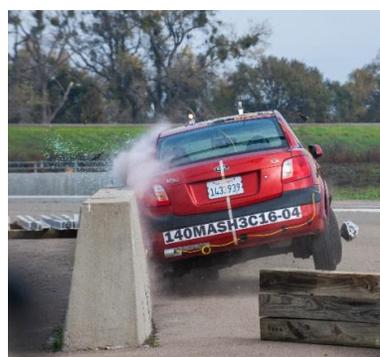
New Jersey
Test No. 2214NJ-1 [22]

Single Slope
Test No. 140MASH3c16-04 [23]

A 2007 study of over 100 previously conducted crash tests reached similar conclusions [21]. Safety shape barriers showed higher tire climb and vehicle roll during crash testing. Single slope barriers showed improved vehicle stability over safety shape barriers, but still had moderate amounts of climb and roll. Vertical face barriers minimized tire climb and vehicle roll with only slightly increased vehicle decelerations (well within MASH safety limits). Examples of vehicle roll and climb are shown in Figure 5.

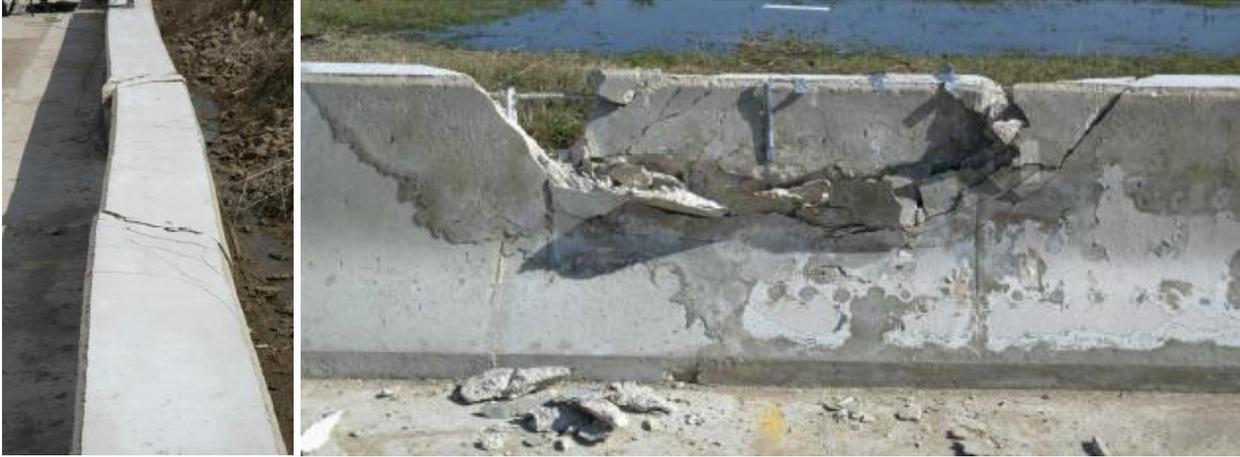
Figure 6. Punching Shear Failures of Concrete Barriers [29]

Existing AASHTO LRFD BDS guidance does not discuss punching shear as a possible failure mechanism for concrete barriers. However, recent research has demonstrated that punching shear behavior can occur and may control the strength of concrete barriers [27-29]. Examples of punching shear failures in concrete barriers are shown in Figure 6.

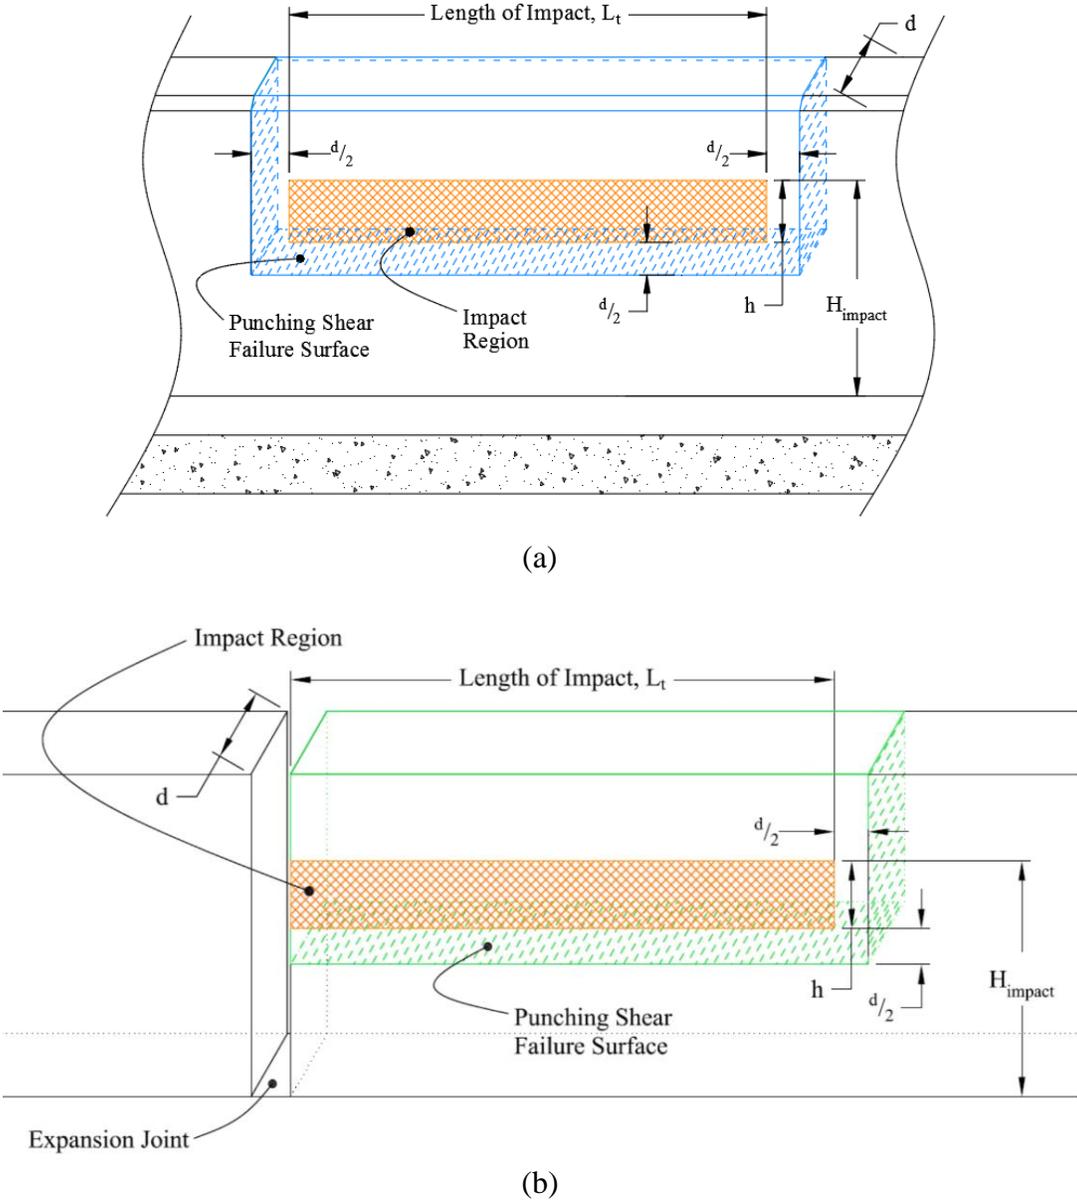
Figure 7. Punching Shear Failure Patterns for (a) Interior Sections and (b) End Sections

The critical perimeter for barrier punching shear can be defined by a box formed around the impact load applied over a length of L_t and at a height of H_e [26]. Shear failure surfaces extend outward from the loaded region at approximately 45-degree angles. Thus, mid-depth of the shear failure region extends a distance equal to half the depth, $d/2$, below the impact region and on both the upstream and downstream ends of the impact region. The assumed shear failure perimeters for both interior and end section conditions are demonstrated in Figure 7.

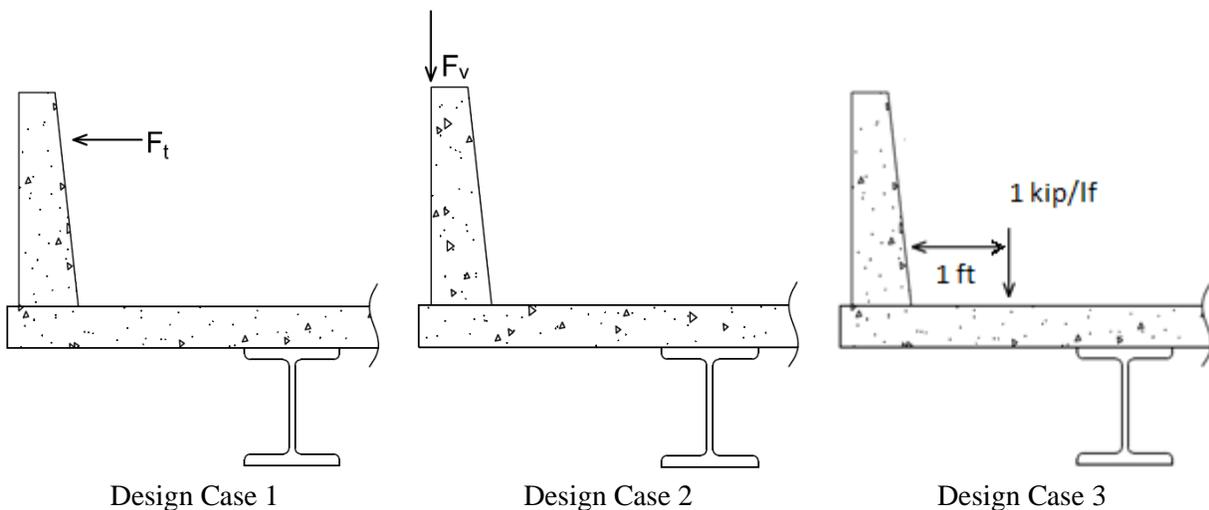
Figure 8. AASHTO LRFD BDS Bridge Deck Overhang Design Cases

Design Case 1 includes the lateral impact forces, F_t , developed during vehicle impacts with the bridge rail, and is analyzed considering the Extreme Event Load Combination II limit state. Design Case 2 includes the vertical impact forces, F_v , resulting from vehicle impacts to the bridge rail, and is also analyzed with the Extreme Event Load Combination II limit state. Both the lateral and vertical impact loads are functions of the Test Level of the bridge railing, as discussed in Section 2.2. Finally, Design Case III addresses the vertical vehicle wheel loads occupying the overhang region at any point in time. As such, Design Case 3 is independent of bridge rail impact considerations, and is analyzed with the Load Combination Strength I limit state. All three Design Cases are shown in Figure 8.

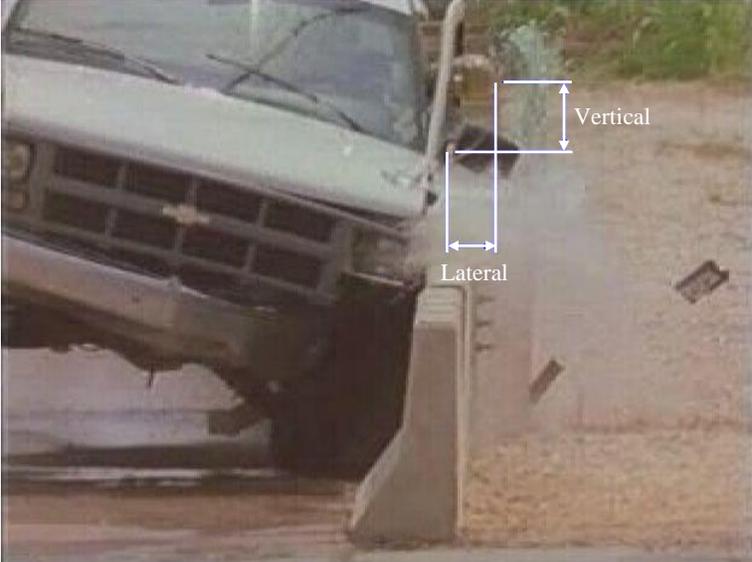
Figure 12. Measurement of Head Ejection Envelope [7]

In 2007, Rosenbaugh et al. analyzed digital video of full-scale crash tests to develop a head ejection envelope [7]. Lateral and vertical ejection of seatbelted dummies were measured from the lower edge of the window, as shown in Figure 12. By superimposing dummy head locations during multiple impacts, head ejection envelopes were developed for both small car and pickup truck impacts. The head ejection envelope was adjusted to account for vehicle roll toward the barrier and interpolated to account for midsize vehicles, such as SUVs and small pickup trucks. Barriers and attachments in violation of the head ejection envelope would be at risk for head slap during vehicle impacts. The final head ejection envelope is shown in Figure 13.

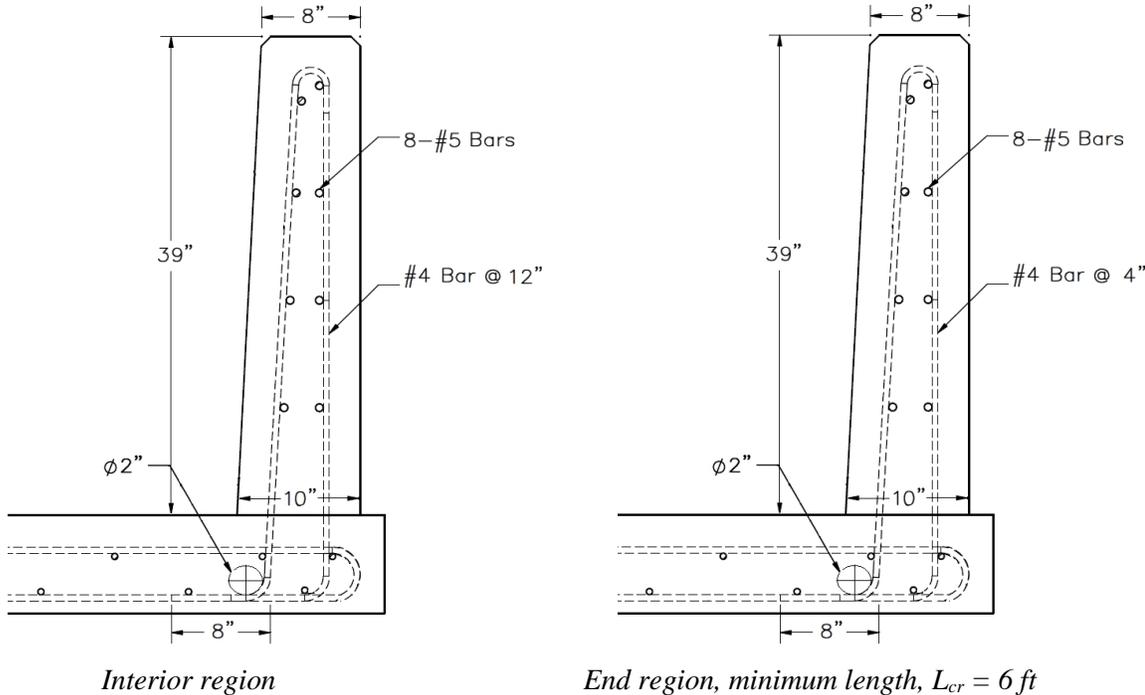
Figure 15. Cross Sections of Concrete Bridge Rail Design

An end region configuration was designed with the same methodology described above for interior regions, except the yield-line analysis equations were switched to the end region calculations provided in Section 13 of AASHTO LRFD BDS [15]. Additionally, it was desired to maintain the same bridge rail width and longitudinal steel pattern for construction purposes. Thus, only the stirrup sizes and spacing were varied. The optimal barrier end region design configuration consisted of an 8-in. top width, eight #5 longitudinal bars, and a #4 stirrup spaced at 4 in. on-center, which provided a capacity of 90.9 kips. The calculated critical length of the end section was 6.1 ft. Cross sections for both the interior and end regions of the new TL-4 barrier are shown in Figure 15.

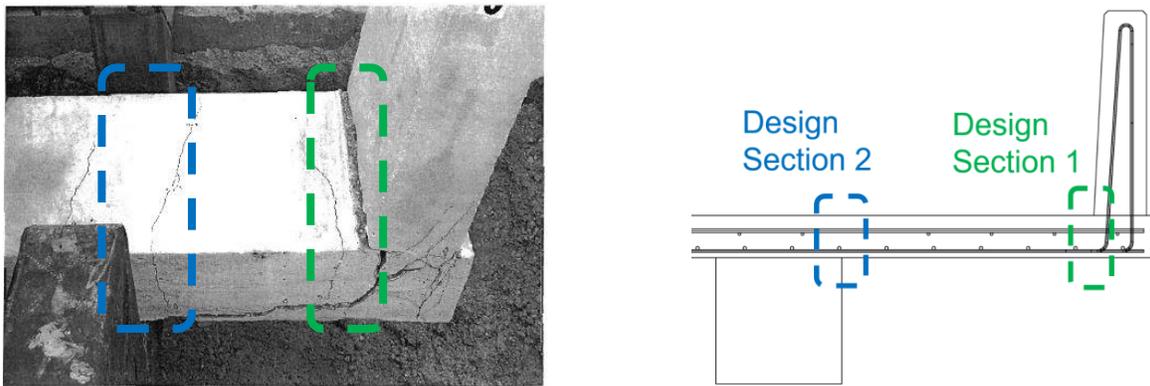
Figure 16. Photo [27] and Diagram Showing Locations for Critical Deck Design Sections

Two critical deck sections were identified, as shown in Figure 16. Design Section 1 is located adjacent to the face of the bridge rail where barrier shear loads become tensile loads in the deck. Due to its close proximity to the edge of the deck, transverse deck bars may not have adequate development length, thereby limiting the effective strength of the rebar and reducing the strength of the deck. Design Section 2 is located over the external support girder and is often the location of maximum flexure in the deck overhang. The exact location of Design Section 2 is dependent upon the type of girder and is described in AASHTO LRFD BDS Section 4.6.2.1.6 [15]. For example, for a typical rolled steel girder, such as the girder shown in Figures 17 and 18, the critical section is considered to be one-fourth of the steel flange width away from the center of the girder [15, 31].

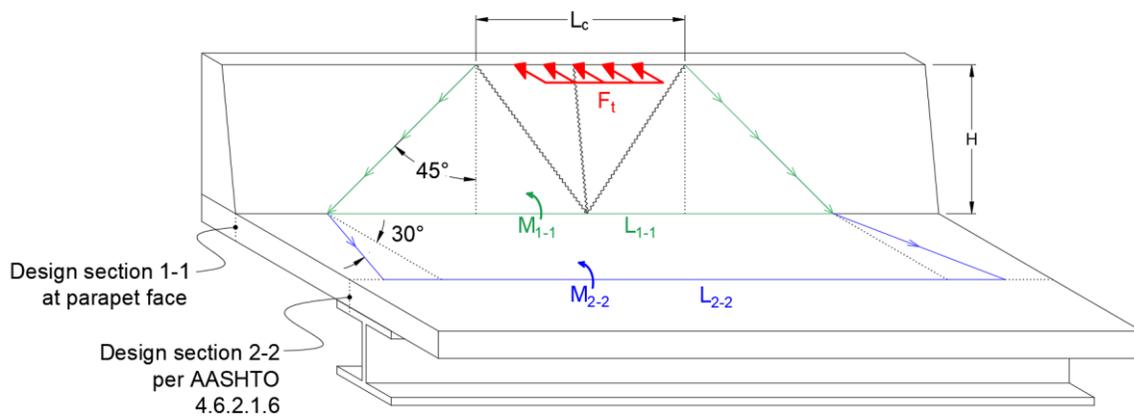
Figure 17. Distribution of Impact Demands to Deck Design Sections 1 and 2, Interior Section

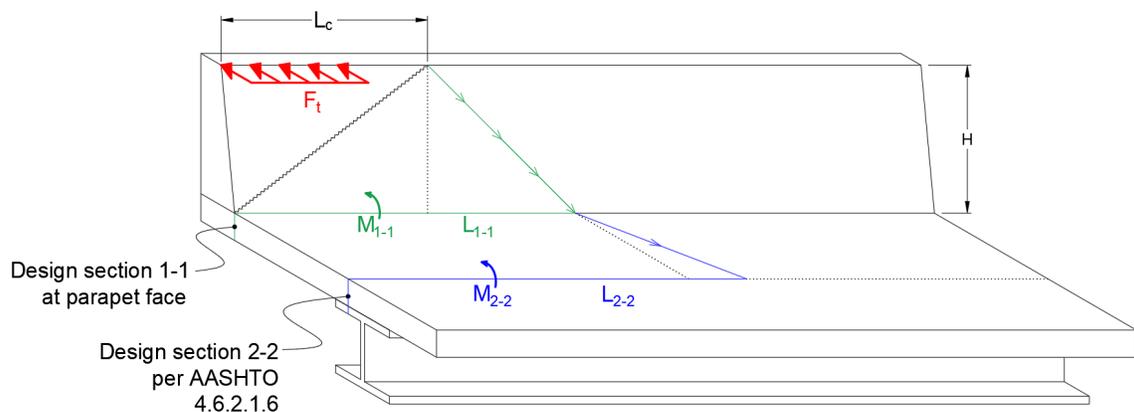
Figure 18. Distribution of Impact Demands to Deck Design Sections 1 and 2, End Section

where Y is the distance from Design Section 1 to Design Section 2. This behavior is demonstrated at an end condition in Figure 18. The load length for an exterior section at Design Section 2, $L_{s2,end}$, was estimated using Equation 9.

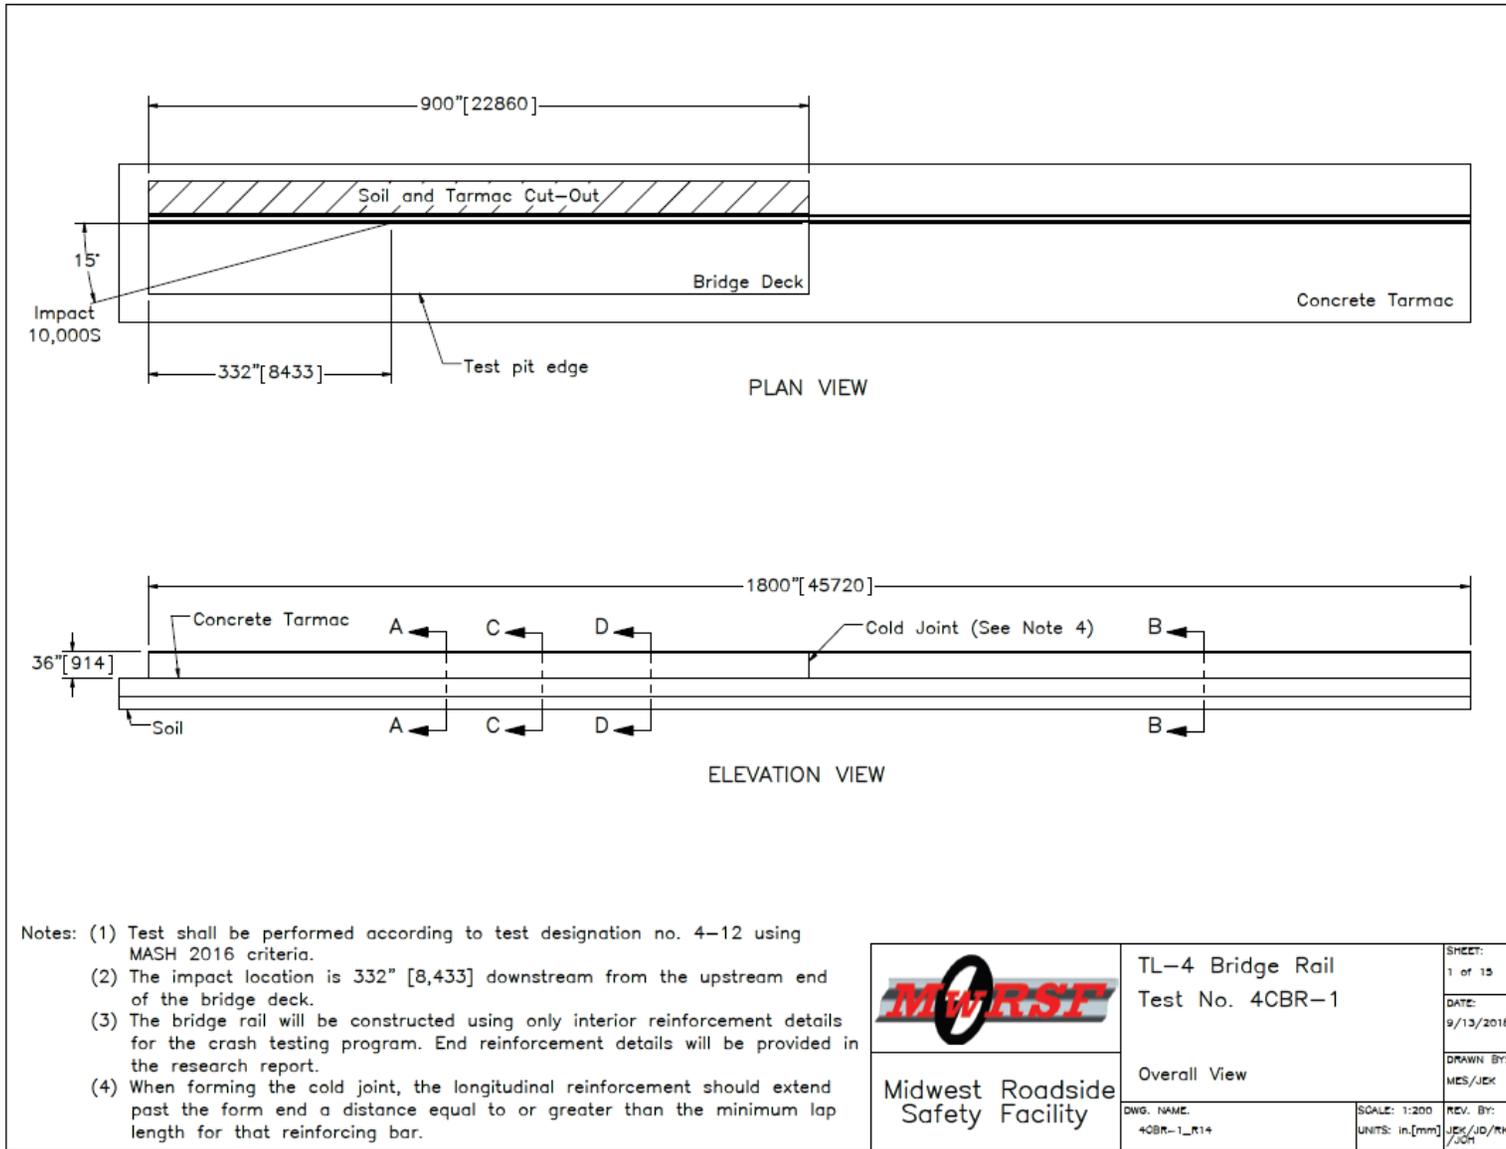
Figure 19. TL-4 Bridge Rail Test Installation, Test No. 4CBR-1

The bridge rail and deck were designed for a concrete compressive strength of 5,000 psi. The actual compressive strength for the deck and bridge rail were 6,170 psi and 5,090 psi, respectively. All steel rebar had a minimum yield strength of 60 ksi. Material specifications, mill certifications, and certificates of conformity for the system materials are shown in Appendix A.

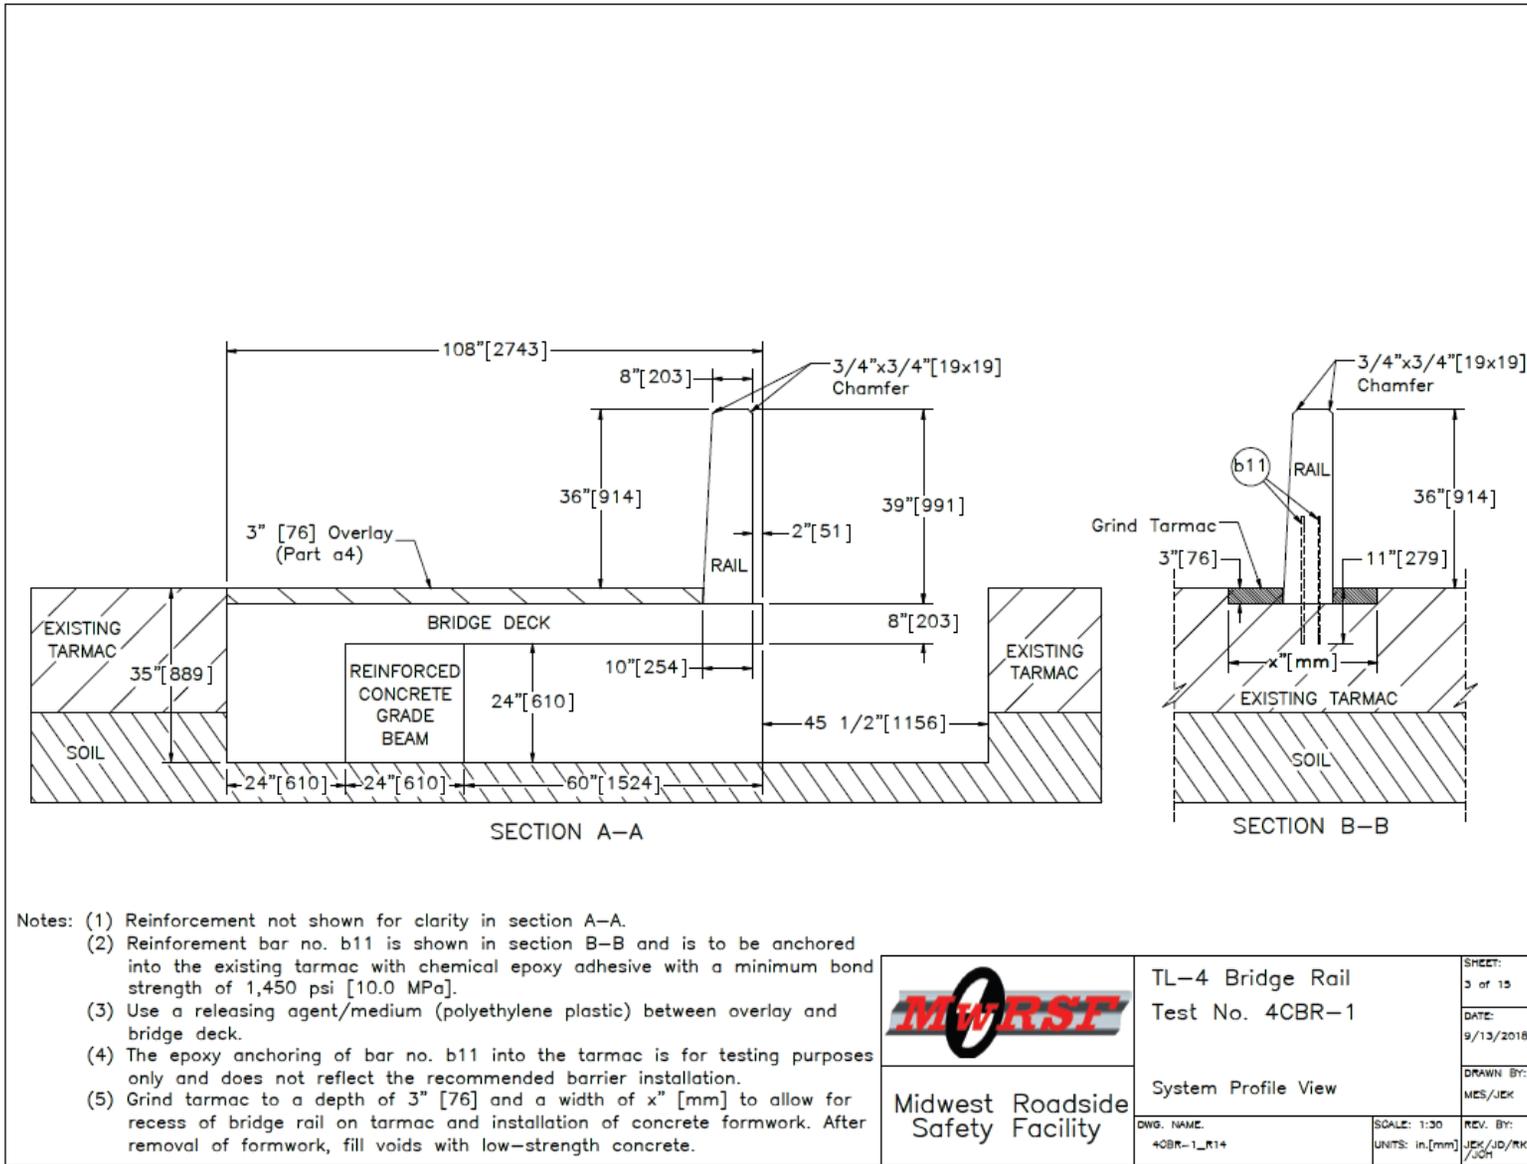
Figure 21. System Cross Sections, Test No. 4CBR-1

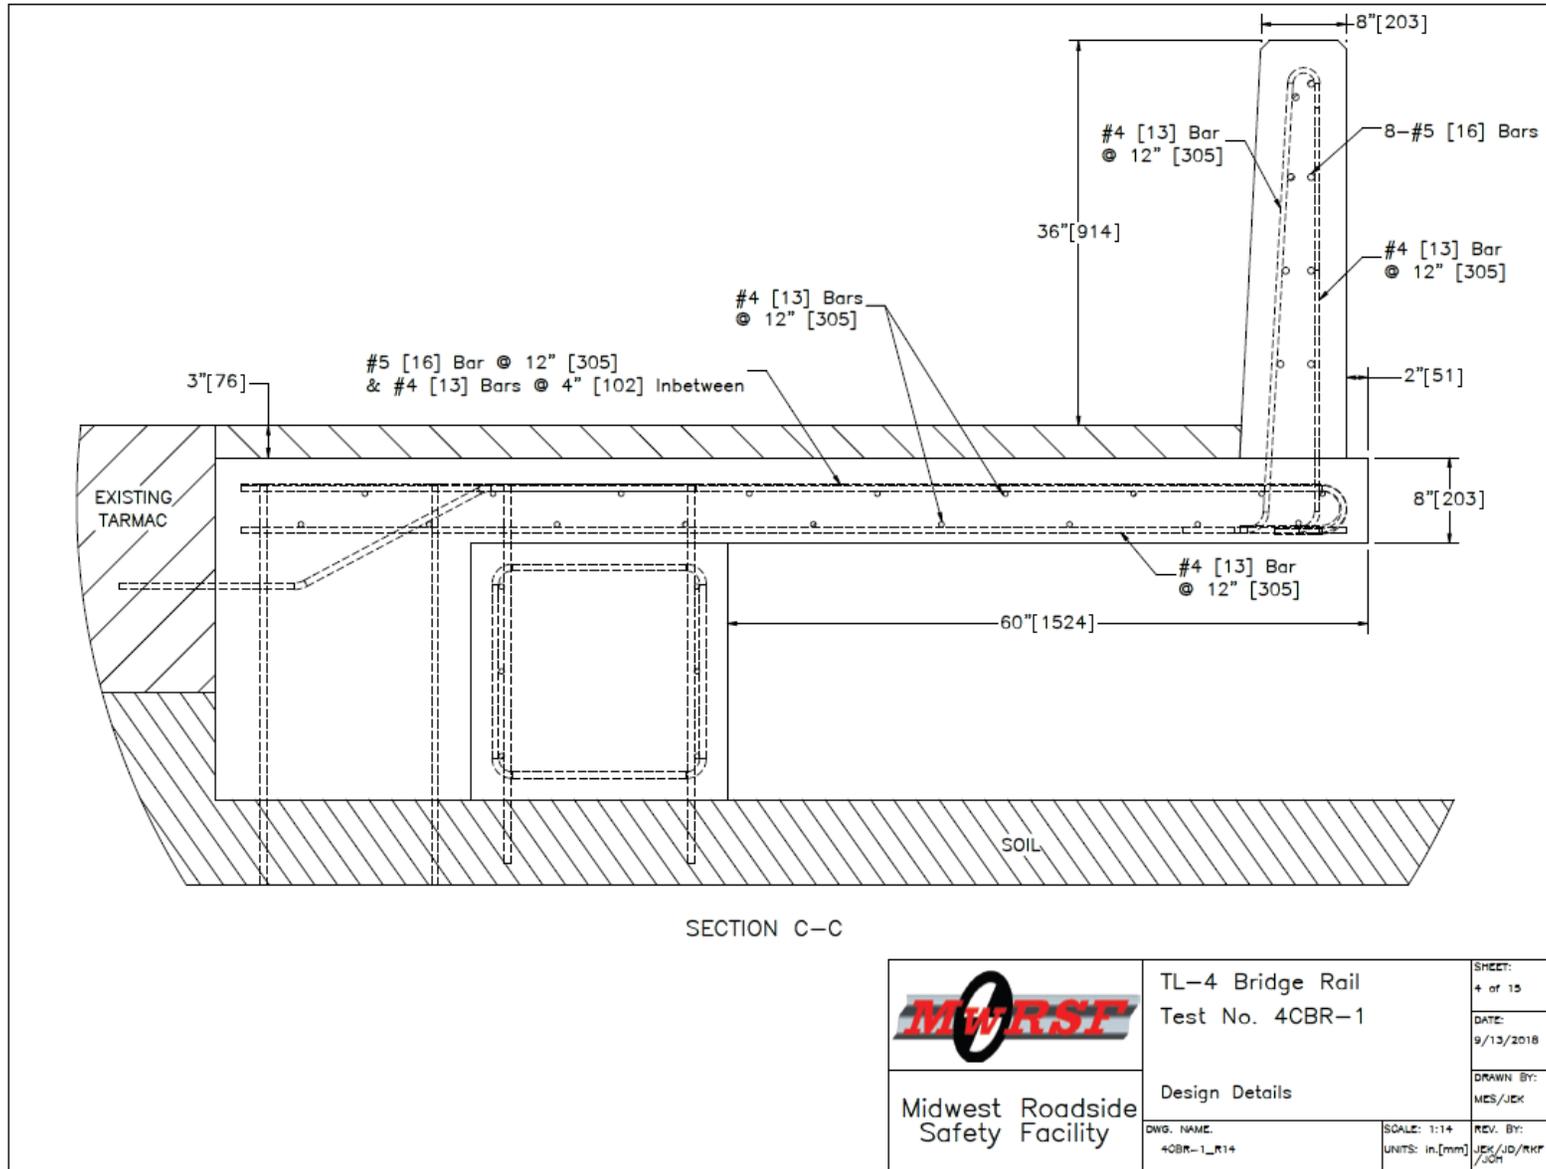
Figure 22. TL-4 Bridge Rail Design Details, Test No. 4CBR-1

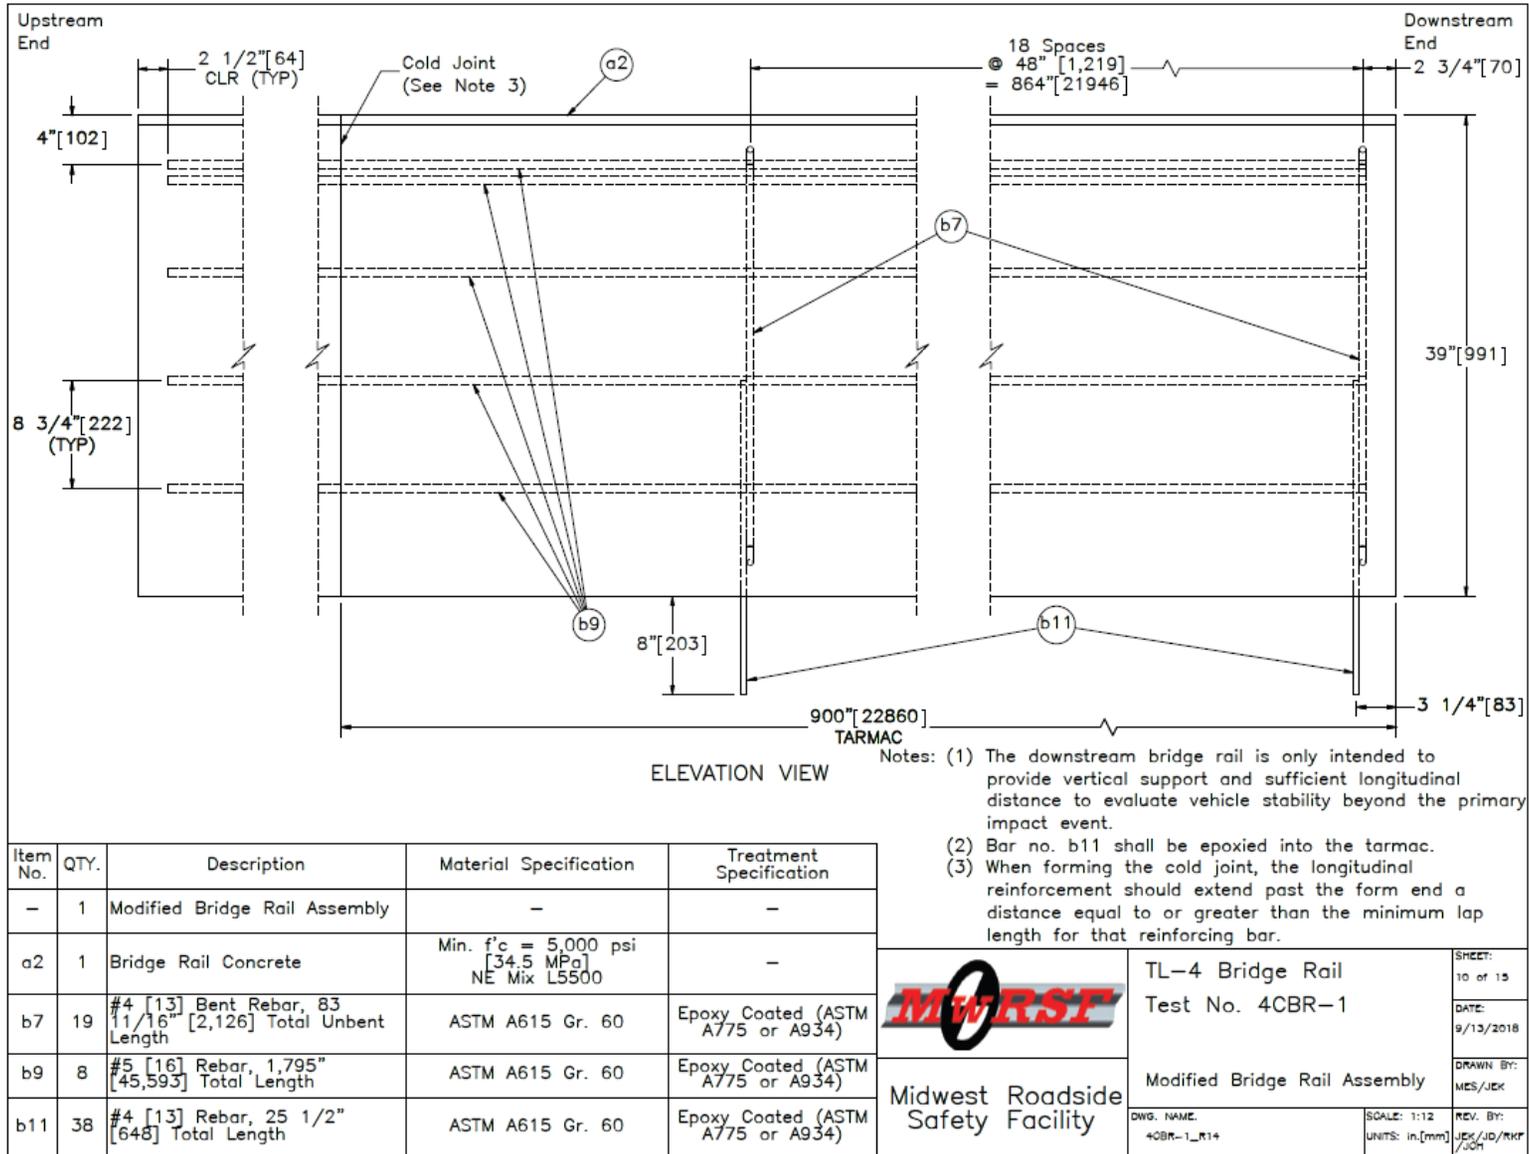
Figure 28. Modified Bridge Rail for Downstream Half of System, Test No. 4CBR-1

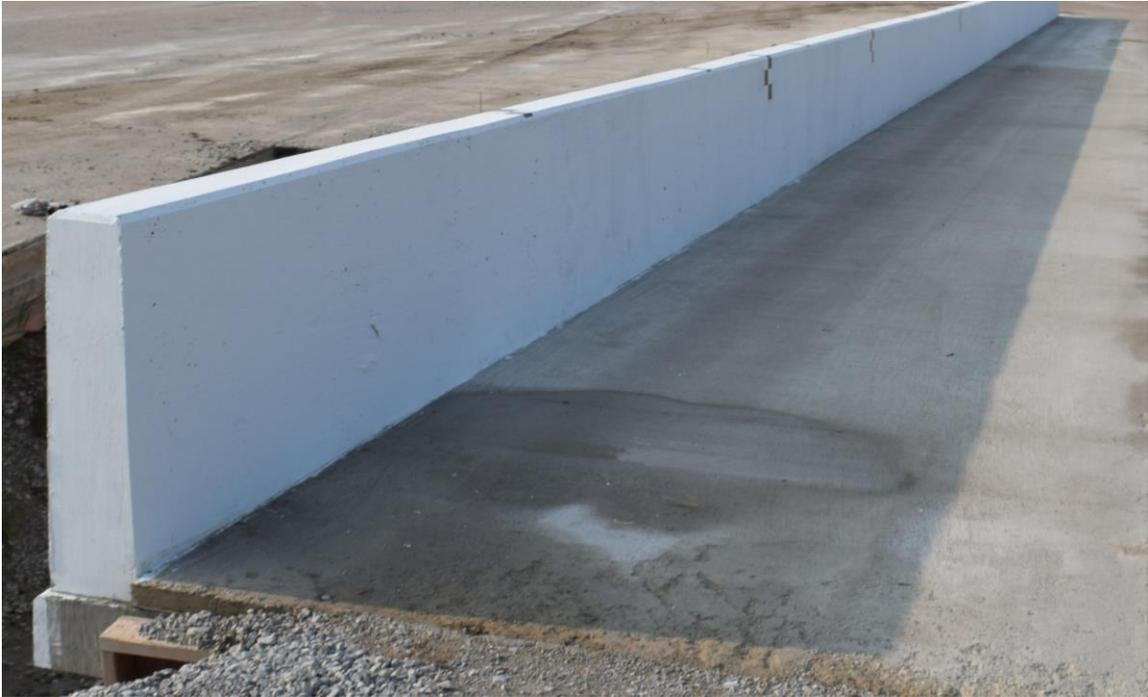
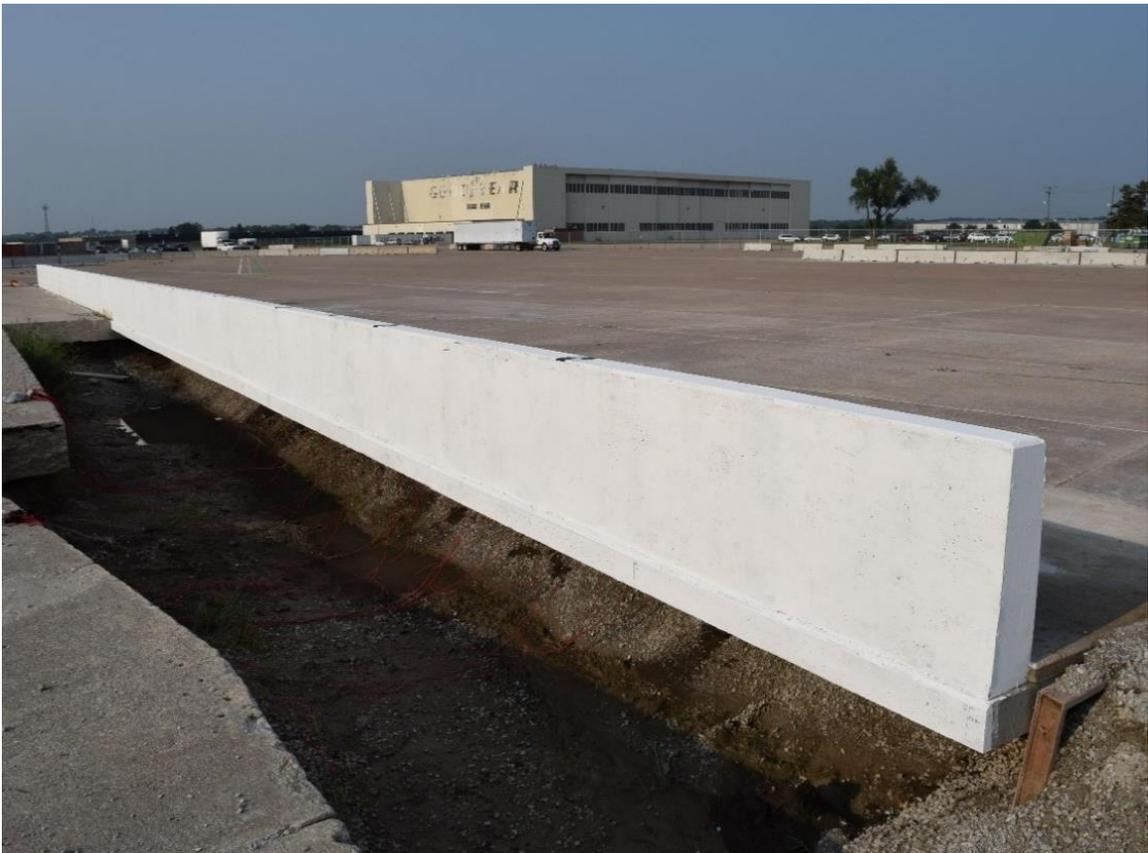
Figure 34. Test Installation Photographs, Test No. 4CBR-1

The test installation for the new TL-4 bridge rail was 150 ft long. The upstream half of the installation was attached to a simulated bridge deck, while the downstream half of the bridge rail was attached directly to the test site's concrete tarmac. The system was impacted on the upstream half of the installation in order to evaluate the bridge rail and deck under maximum loading conditions. The downstream half of the installation was only necessary to allow adequate time and distance for the single-unit truck box to lean on the barrier and return to an upright position before exiting the system, thus evaluating vehicle stability. The critical test configuration for the reinforced concrete bridge rail incorporated a 3-in. overlay on the bridge deck. Thus, the 39-in. tall bridge rail extended only 36 in. above the roadway surface. This configuration allowed for the greatest impact height and moment arm above the bridge deck. Design details for the TL-4 concrete bridge rail are shown in Figures 19 through 33, and photographs of the test installation are shown in Figure 34.

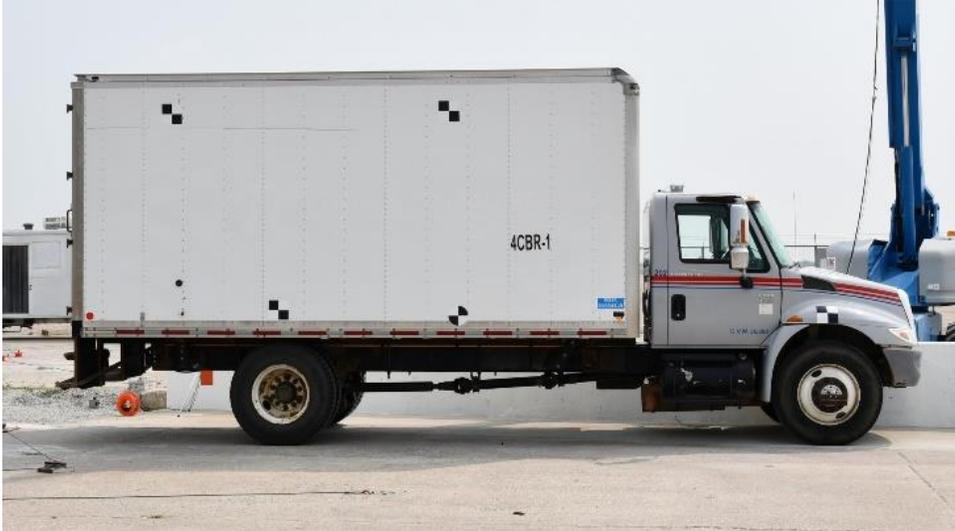
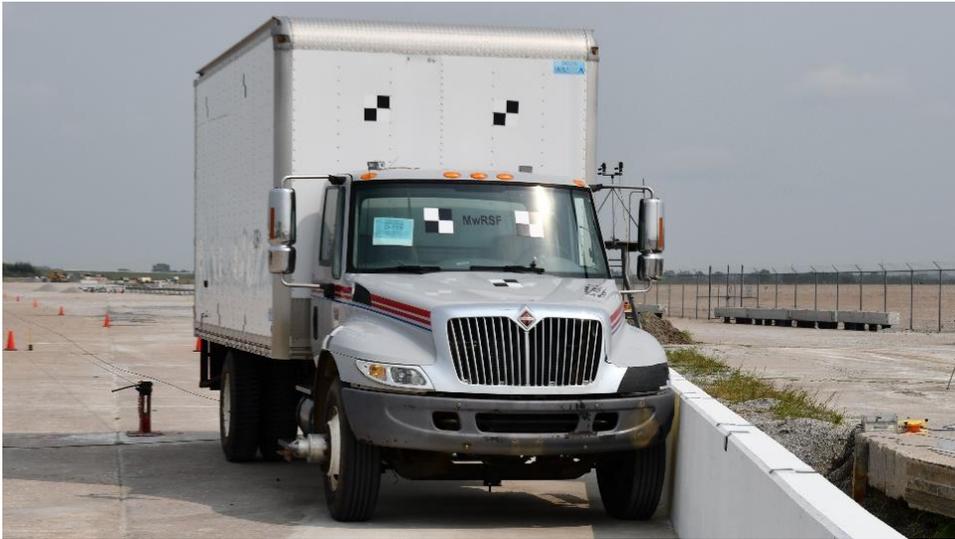
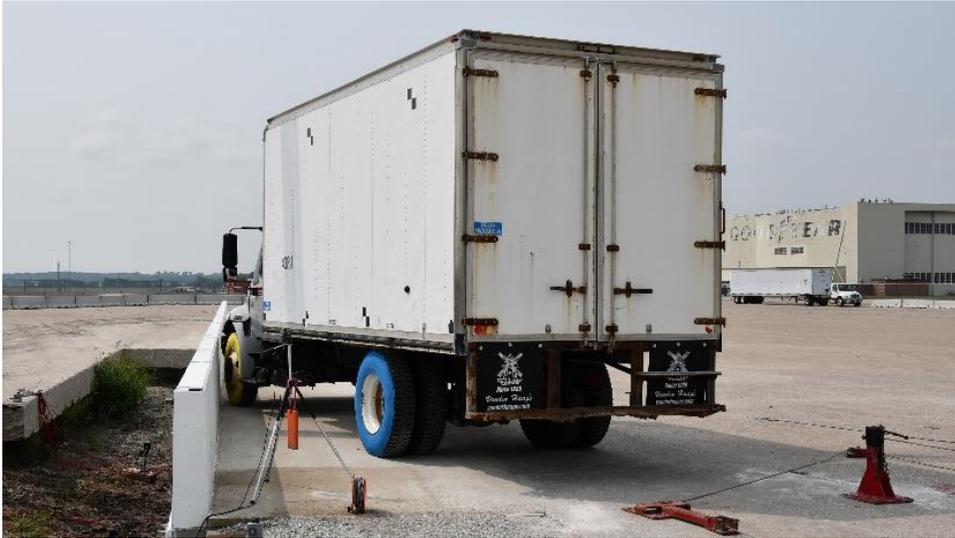
Figure 35. Test Vehicle, Test No. 4CBR-1

For test no. 4CBR-1, a 2005 International 4300 single-unit truck was used as the test vehicle. The curb, test inertial, and gross static vehicle weights were 14,742 lb, 22,198 lb, and 22,360 lb, respectively. The test vehicle and ballast are shown in Figures 35 through 37 and vehicle dimensions are shown in Figure 38.

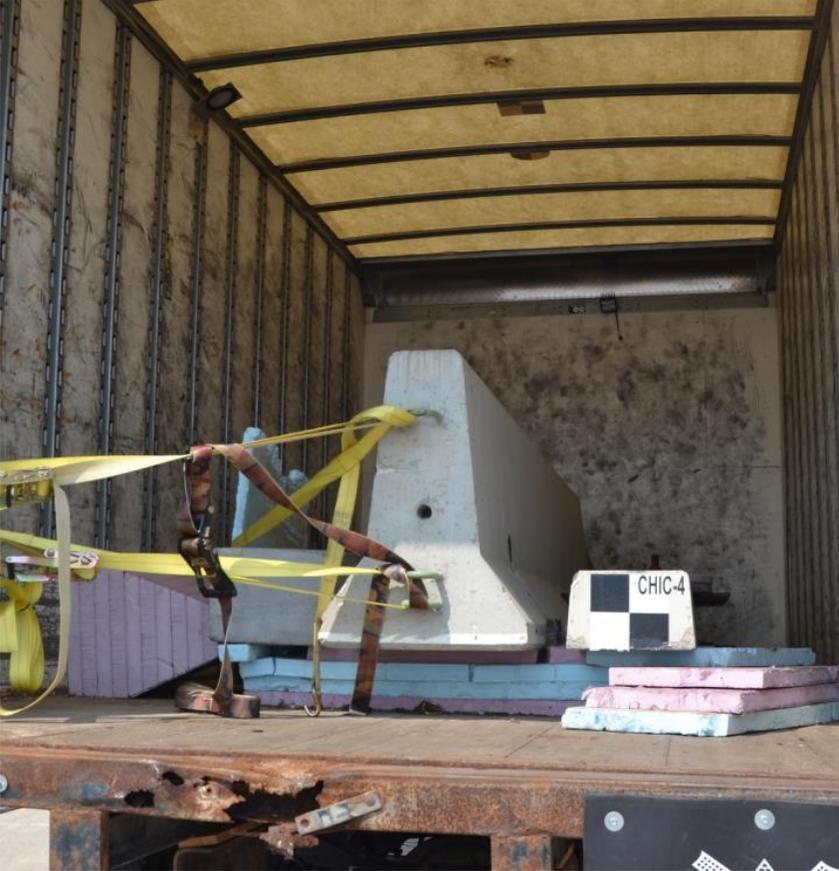
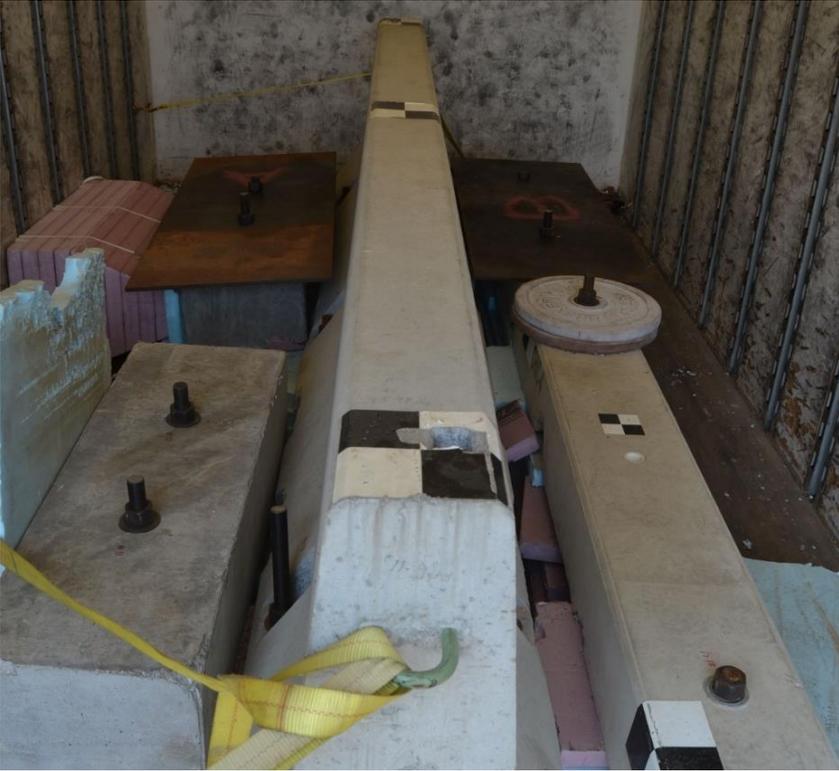
Figure 36. Test Vehicle Ballast, Test No. 4CBR-1
