DEVELOPMENT AND TESTING OF AN OPTIMIZED MASH TL-4 CONCRETE BRIDGE RAIL

MwRSF Research Report No. TRP-03-415-21
March 26, 2021

16. Abstract A new concrete bridge rail was developed and optimized using recently updated <i>Manual for Assessing Safety Hardware</i> (MASH) Test-Level 4 (TL-4) design loads. The rail was optimized to maximize vehicle stability, minimize installation costs, and mitigate the potential for deck damage by minimizing loads transferred to the deck. Additionally, the bridge rail was designed with a 39-in. installation height so that it would remain crashworthy after future roadway overlays up to 3 in. thick. The barrier had a front face with a 3-degree slope (i.e., batter) away from vertical to promote vehicle stability during impacts while also providing some slope to allow for slipforming real-world installations. Yield-line theory was utilized to design both interior and end regions of the barrier. Further, minimum deck strengths were determined and a deck overhang design procedure was provided for users desiring to modify their existing deck details. Finally, MASH test designation no. 4-12 was conducted on the new bridge rail to evaluate its safety performa

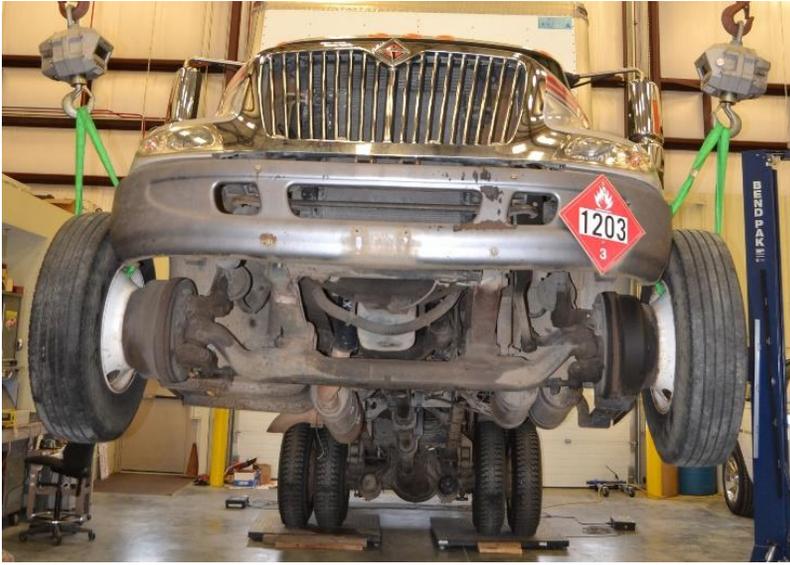
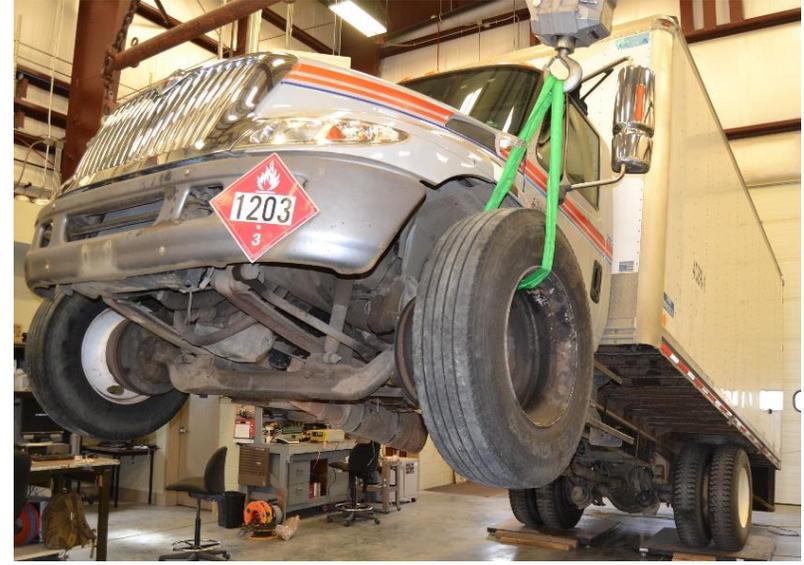
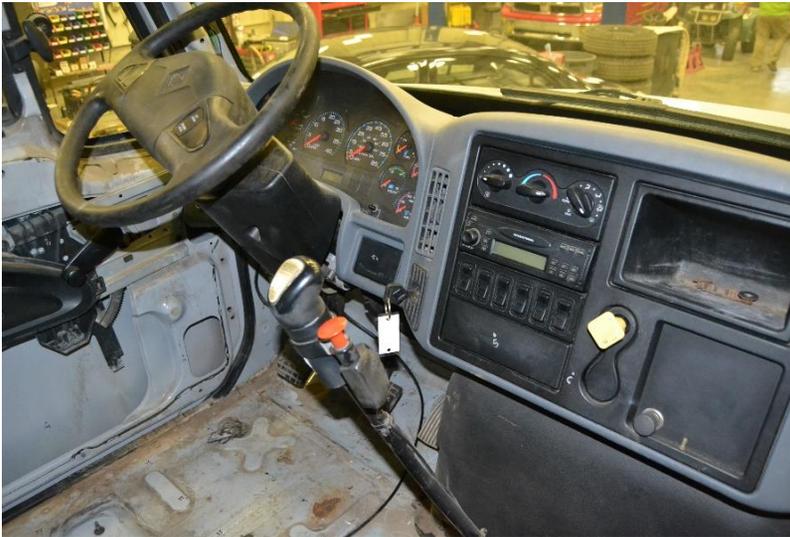
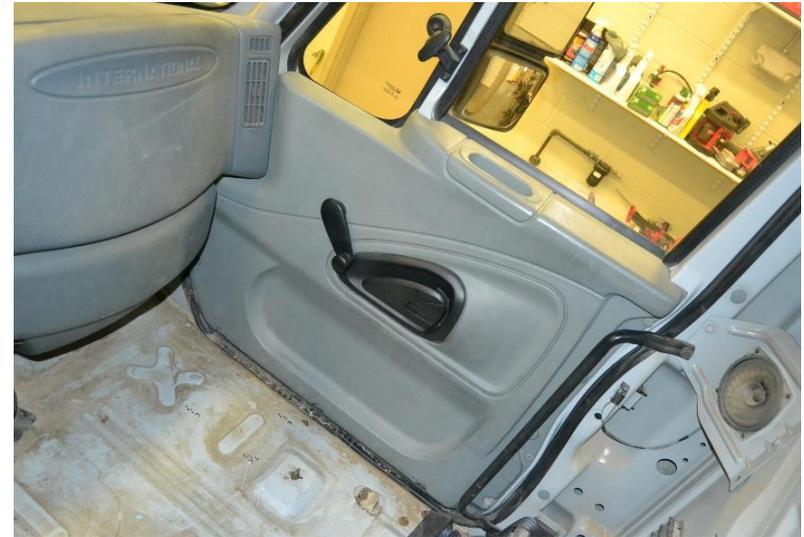
Figure 37. Test Vehicle's Interior Floorboards and Undercarriage, Test No. 4CBR-1

For test no. 4CBR-1, a 2005 International 4300 single-unit truck was used as the test vehicle. The curb, test inertial, and gross static vehicle weights were 14,742 lb, 22,198 lb, and 22,360 lb, respectively. The test vehicle and ballast are shown in Figures 35 through 37 and vehicle dimensions are shown in Figure 38.

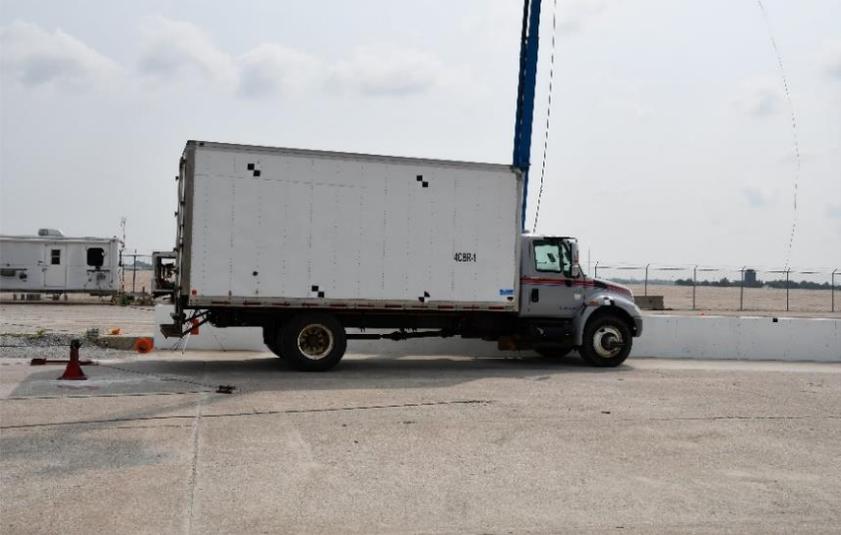
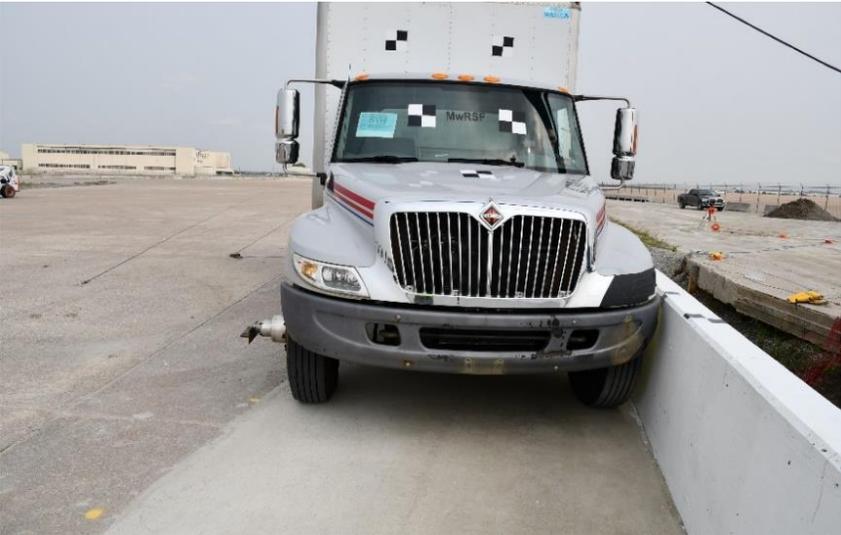
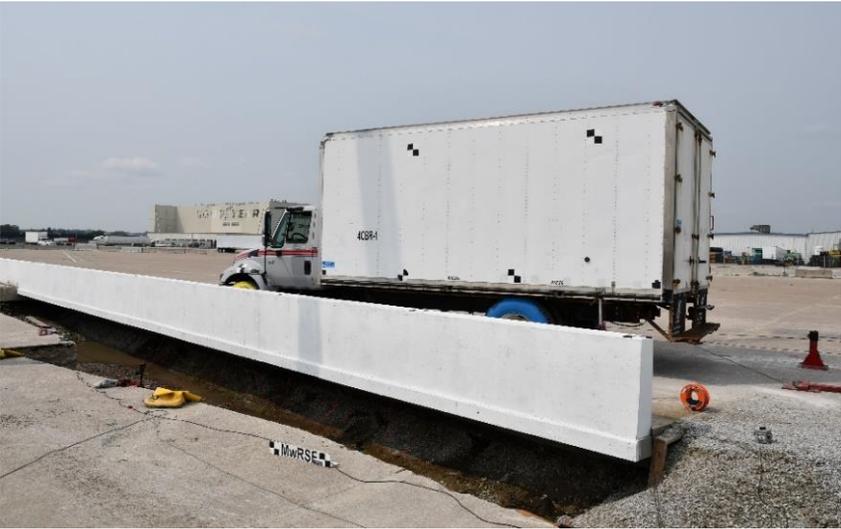
Figure 41. Impact Location, Test No. 4CBR-1

Initial vehicle impact was to occur 27 ft – 8 in. downstream from the upstream end of barrier, as shown in Figure 41, which was selected to load the center of the simulated bridge deck and avoid loads transferring out close to the ends of the deck. During test no. 4CBR-1, the 22,198-lb SUT impacted the bridge rail 4 in. upstream from the targeted impact point at a speed of 57.6 mph and an angle of 16.0 degrees. The barrier contained and redirected the SUT with minimal system deflection and negligible system damage. The SUT reached a maximum roll angle of 35 degrees during redirection and exited the system with a speed and angle of 41.7 mph and 2.8 degrees, respectively. After exiting the system, the SUT rolled downstream, impacted a row of portable concrete barriers, ruptured a few of the barrier connections, and came to rest on top of one of the barrier segments approximately 350 ft downstream from impact. A detailed description of the sequential impact events is contained in Table 11, and sequential photographs of the impact event are shown in Figures 42 through 44. Documentary photographs are shown in Figure 45. Photographs of the vehicle trajectory and final position are shown in Figure 46.

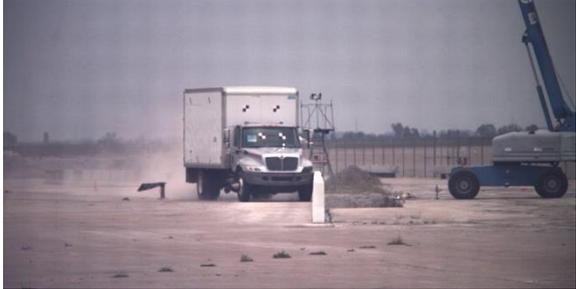
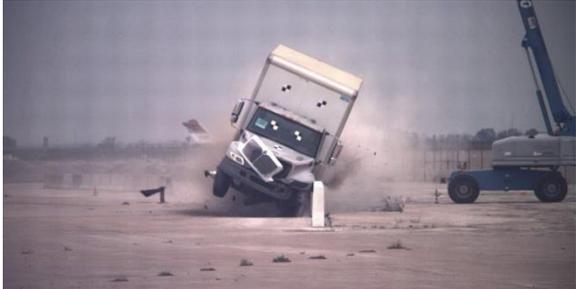
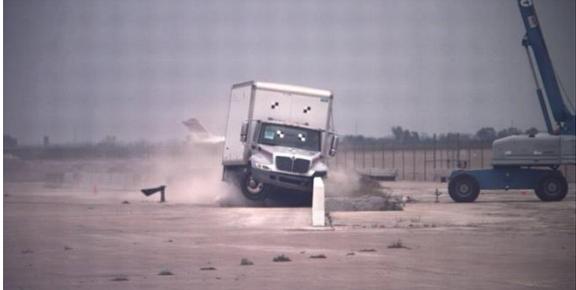
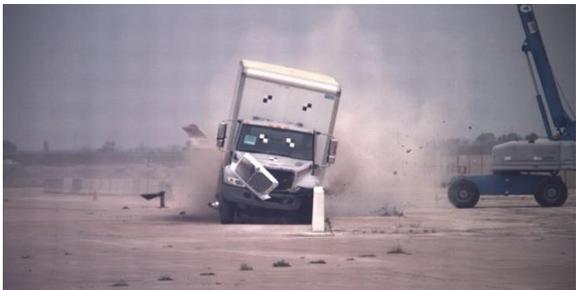
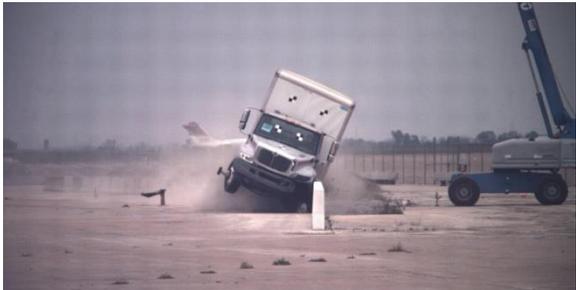
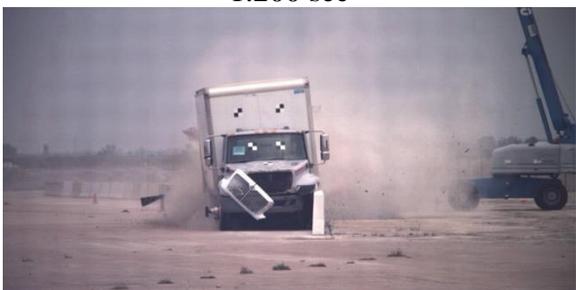
Figure 42. Sequential Photographs, Test No. 4CBR-1

1.828	Vehicle's left-front tire regained contact with ground.
4.300	Vehicle impacted portable concrete barriers used for vehicle containment.
4.800	Vehicle overrode a portable concrete barrier segment.

8.000	Vehicle came to rest approximately 350 feet downstream from impact.

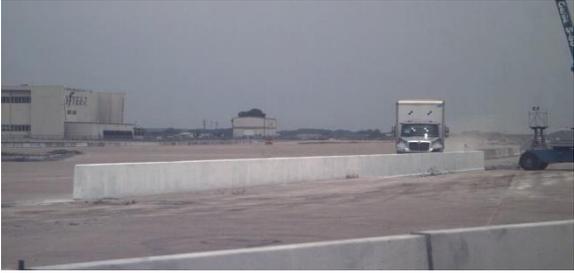
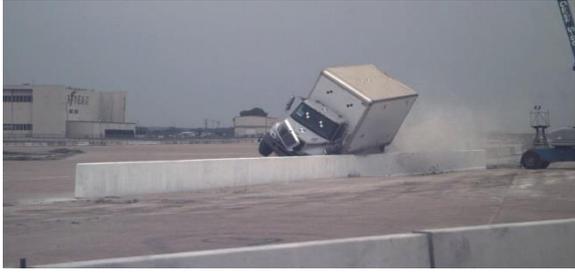
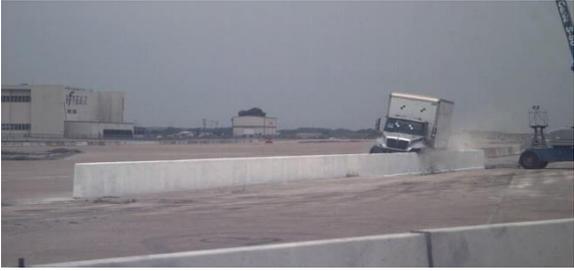
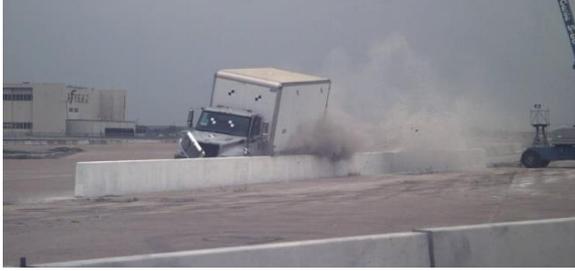
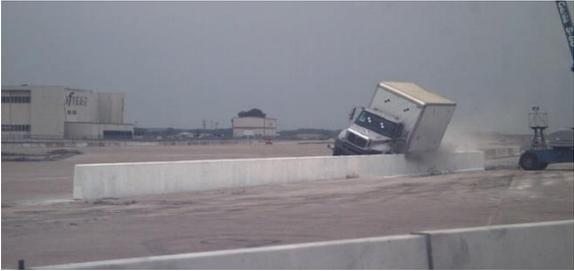
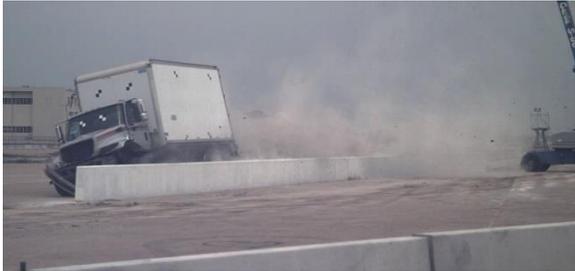
Figure 43. Additional Sequential Photographs, Test No. 4CBR-1

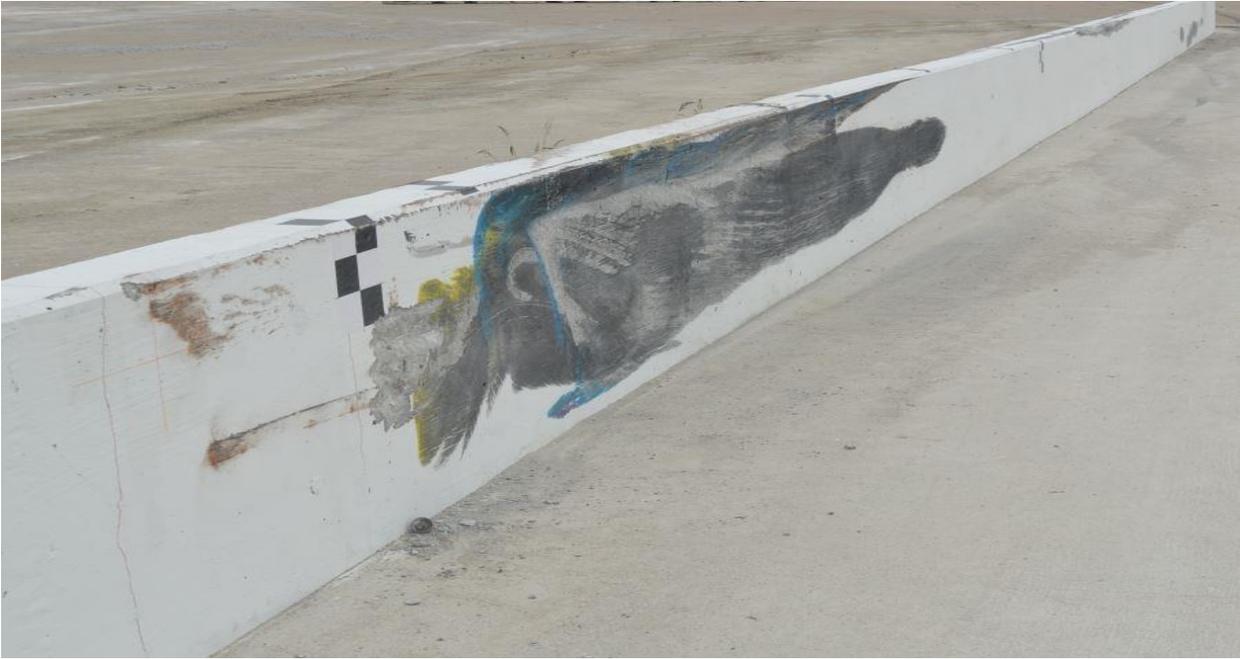
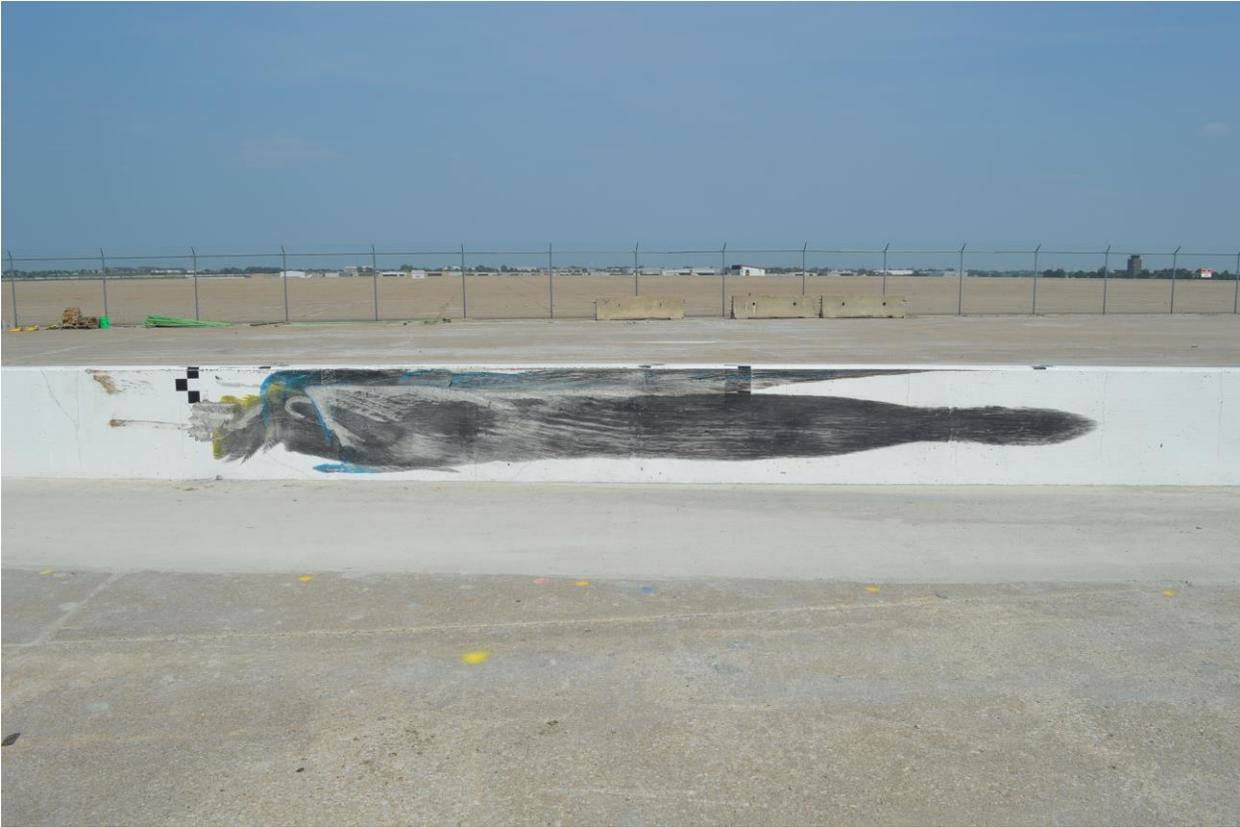
Figure 47. Overall System Damage, Test No. 4CBR-1

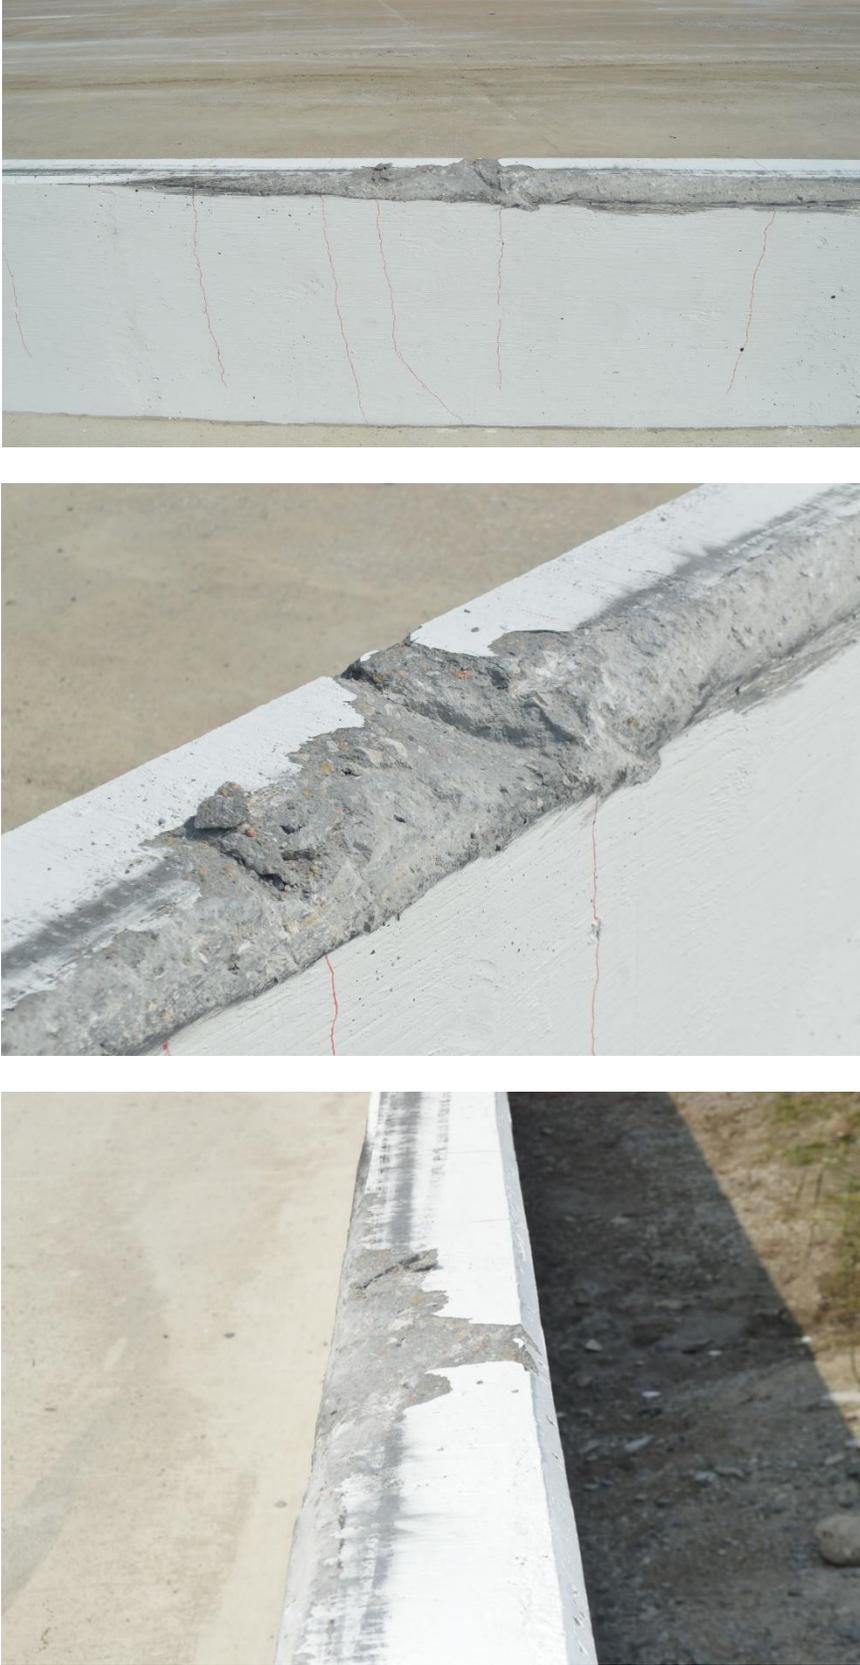
Figure 48. System Damage, Downstream Gouge Details, Test No. 4CBR-1

The length of vehicle contact was approximately 112 ft. The primary contact mark on the face of the bridge rail began at the impact point and extended 25 ft downstream. Another significant contact mark was observed on the top face, starting 27 ft – 8 in. downstream from the impact point and spanning 17 ft – 8 in., coinciding with the cargo box leaning on the barrier. Less severe contact marks were observed on the top face of the barrier starting 45 ft – 7 in. from the impact point and extending 42 ft – 4 in. downstream. Additionally, minor contact marks were observed on the front face of the barrier beginning 44 ft – 3 in. downstream from impact and continuing to the downstream end of the system.

Damage to the barrier was minimal, as shown in Figures 47 through 50. Barrier damage consisted of contact marks, concrete gouges and spalling, and minor cracks. Shrinkage cracks present before testing were highlighted with a red marker, as can be seen in the damage documentation photographs.

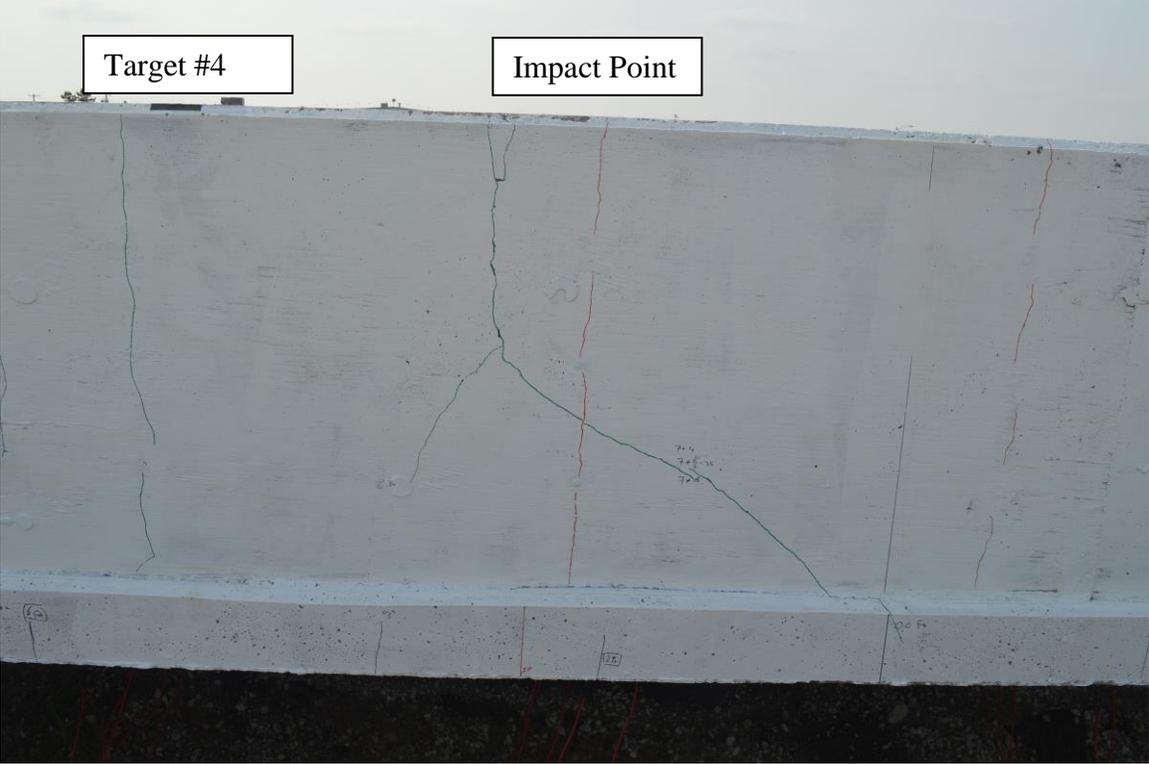
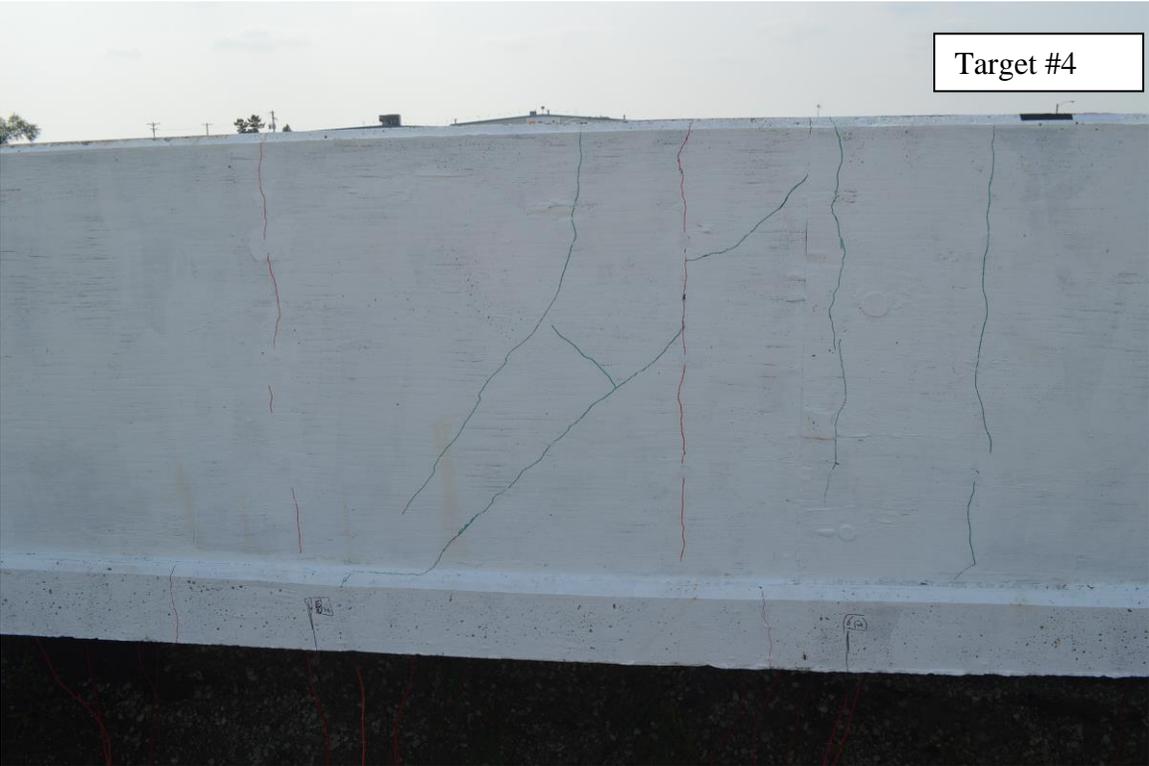
Note: Red lines are shrinkage cracks present before testing. Green lines are cracks from impact.

Figure 49. System Damage, Backside of Bridge Rail, Test No. 4CBR-1

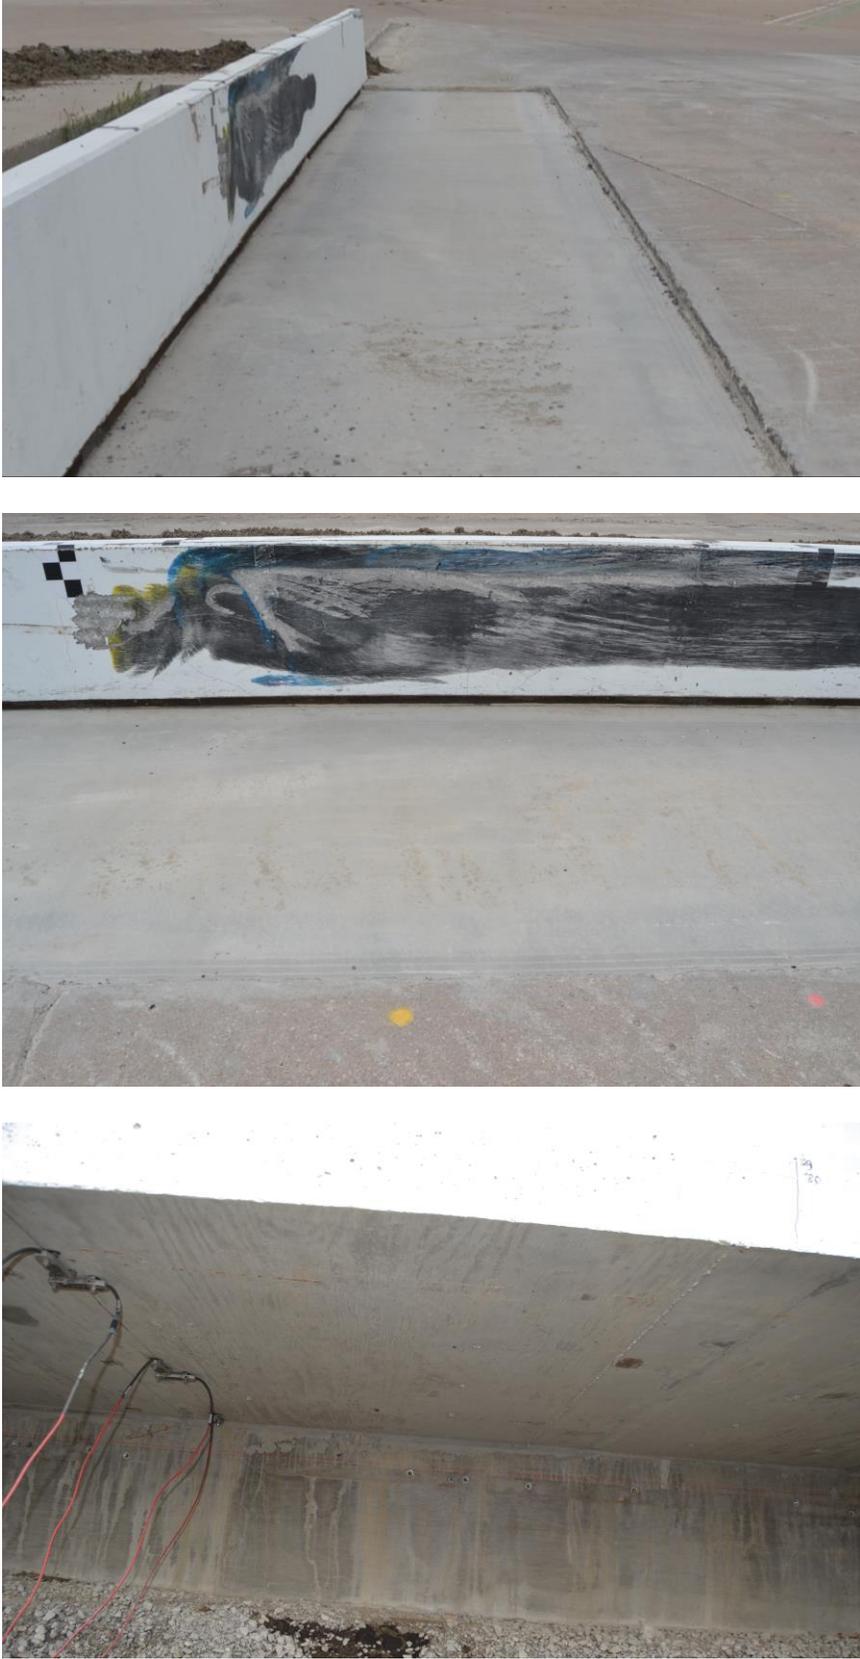
Figure 50. Deck Damage, Test No. 4CBR-1

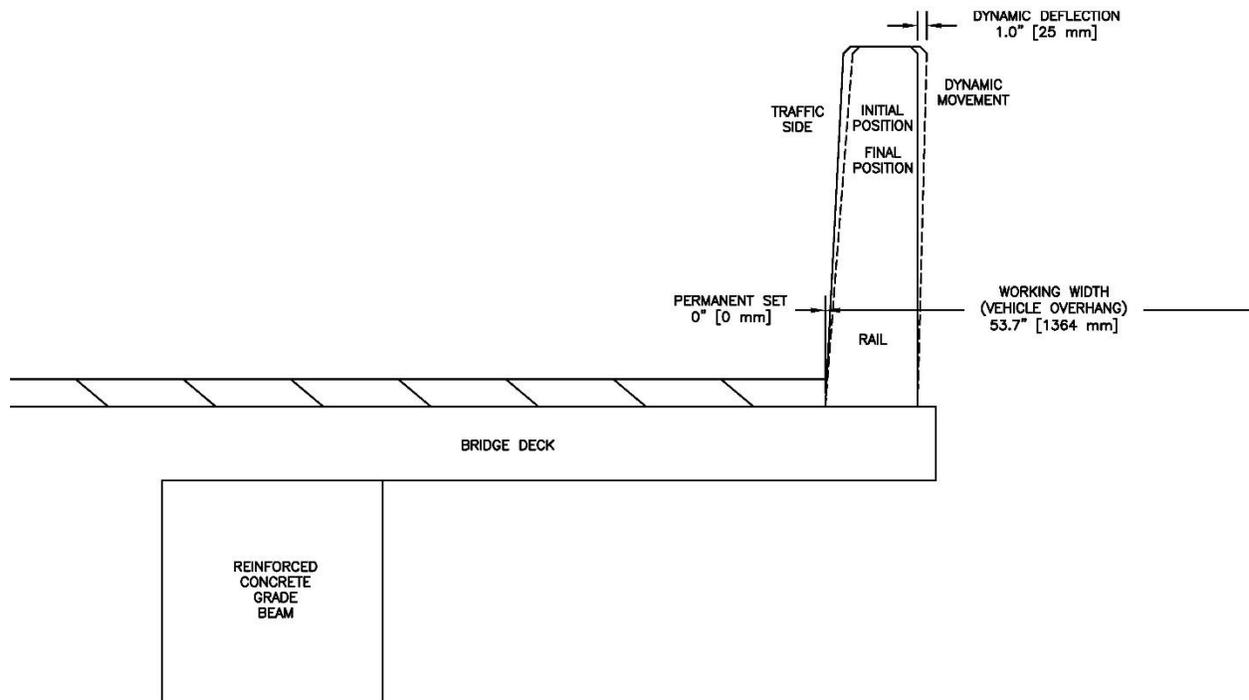
Figure 51. Permanent Set, Dynamic Deflection, and Working Width, Test No. 4CBR-1

The maximum lateral dynamic barrier deflection, including flexure in the deck, was 1.0 in., which occurred 22 ft – 11 in. downstream from the impact point, as determined from high-speed digital video analysis. After the impact event, the deck overhang and barrier both returned to their original positions resulting in a permanent set of 0.0 in. The working width of the system was 53.7 in., also determined from high-speed digital video analysis. A schematic of the permanent set, dynamic deflection, and working width is shown in Figure 51.

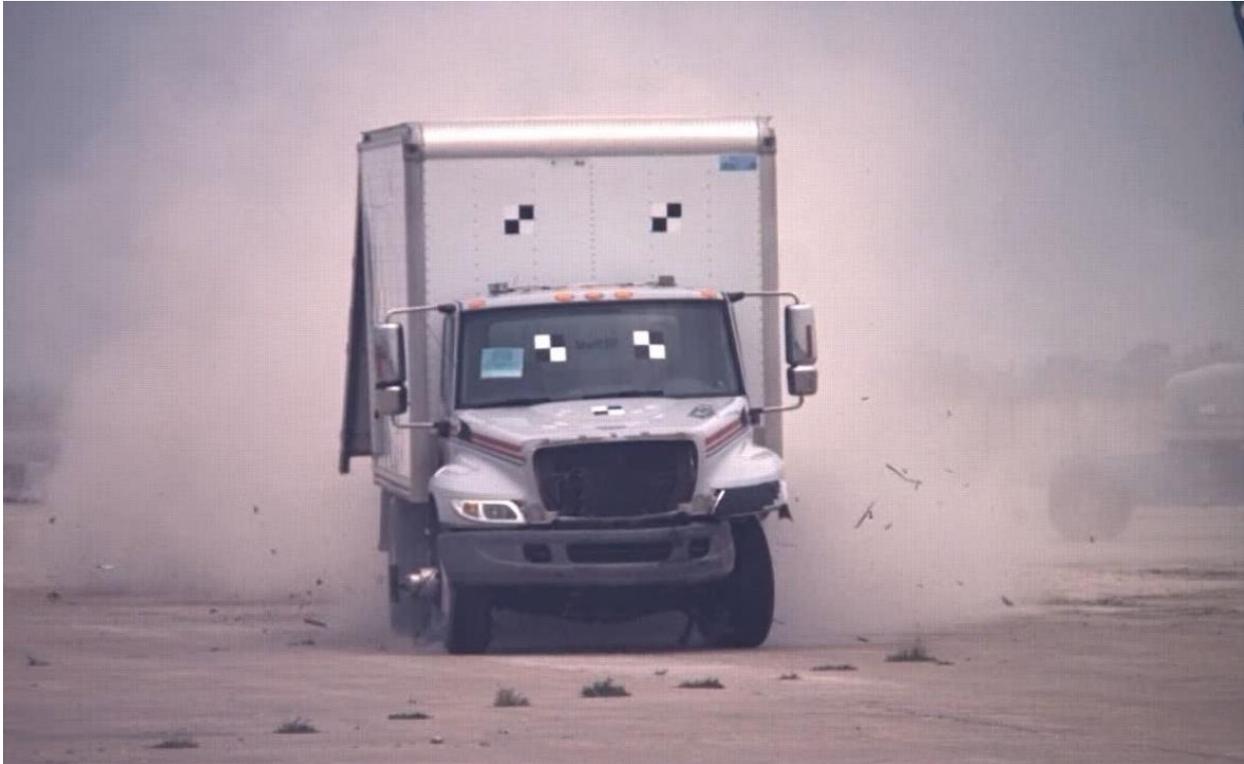
Figure 52. Vehicle Damage after Primary Impact

In the impact with the concrete bridge rail system, the test vehicle sustained minimal damage concentrated on the left-front corner of the vehicle. The grille disengaged from the vehicle. The left side of the front bumper was deformed inward and backward. The left fender was pushed upward and dented inward. The left-front and left-rear wheel assemblies were deformed, and deformations and gouging were present on the left-side wheel rims. The left side of the rear bumper was dented and scuffed. Additionally, the right-side box door was removed from its hinges. The damage sustained by the vehicle in the impact with the bridge rail system, prior to its secondary impact with the PCBs, is shown in Figure 52. Note that the vehicle was rolling downstream on all tires.

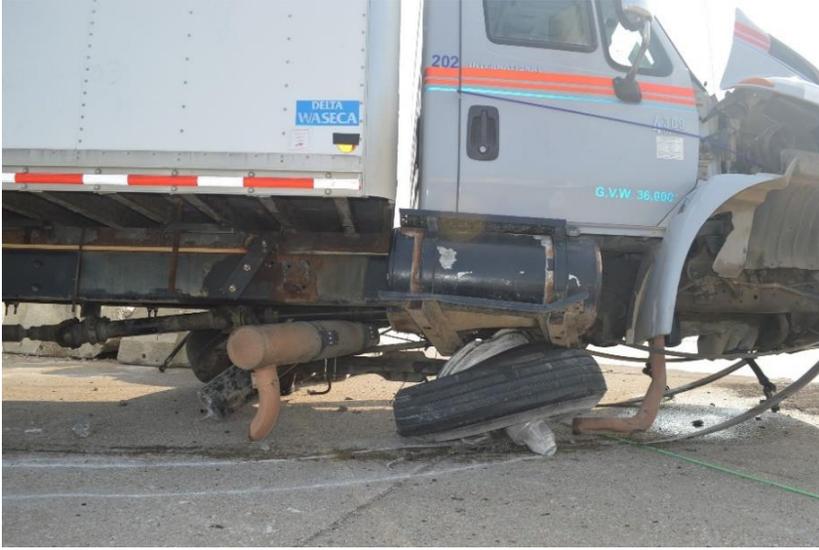
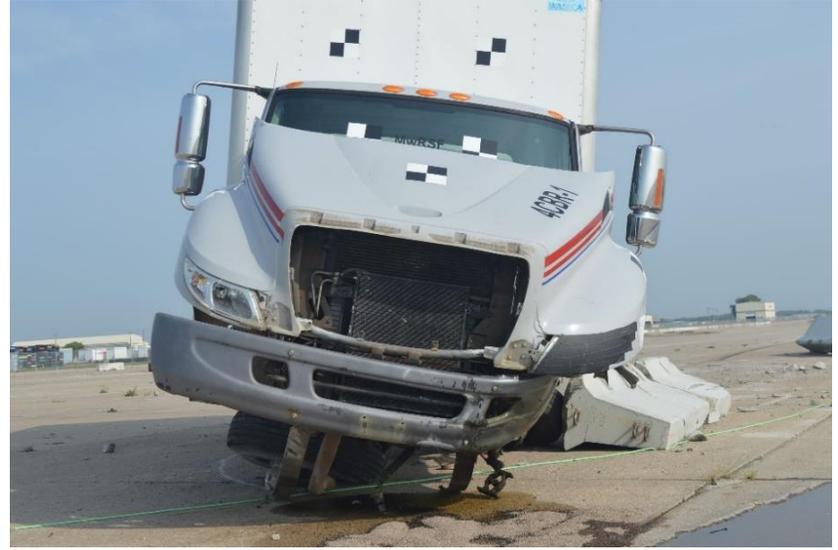
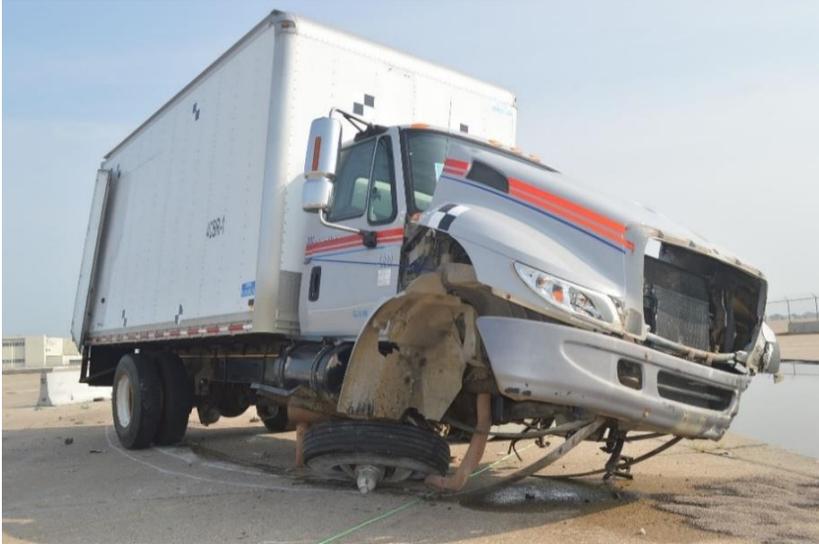
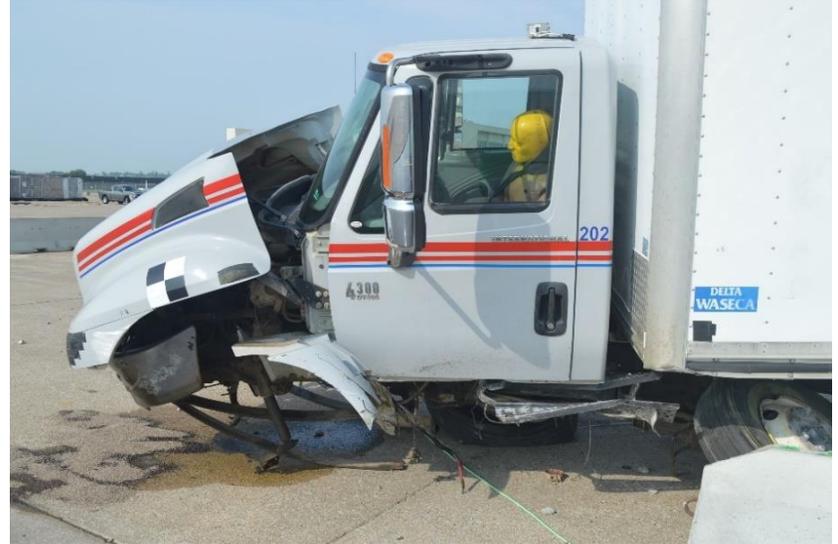
Figure 53. Left- and Right-Side Vehicle Damage, Test No. 4CBR-1

After the test, the vehicle suffered severe damage in a secondary impact where the vehicle broke through and overrode a PCB installation. Severe damage was sustained by the front end and undercarriage of the vehicle, including complete disengagement of the front axle, severing of the brake lines, backward crushing of the engine compartment, and separation of the floor pan seam near the left-front corner of the occupant compartment. Less severe damage included tearing of the front tires and denting and gouging of the undercarriage in multiple locations.

The total damage sustained by the vehicle in both test no. 4CBR-1 and the subsequent impact with the arresting structure is shown in Figures 53 through 56. Overall, the damage to the vehicle was severe, although the damage sustained in the actual impact with the concrete bridge rail system was minimal. The maximum occupant compartment intrusions are listed in Table 12 along with the intrusion limits established in MASH 2016 [3] for various areas of the occupant compartment. Complete occupant compartment and vehicle deformations and the corresponding locations are provided in Appendix C. MASH 2016 defines intrusion or deformation as the occupant compartment being deformed and reduced in size with no observed penetration. The floor pan deformation and seam opening near the left-front corner of the heavily-corroded floor pan, as shown in Figure 56, were sustained during the secondary impact as the front axle and tire were driven backward and under the occupant compartment. Consequently, the floor pan seam opening was not included in the safety evaluation of the bridge rail system. Therefore, none of the established MASH 2016 deformation limits were violated in test no. 4CBR-1. Outward deformations, which are denoted as negative numbers in Appendix C, are not considered crush toward the occupant and are not evaluated by MASH 2016 criteria.

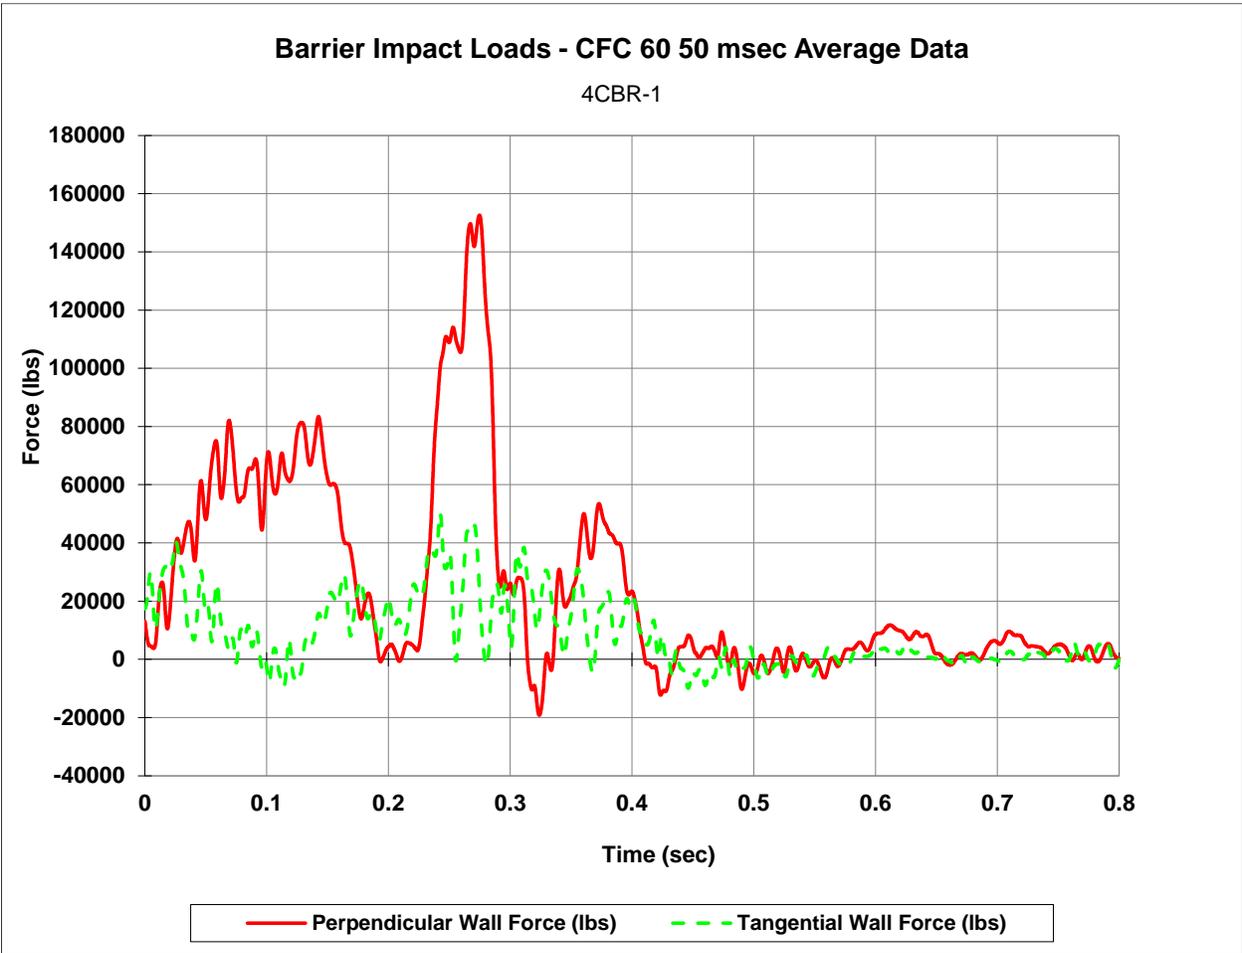
Figure 57. Perpendicular and Tangential Impact Forces, Test No. 4CBR-1

The longitudinal and lateral vehicle accelerations, as measured at the vehicle’s c.g., were processed using an SAE CFC-60 filter and a 50-msec moving average. The 50-msec moving average vehicle accelerations were then combined with the uncoupled yaw angle versus time data in order to estimate the vehicular loading applied to the barrier system. From the data analysis, the perpendicular impact forces were determined for the bridge rail, as shown in Figure 57. A maximum perpendicular (i.e., lateral) impact load equal to 153 kips was imparted on the barrier at 0.275 s after impact, as determined by the SLICE-2 unit. A peak frictional load of 50 kips was observed 0.244 s after impact. Note, these impact loads are significantly higher than expected. Previously measured impact loads from MASH TL-4 crash tests using this estimation procedure were typically between 95 kips and 110 kips [17-18].
