DEVELOPMENT AND EVALUATION OF *MASH* TL-4 GUARDRAIL SYSTEM

Test Report 0-7019-R1

TEXAS A&M TRANSPORTATION INSTITUTE
COLLEGE STATION, TEXAS

TEXAS DEPARTMENT OF TRANSPORTATION

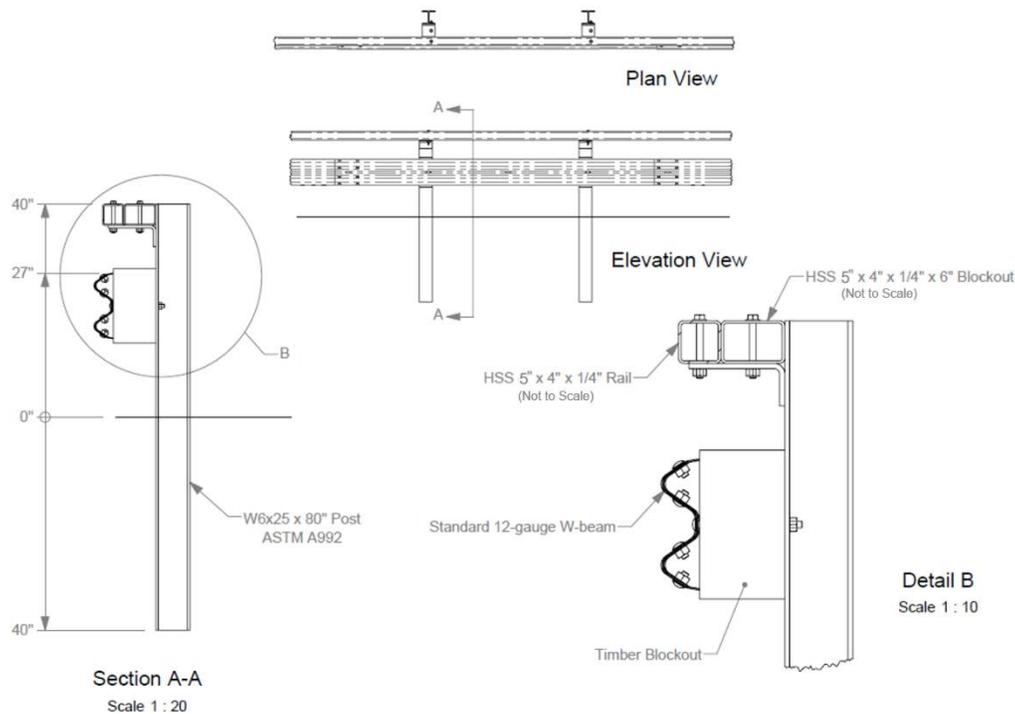
Figure 2.1. Preliminary Design Concept Selected for Simulation Analysis and Detailed Design.

Figure 2.1 shows the preliminary design concept selected for further development through simulation and testing. The design was comprised of a standard W-beam guardrail and a 5-inch \times 4-inch \times 1/4-inch hollow structural section (HSS) tube rail, both supported on W6 \times 25 posts with 6.25-ft post spacing. The height to the top of the W-beam and the HSS rails was 27 inches and 40 inches, respectively. The posts were embedded 40 inches in soil. The W-beam guardrail used standard 6-inch-wide and 8-inch-deep wood blockouts, while the HSS beam had 5-inch \times 4-inch \times 1/4-inch HSS tube blockouts at the post attachment locations.

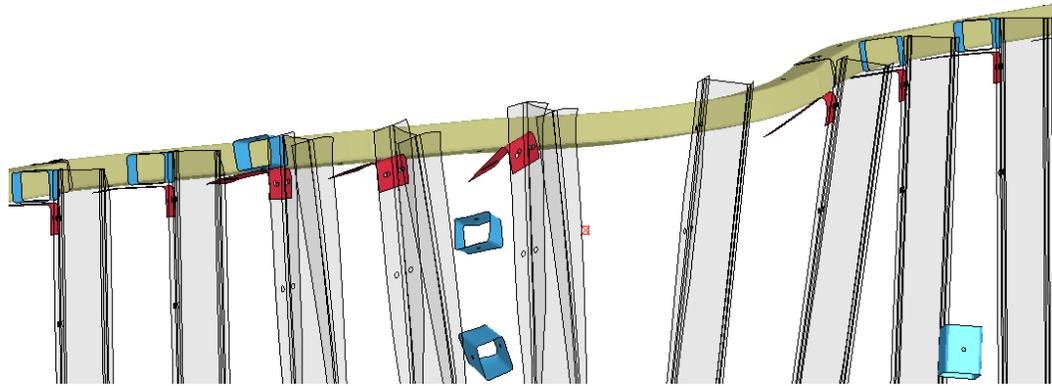
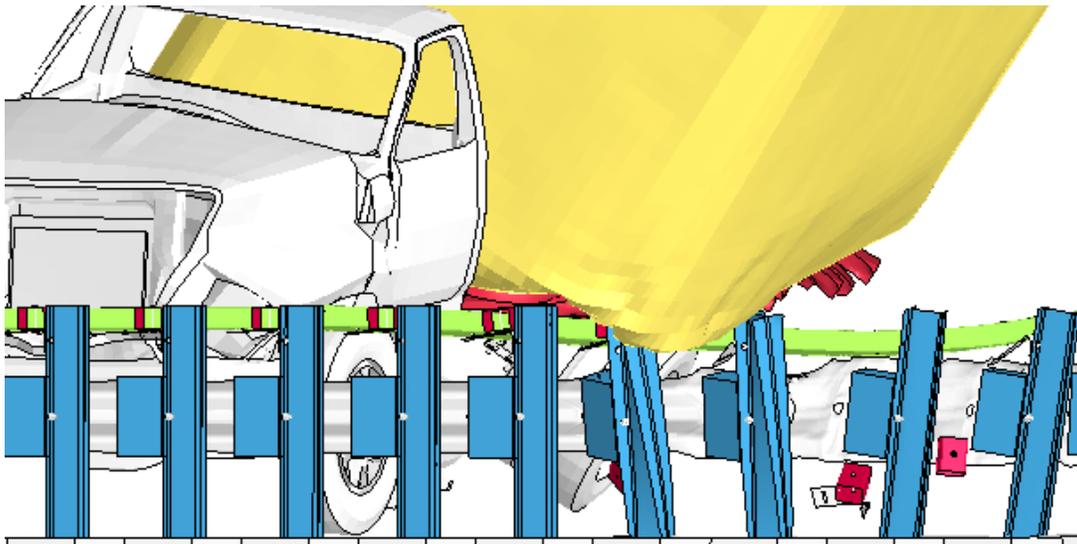
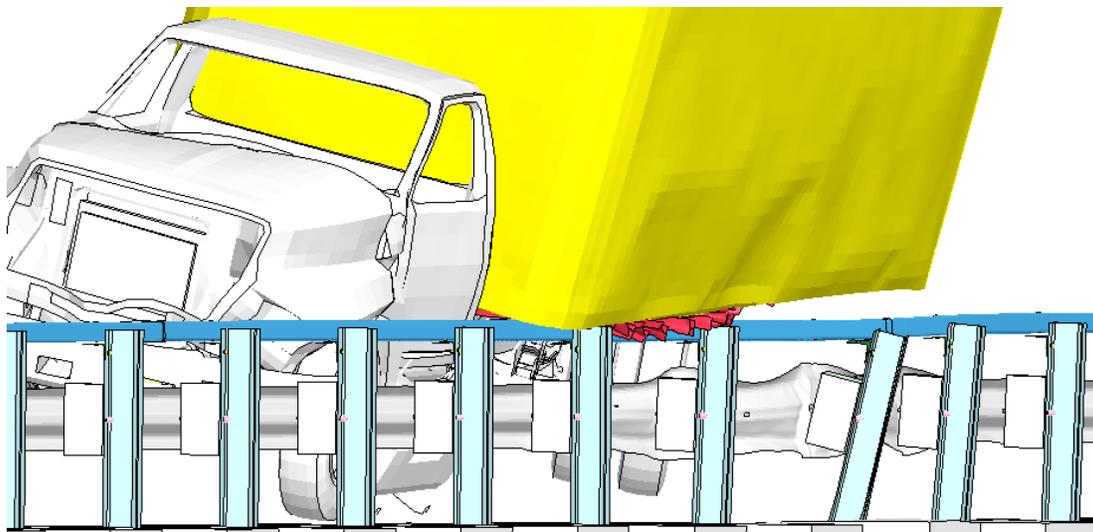
(a) Vertical Deflection of Top HSS Rail and Bending of Support Angles.

(b) Interaction between Vehicle's Box and Crossmembers with Post Tops and HSS Blockouts.

(c) Improved Design with Reduced Interaction between Post Tops and Vehicle's Box. Vertical Bending of Top Rail Is Also Reduced.

The preliminary design incorporated a 12-gauge W-beam guardrail. Impact simulation with the pickup truck showed that due to the use of stiffer posts for the TL-4 guardrail, the 12-gauge W-beam tended to wrap around the blockouts at post locations in the impact region (see Figure 2.5). This resulted in localized pocketing of the vehicle and caused vehicular instability. While the FE model of the W-beam guardrail did not incorporate material rupture, the plastic strain contours of the guardrail showed high plastic strain around the post blockouts due to the localized pocketing and interaction with the impacting vehicle (see Figure 2.6). Such high plastic strain increases the likelihood of a rail rupture during crash testing. To reduce the probability of a rail rupture, the researchers performed additional simulations using a 10-gauge W-beam guardrail. These results are also shown in Figure 2.5 and Figure 2.6. The 10-gauge W-beam guardrail significantly reduced the pocketing and the resulting plastic strains. It also improved the overall kinematics of the vehicle redirection in the simulations. Based on these results, the 10-gauge guardrail was used in the final design.

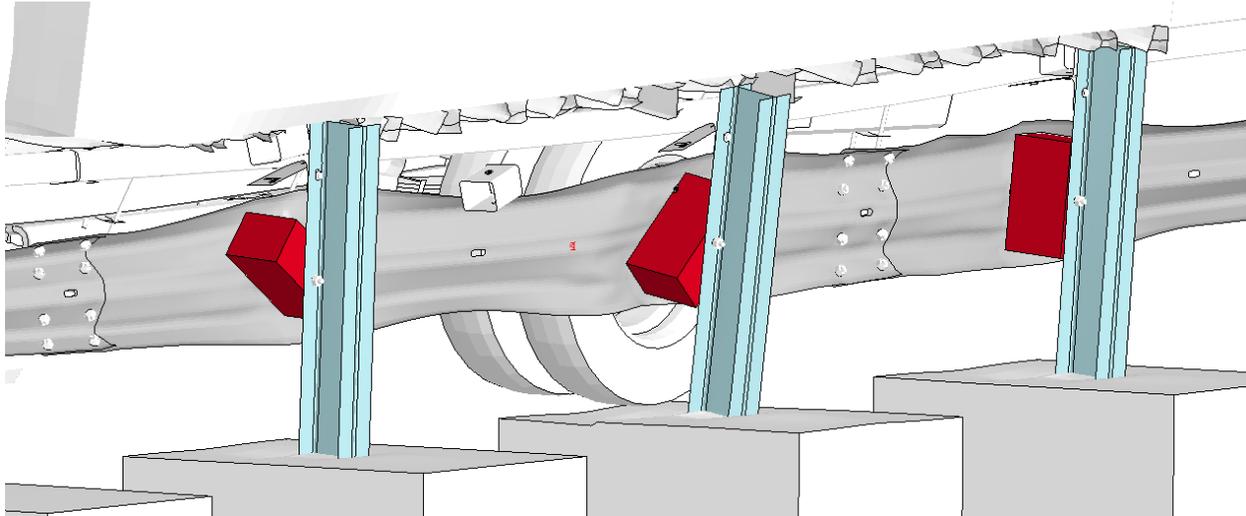
Figure 2.7. Rotation of Wood Blockouts during Impact.

guardrail wrapping around the corners of the blockout, which causes localized stress concentrations and increases the possibility of rail rupture when the vehicle interacts with the guardrail at a post location. To prevent the blockout rotation, the researchers modified the preliminary design to incorporate two ¼-inch-diameter, 5-inch-long hex-head lag bolts that passed through the flange of the post to secure the wood blockouts. In the final crash-tested design, these lag bolts were replaced with an additional guardrail bolt for ease of installation.

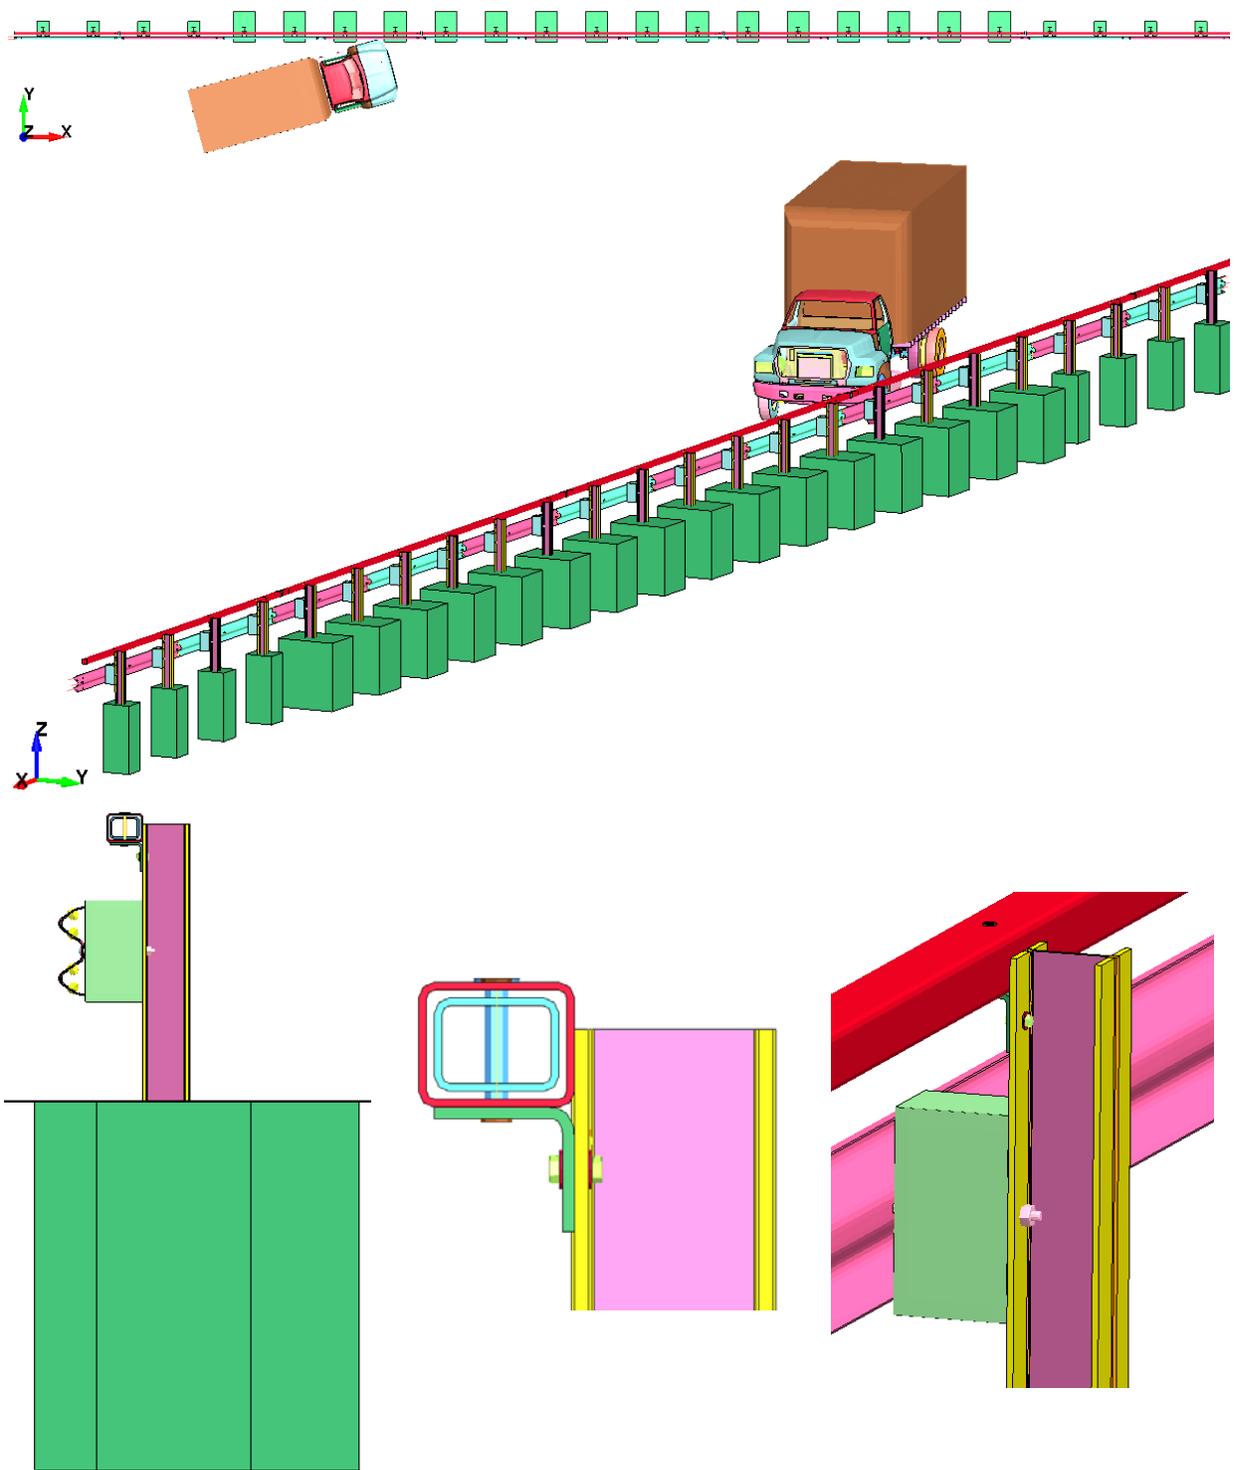
Figure 2.8. FE Model of the Guardrail System Design Recommended for Full-Scale Testing.

After developing the modified model, the researchers simulated the *MASH* impact conditions with this design, and it performed acceptably for TL-4. Details of these impact simulations are presented next.

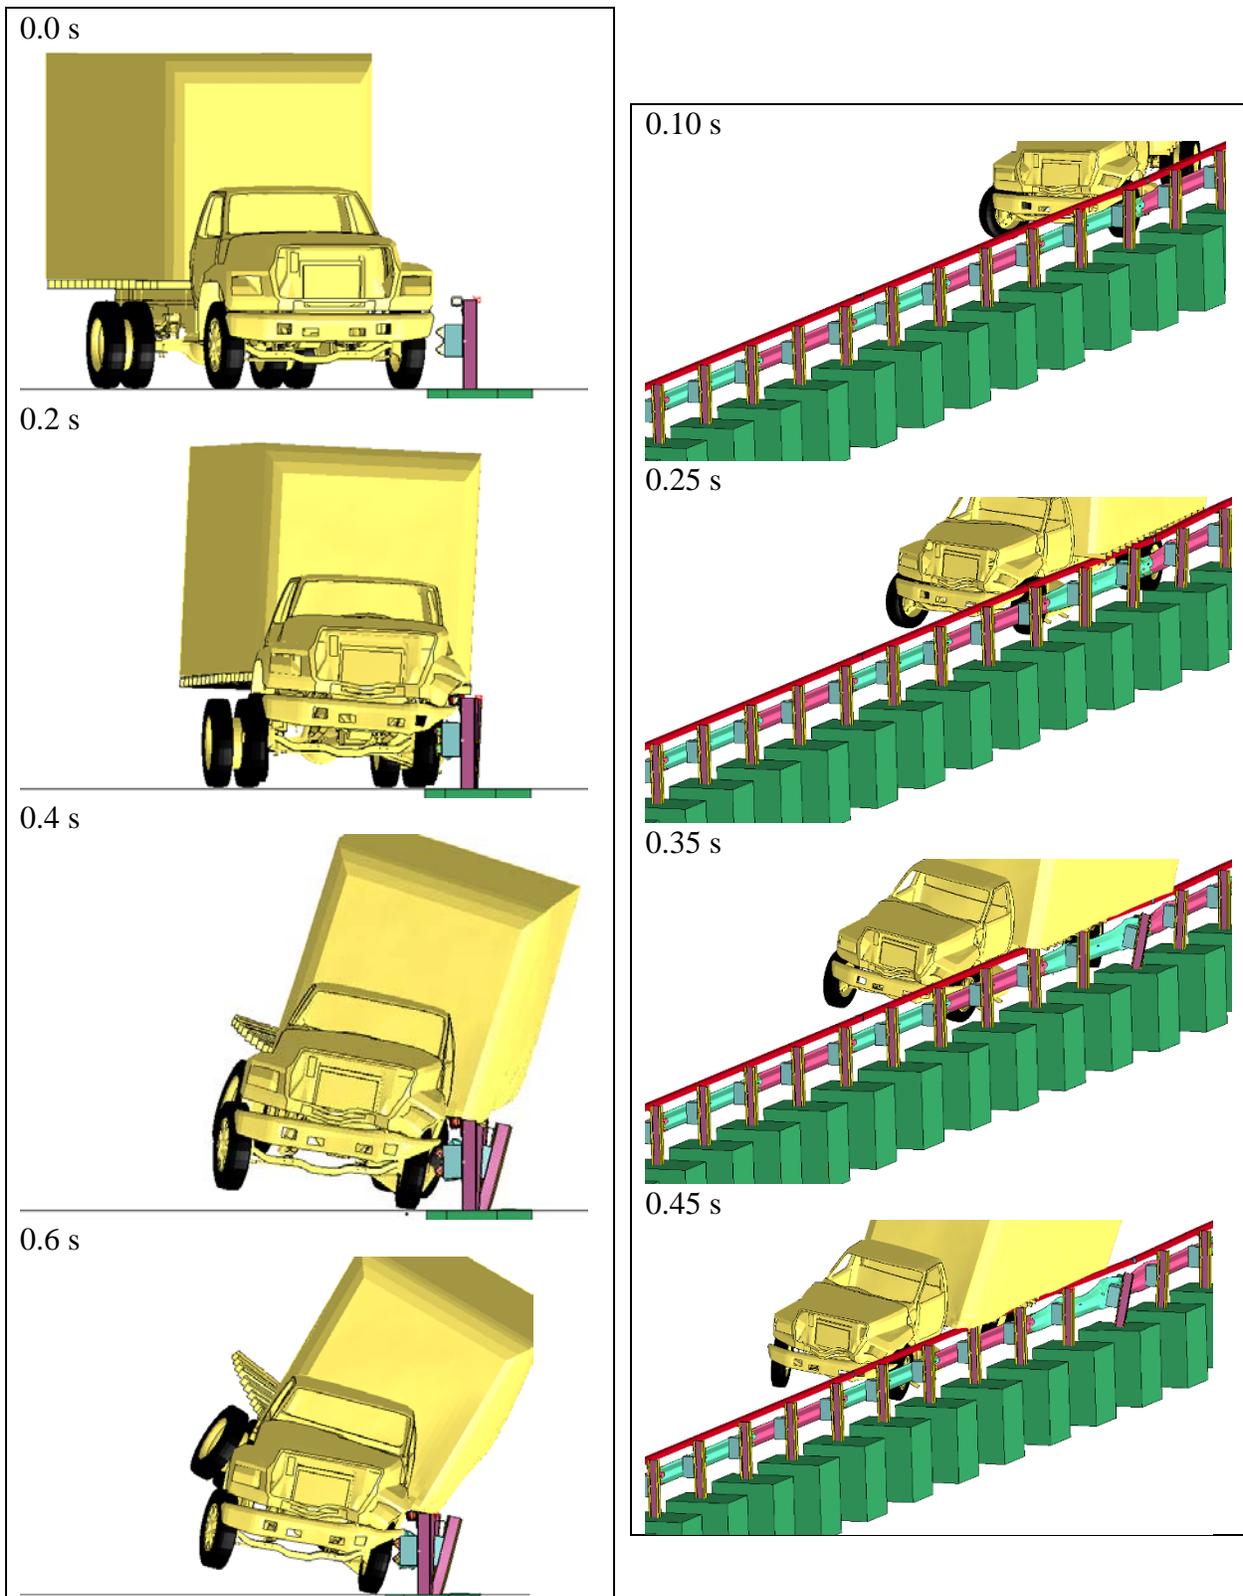
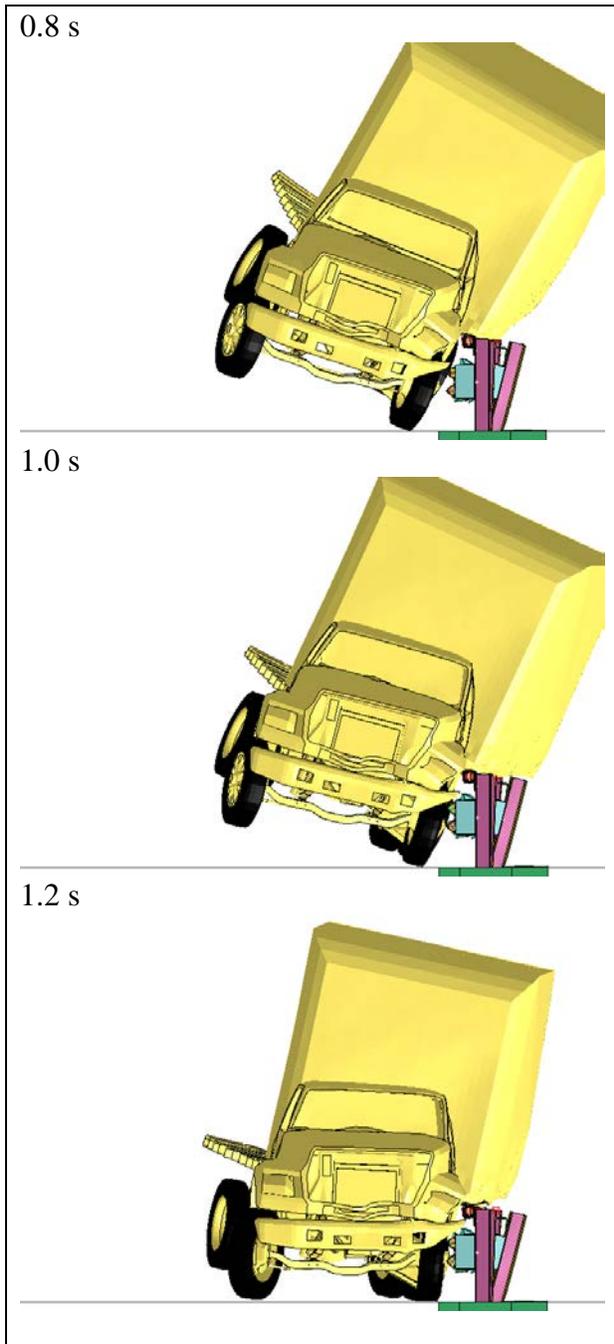
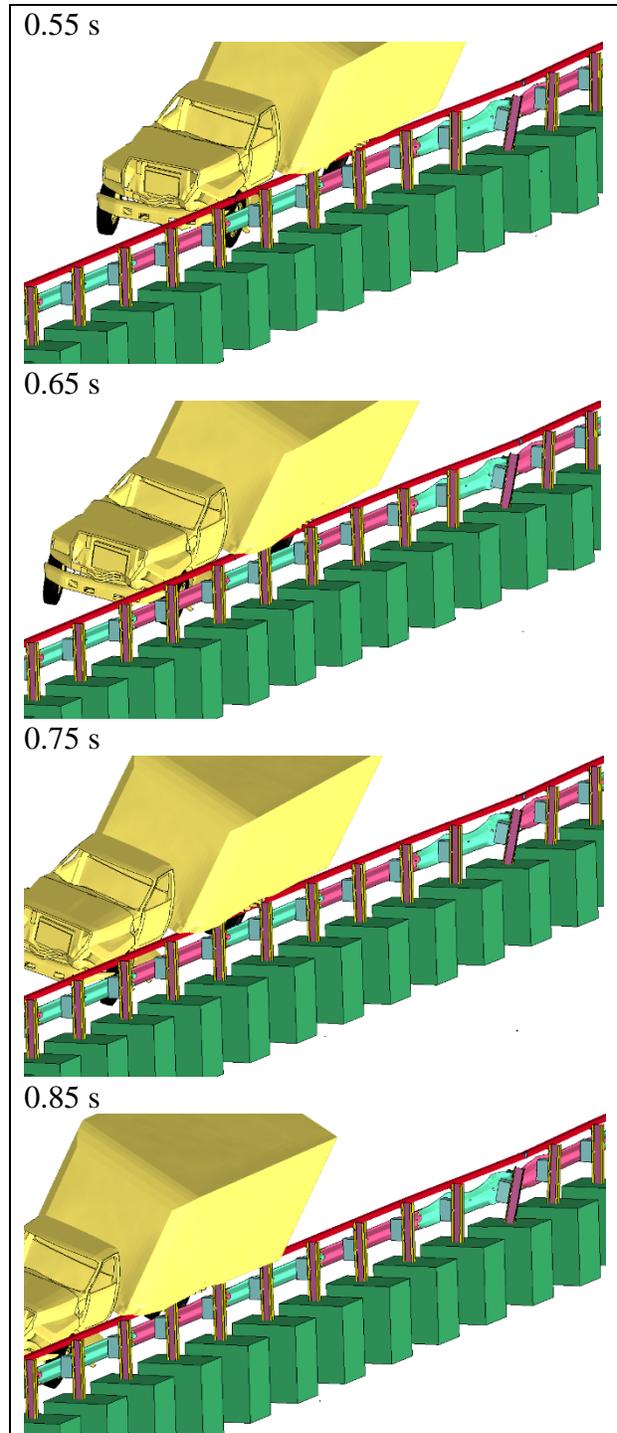
Figure 2.9. FE Simulation Results of Proposed Design for MASH Test 4-12 Impact.

Figure 2.9. FE Simulation Results of Proposed Design for *MASH* Test 4-12 Impact (Continued).

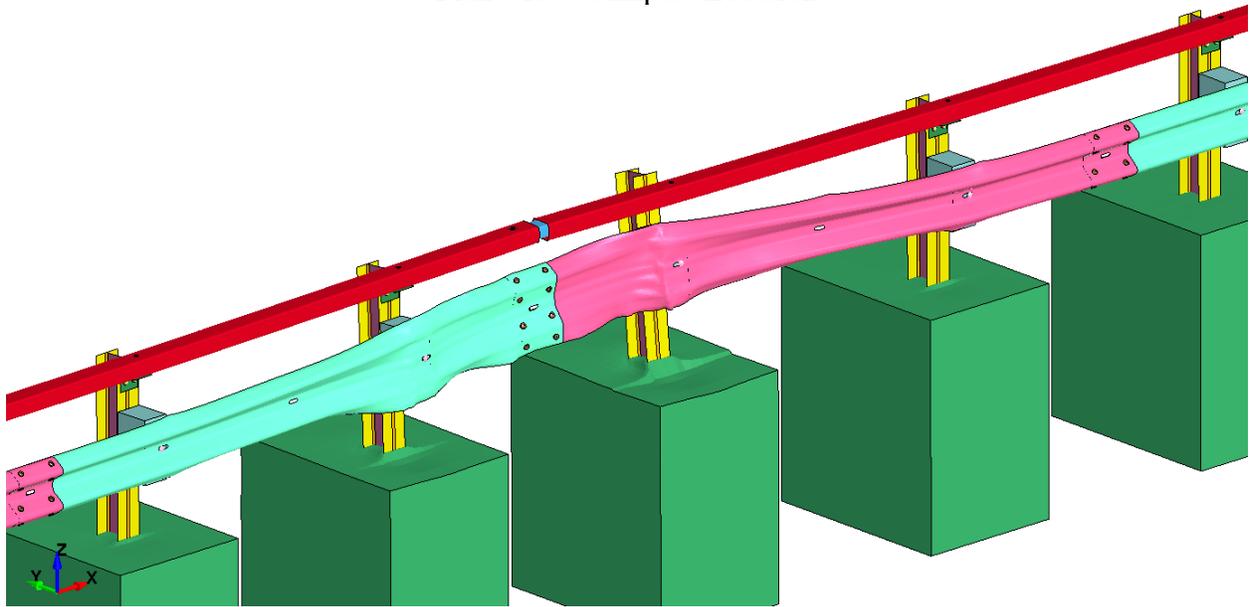
Figure 2.12. Barrier Damage after *MASH* Test 4-11 Impact Simulation.

Isometric View at Impact Location

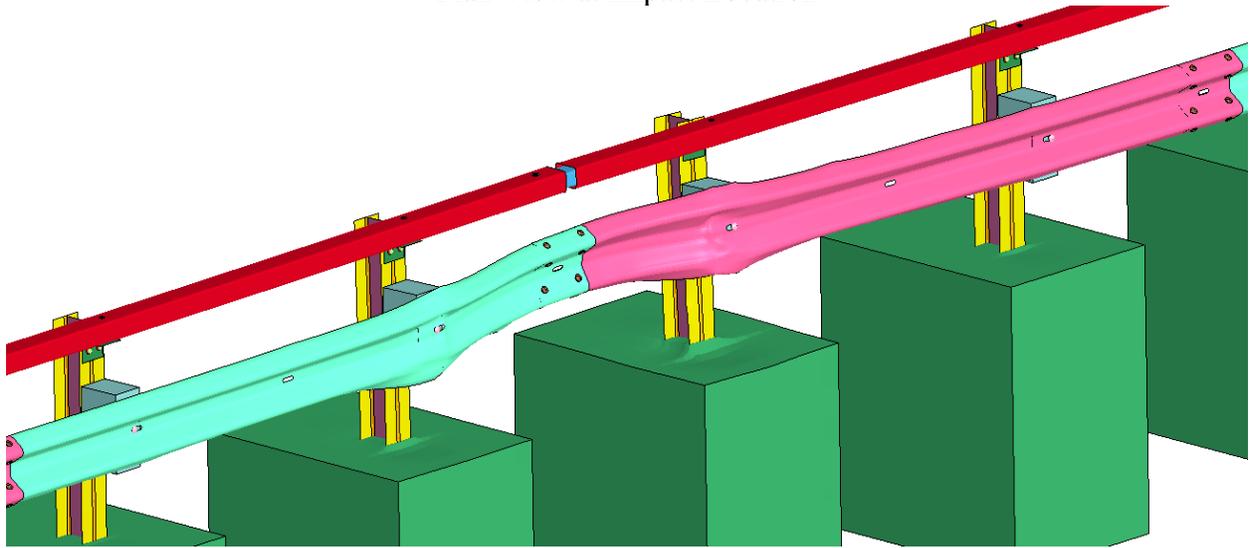
Figure 2.14. Barrier Damage after *MASH* Test 4-10 Impact Simulation.

Isometric View at Impact Location

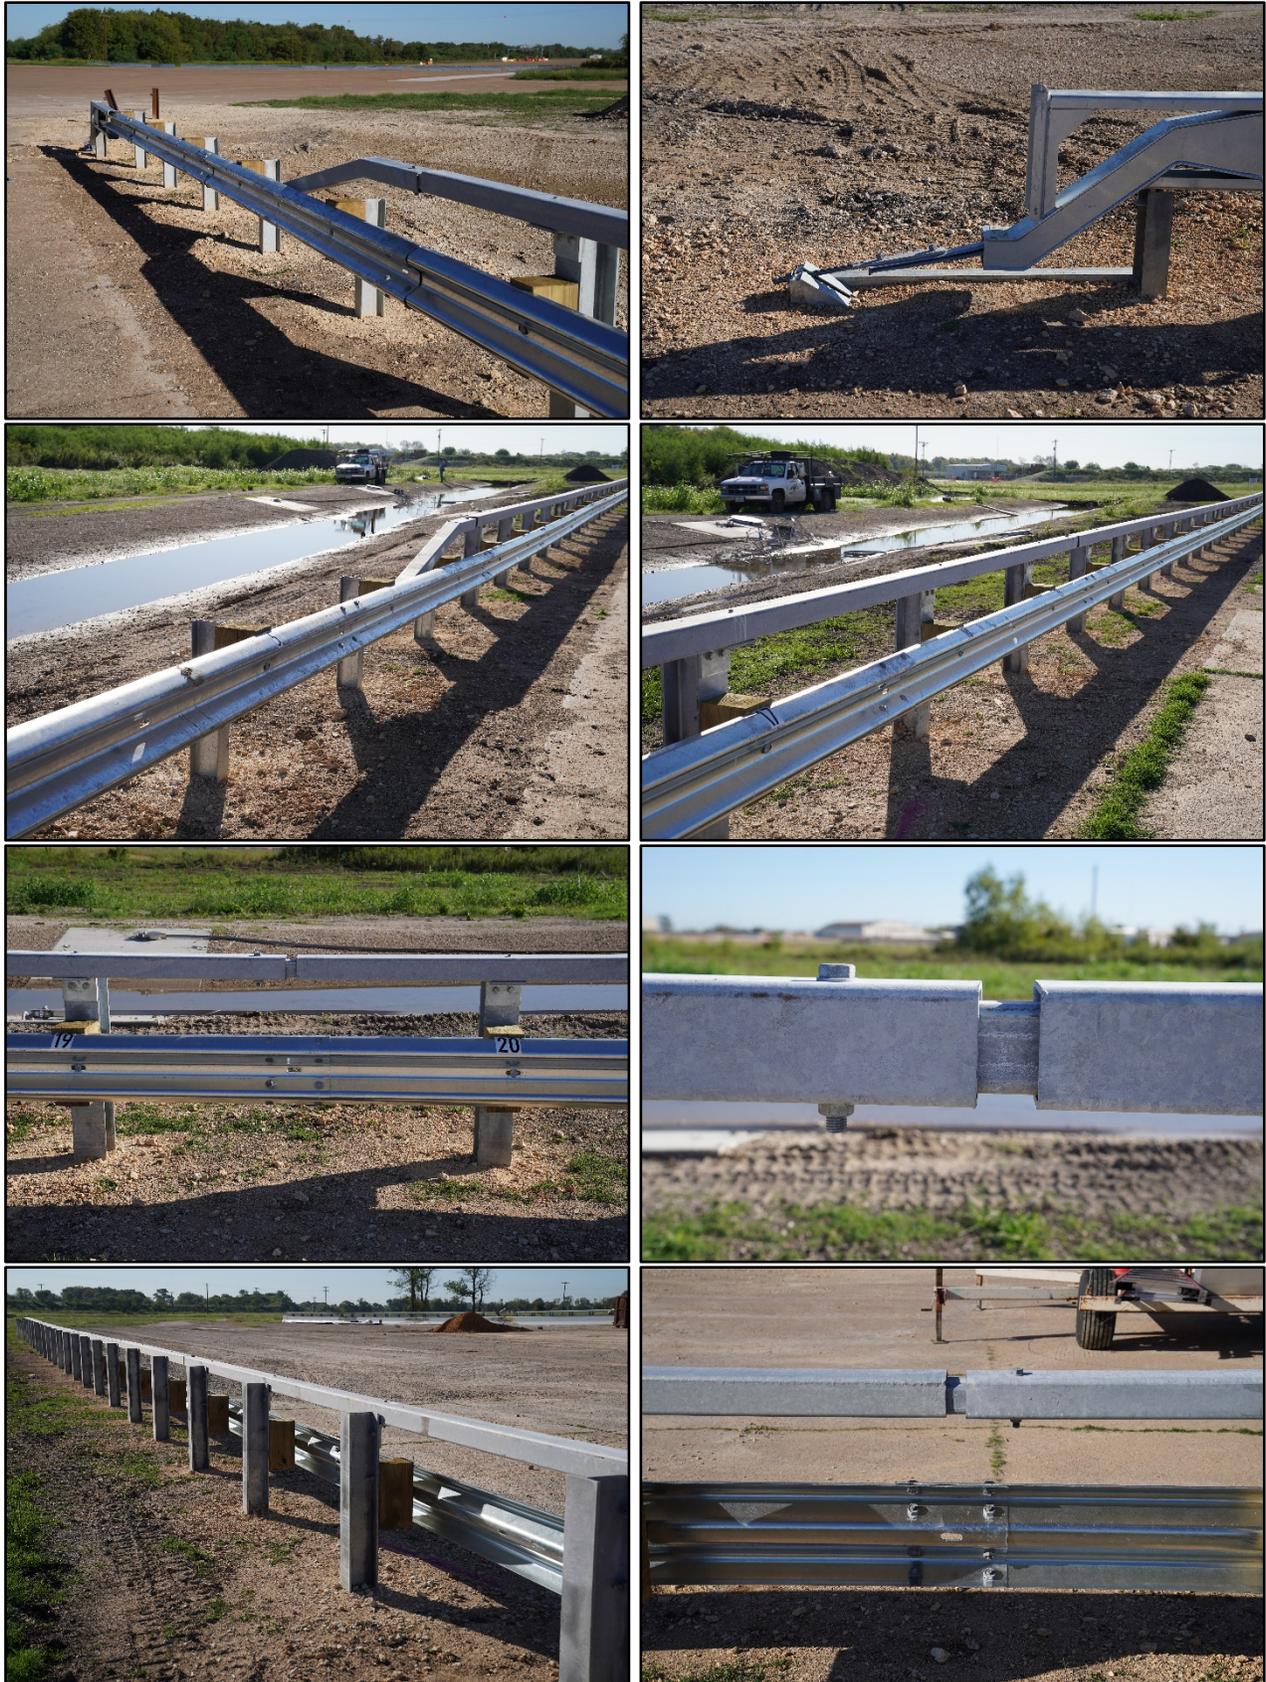
Figure 3.1. MASH TL-4 Guardrail System Details.

Figure 3.1 presents the overall information on the *MASH* TL-4 guardrail system, and Figure 3.2 provides photographs of the installation. Appendix A provides further details on the guardrail system. Drawings were provided by the TTI Proving Ground, and construction was performed by DMA Construction Inc. and supervised by TTI Proving Ground personnel.

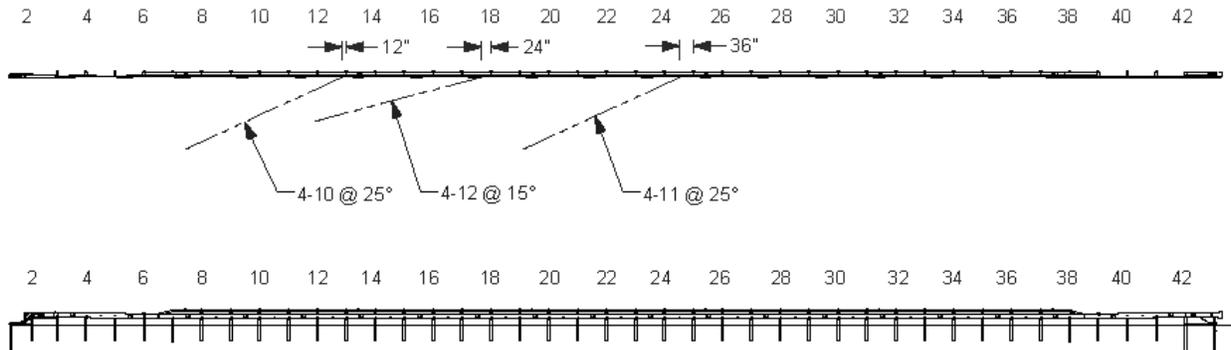
Figure 4.1. Target CIP for *MASH* TL-4 Tests on *MASH* TL-4 Guardrail System.

Table 4.1 shows the test conditions and evaluation criteria for *MASH* TL-4 for longitudinal barriers. The target critical impact points (CIPs) for each test were determined using the impact simulations of the FE model of the guardrail system under *MASH* TL-4 impact conditions. Figure 4.1 shows the target CIP for *MASH* Tests 4-10, 4-11, and 4-12 on the guardrail system.

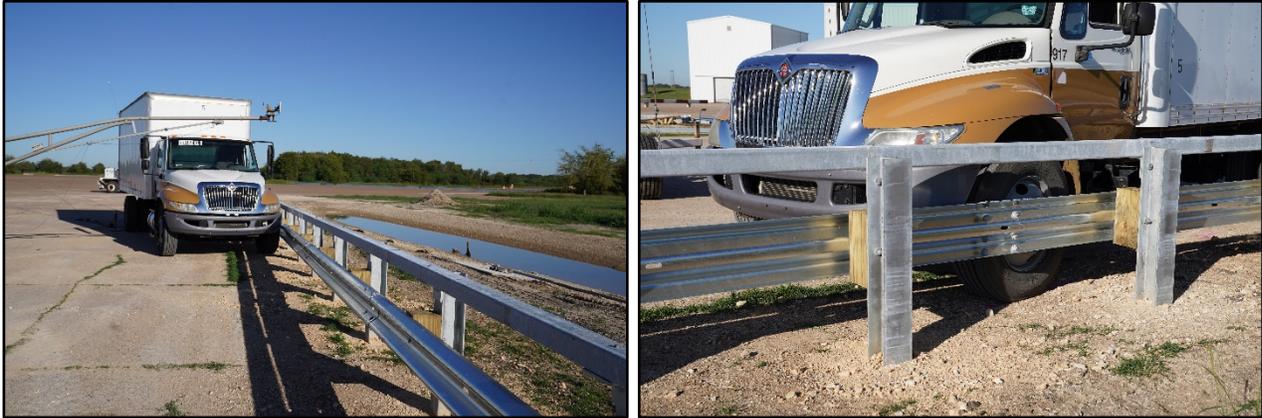
Figure 6.1. Guardrail System and Test Vehicle Geometrics for Test No. 440190-01-1.

MASH Test 4-12 involves a 10000S vehicle weighing 22,000 lb \pm 660 lb impacting the CIP of the longitudinal barrier at an impact speed of 56 mi/h \pm 2.5 mi/h and an angle of 15 degrees \pm 1.5 degrees. The CIP for MASH Test 4-12 on the MASH TL-4 guardrail system was 2.0 ft \pm 1 ft upstream of the centerline of post 18. Figure 4.1 and Figure 6.1 depict the target impact setup.

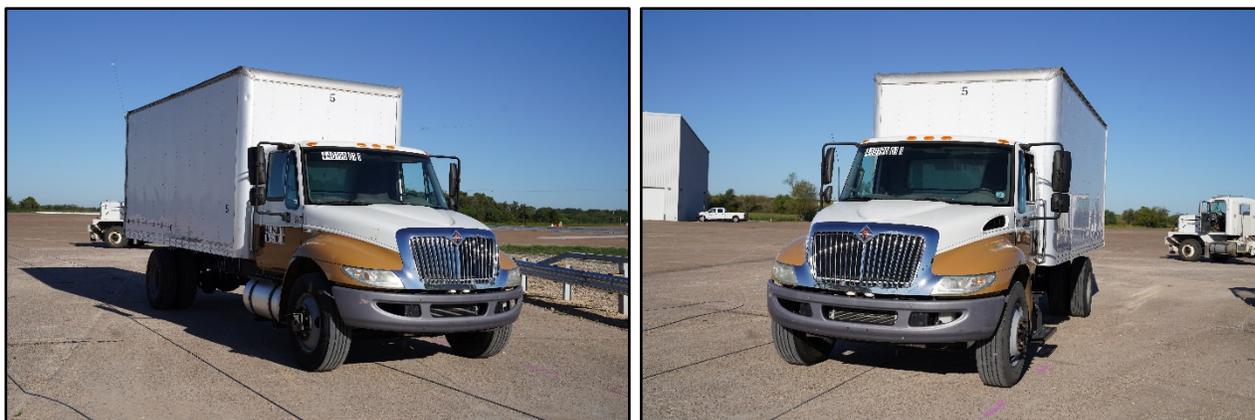
Figure 6.2. Test Vehicle before Test No. 440190-01-1.

Figure 6.2 shows the 2012 International 4300 SUT used for the crash test. The vehicle's test inertia weight was 22,290 lb, and its gross static weight was 22,290 lb. The height to the lower edge of the vehicle bumper was 18.25 inches, and the height to the upper edge of the bumper was 33.25 inches. The height to the center of gravity of the vehicle's ballast was 62.8 inches. Table D.1 in Appendix D.1 gives additional dimensions and information on the vehicle. The vehicle was directed into the installation using a cable reverse tow and guidance system, and was released to be freewheeling and unrestrained just prior to impact.

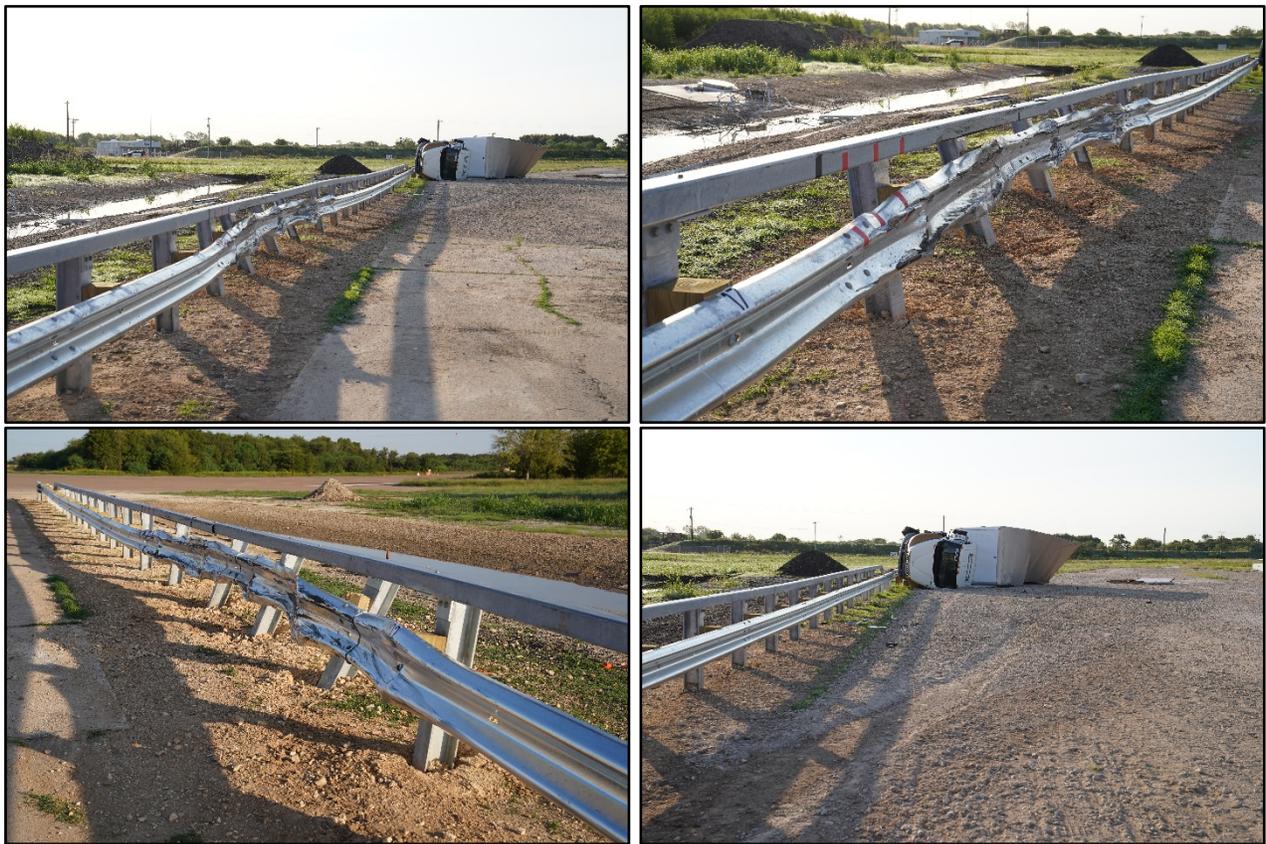
Figure 6.3. Guardrail after Test No. 440190-01-1.

Figure 6.3 through Figure 6.5 show the damage to the guardrail. The soil was disturbed between posts 5 and 15, and also at post 26. At post 14, the top rail bolt sheared at the bottom. The top rail was disconnected from posts 18 through 20, and both rails were disconnected from post 21. The wood blockout at post 21 remained attached to the post and had a slight counterclockwise rotation. The top rail bolts sheared and were missing at posts 25, 37, and 38. The top rail bolts sheared at posts 30 and 31 but were present in the bolt holes. The top of post 39

was bent toward the traffic side, and the blockout was rotated 45 degrees clockwise. The bottom rail released from the wood blockout at post 40. The bottom rail was deformed from the point of impact until post 22, and then again from posts 39 through 41. The bottom rail had a horizontal 5-inch-long gash just downstream of the joint between posts 17 and 18. Table 6.2 provides movement noted at the posts.

Working width* was 103.8 inches, and height of working width was 122.6 inches. Maximum dynamic deflection and permanent deformation of the guardrail system were 30.2 inches and 20.5 inches, respectively. For the upper HSS rail, the maximum dynamic deflection was 30.2 inches and the maximum permanent deformation was 10.25 inches at post 21. For the lower W-beam rail, the maximum dynamic deflection was 25.9 inches and the maximum permanent deformation was 20.5 inches at 29 inches upstream from the centerline of post 20.

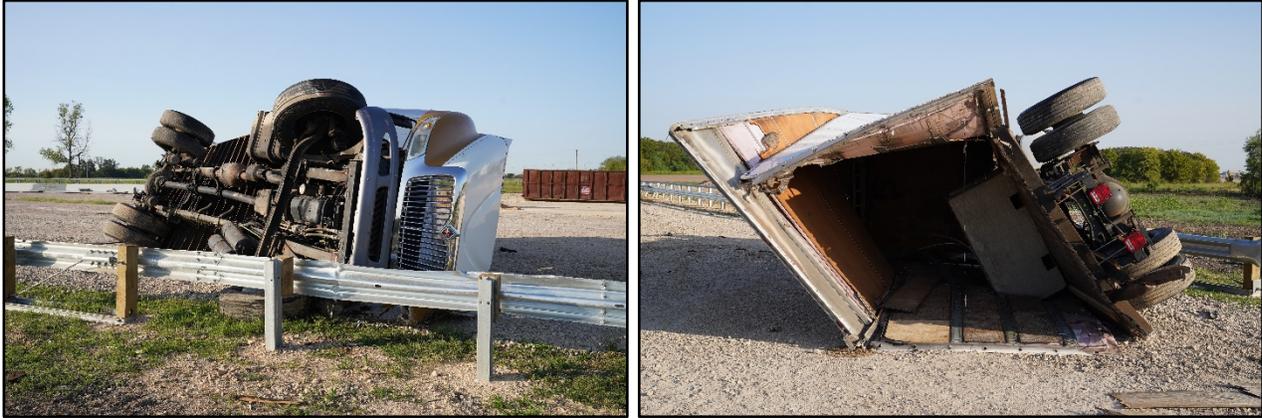
Figure 6.6. Test Vehicle after Test No. 440190-01-1.

Figure 6.6 and Figure 6.7 show the damage sustained by the vehicle. The front bumper, hood, left front spring assembly, left front U-bolts, left front axle, left front tire and rim, left front floor pan, left door and window glass, windshield, left cab corner, left battery box and side steps, left side of box, and left rear outside tire and rim were damaged. No damage to the fuel tank was observed. Maximum exterior crush to the vehicle was 9.5 inches in the side plane at the left front

corner at bumper height. Maximum occupant compartment deformation was 3.0 inches in the left front corner of the floor pan. Figure 6.8 shows the interior of the vehicle.

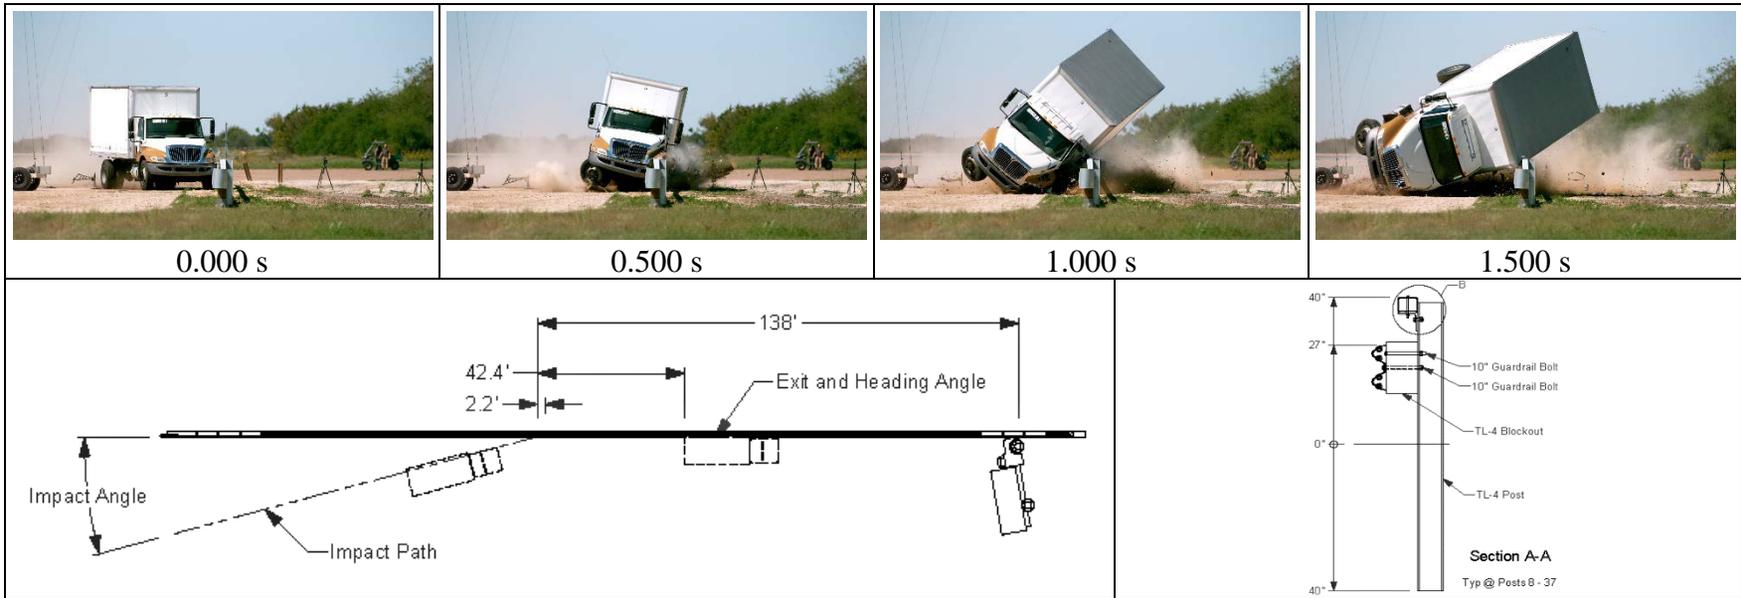
Data from the accelerometers were digitized for informational purposes only, and results are reported in Figure 6.9. Figure D.3 in Appendix D.3 shows the vehicle angular displacements, and Figures D.4 through D.9 in Appendix D.4 show acceleration versus time traces. Figure 6.9 summarizes pertinent information from the test.

<p>General Information</p> <p>Test Agency..... Texas A&M Transportation Institute (TTI)</p> <p>Test Standard Test No. MASH Test 4-12</p> <p>TTI Test No. 440190-01-1</p> <p>Test Date 2020-09-30</p> <p>Test Article</p> <p>Type Longitudinal Barrier—Guardrail</p> <p>Name MASH TL-4 Guardrail System</p> <p>Installation Length..... 260 ft 1½ inches</p> <p>Material or Key Elements ... Guardrail system with W-beam and HSS tube rail elements mounted on steel posts</p> <p>Soil Type and Condition AASHTO M147-65, Grade B Soil (crushed limestone)</p> <p>Test Vehicle</p> <p>Type/Designation 10000S</p> <p>Make and Model 2012 International 4300 SUT</p> <p>Curb..... 13,460 lb</p> <p>Test Inertial..... 22,290 lb</p> <p>Dummy No dummy</p> <p>Gross Static 22,290 lb</p>	<p>Impact Conditions</p> <p>Speed 58.6 mi/h</p> <p>Angle 15.0°</p> <p>Location/Orientation 2.2 ft upstream of post 18</p> <p>Impact Severity..... 171 kip-ft</p> <p>Exit Conditions</p> <p>Speed Stopped</p> <p>Trajectory/Heading Angle... Along guardrail</p> <p>Occupant Risk Values</p> <p>Longitudinal OIV 10.2 ft/s</p> <p>Lateral OIV 9.2 ft/s</p> <p>Longitudinal Ridedown 3.0 g</p> <p>Lateral Ridedown 4.8 g</p> <p>THIV 3.9 m/s</p> <p>ASI 0.4</p> <p>Max. 0.050-s Average</p> <p>Longitudinal -2.2 g</p> <p>Lateral..... 3.5 g</p> <p>Vertical..... 3.3 g</p>	<p>Post-Impact Trajectory</p> <p>Stopping Distance..... 138 ft downstream</p> <p>Adjacent to traffic face</p> <p>Vehicle Stability</p> <p>Maximum Roll Angle 130°</p> <p>Maximum Pitch Angle 14°</p> <p>Maximum Yaw Angle 223°</p> <p>Vehicle Snagging..... No</p> <p>Vehicle Pocketing No</p> <p>Test Article Deflections</p> <p>Dynamic..... 30.2 inches</p> <p>Permanent 20.5 inches</p> <p>Working Width..... 103.8 inches</p> <p>Height of Working Width 122.6 inches</p> <p>Vehicle Damage</p> <p>VDS N/A</p> <p>CDC N/A</p> <p>Max. Exterior Deformation..... 9.5 inches</p> <p>OCDI..... N/A</p> <p>Max. Occupant Compartment Deformation 3.0 inches</p>

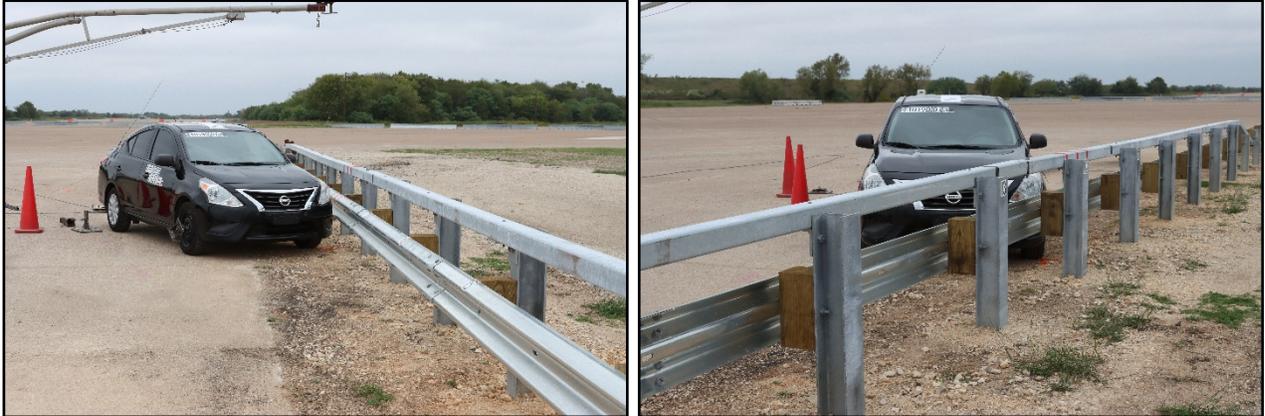
Figure 7.1. Guardrail System/Test Vehicle Geometrics for Test No. 440190-01-3.

MASH Test 4-10 involves an 1100C vehicle weighing 2420 lb \pm 55 lb impacting the CIP of the longitudinal barrier at an impact speed of 62 mi/h \pm 2.5 mi/h and an angle of 25 degrees \pm 1.5 degrees. The CIP for MASH Test 4-10 on the MASH TL-4 guardrail system was 1 ft \pm 1 ft upstream of the centerline of post 13. Figure 4.1 and Figure 7.1 depict the target impact setup.

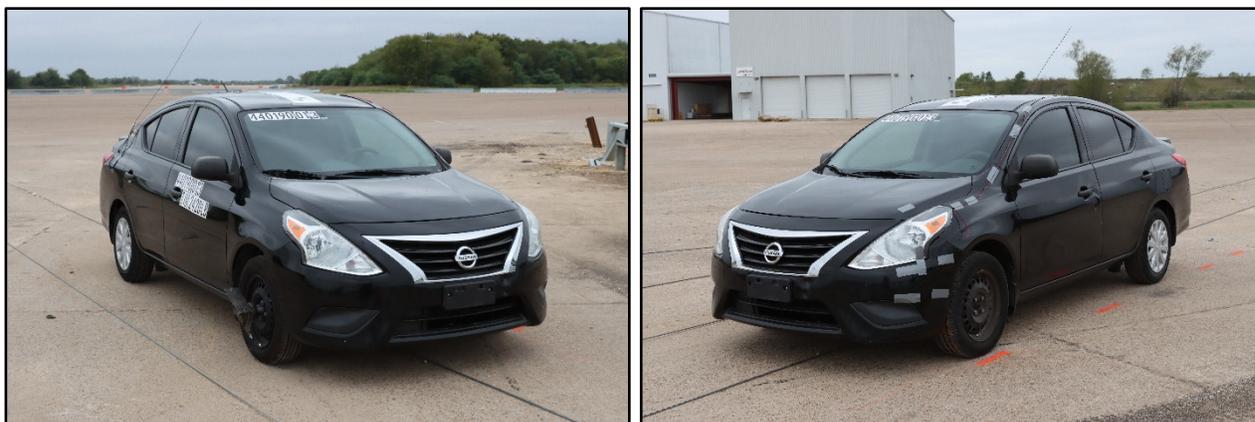
Figure 7.2. Test Vehicle before Test No. 440190-01-3.

Figure 7.2 shows the 2015 Nissan Versa used for the crash test. The vehicle's test inertia weight was 2428 lb, and its gross static weight was 2593 lb. The height to the lower edge of the vehicle bumper was 7.0 inches, and the height to the upper edge of the bumper was 22.25 inches. Table E.1 in Appendix E.1 gives additional dimensions and information on the vehicle. The vehicle was directed into the installation using a cable reverse tow and guidance system, and was released to be freewheeling and unrestrained just prior to impact.

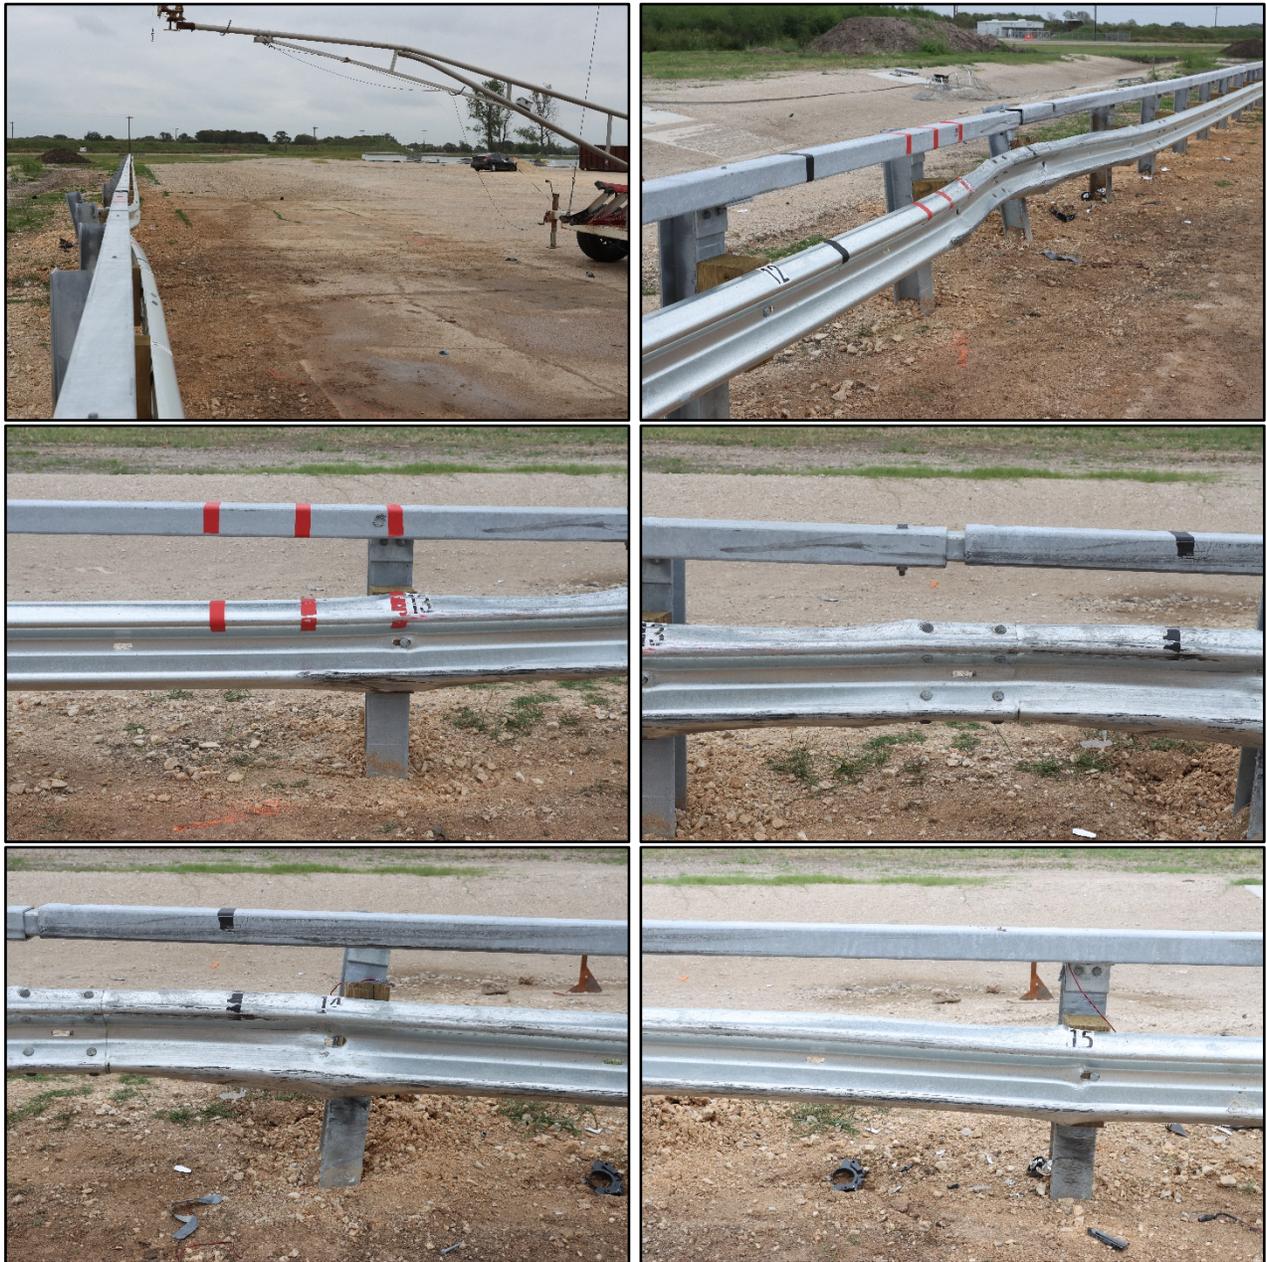
Figure 7.3. Guardrail after Test No. 440190-01-3.

Figure 7.3 shows the damage to the *MASH* TL-4 guardrail system. The soil was disturbed from posts 3 through 11 and from posts 17 through 19. Post 12 had a 1/8-inch gap in the soil on the traffic side. Post 13 had a 2-inch gap on the traffic side, a 1/2-inch gap on the field side, and was leaning 6 degrees back from vertical. Post 14 had a 5 1/2-inch gap on the traffic side and a 3/4-inch gap on the field side. Post 14 was leaning back 14 degrees from vertical, and the W-beam rail released from its blockout. Post 15 had a 1-inch gap on the traffic side and was leaning 2 degrees back from vertical. The bottom rail was deformed from impact until post 15, and the top rail was detached from posts 13 through 15. There was also scuffing present on both rails

along the length of contact. Working width* was 36.5 inches, and height of working width was 38.1 inches. Maximum dynamic deflection during the test was 15.1 inches, and maximum permanent deformation was 11.6 inches.

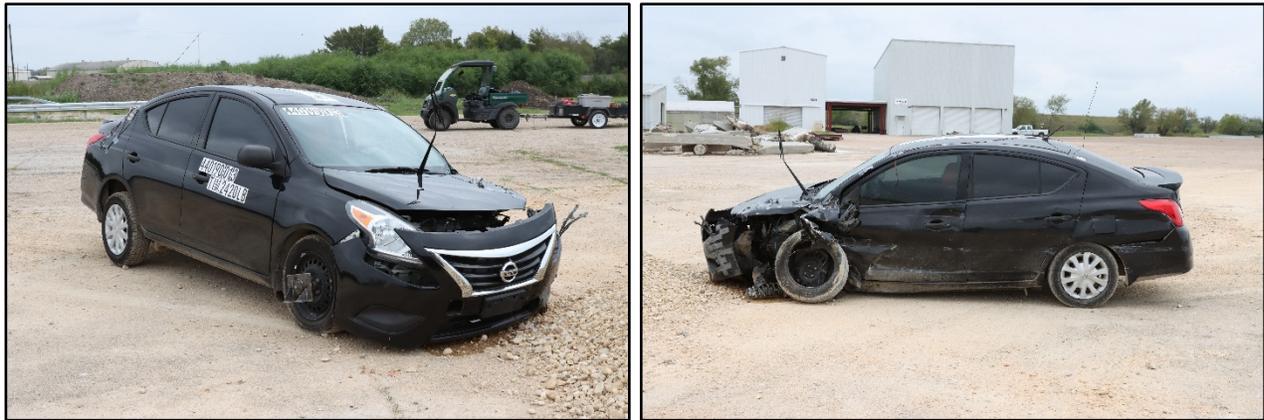
Figure 7.4. Test Vehicle after Test No. 440190-01-3.

Figure 7.4 shows the damage sustained by the vehicle. The front bumper, hood, left front fender, radiator and support, left front strut and tower, left control arm, left tire and rim, sway bar, left tie rod end, left front and rear doors, left front floor pan, left rear quarter panel, and rear bumper were damaged. The windshield sustained stress cracks radiating upward and inward from the left A-post. No fuel tank damage was observed. Maximum exterior crush to the vehicle was 12.0 inches in the front plane at the left front corner at bumper height. Maximum occupant compartment deformation was 4.0 inches in the left front kick panel area. Figure 7.5 shows the interior of the vehicle. Tables E.2 and E.3 in Appendix E.1 provide exterior crush and occupant compartment measurements.
