DEVELOPMENT AND EVALUATION OF *MASH* TL-4 GUARDRAIL SYSTEM

Test Report 0-7019-R1

TEXAS A&M TRANSPORTATION INSTITUTE
COLLEGE STATION, TEXAS

TEXAS DEPARTMENT OF TRANSPORTATION

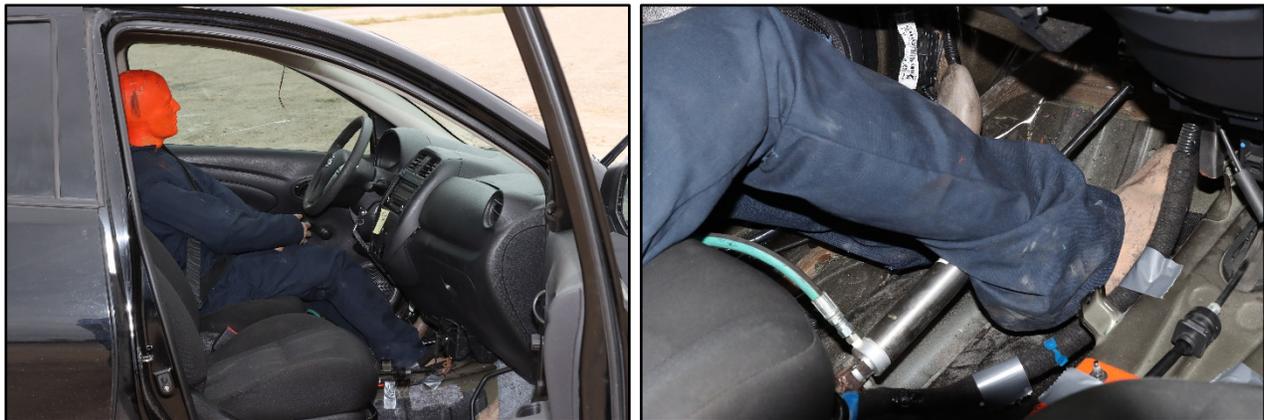
Figure 7.5. Interior of Test Vehicle after Test No. 440190-01-3.

Figure 7.4 shows the damage sustained by the vehicle. The front bumper, hood, left front fender, radiator and support, left front strut and tower, left control arm, left tire and rim, sway bar, left tie rod end, left front and rear doors, left front floor pan, left rear quarter panel, and rear bumper were damaged. The windshield sustained stress cracks radiating upward and inward from the left A-post. No fuel tank damage was observed. Maximum exterior crush to the vehicle was 12.0 inches in the front plane at the left front corner at bumper height. Maximum occupant compartment deformation was 4.0 inches in the left front kick panel area. Figure 7.5 shows the interior of the vehicle. Tables E.2 and E.3 in Appendix E.1 provide exterior crush and occupant compartment measurements.

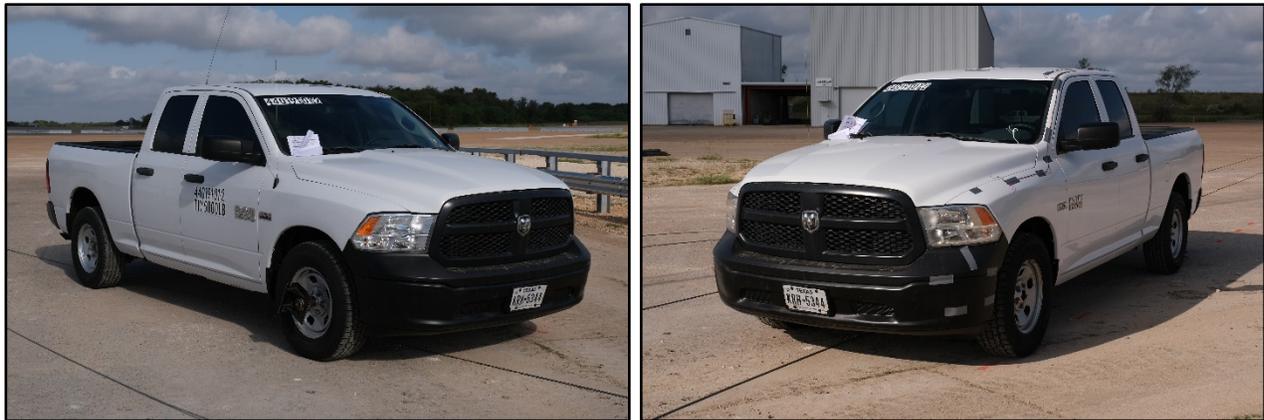
Figure 8.2. Test Vehicle before Test No. 440190-01-2.

Figure 8.2 shows the 2016 RAM 1500 pickup truck used for the crash test. The vehicle's test inertia weight was 5073 lb, and its gross static weight was 5238 lb. The height to the lower edge of the vehicle bumper was 11.75 inches, and height to the upper edge of the bumper was 27.0 inches. The height to the vehicle's center of gravity was 28.0 inches. Tables F.1 and F.2 in Appendix F.1 give additional dimensions and information on the vehicle. The vehicle was directed into the installation using a cable reverse tow and guidance system, and was released to be freewheeling and unrestrained just prior to impact.

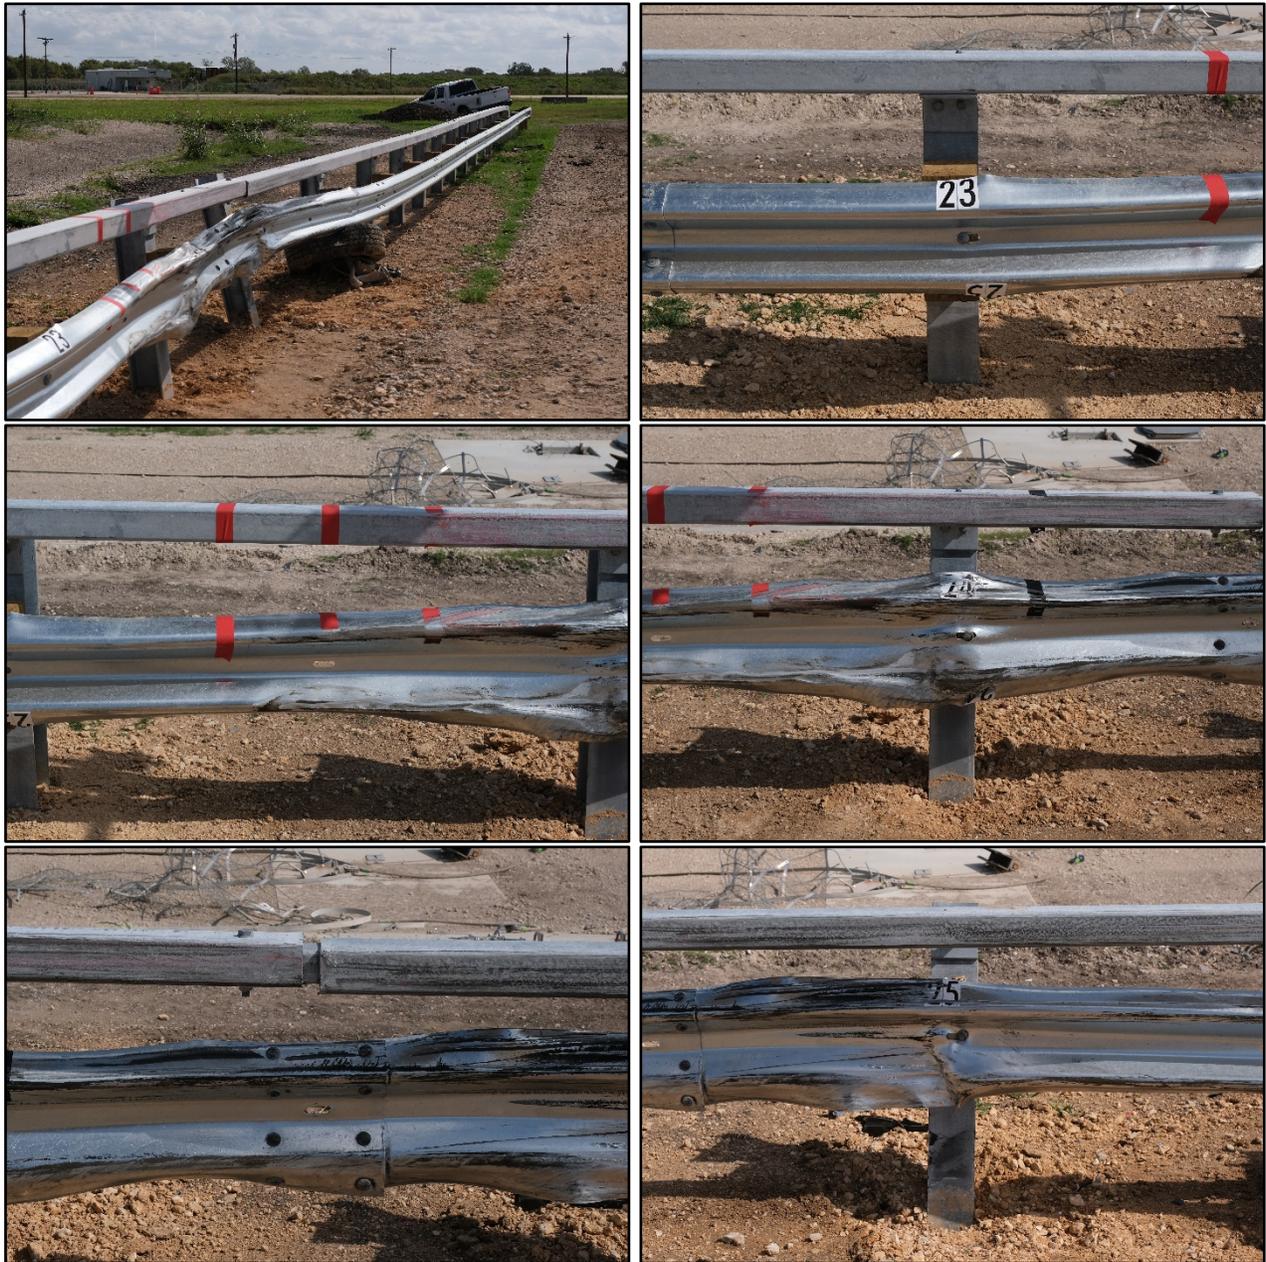
Figure 8.3. Guardrail after Test No. 440190-01-2.

Figure 8.3 and Figure 8.4 show the damage to the guardrail, and Table 8.2 provides post movement. The top rail released from posts 24–26, and the bottom rail released from post 26. There was also scuffing and deformation of the bottom rail between posts 24 and 26. The blockout at post 25 was rotated counterclockwise. The maximum deformation of the top rail was

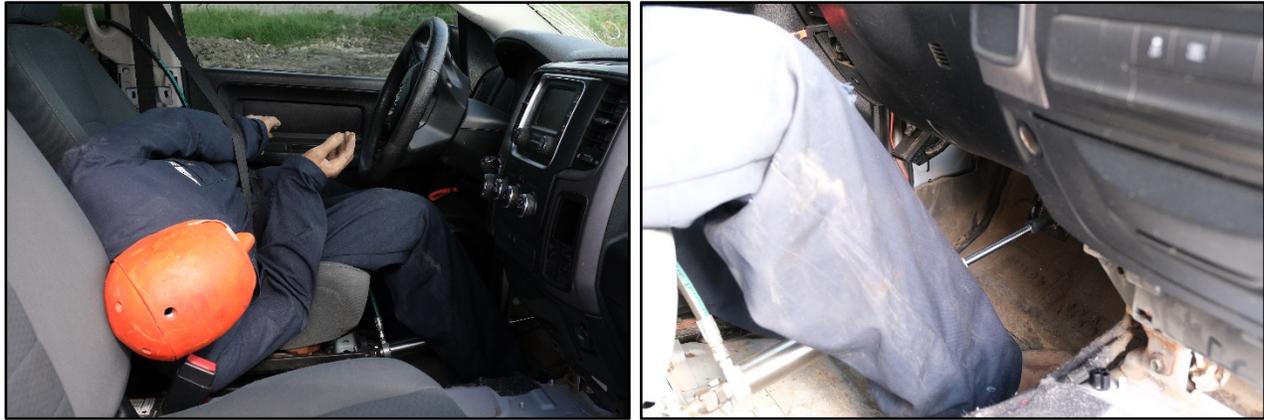
Figure 8.6. Interior of Test Vehicle after Test No. 440190-01-2.

Figure 8.5 shows the damage sustained by the vehicle. The front bumper, hood, grill, radiator and support, left front fender, left front tire and rim, left upper and lower control arms, sway bar, left tie rod end, left front and rear door, left rear exterior bed, left rear tire and rim, and rear bumper were damaged. The windshield sustained stress cracks radiating upward and inward from the left lower corner. No fuel tank damage was observed. Maximum exterior crush to the vehicle was 11.0 inches in the front plane at the left front corner at bumper height. Maximum occupant compartment deformation was 0.5 inches in the left front firewall area and the left front kick panel. Figure 8.6 shows the interior of the vehicle. Tables F.3 and F.4 in Appendix F.1 provide exterior crush and occupant compartment measurements.
