Test Report No. 610221-01-1
Test Report Date: October 2018

**MASH TEST 4-12 ON KEYED-IN SINGLE-SLOPE BARRIER WITH
40-FT SEGMENT LENGTH**

Sponsored by
Roadside Safety Research Program Pooled Fund
Study No. TPF-5(114)

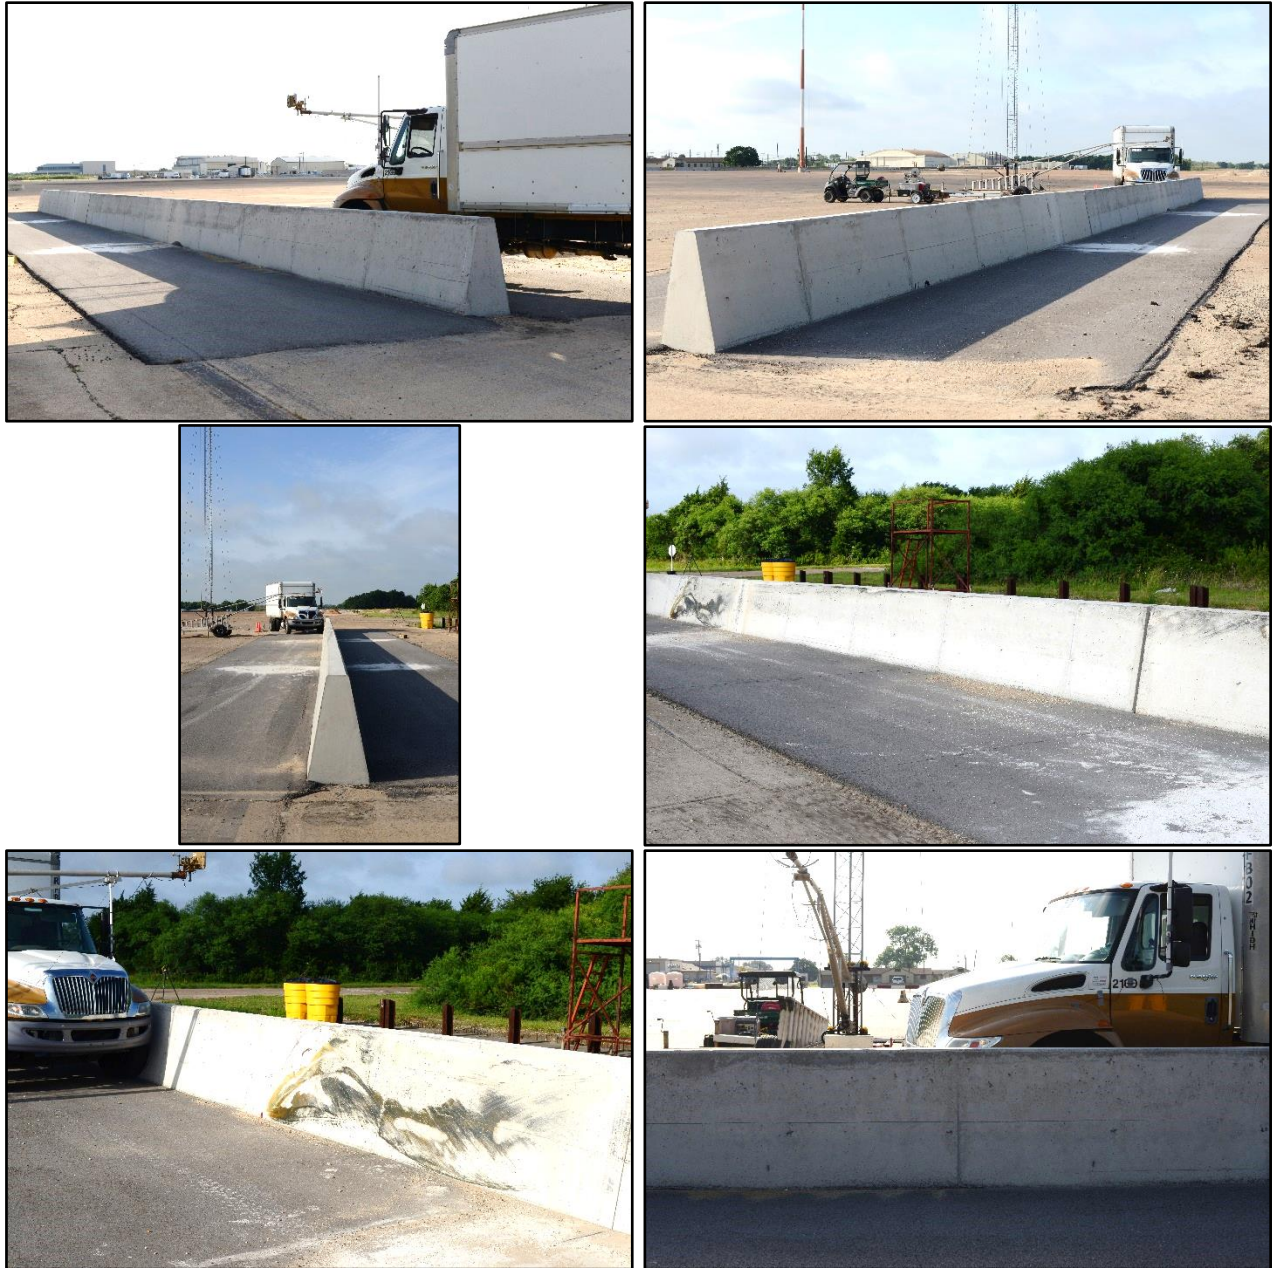
Figure 2.2. Keyed-In Single Slope Barrier prior to Testing.

Figure 2.1 presents overall information on the keyed-in single slope barrier, and Figure 2.2 provides photographs of the installation. Appendix A provides further details of the barrier.

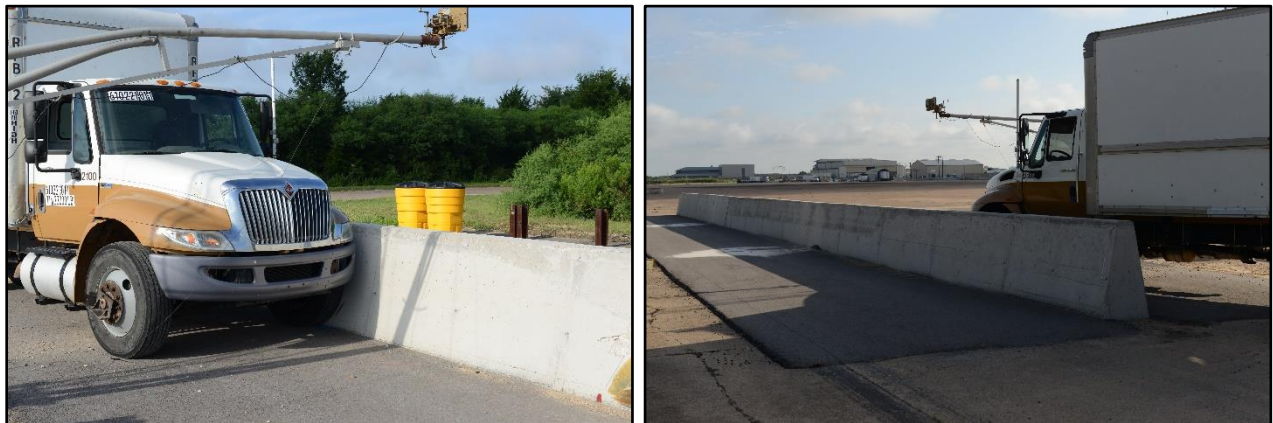
Figure 5.1. Keyed-In Single Slope Barrier/Test Vehicle Geometrics for Test No. 610221-01-1.

Figures 5.1 and 5.2 show the 2013 International 4300 single-unit truck used for the crash test. The vehicle's test inertia weight was 22,210 lb, and its gross static weight was 22,210 lb. The height to the lower edge of the vehicle bumper was 18.5 inches, and height to the upper edge of the bumper was 33.5 inches. The height to the ballast's center of gravity was 62.5 inches. Table B.1 in Appendix B1 gives additional dimensions and information on the vehicle. The vehicle was directed into the installation using a cable reverse tow and guidance system, and was released to be freewheeling and unrestrained just prior to impact.

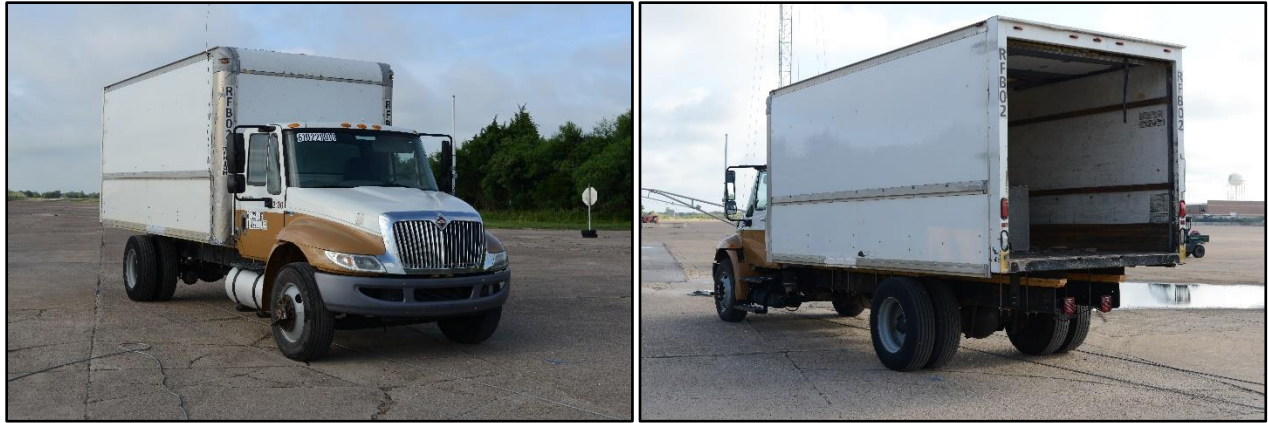
Figure 5.2. Test Vehicle before Test No. 610221-01-1.

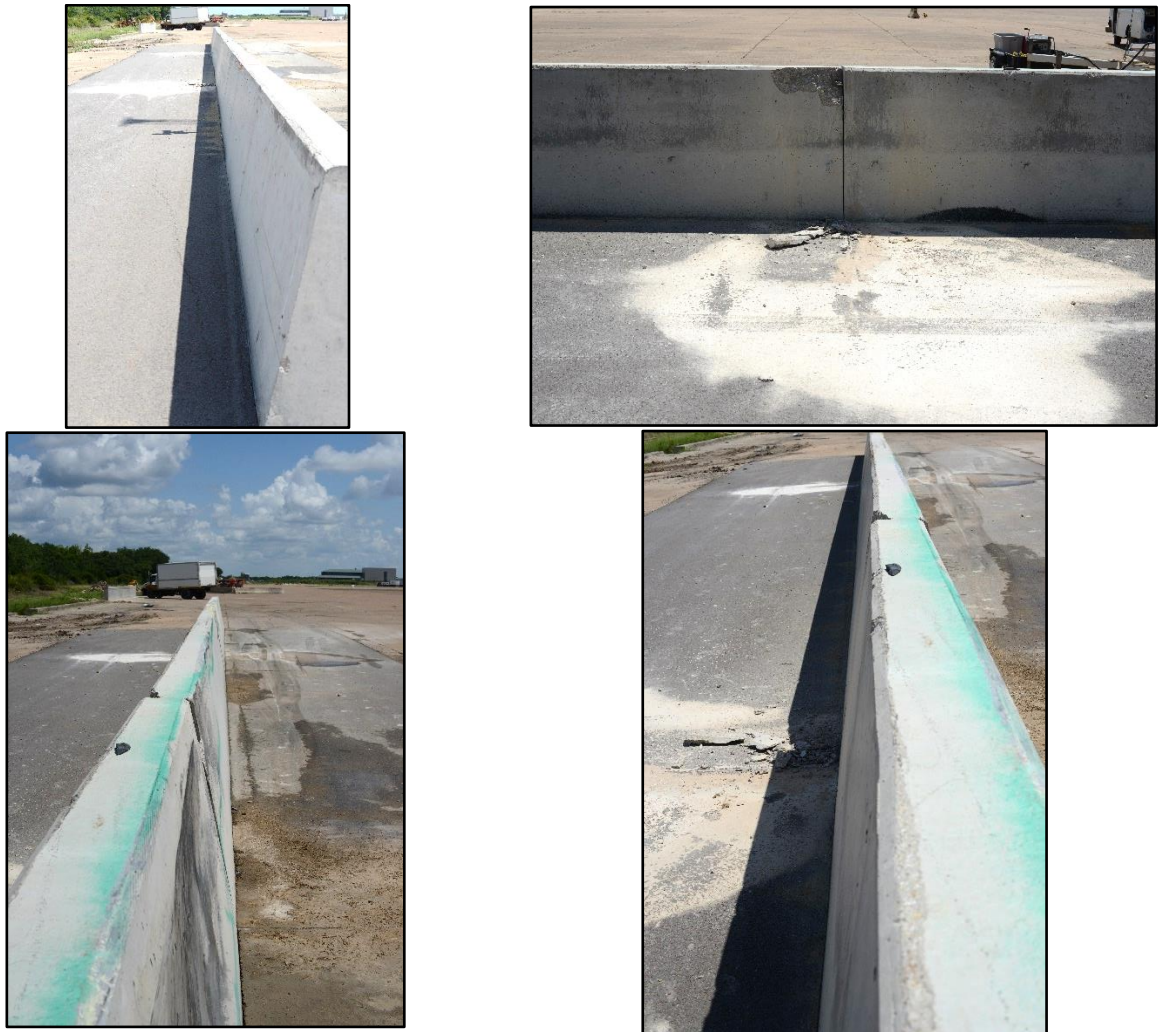
Figure 5.3. Keyed-In Single Slope Barrier after Test No. 610221-01-1.

Figure 5.3 shows the damage to the barrier. The traffic face of the barrier was gouged 1.25 inches at impact. The downstream end of the 40-ft long impact segment was leaning toward the field side 0.75 inch at the top. Working width was 59.8 inches at a height of 112.4 inches. Maximum dynamic deflection during the test was 5.8 inches, and maximum permanent deflection was 0.75 inch.

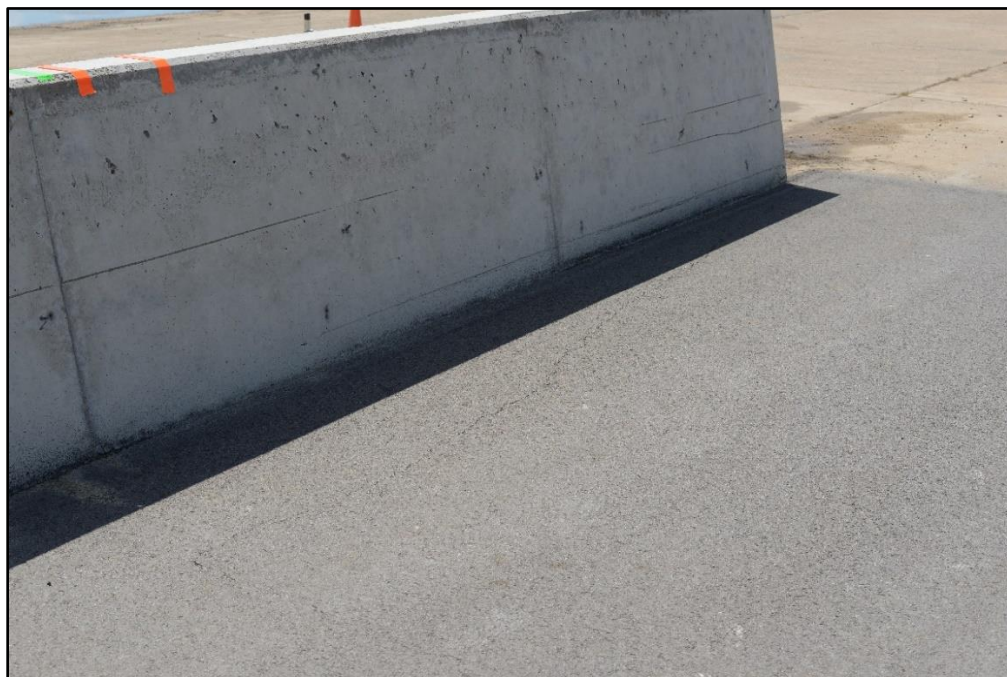
Figure 5.4. Keyed-In Single Slope Barrier Asphalt after Test No. 610221-01-1.

Figure 5.4 shows the damage to the asphalt at the base of the barrier. The base of the barrier was pushed back toward the protected side leaving a ½-inch gap from the face of the

barrier to the start of the asphalt. A single crack in the asphalt began on the back side of the barrier at the upstream end. The crack propagated through the asphalt to 28 inches back from the impact zone.

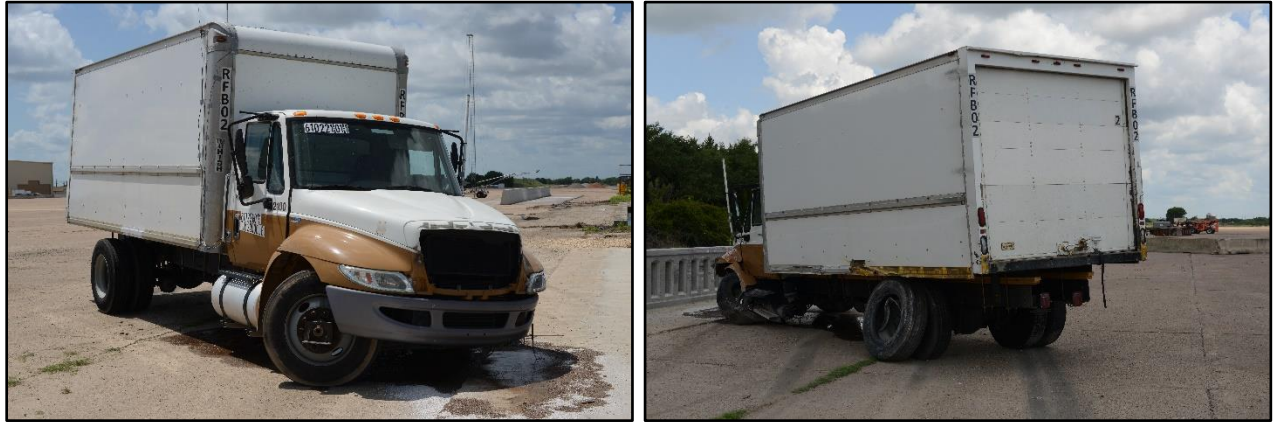
Figure 5.5. Test Vehicle after Test No. 610221-01-1.

Figure 5. shows the damage sustained by the vehicle. The front bumper, hood, left front tire and rim, left battery box, left lower edge of cargo box, and left rear outer tire and rim were damaged. Maximum exterior crush to the vehicle was 18.0 inches in the side plane at the left front corner at bumper height. Maximum occupant compartment deformation was 4.0 inches in the left side kick panel area. Figure 5. shows the interior of the vehicle.

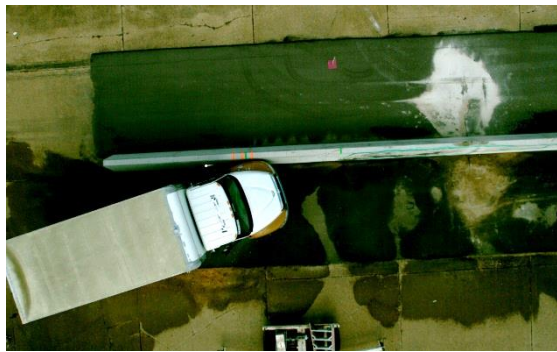
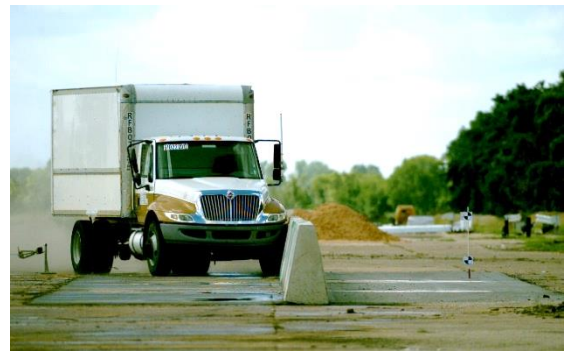
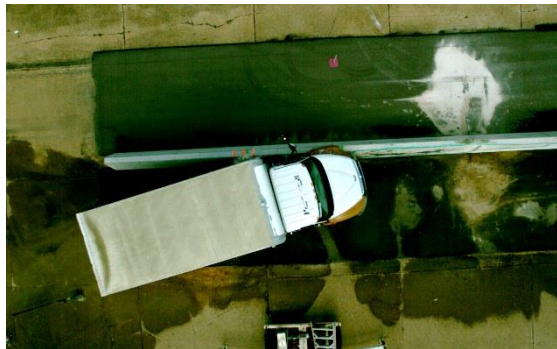
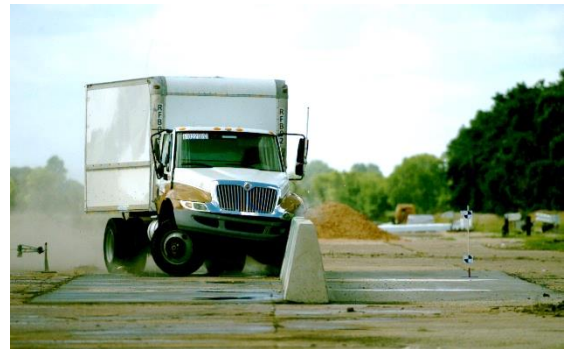
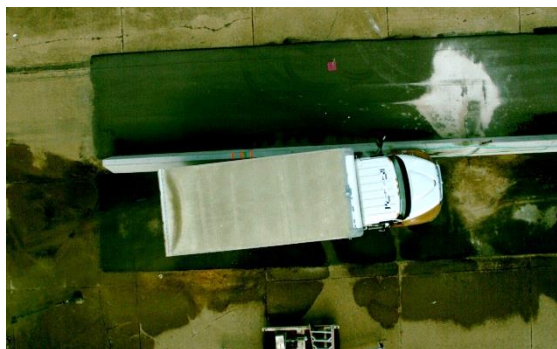
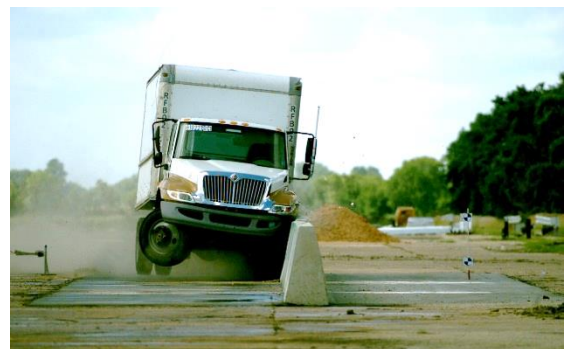
Figure B.1. Sequential Photographs for Test No. 610221-01-1 (Overhead and Frontal Views).

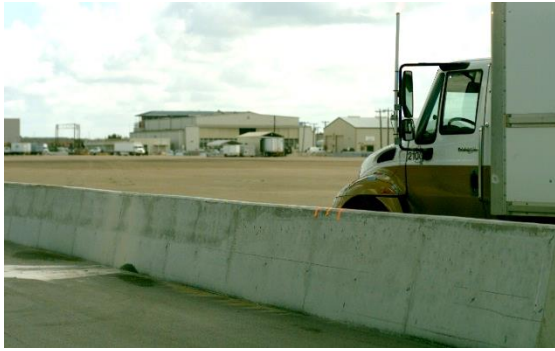
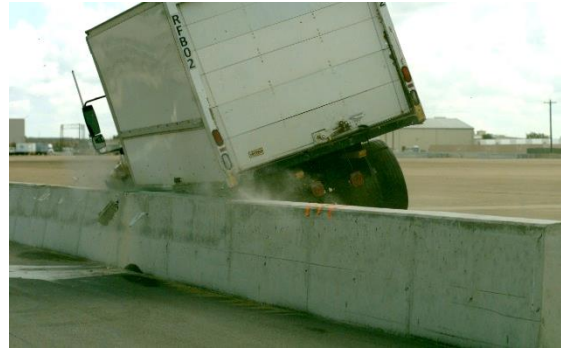
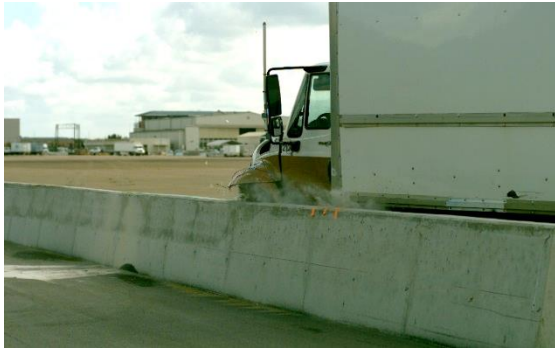
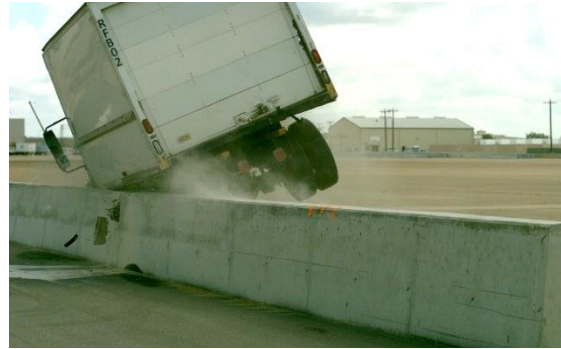
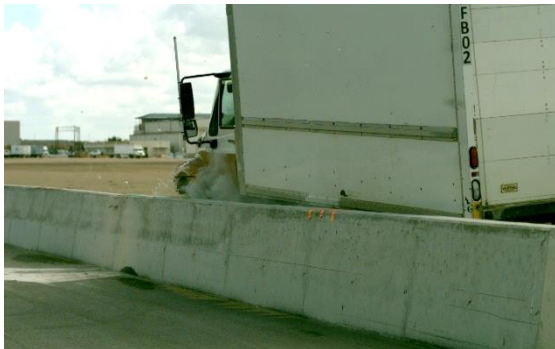
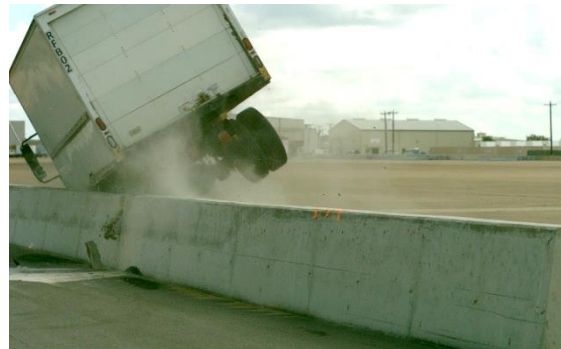
Figure B.2. Sequential Photographs for Test No. 610221-01-1 (Rear View).

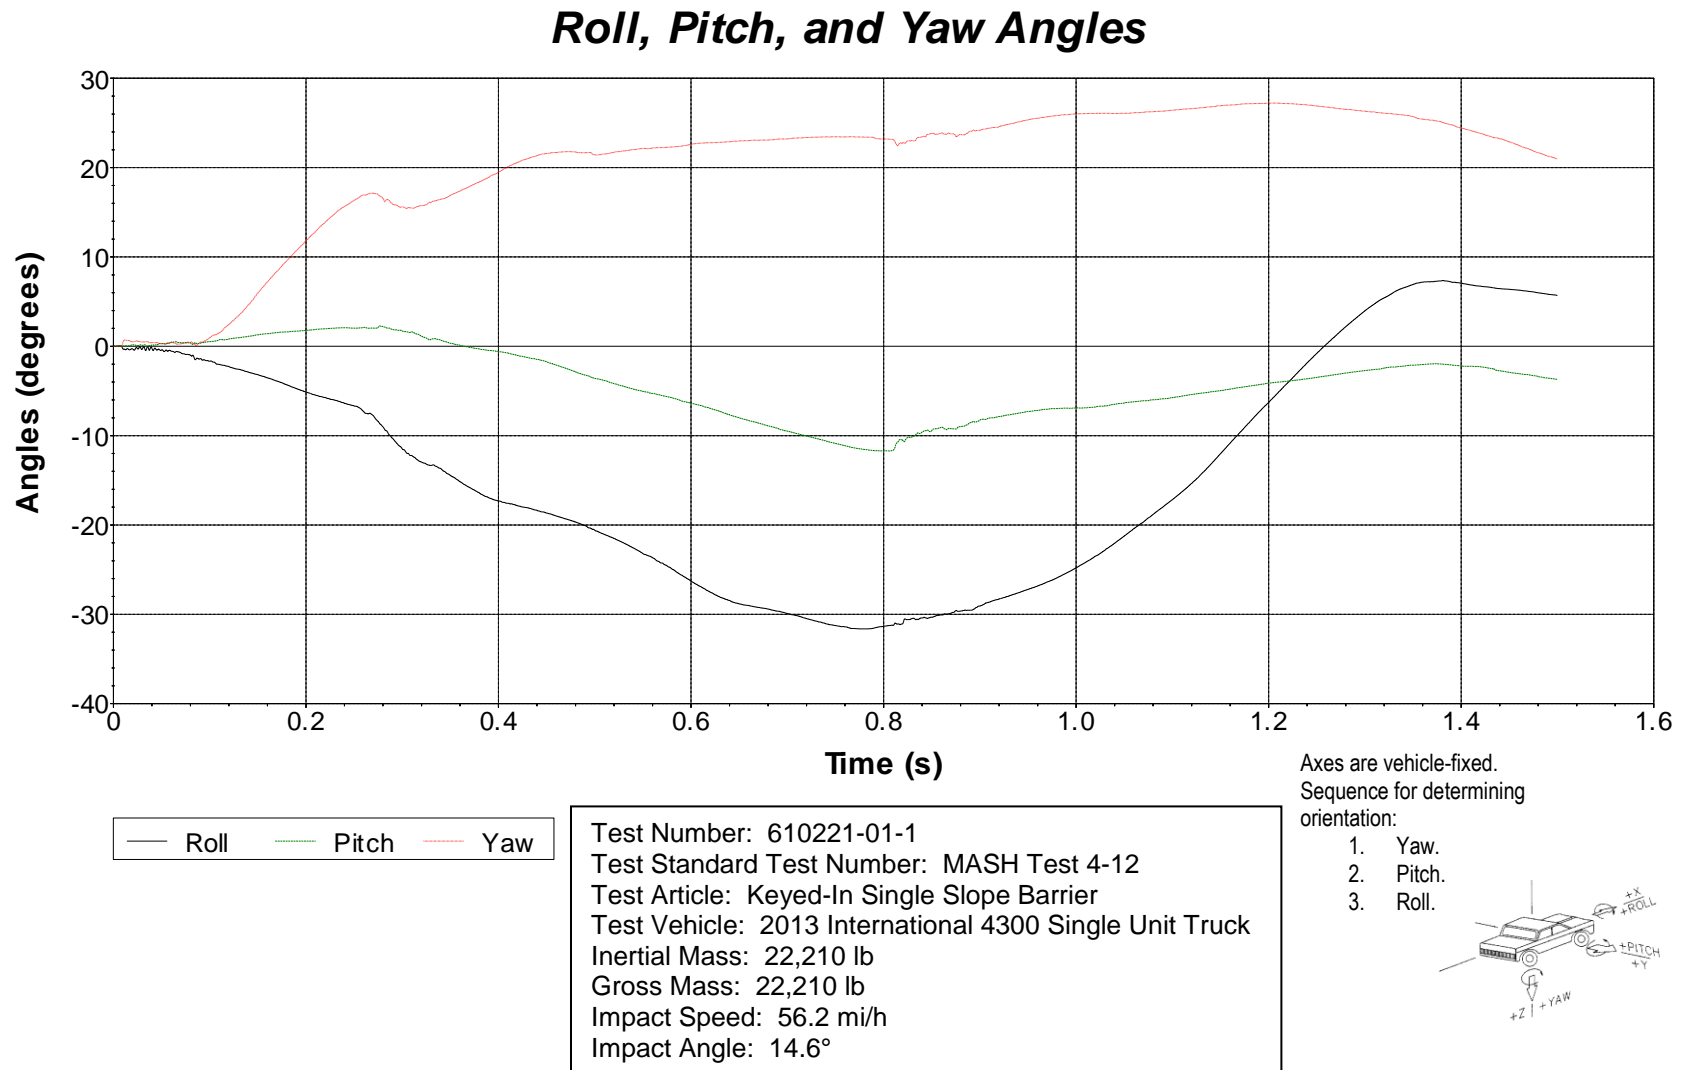
Figure B.3. Vehicle Angular Displacements for Test No. 610221-01-1.

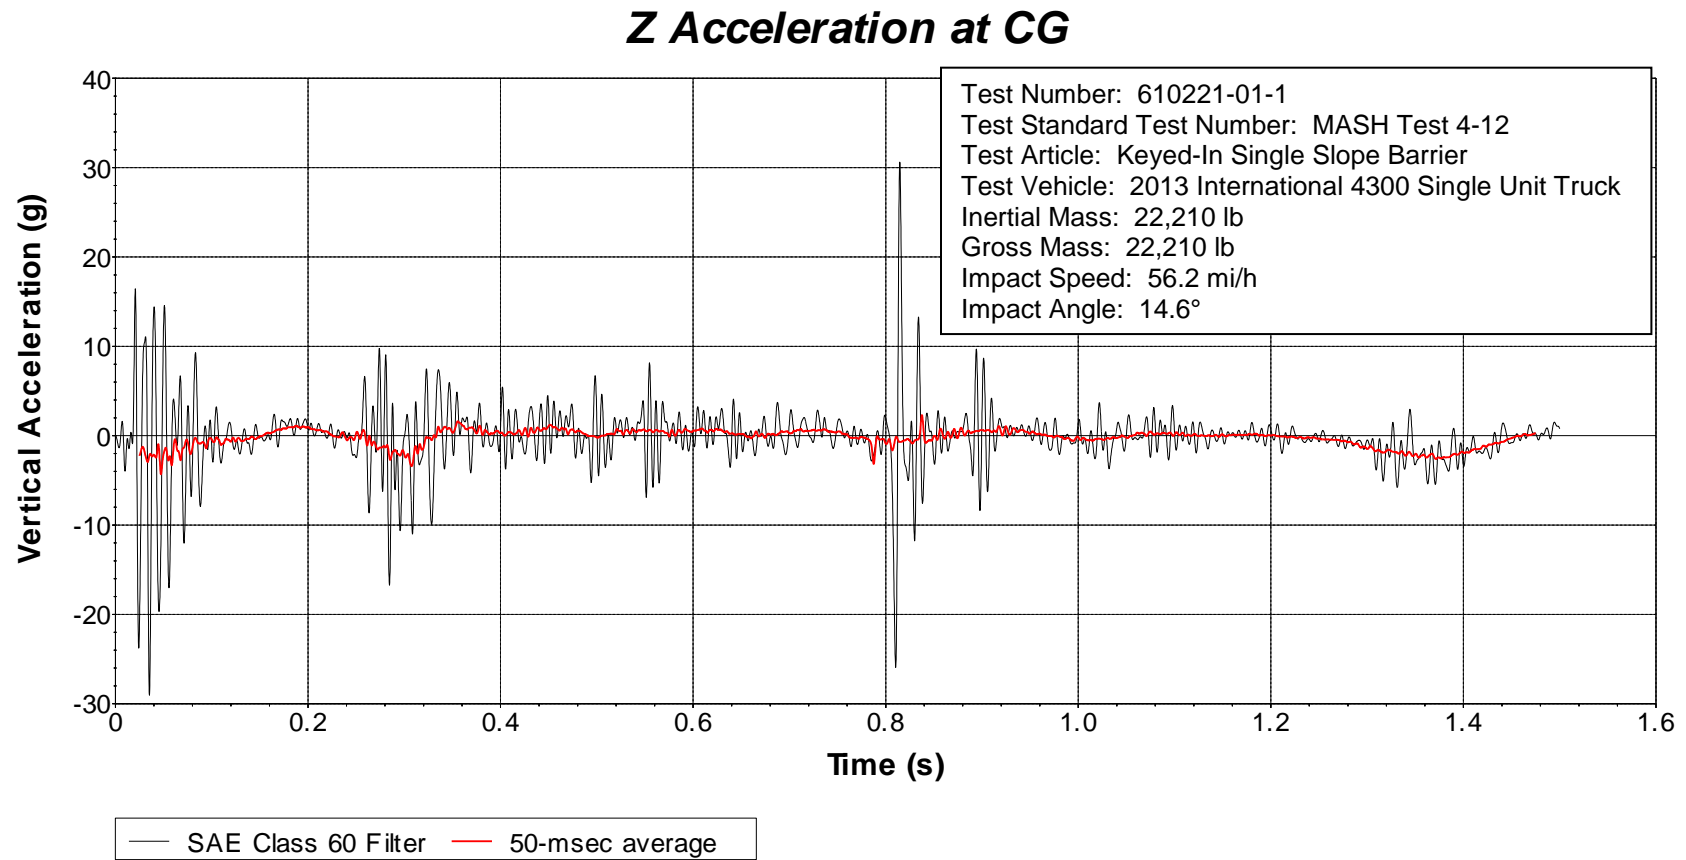
**Figure B.6. Vehicle Vertical Accelerometer Trace for Test No. 610221-01-1
(Accelerometer Located at Center of Gravity).**
