**Test Report No. 611971-03**  
**Test Report Date: March 2020**

## **MASH TL-3 EVALUATION OF W-BEAM MEDIAN BARRIER WITH RUB RAIL**

Contract No.: 1901472  
Test Nos.: 611971-03-1 / 611971-03-2  
Test Dates: 2019-09-11 / 2019-09-17

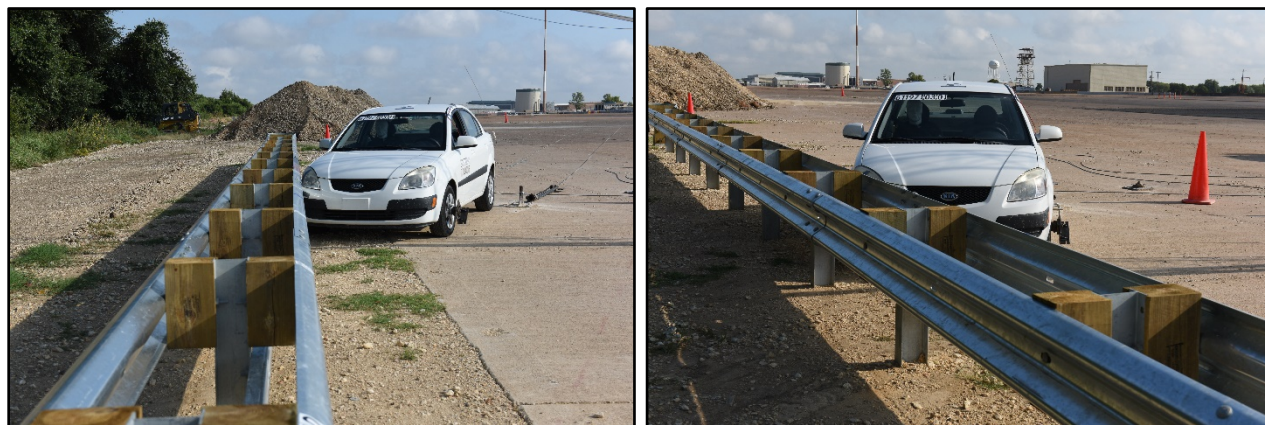
**Figure 5.1. Median Barrier/Test Vehicle Geometrics for Test No. 611971-03-1.**

Figures 5.1 and 5.2 show the 2009 Kia Rio used for the crash test. The vehicle's test inertia weight was 2438 lb, and its gross static weight was 2603 lb. The height to the lower edge of the vehicle front bumper was 7.75 inches, and height to the upper edge of the bumper was 21.5 inches. Table D.1 in Appendix D1 gives additional dimensions and information on the vehicle. The vehicle was directed into the installation using a cable reverse tow and guidance system and was released to be freewheeling and unrestrained just prior to impact.

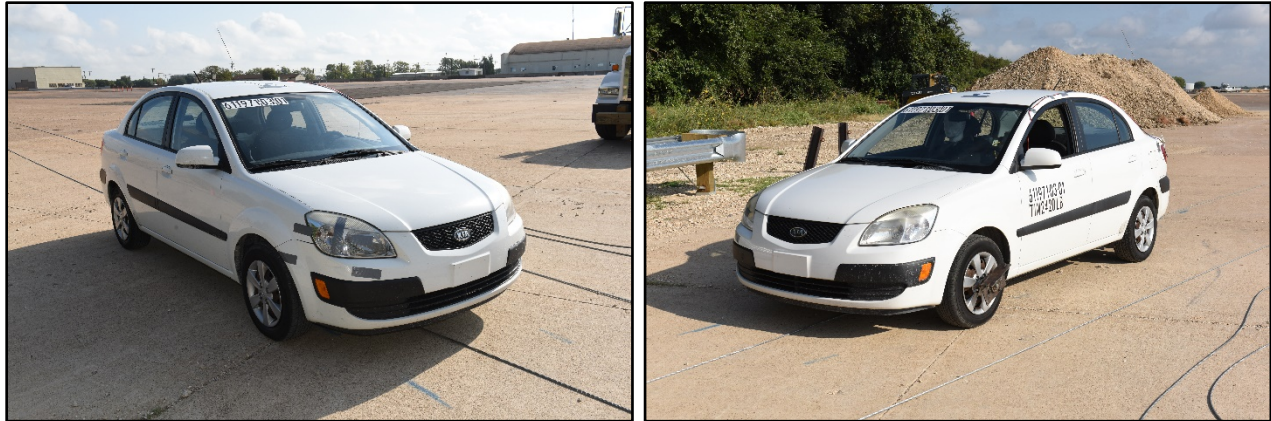
**Figure 5.2. Test Vehicle before Test No. 611971-03-1.**

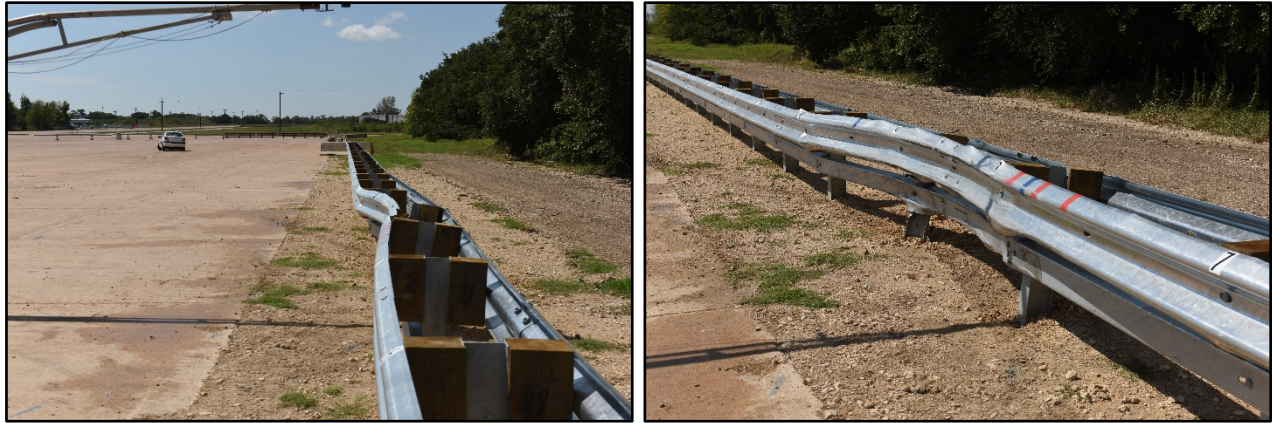
**Figure 5.3. Median Barrier after Test No. 611971-03-1.**

Figures 5.3 through 5.7 show the damage to the W-beam median barrier with rub rail. There was minimal soil disturbance at post 1, but no visible post movement. Post 9 was twisted and deformed. The field side breakout at post 9 was split, with one portion landing 10 ft behind the rail. See Table 5.2 for movement of posts 7, 8, and 10.

There was no post movement observed past post 10. The W-beam rail on the field side released from posts 10, 11, and 12. The rub rail and traffic side W-beam were deformed and scuffed in the impact area.

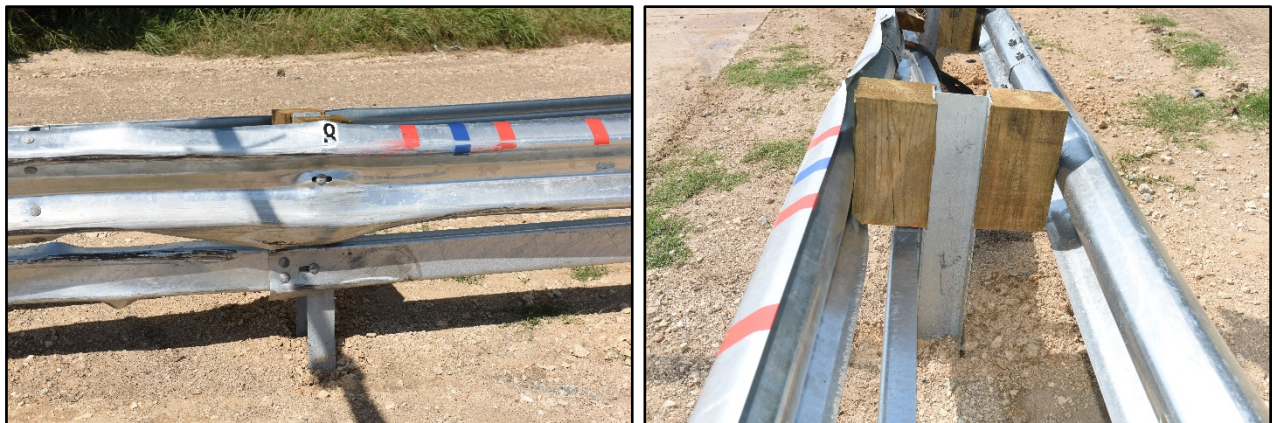
**Figure 5.4. Post 8 after Test No. 611971-03-1.**

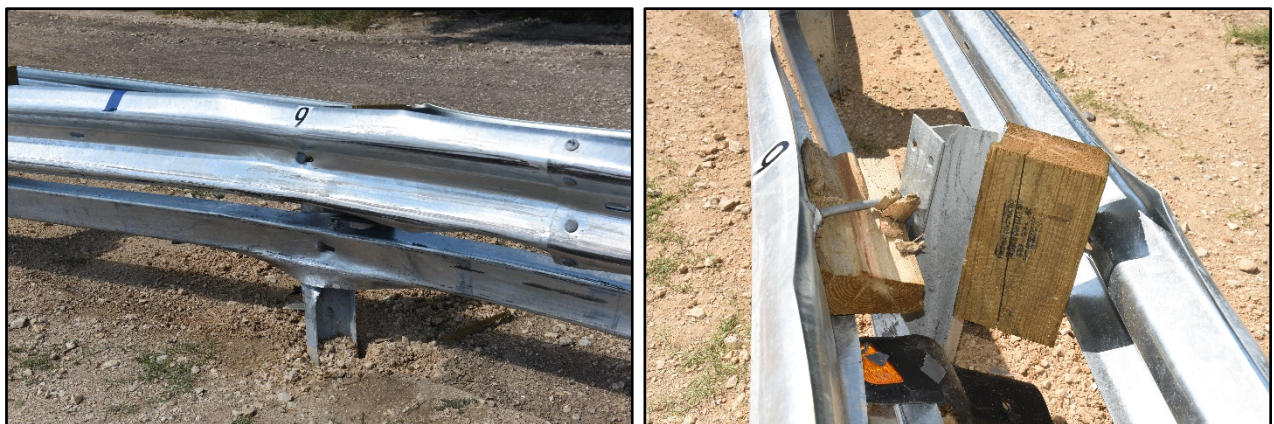
**Figure 5.5. Post 9 after Test No. 611971-03-1.**

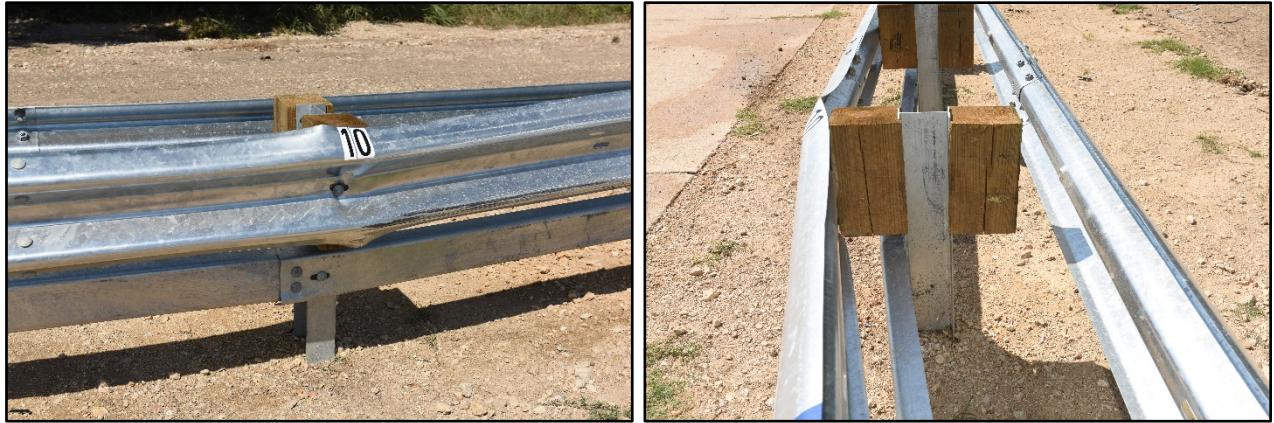
**Figure 5.6. Post 10 after Test No. 611971-03-1.**

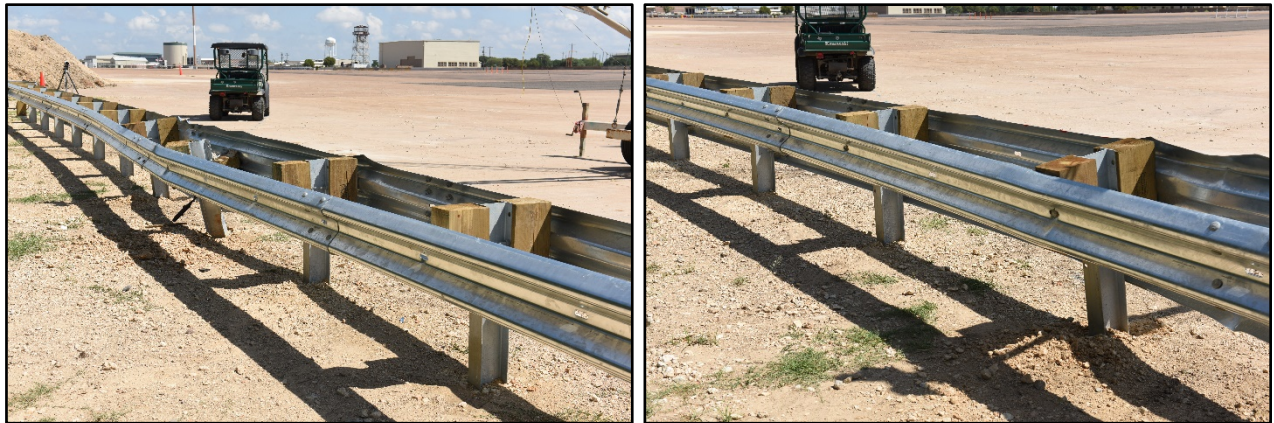
**Figure 5.7. Field Side of Median Barrier after Test No. 611971-03-1.**

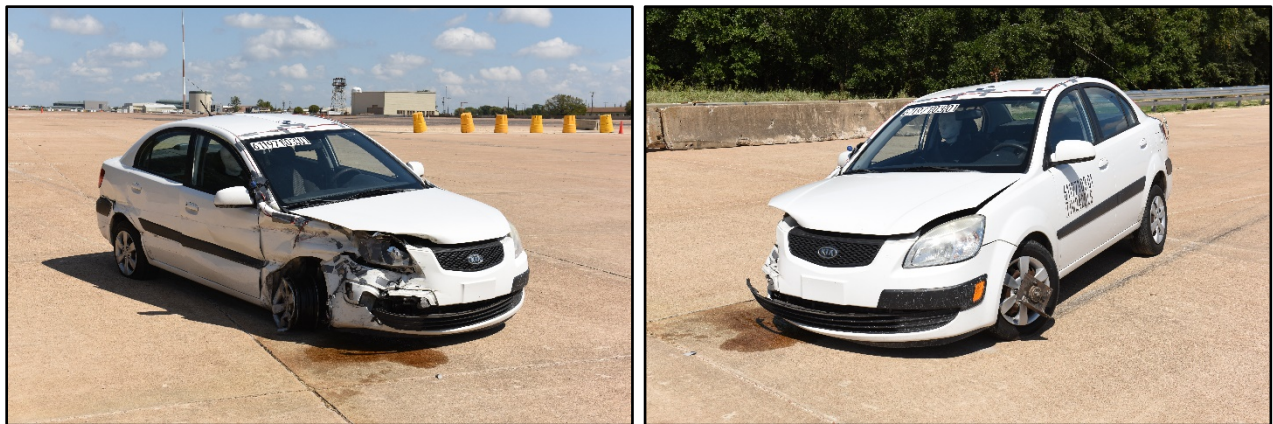
**Figure 5.8. Test Vehicle after Test No. 611971-03-1.**

Figure 5.8 shows the damage sustained by the vehicle. The front bumper, hood, right front fender, right front tire and rim, right front and rear doors, right rear quarter panel, and rear bumper were damaged. Maximum exterior crush to the vehicle was 10.0 inches in the side plane at the right front corner at bumper height. No occupant compartment deformation or intrusion was observed. Figure 5.9 shows the interior of the vehicle. Tables D.2 and D.3 in Appendix D1 provide exterior crush and occupant compartment measurements.

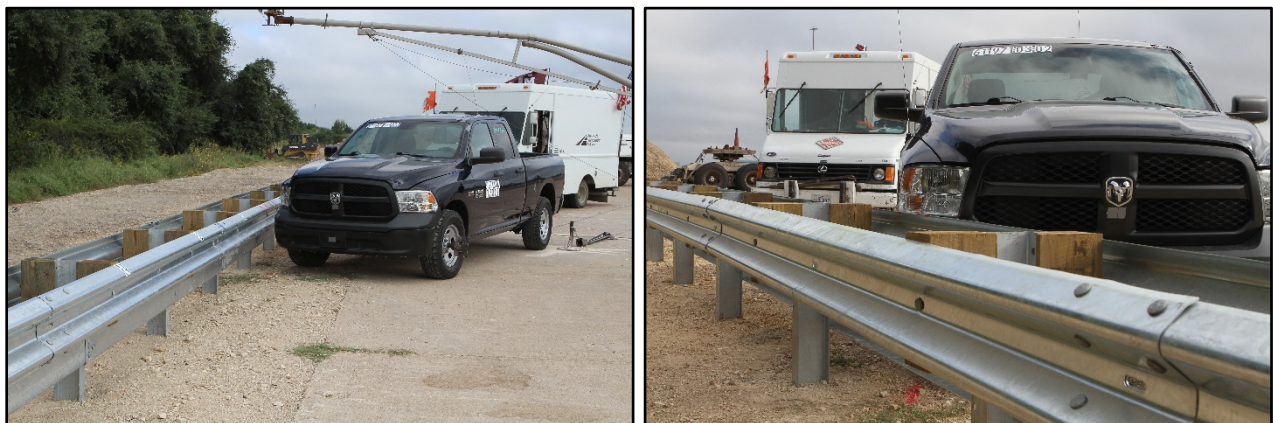
**Figure 6.1. Median Barrier/Test Vehicle Geometries for Test No. 611971-03-2.**

Figures 6.1 and 6.2 show the 2016 RAM 1500 pickup truck used for the crash test. The vehicle's test inertia weight was 5041 lb, and its gross static weight was 5041 lb. The height to the lower edge of the vehicle front bumper was 11.75 inches, and height to the upper edge of the bumper was 27.0 inches. The height to the vehicle's center of gravity was 28.5 inches. Tables E.1 and E.2 in Appendix D1 give additional dimensions and information on the vehicle. The vehicle was directed into the installation using a cable reverse tow and guidance system and was released to be freewheeling and unrestrained just prior to impact.

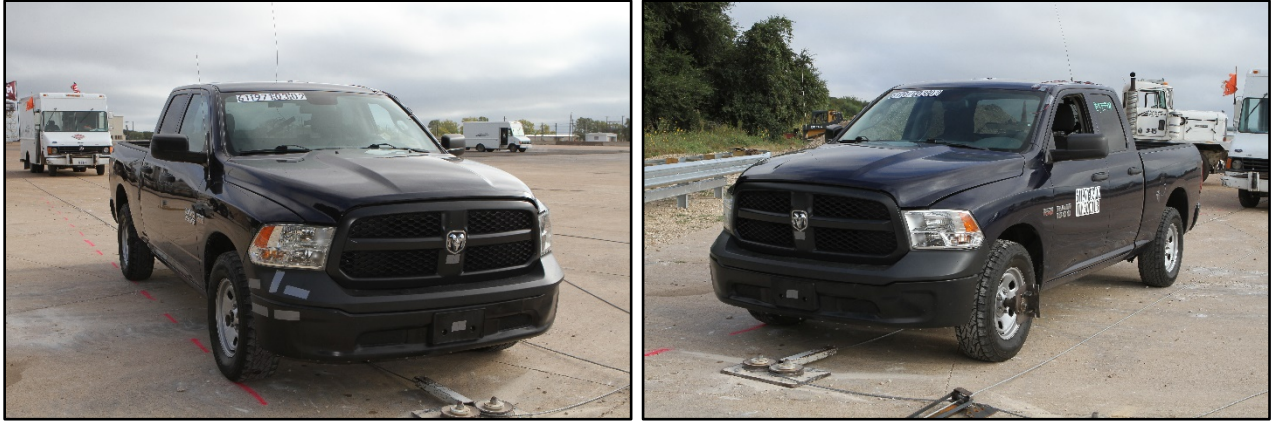
**Figure 6.2. Test Vehicle before Test No. 611971-03-2.**

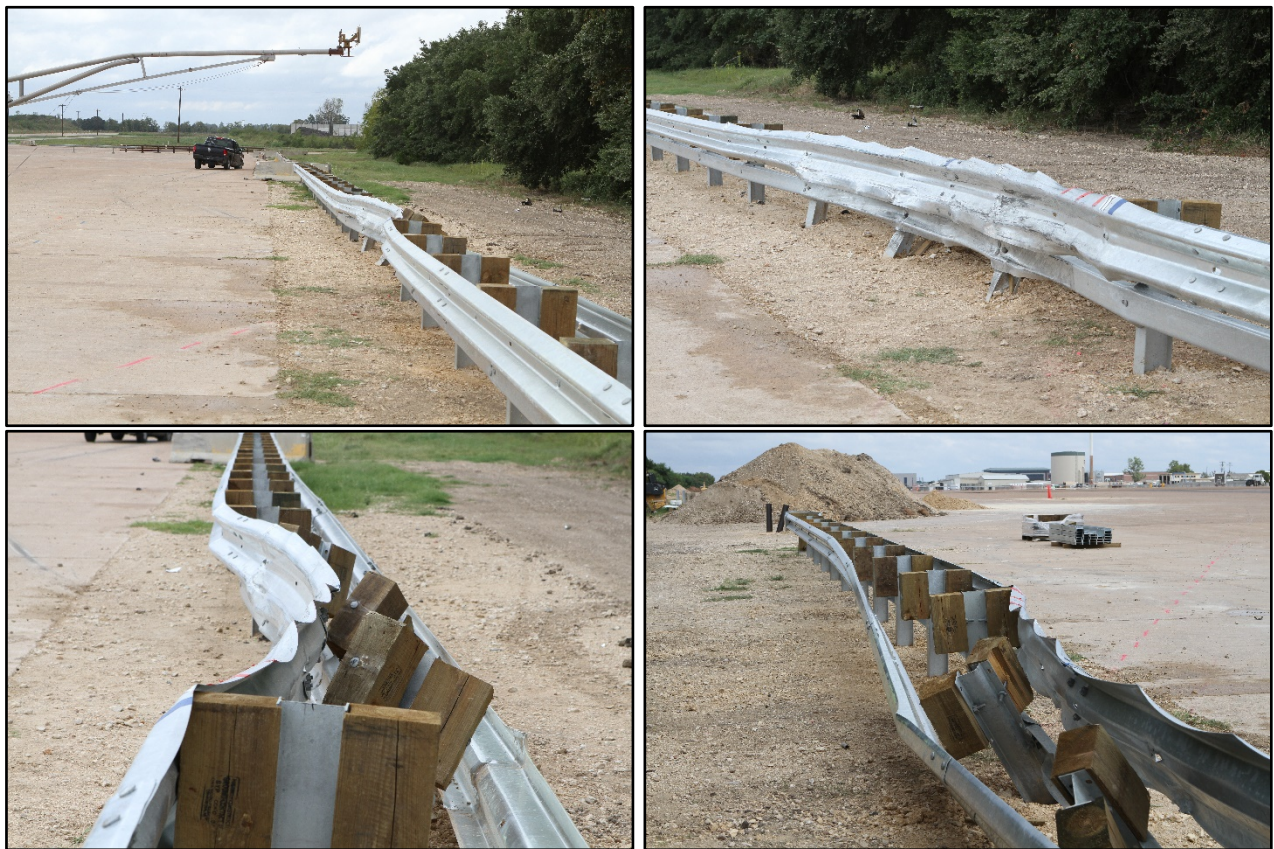
**Figure 6.3. Median Barrier after Test No. 611971-03-2.**

Figures 6.3 through 6.9 show the damage to the test installation. There was minimal soil disturbance at post 1, and a 1/8-inch gap between the soil and post on the upstream side. Posts 12 through 14 were rotated and deformed. See Table 6.2 for more information on post movement.

There was no post movement observed past post 15. The W-beam rail released from posts 7 through 18 on the field side and posts 12 through 14 on the traffic side. The rub rail and traffic side W-beam were deformed and scuffed in the impact area.

Working width\* was 52.6 inches, and height of working width was 31.0 inches. Maximum dynamic deflection during the test was 28.1 inches, and maximum permanent deformation was 20.25 inches.

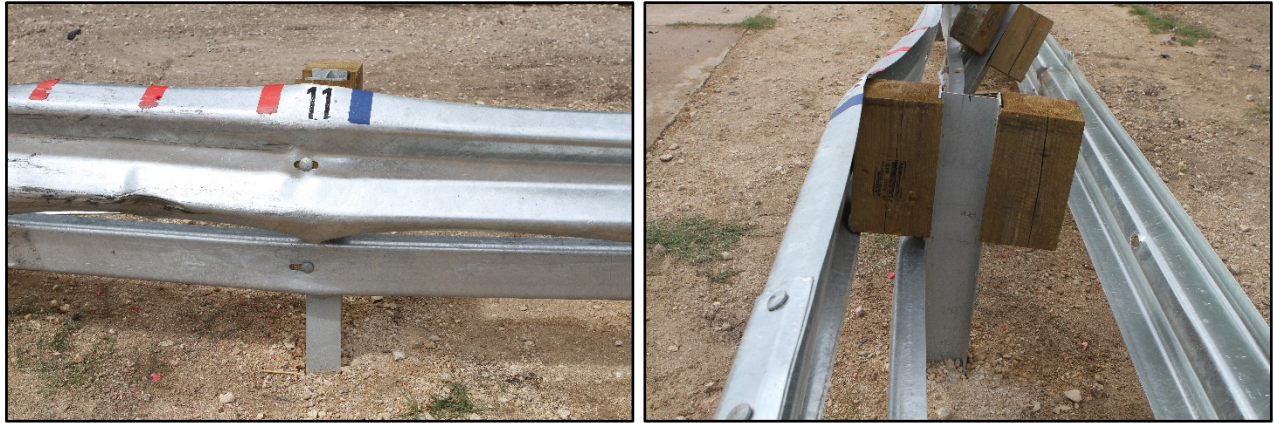
**Figure 6.4. Post 11 after Test No. 611971-03-2.**

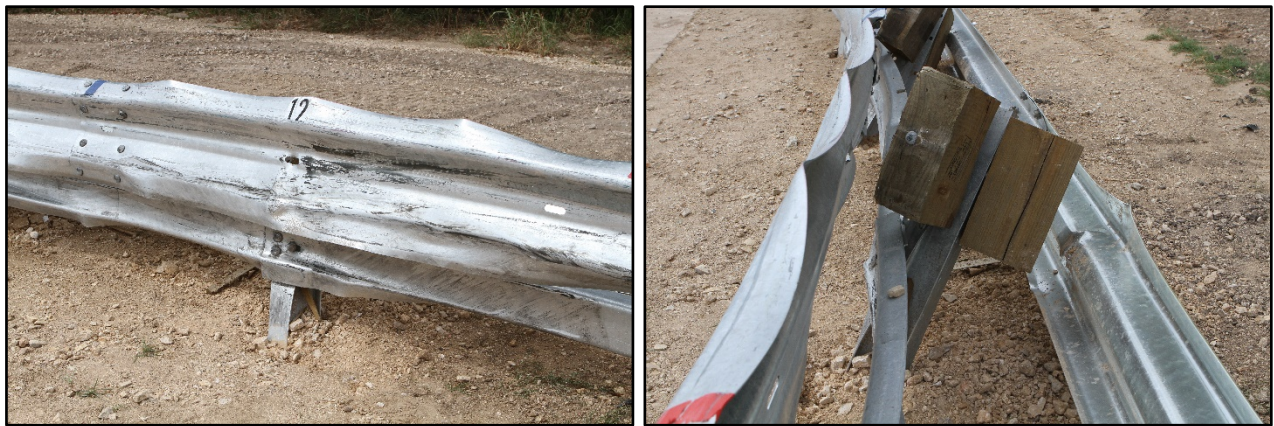
**Figure 6.5. Post 12 after Test No. 611971-03-2.**

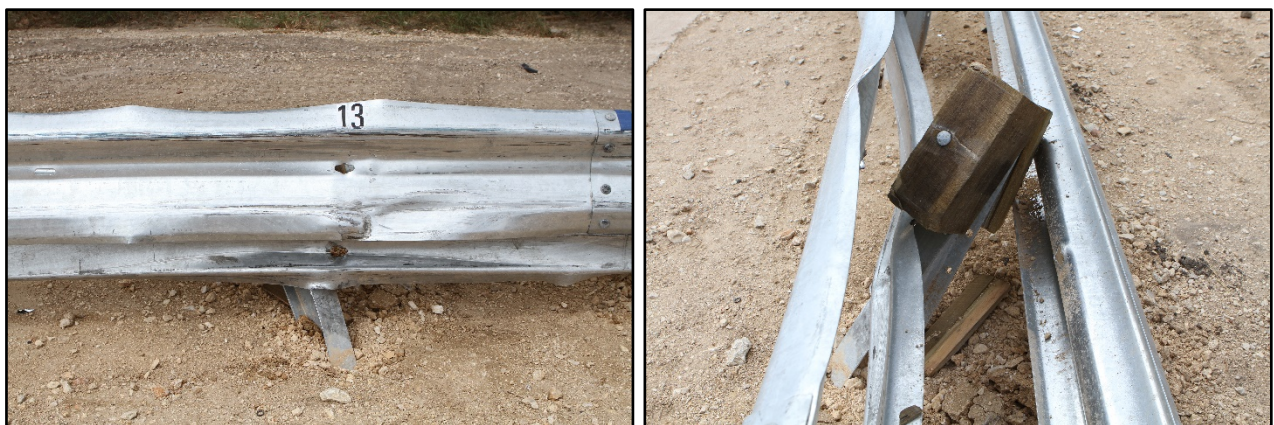
**Figure 6.6. Post 13 after Test No. 611971-03-2.**

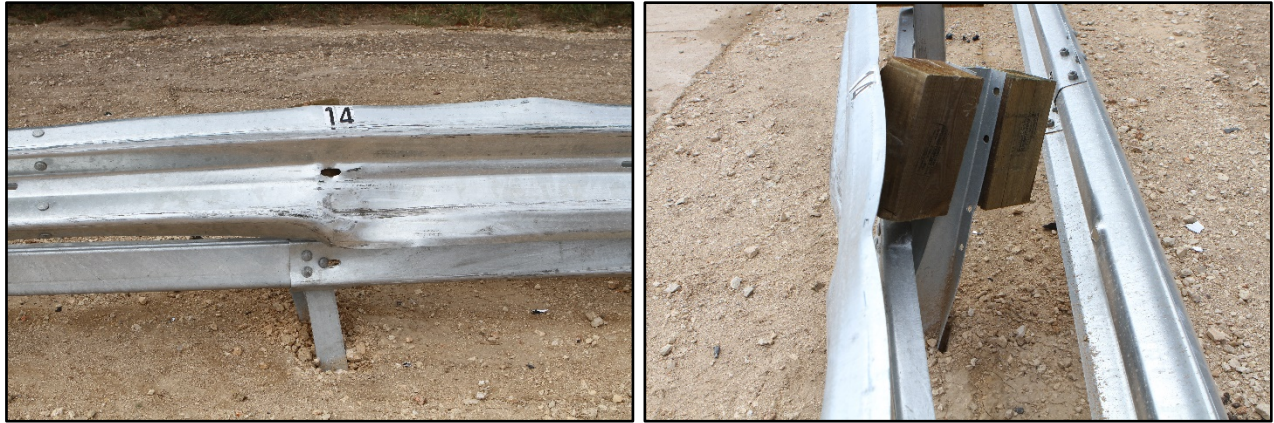
**Figure 6.7. Median Barrier after Test No. 611971-03-2.**

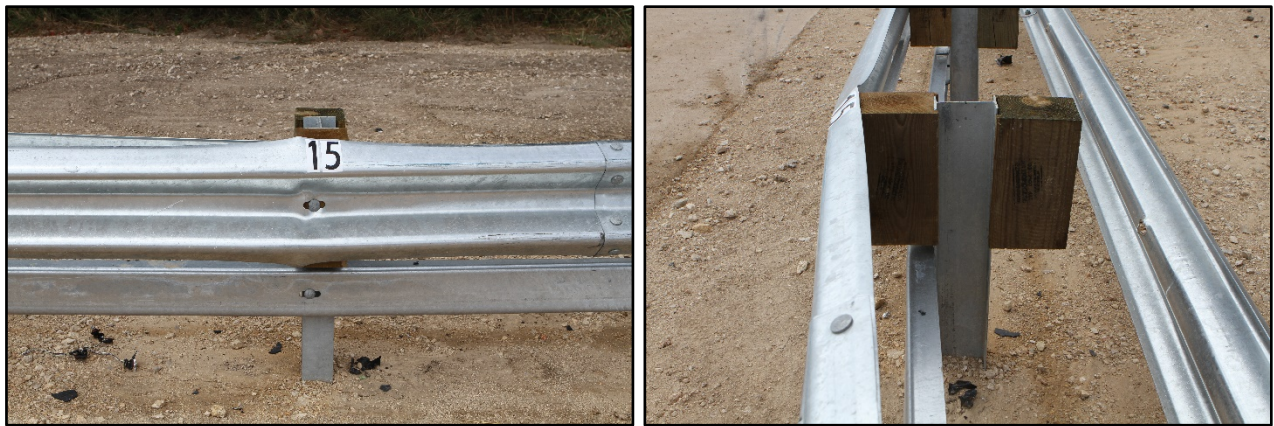
**Figure 6.8. Median Barrier after Test No. 611971-03-2.**

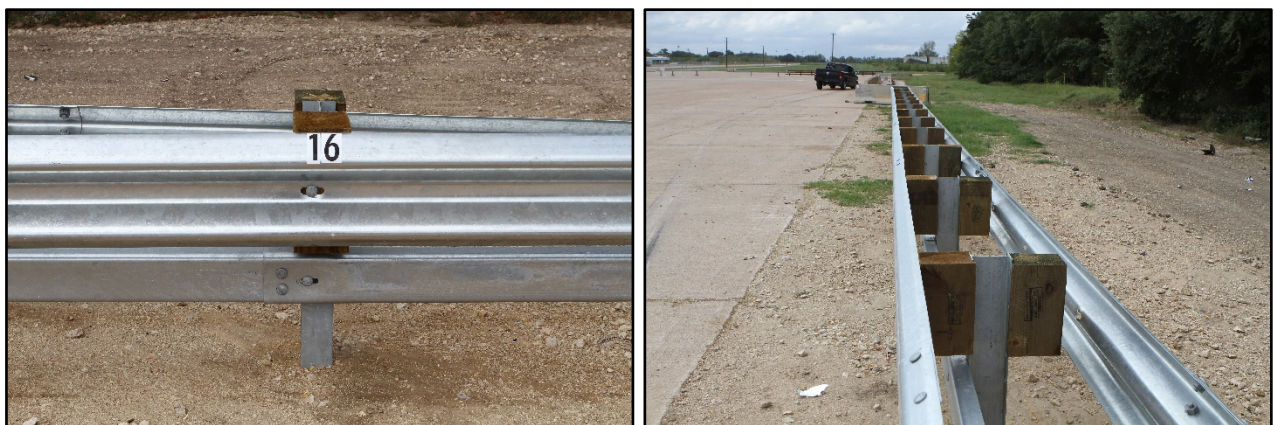
**Figure 6.9. Posts 14-16 after Test No. 611971-03-2.**

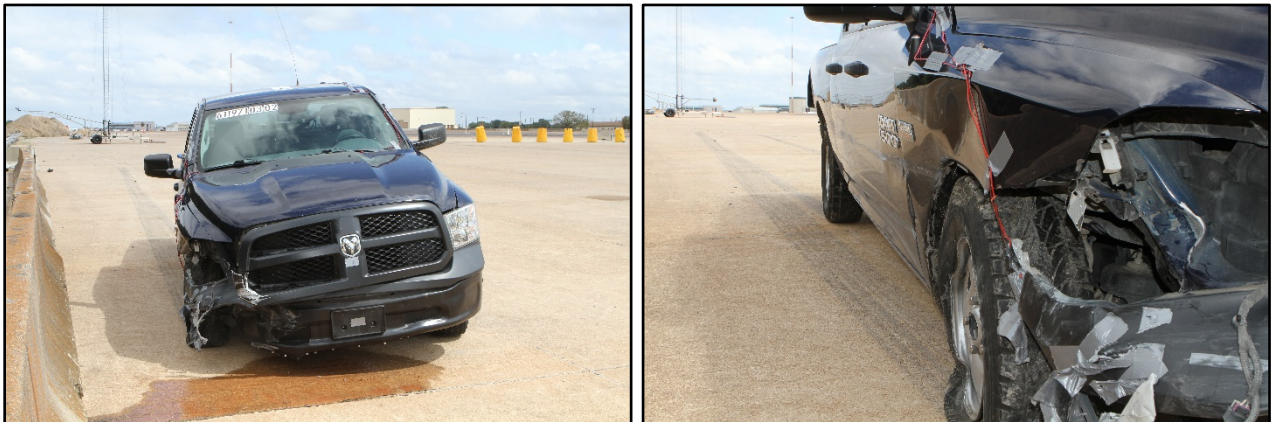
**Figure 6.10. Test Vehicle after Test No. 611971-03-2.**

Figure 6.10 shows the damage sustained by the vehicle. The front bumper, radiator and support, right front fender, right front tire and rim, right front and rear doors, right rear cab corner, right rear exterior bed, and rear bumper were damaged. Maximum exterior crush to the vehicle was 11.0 inches in the front and side planes at the right front corner at bumper height. No occupant compartment deformation or intrusion was observed. Figure 6.11 shows the interior of the vehicle. Tables E.3 and E.4 in Appendix E1 provide exterior crush and occupant compartment measurements.
