## **Roadside Safety Pooled Fund**

**Test Report No. 609301-01-1**

### **MASH TEST 3-10 OF GUARDRAIL SYSTEM ON 1H:1V SLOPE**

**Roadside Safety Research Program Pooled Fund  
Study No. TPF-5(114)**

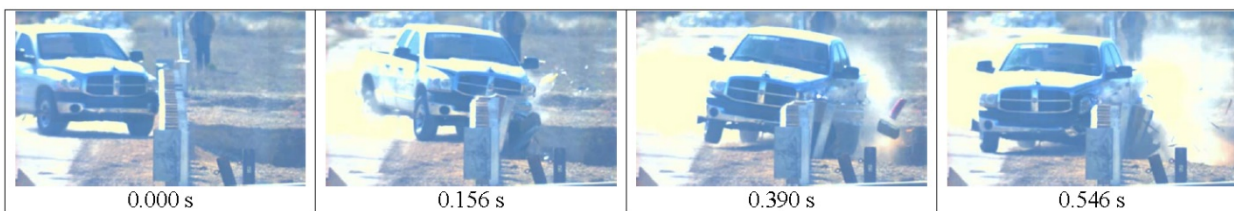
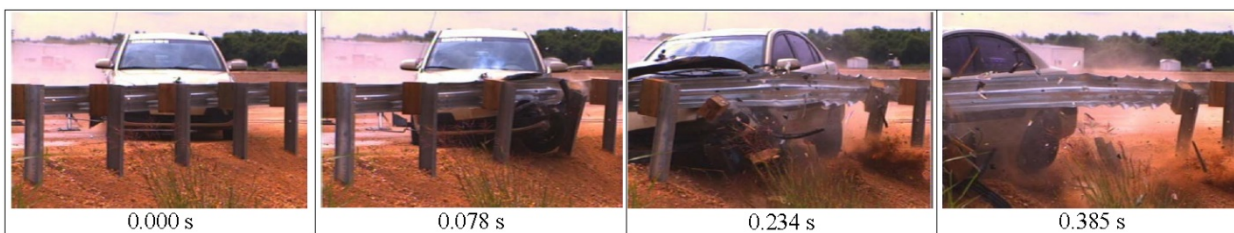
**(a) Test No. 405160-20-1**

**(b) Test No. 405160-20-2**

**Figure 1.4. Sequential Photos of MASH 3-11 and MASH 3-10.**

The test vehicle was successfully redirected by the guardrail system in each test. The test evaluation metrics were all within the limit of *MASH* test evaluation metrics. Hence, both tests passed *MASH* test evaluation criteria. Sequential images of both tests are shown in Figure 1.4.

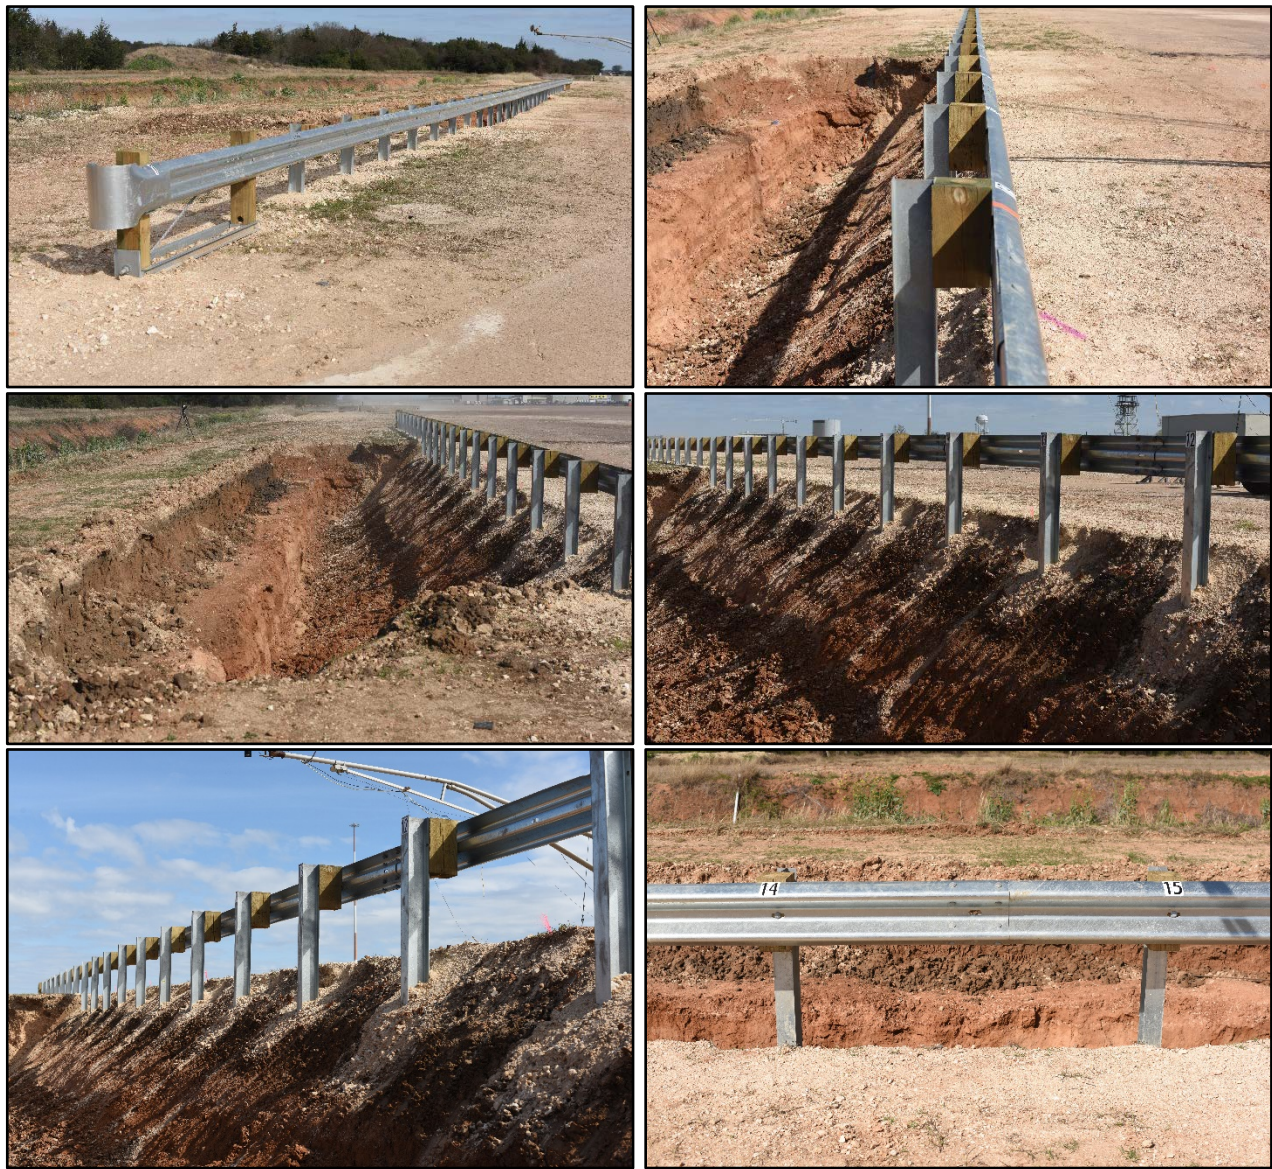
Figure 2.1. Guardrail on 1H:1V Slope prior to Test No. 609301-01-1.

The test installation consisted of a flexible W-beam guardrail system, with the top edge of the rail 31 inches above the roadway. The length of need portion (W-beam guardrail, supported by 9-ft long, W6×8.5 posts on 75-inch spacings, and offset from the posts with routed timber blockouts, with the rail splices midspan between the posts) was 162.5 ft long. It was anchored on each end with a TxDOT DAT terminal, for a total installation length of 181.25 ft. The ground sloped down and toward the field side at 45 degrees (1:1 slope) in the impact area, beginning approximately at the traffic side face of the guardrail, and extending for 8 ft to the field side and 8 ft deep. Figure 2.1 provides photographs of the installation. Appendix A.1 and A.2 provide further details of the guardrail on 1H:1V slope.

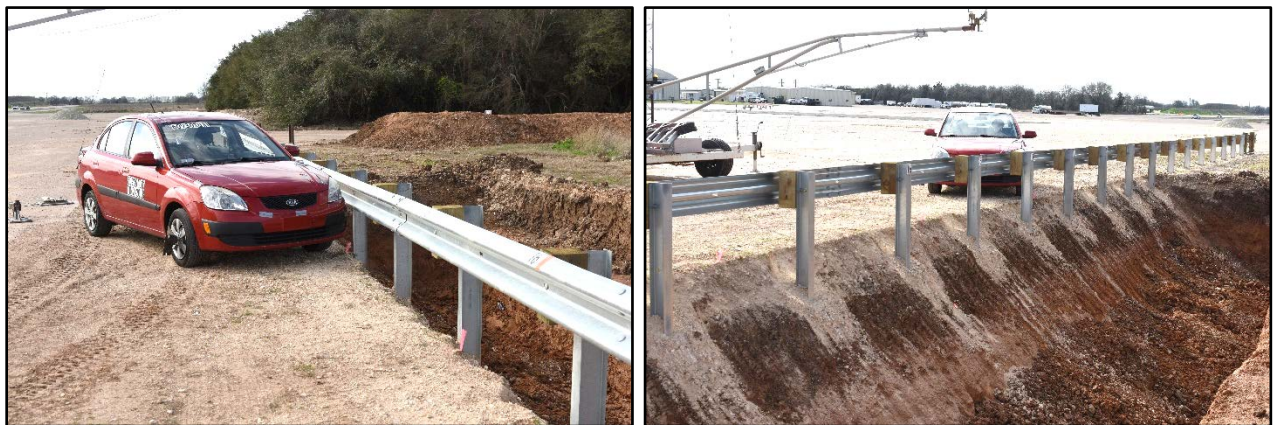
**Figure 2.2. Guardrail on 1H:1V Slope/Test Vehicle Geometrics for Test No. 609301-01-1.**

Figure 2.2 shows the 2009 Kia Rio used for the crash test. The vehicle's test inertia weight was 2437 lb, and its gross static weight was 2602 lb. The height to the lower edge of the vehicle bumper was 7.75 inches, and height to the upper edge of the bumper was 21.5 inches. The vehicle was directed into the installation using the cable reverse tow and guidance system, and was released to be freewheeling and unrestrained just prior to impact. Table A.2 in Appendix A.4 provides measurements of the vehicle.

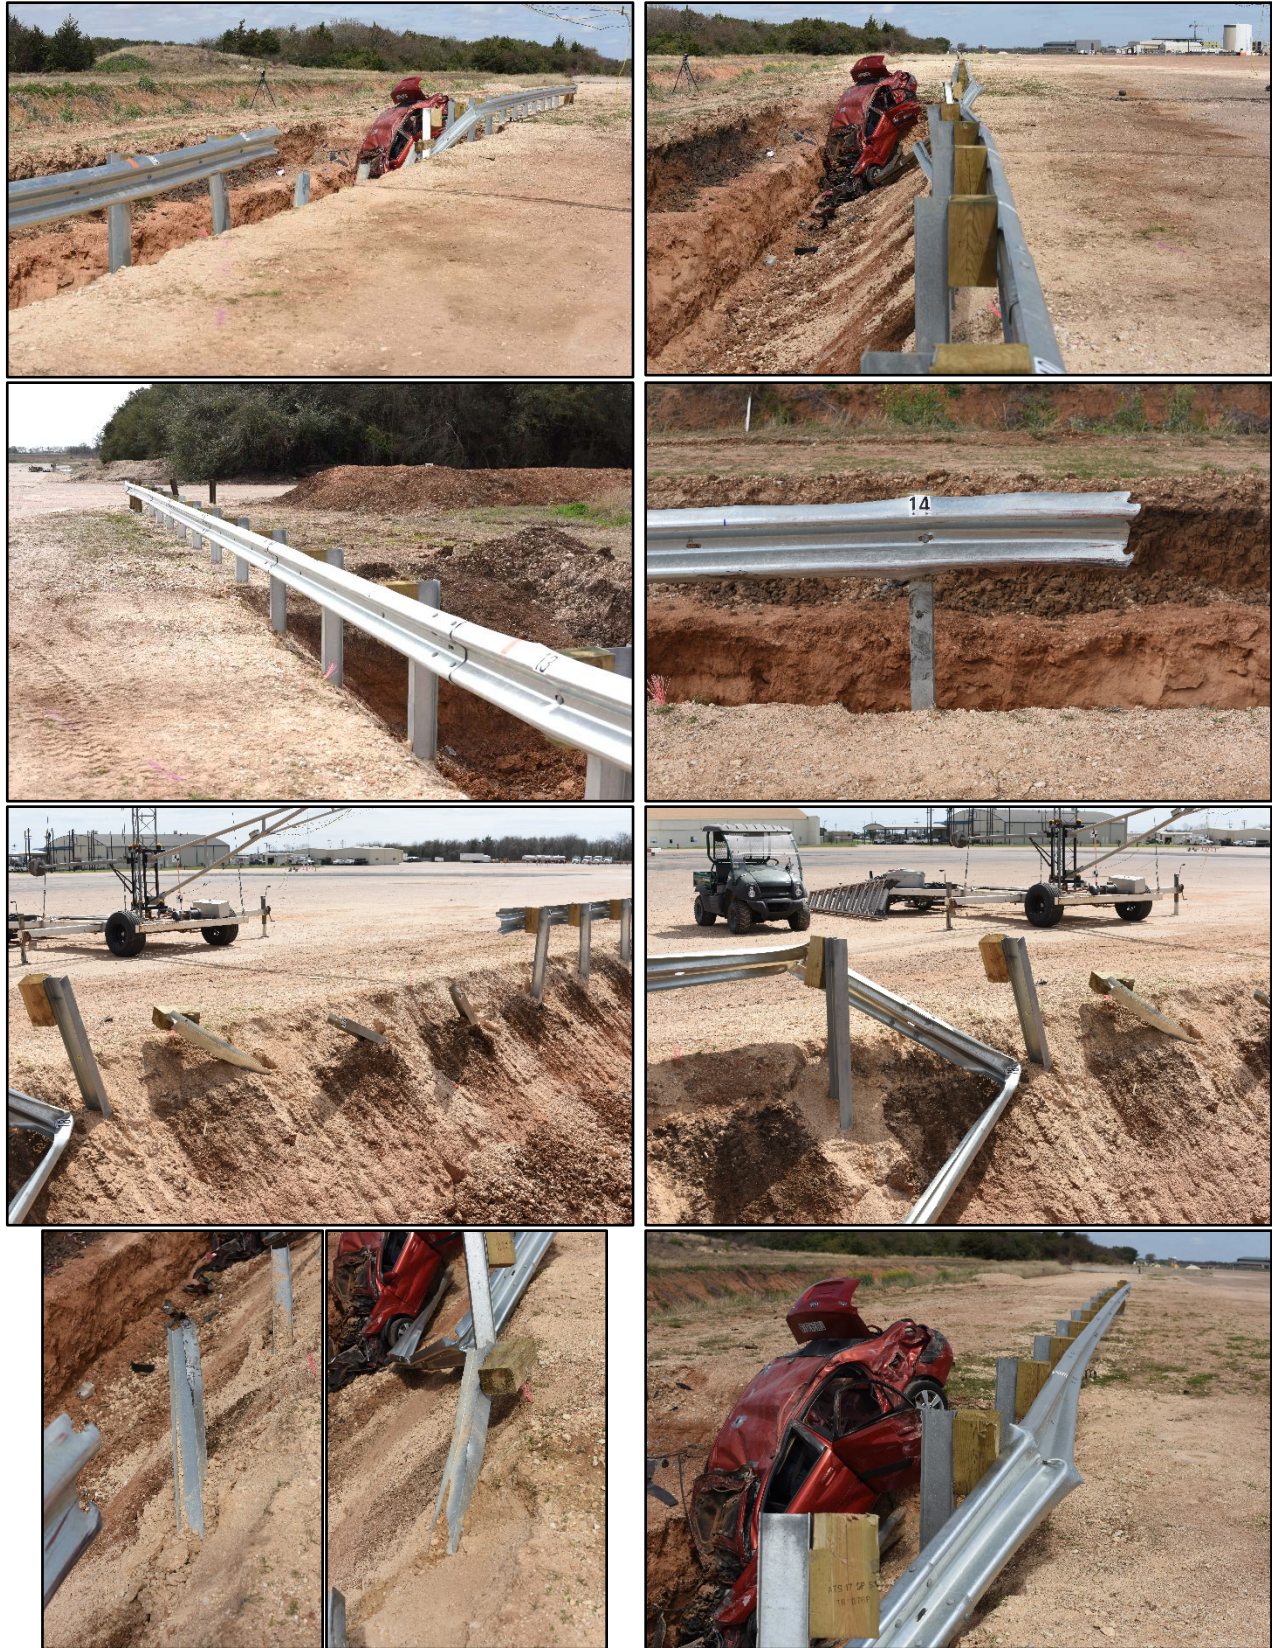
**Figure 2.3. Guardrail on 1H:1V Slope after Test No. 609301-01-1.**

Figure 2.3 shows the damage to the guardrail on 1H:1V slope. The soil around post 1 and 12 was disturbed. Post 13 deflected 0.4 inch toward the field side, and post 14 deflected 4.0 inches toward the field side. The rail element tore at the splice between posts 14 and 15. The rail element released from posts 15-18, and the blockouts released from the posts 15 and 16. Posts 15-17 were leaning downstream at 35 degrees from vertical, and post 18 was leaning downstream at 68 degrees from vertical and deflected toward the field side 1.0 inch. No movement was noted at other posts.

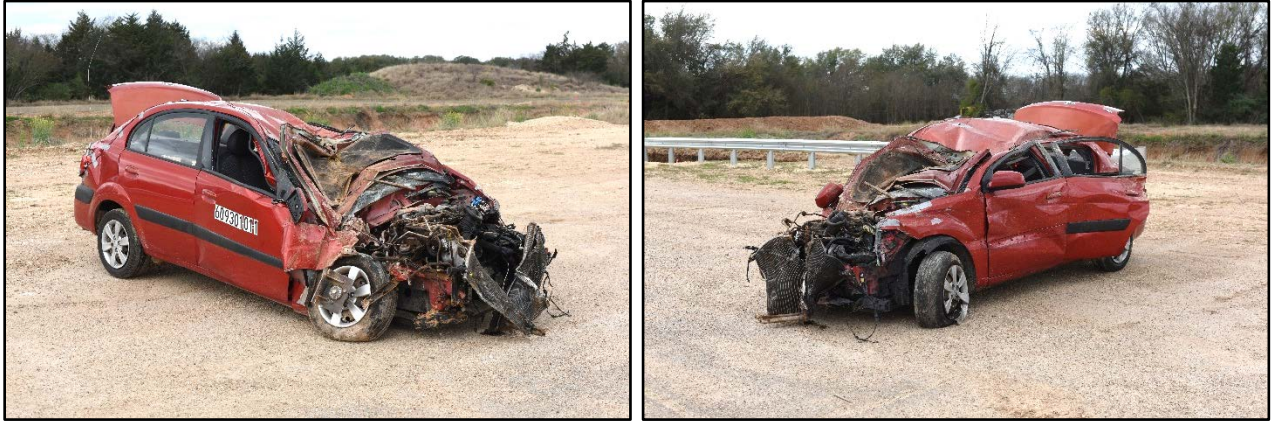
**Figure 2.4. Test Vehicle after Test No. 609301-01-1.**

Due to vehicle rollover, the vehicle sustained damage to all exterior components as shown in Figure 2.4. Figure 2.5 shows the interior of the vehicle.

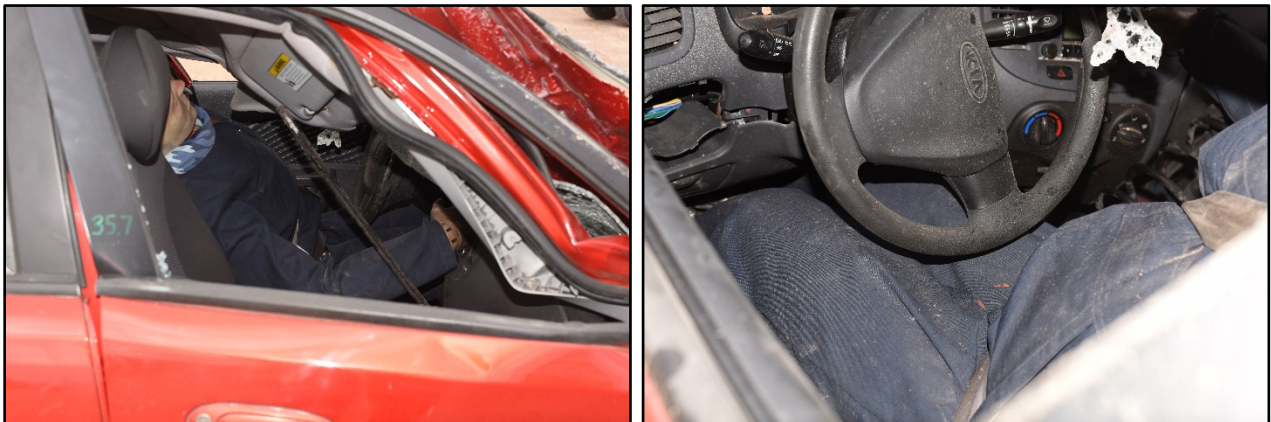
**Figure 2.5. Interior of Test Vehicle after Test No. 609301-01-1.**

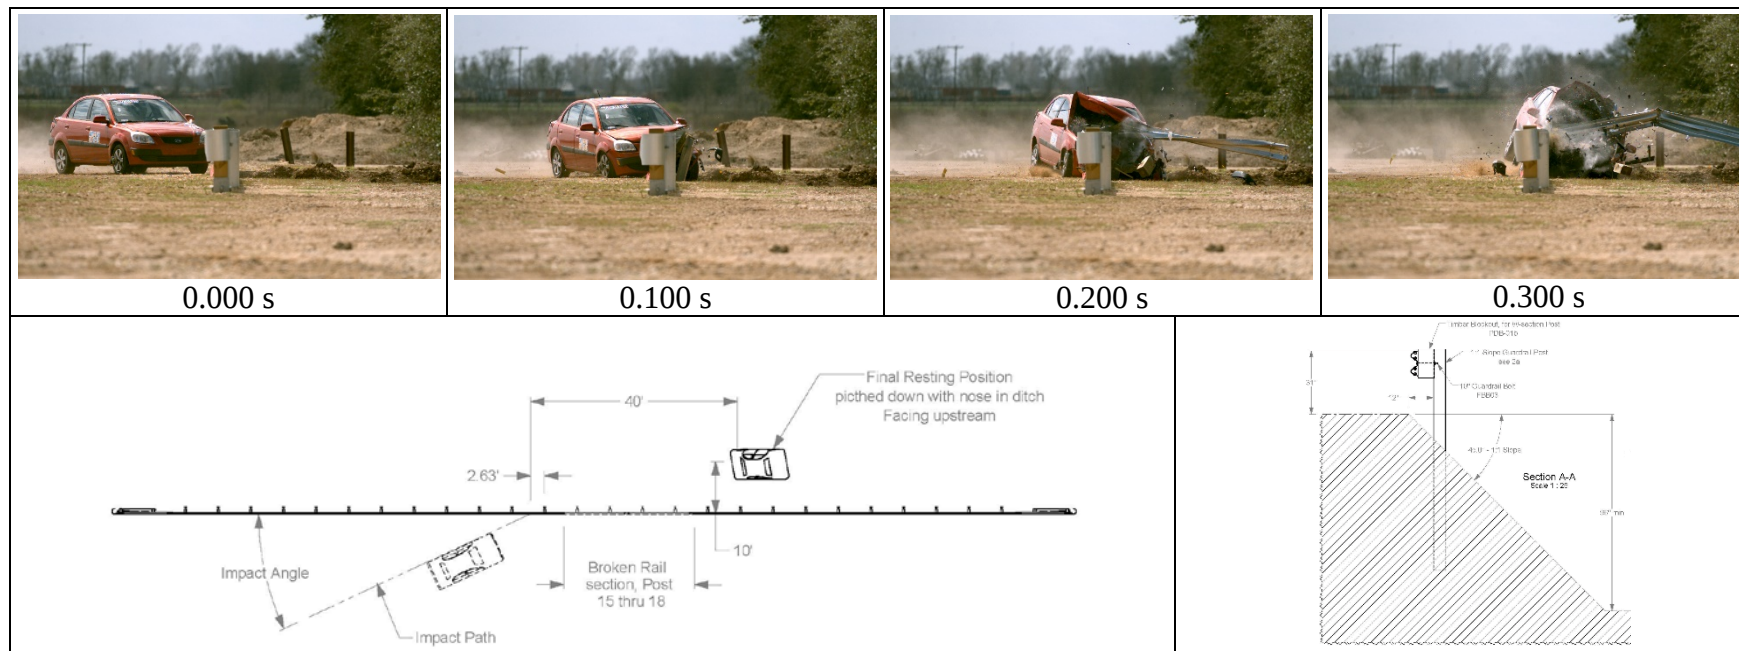
Type ..... Longitudinal Barrier – Guardrail  
 Name ..... Guardrail on 1H:1V Slope  
 Installation Length..... 181 ft 3 inches  
 Material or Key Elements... 31-inch W-Beam Guardrail on 9 ft W6x8.5 steel posts with wood blockouts spaced at 75 inches on 1H:1V slope  
 Soil Type and Condition ..... Embedded in AASHTO M147-65(2004), grading B Soil (crushed limestone)

Exit Conditions  
 Speed ..... 57.4 mi/h  
 Angle ..... 20.8°

Dynamic..... Rail Ruptured  
 Permanent ..... Rail Ruptured  
 Working Width..... 15 ft  
 Height of Working Width ..... NA

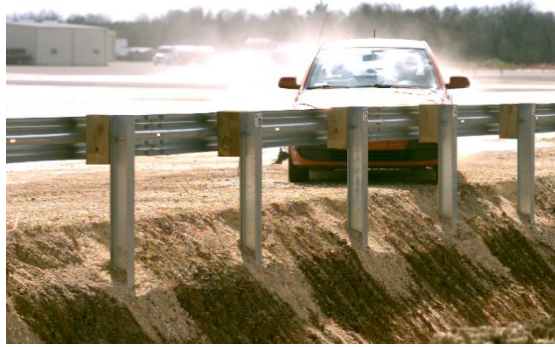
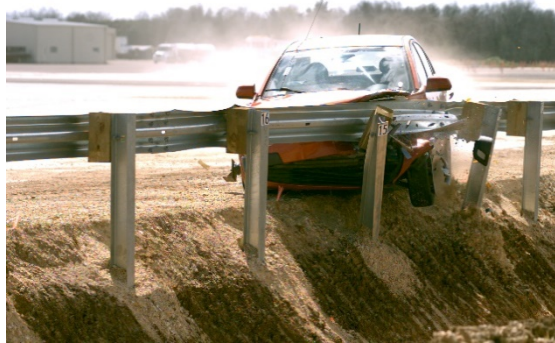
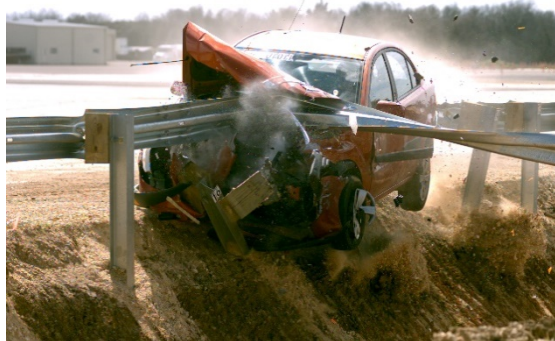
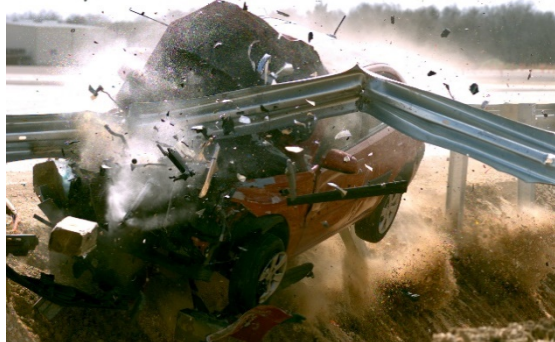
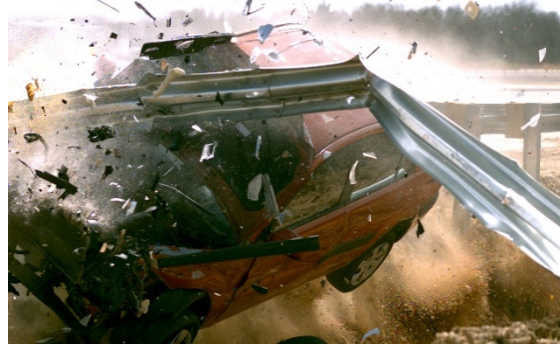
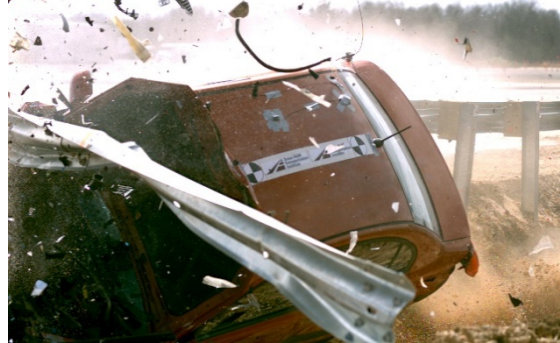
**Figure A.2. Sequential Photographs for Test No. 609301-01-1 (Rear View).**
