Test Report No. 611901-06

Test Report Date: August 2021

MASH TL-4 EVALUATION OF FLARED CAST-IN-PLACE CONCRETE BARRIER

Sponsored by
Roadside Safety Pooled Fund Group

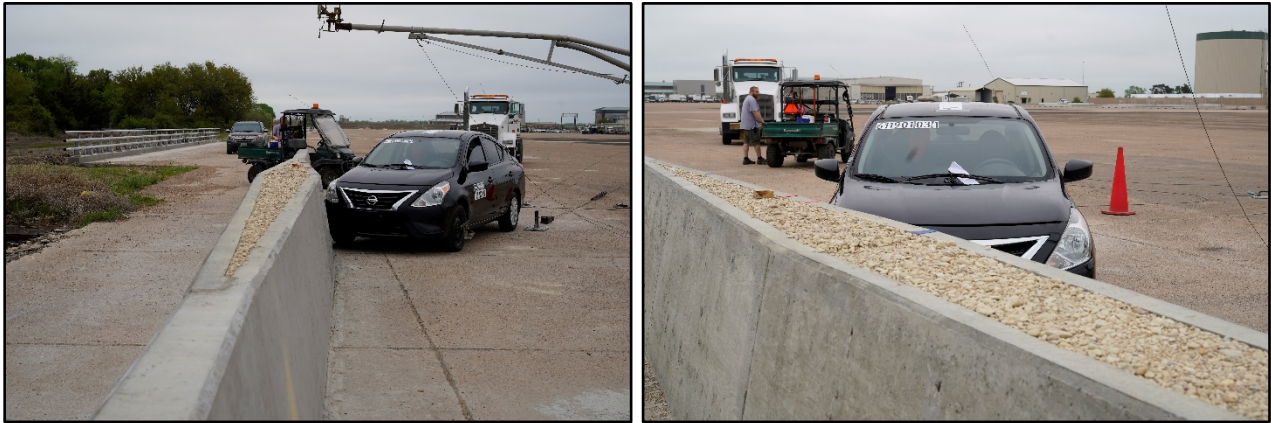
MASH Test 4-10 involves a 1100C vehicle weighing $2420 \text{ lb} \pm 55 \text{ lb}$ impacting the CIP of the longitudinal barrier at an impact speed of $62 \text{ mi/h} \pm 2.5 \text{ mi/h}$ and an angle of $25 \text{ degrees} \pm 1.5 \text{ degrees}$. The CIP for *MASH* Test 4-10 on the barrier system was $5.0 \text{ ft} \pm 1 \text{ ft}$ upstream of the centerline of the maximum width of the flare. Figure 4.1 and Figure 6.1 depict the target impact setup.

Figure 6.1. Barrier System/Test Vehicle Geometries for Test No. 611901-03-1.

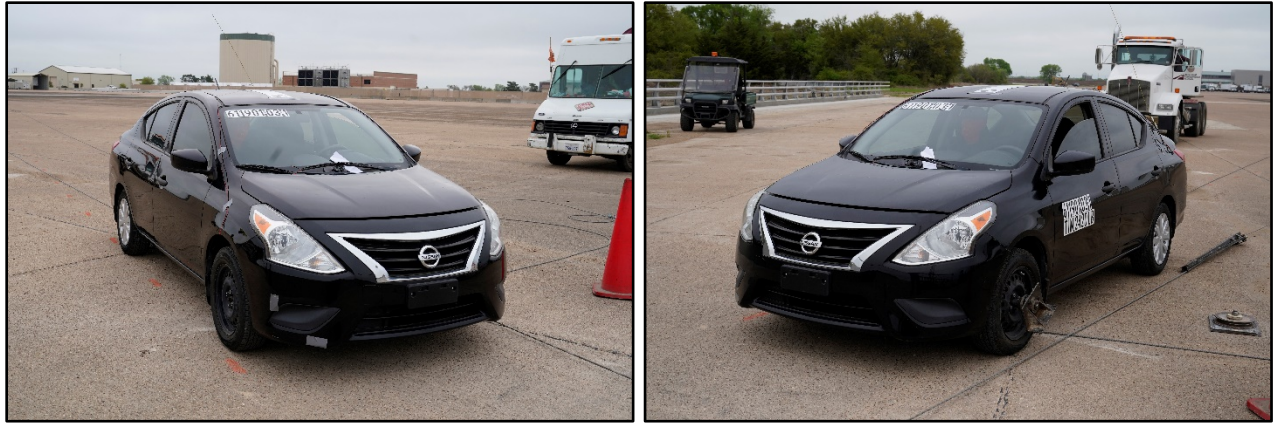
Figure 6.2 shows the 2016 Nissan Versa used for the crash test. The vehicle's test inertia weight was 2432 lb, and its gross static weight was 2597 lb. The height to the lower edge of the vehicle bumper was 7.00 inches, and the height to the upper edge of the bumper was 22.3 inches. Table C.1 in Appendix C.1 gives additional dimensions and information on the vehicle. The vehicle was directed into the installation using a cable reverse tow and guidance system, and was released to be freewheeling and unrestrained just prior to impact.

Figure 6.2. Test Vehicle before Test No. 611901-03-1.

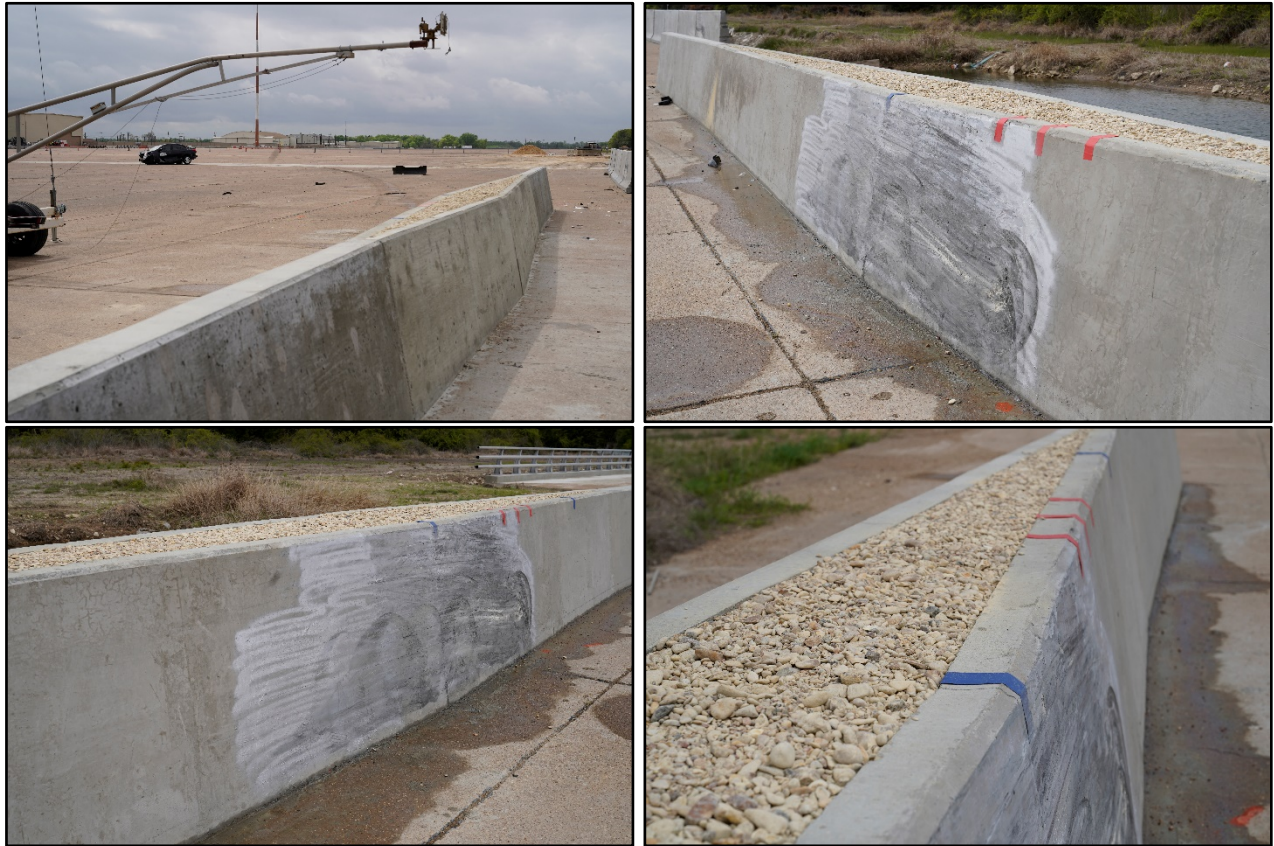
Figure 6.3 shows the damage to the barrier system. There was minor gouging and scuffing on the concrete at impact. Working width* was 41.25 inches, and height of working

width was at the toe of the barrier. No measurable dynamic deflection during the test or permanent deformation after the test was observed.

Figure 6.3. Barrier System after Test No. 611901-03-1.

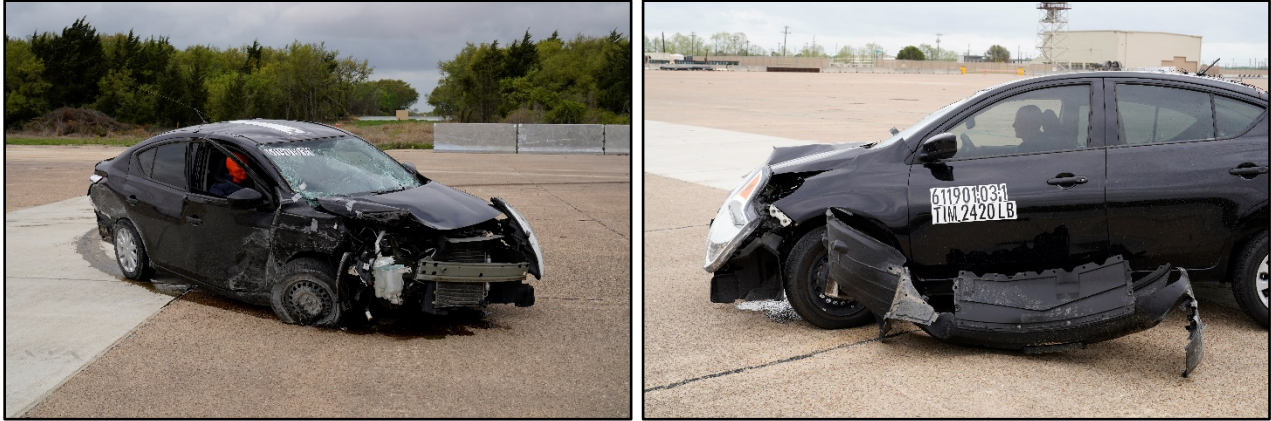
Figure 6.4 shows the damage sustained by the vehicle. The front bumper, hood, grill, radiator and support, right front fender, right front strut and tower, right front tire and rim, right A-pillar, right front floor pan, right front corner of the roof, right front door and window glass, right rear door, right rear quarter panel, and rear bumper were damaged. The windshield sustained stress cracks radiating upward and inward from the lower right corner. No fuel tank damage was observed. Maximum exterior crush to the vehicle was 10.0 inches in the front plane at the right front corner at bumper height. Maximum occupant compartment deformation was 3.5 inches in the kick panel/toe pan area and 3.0 inches in the right front firewall area. Figure 6.5 shows the interior of the vehicle. Tables C.2 and C.3 in Appendix C.1 provide exterior crush and occupant compartment measurements.

Figure 6.4. Test Vehicle after Test No. 611901-03-1.

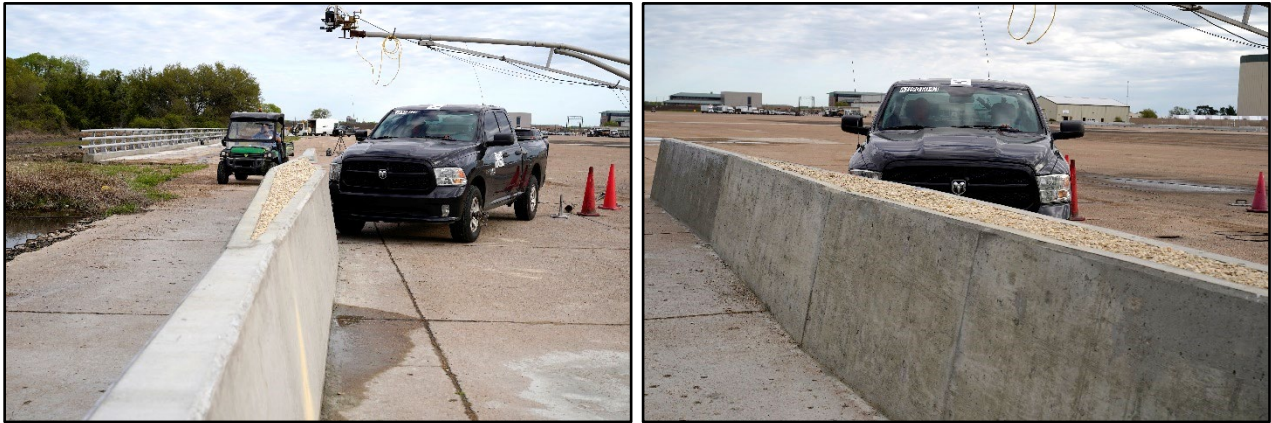
MASH Test 4-11 involves a 2270P vehicle weighing $5000 \text{ lb} \pm 110 \text{ lb}$ impacting the CIP of the longitudinal barrier at an impact speed of $62 \text{ mi/h} \pm 2.5 \text{ mi/h}$ and an angle of $25 \text{ degrees} \pm 1.5 \text{ degrees}$. The CIP for *MASH* Test 4-11 on the barrier system was $5.0 \text{ ft} \pm 1 \text{ ft}$ upstream of the centerline of the maximum width of the flare. Figure 4.1 and Figure 7.1 depict the target impact setup.

Figure 7.1. Barrier System/Test Vehicle Geometrics for Test No. 611901-04-1.

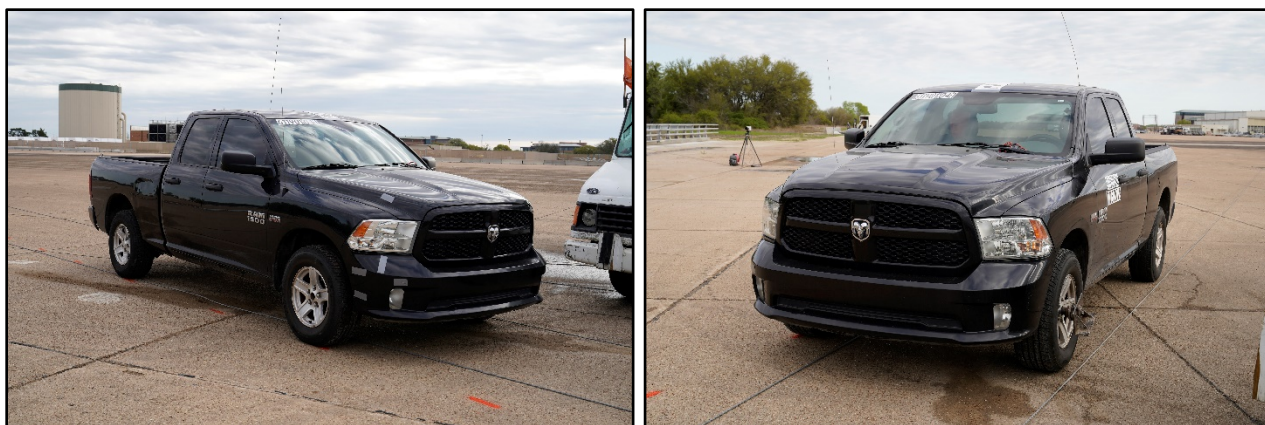
Figure 7.2 shows the 2015 RAM 1500 pickup truck used for the crash test. The vehicle's test inertia weight was 5020 lb, and its gross static weight was 5185 lb. The height to the lower edge of the vehicle bumper was 11.75 inches, and height to the upper edge of the bumper was 27.0 inches. The height to the vehicle's center of gravity was 28.75 inches. Tables D.1 and D.2 in Appendix D.1 give additional dimensions and information on the vehicle. The vehicle was directed into the installation using a cable reverse tow and guidance system, and was released to be freewheeling and unrestrained just prior to impact.

Figure 7.2. Test Vehicle before Test No. 611901-04-1.

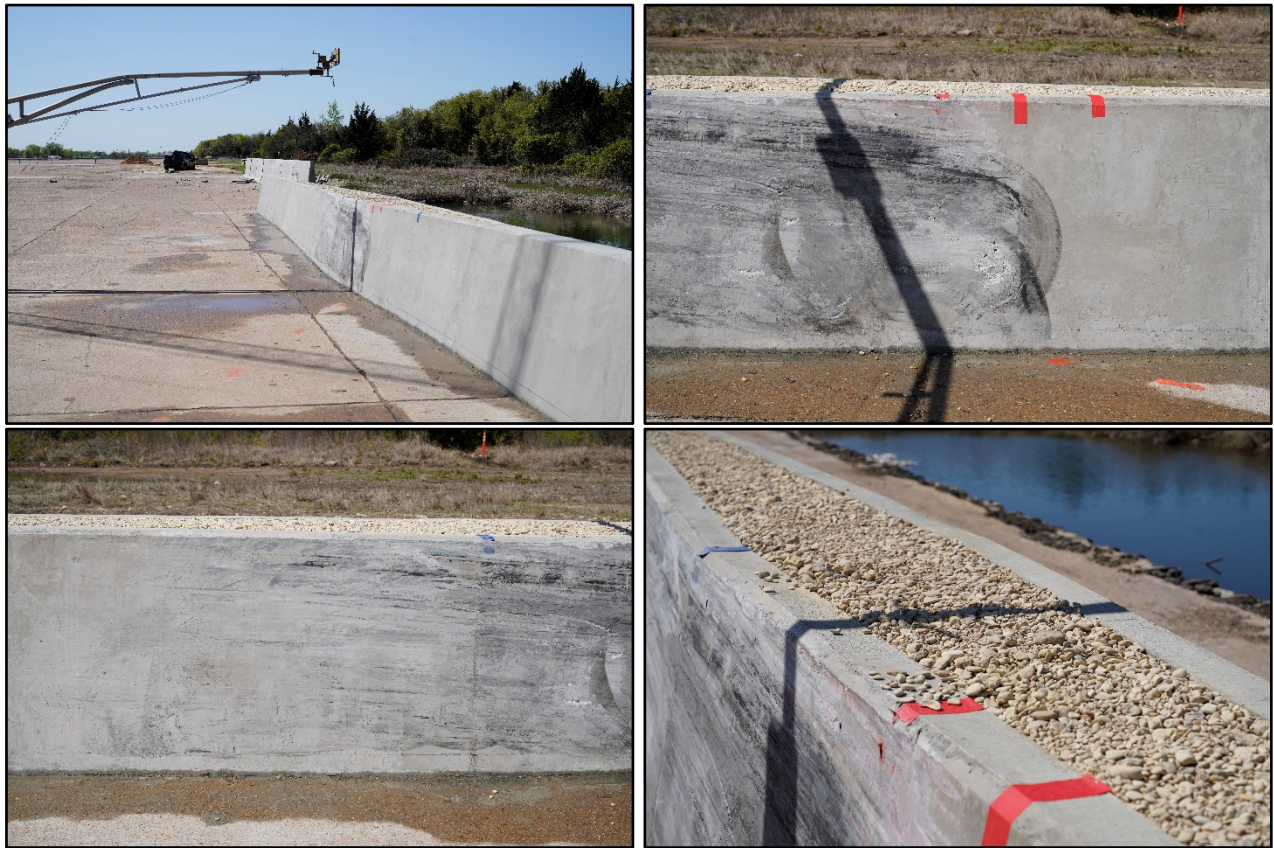
Figure 7.3 shows the damage to the barrier system. There was minor gouging of the barrier face at impact from the wheel lugs, and the face of the concrete was scuffed at impact and downstream of it. There were some cracks on the field side at 8.0 inches downstream of impact.

Working width* was 41.25 inches, and height of working width was at the toe of the barrier. No measurable dynamic deflection during the test nor permanent deformation after the test was observed.

Figure 7.3. Barrier System after Test No. 611901-04-1.

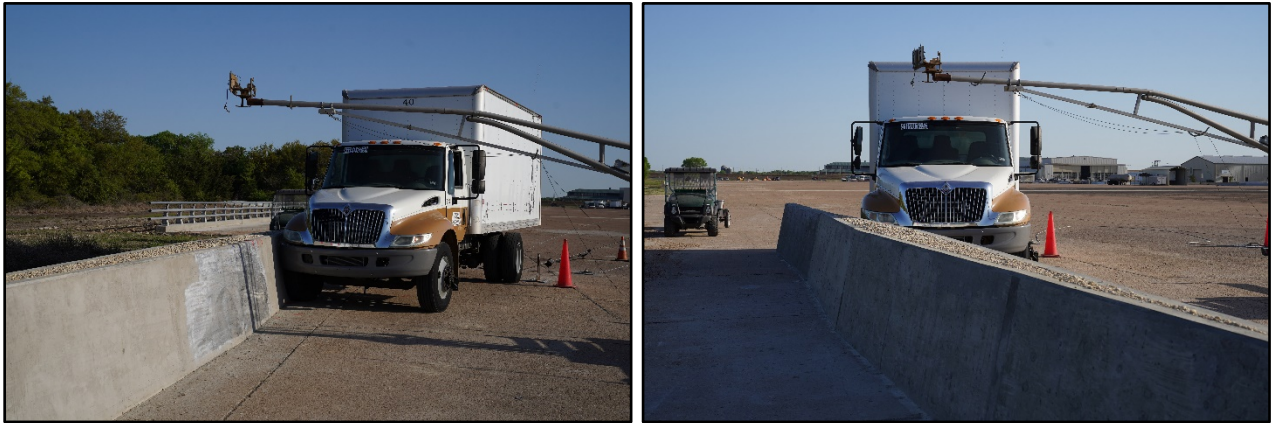
MASH Test 4-12 involves a 10000S vehicle weighing $22,000 \text{ lb} \pm 660 \text{ lb}$ impacting the CIP of the longitudinal barrier at an impact speed of $56 \text{ mi/h} \pm 2.5 \text{ mi/h}$ and an angle of $15 \text{ degrees} \pm 1.5 \text{ degrees}$. The CIP for *MASH* Test 4-12 on the barrier system was $10.0 \text{ ft} \pm 1 \text{ ft}$ upstream of the centerline of the maximum width of the flare. Figure 4.1 and Figure 8.1 depict the target impact setup.

Figure 8.1. Barrier System/Test Vehicle Geometrics for Test No. 611901-05-1.

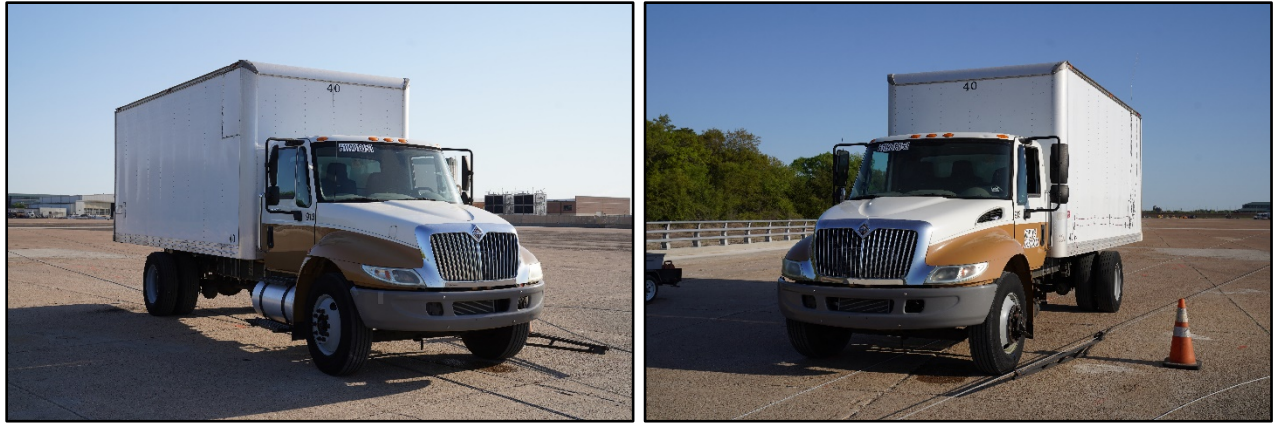
Figure 8.2 shows the 2009 International 4300 single-unit truck used for the crash test. The vehicle's test inertia weight was 22,140 lb, and its gross static weight was 22,140 lb. The height to the lower edge of the vehicle bumper was 18.25 inches, and height to the upper edge of the bumper was 33.25 inches. The height to the center of gravity of the vehicle's ballast was 63.5 inches. Table E.1 in Appendix E.1 gives additional dimensions and information on the vehicle. The vehicle was directed into the installation using a cable reverse tow and guidance system, and was released to be freewheeling and unrestrained just prior to impact.

Figure 8.2. Test Vehicle before Test No. 611901-05-1.

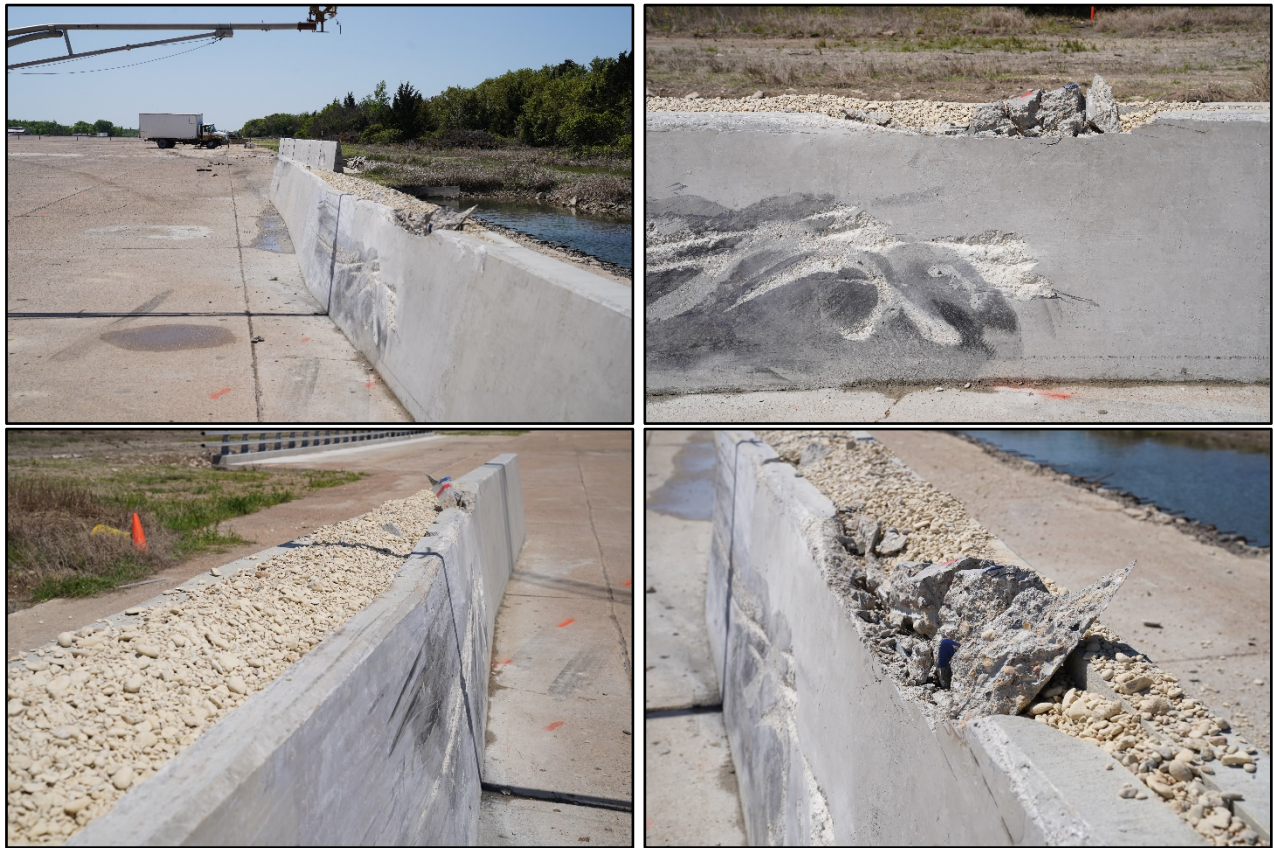
spalling and exposed rebar. Working width* was 54.9 inches, and height of working width was 123.7 inches. No measurable dynamic deflection during the test or permanent deformation after the test was observed.

Figure 8.3. Barrier System after Test No. 611901-05-1.

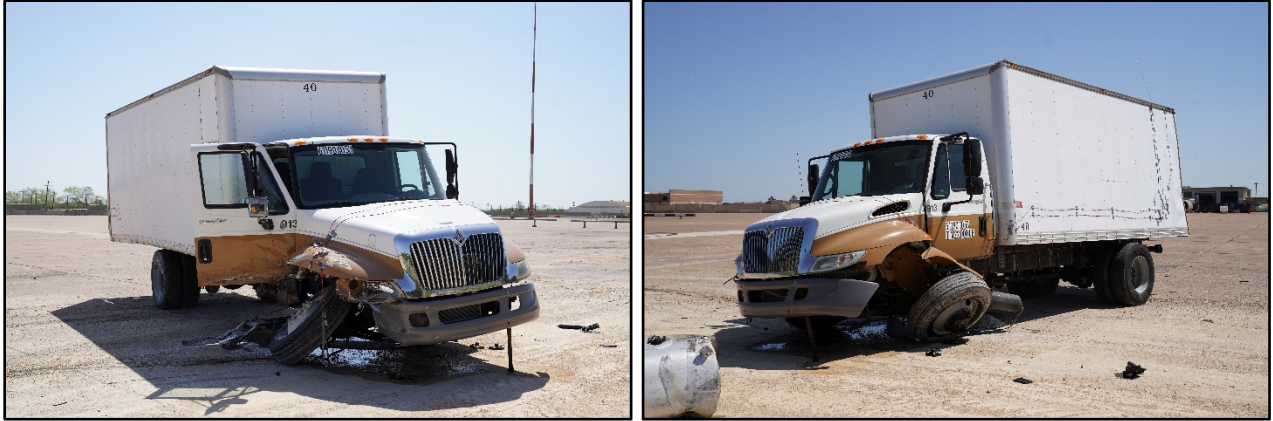
Figure 8.5 shows the damage sustained by the vehicle. The front bumper, hood, right front tire and rim, front axle and spring assembly, right side step, right door, right lower corner of the box, and right rear outer tire and rim were damaged. The fuel tank was dislodged and separated from the truck. Maximum exterior crush to the vehicle was 10.0 inches in the side plane at the right front corner at bumper height. Maximum occupant compartment deformation was 4.0 inches in the right front floor pan and firewall. Figure 8.6 shows the interior of the vehicle.

Figure 8.5. Test Vehicle after Test No. 611901-05-1.
