Test Report No. 613011-01
Test Report Date: June 2021

MASH TL-3 EVALUATION OF GUARDRAIL ON 6H:1V SLOPE

Contract No.: T4541-DL-01
Test Nos.: 613011-01-1 and 613011-01-2
Test Dates: 2021-01-06 and 2021-01-25

TEXAS A&M TRANSPORTATION INSTITUTE PROVING GROUND

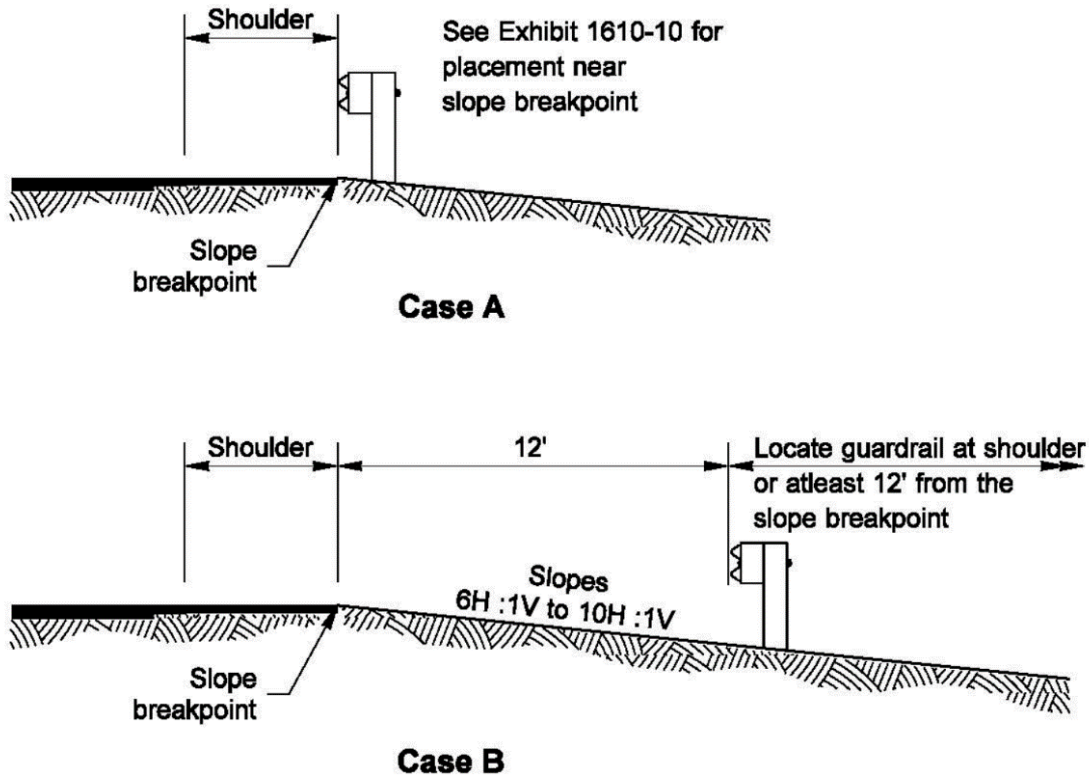
Figure 1.1. Beam Guardrail Installation on 6H:1V and 10H:1V Slopes (WSDOT Manual Exhibit 1610-9).

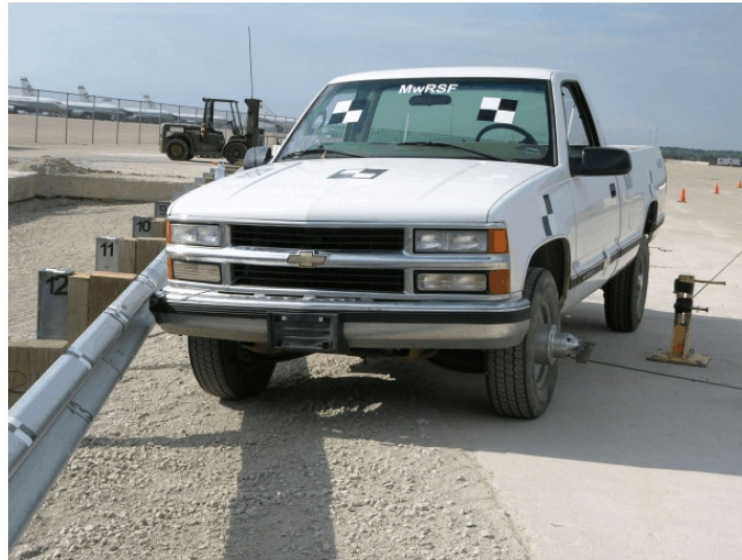
Figure 1.2. NCHRP Report 350 Pickup Truck at Impact Point of MSG Guardrail on 8H:1V Slope (MwRSF Report TRP-03-188-08).

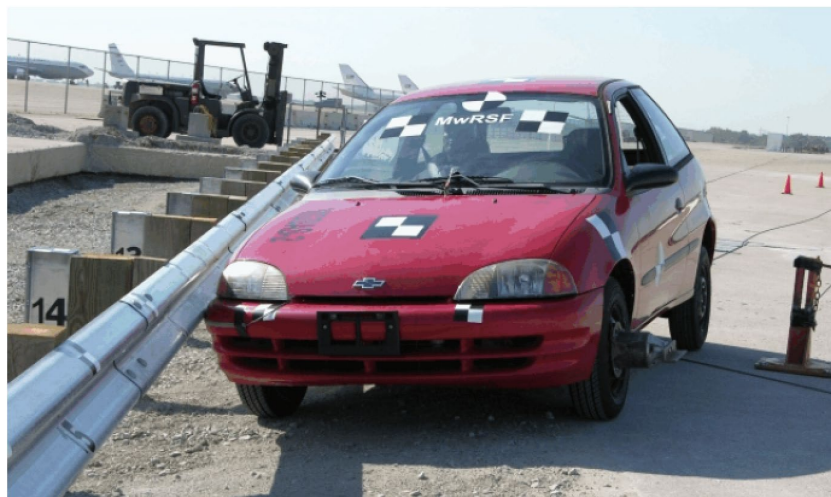
Figure 1.3. NCHRP Report 350 Small Car at Impact Point of MSG Guardrail on 8H:1V Slope (MwRSF Report TRP-03-188-08).

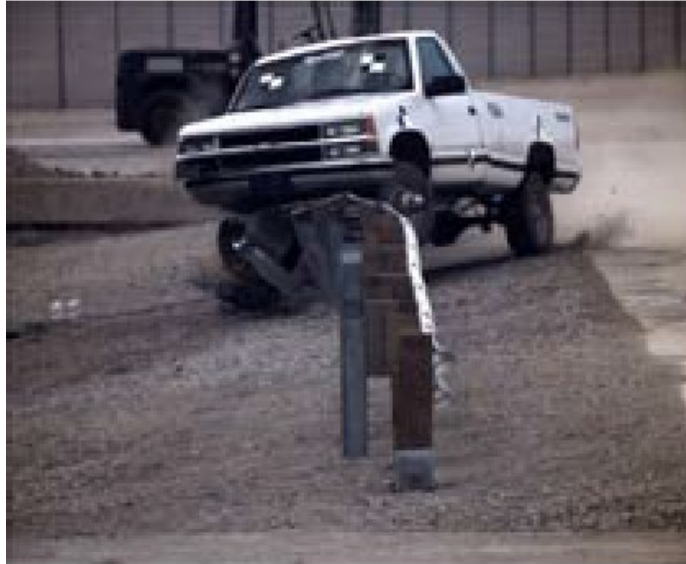
Figure 1.4. Pickup Truck almost Overriding MSG Guardrail on 8H:1V Slope (MwRSF Report TRP-03-188-08).

Although the tests were deemed passed per the NCHRP Report 350 criteria, the guardrail was barely able to prevent the pickup truck from overriding it as shown in Figure 1.4.

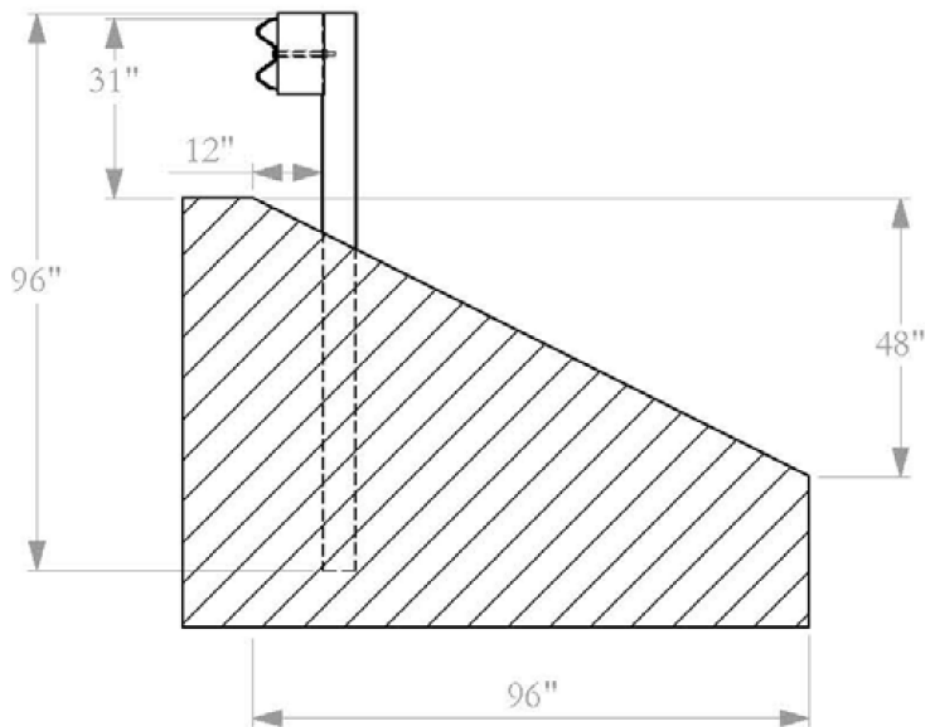
Figure 1.5. Cross Section of Guardrail on 2H:1V Slope System Tested by TTI.

A more recent effort by TTI resulted in conducting two full scale AASHTO *Manual for Assessing Safety Hardware (MASH)* TL-3 crash tests of a 31-in high guardrail system placed on 2H:1V slope (5, 6, 7). The posts were placed 1-ft from the slope break such that the face of the guardrail was aligned with the slope break as shown in Figure 1.5, Figure 1.6, and Figure 1.7.

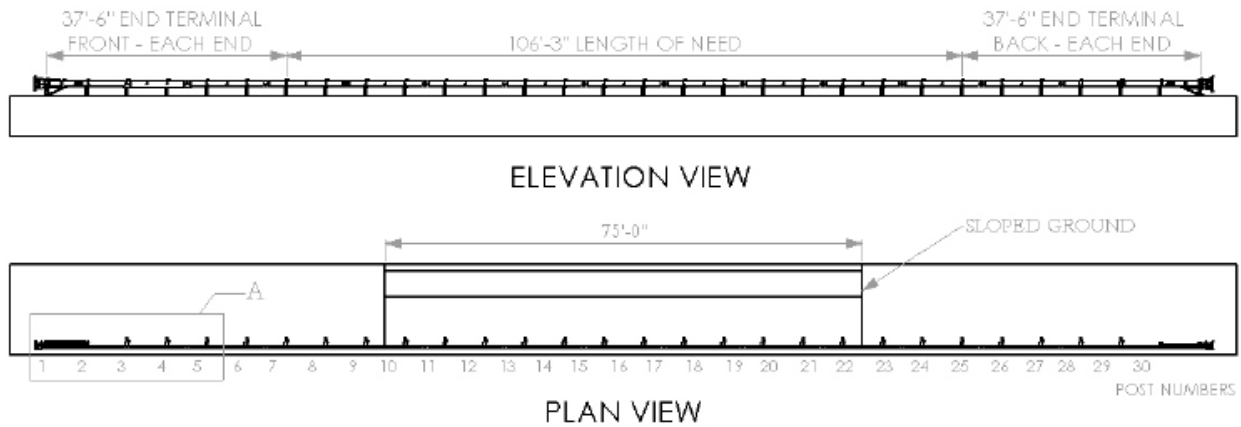
Figure 1.6. Guardrail on 2H:1V Slope System Tested by TTI.

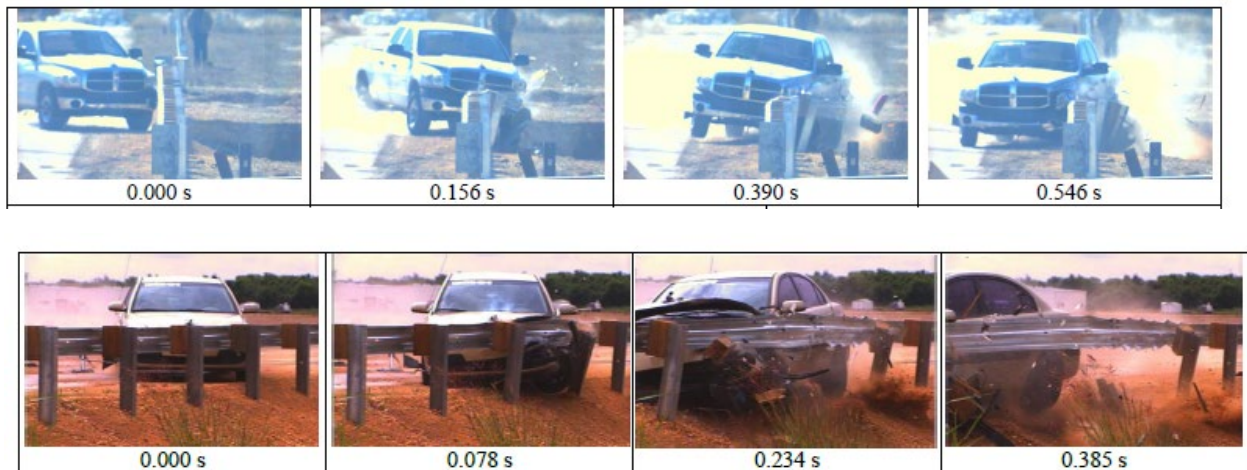
Figure 1.7. Sequential of *MASH* Tests 3-11 and 3-10 of the Guardrail on 2H:1V Slope System.

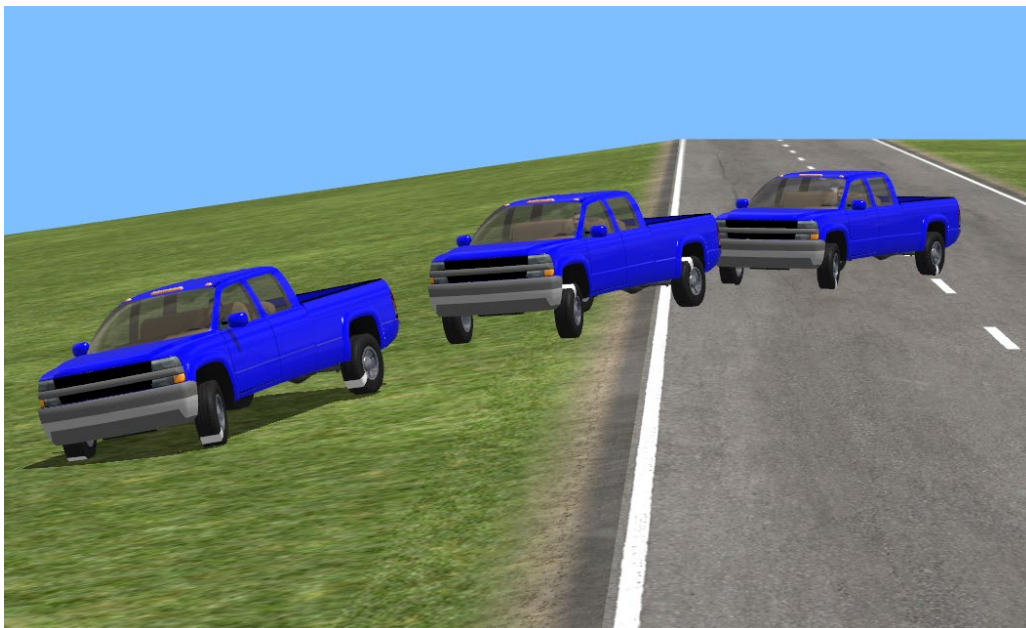
Figure 1.8. Vehicular Trajectory Simulation.

The researchers conducted vehicular trajectory simulations of both the small car and the pickup truck over a 6H:1V slope to find the profile of the front stiff point (such as bumper corner) trajectory over the 6H:1V slope. Once these trajectories were developed, the researchers identified the most critical location for guardrail placement on the 6H:1V slope based on worst vehicular orientation from these profiles. A sample vehicle trajectory is shown in Figure 1.8

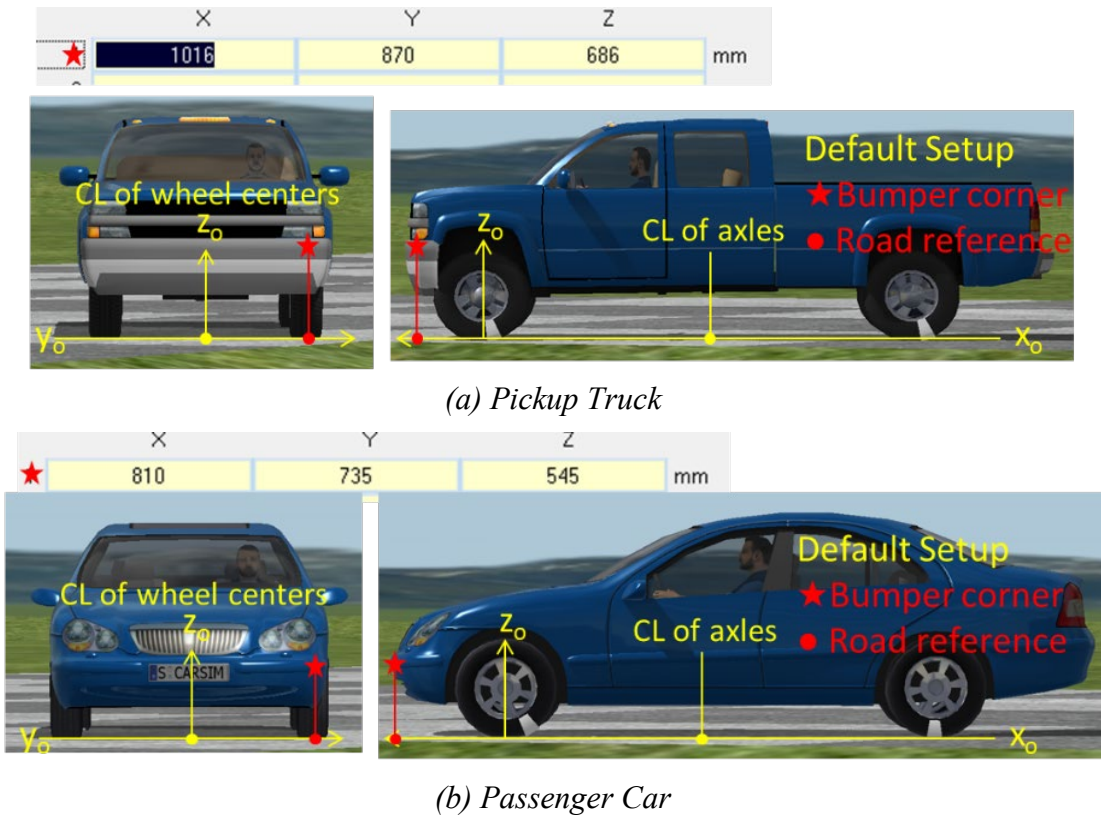
Figure 2.1. Bumper Corner and Road Reference Points for Trajectory.

To find the profile of the front stiff point (bumper corner) trajectory over the slope, the bumper corner and road reference were set up for CarSim models. Figure 2.1 shows the setup points for both pickup truck and passenger car models.

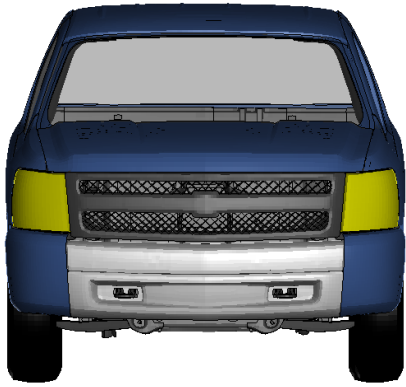
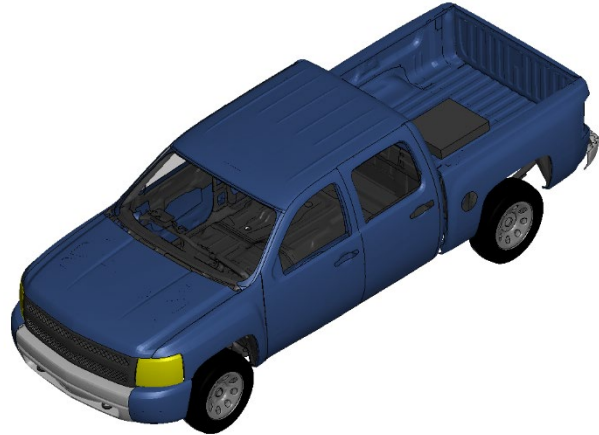
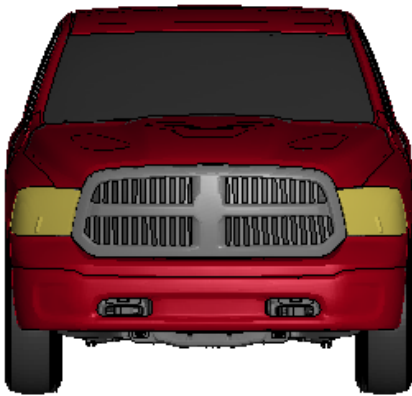
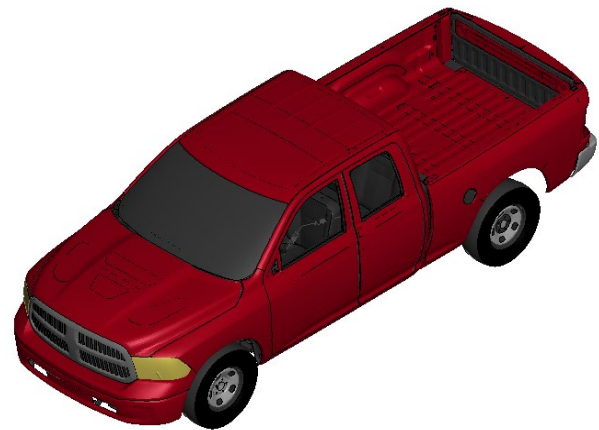
Figure 2.2. Truck Models used for FE Simulation.

(a) Chevrolet Silverado - Front view

(b) Chevrolet Silverado - Isometric view

(a) Dodge Ram - Front view

(b) Dodge Ram - Isometric view

For LS-DYNA simulation, the Center for Collision Safety and Analysis Team at the George Mason University developed the finite element (FE) truck and passenger car models. To obtain more data for trajectory profiles for the pickup truck, two different models (shown in Figure 2.2) were used: a FE Chevrolet Silverado model and a FE Dodge Ram model. For the passenger car, a FE Toyota Yaris model shown in Figure 2.3 was used.

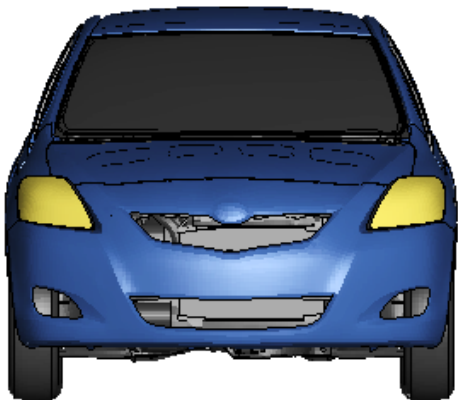
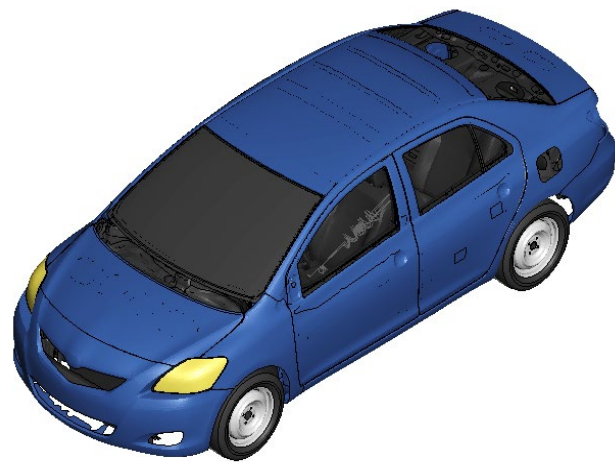
Figure 2.3. Passenger Car Model used for FE Simulation.

(a) Toyota Yaris - Front view

(b) Toyota Yaris - Isometric view

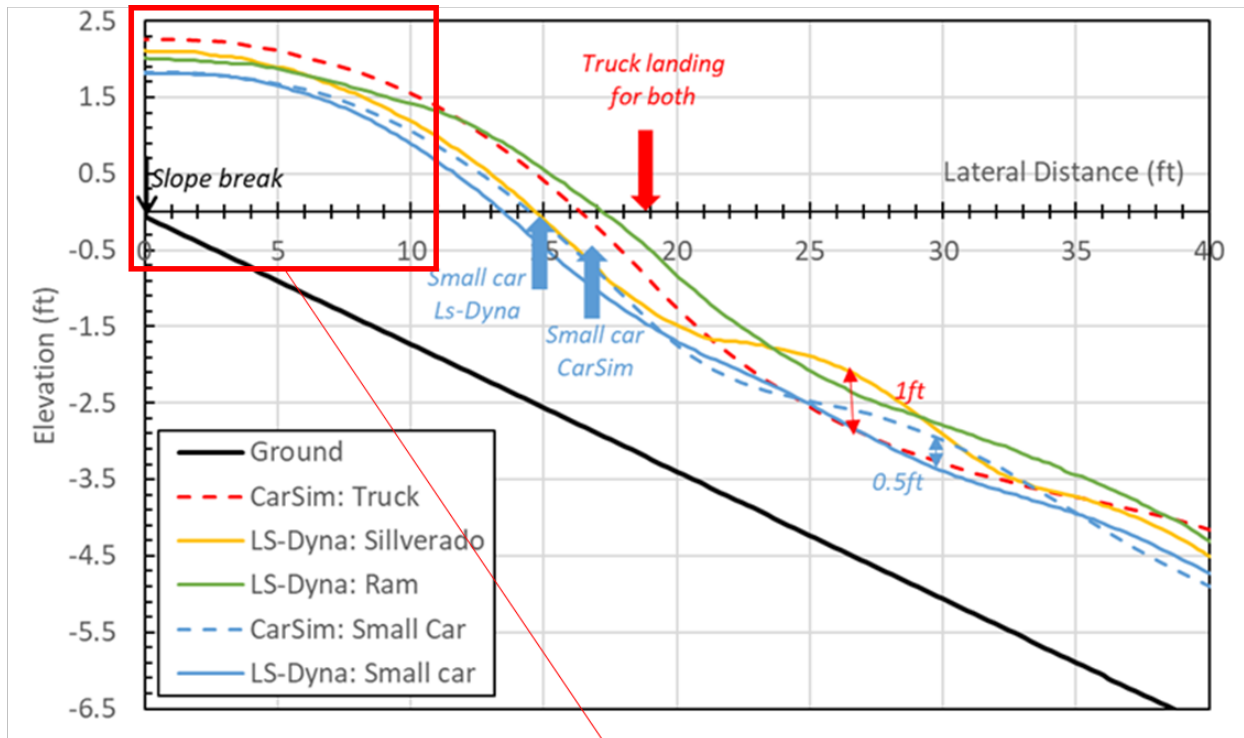
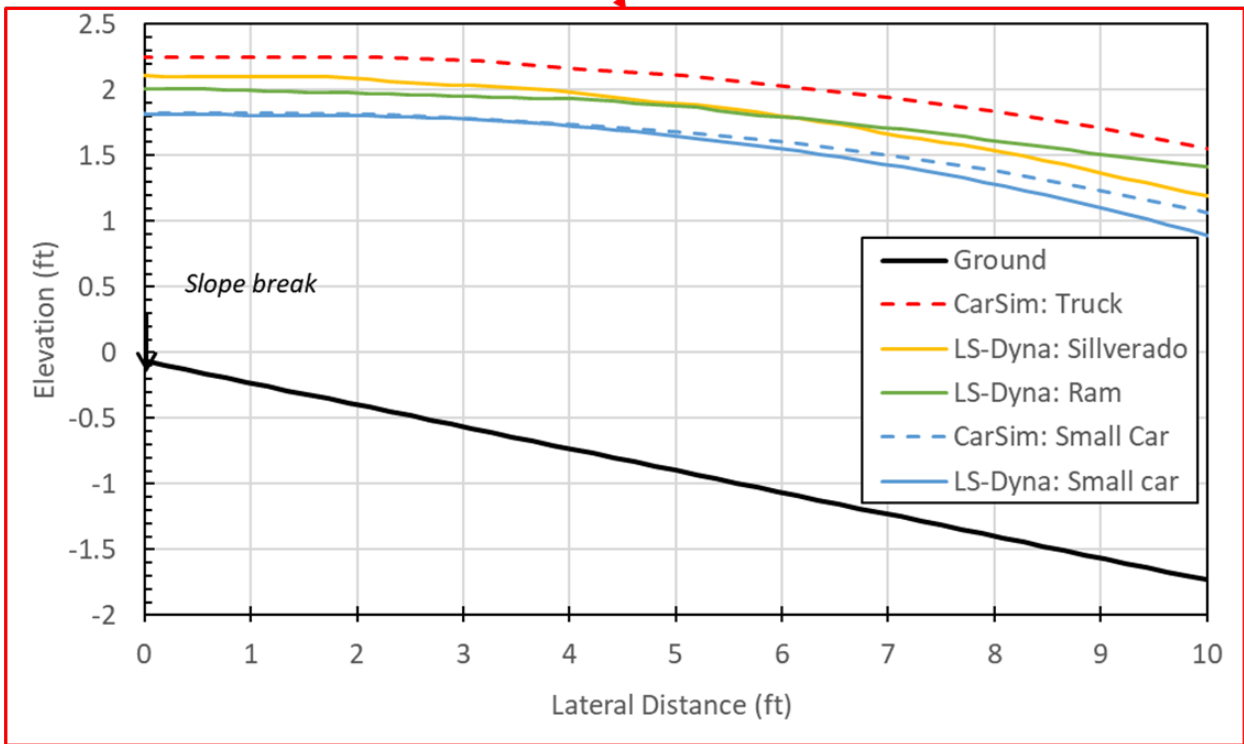
Figure 2.4. Vehicular Bumper Corner Height for CarSim and LS-DYNA Models.

Trajectory simulations were conducted to find the profile of the bumper corner by using both CarSim and LS-DYNA. Figure 2.4 shows the profiles of vehicle bumper height with respect to local terrain along the slope. Each model has a different trajectory profile. The differences are caused by the properties of vehicles, such as steering and suspension linkages, joints, and springs and dampers properties (9). Therefore, in this study both the trajectory simulation results from CarSim and LS-DYNA models are used to obtain various vehicular trajectory profiles.

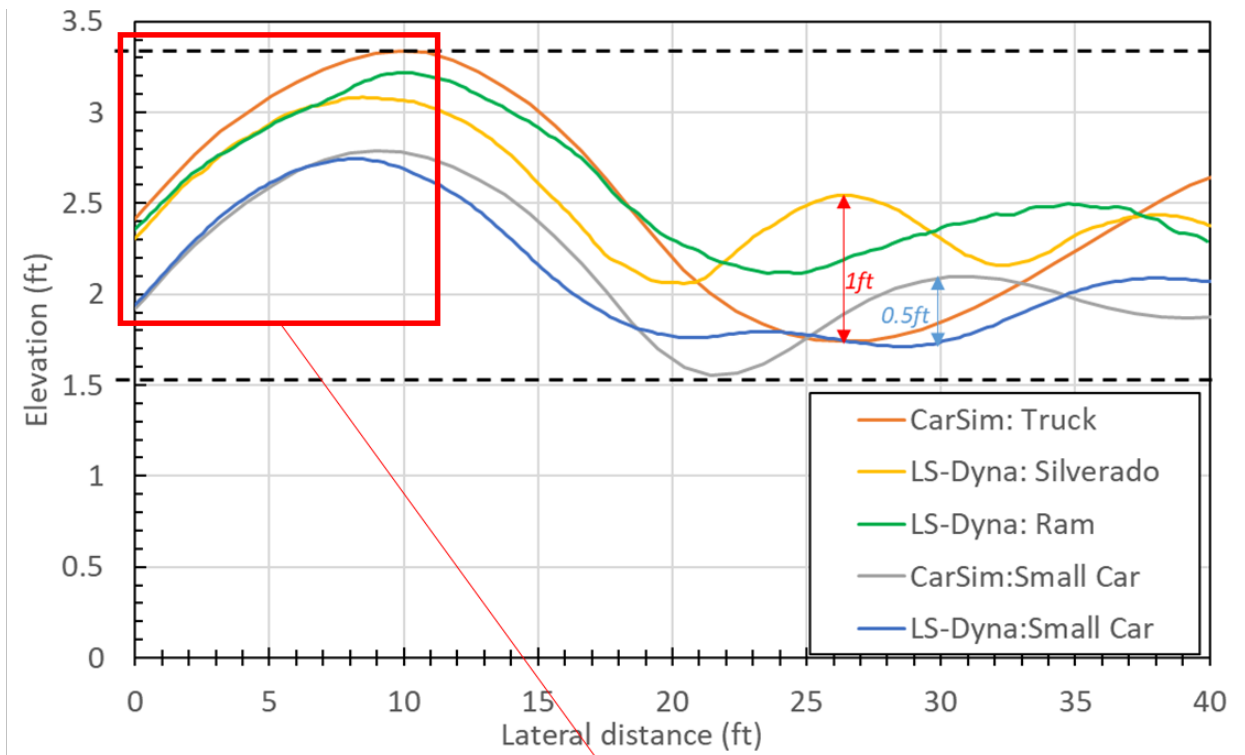
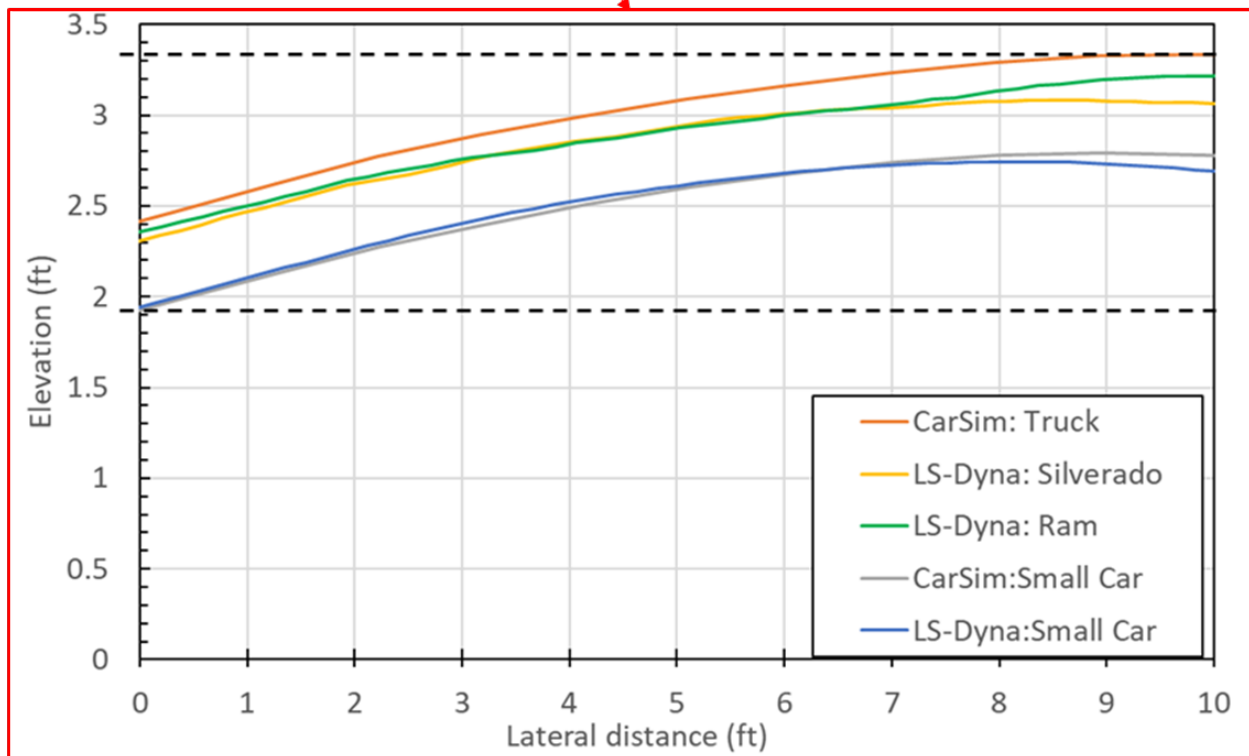
Figure 2.5. Relative Bumper Corner Height for CarSim and LS-DYNA Vehicle Models.

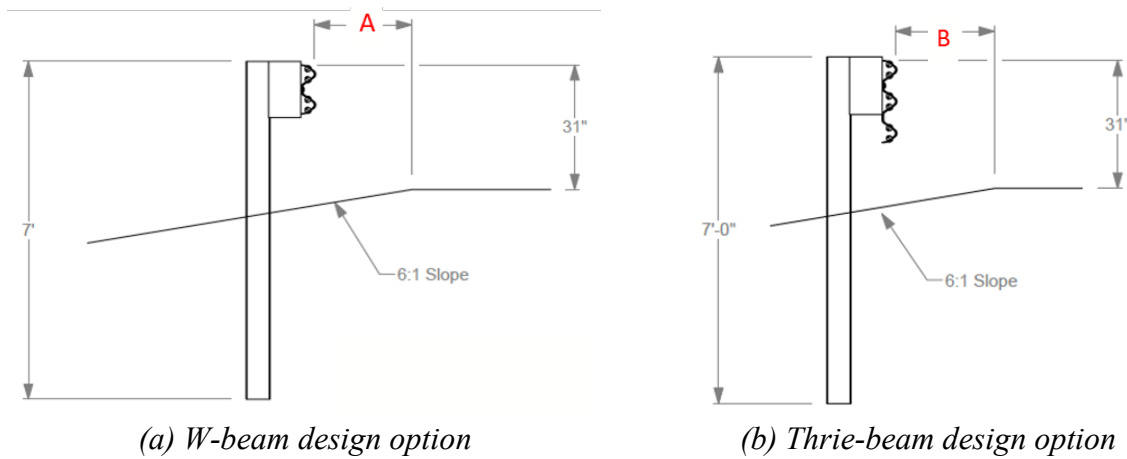
Figure 3.1 Elevation View of Design Options.

A total of eight design options were proposed: four options were proposed for W-beam systems and the other four options for thrie-beam systems. The offset distance from the slope break ('A' and 'B') varied with each option. The height of the guardrail systems was 31 inches high from the flat ground for all options, and the post was 7 ft long. Figure 3.1 shows an overview of the suggested design options. Offset distances ('A' and 'B') are 2 ft, 4 ft, and 6 ft from the slope break. For the option with a 6-ft offset distance, an additional design option with a rubrail was suggested for each guardrail system. Table 3.1 shows the design option matrix.

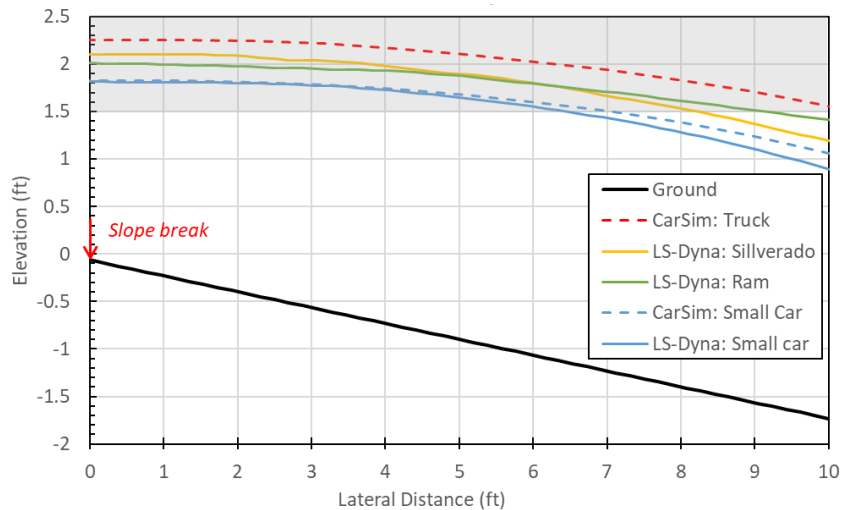
Figure 3.2. Bumper Corner Profile with Heights Covered by W-Beam (Shaded Area).

Options are not proposed for an offset distance greater than 6 ft since the possible lowest bumper corner height should not be lower than the 31-inch height W-beam guardrail system (shaded area in Figure 3.2).

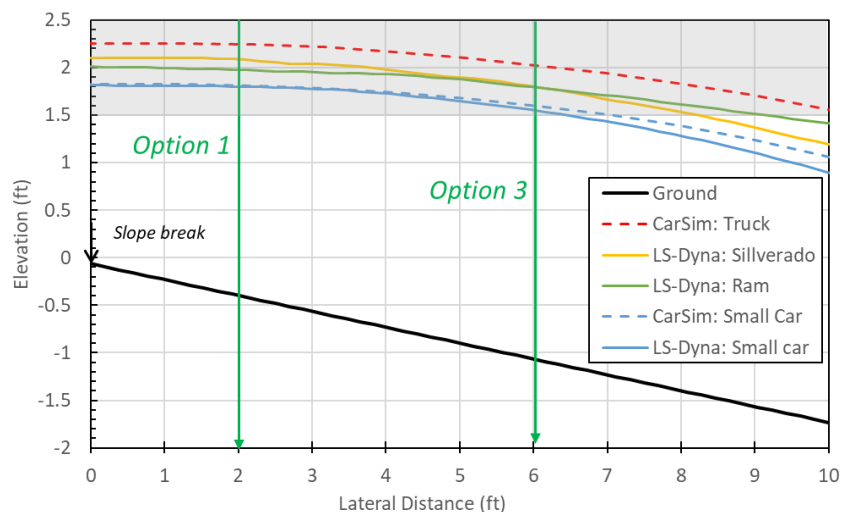
Figure 3.3. Trajectory Profile with Preferred Design Option Location.

Among the proposed design options, the sponsor preferred designs were selected for an impact simulation test; Option 1 (W-beam guardrail with an offset distance of 2 ft) and Option 3 (W-beam guardrail with an offset distance of 6 ft). Figure 3.3 shows the vehicular bumper corner height profile with the location of the preferred design options. The plots show that Option 3 is more critical for the impact than Option 1 since the bumper corners are only placed on the lower part of the W-beam. Figure 3.4 shows the schematic configuration of the preferred design options.

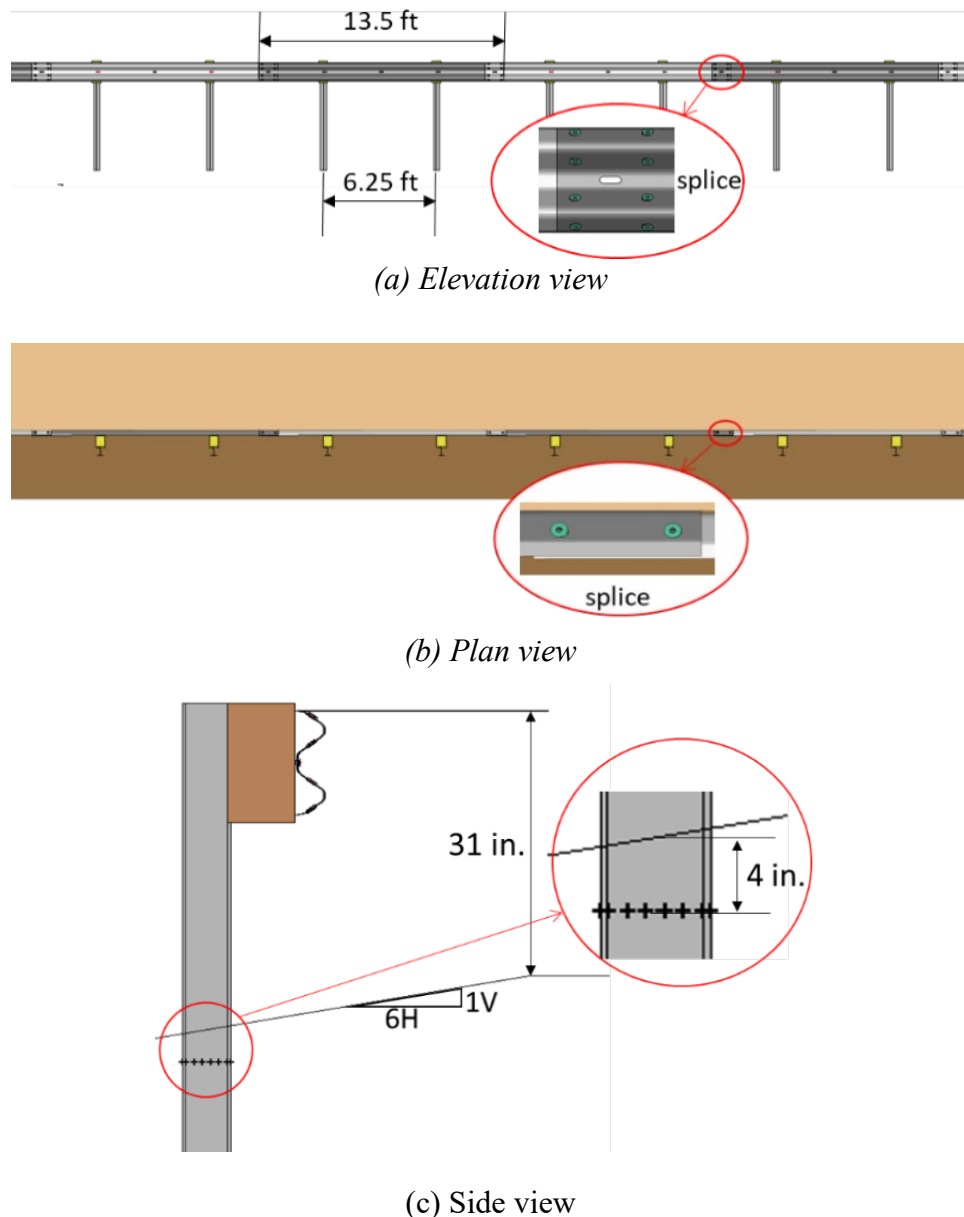
Figure 3.5. W-Beam Guardrail System on 6H:1V Slope used for FE Simulation.

Figure 3.5 shows details of the finite element (FE) guardrail system model that was developed to perform computational impact simulations. For the time-efficient simulation run, the posts for the guardrail system were fixed, and movement was constrained 4 inches below the ground as an efficient way to approximately represent the plastic hinge of the steel post instead of explicitly modeling the soil continuum.

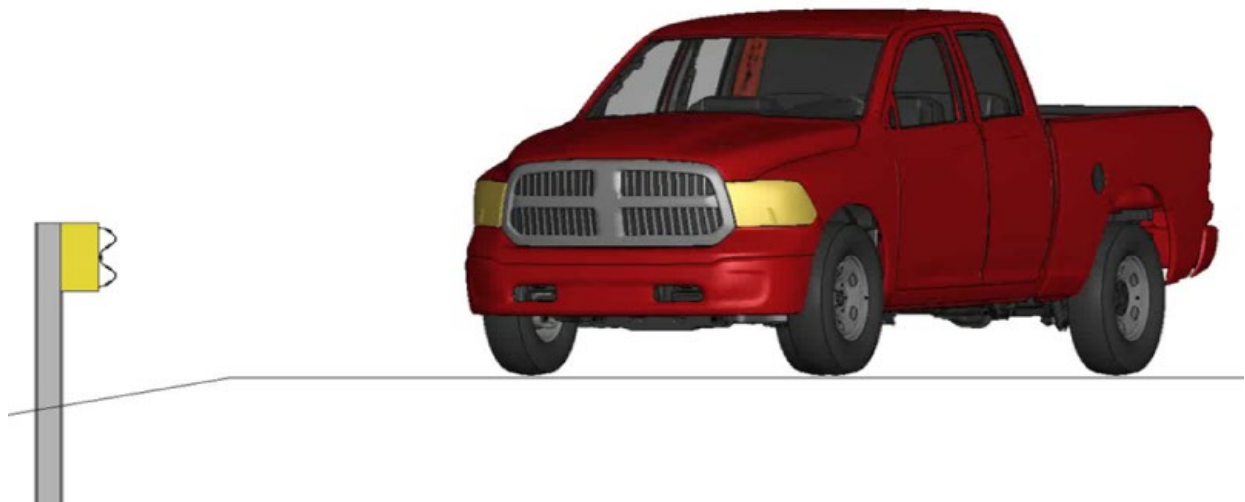
Figure 3.7. Truck Setting with Option 1 W-Beam Guardrail with 24-inch Offset.

For *MASH* Test 3-11 simulation, the FE Ram model was used and set with an initial angle and speed of 25 degrees and 62.5 mph, respectively, to replicate *MASH* Test 3-11. Figure 3.7 shows the truck setup with Option 1 W-beam guardrail system with 24-inch offset.

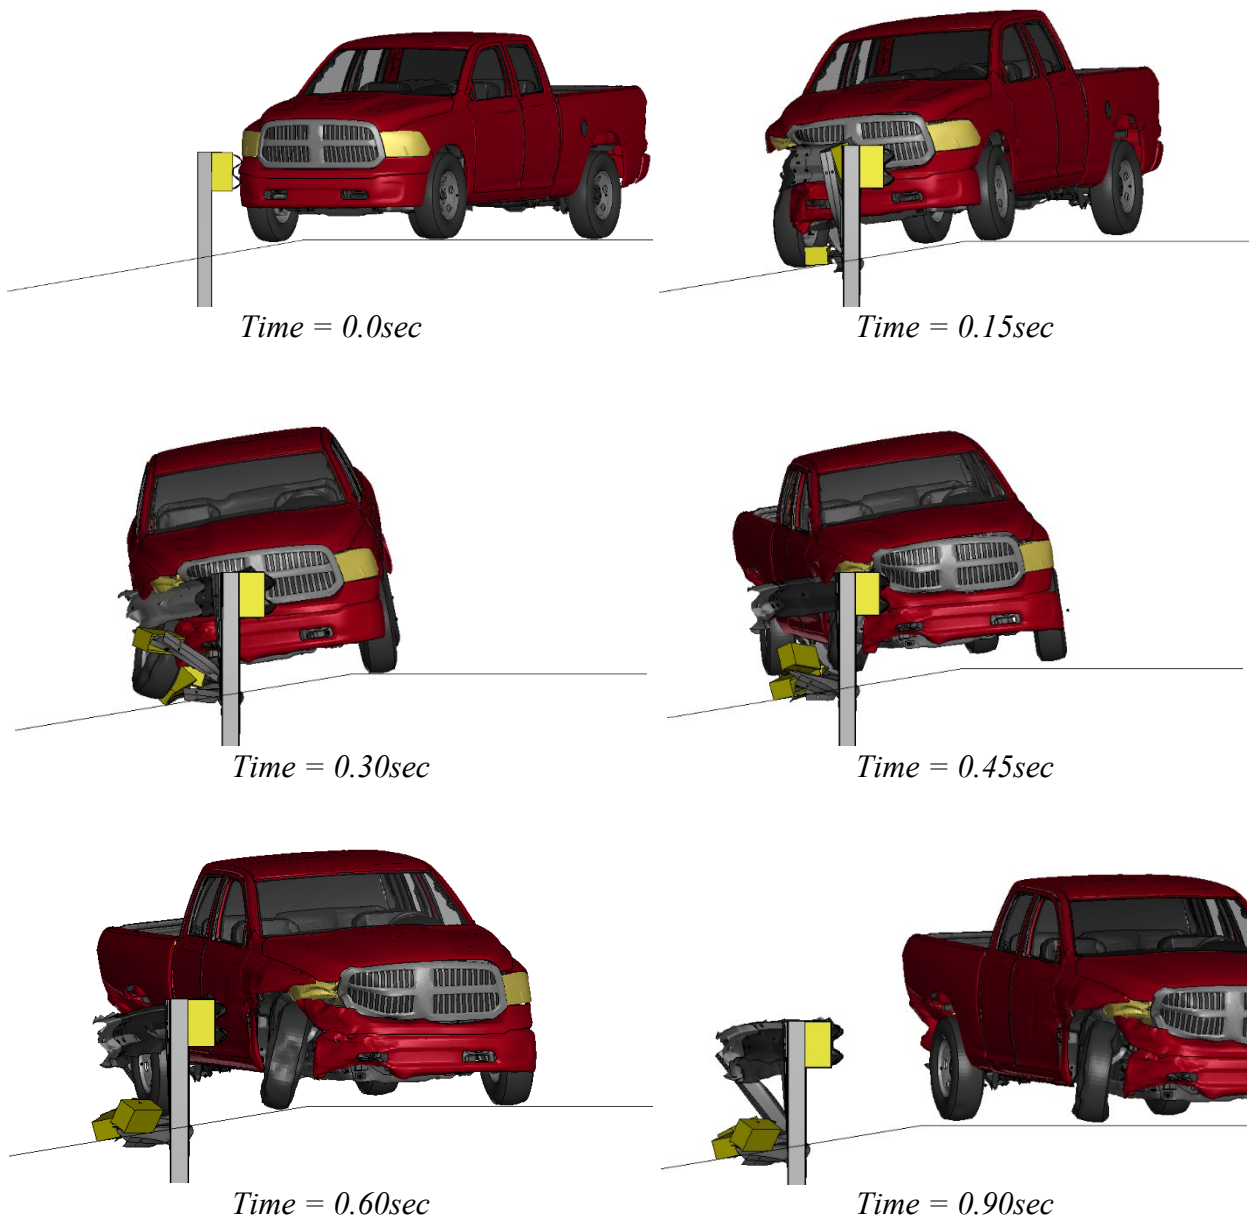
Figure 3.8. Sequential Images for Truck Simulation with W-Beam Guardrail with 24-inch Offset.

Figure 3.8 shows the time frame (sequential images) for the truck simulation test. The truck was redirected and maintained an upright position. The occupant risk factors determined by TRAP are listed in Table 3.2. The simulation test passed by satisfying *MASH* TL-3 limits.

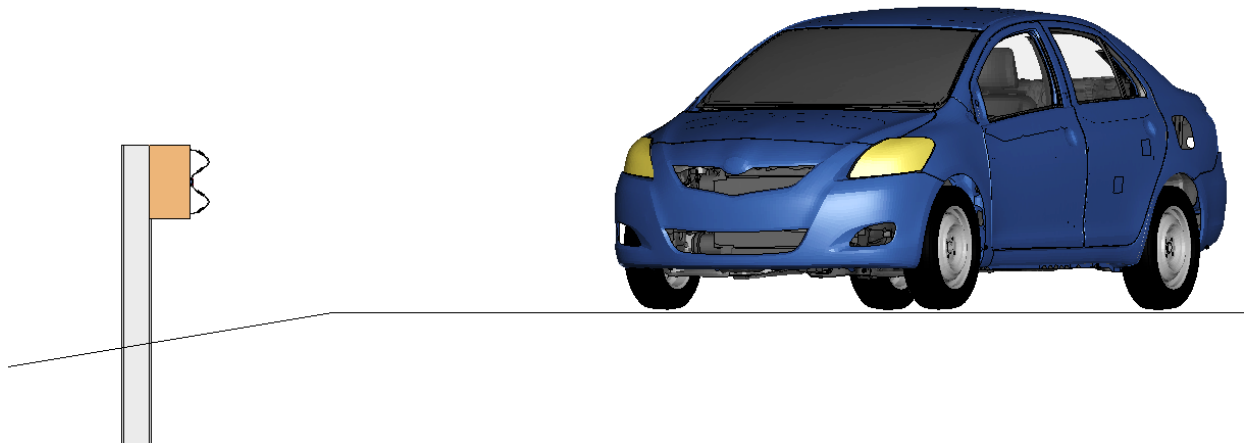
Figure 3.9. Passenger Car setting with Option 1 W-beam Guardrail with 24-inch Offset.

Passenger car FE model was set with initial angle and speed at 25 degrees and 62.5 mph, respectively, to replicate *MASH* Test 3-10. Figure 3.9 shows the passenger car vehicle setup with Option 1 W-beam guardrail system with 24-inch offset.

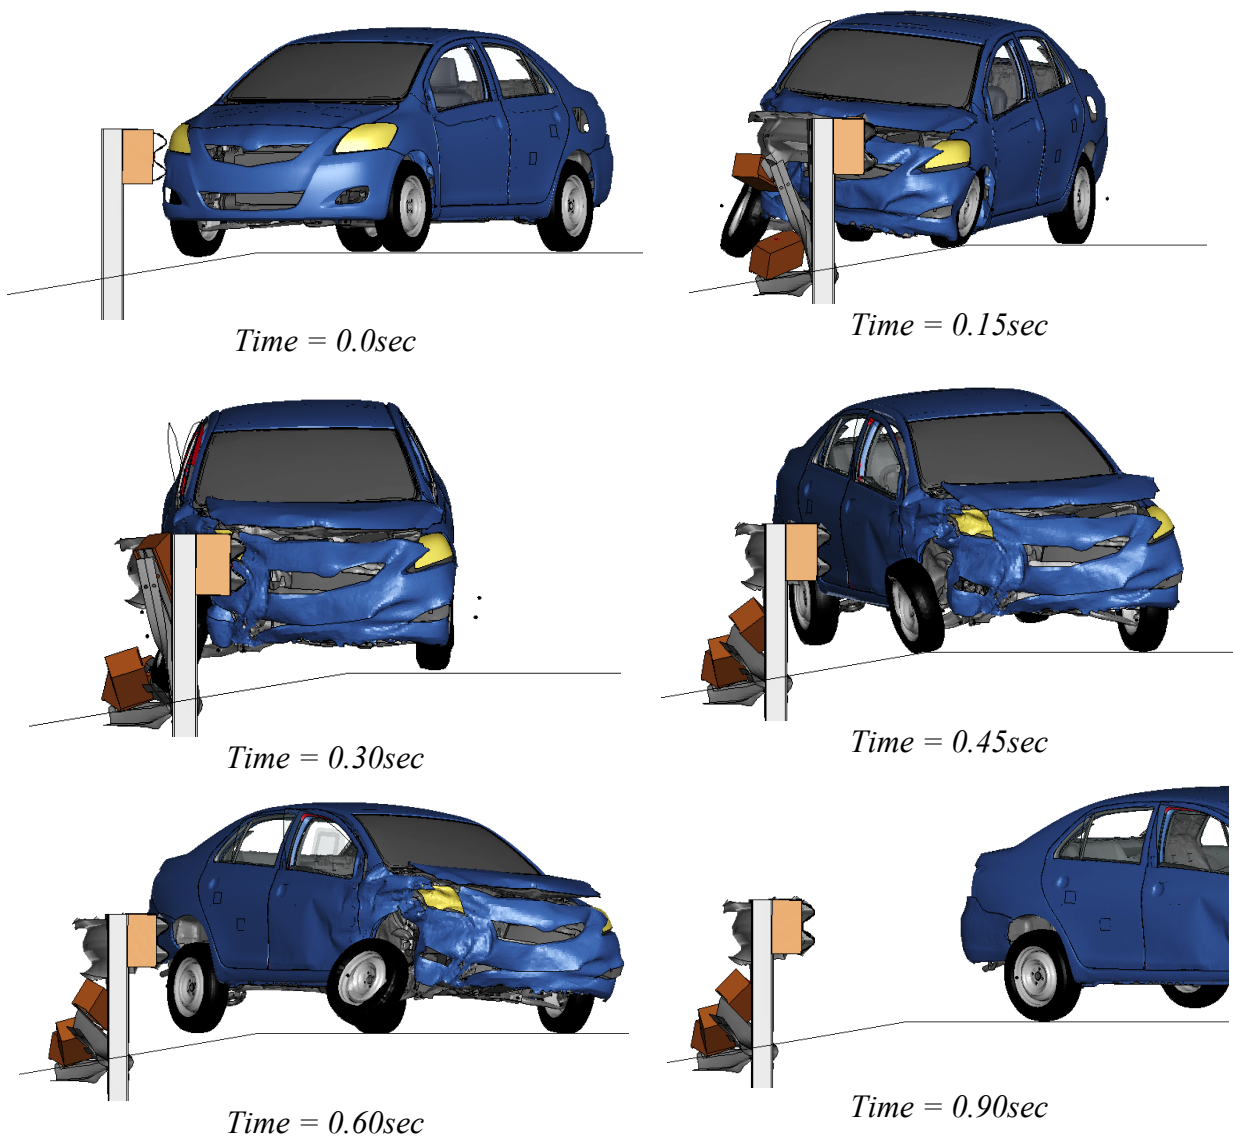
Figure 3.10. Sequential Images of Passenger Car Simulation for W-beam Guardrail with 24-inch Offset.

Figure 3.10 shows the time frame (sequential images) for the passenger car simulation test. The simulation test for the passenger car passed (the car was redirected, stayed on the road, and maintained an upright position after impacting). To investigate the occupant risk factors, TRAP was used, and Table 3.3 lists the factors. All the factors meet the limit specified in *MASH* TL-3 criteria.

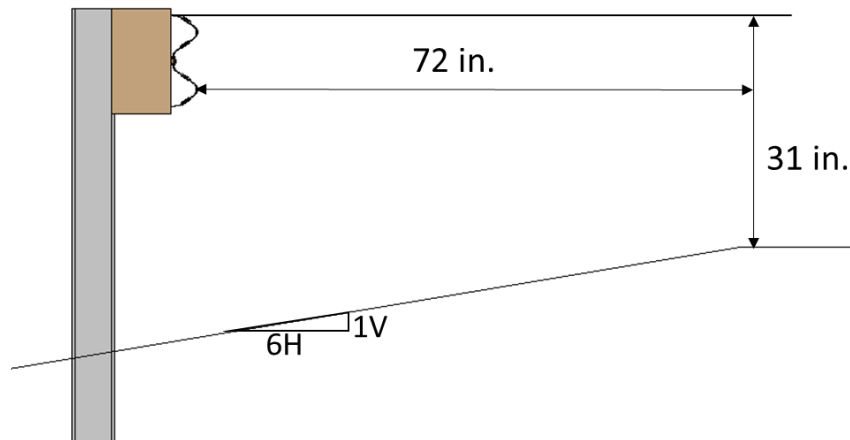
Figure 3.11. Preferred Design: W-Beam Guardrail with 72-inch (6-ft) Offset from Slope Break (Option 3).

Figure 3.11 shows the configuration of the W-beam guardrail system Option 3, which has an offset distance of 72 inches (6 ft) from the slope break. This system does not have a rubrail. As mentioned previously, this design option is more critical for impacting than Option 1. Therefore, to find the critical impact point (CIP), computational simulations were conducted for impacting a vehicle model at four different points (mid-span, post before splice, splice, and post after splice). To assess the criticality of the impact points, occupant risk factors were evaluated for the simulations designed to impact four different impact points.

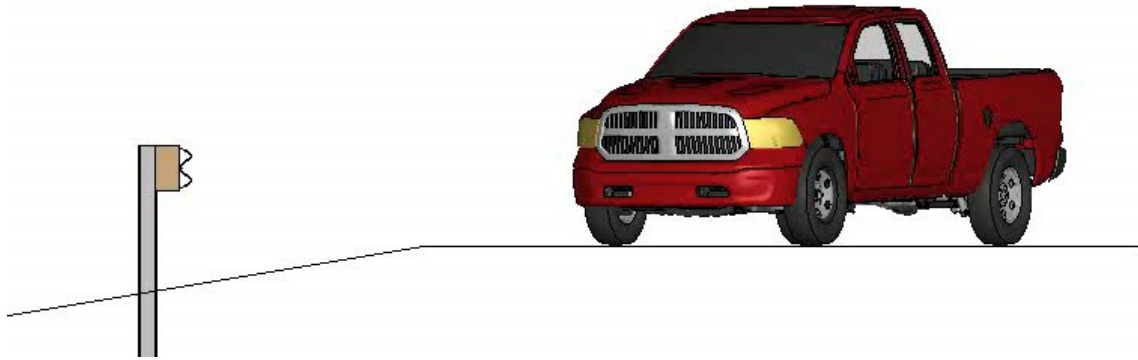
Figure 3.12. Truck Setting with Option 3 W-Beam Guardrail with 72-inch Offset.

For MASH Test 3-11 impact simulation, the FE Ram model was used and set with an initial angle and speed of 25 degrees and 62.5 mph to replicate MASH Test 3-11. Figure 3.12 shows the truck setup with Option 3 W-beam guardrail system.

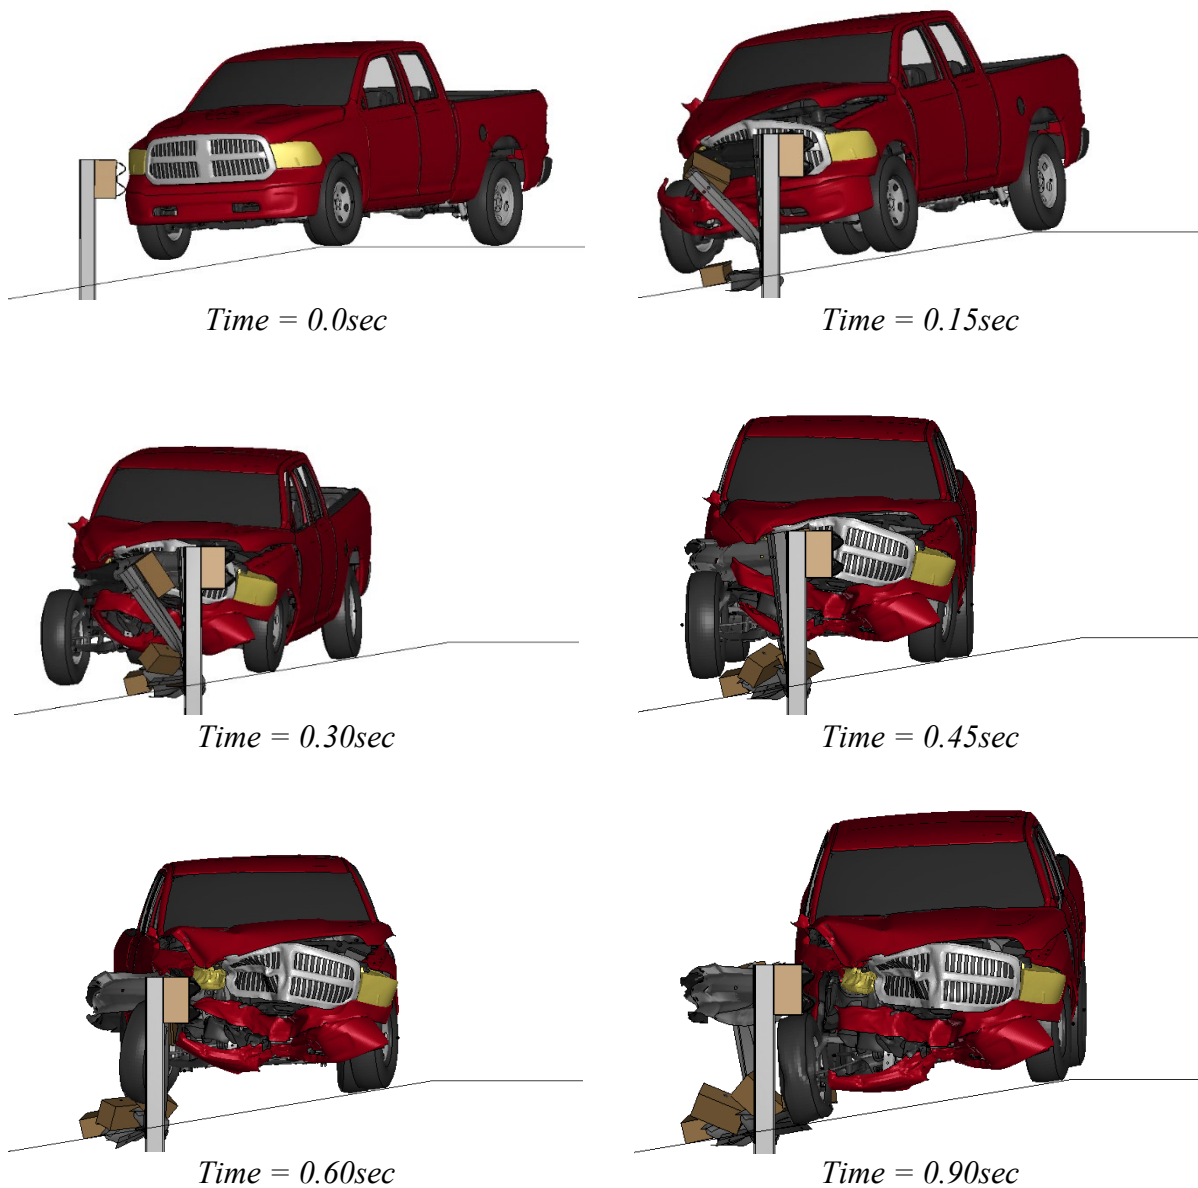
Figure 3.13. Sequential Images for Truck Simulation Impacting at Post after Splice of W-Beam Guardrail with 72-inch Offset.

Figure 3.13 shows the time frame (sequential images) for the truck impact simulation impacting a post after a splice.

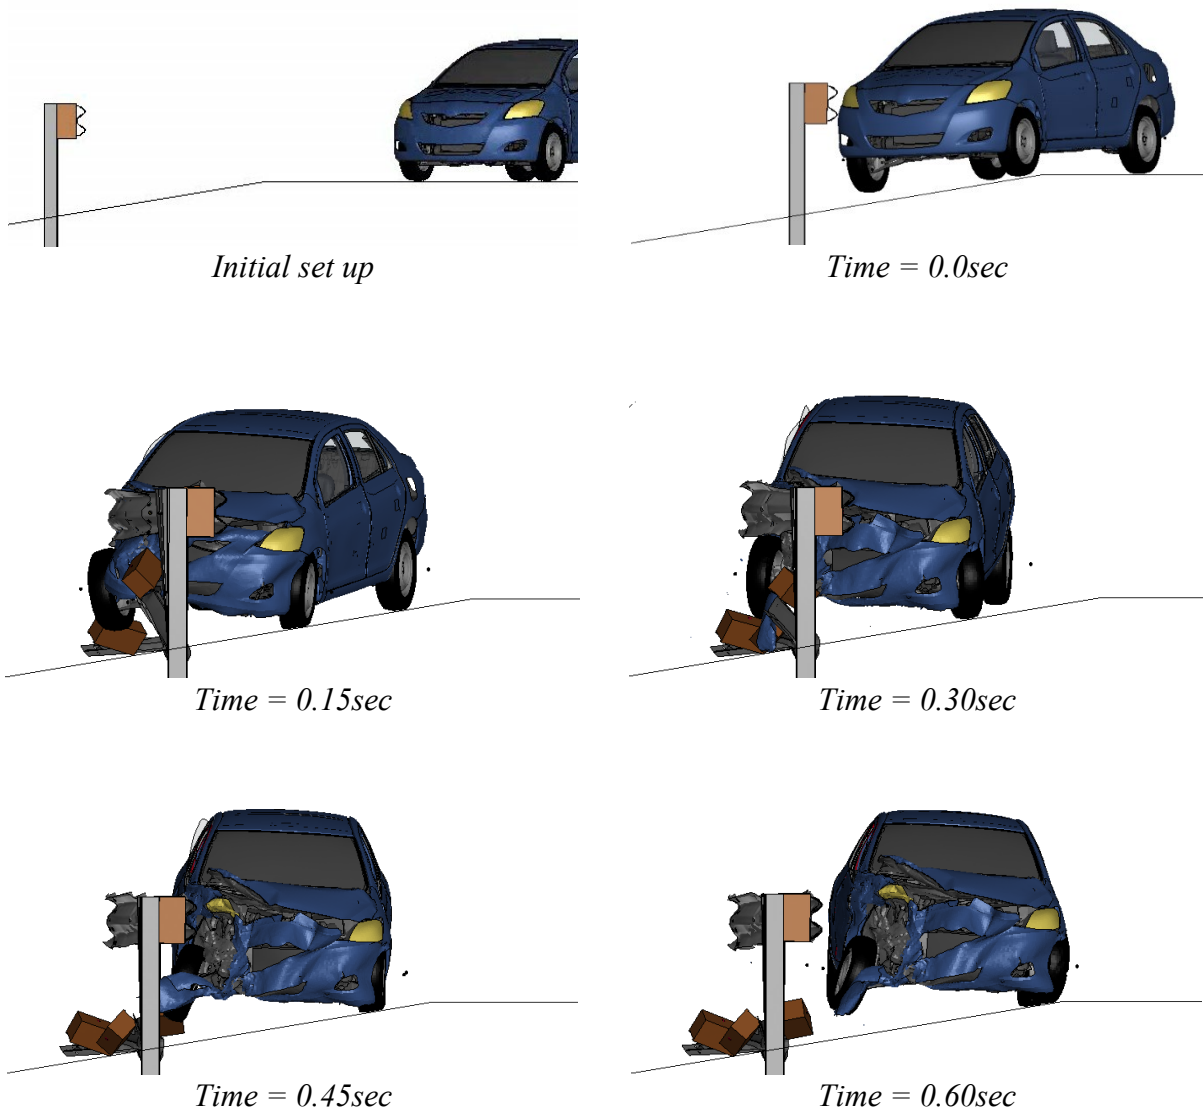
Figure 3.15. Sequential Images for Passenger Car Simulation Impacting at Splice of W-Beam Guardrail with 72-inch Offset.

Figure 3.15 shows the time frame (sequential images) for the simulation with the passenger car impacting at a splice.
