Test Report No. 613011-01
Test Report Date: June 2021

MASH TL-3 EVALUATION OF GUARDRAIL ON 6H:1V SLOPE

Contract No.: T4541-DL-01
Test Nos.: 613011-01-1 and 613011-01-2
Test Dates: 2021-01-06 and 2021-01-25

TEXAS A&M TRANSPORTATION INSTITUTE PROVING GROUND

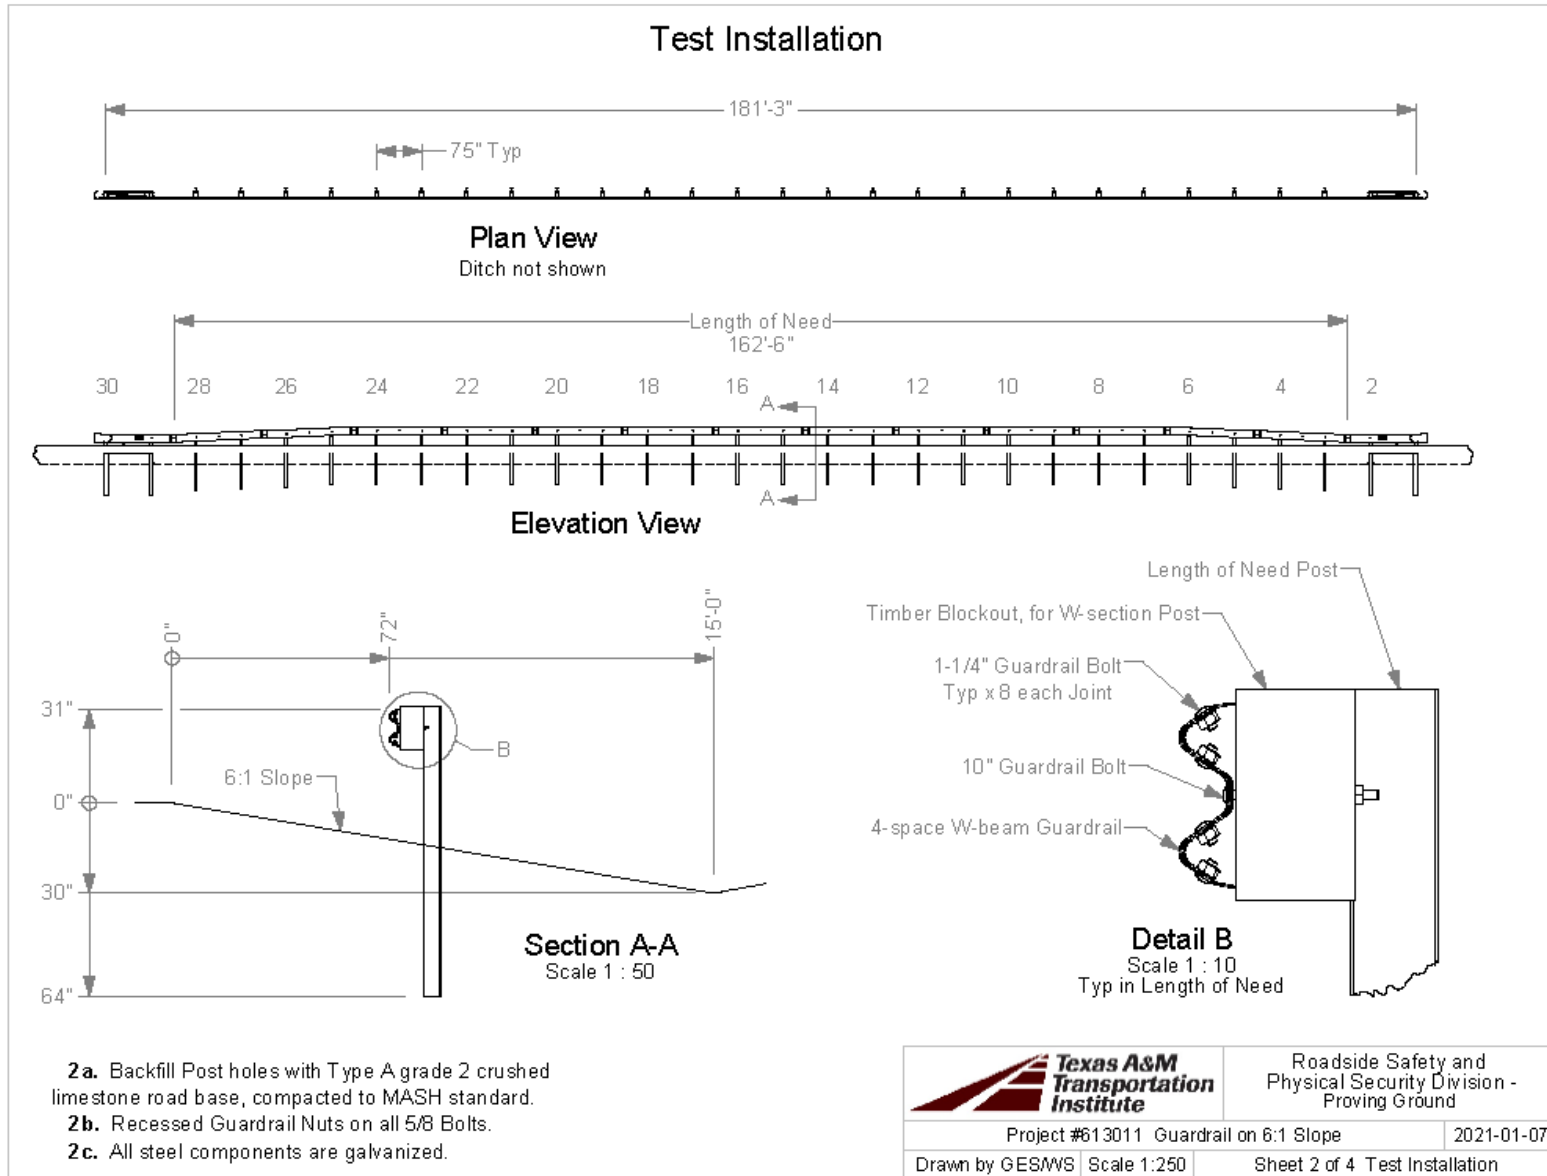
Figure 4.1. Details of Guardrail on 6H:1V Slope.

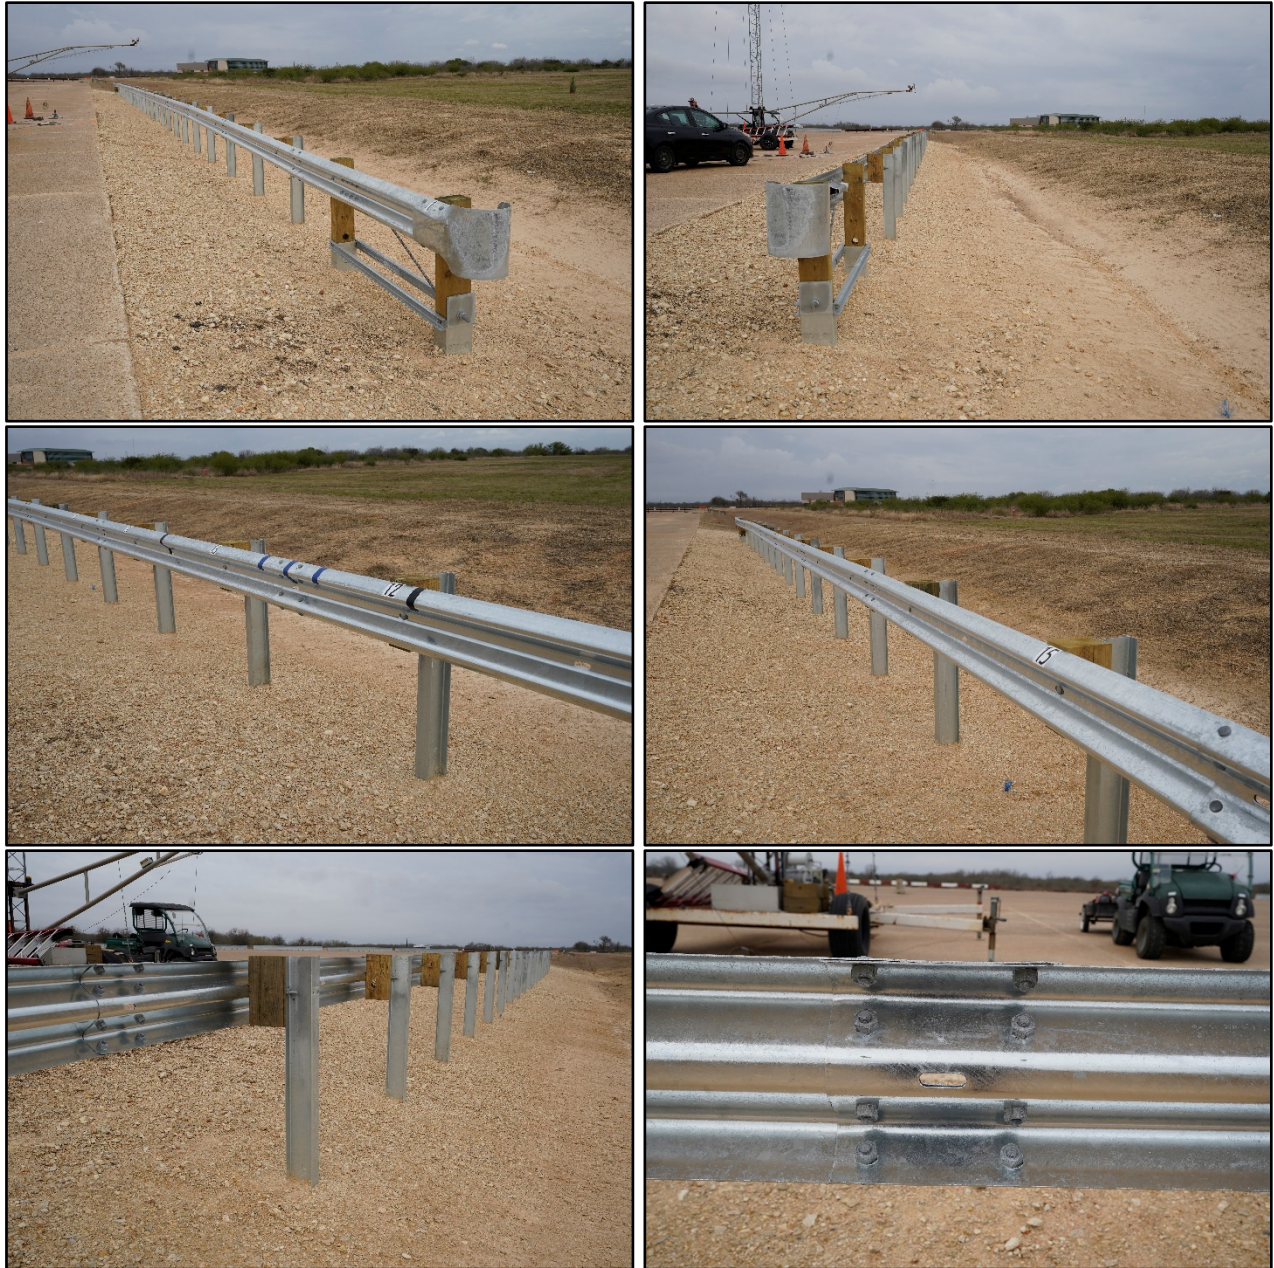
Figure 4.2. Guardrail on 6H:1V Slope prior to Testing.

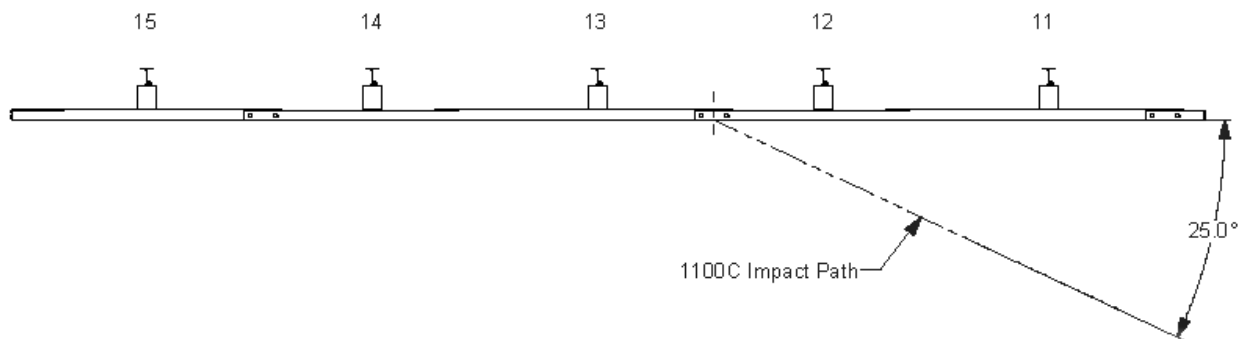
Figure 5.1. Target CIP for *MASH* Test 3-10 on Guardrail on 6H:1V Slope.

Table 5.1 shows the test conditions and evaluation criteria for *MASH* TL-3 for longitudinal barriers. The target critical impact points (CIPs) for each test were determined using the information provided in *MASH* Section 2.2.1 and Section 2.3.2. Figure 5.1 shows the target CIP for *MASH* Test 3-10 and Figure 5.2 shows the target CIP for *MASH* 3-11 on the guardrail on 6H:V1 slope.

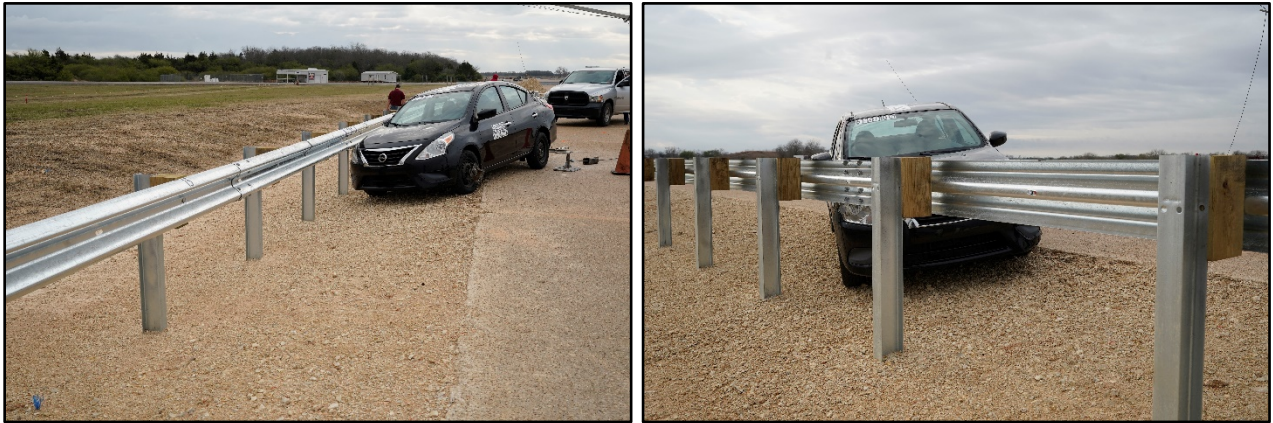
Figure 7.1. Guardrail/Test Vehicle Geometrics for Test No. 613011-01-1.

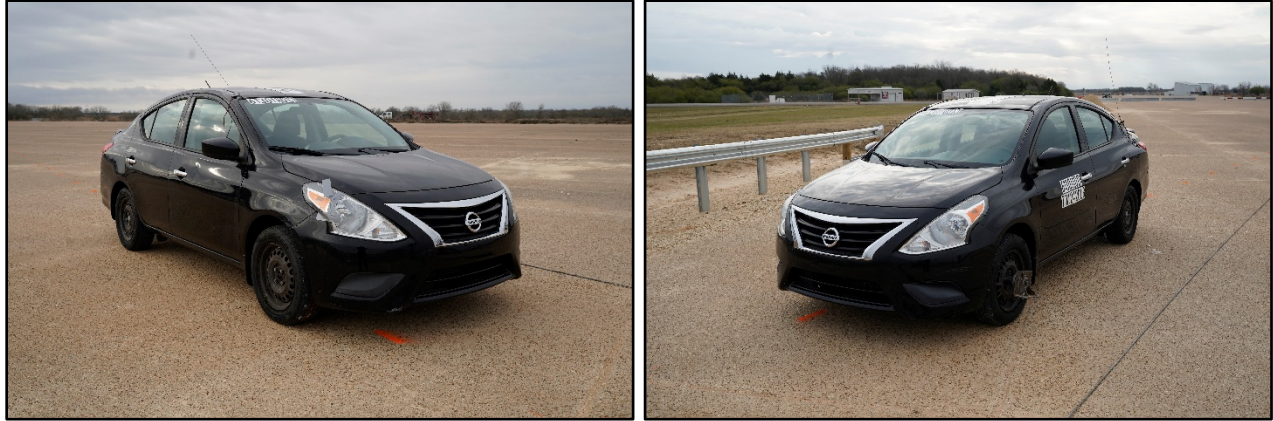
Figure 7.2. Test Vehicle before Test No. 613011-01-1.

Figure 7.2 shows the 2015 Nissan Versa used for the crash test. The vehicle's test inertia weight was 2434 lb, and its gross static weight was 2599 lb. The height to the lower edge of the vehicle bumper was 7.0 inches, and the height to the upper edge of the bumper was 22.25 inches. Table D.1 in Appendix D.1 gives additional dimensions and information on the vehicle. The vehicle was directed into the installation using a cable reverse tow and guidance system, and was released to be freewheeling and unrestrained just prior to impact.

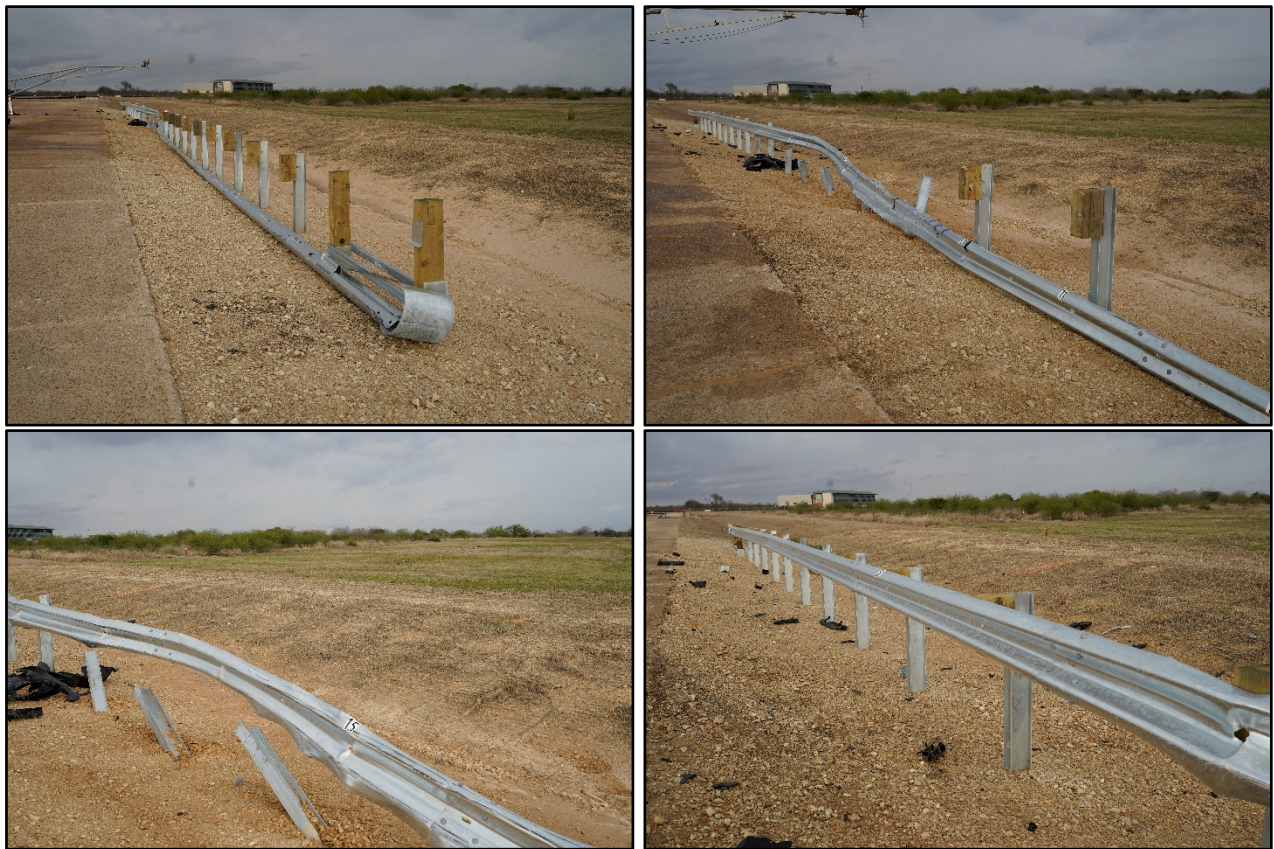
Figure 7.3 through Figure 7.5 show the damage to the guardrail on 6H:1V slope. The rail released from posts 1 through 18. The blockouts released from posts 13 through 17. One blockout came to rest 89 ft to the field side and 140 ft downstream of the impact point. Post 1 had a 3/4-inch gap in the soil on the upstream side. Post 2 had a 1/8-inch gap on the downstream side, and the rail was ripped at the bolt. There was no movement noted for posts 3 through 11. Post 12 had a 1/2-inch gap on the traffic side, a 1/4-inch gap on the field side and the post was leaning

Figure 7.3. Guardrail on 6H:1V Slope after Test No. 613011-01-1.

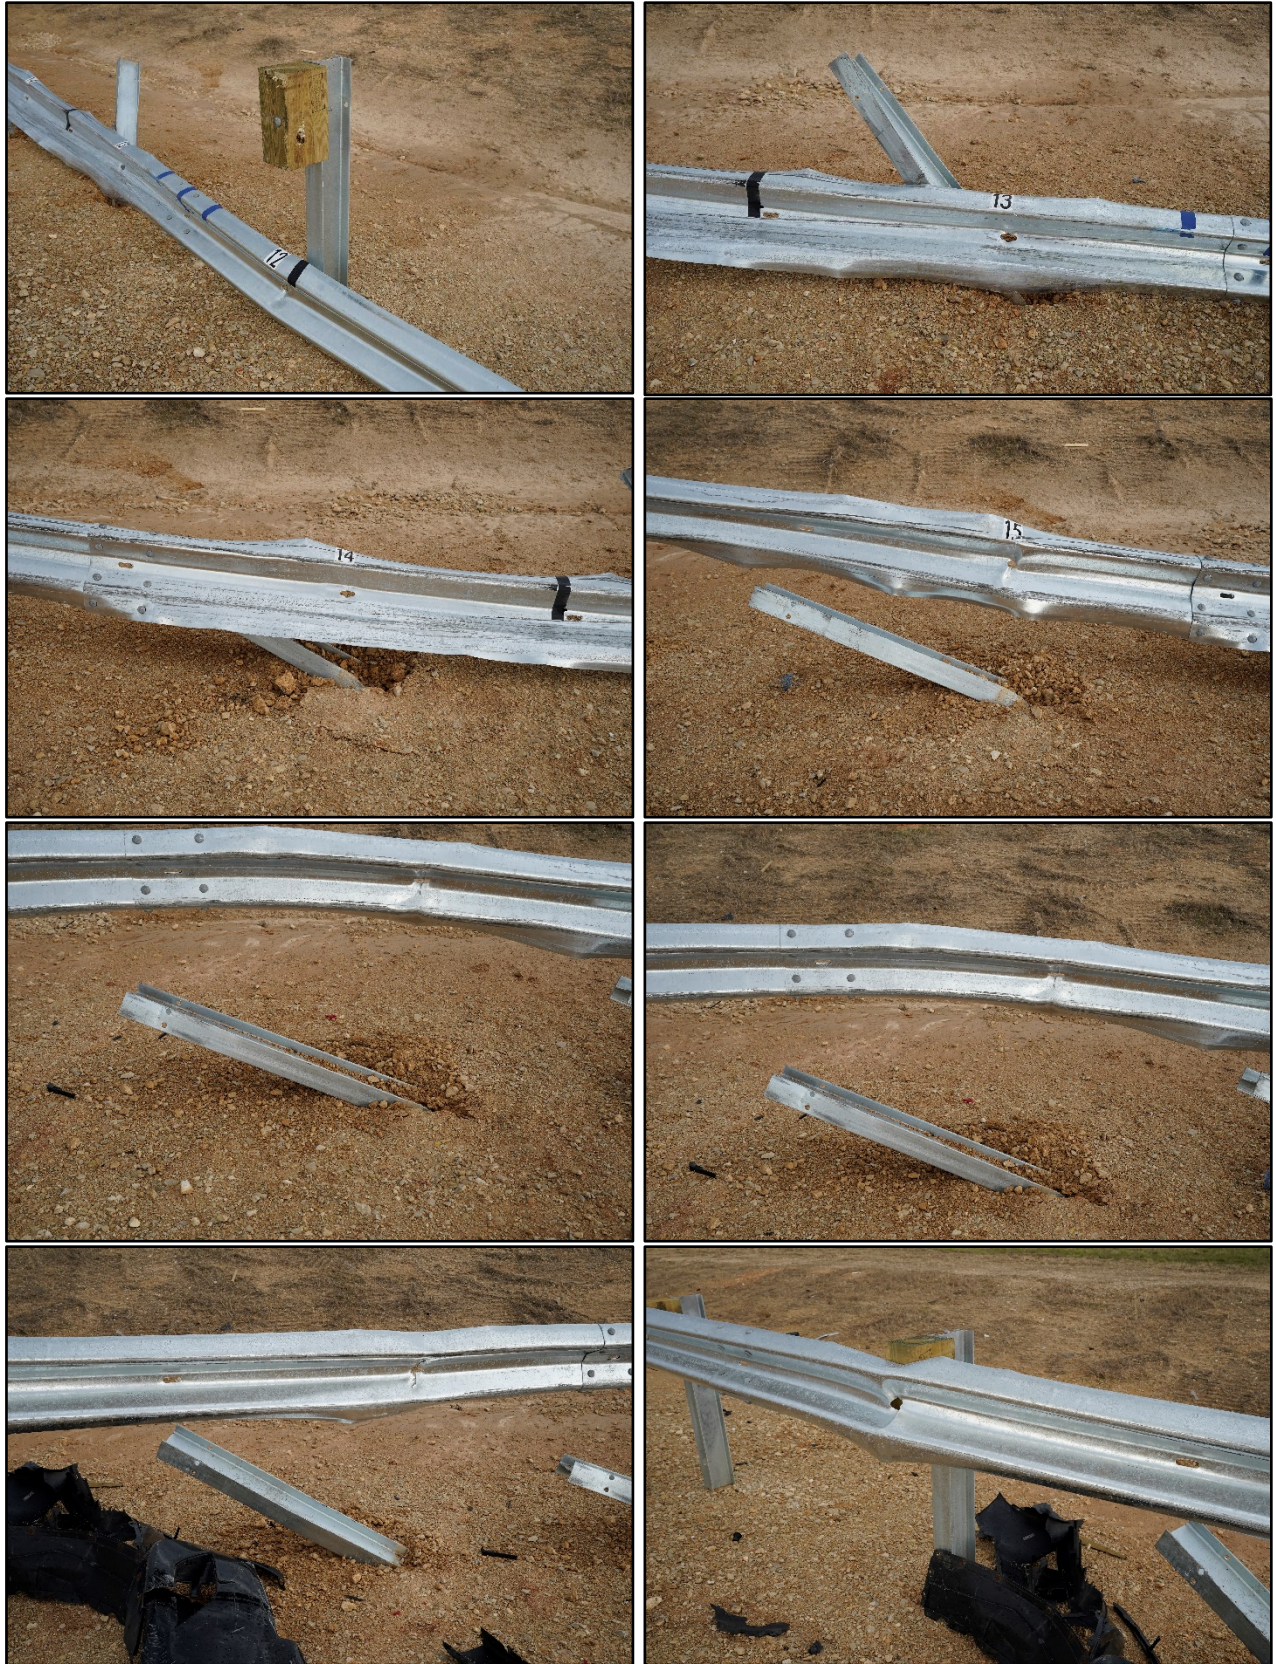
Figure 7.4. Damage to Posts 12-19 after Test No. 613011-01-1.

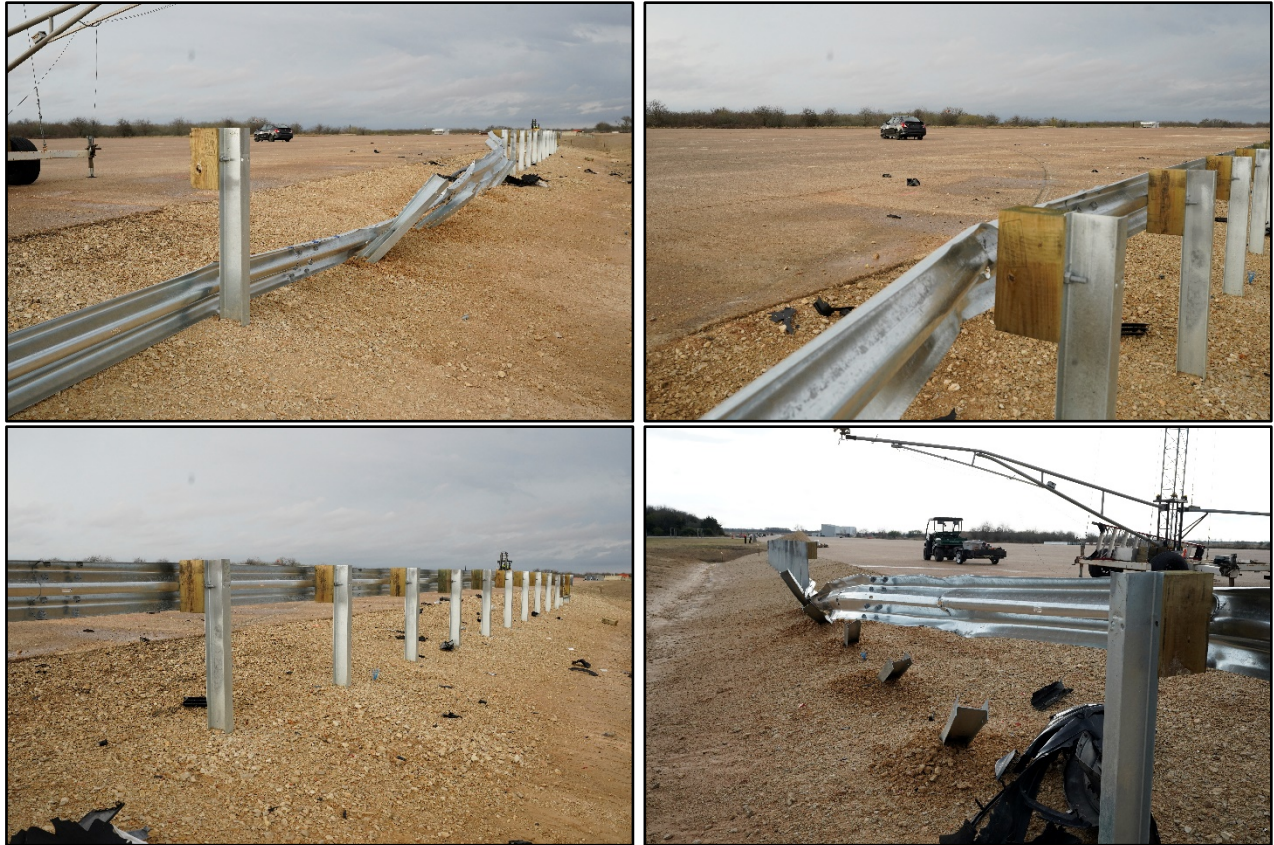
Figure 7.5. Field Side after Test No. 613011-01-1.

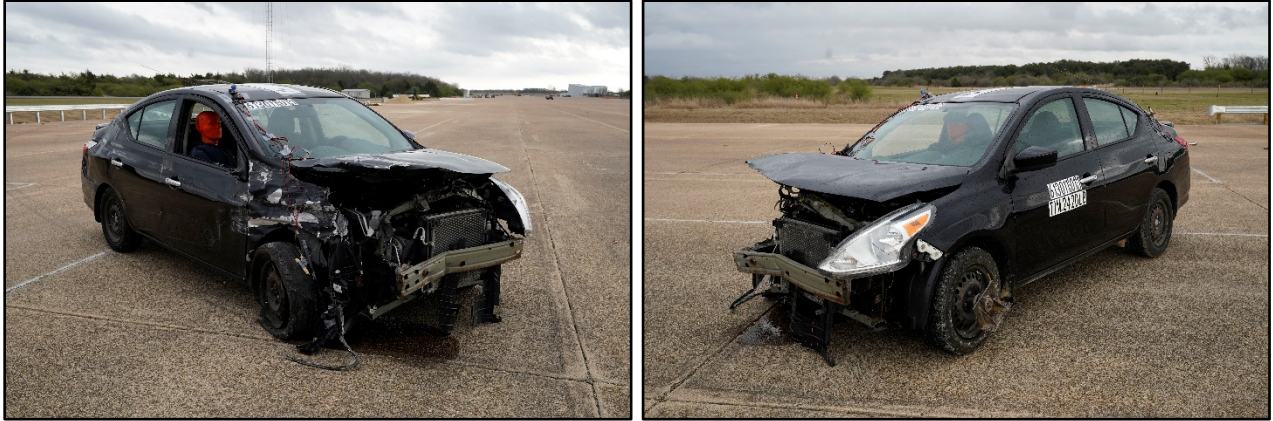
Figure 7.6 shows the damage sustained by the vehicle. The front bumper, hood, radiator and support, right front fender, right front tire and rim, floor pan, right front door and window glass, right rear door, right rear quarter panel, and rear bumper were damaged. The windshield sustained stress cracking radiating upward and inward from the right lower corner. No fuel tank damage was observed. Maximum exterior crush to the vehicle was 7.0 inches in the front and side planes at the right front corner at bumper height. Maximum occupant compartment deformation was 0.5 inch in the right side floor pan. Figure 7.7 shows the interior of the vehicle. Tables D.2 and D.3 in Appendix D.1 provide exterior crush and occupant compartment measurements.

Figure 7.6. Test Vehicle after Test No. 613011-01-1.

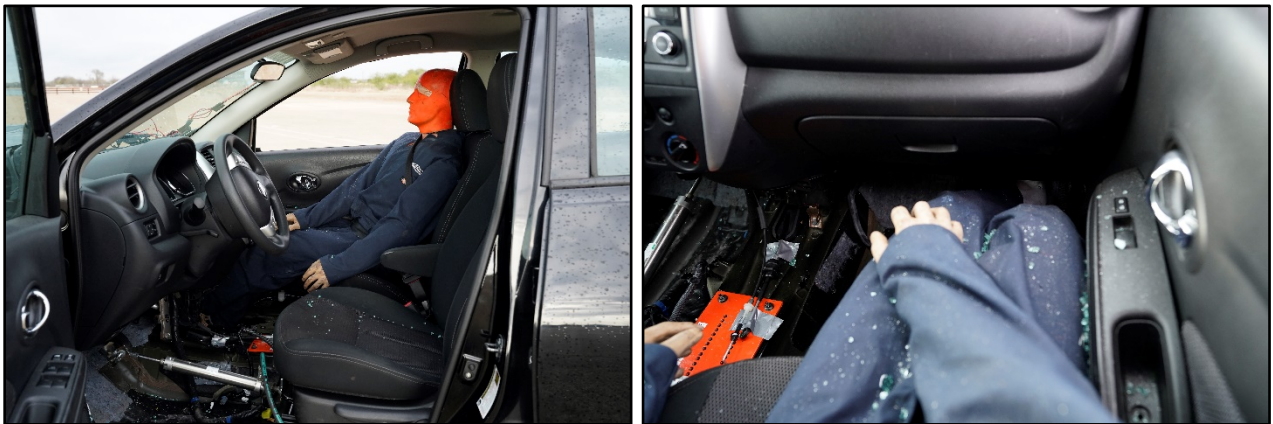
Figure 7.7. Interior of Test Vehicle after Test No. 613011-01-1.

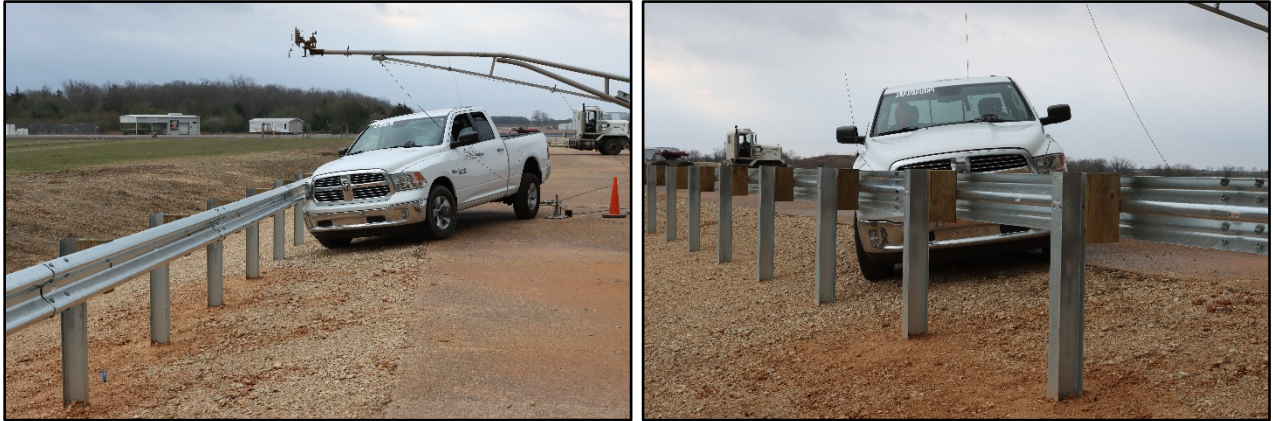
Figure 8.1. Guardrail/Test Vehicle Geometrics for Test No. 613011-01-2.

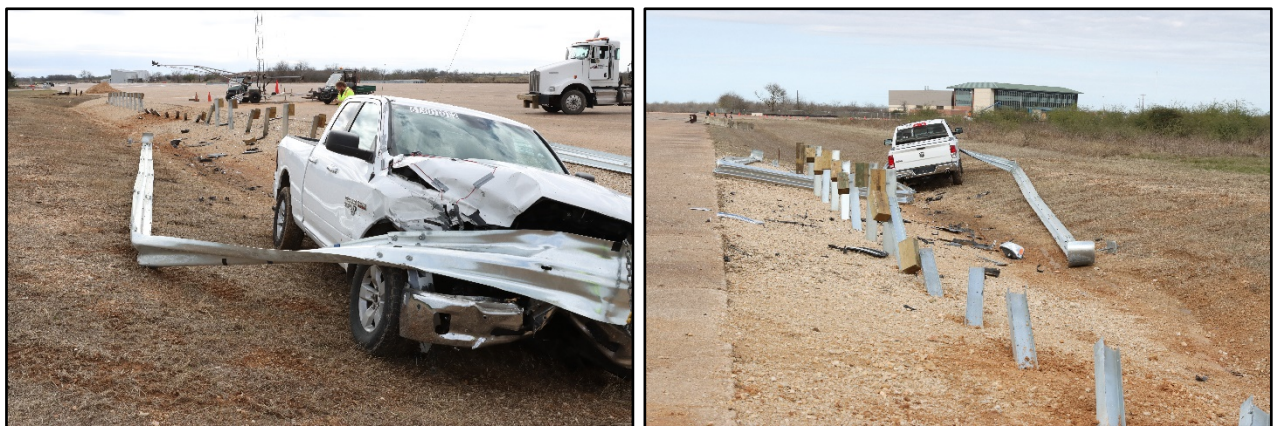
Figure 8.3 shows the damage to the guardrail on 6H:1V slope. The rail released from all posts and blockouts. The slot at post 2 tore 1¼ inches downward. The upstream rail at the joint between posts 16 and 17 ripped from the top to the center of the rail. All other slots at locations where they were mounted onto a post were damaged from the bolts pulling through.

Post 1 sheared at the top of the bottom brace. The remaining section of post had a 1¼-inch gap in the soil on the downstream side, and it was leaning 3 degrees downstream from vertical. The broken off section of post came to rest 41 ft downstream and 18 ft towards the

traffic lanes. Post 2 had a $\frac{5}{8}$ -inch gap in the soil on the upstream side, and a $\frac{3}{4}$ -inch gap on the downstream side. The post was slightly splintered as well. For posts 3 through 10, the only noted damage was that the soil was disturbed. Post 11 was twisted 45 degrees clockwise and had a $\frac{1}{8}$ -inch gap in the soil on the traffic side of the post. Post 12 was twisted 80 degrees clockwise, had a $3\frac{1}{4}$ -inch gap on the traffic side of the post, and a $\frac{3}{4}$ -inch gap on the field side.

The blackout was missing from posts 13 through 18, and deflection could not be measured because all the soil and. Post 13 was leaning 74 degrees downstream, and its blackout landed 81 ft towards the field side and 111 ft downstream. Post 14 was leaning 66 degrees downstream, and the bolt hole was ripped open. Its blackout split in half vertically, with one half landing 3 ft toward the field side and 53 inches downstream, and the other half landing 40 ft toward the field side and 96 ft downstream. The bolt hole on post 15 ripped open as well, and the post was leaning 69 degrees downstream. Its blackout came to rest 25 ft towards the field side and 151 ft downstream. Post 16 was leaning 73 degrees downstream, and its blackout landed 10 ft towards the field side and 121 feet downstream. Post 17 was leaning 67 degrees downstream, and its blackout fell 9 ft towards the field side and 111 ft downstream. Post 18 was leaning 68 degrees downstream, and its blackout came to rest 3 ft towards the field side and 40 ft downstream. Post 19 was leaning downstream 20 degrees and rotated 25 degrees clockwise.

Figure 8.3. Guardrail after Test No. 613011-01-2.

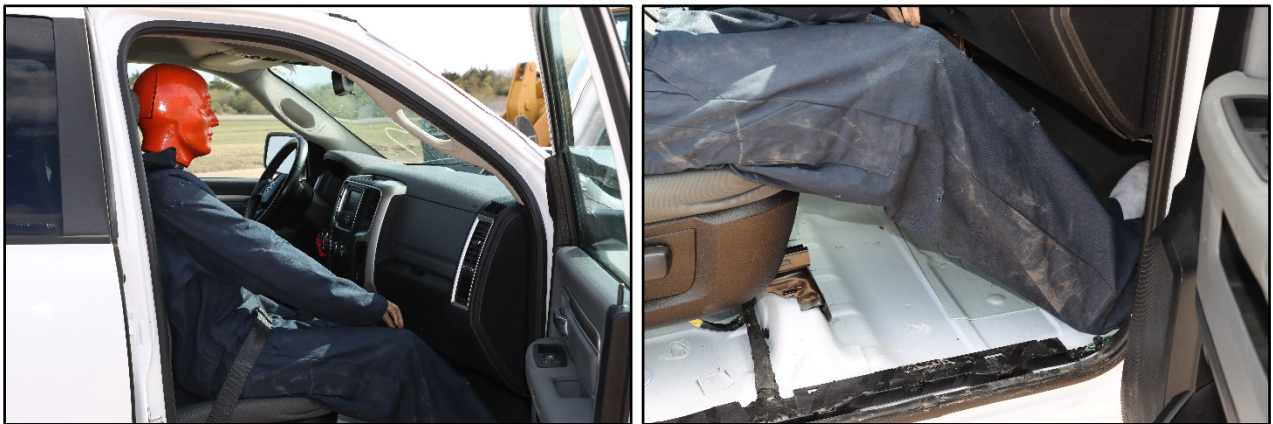
Figure 8.5. Interior of Test Vehicle after Test No. 613011-01-2.

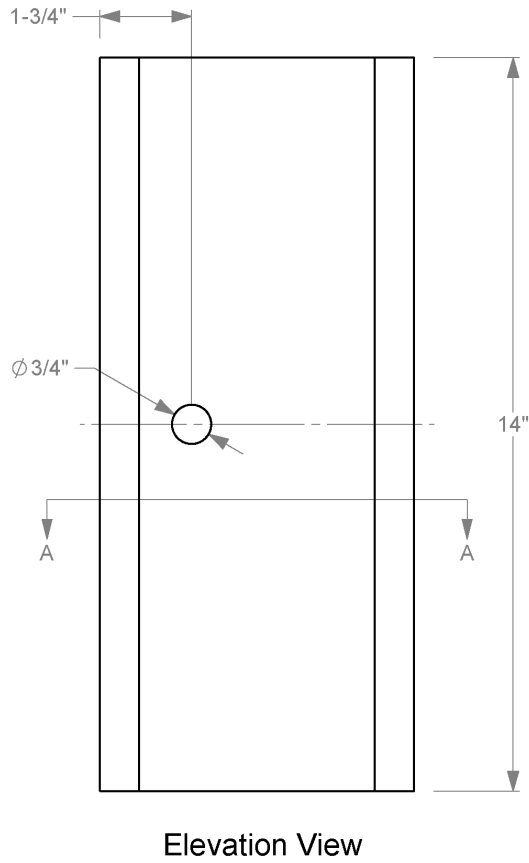
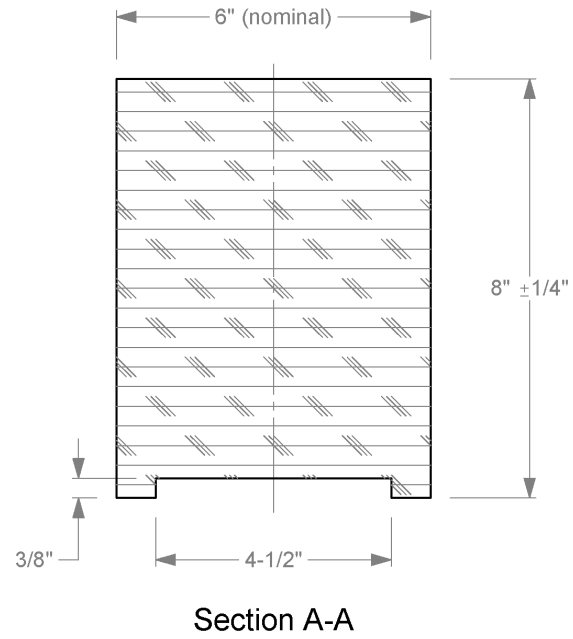
Timber Blockout for W-section Post

1a. Timber blockouts are treated with a preservative in accordance with AASHTO M 133 after all cutting and drilling.

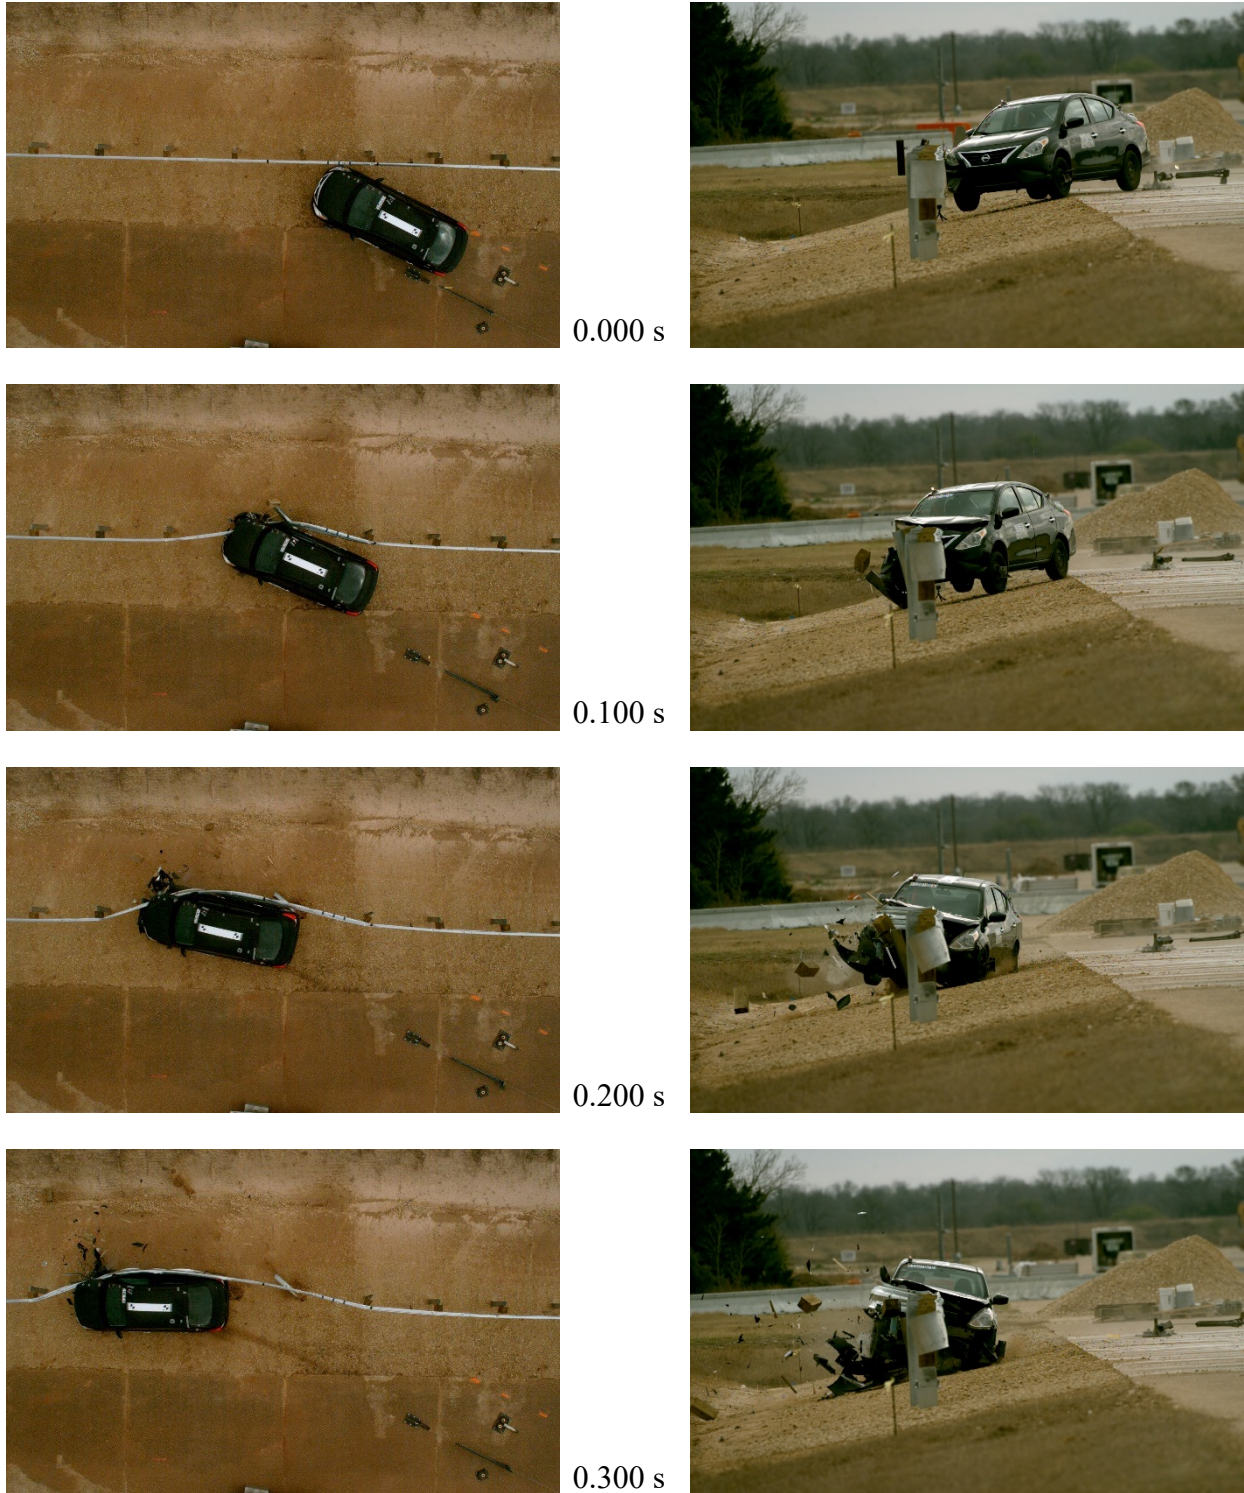
Figure D.1. Sequential Photographs for Test No. 613011-01-1 (Overhead and Frontal Views).

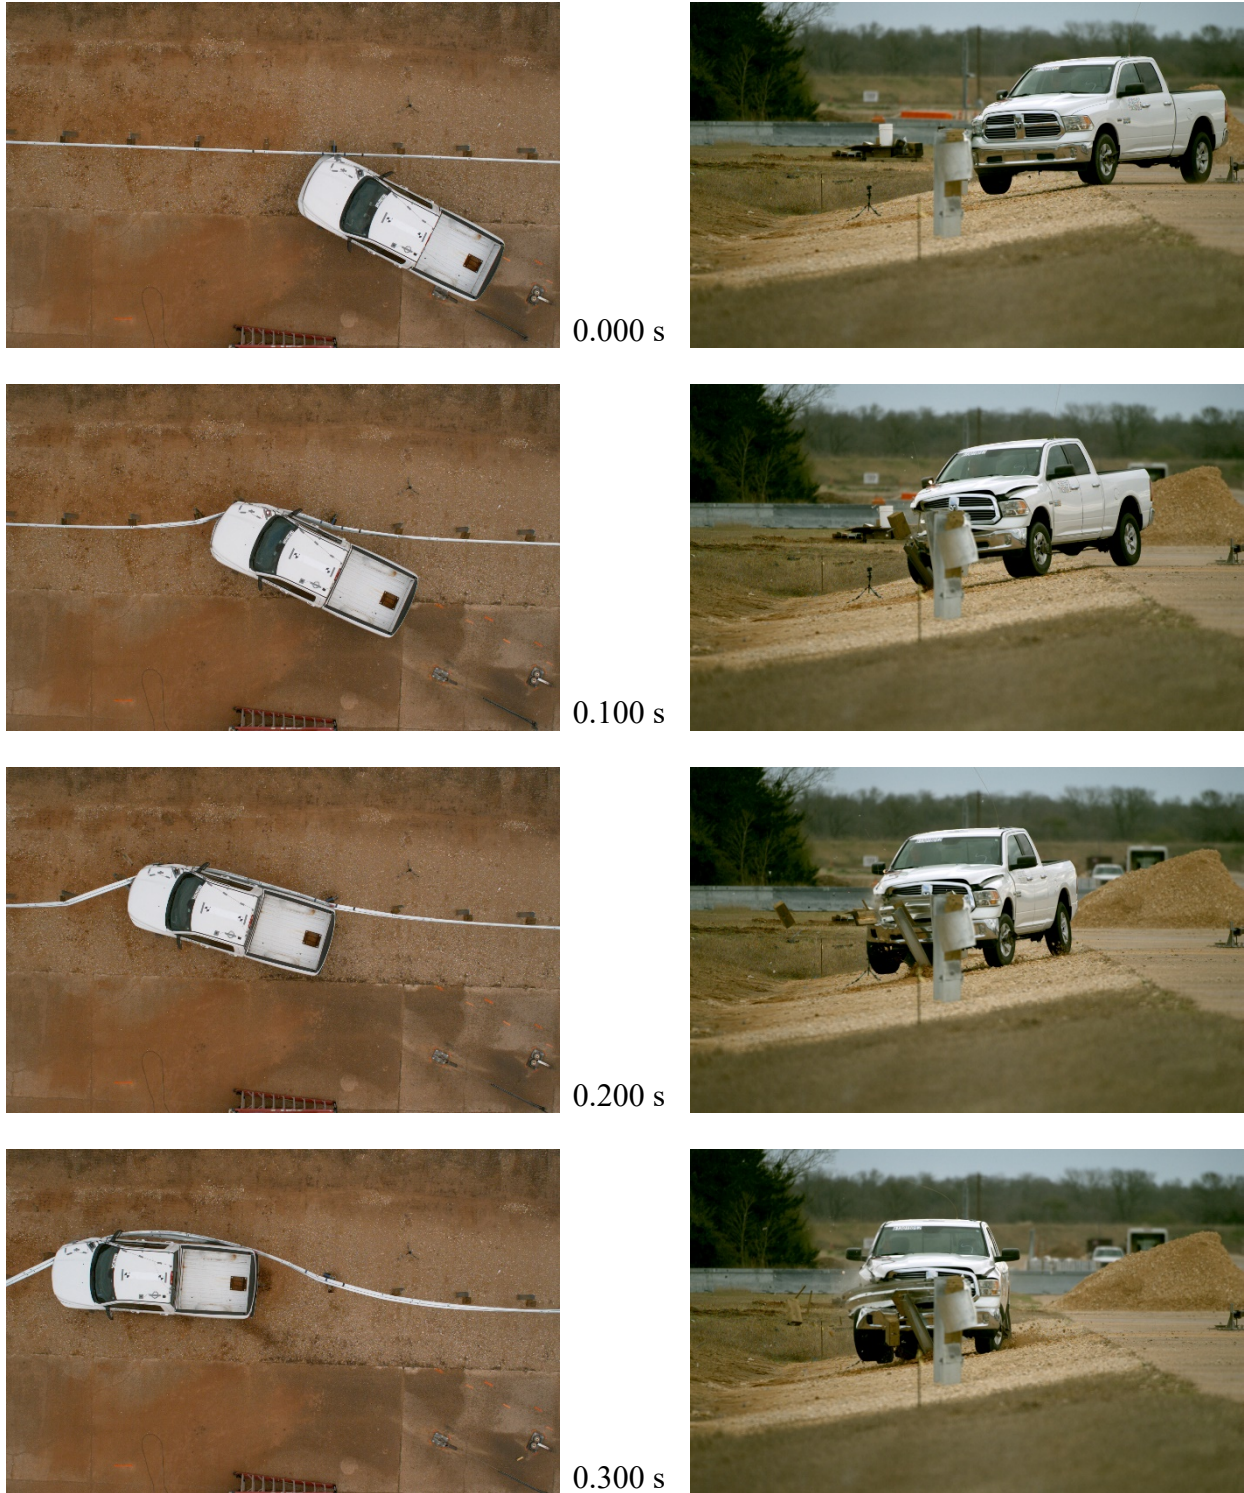
Figure E.1. Sequential Photographs for Test No. 613011-01-2 (Overhead and Frontal Views).

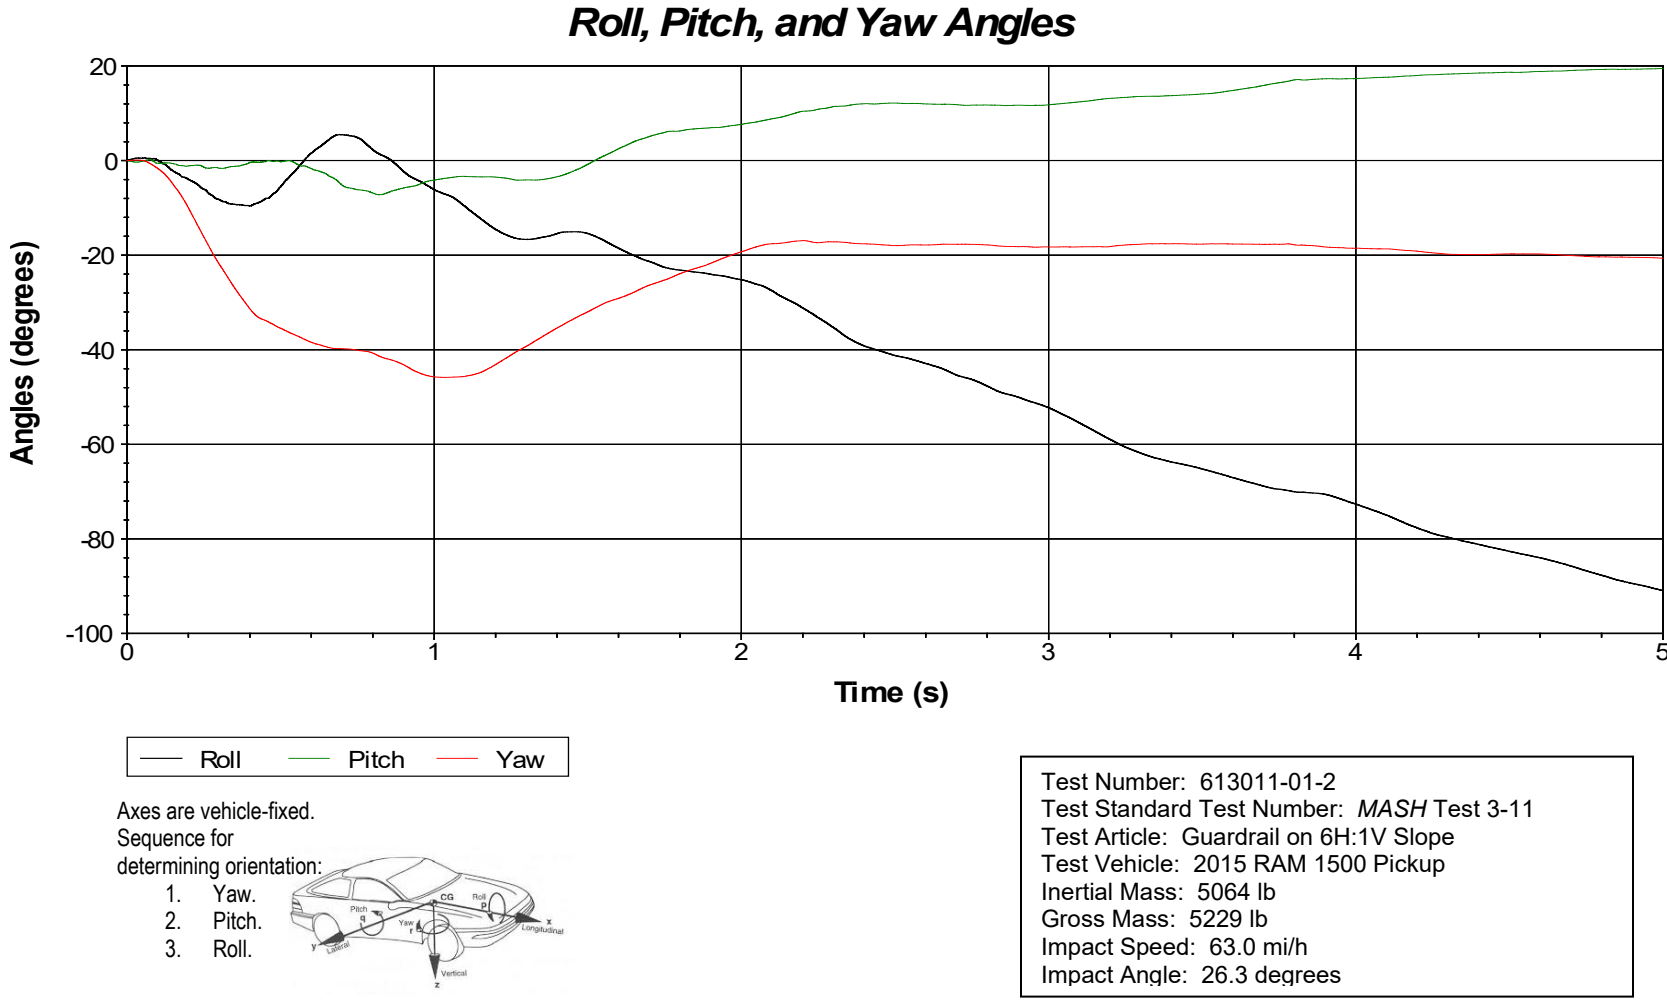
Figure E.3. Vehicle Angular Displacements for Test No. 613011-01-2.
