**Test Report No. 613121-01-1**  
**Test Report Date: August 2021**

***MASH TEST 3-21 EVALUATION OF SHORT W-BEAM  
TRANSITION***

Sponsored by  
**Roadside Safety Research Program Pooled Fund**  
**Study No. TPF-5(114)**

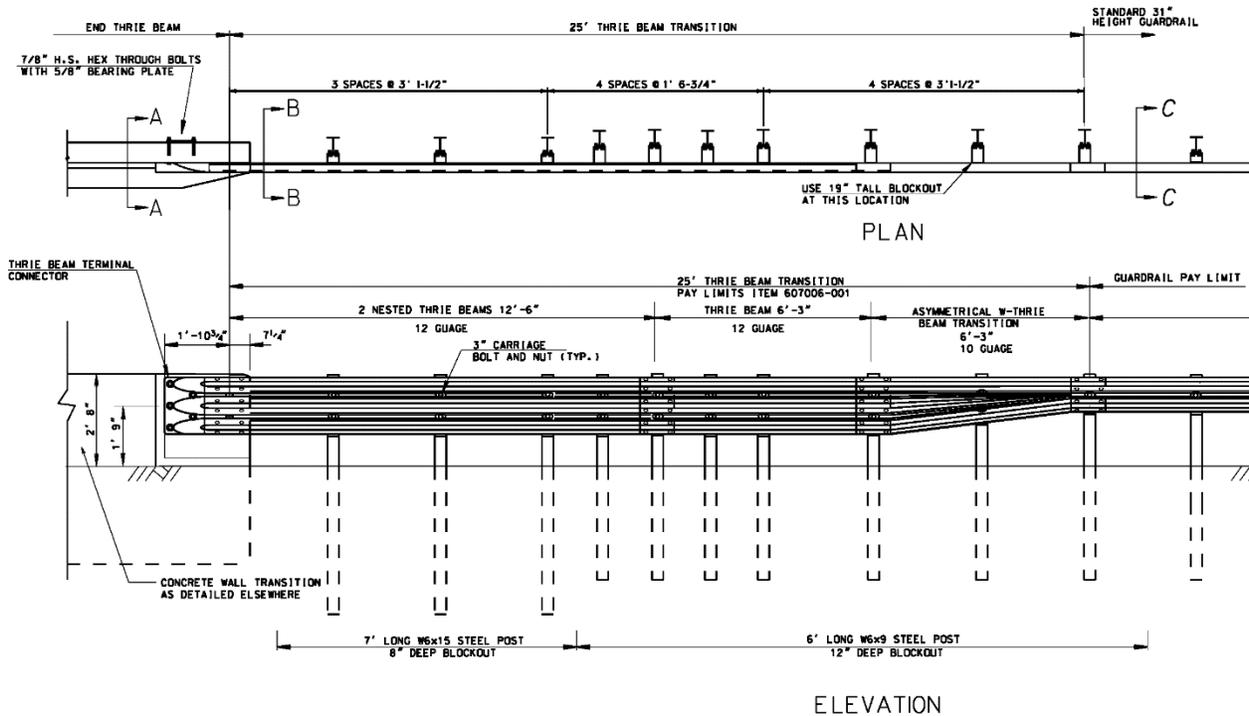
Figure 1.1. Thrie Beam Guardrail Bridge Transition and Connection [WVDOT Standard Drawing, 2016].

Figure 1.1 shows a similar transition design that was used for the installation constructed during this project. The objective was to reduce the 25-ft transition length. For this purpose, the TTI research team first performed an engineering review of available transition systems and their design variables to shortlist a set of candidates for modeling and evaluation. The researchers conducted a series of simulations of the candidate set. The final design was then crash tested for *MASH* TL-3 compliance.

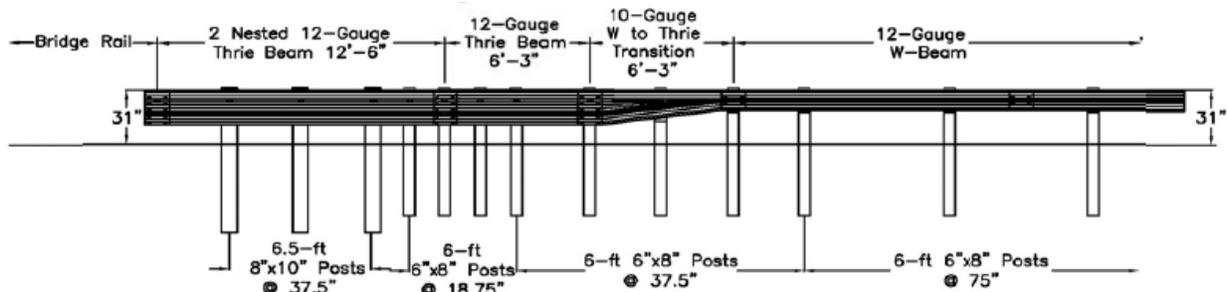
Figure 2.1. MwRSF Simplified Steel Post Stiffness Transition System.

A new, simplified steel-post stiffness transition between the MGS and a thrie beam AGT previously accepted by FHWA was developed and tested for this project. This system consists of standard steel posts and an asymmetric W-to-thrie transition element. A very stiff thrie beam guardrail transition was used during the full-scale crash test. This system satisfied all *MASH* TL-3 criteria. Figure 2.1 illustrates the details of the recommended transition design for the MGS system to thrie beam. The design is similar to the standard approach transition that West Virginia Department of Transportation is using.

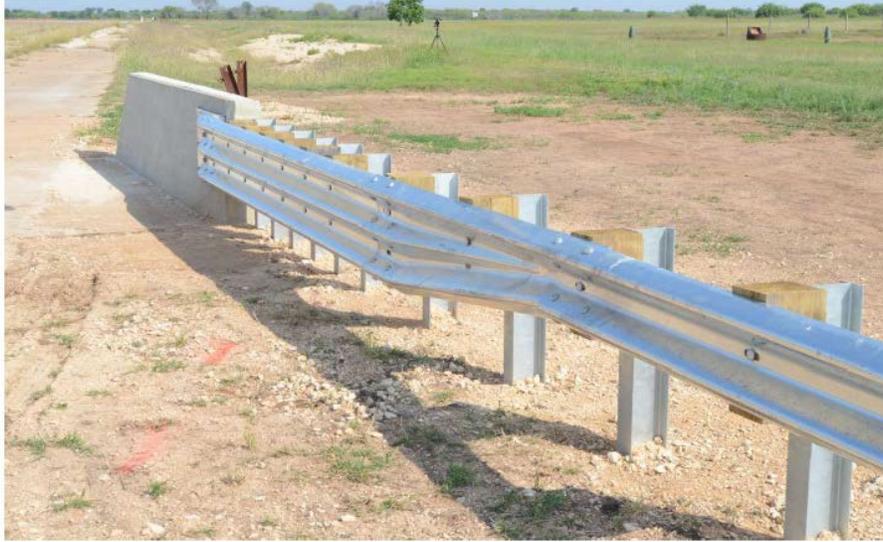
**Figure 2.2. Simplified Thrie Beam transition without Curb and Rubrail.**

TTI researchers evaluated the performance of a simplified approach transition design without a curb or a rubrail (Figure 2.2) (3). The test was performed in accordance with the *MASH* criteria under the impact conditions for Test Designation 3-21.

The single slope bridge rail was constructed according to the Texas Department of Transportation (TxDOT) standards with a height of 36 inches. The guardrail was constructed using 19 posts. Posts 1 and 2 were installed as part of the standard 31-inch ET-2000 Terminal. Posts 3 through 11 were installed as part of a standard 12-gauge W-Beam Guardrail (RWM04a). Each post in this section is a 72-inch long W6×8.5 SLP (PEW01) attached to the 12-gauge rail element using an 8-inch wood blockout. The posts were placed at the mid-span of each rail. Between posts 11 and 13, a 10-gauge thrie beam to W-beam asymmetric transition piece is utilized and is supported by a 72-inch long W6×8.5 SLP. A nested 12-gauge thrie beam (RTM02a) rail is used between post 13 and the end of the single slope barrier. In this section, 84-inch long W6×8.5 posts with 6×8×18-inch wood blockouts are used. A 10-gauge thrie beam end shoe (RTE01b) is used to attach the nested thrie beam to the ¼-inch thick adapter plate.

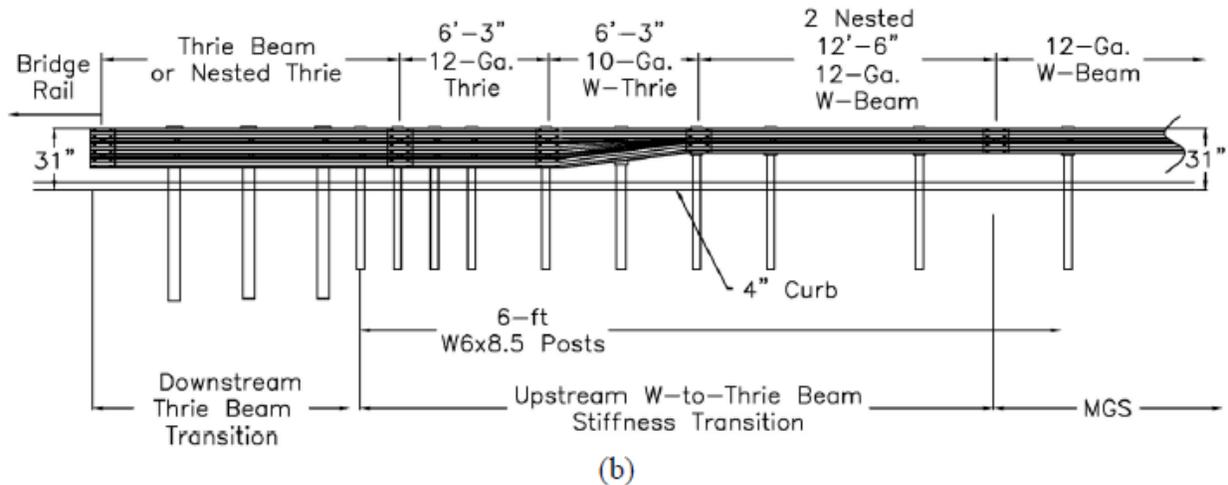
**Figure 2.3. MGS to Thrie Beam Stiffness Transition Details with Curb.**

MwRSF researchers developed a stiffness transition with a 4-inch tall concrete curb to connect MGS to a previously developed thrie beam approach guardrail system (4). The test installation is shown in Figure 2.3.

Three crash tests were conducted: Test Nos. MWTC-1, MWTC-2, and MWTC-3. Test Nos. MWTC-1 and MWTC-2 were performed according to test designation *MASH* Test No. 3-20 with an 1100C small car. Test No. MWTC-3 was performed according to test designation *MASH* Test No. 3-21 with a 2270P pickup truck. In the first crash test (Test No. MWTC-1), the MGS Stiffness Transition with Curb did not perform acceptably. The front of the 1100C vehicle penetrated under the W-beam rail while the wheel overrode the curb. The combination of these events resulted in the W-beam rail to rupture at the splice adjacent to the rail elements, which eventually caused the W-beam rail to rupture.

After the failed crash test, the design was modified to incorporate an additional 12 gauge W-beam segment such that 12.5 ft of nested guardrail preceded the asymmetric W-beam to thrie beam transition element. After this modification was incorporated in the stiffness transition system, Test Nos. MWTC-2 and MWTC-3 were performed with an 1100C small car and 2270P pickup truck, respectively. The modification resulted in a successful completion of the *MASH* TL-3 testing matrix. Therefore, this system was found to satisfy current safety standards.

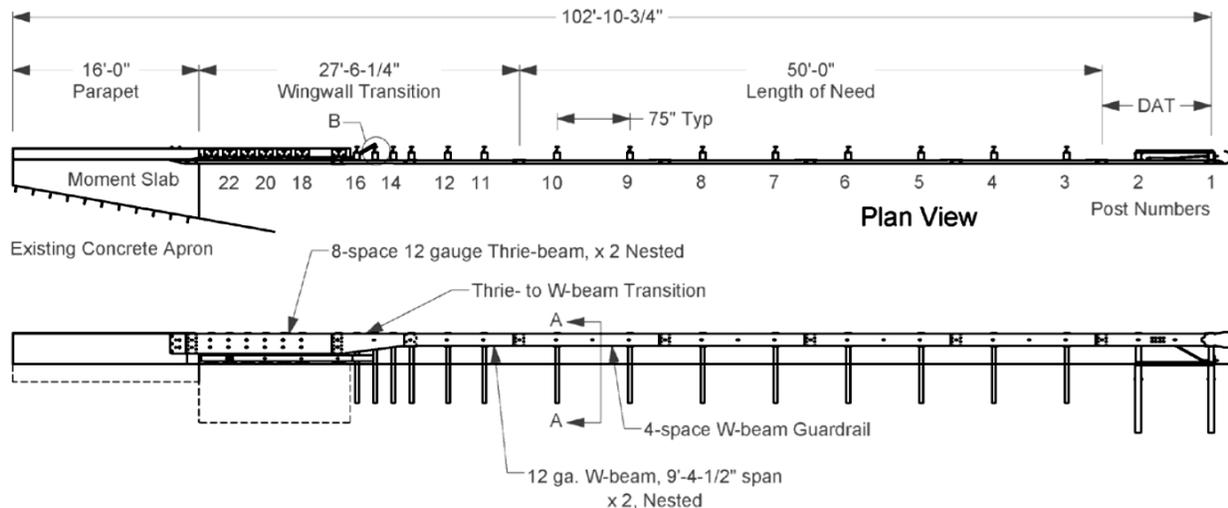
**Figure 2.4. Installation Details for Transition on Wingwall.**

The Guardrail to Rigid Barrier Transition Attached to Bridge or Culvert Structure installation consisted of a 16-ft long reinforced concrete parapet and moment slab, a 27 ft-6¼ inch long W-beam to thrie-beam to parapet transition section that was anchored to the parapet, 50 ft of W-beam guardrail, and a TxDOT Downstream Anchor Terminal (DAT). The posts in the thrie-beam portion of the installation were anchored to a reinforced concrete wingwall that was embedded in the soil with the top at grade, and the rest of the posts were embedded directly into the soil. The top edge of the thrie-beam and W-beam rails were at 31 inches above grade. The wingwall was 13 ft long, 12 inches thick, and 5 ft deep. A C6×8.2 rub rail was positioned below the thrie-beam section of the transition. Figure 2.4 shows the transition installation on a wingwall.

The target critical impact points (CIPs) were determined using computer simulation. Three crash tests were conducted. Two on the upstream of the transition and one on the downstream. The target CIPs for *MASH* Test 3-20 (Test No. 469549-01-1) and *MASH* Test 3-21 (Test No. 469549-01-2) were the centerline of post 13 and 14, respectively. The target CIP for *MASH* Test 3-21 (Test No. 469549-01-4) was 5 inches downstream of the centerline of post 19 at the connection with the rail.

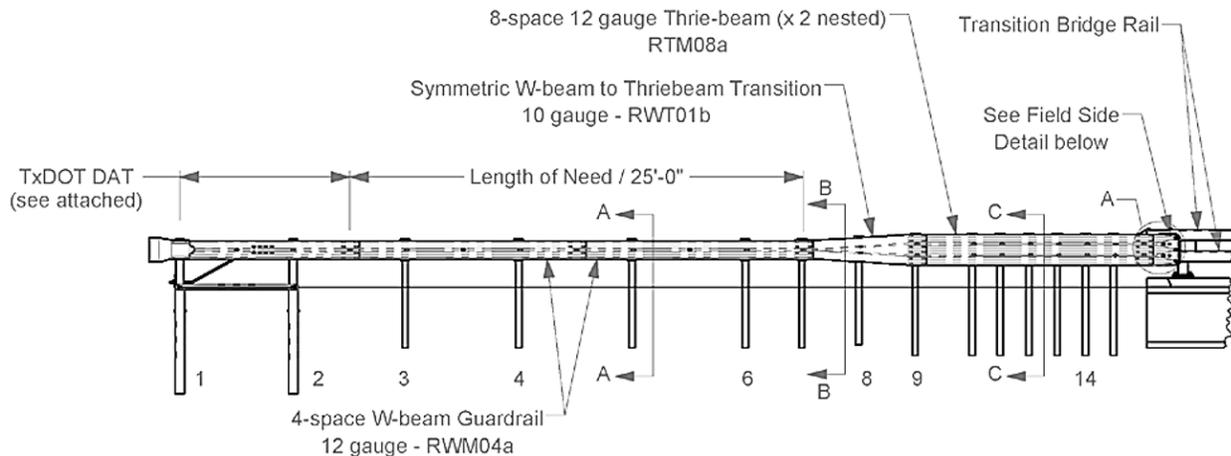
**Figure 2.5. Details of 2019 *MASH* 2-Tube Bridge Rail Thrie Beam Transition.**

TTI researchers assessed the performance of the 2019 *MASH* 2-Tube Bridge Rail Thrie Beam Transition according to the safety-performance evaluation guidelines included in AASHTO *MASH* (6).

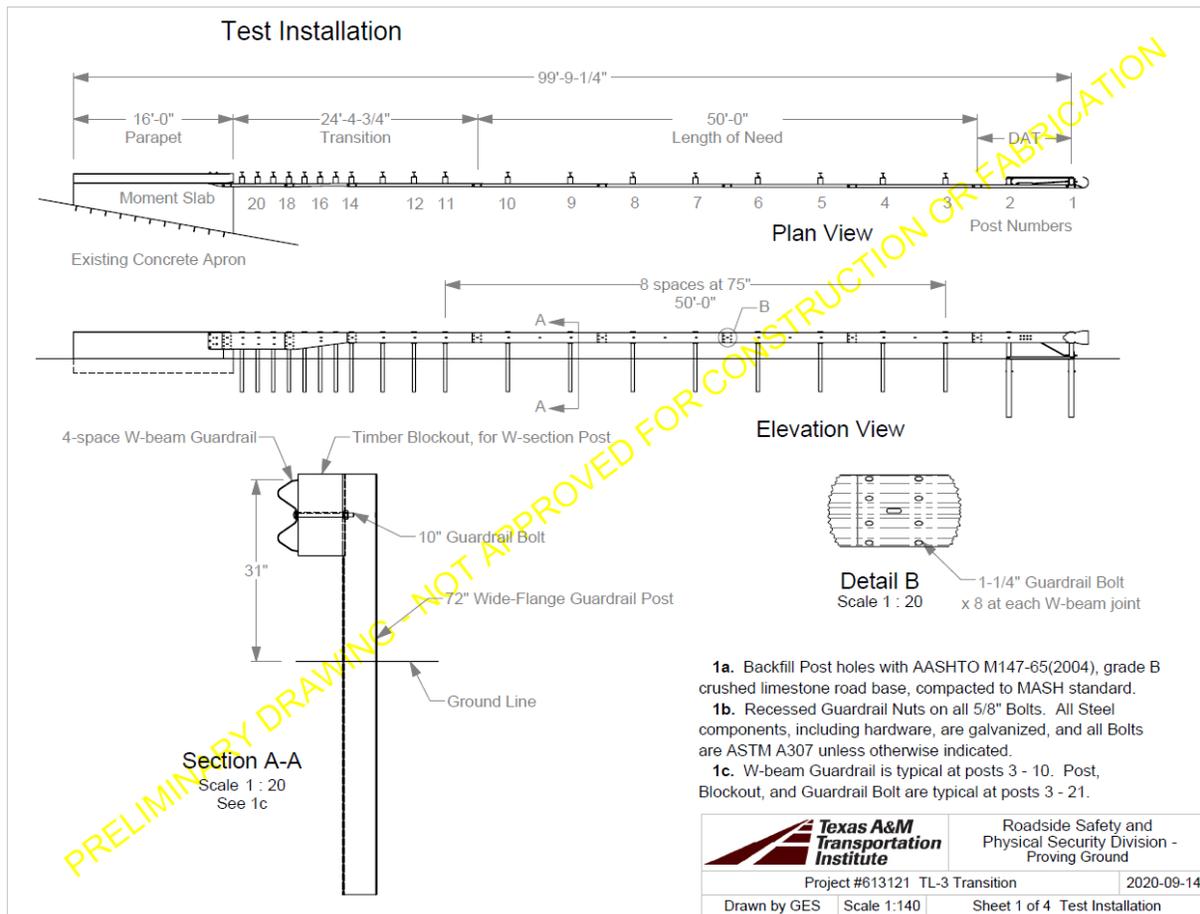
**Figure 3.1. Plan View and Elevation of Installation.**

The 99 ft-5¼ inch installation consists of four sections: A 16-ft vertical wall parapet, a 24 ft-4¾ inch transition section, a 50 ft length of need, and a 9 ft-½ inch TxDOT DAT. All the posts are 72-inch long W6×8.5 with 6×8×14-inch wood blockouts throughout the test installation. A 6 ft-¼ inch long nested Thrie beam is connecting the W-to-thrie segment to the concrete parapet via a 10 gauge thrie beam end shoe. Figure 3.1 through Figure 3.4 show details of the transition design used in the preliminary simulation effort.

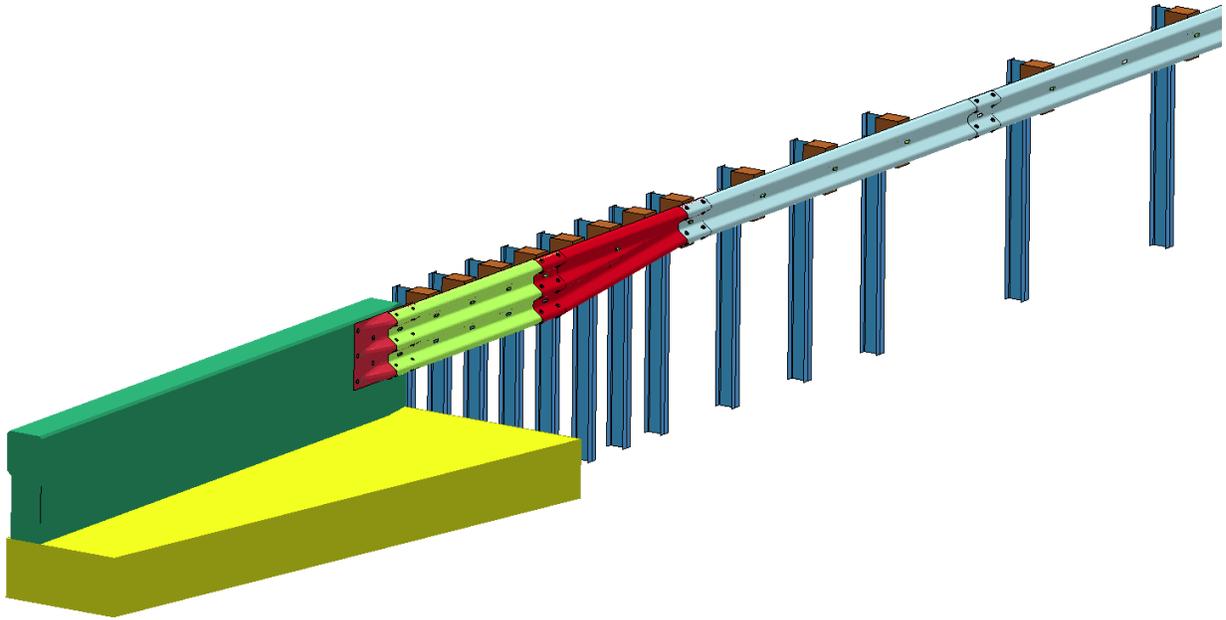
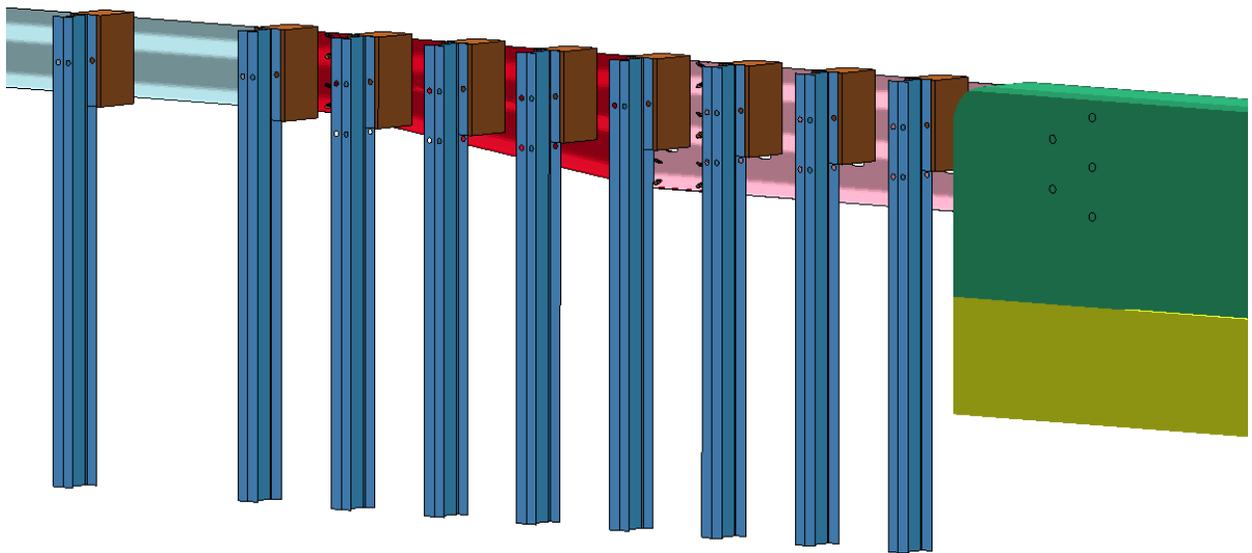
An explicit finite element model of the transition system was created using detailed geometrical and material properties. Figure 3.5 and Figure 3.6 show the front and rear views of the system modeled, including the moment slab, parapet, transition posts, nested thrie section, and approaching W-beam guardrail. The rear view shows the utilization of 14-inch blockouts all through the system. The moment slab was modeled as rigid and did not consider any material failure from the impact loads. The shorter transition system comprised of a nested 6 ft-3 inch 12 gauge thrie-beam followed by an asymmetric W-to-thrie transition segment. Figure 3.7 shows views of the *MASH* 1100C and 2270P vehicle models used in the computer simulations.

**Figure 3.5. Front View of System.**

**Figure 3.6. Rear View of System.**

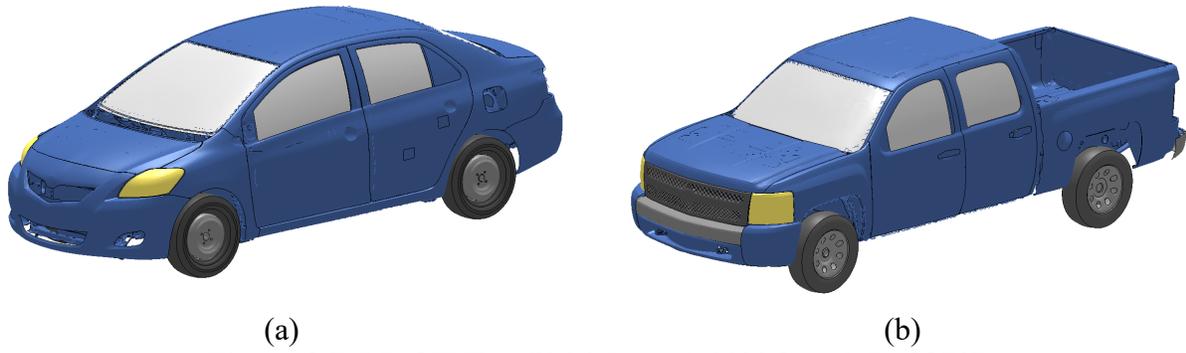
**Figure 3.7. MASH Test Vehicles: (a) 1100C and (b) 2270P.**

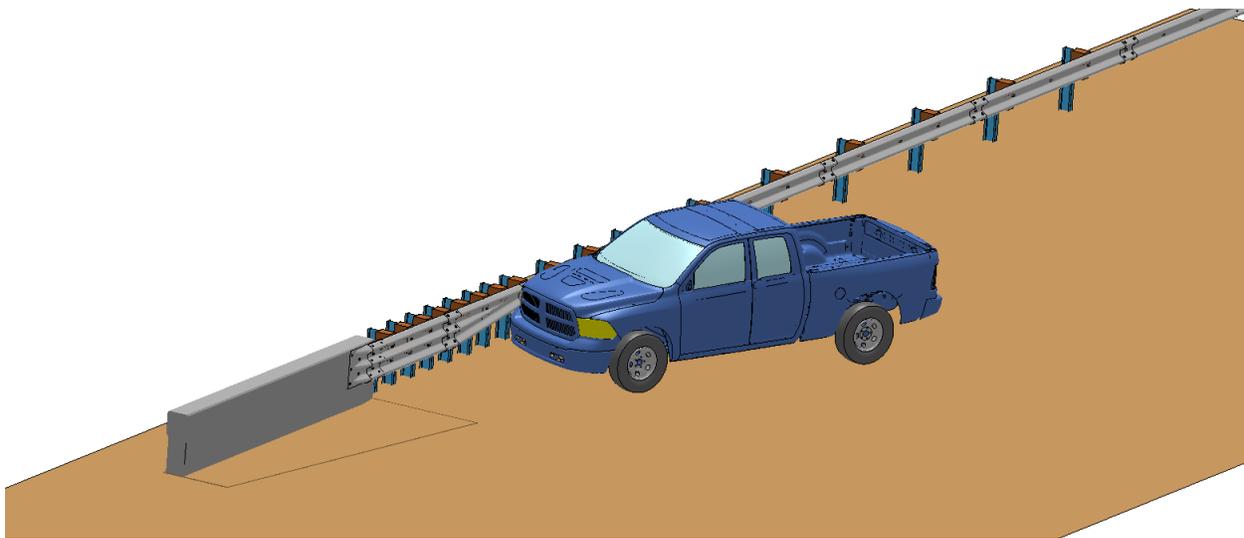
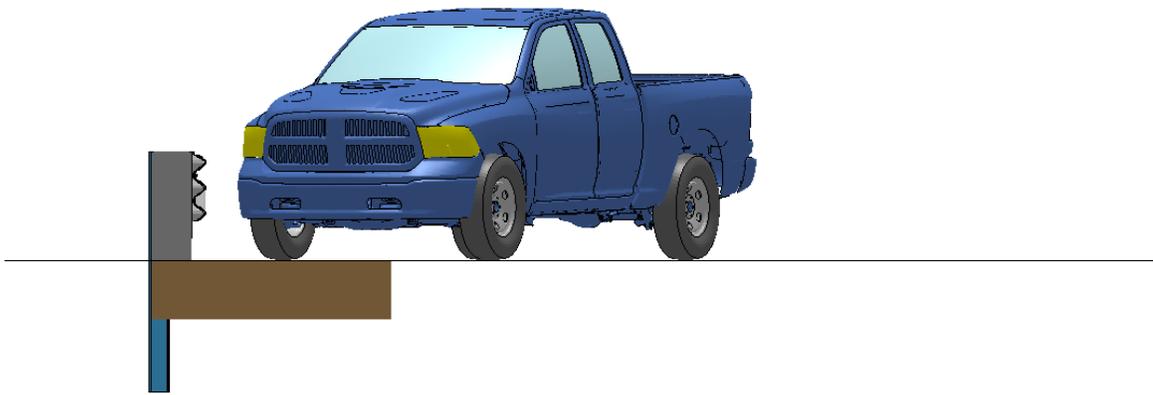
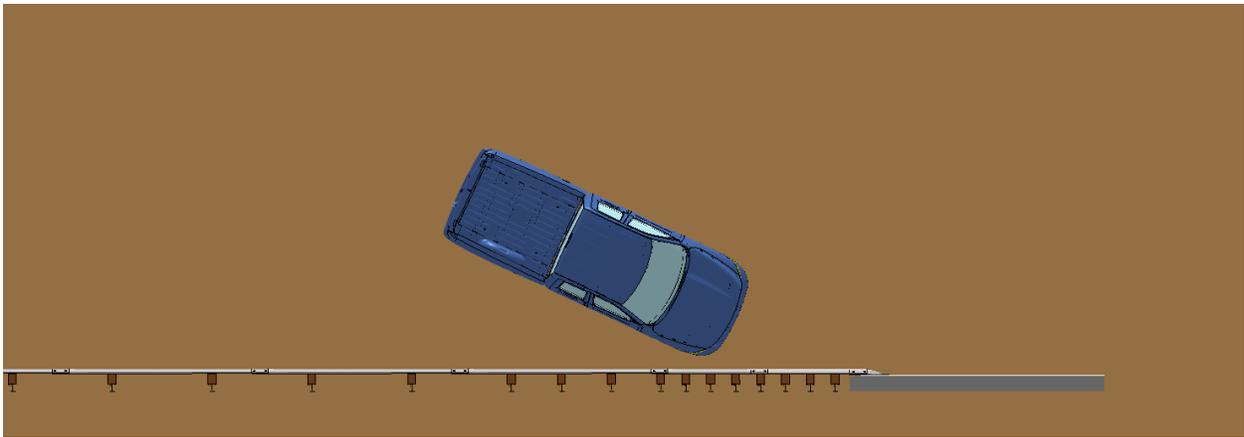
Figure 3.8 through Figure 3.10 show the images of the vehicle setup for this impact simulation. The vehicle used in this simulation is a 2270P vehicle weighing 5000 lb and impacting the barrier at a speed of 62 mph and an angle of 25 degrees.

**Figure 3.8. MASH 2270P Vehicle/Installation Setup – Isometric View.**

**Figure 3.9. *MASH 2270P* Vehicle/Installation Setup – Front View.**

**Figure 3.10. *MASH 2270P* Vehicle/Installation Setup – Top View.**

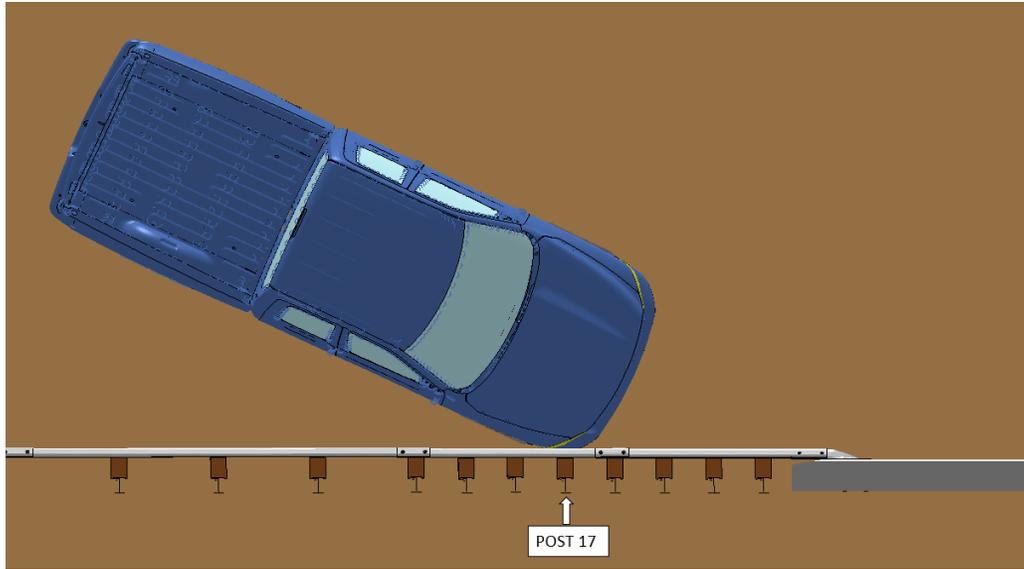
Figure 3.11. Target CIP for *MASH* Test 3-21.

According to the literature review section, in transitions without curb or rubrail, the main reason for failing full-scale crash test was vehicle rollover. Thus, the researchers investigated various design modifications to improve the system performance and reduce vehicular instability. The parametric analysis indicated that the maximum roll angle occurs when the target critical impact point (CIP) is the centerline of post 17 (Figure 3.11). The sequential images of the simulation are presented in Figure 3.12.

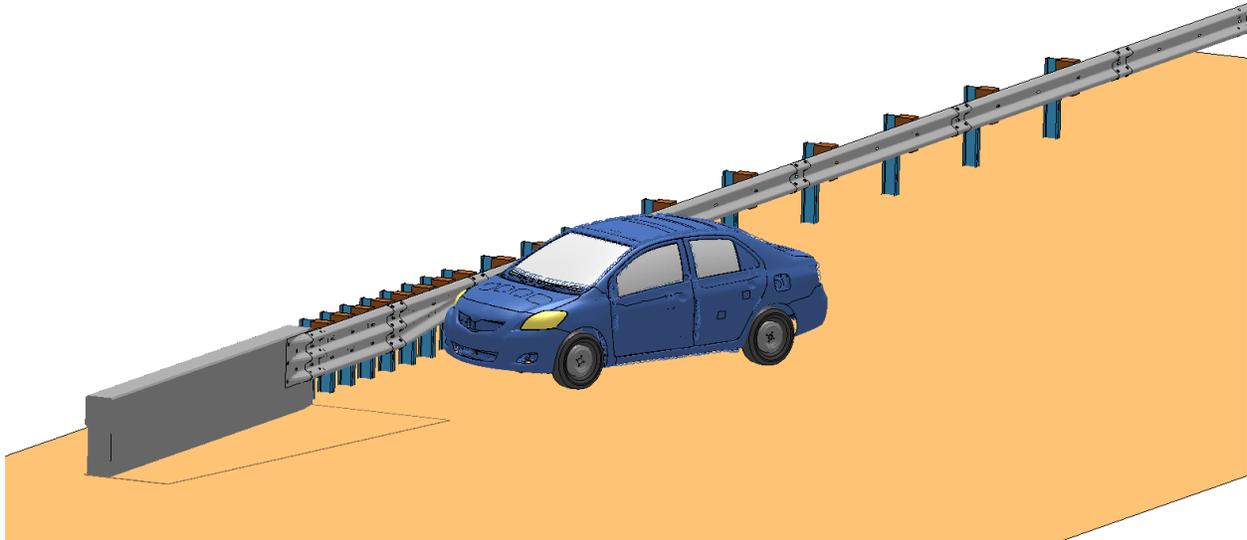
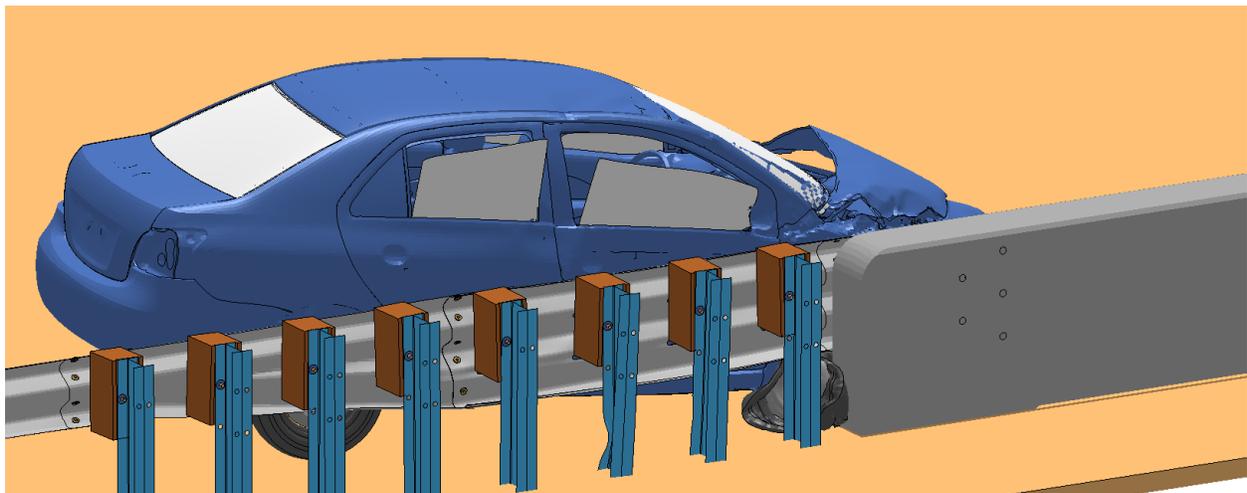
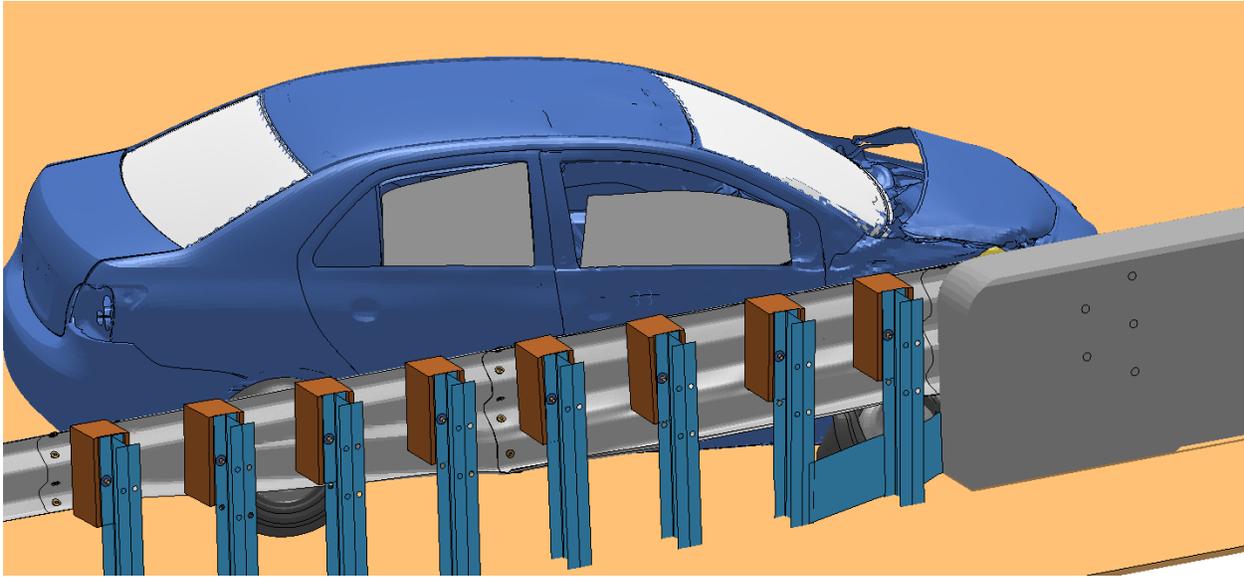
Figure 3.13 shows the vehicle setup for small car impact simulation. The vehicle used in this simulation is a 1100C vehicle impacting the barrier at a speed of 62 mph and an angle of 25 degrees. As depicted in Figure 3.14, the impact side tire experienced severe snagging to the parapet toe that may cause higher occupant risk factors in a full-scale crash test. To reduce the possibility of tire snagging, a deflector plate was placed between the parapet toe and the field side flange of Post 20 (the second post from the parapet) (Figure 3.15).

**Figure 3.13. MASH 1100C Vehicle/Installation Setup – Isometric View.**

**Figure 3.14. MASH 1100C Vehicle/Installation Setup – Tire Snagging to Parapet.**

**Figure 3.15. *MASH* 1100C Vehicle/Installation Setup – Effect of Added Deflector Plate in Reducing Tire Snagging.**

- Shorter blockouts (14-inch W-beam blockouts) behind the thrie beam to allow the bottom of the thrie beam to bend inward upon the impact to dissipate the energy and consequently reduce the bottom of the vehicle bouncing back. This design would reduce the possibility of excessive roll angle observed in previous transitions of similar structure (transitions without any curb and/or rubrail) that caused vehicular instability, and rollover in some cases.
- A deflector plate or a similar method for a smooth redirection of the small car tire from the concrete parapet's blunt end.

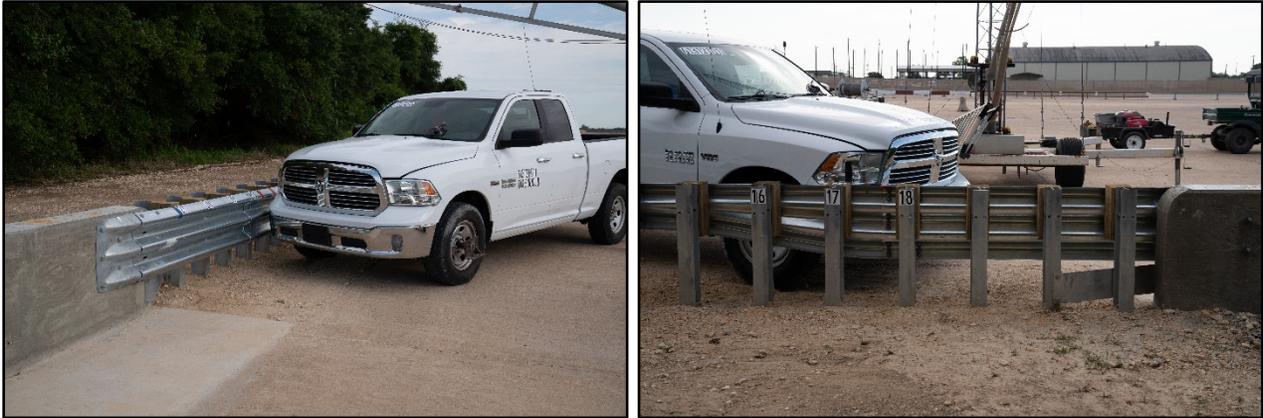
**Figure 7.1. Transition/Test Vehicle Geometrics for Test No. 613121-01-1.**

*MASH* Test 3-21 involves a 2270P vehicle weighing 5000 lb  $\pm$  110 lb impacting the CIP of the longitudinal barrier at an impact speed of 62 mi/h  $\pm$  2.5 mi/h and an angle of 25 degrees  $\pm$  1.5 degrees. The CIP for *MASH* Test 3-21 on the short transition was at the centerline of post 17  $\pm$  1 ft. Figure 5.1 and Figure 7.1 depict the target impact setup.

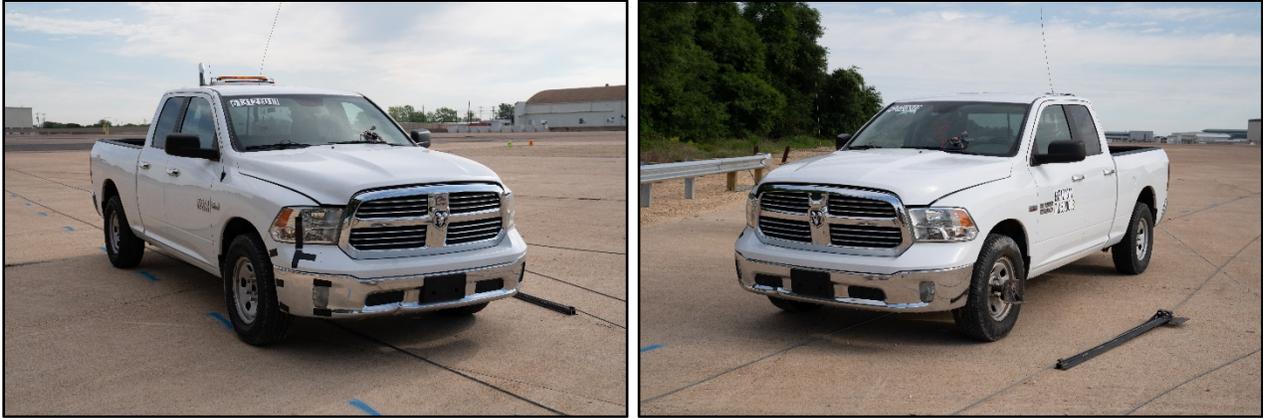
**Figure 7.2. Test Vehicle before Test No. 613121-01-1.**

Figure 7.2 shows the 2016 RAM 1500 pickup truck used for the crash test. The vehicle's test inertia weight was 5061 lb, and its gross static weight was 5226 lb. The height to the lower edge of the vehicle bumper was 11.75 inches, and height to the upper edge of the bumper was 27.0 inches. The height to the vehicle's center of gravity was 28.25 inches. Tables D.1 and D.2 in Appendix D.1 give additional dimensions and information on the vehicle. The vehicle was directed into the installation using a cable reverse tow and guidance system, and was released to be freewheeling and unrestrained just prior to impact.

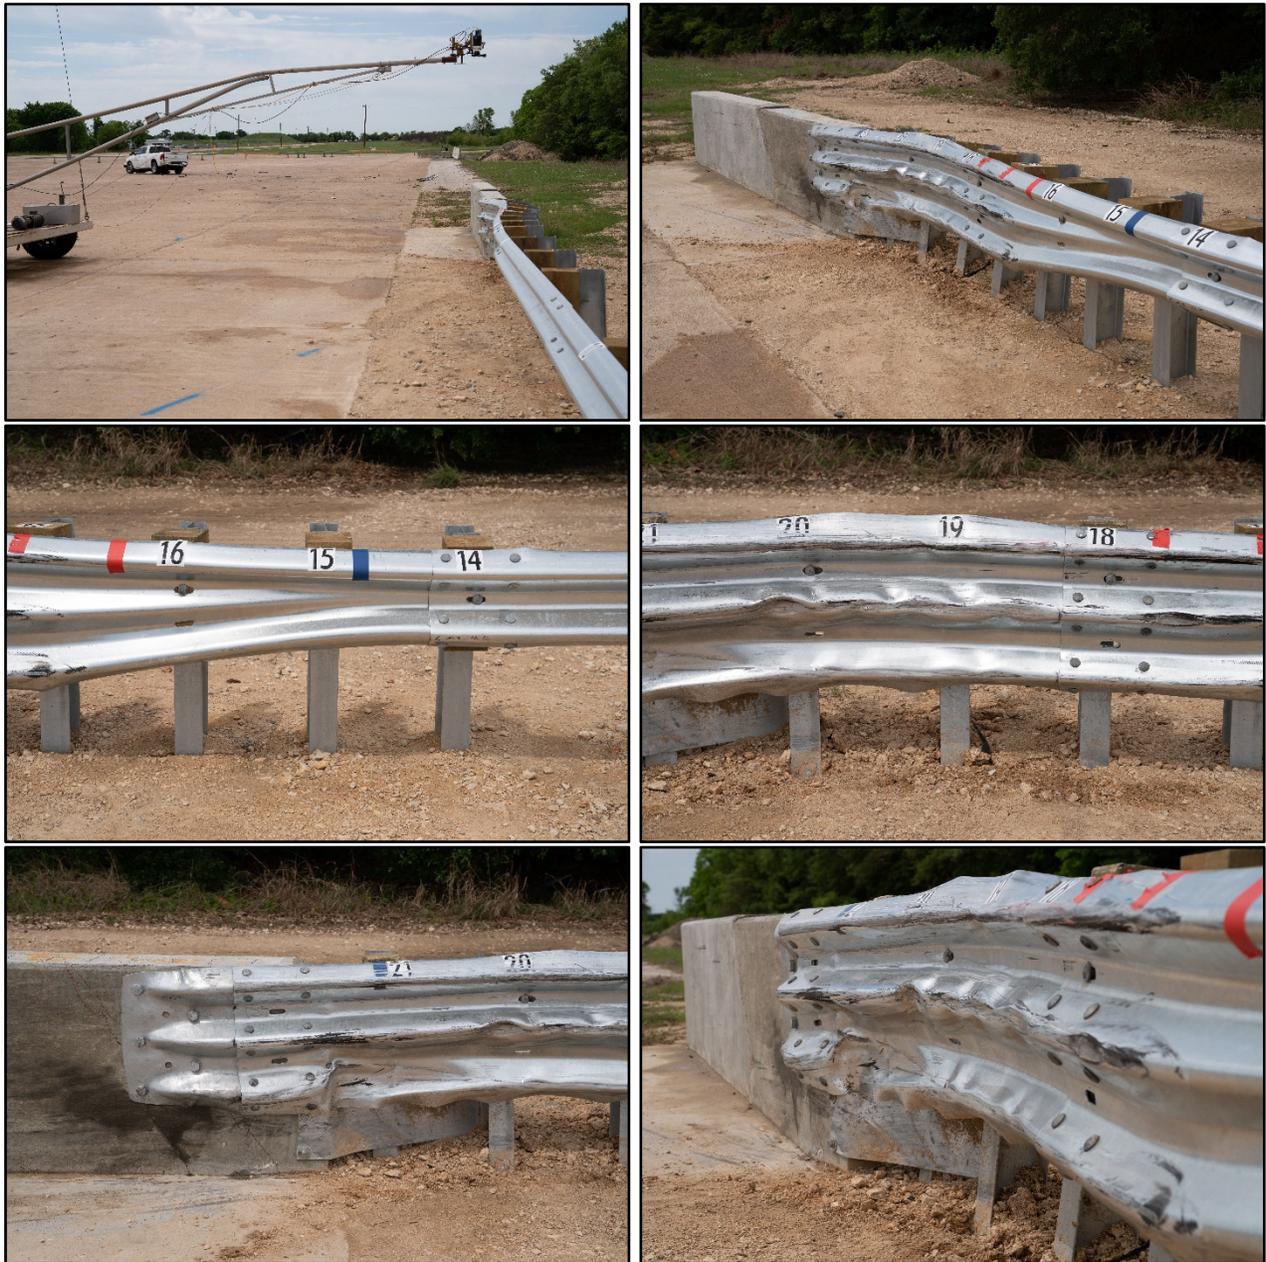
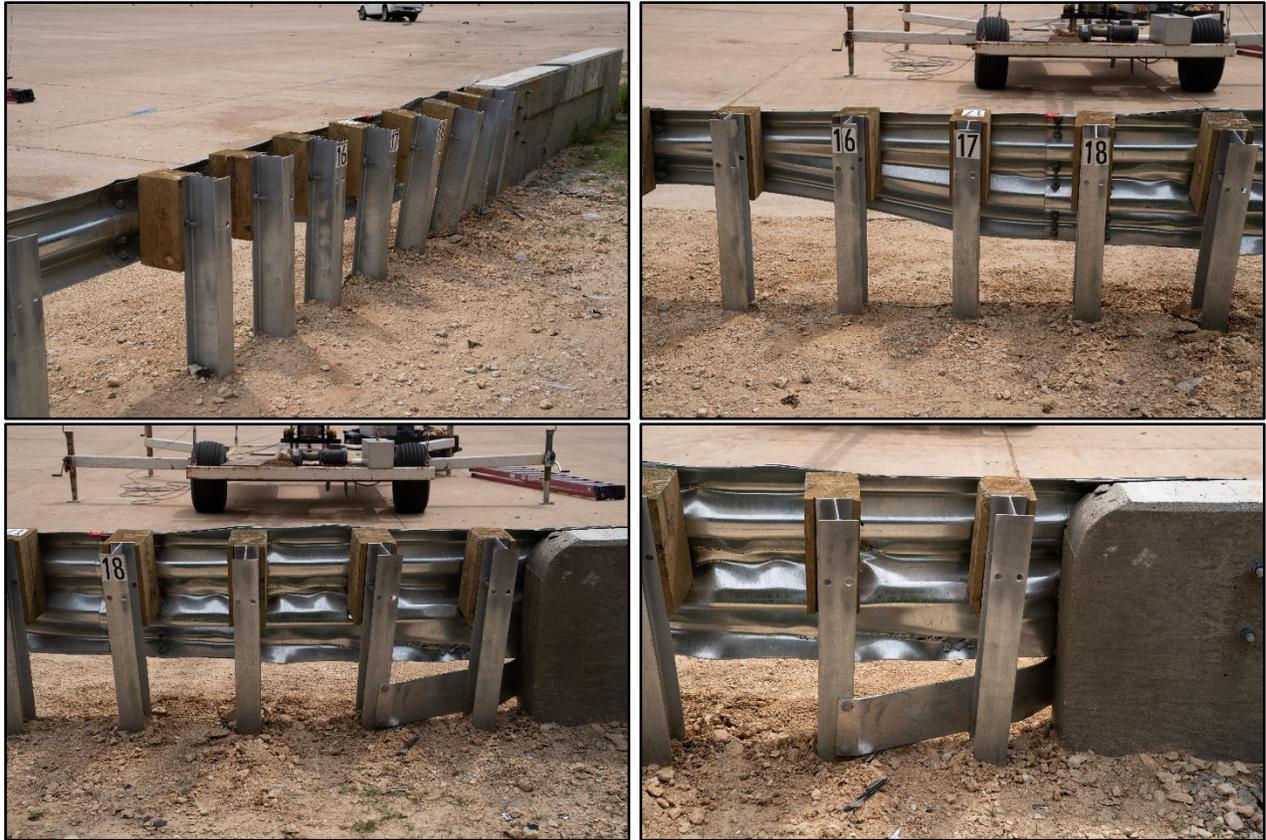
Figure 7.3 and Figure 7.4 show the damage to the transition. The existing cracks were marked in black, and the post-impact cracks were marked in red. The rail was scuffed and deformed at impact. The soil was disturbed at posts 14 and 15, and there was slight spalling on the upstream end of the concrete barrier. Table 7.2 provides additional measurements and

damage details. Working width\* was 27.6 inches, and height of working width was 29.7 inches. Maximum dynamic deflection during the test was 10.4 inches, and maximum permanent deformation was 7.8 inches.

**Figure 7.3. Transition after Test No. 613121-01-1.**

**Figure 7.4. Field Side of Transition after Test No. 613121-01-1.**

The researchers believe that excessive deflection at the immediate upstream regions caused a higher interaction of the vehicle with the parapet blunt end which resulted in a higher ridedown acceleration than the *MASH* maximum limit. The deflector plate helped to reduce tire snagging and possible instability of the vehicle that was observed in previous similar systems. However, the deflector plate was not adequate in controlling the vehicle-parapet interaction. The following are possible design changes that could improve the performance of the system.

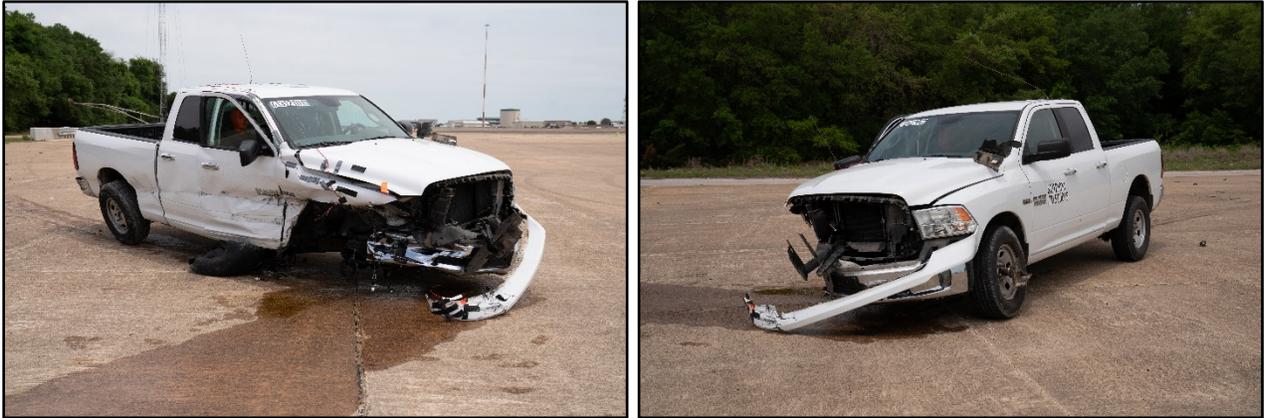
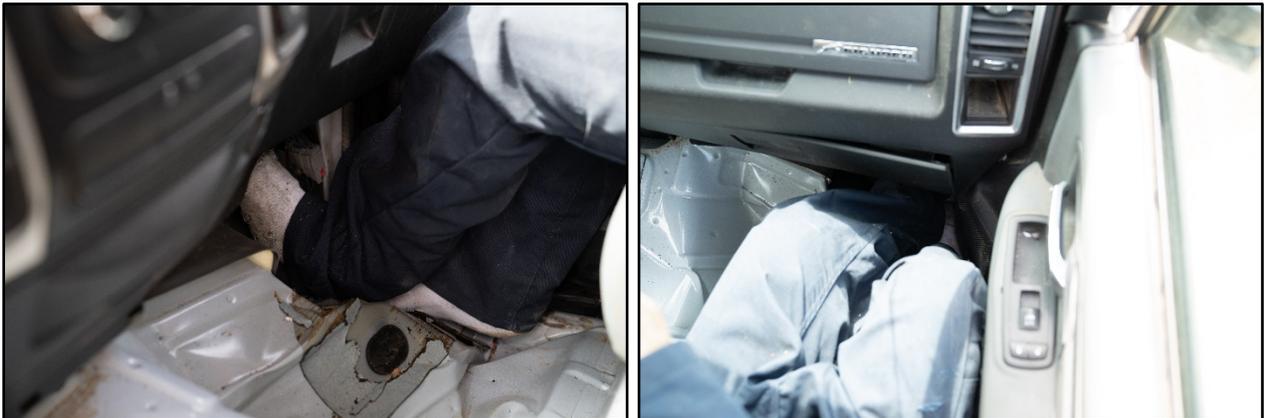
Figure 7.5 shows the damage sustained by the vehicle. The front bumper, hood, grill, radiator and support, right front fender, right frame rail, right upper and lower control arms, right front tire and rim, right front corner of the floor pan, right front door, right front and rear doors, right lower cab corner, right exterior bed, right rear rim, and rear bumper were damaged. The windshield sustained stress cracks radiating upward and inward from the right lower corner. No fuel tank damage was observed. Maximum exterior crush to the vehicle was 16.0 inches in the front and side planes at the right front corner at bumper height. Maximum occupant compartment deformation was 7.75 inches in the right front firewall/toe pan area. Figure 7.6 shows the interior

of the vehicle. Tables D.3 and D.4 in Appendix D.1 provide exterior crush and occupant compartment measurements.

**Figure 7.5. Test Vehicle after Test No. 613121-01-1.**

**Figure 7.6. Interior of Test Vehicle after Test No. 613121-01-1.**

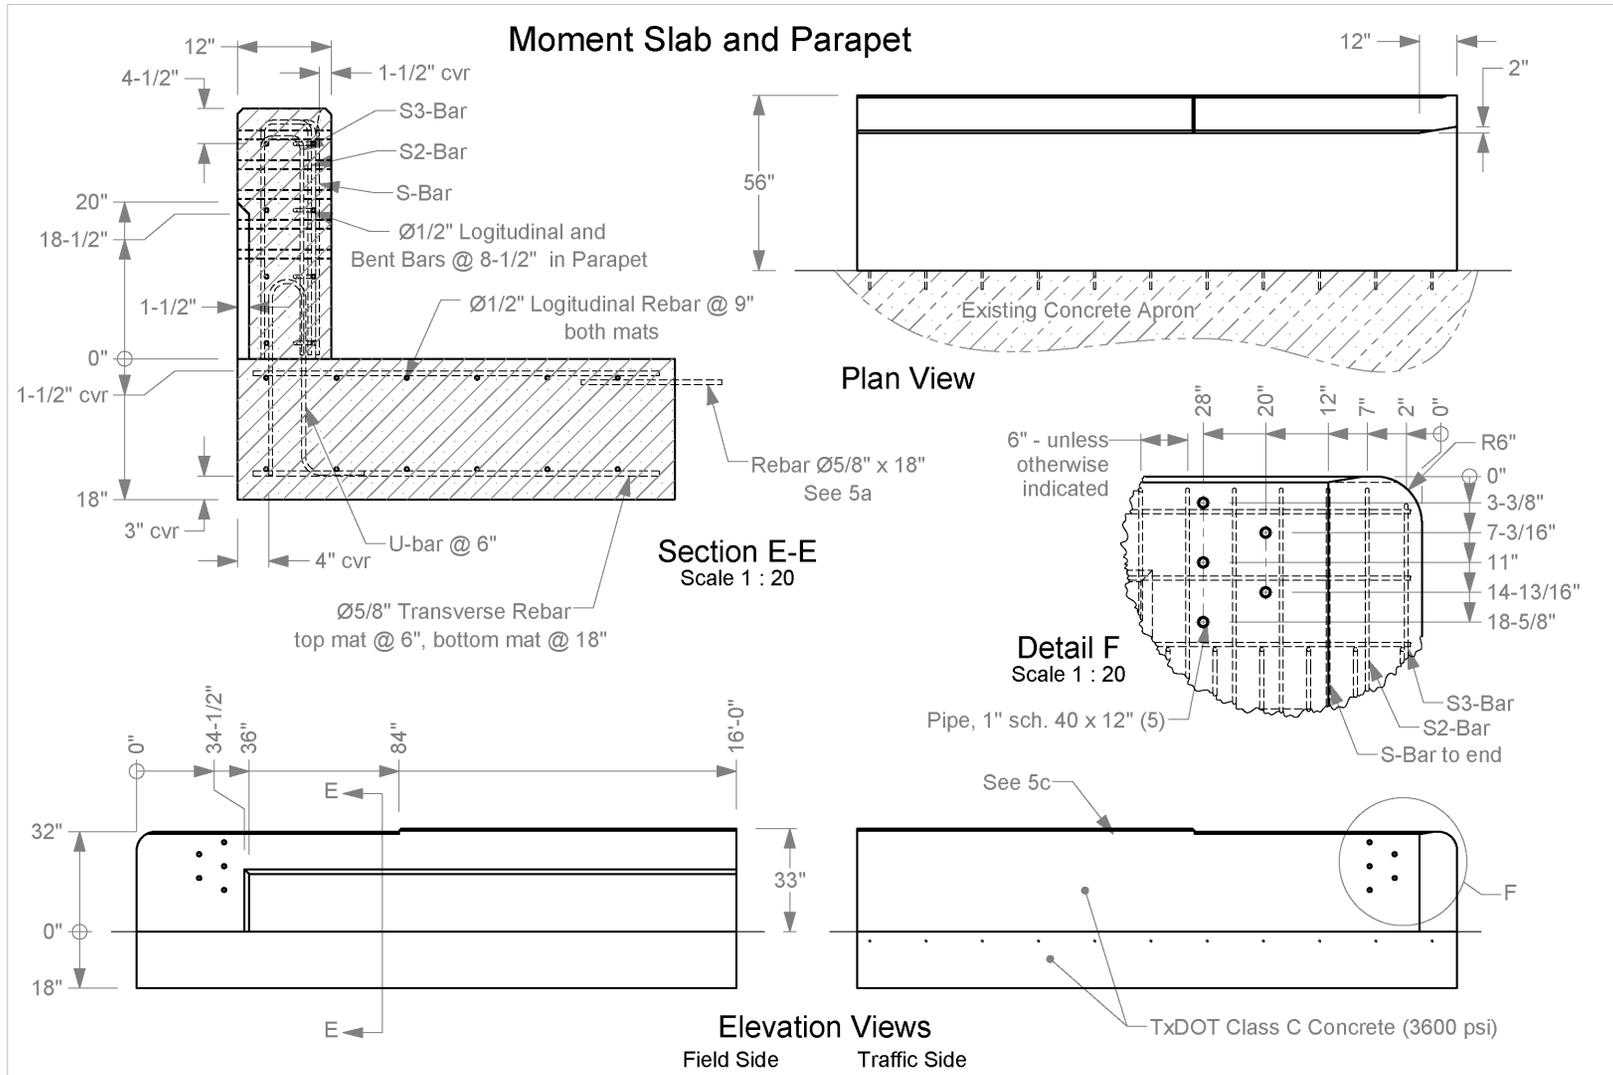
Roadside Safety and Physical Security Division - Proving Ground	
	Project #613121 TL-3 Transition	2021-04-01
Drawn by GES	Scale 1:50	Sheet 5 of 6 Moment Slab and Parapet

- 5a.** Secure in existing concrete apron with Hilti HIT-RE 500 V3 epoxy according to manufacturer's instructions, with 6" embedment at 18" spacing.
- 5b.** All rebar dimensions are to center unless otherwise indicated by "cvr" (cover).
- 5c.** 1" chamfer (3/4" each way) exposed edges of parapet as shown.
