**Test Report No. 613121-01-1**  
**Test Report Date: August 2021**

***MASH TEST 3-21 EVALUATION OF SHORT W-BEAM  
TRANSITION***

Sponsored by  
**Roadside Safety Research Program Pooled Fund**  
**Study No. TPF-5(114)**

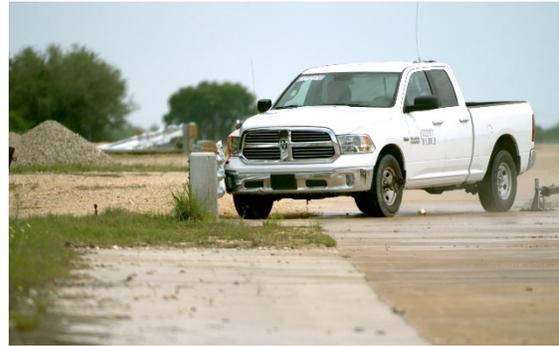
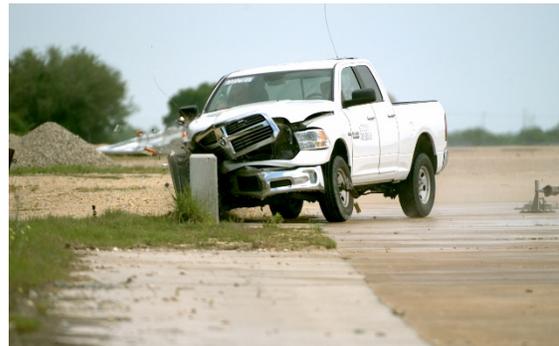
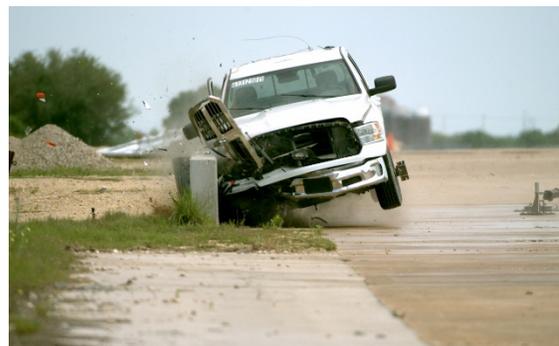
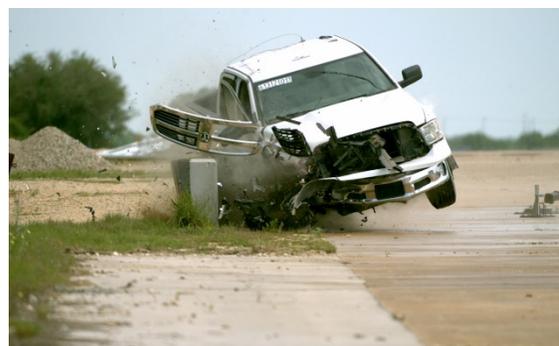
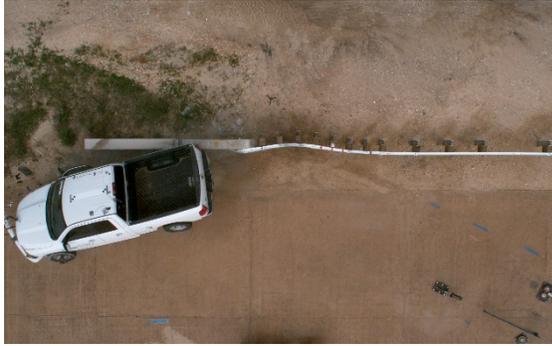
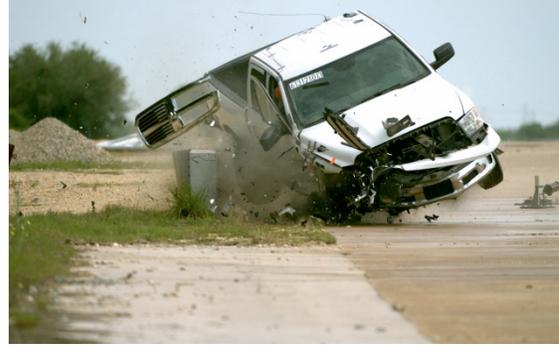
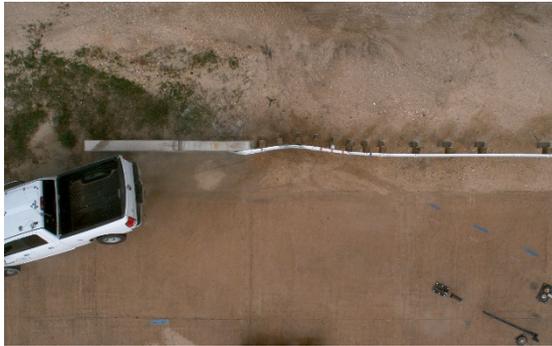
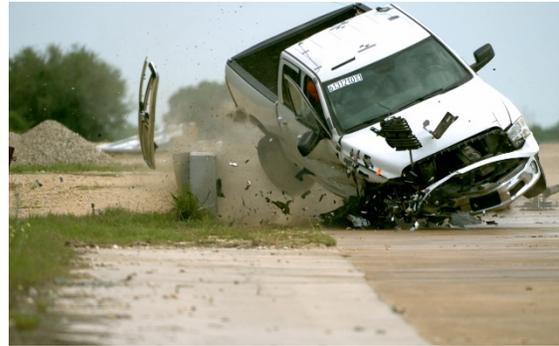
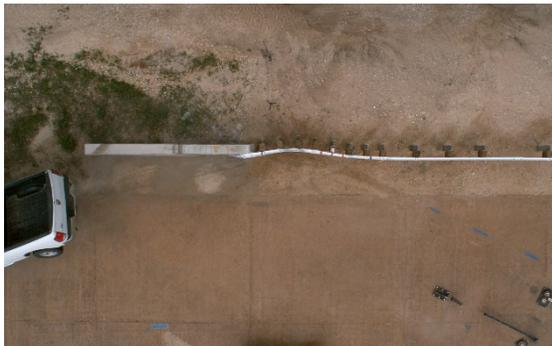
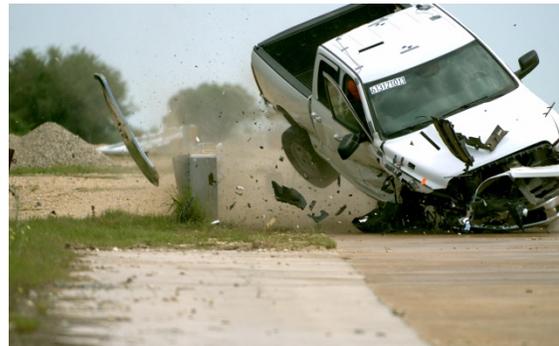
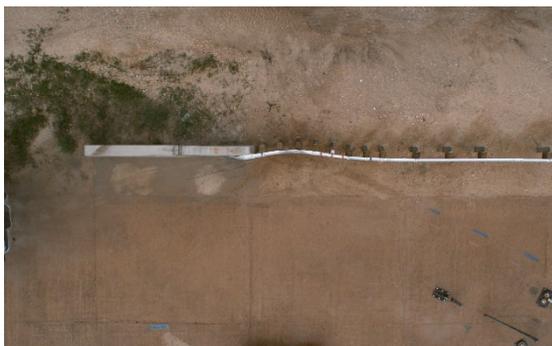
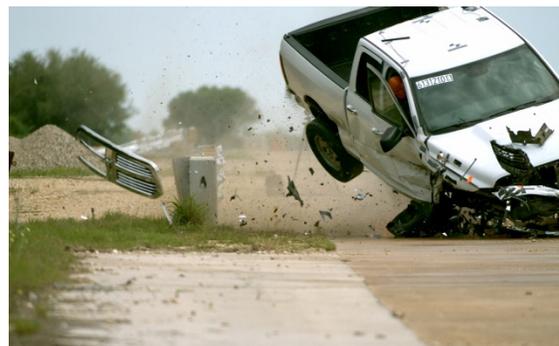
**Figure D.1. Sequential Photographs for Test No. 613121-01-1 (Overhead and Frontal Views).**

**Figure D.1. Sequential Photographs for Test No. 613121-01-1 (Overhead and Frontal Views) (Continued).**

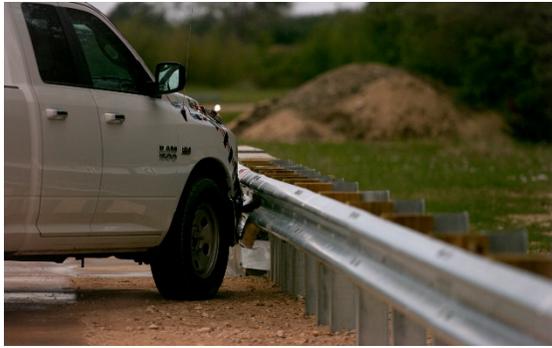
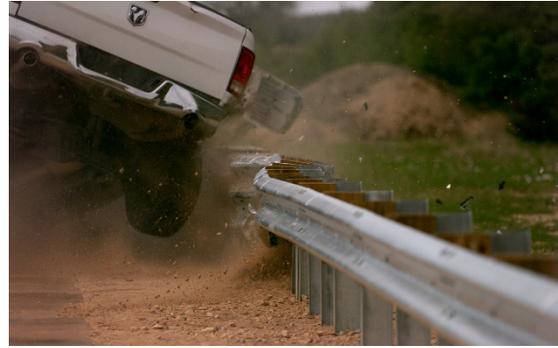
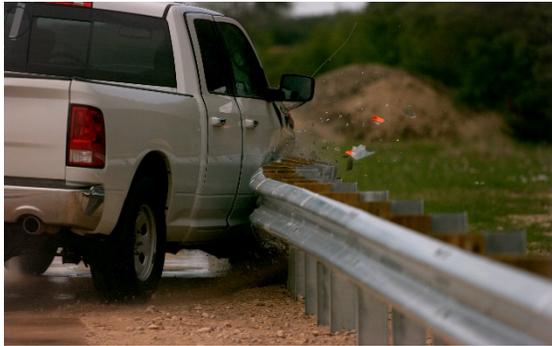
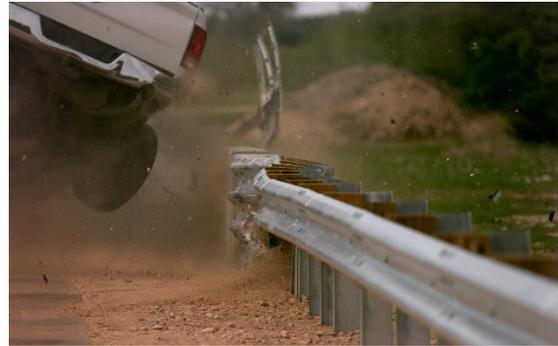
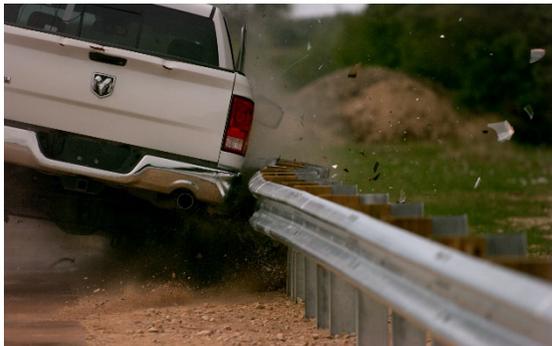
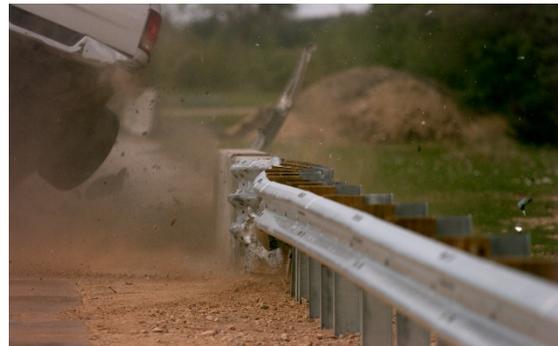
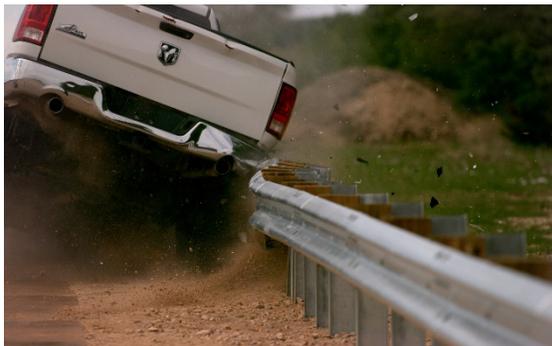
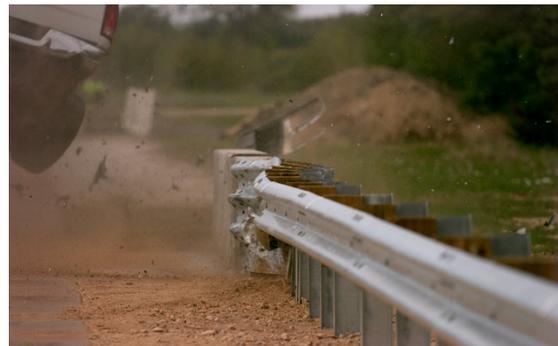
**Figure D.2. Sequential Photographs for Test No. 613121-01-1 (Rear View).**

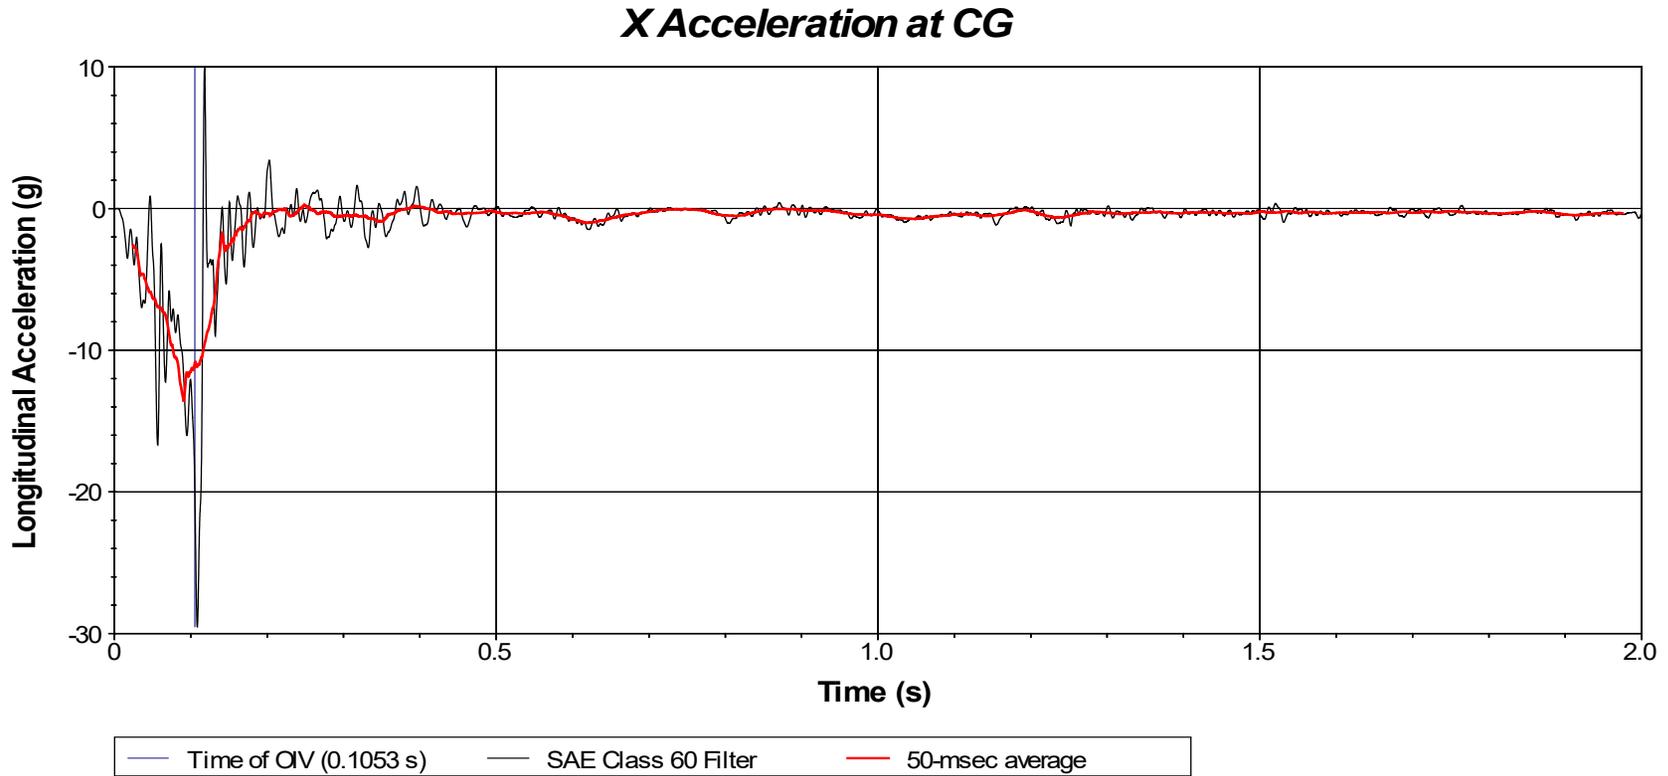
**Figure D.4. Vehicle Longitudinal Accelerometer Trace for Test No. 613121-01-1  
(Accelerometer Located at Center of Gravity).**

Test Number: 613121-01-1  
Test Standard Test Number: MASH Test 3-21  
Test Article: Short Transition  
Test Vehicle: 2016 RAM 1500 Pickup  
Inertial Mass: 5061 lb  
Gross Mass: 5226 lb  
Impact Speed: 62.6 mi/h  
Impact Angle: 25.4 degrees

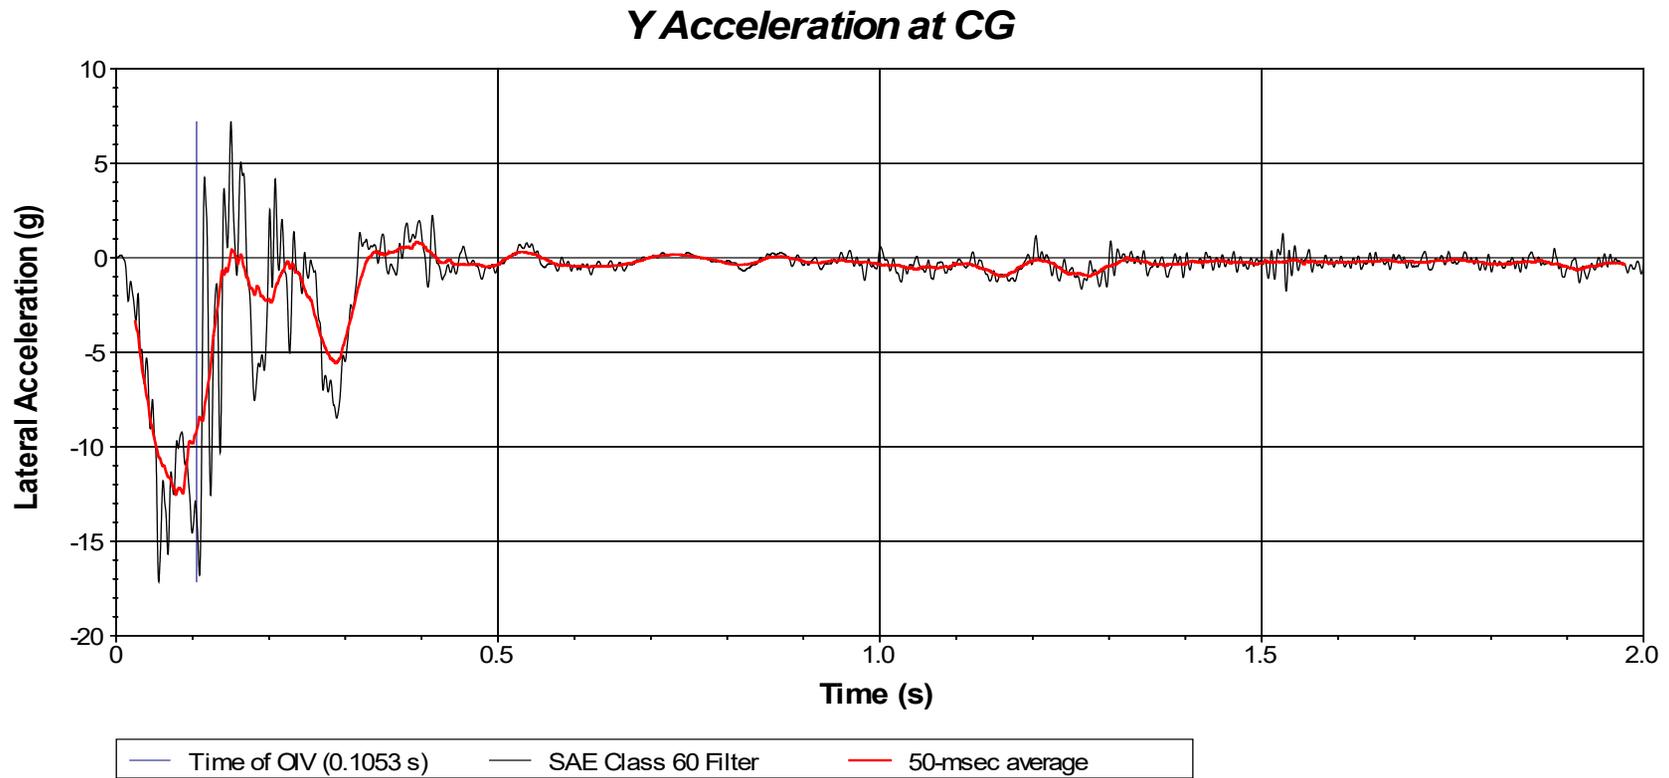
**Figure D.5. Vehicle Lateral Accelerometer Trace for Test No. 613121-01-1  
(Accelerometer Located at Center of Gravity).**

Test Number: 613121-01-1  
Test Standard Test Number: *MASH* Test 3-21  
Test Article: Short Transition  
Test Vehicle: 2016 RAM 1500 Pickup  
Inertial Mass: 5061 lb  
Gross Mass: 5226 lb  
Impact Speed: 62.6 mi/h  
Impact Angle: 25.4 degrees
