Test Report No. 613131-03-1 & 2

Test Report Date: January 2022

MASH TL-4 EVALUATION OF CONCRETE MEDIAN BARRIER WITH FENCE MOUNTED ON TOP

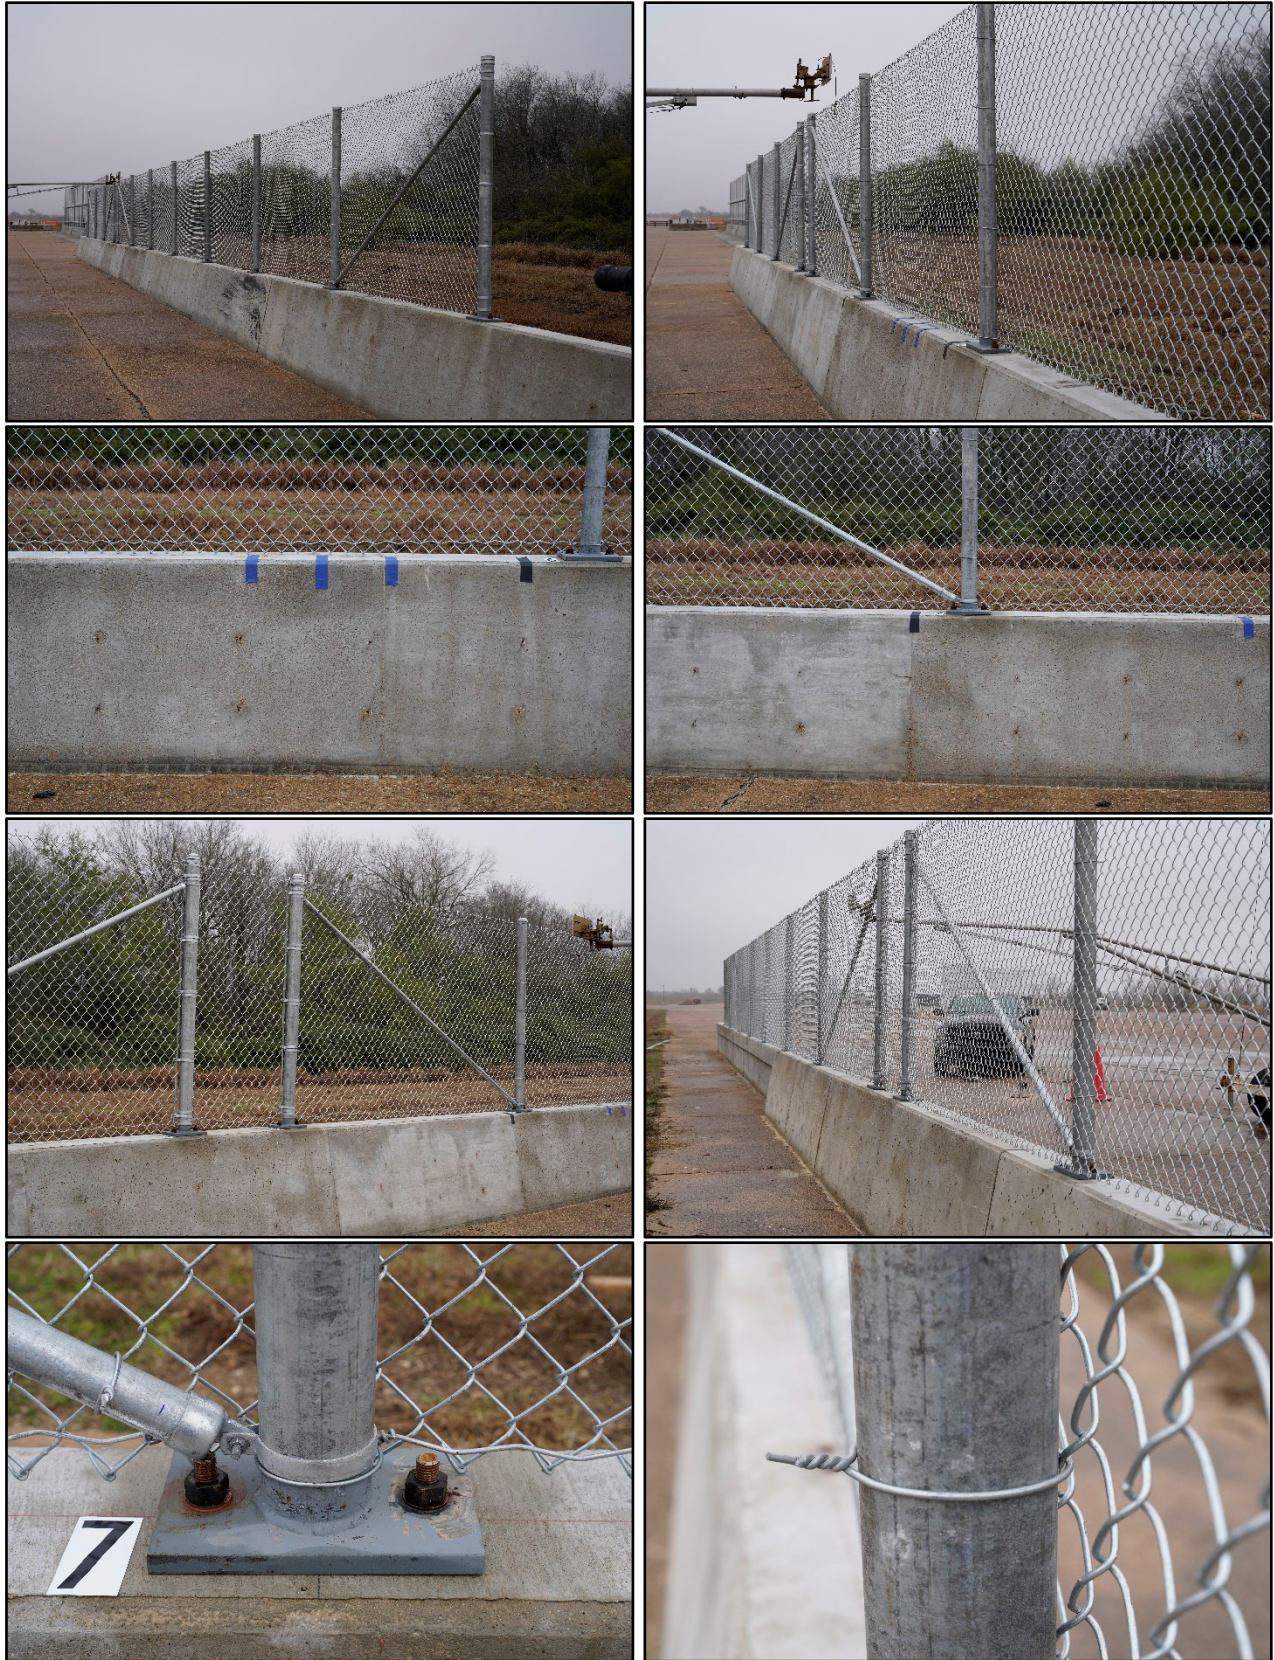
Figure 4.2. CMB with Fence Mounted on Top prior to Test No. 613131-01-1.

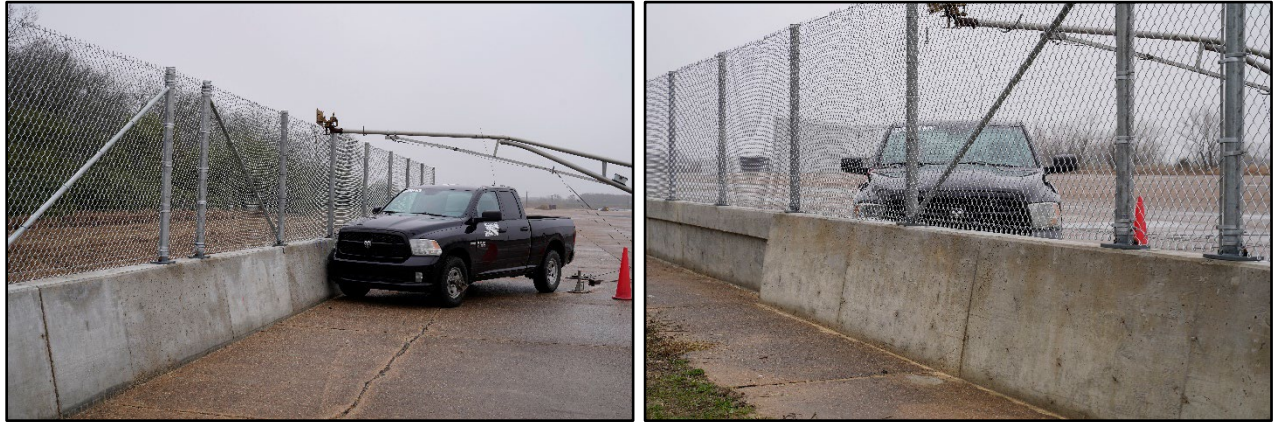
Figure 4.3. CMB/Test Vehicle Geometrics for Test No. 613131-03-1.

MASH Test 4-11 involves a 2270P vehicle weighing 5000 lb \pm 110 lb impacting the CIP of the longitudinal barrier at an impact speed of 62 mi/h \pm 2.5 mi/h and an angle of 25 degrees \pm 1.5 degrees. The CIP for *MASH* Test 4-11 on the CMB with fence mounted on top was 6.1 ft (73 inches) \pm 1 ft upstream of centerline of post 7 of the median barrier section. Figure 2.1 and Figure 4.3 depict the target impact setup.

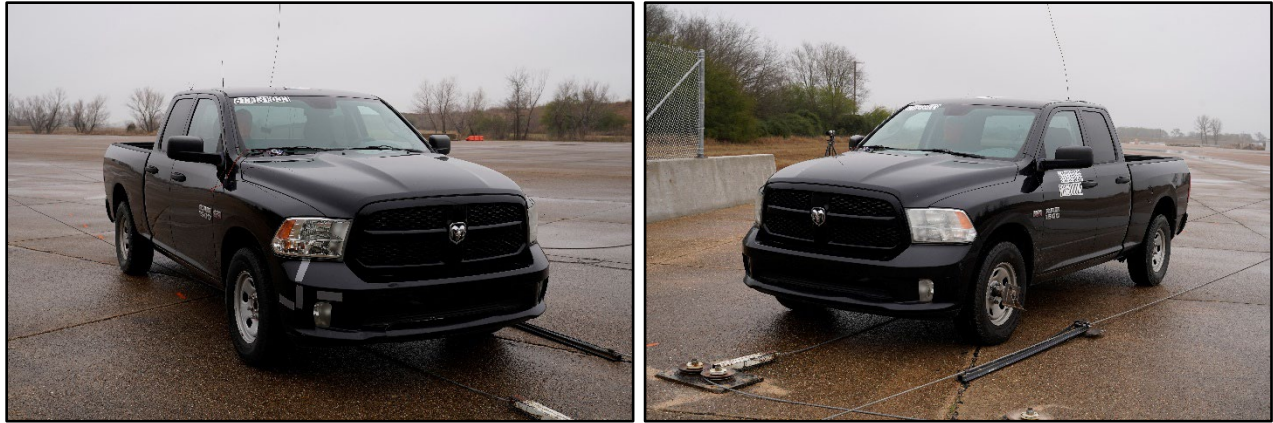
Figure 4.4. Test Vehicle before Test No. 613131-03-1.

Figure 4.4 shows the 2015 RAM 1500 pickup truck used for the crash test. The vehicle's test inertia weight was 5042 lb, and its gross static weight was 5207 lb. The height to the lower edge of the vehicle bumper was 11.75 inches, and height to the upper edge of the bumper was 27.0 inches. The height to the vehicle's center of gravity was 28.25 inches. Tables C.1 and C.2 in Appendix C.1 give additional dimensions and information on the vehicle. The vehicle was directed into the installation using a cable reverse tow and guidance system and was released to be freewheeling and unrestrained just prior to impact.

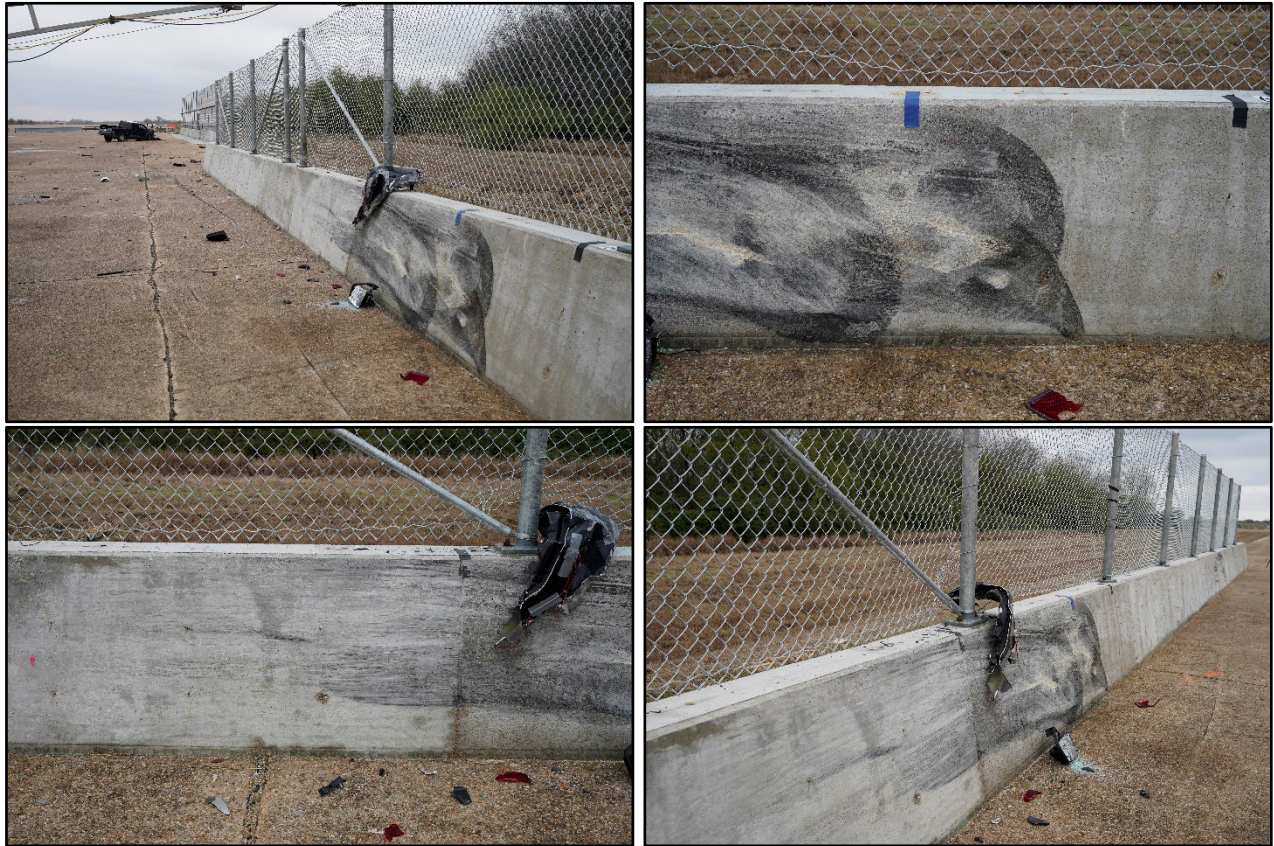
Figure 4.5. CMB after Test No. 613131-03-1.

Figure 4.5 shows the damage to the CMB with fence mounted on top. There was some scuffing and gouging on the concrete barrier at the impact site. The chain-link was deformed towards the field side of the installation near post 7. On the field side of the installation, a debris field of very small vehicle pieces measured 24.5 ft wide and 9 ft towards the field side. Working

width* was 30.2 inches, and height of working width was 42.5 inches. Maximum dynamic deflection during the test was 16.4 inches at the bottom of the chain link fence.

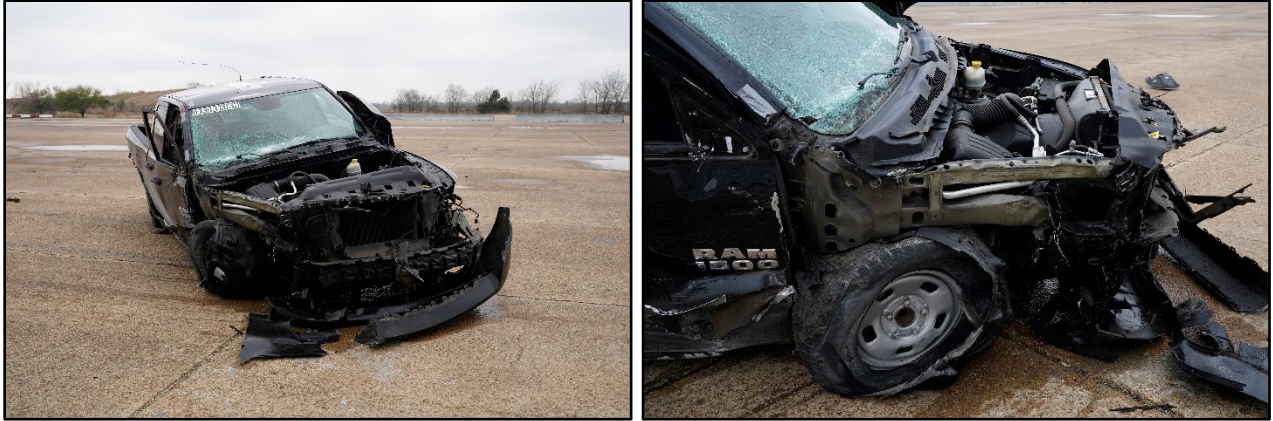
Figure 4.6. Test Vehicle after Test No. 613131-03-1.

Figure 4.6 shows the damage sustained by the vehicle. The front bumper, hood, grill, radiator and support, right front fender, right front tire and rim, right front upper and lower control arms, right front floor pan, right front door and window glass, right rear door, right rear cab corner, right rear exterior bed, rear bumper, and rear tail gate were damaged. The windshield was shattered along the lower edge near the hood, and there was a small hole in the right lower edge due to shear in the liner, not by penetration by the test article. No fuel tank damage was observed. Maximum exterior crush to the vehicle was 10.0 inches in the side plane at the right front corner at bumper height. Maximum occupant compartment deformation was 6.5 inches in the right kick panel/floor pan area. Figure 4.7 shows the interior of the vehicle. Tables C.3 and C.4 in Appendix C.1 provide exterior crush and occupant compartment measurements.

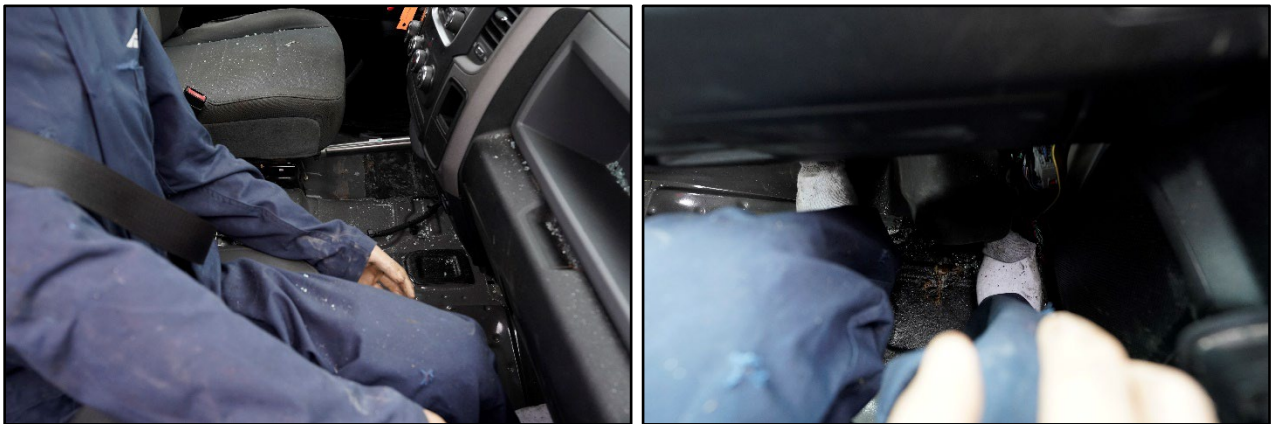
Figure 4.7. Interior of Test Vehicle after Test No. 613131-03-1.

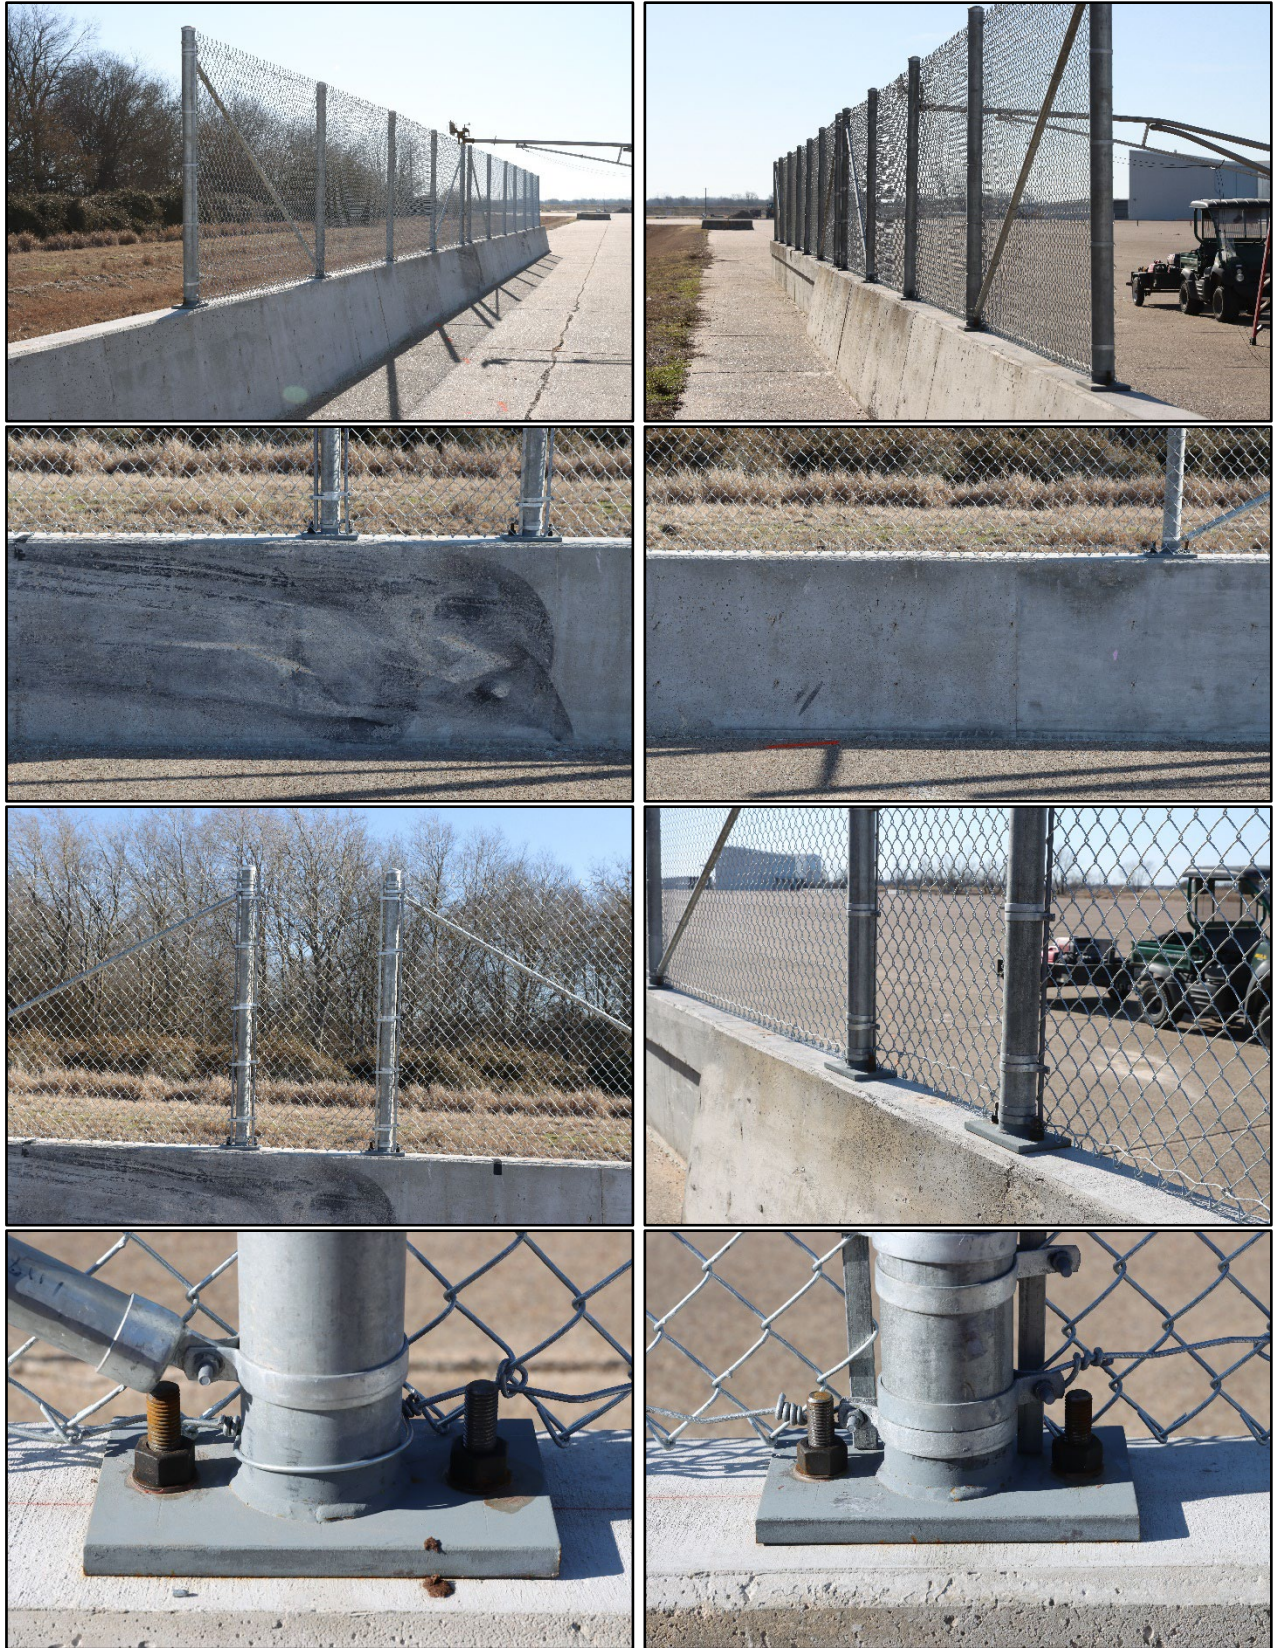
Figure 5.2. CMB with Fence Mounted on Top prior to Test No. 613131-01-2.

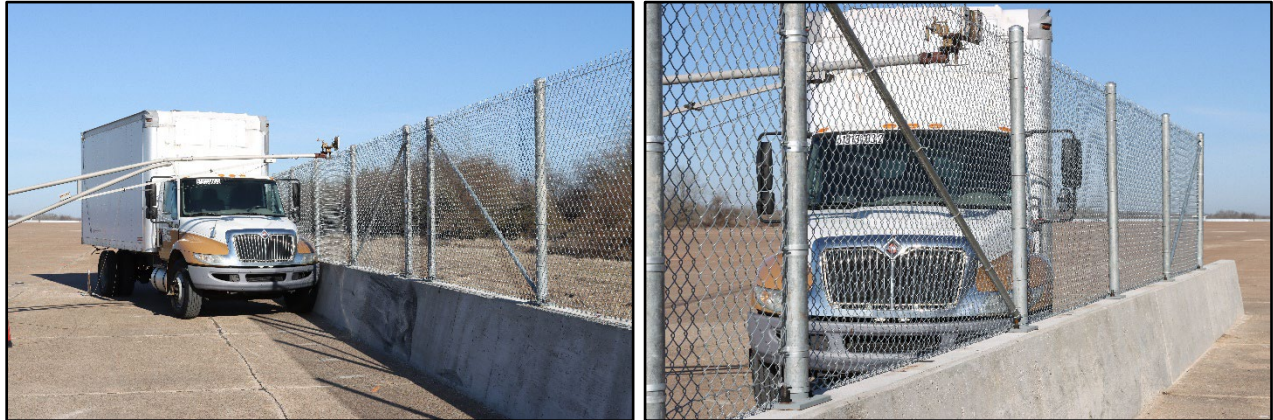
Figure 5.3. CMB/Test Vehicle Geometrics for Test No. 613131-03-2.

MASH Test 4-12 involves a 10000S vehicle weighing $22,000 \text{ lb} \pm 660 \text{ lb}$ impacting the CIP of the longitudinal barrier at an impact speed of $56 \text{ mi/h} \pm 2.5 \text{ mi/h}$ and an angle of $15 \text{ degrees} \pm 1.5 \text{ degrees}$. The CIP for *MASH* Test 4-12 on the CMB with fence mounted on top was $5 \text{ ft} \pm 1 \text{ ft}$ upstream of the centerline of post 4 of the median barrier section. Figure 2.1 and Figure 5.3 depict the target impact setup.

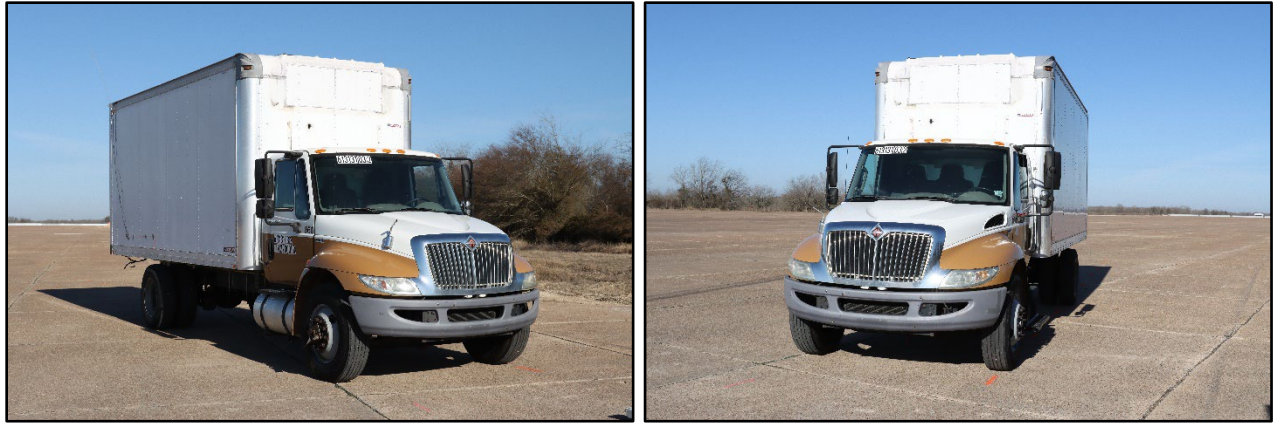
Figure 5.4. Test Vehicle before Test No. 613131-03-2.

Figure 5.4 shows the 2012 International 4300 single-unit truck used for the crash test. The vehicle's test inertia weight was 22,650 lb, and its gross static weight was 22,650 lb. The height to the lower edge of the vehicle bumper was 18.25 inches, and height to the upper edge of the bumper was 33.25 inches. The height to the center of gravity of the vehicle's ballast was 61.75 inches. Table E.1 in Appendix E.1 gives additional dimensions and information on the vehicle. The vehicle was directed into the installation using a cable reverse tow and guidance system and was released to be freewheeling and unrestrained just prior to impact.

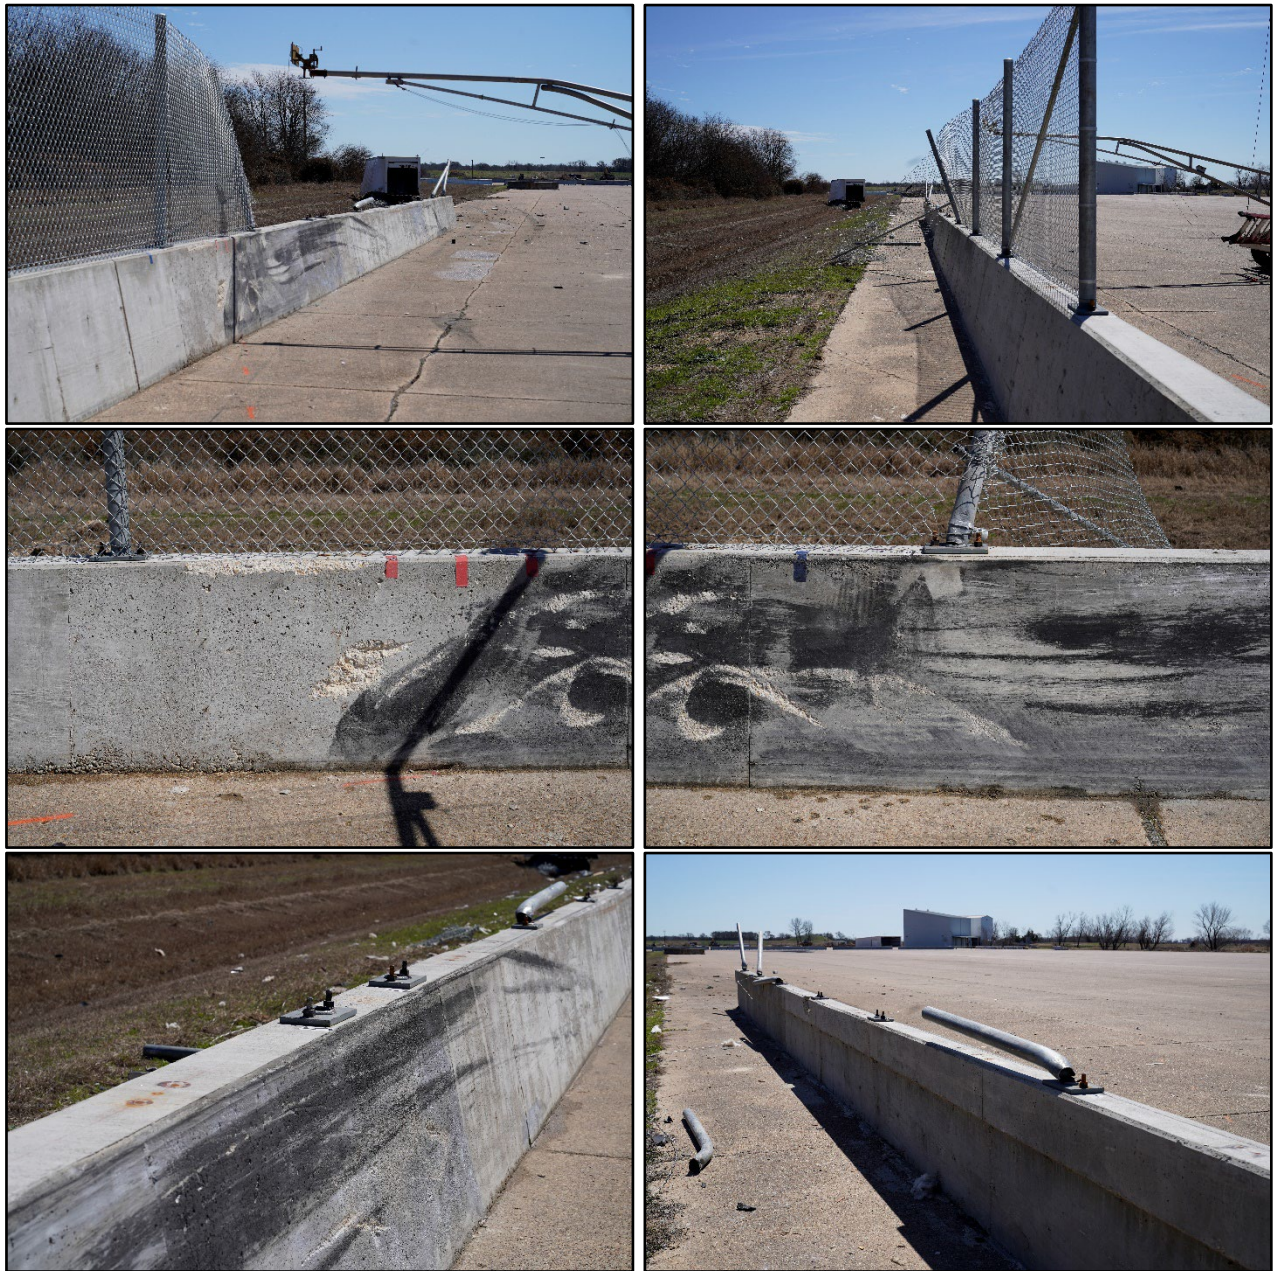
Figure 5.5. CMB after Test No. 613131-03-2.

Figure 5.5 and Figure 5.6 show the damage to the CMB with fence mounted on top. There was some scuffing and gouging present on the concrete barriers. Post 4 was leaning 23 degrees towards the field side and slightly downstream. The post was also torn at the base plate. Posts 5, 6, 8, and 9 were completely sheared off at the base plate. Posts 7, 10, and 11 were torn at the base plate, but remained attached. Post 12 was leaning 58 degrees downstream and was deformed near its baseplate. Parts of the posts and fence landed 9 ft toward the field side of the barrier, and the remainder of the fence beyond post 4 was dragged by the vehicle until the

vehicle came to rest. Working width* was 76.6 inches, and height of working width was 143.5 inches. There was no permanent deformation in the barrier. Maximum dynamic deflection during the test was unobtainable due to camera view concealment.

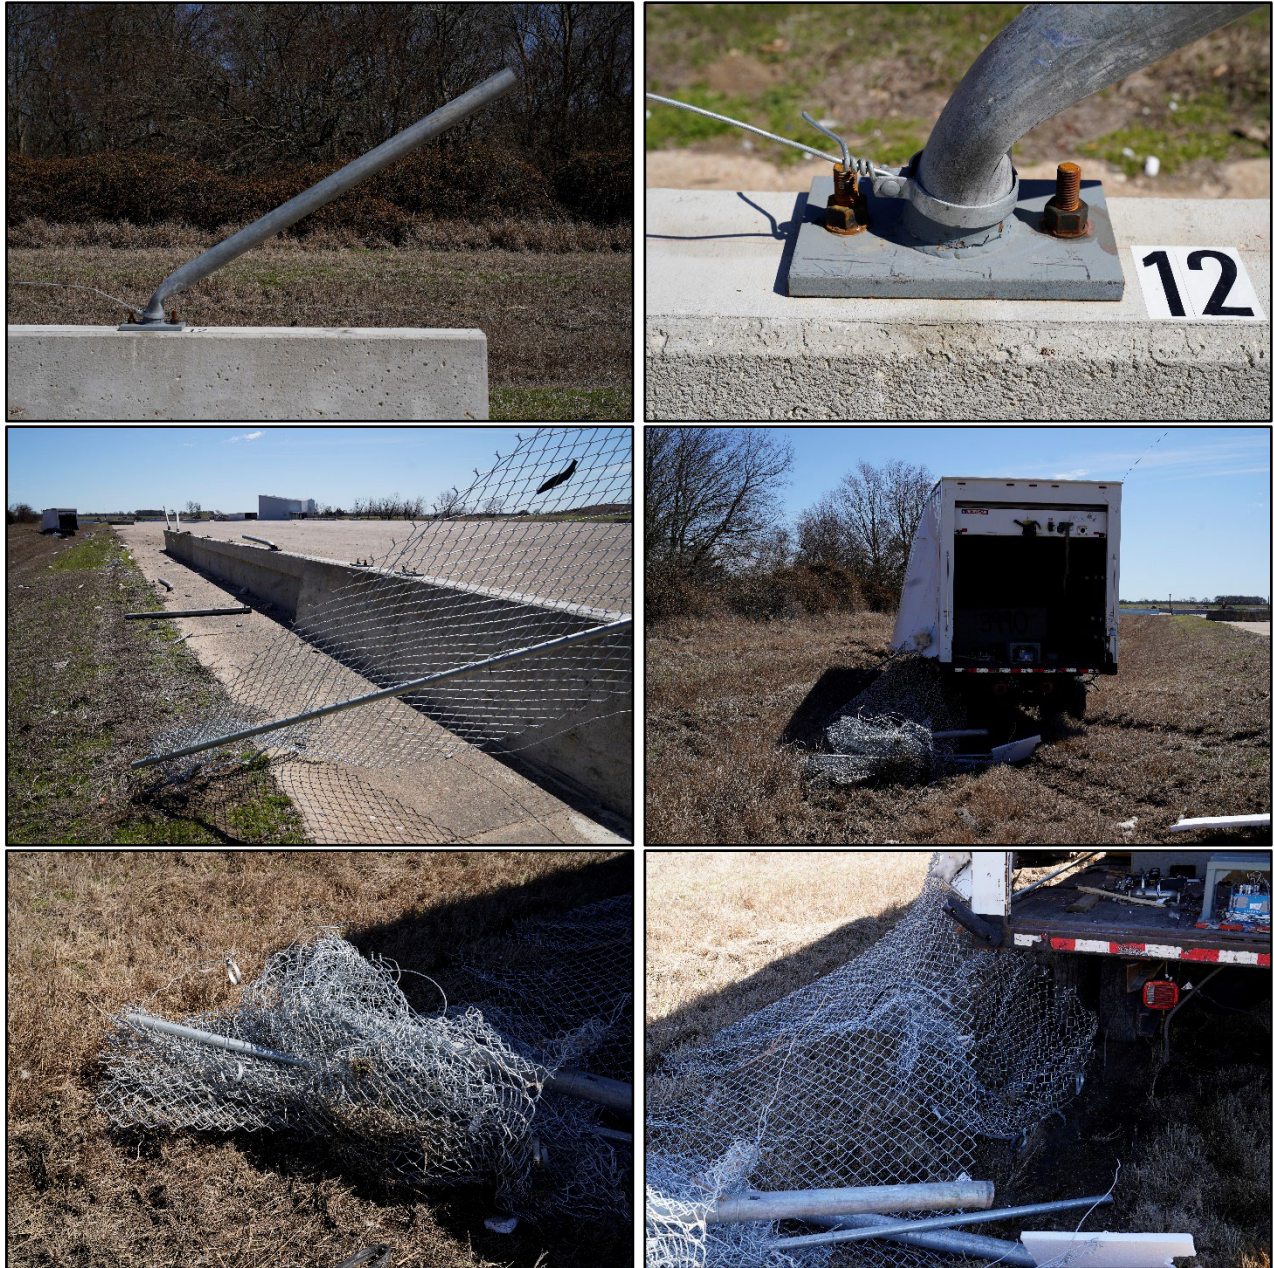
Figure 5.7. Post 12 and Separated Chain Link Fence after Test No. 613131-03-2.

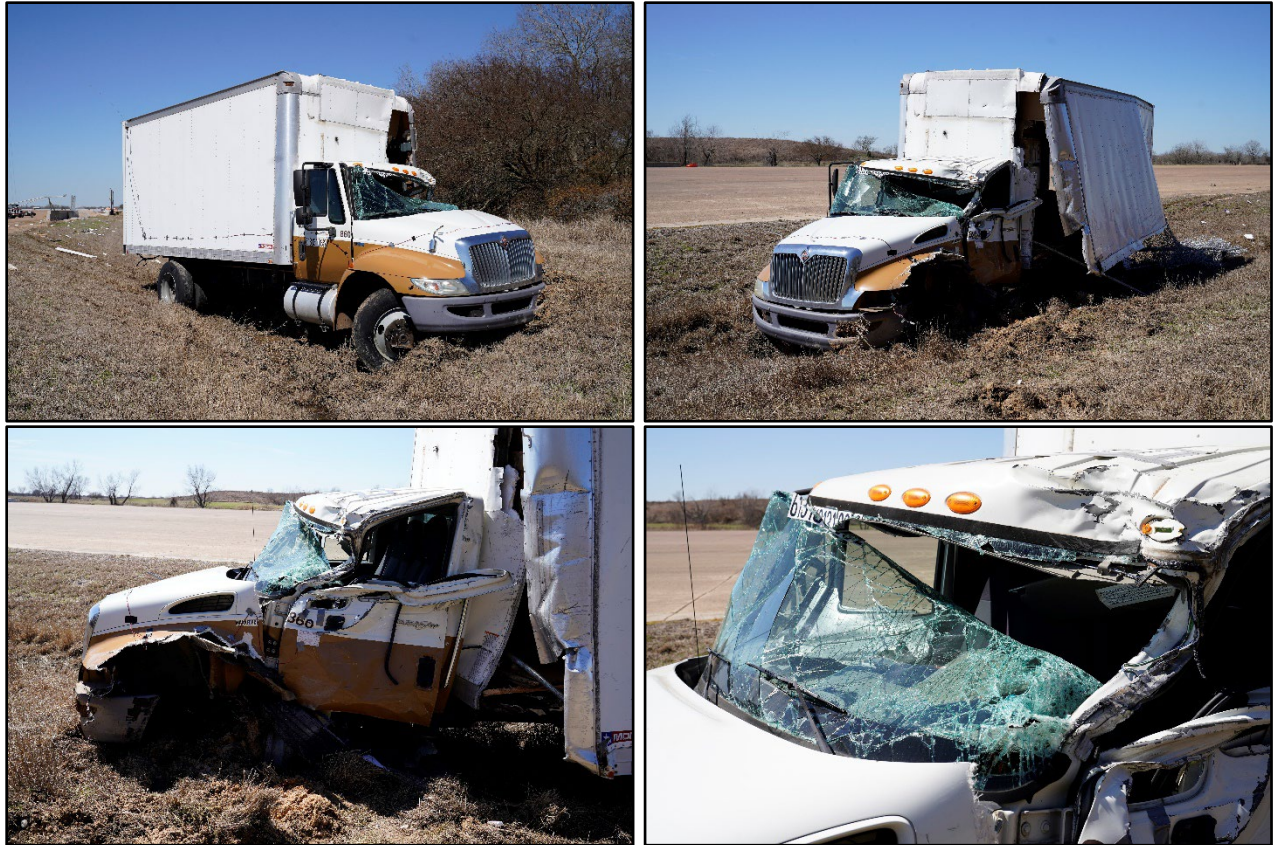
Figure 5.8. Test Vehicle after Test No. 613131-03-2.

Figure 5.8 shows the damage sustained by the vehicle. The front bumper, hood, left front tire and rim, left front A-pillar, roof, left door and window glass, left front floor pan, left battery box, left side of the cargo box, and left rear outer tire and rim were damaged. No damage to the fuel tank was observed. Maximum exterior crush to the vehicle was 10.0 inches in the left front corner at bumper height. Maximum occupant compartment deformation was 10.0 inches at the midpoint of the collapsed left A-pillar. The windshield sustained heavy damage, with cracks and tears, and was pulled from its mounting. Figure 5.9 shows the interior of the vehicle.

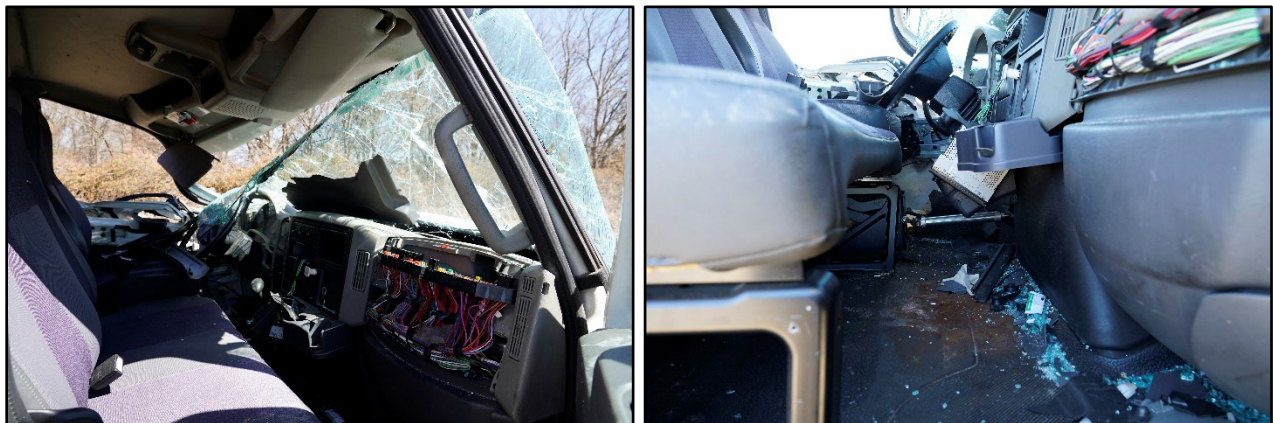
Figure 5.9. Interior of Test Vehicle after Test No. 613131-03-2.
