Test Report No. 615131-01

Development of Thrie-Beam Retrofit for Upgrading Obsolete Bridge Rails

Test Nos.: 615131-01-1 / 615131-01-2

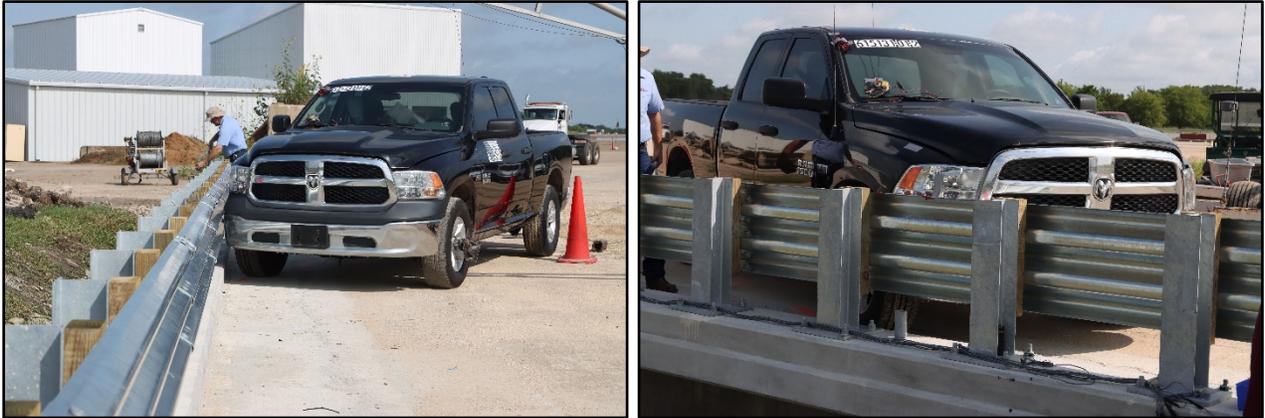
Figure 5.1. Bridge Rail Retrofit/Test Vehicle Geometrics for Test No. 612131-01-2.

MASH Test 3-11 involves a 2270P vehicle weighing 5000 lb \pm 110 lb impacting the CIP of the longitudinal barrier at an impact speed of 62 mi/h \pm 2.5 mi/h and an angle of 25 degrees \pm 1.5 degrees. The CIP for MASH Test 3-11 on the Thrie Beam Bridge Rail Retrofit was 8.0 ft \pm 1 ft upstream of centerline of post 16. Figure 3.1 and Figure 5.1 depict the target impact setup.

The 2270P vehicle weighed 5021 lb, and the actual impact speed and angle were 62.0 mi/h and 25.1 degrees. The actual impact point was 8.2 ft upstream of centerline of post 16. Minimum target impact severity (IS) was 106 kip-ft, and actual IS was 116 kip-ft.

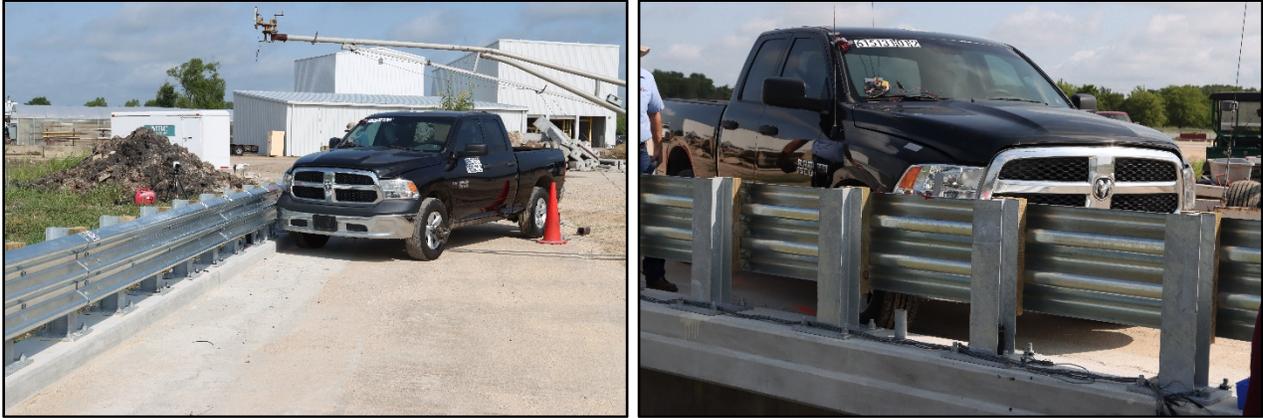
Figure 5.2. Test Vehicle before Test No. 612131-01-2.

Figure 5.2 shows the 2018 RAM 1500 pickup truck used for the crash test. The vehicle's test inertia weight was 5021 lb, and its gross static weight was 5186 lb. The height to the lower edge of the vehicle bumper was 11.75 inches, and height to the upper edge of the bumper was 27.0 inches. The height to the vehicle's center of gravity was 28.5 inches. Tables D.1 and D.2 in Appendix D.1 give additional dimensions and information on the vehicle. The vehicle was directed into the installation using a cable reverse tow and guidance system, and was released to be freewheeling and unrestrained just prior to impact.

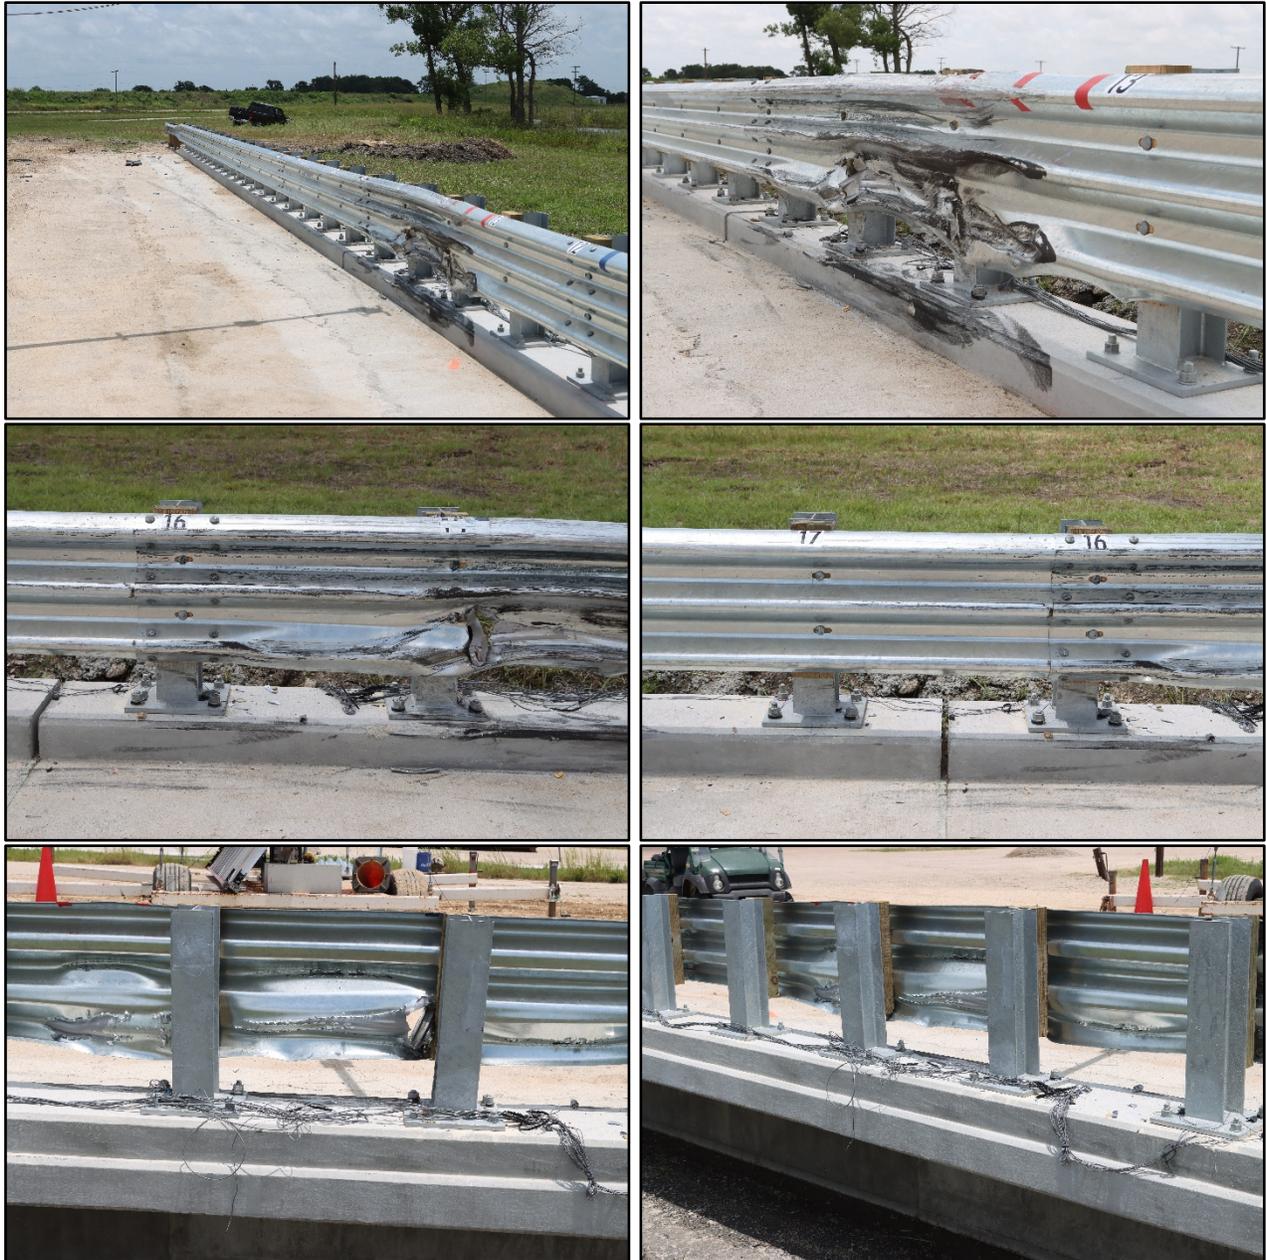
Figure 5.3. Bridge Rail Retrofit after Test No. 612131-01-2.

Figure 5.3 shows the damage to the Thrie Beam Bridge Rail Retrofit. There was scuffing and gouging of the rail and curb at impact and for the duration of contact. The rail tore at post 15 and a piece of the vehicle's tire rim was embedded in the rail. There were cracks in the curb extending from the upstream edge of post 15 to the midspan between posts 14 and 15, and from the upstream edge of post 14 to the midspan between posts 13 and 14. There was also a crack at post 13, and the deck was cracked from the field joint extending upstream to post 14. The lower

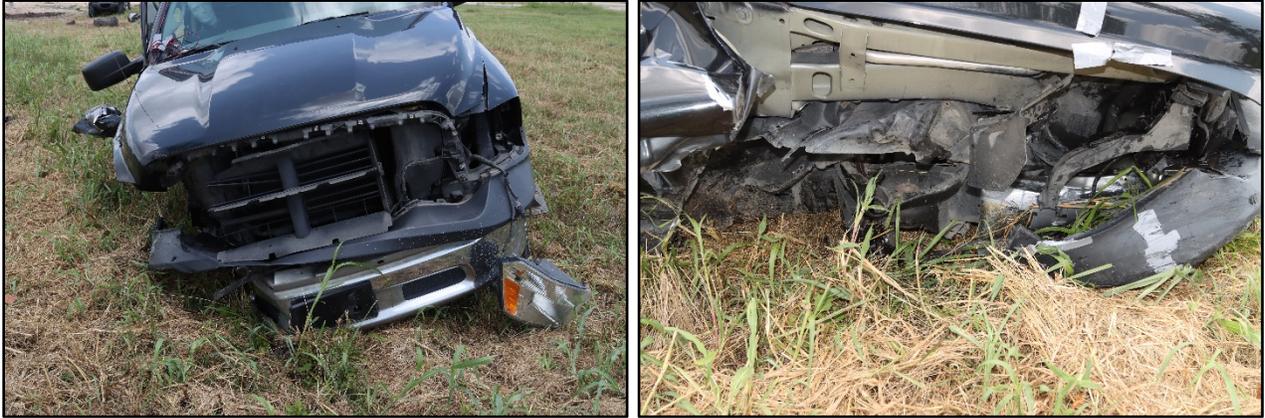
Figure 5.4. Test Vehicle after Test No. 612131-01-2.

Figure 5.4 shows the damage sustained by the vehicle. The front bumper, hood, grill, right front fender, right upper and lower control arms, right frame rail, right front tire and rim, right front floor pan, right front door, right rear door, right rear cab corner, right rear exterior bed, and rear bumper were damaged. The windshield sustained cracks radiating upward and inward from the right lower corner. No fuel tank damage was observed. Maximum exterior crush to the vehicle was 15.0 inches in the side plane at the right front corner at bumper height. Maximum occupant compartment deformation was 3.5 inches in the right kick panel area. Figure 5.5 shows the interior of the vehicle. Tables D.3 and D.4 in Appendix D.1 provide exterior crush and occupant compartment measurements.

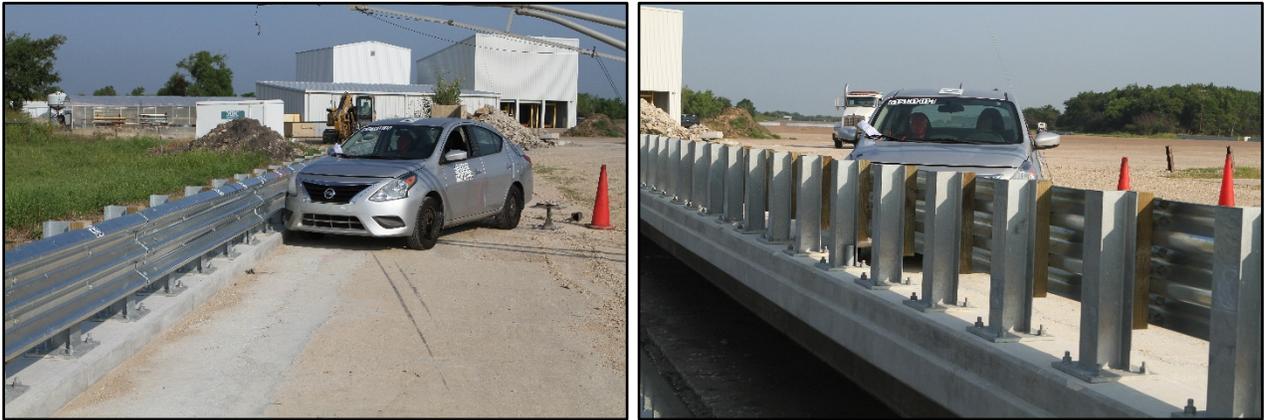
Figure 6.1. Bridge Rail Retrofit/Test Vehicle Geometrics for Test No. 615131-01-1.

MASH Test 3-10 involves a 1100C vehicle weighing $2420 \text{ lb} \pm 55 \text{ lb}$ impacting the CIP of the longitudinal barrier at an impact speed of $62 \text{ mi/h} \pm 2.5 \text{ mi/h}$ and an angle of $25 \text{ degrees} \pm 1.5 \text{ degrees}$. The CIP for MASH Test 3-10 on the Thrie Beam Bridge Rail Retrofit was $3.6 \text{ ft} \pm 1 \text{ ft}$ upstream of the centerline of post 28. Figure 3.1 and Figure 6.1 depict the target impact setup.

The 1100C vehicle weighed 2451 lb, and the actual impact speed and angle were 62.1 mi/h and 24.3 degrees . The actual impact point was 3.2 ft upstream of the centerline of post 28. Minimum target IS was 51 kip-ft, and actual IS was 54 kip-ft.

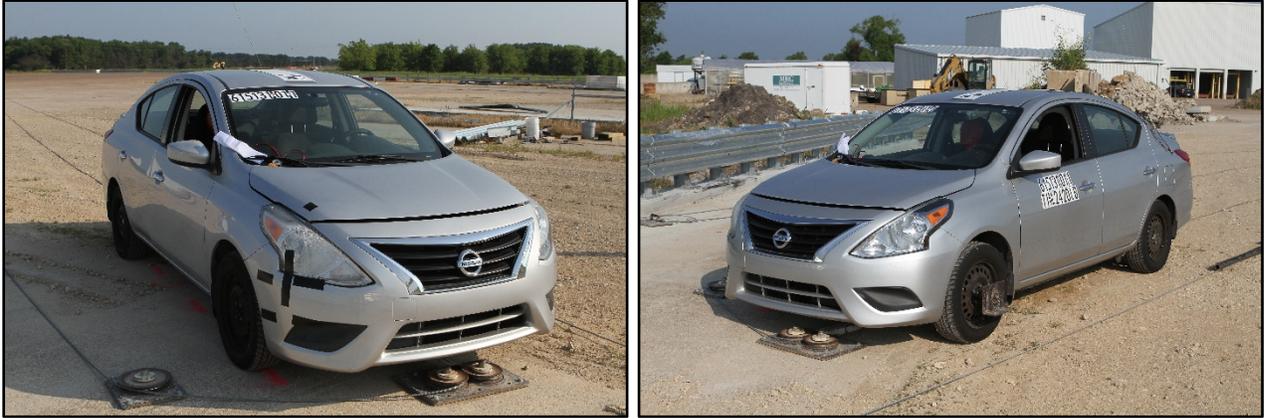
Figure 6.2. Test Vehicle before Test No. 615131-01-1.

Figure 6.2 shows the 2015 Nissan Versa used for the crash test. The vehicle's test inertia weight was 2451 lb, and its gross static weight was 2616 lb. The height to the lower edge of the vehicle bumper was 7.0 inches, and the height to the upper edge of the bumper was 22.25 inches. Table E.1 in Appendix E.1 gives additional dimensions and information on the vehicle. The vehicle was directed into the installation using a cable reverse tow and guidance system, and was released to be freewheeling and unrestrained just prior to impact.

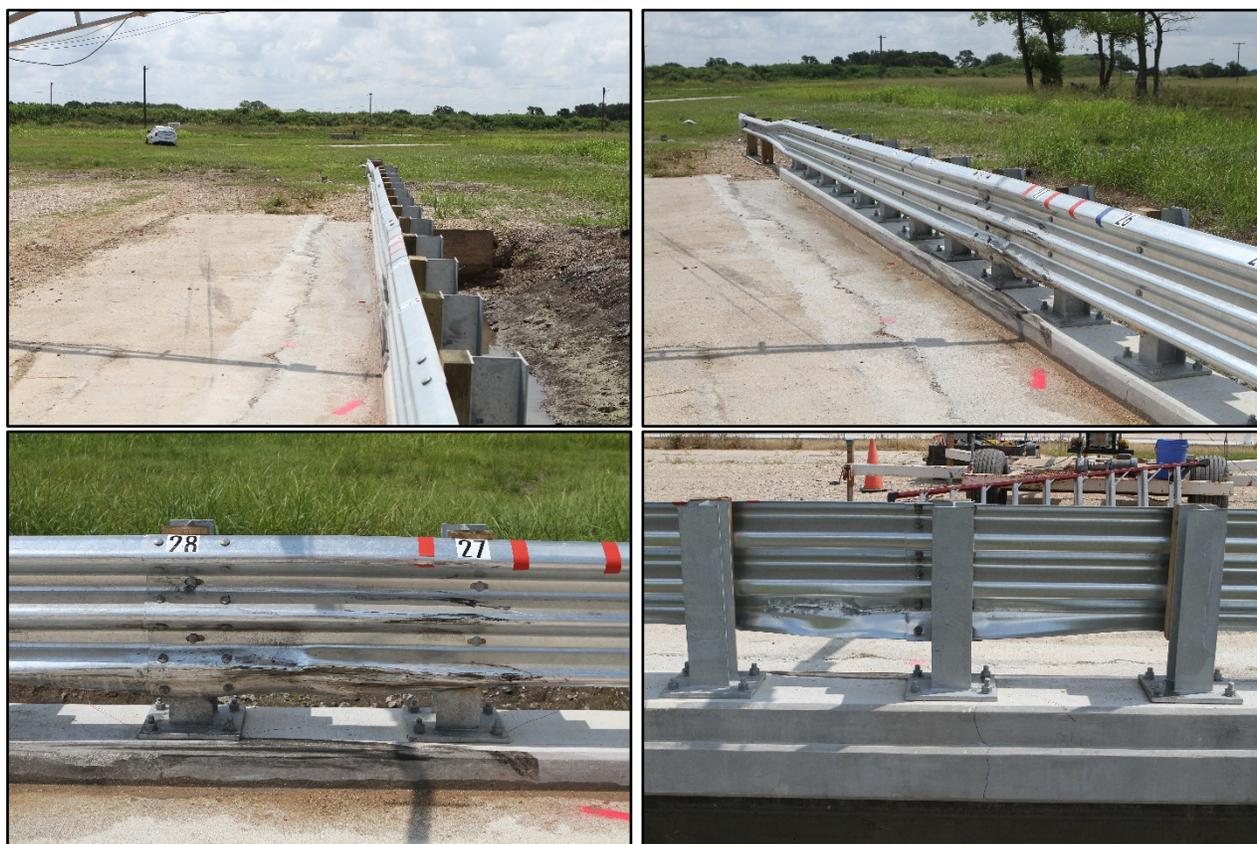
Figure 6.3. Bridge Rail Retrofit after Test No. 615131-01-1.

Figure 6.3 shows the damage to the bridge rail retrofit. There was scuffing and gouging of the rail and curb at impact and for the duration of contact. The lower rib of the thrie-beam was deformed, and the blockout at post 27 was damaged. The curb had some spalling, and there were cracks at posts 27 and 28. Cracks in the curb pre-impact were outlined in blue, and cracks that

occurred post-impact were outlined in red. Working width* was 19.5 inches, and height of working width was 34.0 inches. Maximum dynamic deflection during the test was 2.2 inches, and maximum permanent deformation was 0.9 inch.

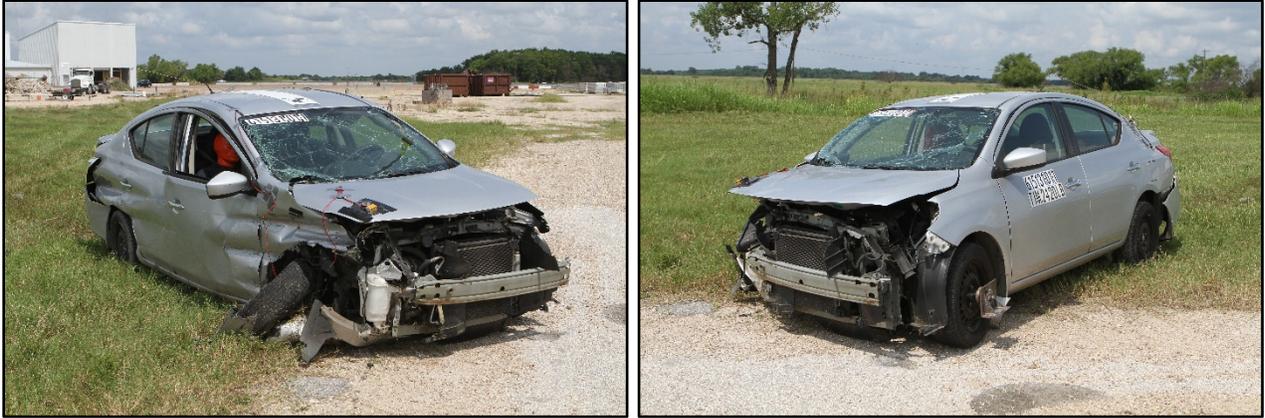
Figure 6.4. Test Vehicle after Test No. 615131-01-1.

Figure 6.4 shows the damage sustained by the vehicle. The front bumper, hood, grill, radiator and support, right front fender, right front tire and rim, right front strut and tower, right inner CV joint, right front floor pan, right front door and window glass, right rear door, right rear rim, right rear quarter panel, and rear bumper were damaged. The windshield sustained cracks radiating upward and inward from the right lower corner. No fuel tank damage was observed. Maximum exterior crush to the vehicle was 10.0 inches in the front plane at the right front corner at bumper height. Maximum occupant compartment deformation was 1.5 inches in the right front floor pan. Figure 6.5 shows the interior of the vehicle. Tables E.2 and E.3 in Appendix E.1 provide exterior crush and occupant compartment measurements.
