Test Report No. 616391-01

**DESIGN AND *MASH* EVALUATION OF TRANSITION BETWEEN  
GUARDRAIL TO ANCHORED PORTABLE CONCRETE BARRIER**

Sponsored by  
**Washington State Department of Transportation (WsDOT)**

**TEXAS A&M TRANSPORTATION INSTITUTE PROVING GROUND**

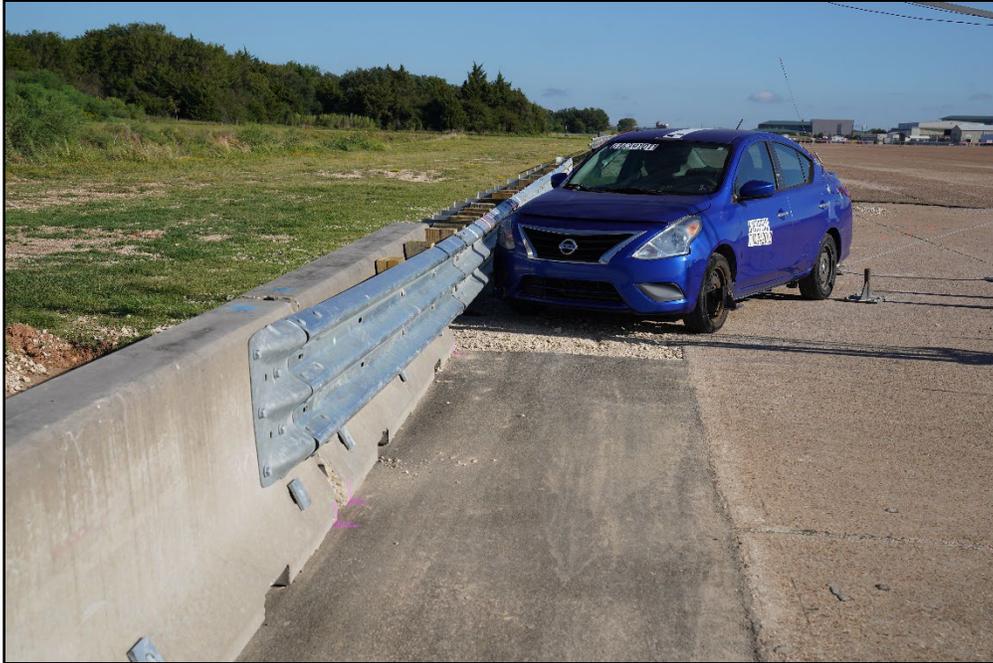
**Figure 6.1. Transition/Test Vehicle Geometrics for Test 616391-01-1.**

See Table 6.1 for details on *MASH* impact conditions for this test and Table 6.2 for the exit parameters. Figure 6.1 and Figure 6.2 depict the target impact setup.

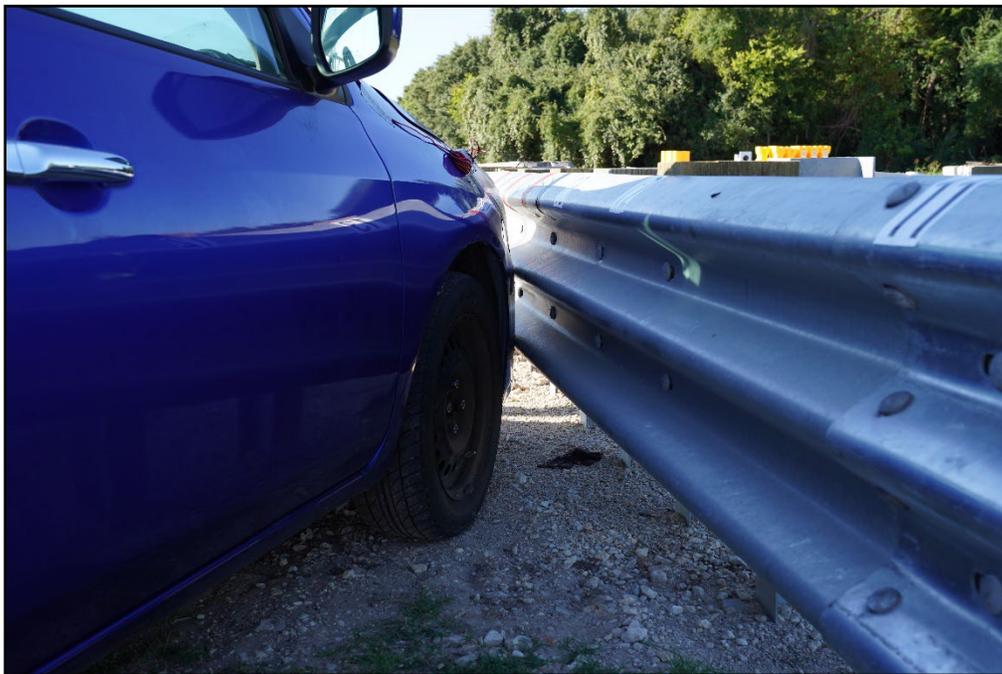
**Figure 6.2. Transition/Test Vehicle Impact Location 616391-01-1.**

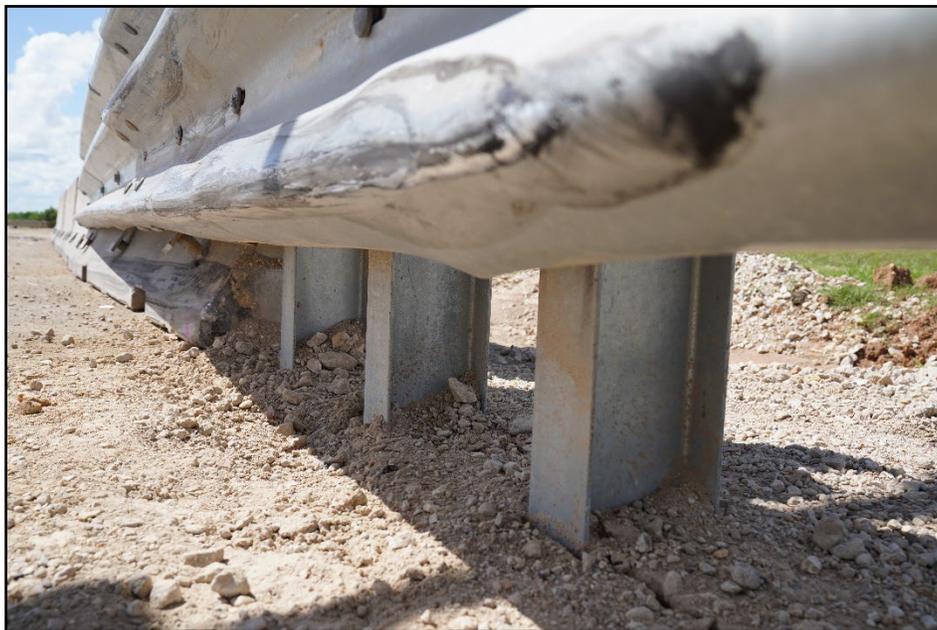
**Figure 6.6. Transition after Test at Grade Near the Impact Point 616391-01-1.**

The rail was scuffed at the impact location and along the length of the contact. The upstream end of the barrier was pushed back 4 inches. Table 6.7 and Table 6.6 describe the damage to the Transition. Figure 6.5 through Figure 6.13 show the damage to the Transition.

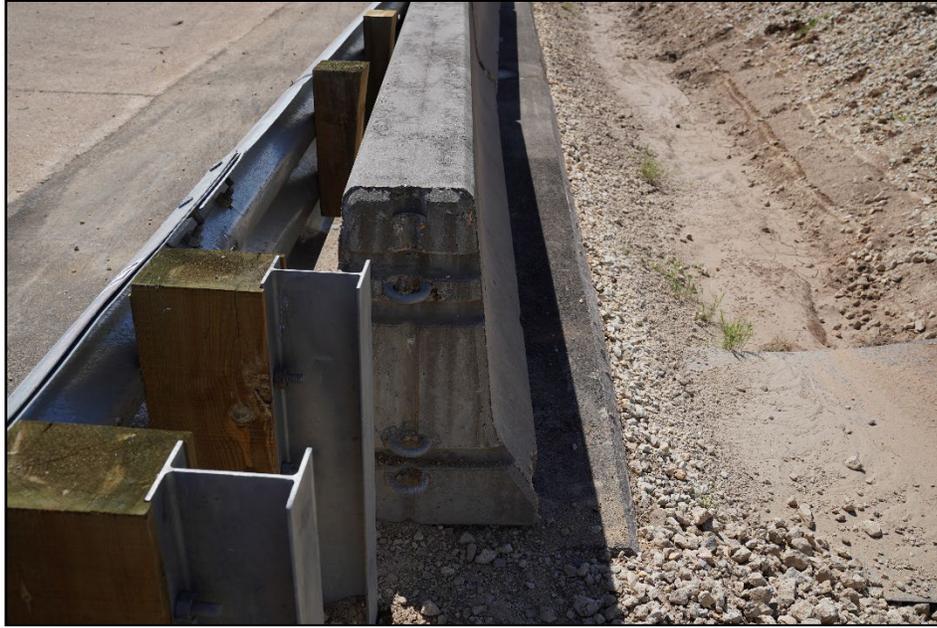
**Figure 6.7. Transition after Test In-line with Portable Concrete Barrier 616391-01-1.**

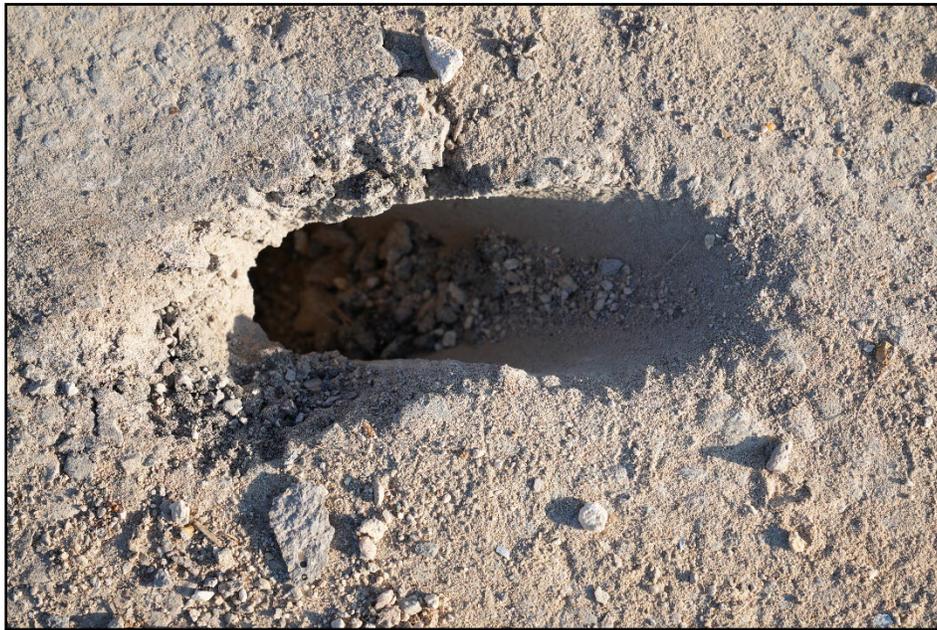
**Figure 6.8. Asphalt Damage at the Upstream Anchor Pin Location 616391-01-1.**

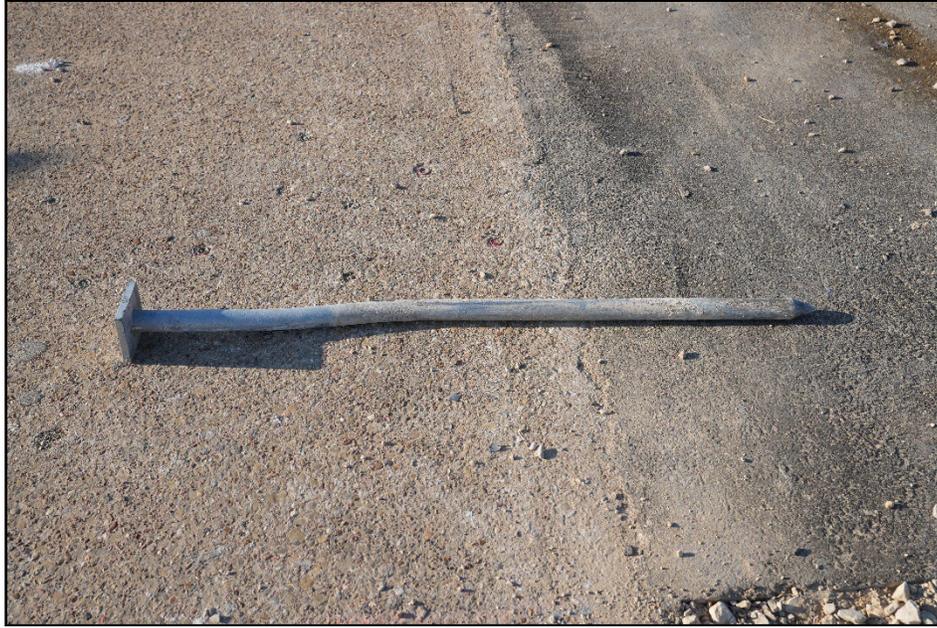
**Figure 6.9. Damage to the Upstream Anchor Pin 616391-01-1.**

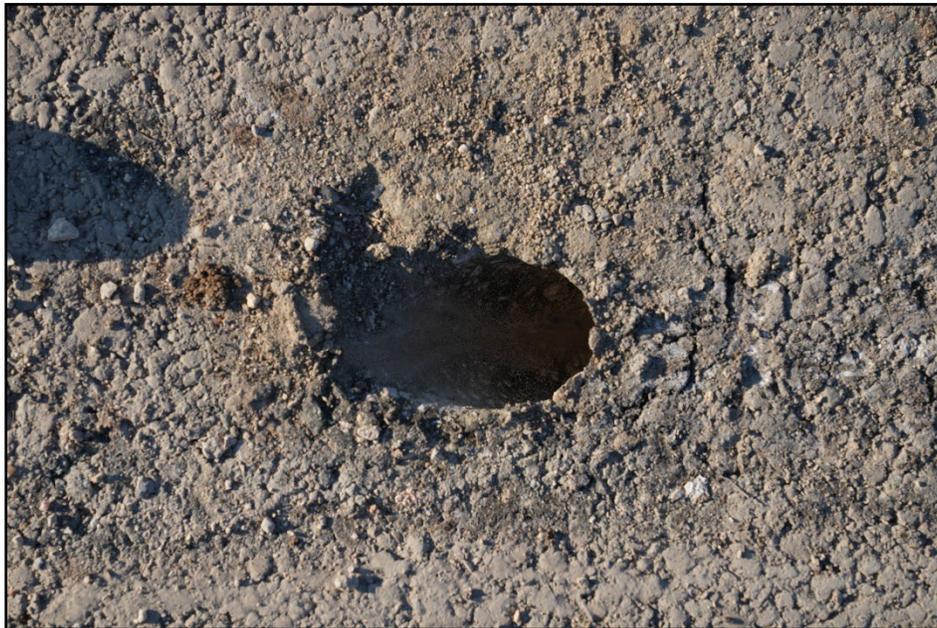
**Figure 6.10. Asphalt Damage at the Middle Anchor Pin Location 616391-01-1.**

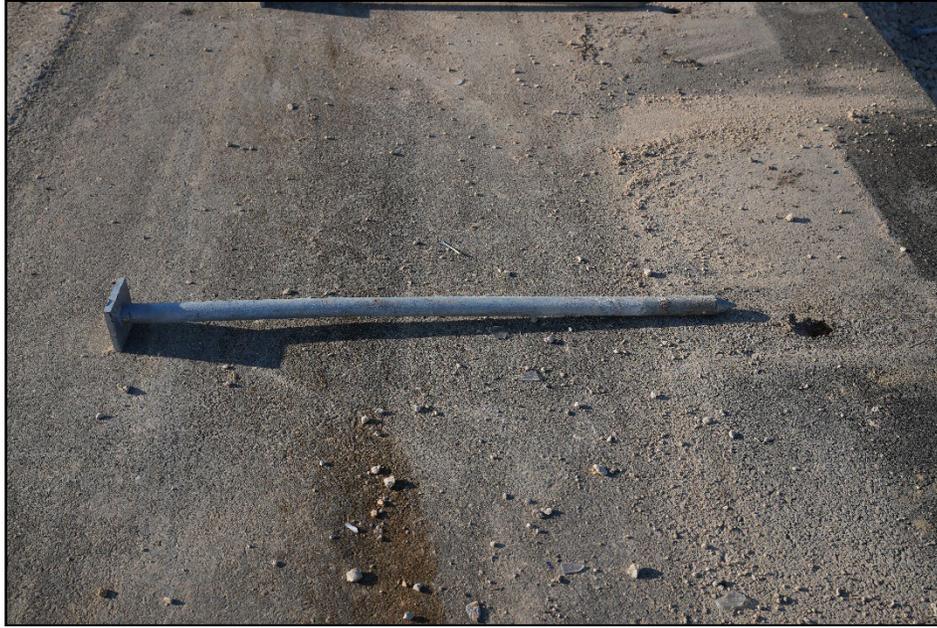
**Figure 6.11. Damage to the Middle Anchor Pin 616391-01-1.**

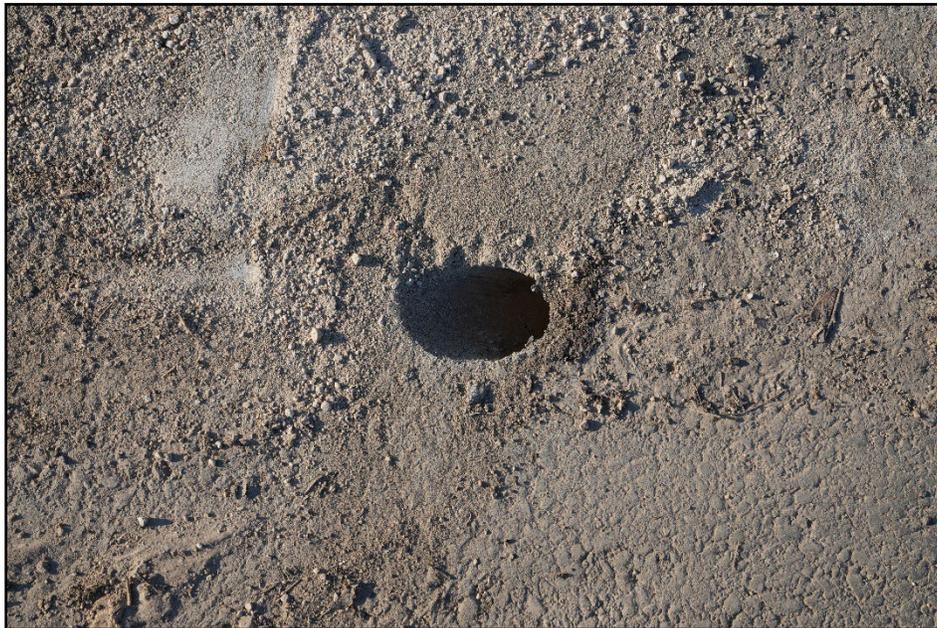
**Figure 6.12. Asphalt Damage at the Downstream Anchor Pin Location 616391-01-1.**

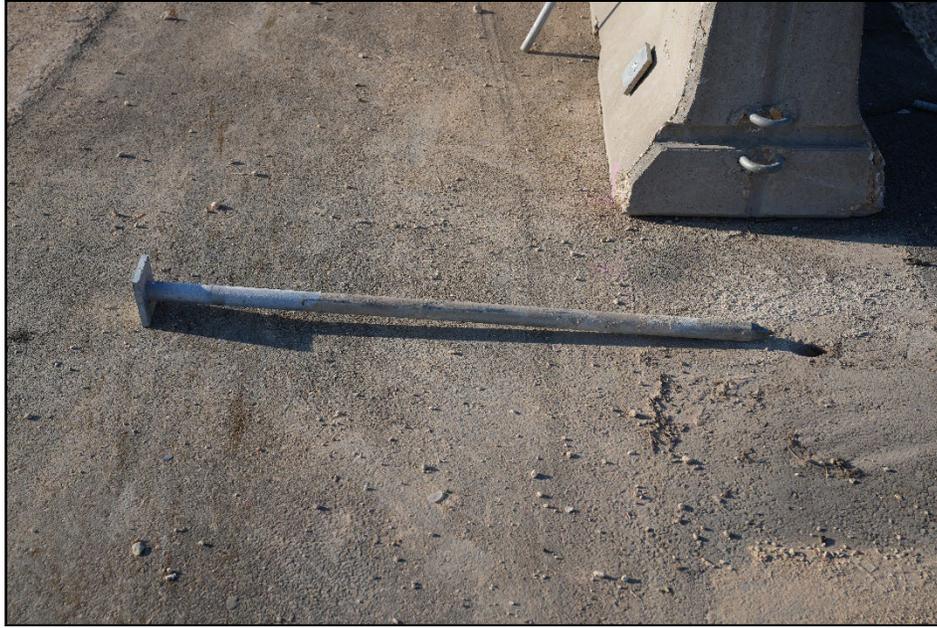
**Figure 6.13. Damage to the Downstream Anchor Pin 616391-01-1.**

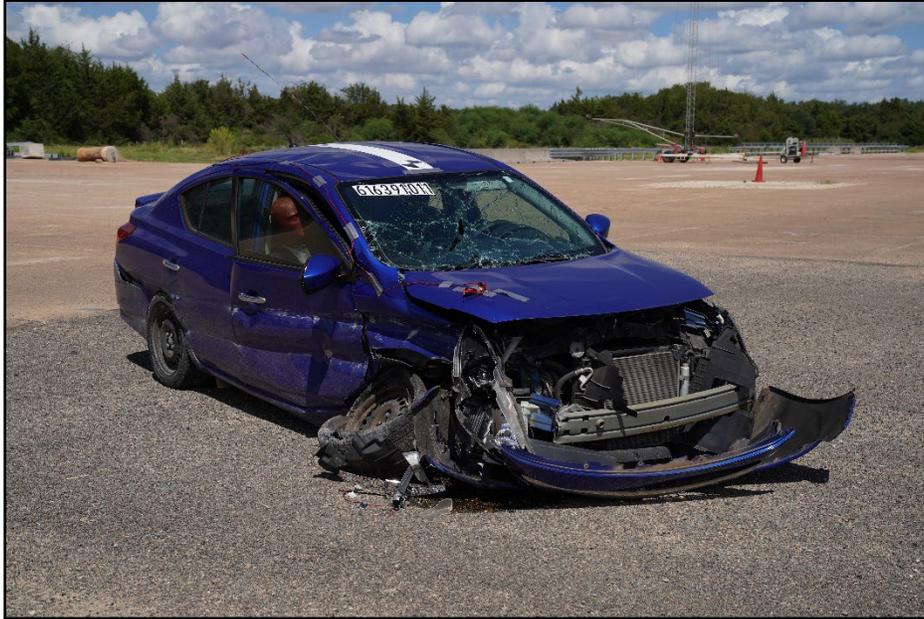
**Figure 6.14. Impact Side of Test Vehicle after Test 616391-01-1.**

Figure 6.14 and Figure 6.15 show the damage sustained by the vehicle. Figure 6.16 and Figure 6.17 show the interior of the test vehicle. Table 6.8 and Table 6.9 provide details on the occupant compartment deformation and exterior vehicle damage. The windshield sustained two tears in the laminate: one measuring 13 inches long  $\times$  1.25 inches wide and the other 8 inches long  $\times$  1.25 inches wide. The windshield's permanent deformation measured 2.75 inches deep. The tears and deformation damage to the windshield was caused by the flexing of the frame members during the impact, and not by any element(s) of the test article. Tables C.2 and C.3 in Appendix C.1 provide exterior crush and occupant compartment measurements.

| Description of Damage to Vehicle: | The front bumper, hood, grill, right front head light, right front tire and rim, right front a-pillar, windshield, right front door, right front floor pan, roof, right rear door and rear bumper were damaged. The windshield was cracked and deformed in an area 45 inches by 29 inches and 2.75 inches deep. The windshield sustained two tears in the laminate: one measuring 13 inches long × 1.25 inches wide and the other 8 inches long × 1.25 inches wide. The windshield's permanent deformation measured 2.75 inches deep. The tears and deformation damage was caused by the flexing of the frame members during the impact and not caused by any element(s) of the test article. The right front door had a 6-inch gap at the top. The roof had 3 small dents, with maximum deformation of 5 inches wide and 0.5 inches deep. |

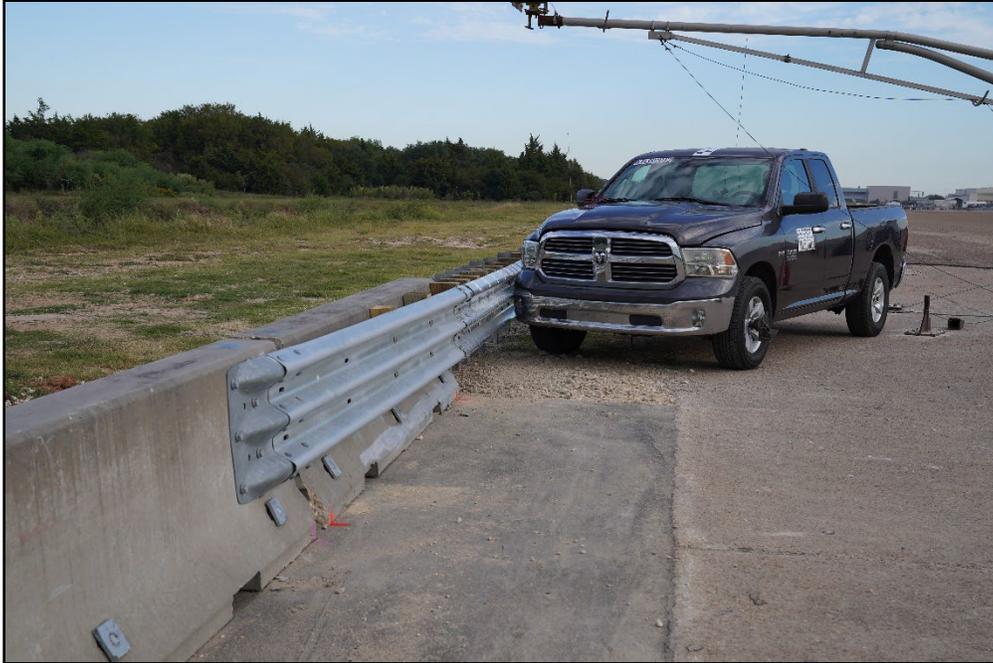
**Figure 7.1. Transition/Test Vehicle Geometrics for Test 616391-01-2.**

See Table 7.1 for details on *MASH* impact conditions for this test and Table 7.2 for the exit parameters. Figure 7.1 and Figure 7.2 depict the target impact setup.

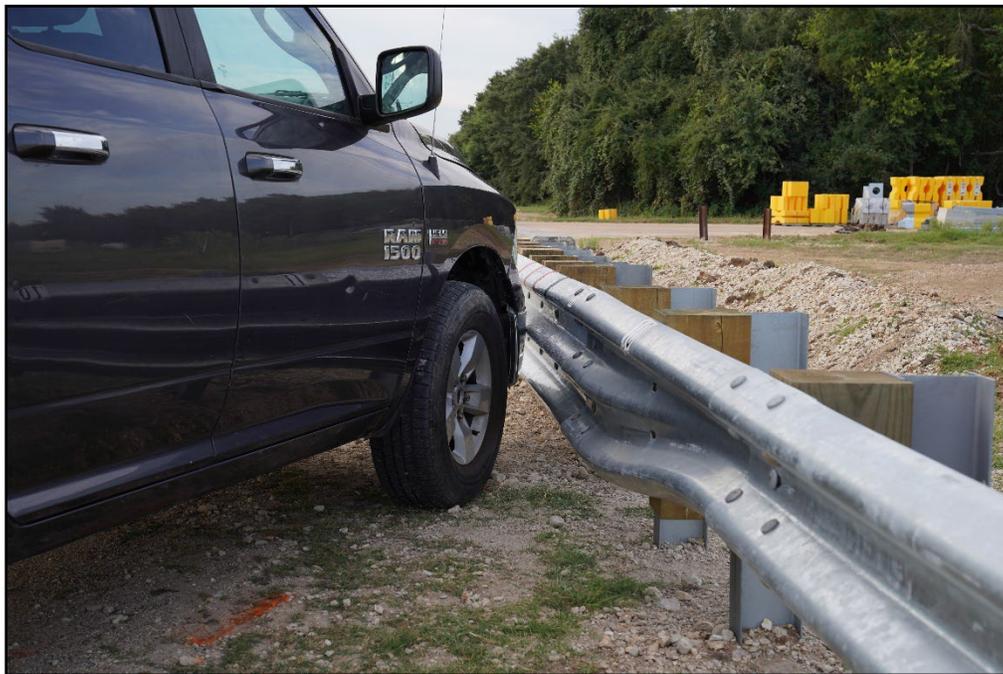
**Figure 7.2. Transition/Test Vehicle Impact Location 616391-01-2.**

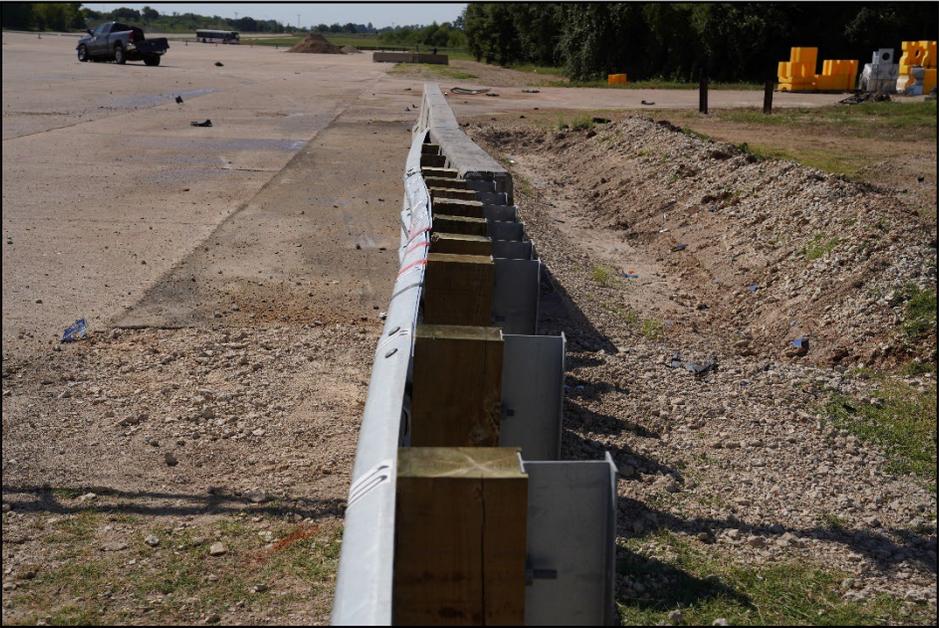
**Figure 7.6. Transition after Test Upstream of Impact In-Line with the Installation 616391-01-2.**

Table 7.6 and Table 7.7 describe the damage to the Transition. Figure 7.5 through Figure 7.13 show the damage to the Transition.

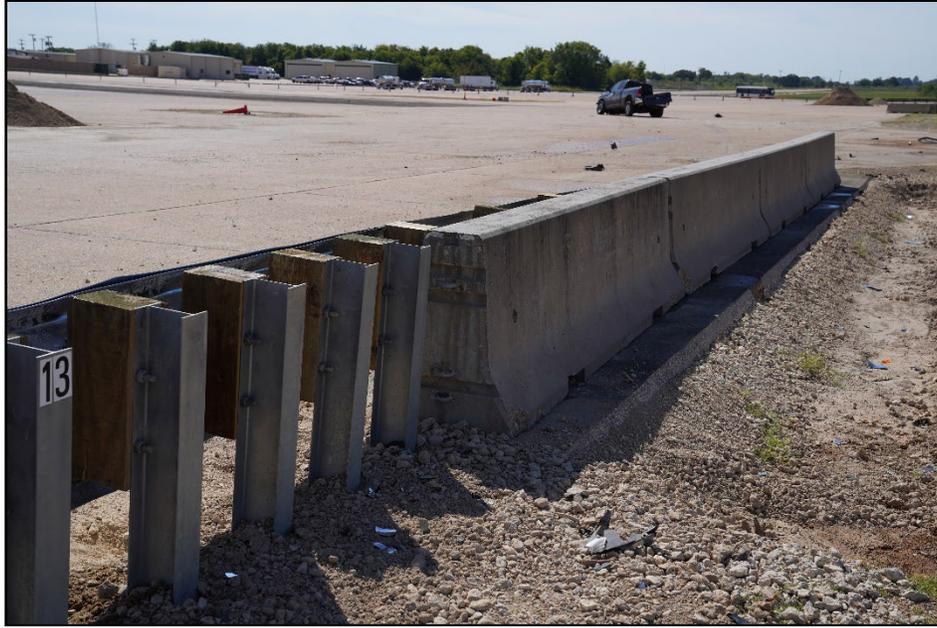
**Figure 7.7. Transition after Test From the Field Side 616391-01-2.**

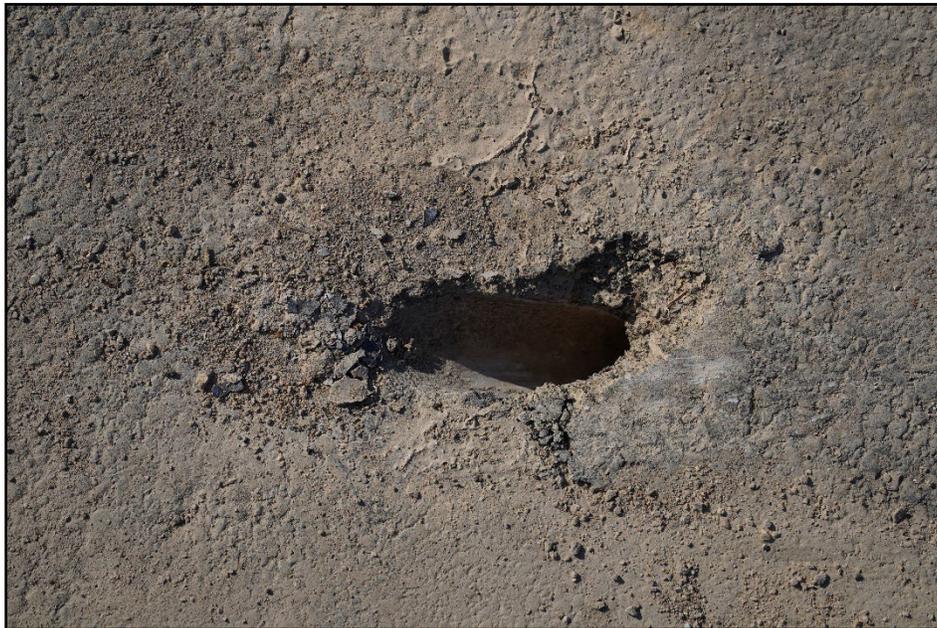
**Figure 7.8. Asphalt Damage at the Upstream Anchor Pin Location 616391-01-2.**

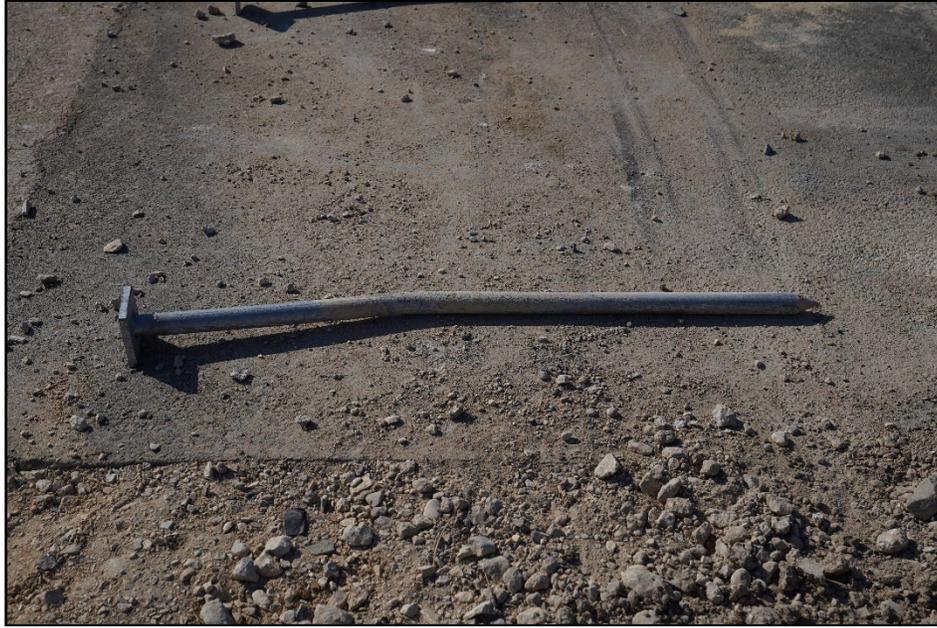
**Figure 7.9. Damage to the Upstream Anchor Pin 616391-01-2.**

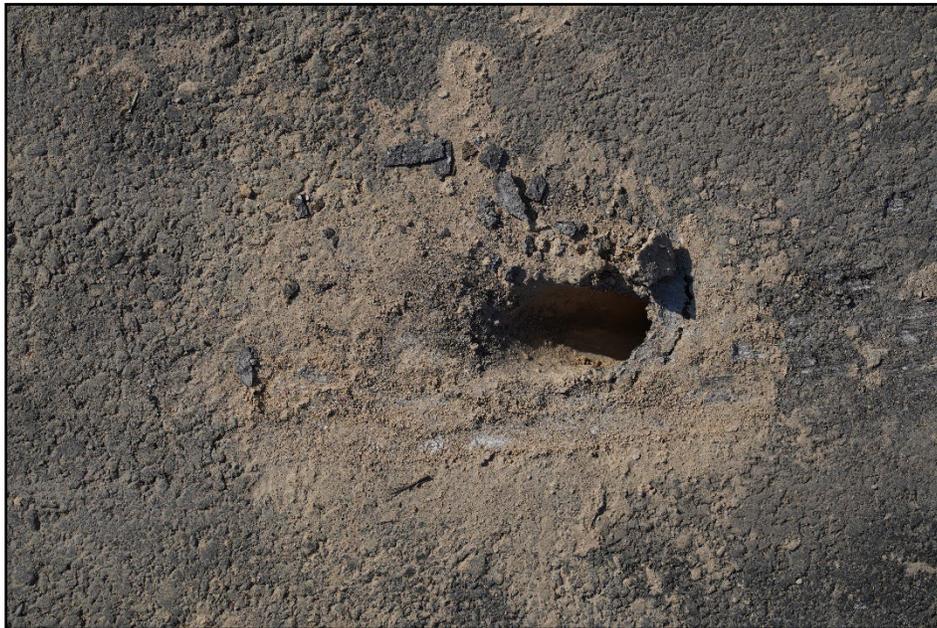
**Figure 7.10. Asphalt Damage at the Middle Anchor Pin Location 616391-01-2.**

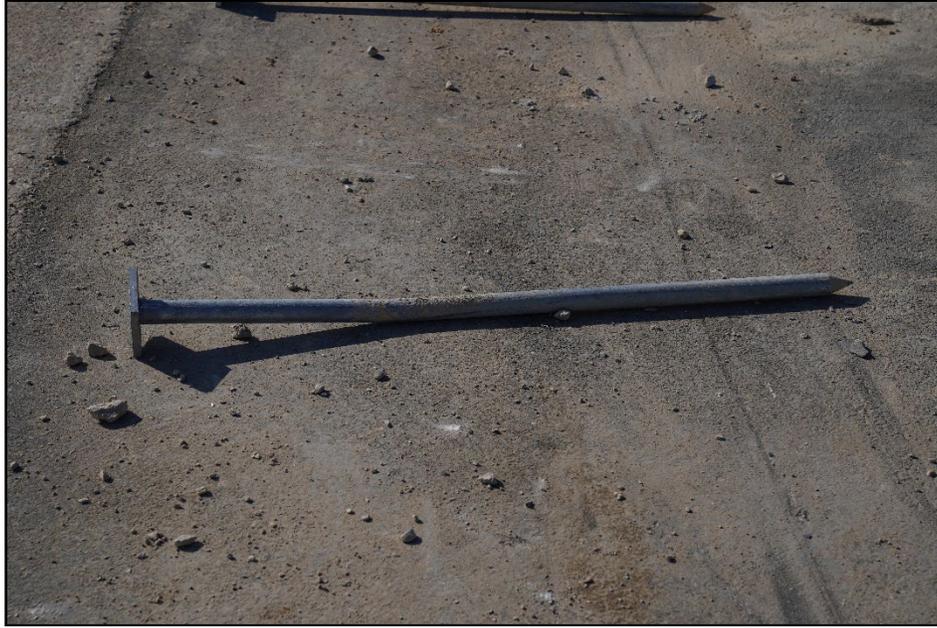
**Figure 7.11. Damage to the Middle Anchor Pin 616391-01-2.**

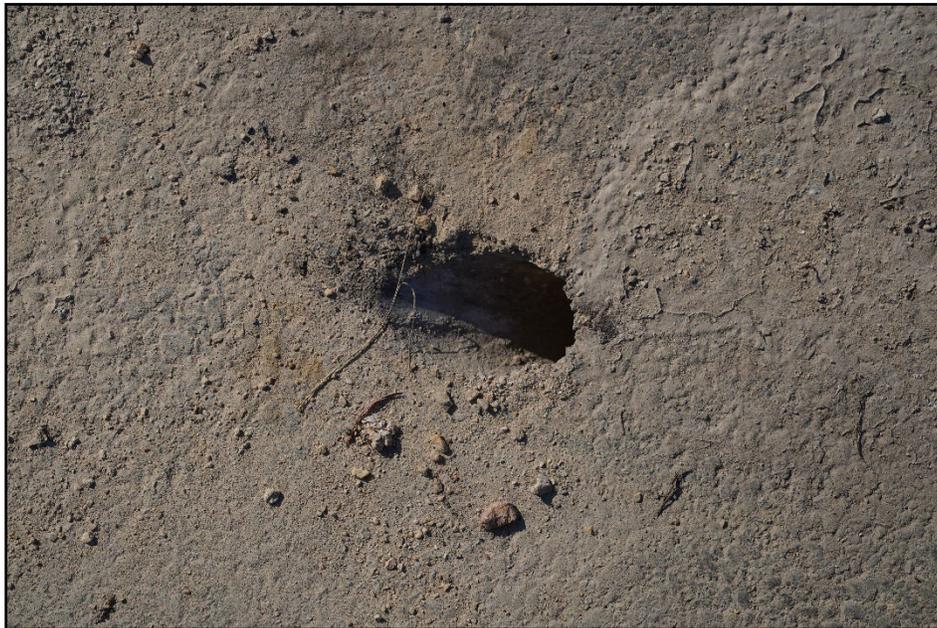
**Figure 7.12. Asphalt Damage at the Downstream Anchor Pin Location 616391-01-2.**

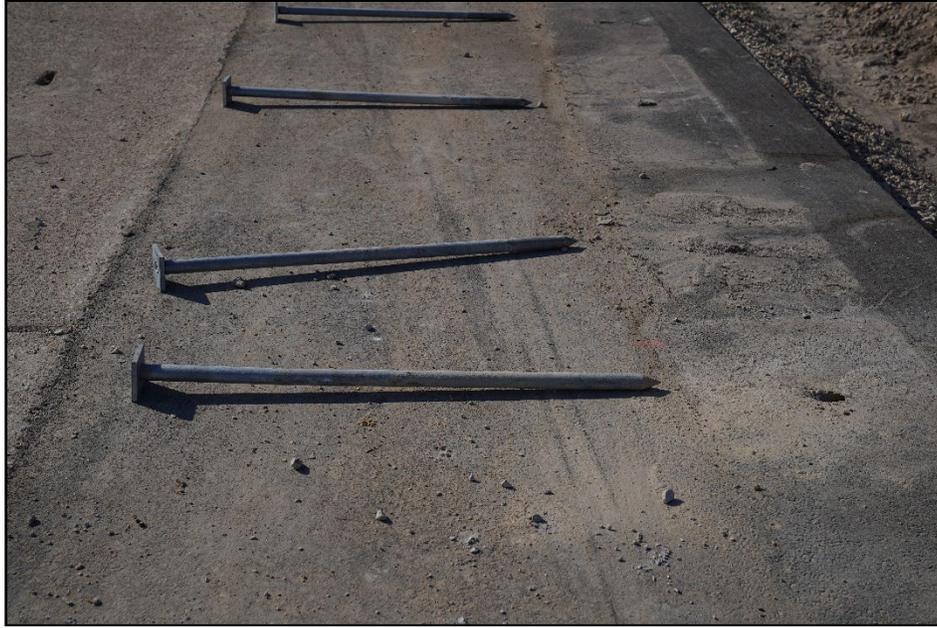
**Figure 7.13. Damage to the Downstream Anchor Pins 616391-01-2.**
