Test Report No. 614341-01

**DESIGN AND TESTING OF *MASH* TL-3 THRIE-BEAM GUARDRAIL
SYSTEM (TGS) FOR ROADSIDE AND MEDIAN APPLICATIONS**

Test No.: 614341-01-1 / 614341-01-3 / 614341-01-2

**Roadside Safety Research for *MASH* Implementation Pooled Fund Group – Study
No. TPF-5(343)**

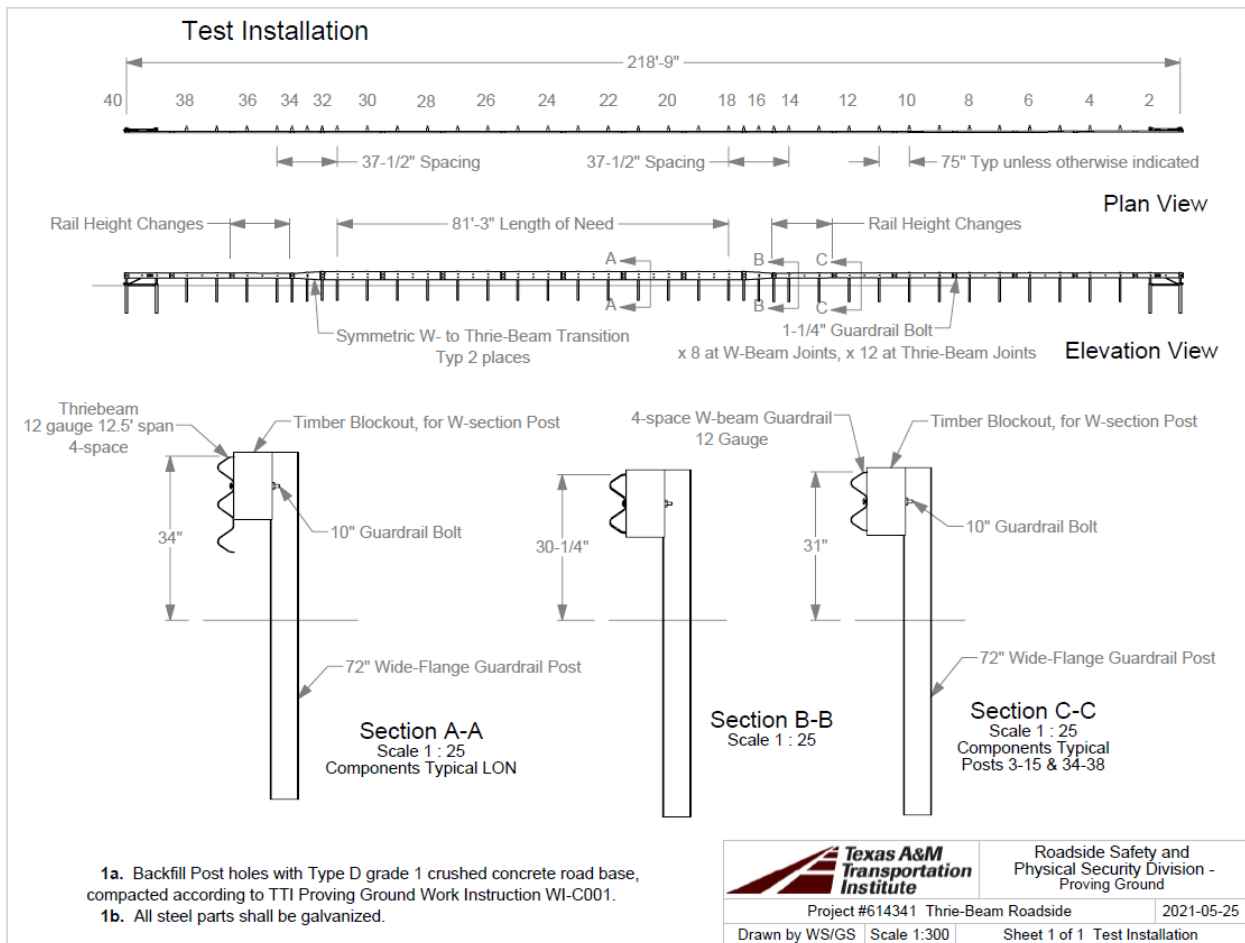
Figure 3.1. Plan View and Elevation View of Roadside TGS Installation.

The 218 ft 9 inch installation consisted of 81 ft 3 inch TGS that is attached to standard W-beam rail using symmetric W-beam-to-thrie-beam transition segments. The post spacing was 75 inches, except for in the transition section where it was 37½ inches. Figure 3.1 and Figure 3.2 show the details of the roadside and median TGS design concepts.

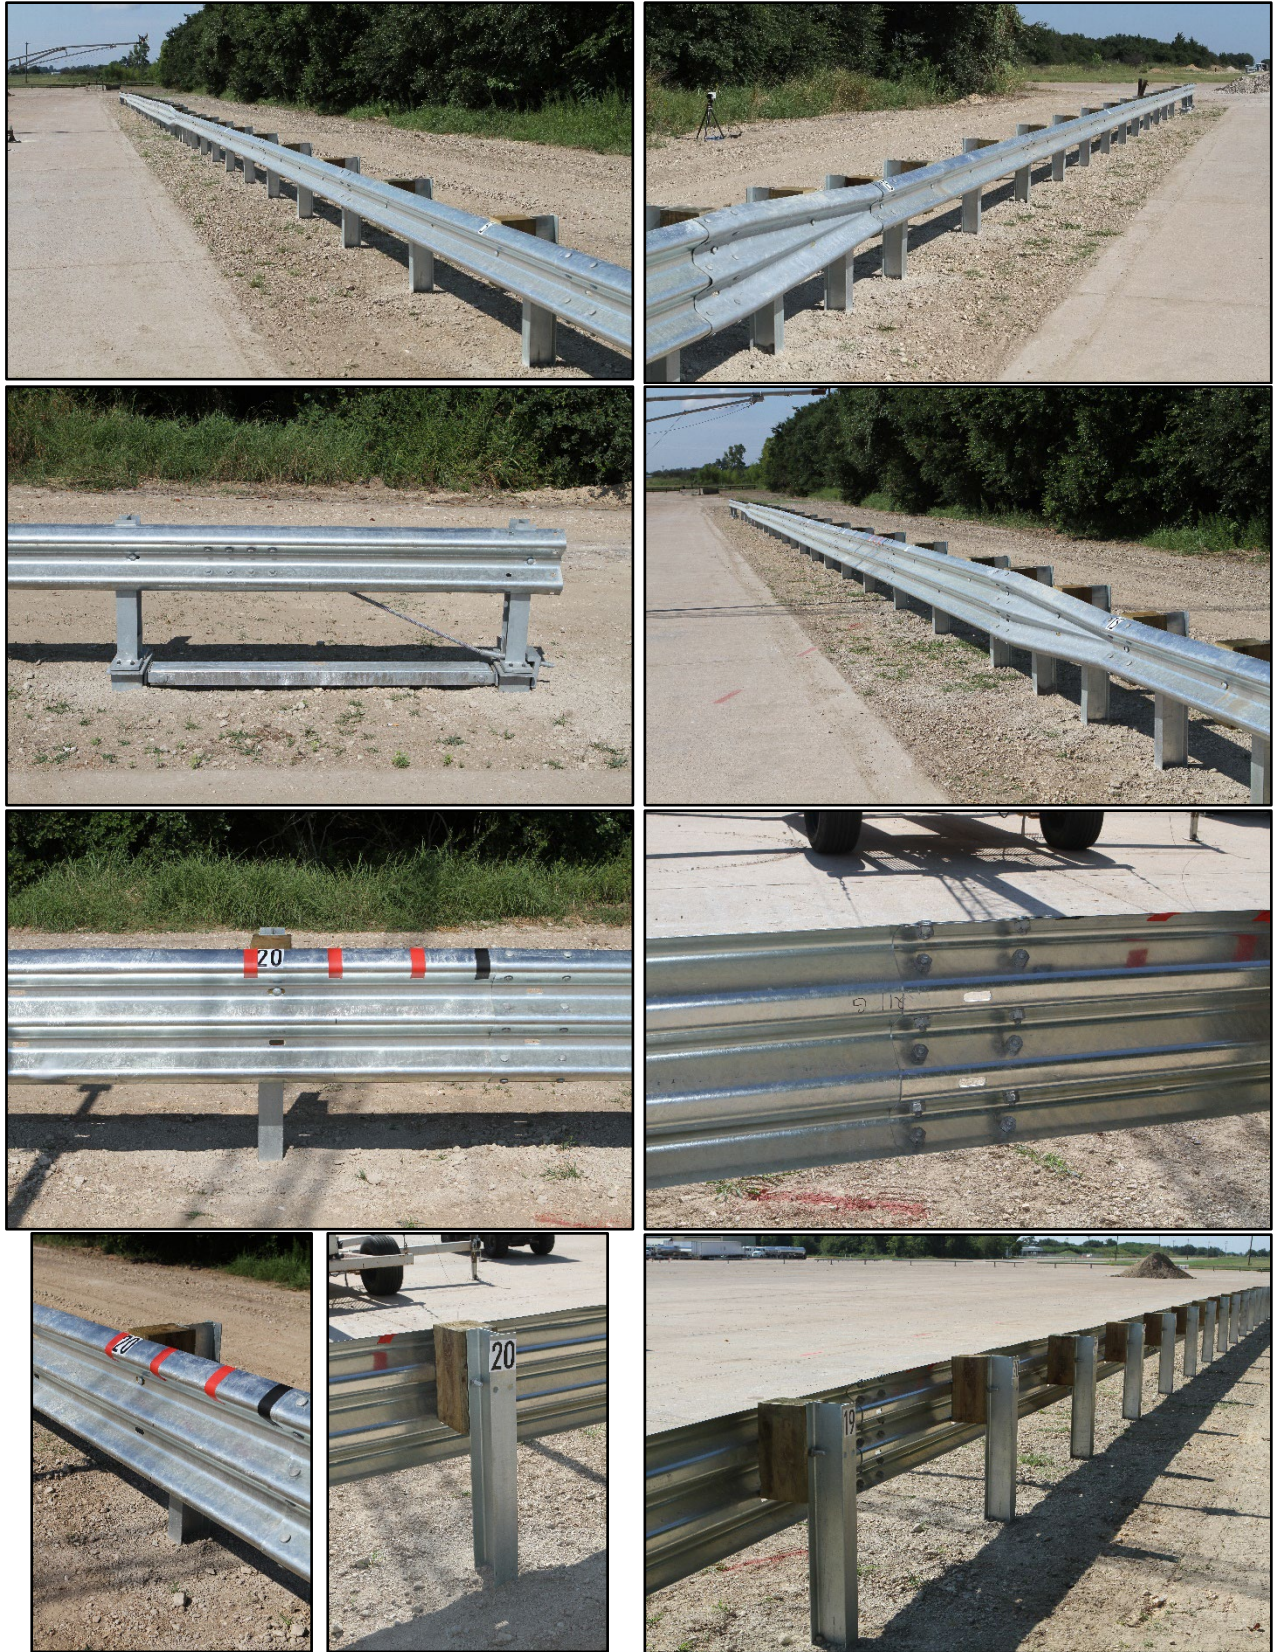
Figure 6.2. Roadside Thrie-beam System prior to Testing.

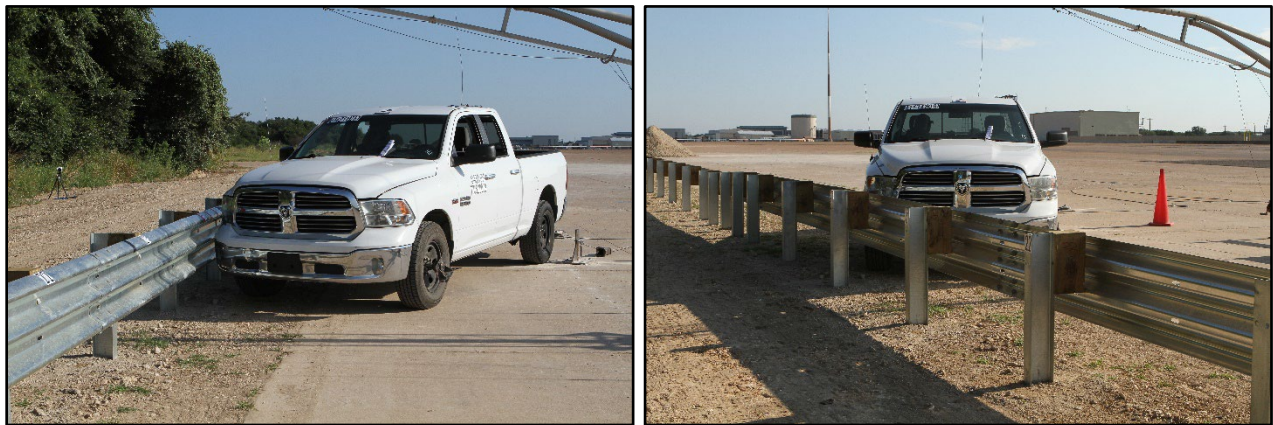
Figure 6.3. Roadside Thrie-beam System/Test Vehicle Geometrics for Test No. 614341-01-1.

MASH Test 3-11 involves a 2270P vehicle weighing 5000 lb \pm 110 lb impacting the CIP of the longitudinal barrier at an impact speed of 62 mi/h \pm 2.5 mi/h and an angle of 25 degrees \pm 1.5 degrees. The CIP for *MASH* Test 3-11 on the roadside Thrie-beam system was 13.3 ft \pm 1 ft upstream of the centerline of post 22. Figure 4.1 and Figure 6.3 depict the target impact setup.

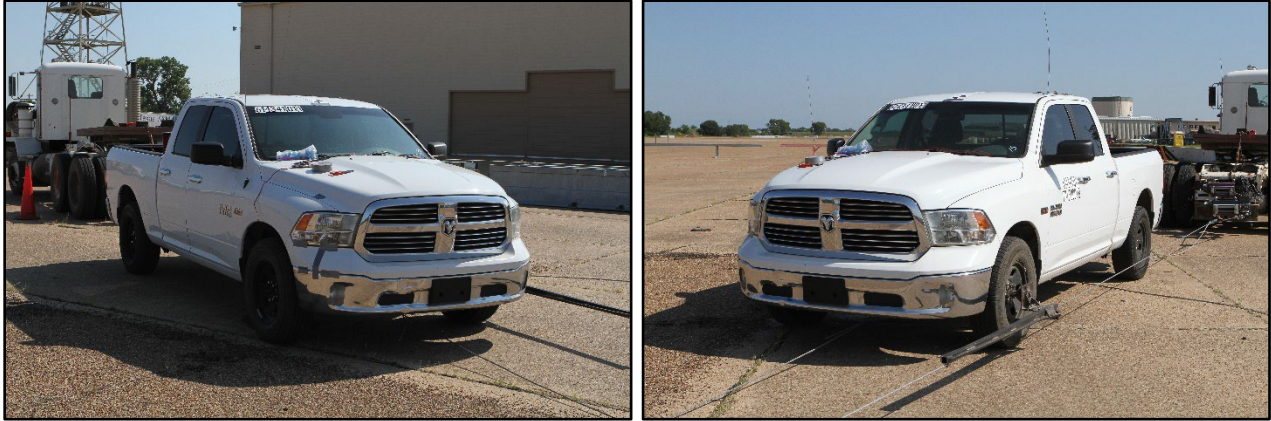
Figure 6.4. Test Vehicle before Test No. 614341-01-1.

Figure 6.4 shows the 2015 RAM 1500 pickup truck used for the crash test. The vehicle's test inertia weight was 5057 lb, and its gross static weight was 5222 lb. The height to the lower edge of the vehicle bumper was 11.75 inches, and the height to the upper edge of the bumper was 27.0 inches. The height to the vehicle's center of gravity was 28.75 inches. Tables D.1 and D.2 in Appendix D.1 give additional dimensions and information on the vehicle. The vehicle was directed into the installation using a cable reverse tow and guidance system and was released to be freewheeling and unrestrained just prior to impact.

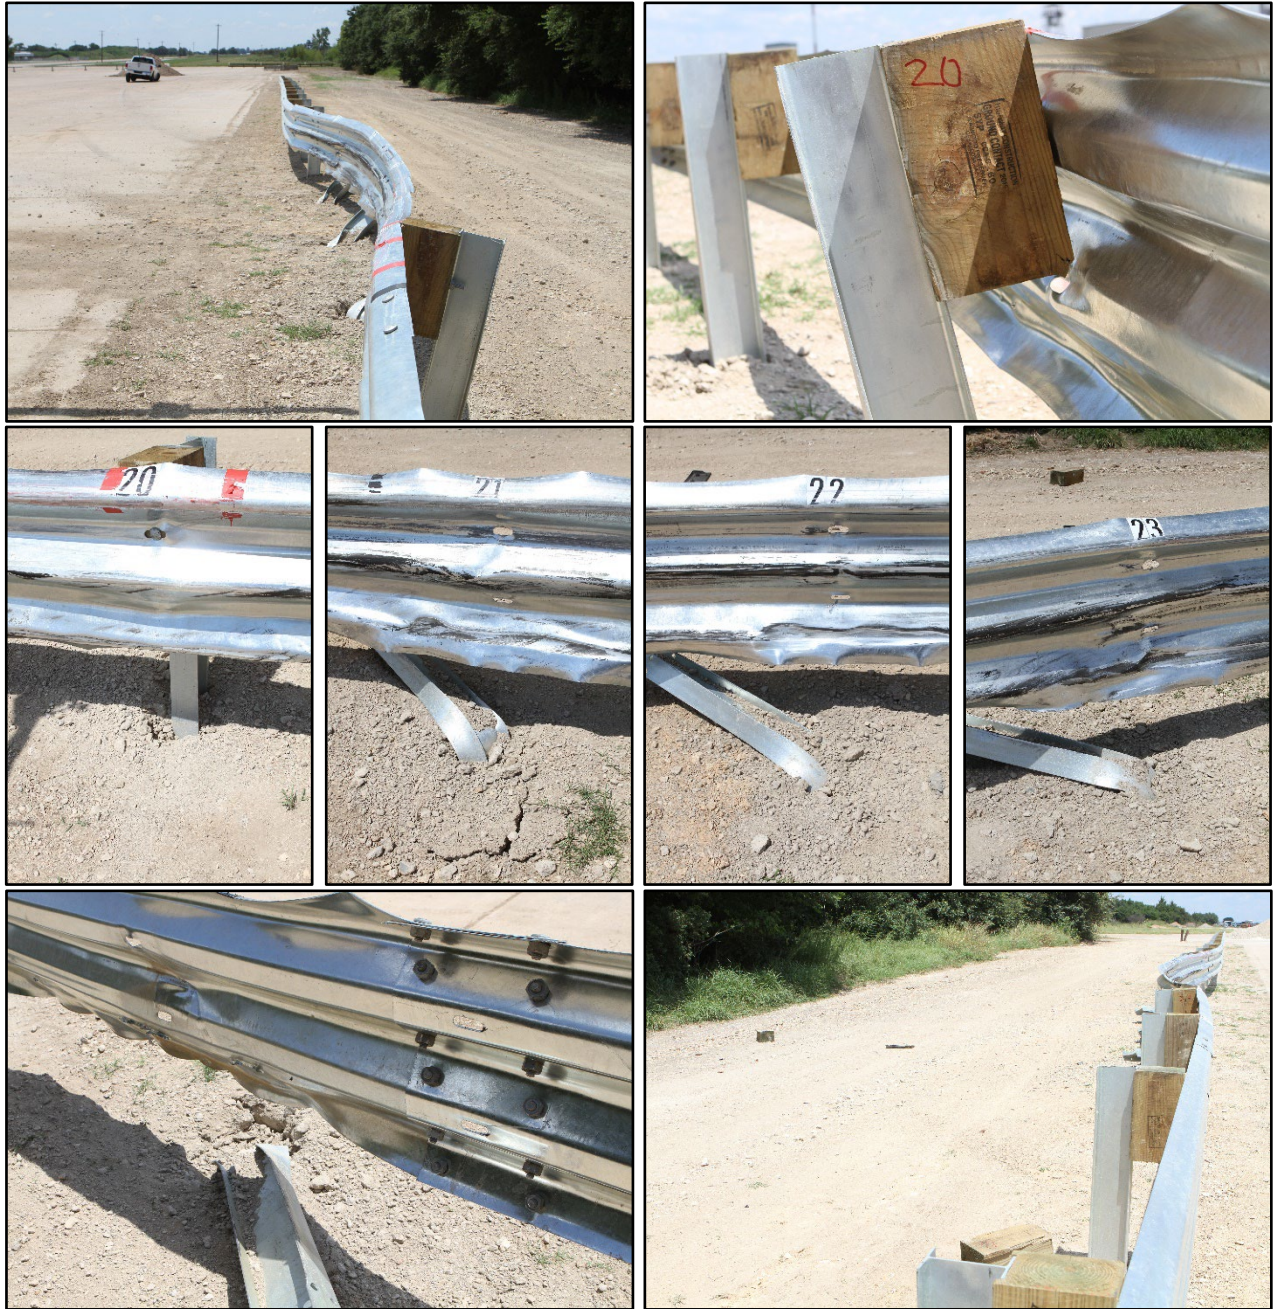
Figure 6.5 shows the damage to the roadside Thrie-beam system. The rail released from posts 13, 21, 22 and 23. Posts 13 and 24 through 30 were rotated counterclockwise, while posts 3 through 12 and 14 through 20 were rotated clockwise. The blockouts were missing from posts 21 through 23. The blockout for post 21 came to rest 19 ft towards the field side and was in-line with the midspan between posts 22 and 23. The blockout for post 22 came to rest 36 ft towards the field side and was in-line with the midspan between posts 23 and 24. The blockout for post 23 came to rest 2 ft towards the field side and was in-line with the centerline of post 26.

Working width* was 55.2 inches, and height of working width was 60.4 inches. Maximum dynamic deflection during the test was 42.1 inches, and maximum permanent deformation was 26.9 inches.

Figure 6.5. Roadside Thrie-beam System after Test No. 614341-01-1.

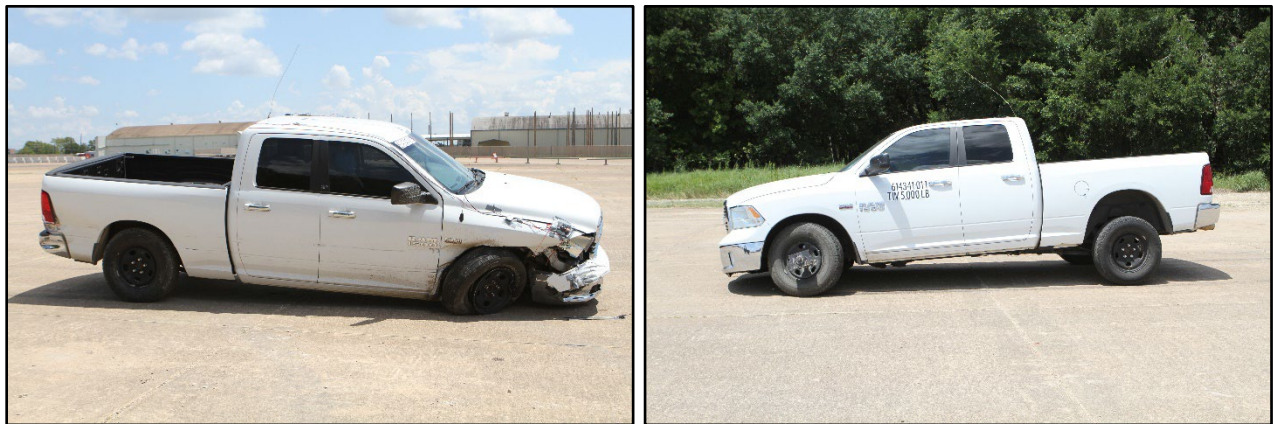
Figure 6.6 shows the damage sustained by the vehicle. The front bumper, grill, right front tire and rim, right front fender, right front and rear doors, right rear lower cab corner, right rear exterior bed, and rear bumper were damaged. No fuel tank damage was observed. Maximum exterior crush to the vehicle was 8.0 inches in the front plane at the right front corner at bumper height. No occupant compartment deformation or intrusion was observed. Figure 6.7 shows the interior of the vehicle. Tables D.3 and D.4 in Appendix D.1 provide exterior crush and occupant compartment measurements.

Figure 6.6. Test Vehicle after Test No. 614341-01-1.

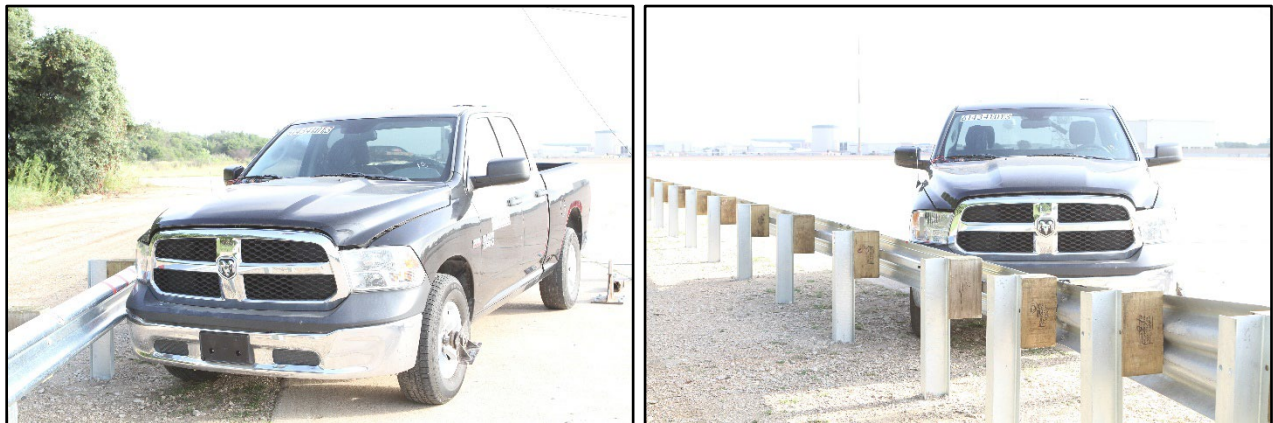
Figure 6.9. Roadside Thrie-beam System/Test Vehicle Geometrics for Test No. 614341-01-3.

MASH Test 321 involves a 2270P vehicle weighing $5000 \text{ lb} \pm 110 \text{ lb}$ impacting the CIP of the transition at an impact speed of $62 \text{ mi/h} \pm 2.5 \text{ mi/h}$ and an angle of $25 \text{ degrees} \pm 1.5 \text{ degrees}$. The CIP for MASH Test 3-21 on the roadside Thrie-beam transition system was $7.3 \text{ ft} \pm 1 \text{ ft}$ upstream of the centerline of post 15 where the symmetric transition piece connects to the W-beam system. Figure 4.2 and Figure 6.9 depict the target impact setup.

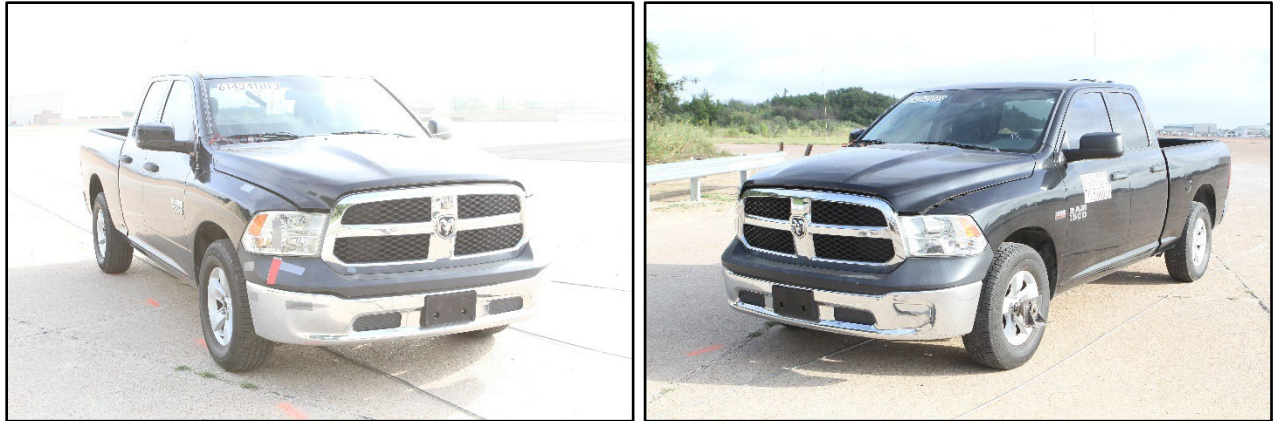
Figure 6.10. Test Vehicle before Test No. 614341-01-3.

Figure 6.10 shows the 2015 RAM 1500 pickup truck used for the crash test. The vehicle's test inertia weight was 5019 lb, and its gross static weight was 5184 lb. The height to the lower edge of the vehicle bumper was 11.75 inches, and the height to the upper edge of the bumper was 27.0 inches. The height to the vehicle's center of gravity was 28.5 inches. Tables D.1 and D.2 in Appendix D.1 give additional dimensions and information on the vehicle. The vehicle was directed into the installation using a cable reverse tow and guidance system and was released to be freewheeling and unrestrained just prior to impact.

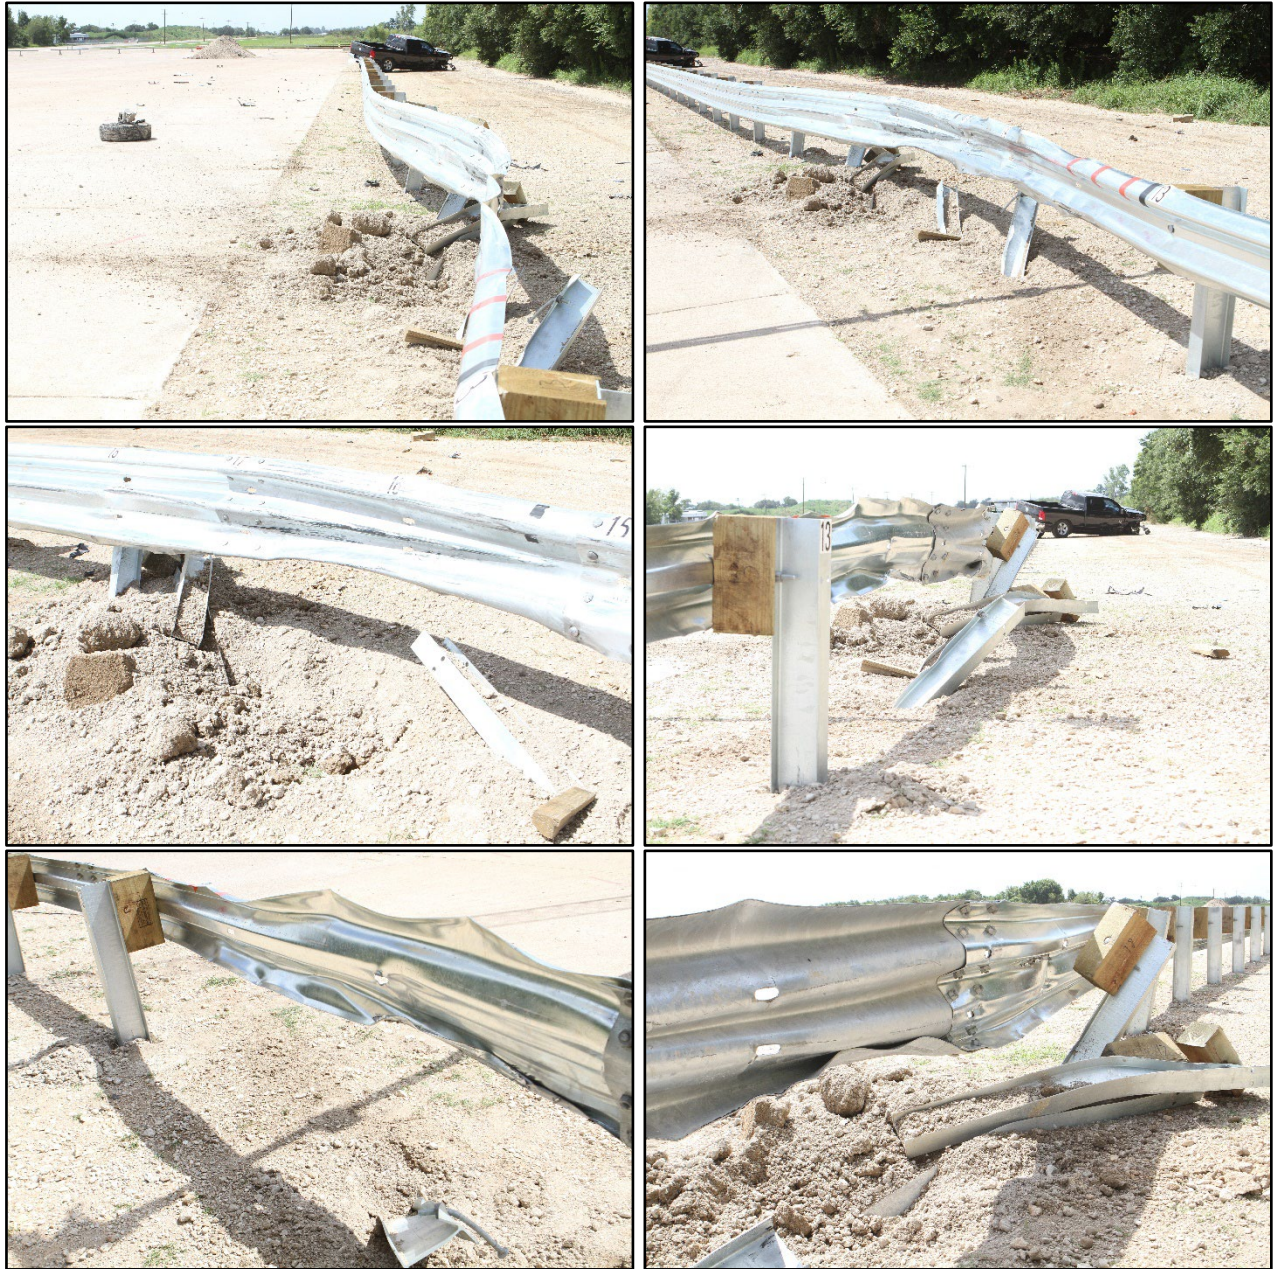
Figure 6.11 shows the damage to the roadside Thrie-beam system. The rail released from posts 14 through 18, and the blockouts were missing from posts 14 through 17. Posts 3 through 12 were rotated clockwise, and post 18 was rotated counterclockwise. Posts 16 and 17 were pulled out of the soil completely. There was no movement noted for posts 21 through 40. Table 6.5 shows post movements after the test.

Working width* was 66.2 inches, and height of working width was 18.5 inches. Maximum dynamic deflection during the test was 38.9 inches, and maximum permanent deformation was 27.3 inches.

Figure 6.11. Roadside Thrie-beam after Test No. 614341-01-3.

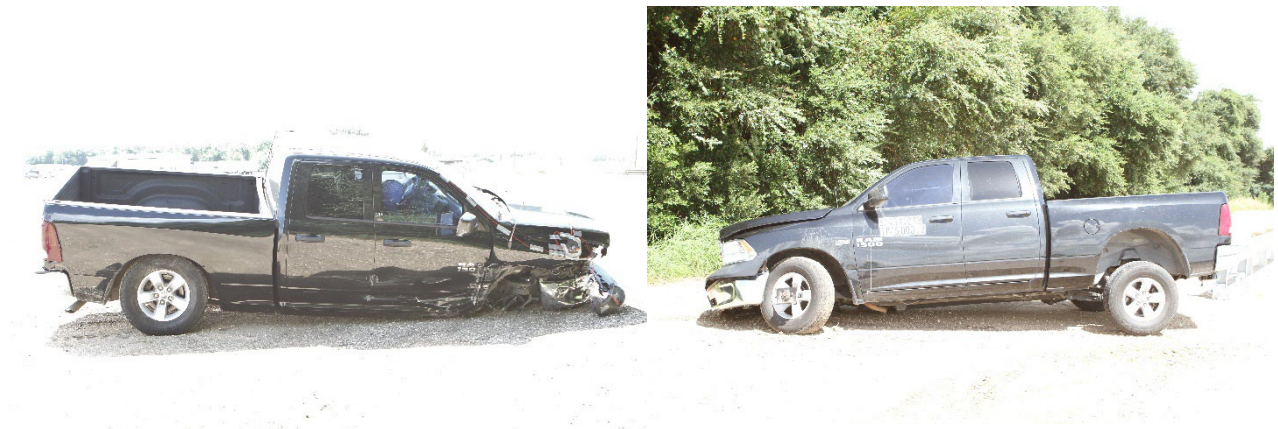
Figure 6.12 shows the damage sustained by the vehicle. The right front bumper, grill, right front tire and rim, right front fender, and right door were damaged. No fuel tank damage was observed. Maximum exterior crush to the vehicle was 17.0 inches in the side plane at the right front corner at bumper height. No occupant compartment deformation or intrusion was observed. Figure 6.13 shows the interior of the vehicle. Tables D.3 and D.4 in Appendix D.1 provide exterior crush and occupant compartment measurements.

Figure 6.12. Test Vehicle after Test No. 614341-01-3.

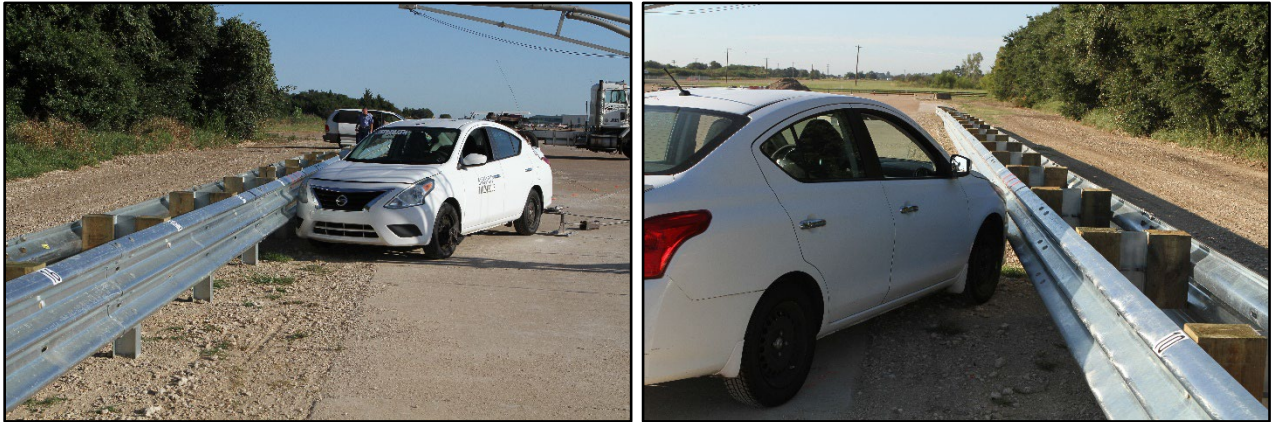
Figure 7.3. Median Thrie-beam System/Test Vehicle Geometrics for Test No. 614341-01-2.

MASH Test 3-10 involves a 1100C vehicle weighing 2420 lb \pm 55 lb impacting the CIP of the longitudinal barrier at an impact speed of 62 mi/h \pm 2.5 mi/h and an angle of 25 degrees \pm 1.5 degrees. The CIP for MASH Test 3-10 on the median Thrie-beam system was 9.3 ft \pm 1 ft upstream of the center of post 14. Figure 4.3 and Figure 7.3 depict the target impact setup.

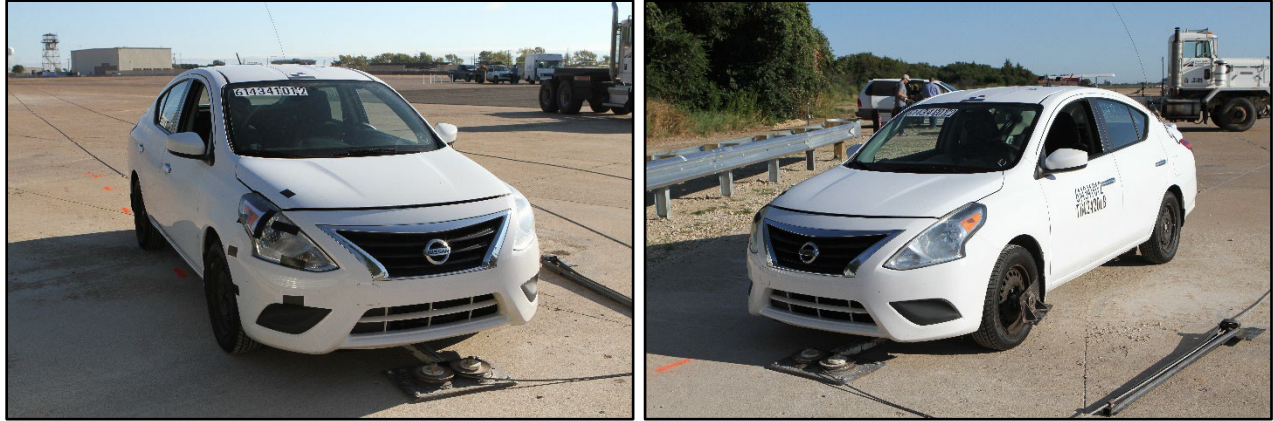
Figure 7.4. Test Vehicle before Test No. 614341-01-2.

Figure 7.4 shows the 2015 Nissan Versa used for the crash test. The vehicle's test inertia weight was 2455 lb, and its gross static weight was 2620 lb. The height to the lower edge of the vehicle bumper was 7.0 inches, and the height to the upper edge of the bumper was 22.25 inches. Table C.1 in Appendix C.1 gives additional dimensions and information on the vehicle. The vehicle was directed into the installation using a cable reverse tow and guidance system and was released to be freewheeling and unrestrained just prior to impact.

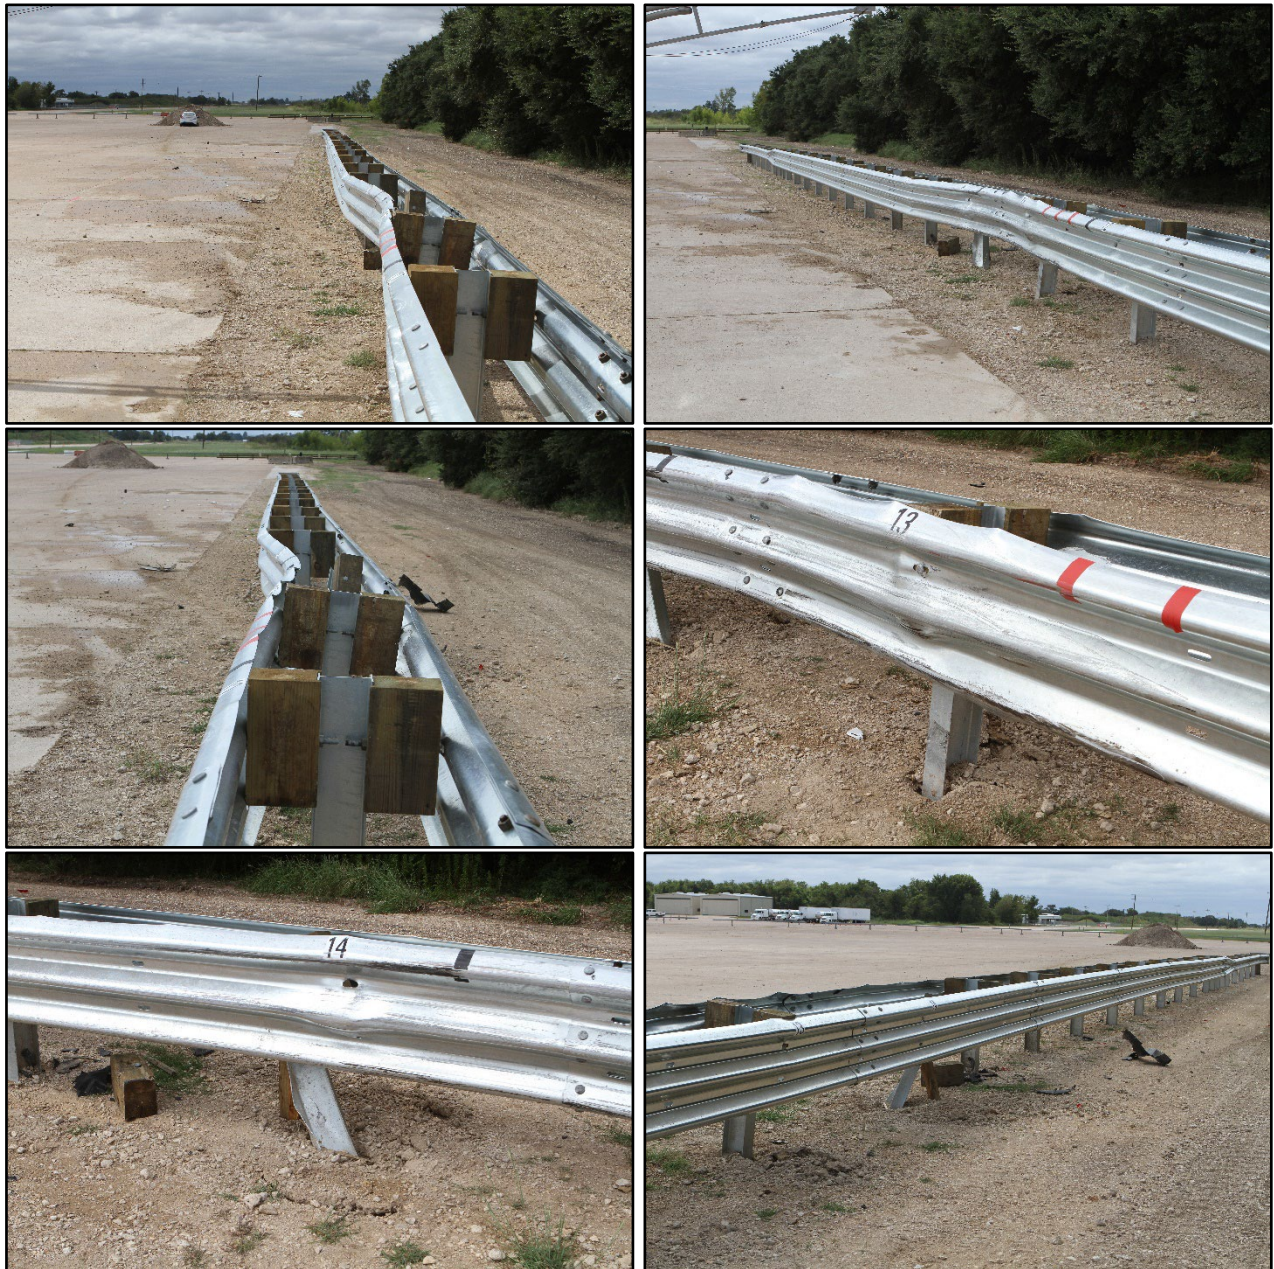
Figure 6.5 shows the damage to the median Thrie-beam system. There was no soil disturbance noted from posts 1 through 9 and 16 through 32. The soil was disturbed at post 10, and significantly disturbed, with no measurable gaps at posts 13 and 14 due to the soil caving back into the post hole. Post 14 rotated clockwise and deformed, and the traffic side blackout released from post 14 and rail due to the bolt shearing at the post. The post 14 field side blackout was damaged. The field side rail released from posts 14 through 17, and the traffic side rail

released from post 14. Table 7.2 shows post movements after the test. Working width* was 38.9 inches, and height of working width was 32.5 inches. Maximum dynamic deflection during the test was 15.4 inches, and maximum permanent deformation was 8.4 inches.

Figure 7.5. Median Thrie-beam System after Test No. 614341-01-2.

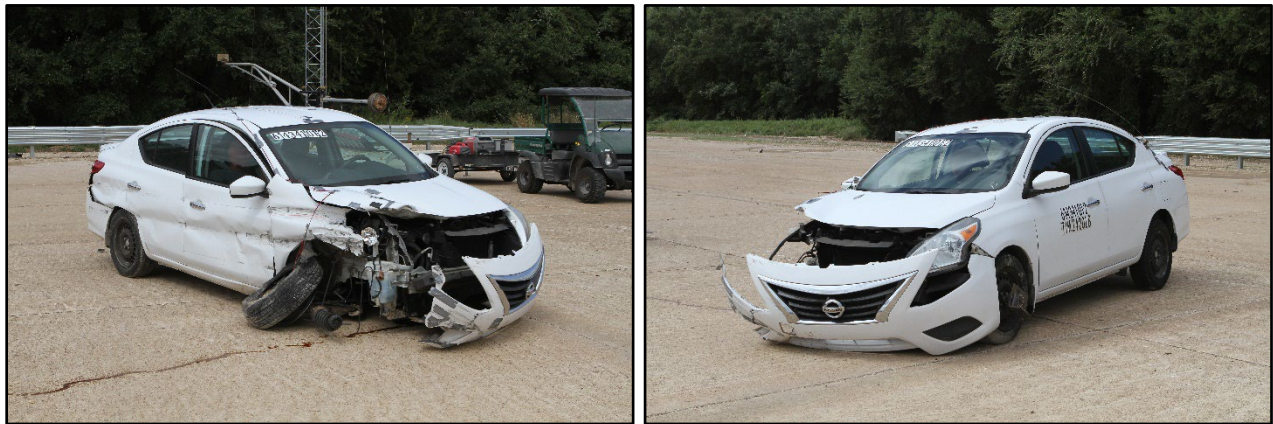
Figure 7.6 shows the damage sustained by the vehicle. The front bumper, grill, hood, right front fender, right front strut and tower, right front tire and rim, right front floor pan, right front and rear doors, right rear quarter panel, and rear bumper were damaged. The windshield had cracks radiating upward and inward from the right lower corner. No fuel tank damage was observed. Maximum exterior crush to the vehicle was 8.0 inches in the side plane at the right front corner at bumper height. Maximum occupant compartment deformation was 3.0 inches in the right front firewall/toe pan area. Figure 7.7 shows the interior of the vehicle. Tables C.2 and C.3 in Appendix C.1 provide exterior crush and occupant compartment measurements.

Figure 7.6. Test Vehicle after Test No. 614341-01-2.
