Test Report No. 616161-01

**EVALUATION OF
CRASHWORTHY ENHANCED HIGHWAY SIGN ASSEMBLIES**

TEXAS A&M TRANSPORTATION INSTITUTE PROVING GROUND

14. Sponsoring Agency Code	
15. Supplementary Notes Name of Contacting Representative: Derwood Sheppard, derwood.sheppard@dot.state.fl.us			
16. Abstract <p>The purpose of the tests reported herein was to assess the performance of the Crashworthy Enhanced Highway Sign Assemblies according to the safety-performance evaluation guidelines included in the American Association of State Highway and Transportation Officials (AASHTO) <i>Manual for Assessing Safety Hardware (MASH)</i>, Second Edition (1). The crash tests were performed in accordance with <i>MASH</i> Test Level 3 (TL-3).</p> <p>This report provides details on the Crashworthy Enhanced Highway Sign Assemblies, the crash tests and results, and the performance assessment of the Crashworthy Enhanced Highway Sign Assemblies for <i>MASH</i> TL-3 longitudinal barrier evaluation criteria.</p> <p>The Crashworthy Enhanced Highway Sign Assemblies met the performance criteria for <i>MASH</i> TL-3 support structures.</p>

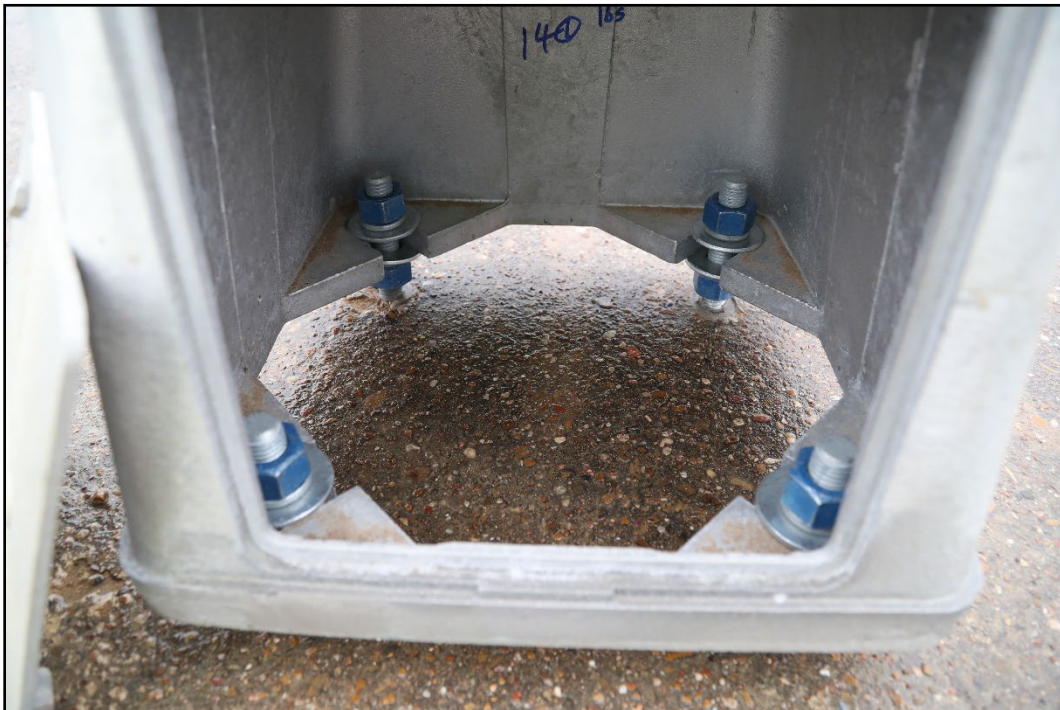
Figure 2.7. The Anchor System of the Crashworthy Enhanced Highway Sign Assemblies prior to Testing.

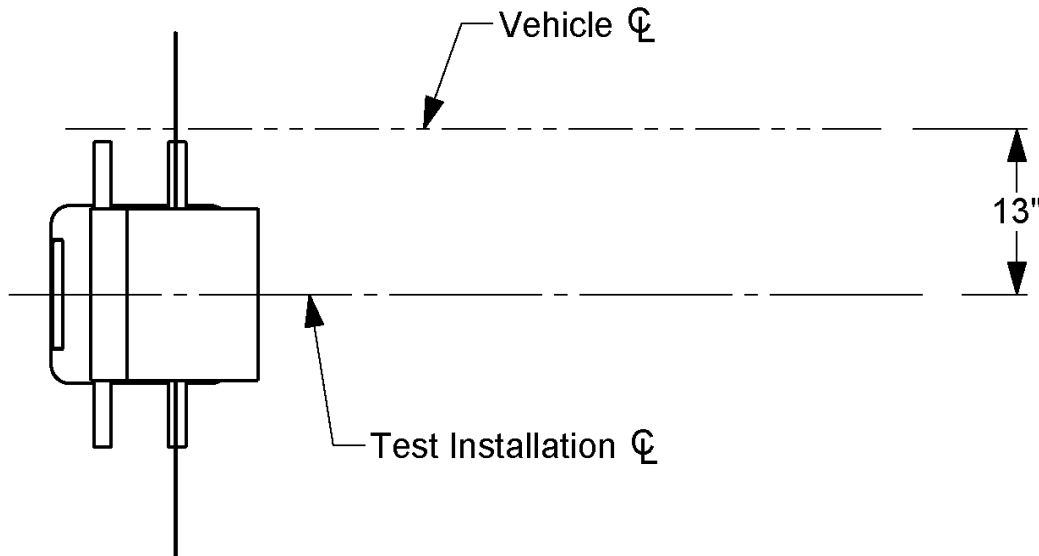
Figure 3.1. Target CIP for *MASH* TL-3 Tests on Crashworthy Enhanced Highway Sign Assemblies.

Table 3.1 shows the test conditions and evaluation criteria for *MASH* TL-3 for support structures. The target critical impact points (CIPs) for each test were determined using the information provided in *MASH* Section 2.2.1 and Section 2.3.2. Figure 3.1 shows the target CIP for *MASH* Tests 3-60 and 3-62 on the Crashworthy Enhanced Highway Sign Assemblies. An engineering evaluation, based on the method from NCHRP Report 318, concluded that the sign would not interact with the 1100C vehicle during the 3-61 test, except for the initial impact (2). This finding concurred with previous studies, and as a result, the test was not performed (3).

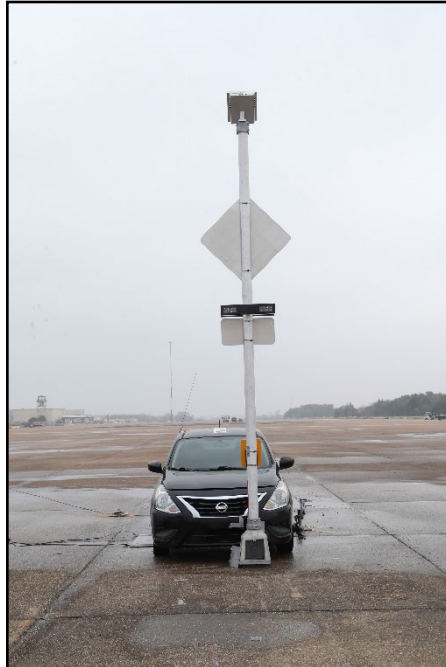
Figure 5.1. Crashworthy Enhanced Highway Sign Assemblies/Test Vehicle Geometrics for Test 616161-01-1.

See Table 5.1 for details on *MASH* impact conditions for this test and Table 5.2 for the exit parameters. Figure 5.1 and Figure 5.2 depict the target impact setup.

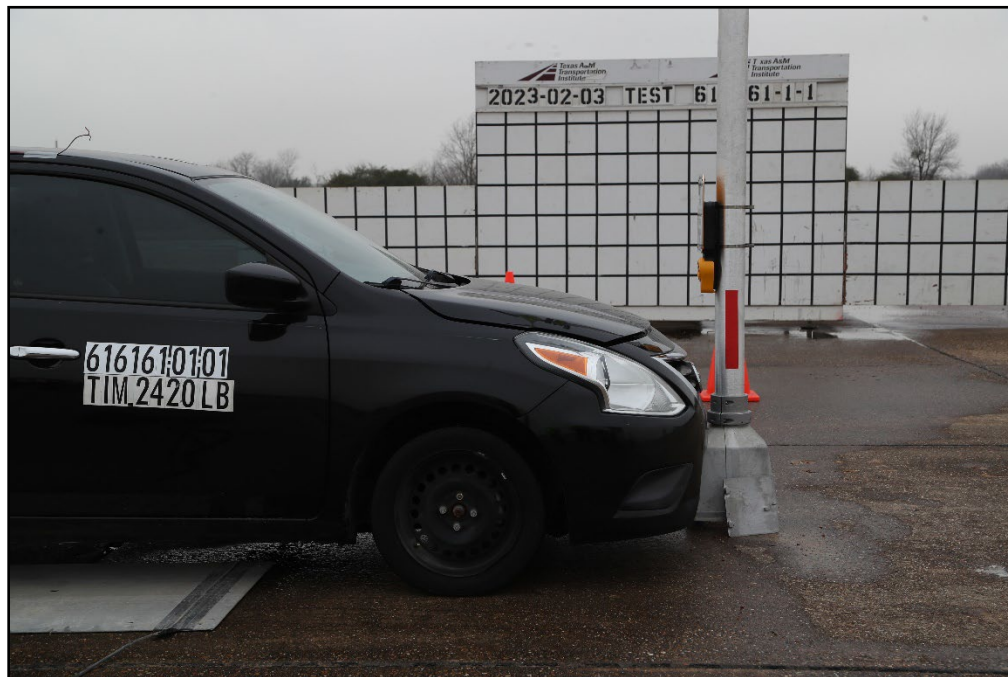
Figure 5.2. Crashworthy Enhanced Highway Sign Assemblies/Test Vehicle Impact Location 616161-01-1.

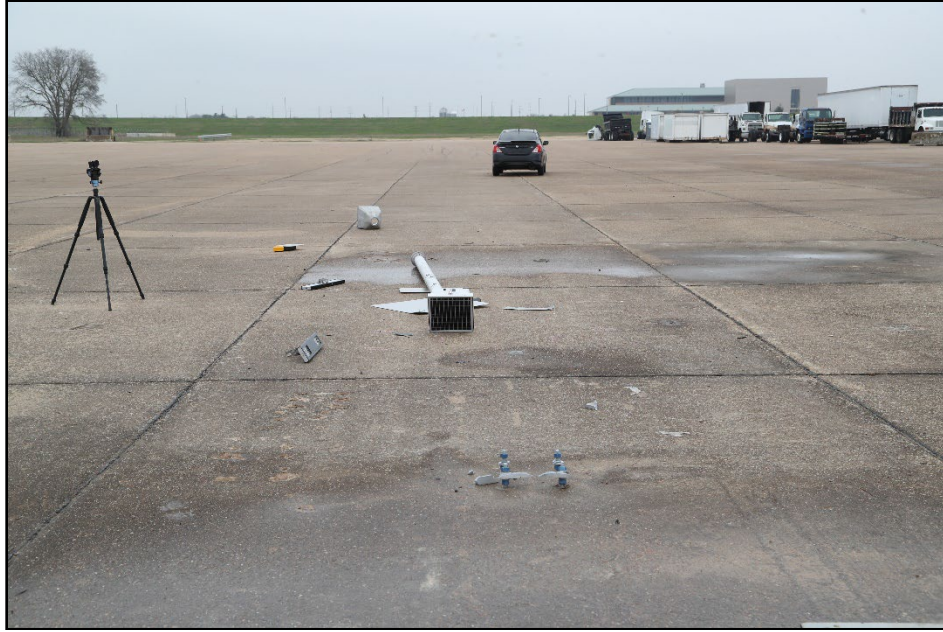
Figure 5.5. Crashworthy Enhanced Highway Sign Assemblies after Test at Impact Location 616161-01-1.

The anchor bolts remained embedded in the concrete, but they were bent. The post landed 20 feet downstream and in-line with the impact path. The debris field from minor components of the installation spanned from the impact path to 10 feet to the left and 50 feet downstream. Figure 5.5 and Figure 5.6 show the damage to the Crashworthy Enhanced Highway Sign Assemblies.

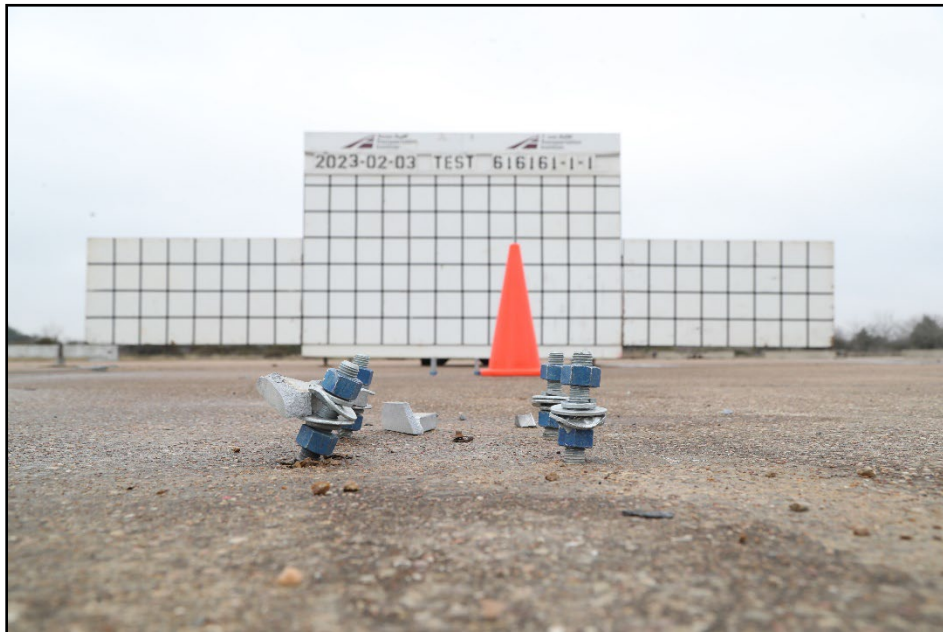
Figure 5.6. Crashworthy Enhanced Highway Sign Assemblies after Test at the Anchor Bolts 616161-01-1.

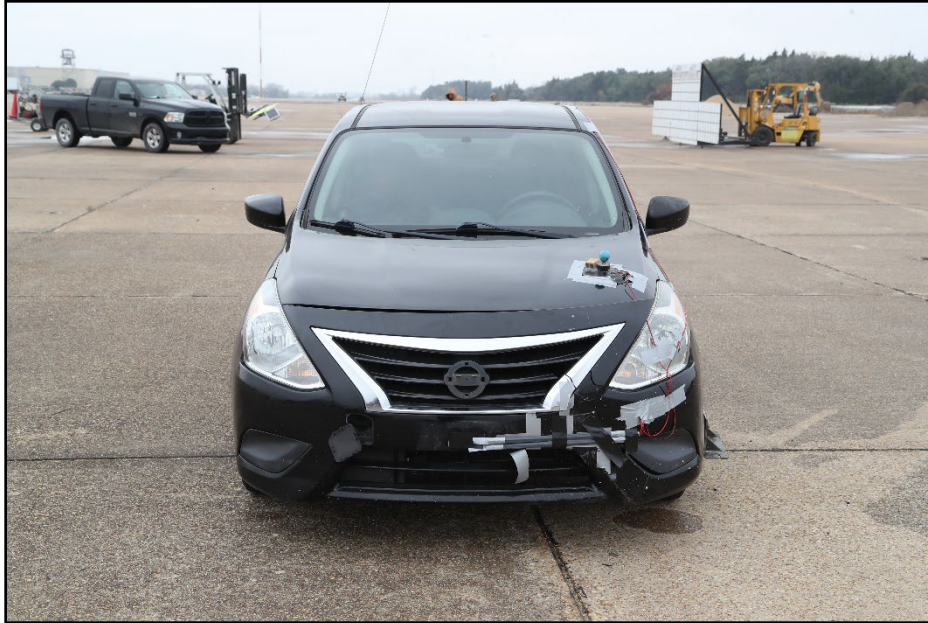
Figure 5.7. Impact Side of Test Vehicle after Test 616161-01-1.

Figure 5.7 and Figure 5.8 show the damage sustained by the vehicle. Figure 5.9 and Figure 5.10 show the interior of the test vehicle. Table 5.7 and Table 5.8 provide details on the occupant compartment deformation and exterior vehicle damage. Figures C.2 and C.3 in Appendix C.1 provide exterior crush and occupant compartment measurements.

Side Windows	The side windows remained intact
Maximum Exterior Deformation	½ inch in the front plane at bumper height
VDS	12FL1
CDC	12FLEN1
Fuel Tank Damage	None
Description of Damage to Vehicle:	The front bumper, trunk lid and spoiler were damaged. The trunk lid had a dent measuring 6 × 8 inches and 0.75 inches deep. The spoiler had a 14-inch long × 5-inch wide break on the left side.

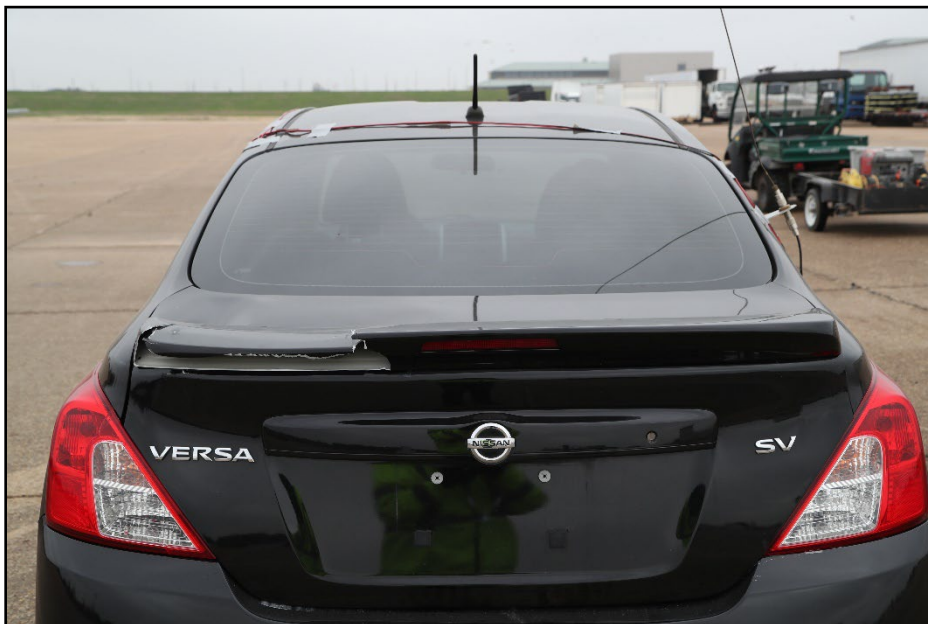
Figure 5.8. Rear Impact Side of Test Vehicle after Test 616161-01-1.

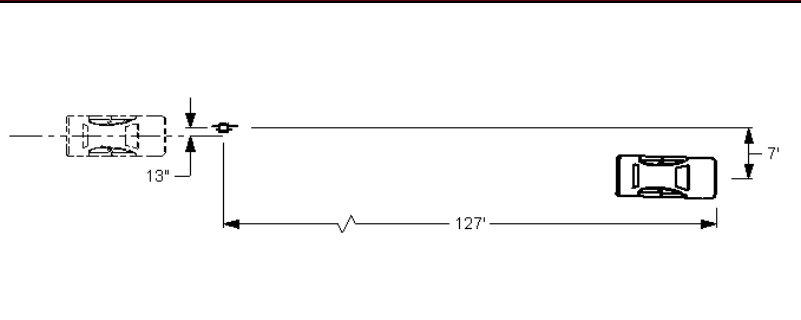
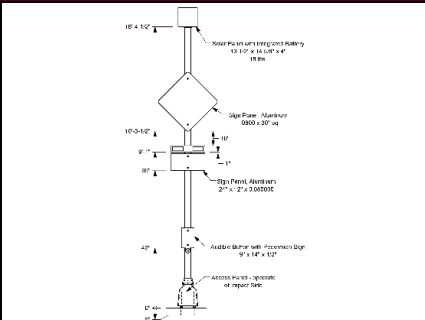
Figure 5.11. Summary of Results for MASH Test 3-60 on Crashworthy Enhanced Highway Sign Assemblies.

Test Date	2023-02-03		
	TEST ARTICLE			
	Type	Support Structure		
Name	Crashworthy Enhanced Highway Sign Assemblies			
Height	16 ft-4½ inches			
Key Materials	4 inch sch. 40 Aluminum pipe, transformer base, 0.08 × 30-inch aluminum sign panel, solar panel, 24 × 12 aluminum sign panel, audible button with sign			
Soil Type and Condition	Concrete, wet

TEST VEHICLE			
	Type/Designation	1100C		
	Year, Make and Model	2017 Nissan Versa		
	Inertial Weight (lb)	2433		
	Dummy (lb)	165		
Gross Static (lb)	2598			
 	IMPACT CONDITIONS			
	Impact Speed (mi/h)	18.9		
	Impact Angle (deg)	0		
	Impact Location	Centerline of the sign post aligned 13 off the centerline of the vehicle towards the driver side		
Kinetic Energy (kip-ft)	29.1			
EXIT CONDITIONS				
Exit Speed (mi/h)	15.0

Stopping Distance	127 ft downstream 7 ft to the right side			
VEHICLE DAMAGE				
VDS	12FL1			
CDC	12FLEN1			
Max. Ext. Deformation	½ inch			
Max Occupant Compartment Deformation	No Occupant Compartment Deformation			
OCCUPANT RISK VALUES				
Long. OIV (ft/s)	5.4	Max 50-ms Long. (g)	-3.2	
Lat. OIV (ft/s)	0.7	Max 50-ms Lat. (g)	-0.6	
Long. Ridedown (g)	0.5	Max 50-ms Vert. (g)	-1.7	
Lat. Ridedown (g)	0.5	Max Roll (deg)	3	
THIV (m/s)	1.7	Max Pitch (deg)	1	
ASI	0.3	Max Yaw (deg)	1	
OCCUPANT RISK VALUES

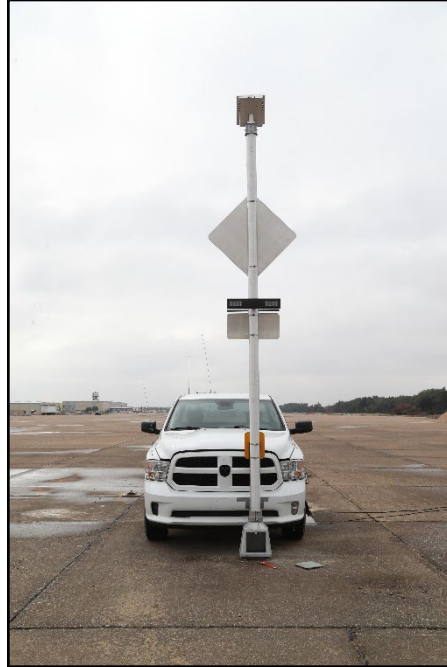
Figure 6.1. Crashworthy Enhanced Highway Sign Assemblies/Test Vehicle Geometrics for Test 616161-01-2.

See Table 6.1 for details on *MASH* impact conditions for this test and Table 6.2 for the exit parameters. Figure 6.1 and Figure 6.2 depict the target impact setup.

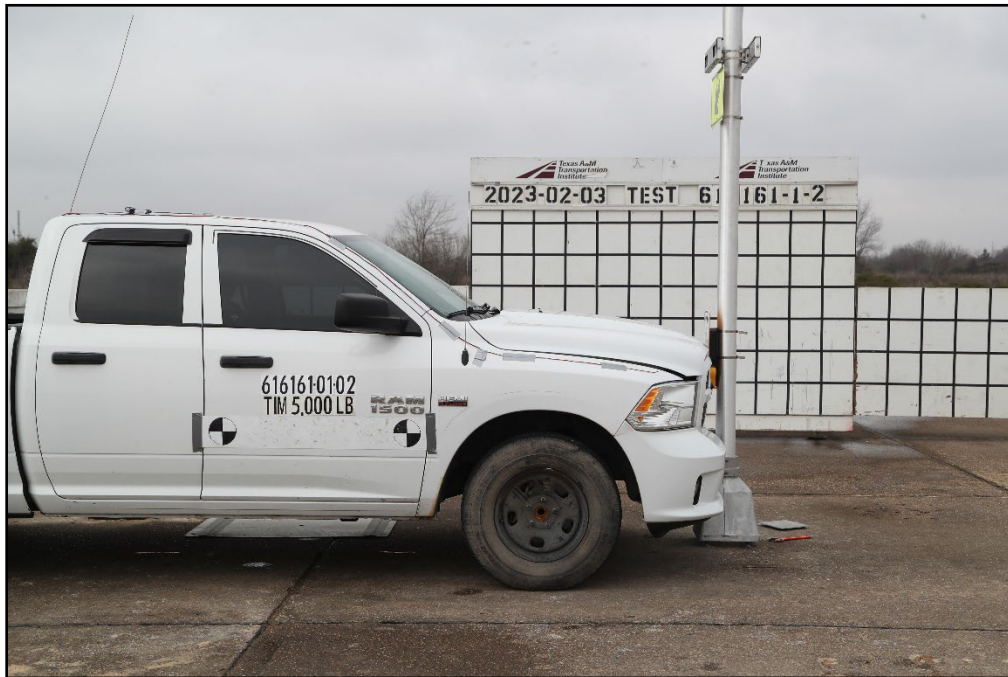
Figure 6.2. Crashworthy Enhanced Highway Sign Assemblies/Test Vehicle Impact Location 616161-01-2.

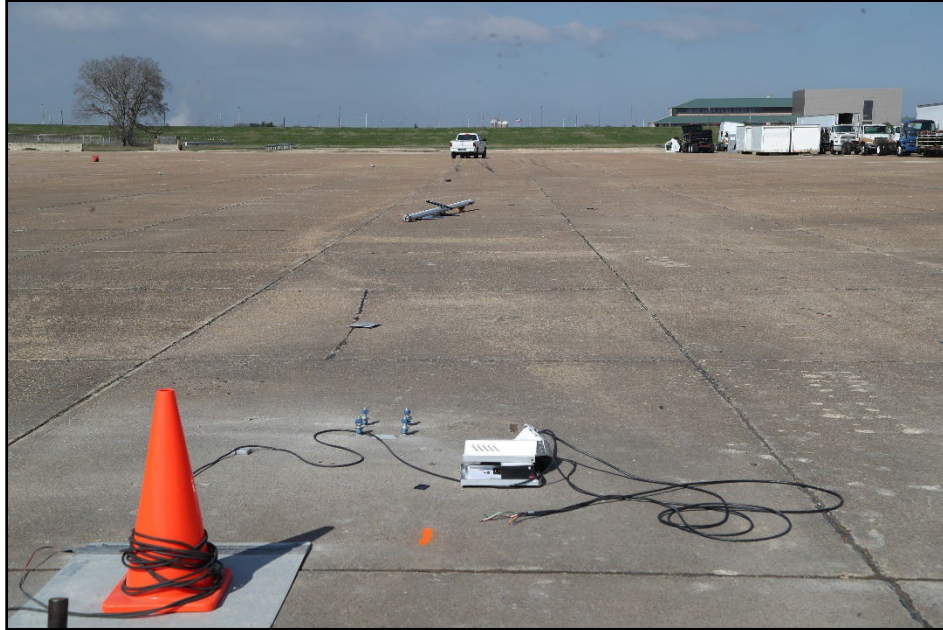
Figure 6.5. Crashworthy Enhanced Highway Sign Assemblies after Test at Impact Location 616161-01-2.

The anchor bolts remained embedded in the concrete, but they were bent. The debris field from the components of the installation spanned from the 2.5 feet to the right to 18 feet to the left and from 2.5 feet upstream to 220 feet downstream. The base of the sign remained under the vehicle. Figure 6.5 and Figure 6.6 show the damage to the Crashworthy Enhanced Highway Sign Assemblies.

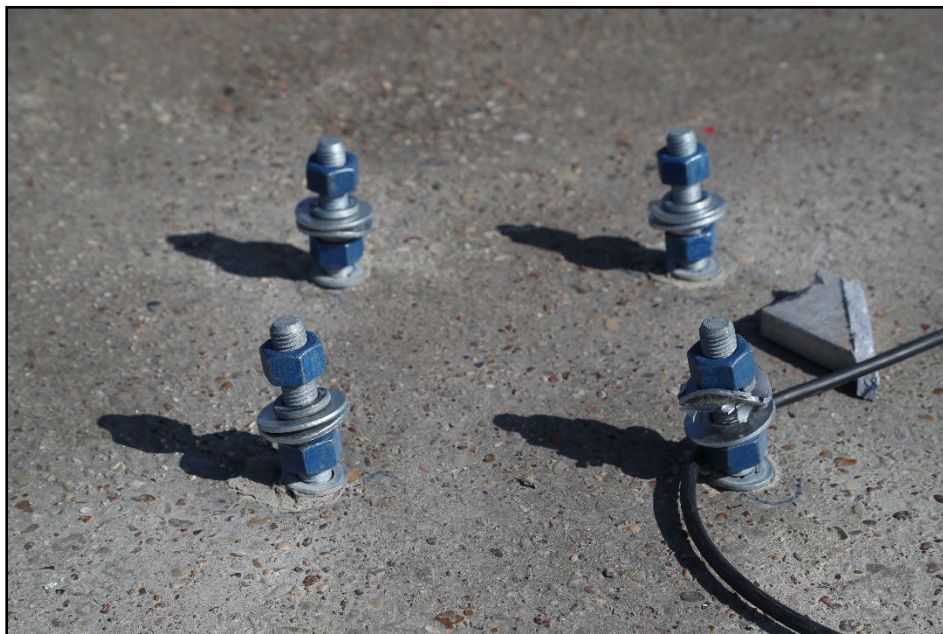
Figure 6.6. Crashworthy Enhanced Highway Sign Assemblies after Test at the Anchor Bolts 616161-01-2.

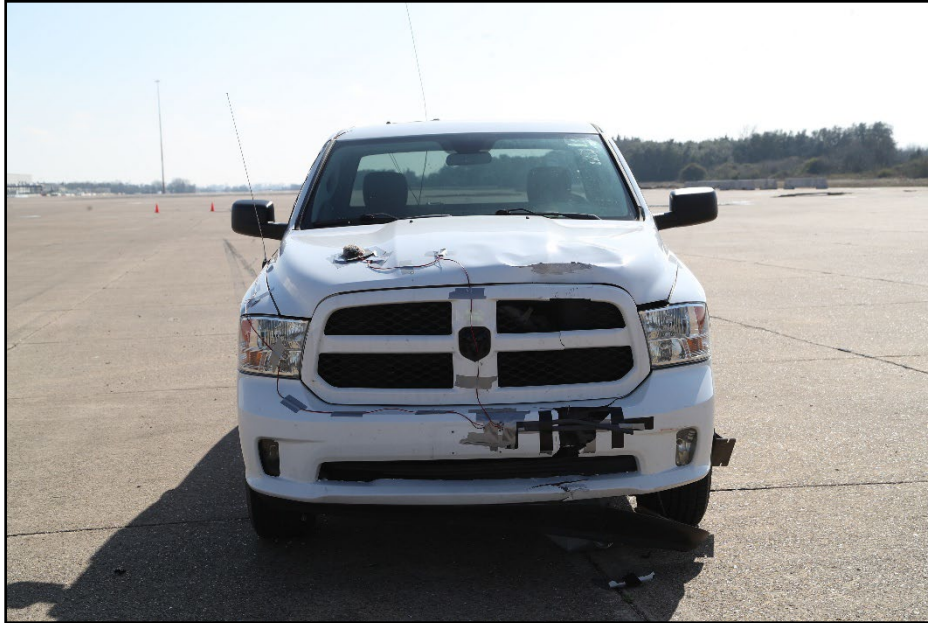
Figure 6.7. Impact Side of Test Vehicle after Test 616161-01-2.

Figure 6.7 and Figure 6.8 show the damage sustained by the vehicle. Figure 6.9 and Figure 6.10 show the interior of the test vehicle. Table 6.7 and Table 6.8 provide details on the occupant compartment deformation and exterior vehicle damage. Figures D.2 and D.3 in Appendix D.1 provide exterior crush and occupant compartment measurements.

Side Windows	The side windows remained intact
Maximum Exterior Deformation	3.5 inches in the front plane at bumper height
VDS	12FL2
CDC	12FLEN1
Fuel Tank Damage	None
Description of Damage to Vehicle:	The front bumper, grill, and hood were damaged. The front bumper had a 8 × 14-inch dent 3.5 inches deep 13 inches to the left of the vehicle's centerline. The hood had a 16 × 11-inch dent that measured 2.5 inches convex in some places and 0.75 inches concave in others.

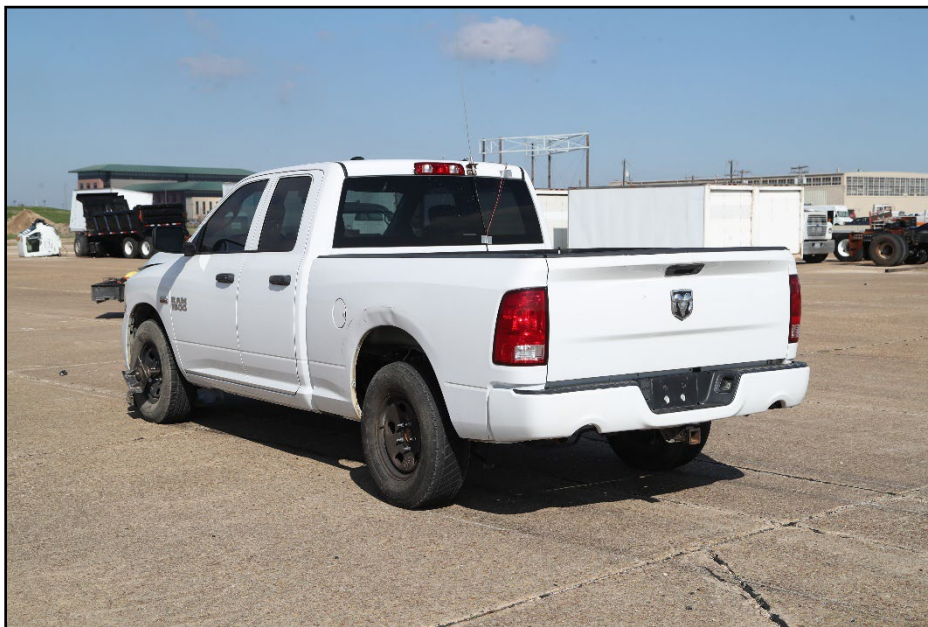
Figure 6.8. Rear Impact Side of Test Vehicle after Test 616161-01-2.

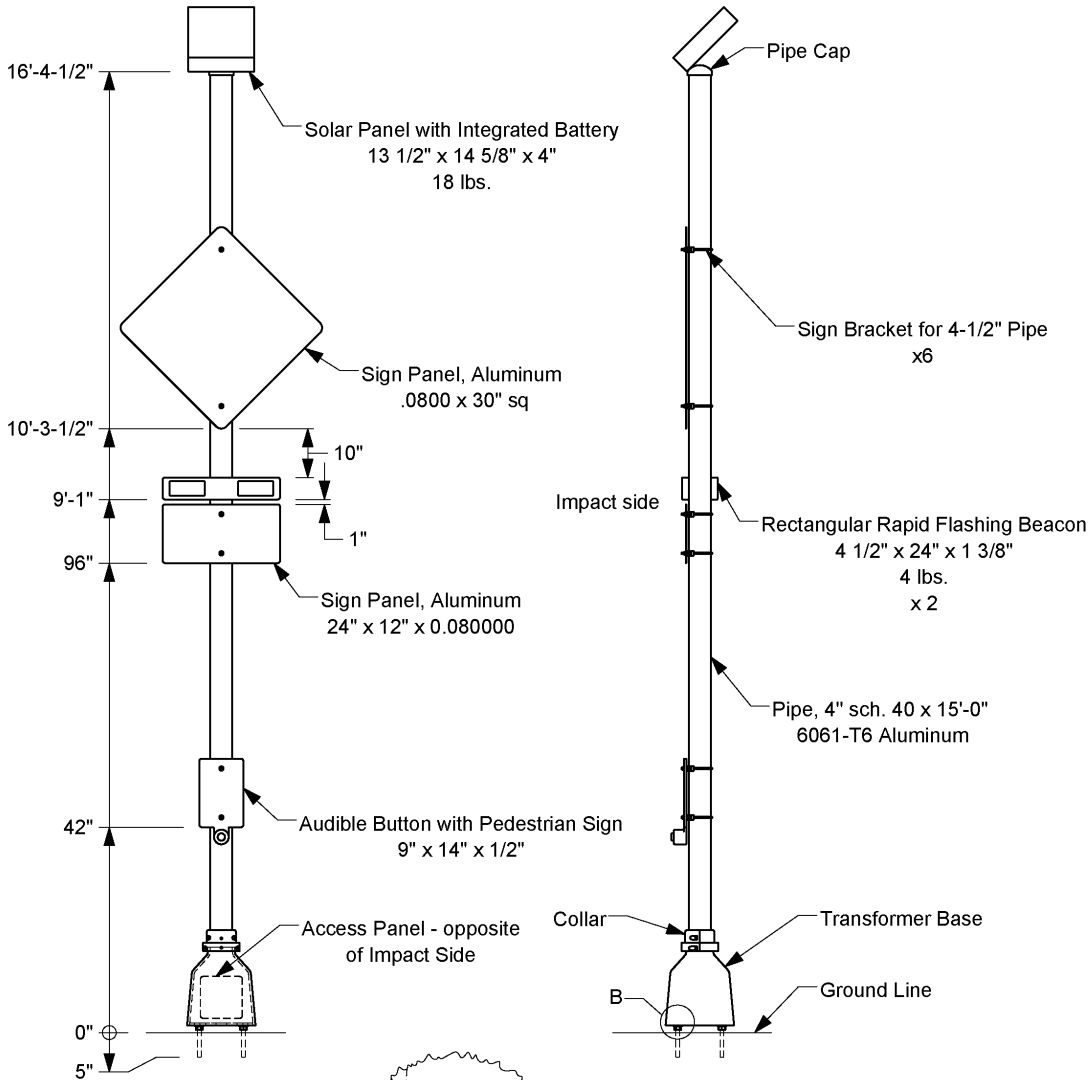
Test Installation

B7 Threaded Rod (x 4), Ø3/4" x 9"
Secure in existing concrete with Hilti
HIT-HY 200-R epoxy.
Leave 4" protruding from concrete.

1a. Sign panels and Flashing Beacon
mount with brackets (see "Parts" sheet)
and worm gear clamps (hose clamps).

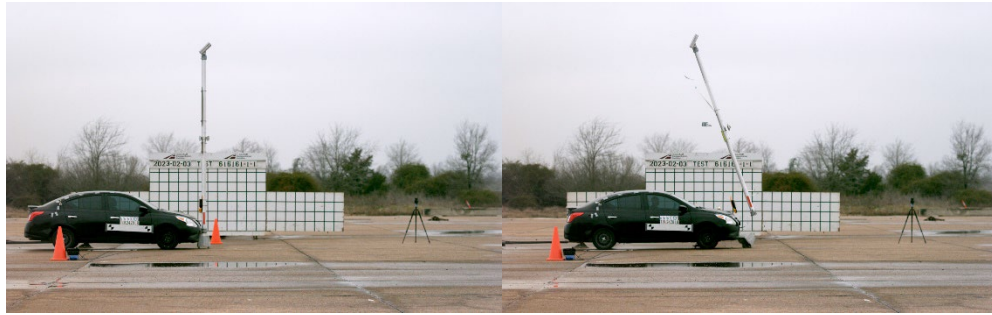
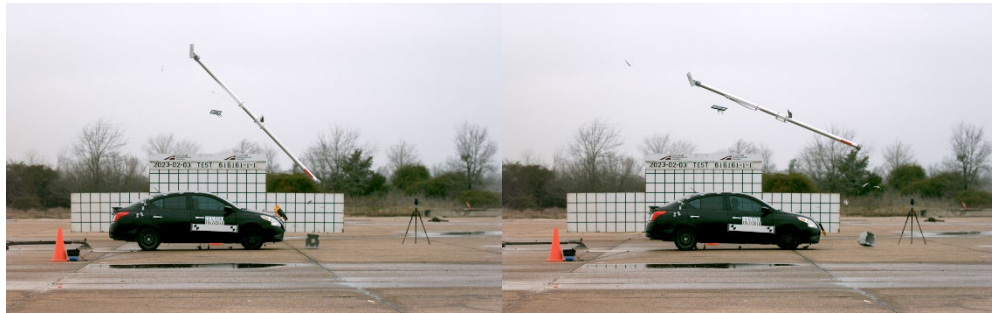
Figure C.4. Sequential Photographs for Test No. 616161-01-1 (Right Angle Views).

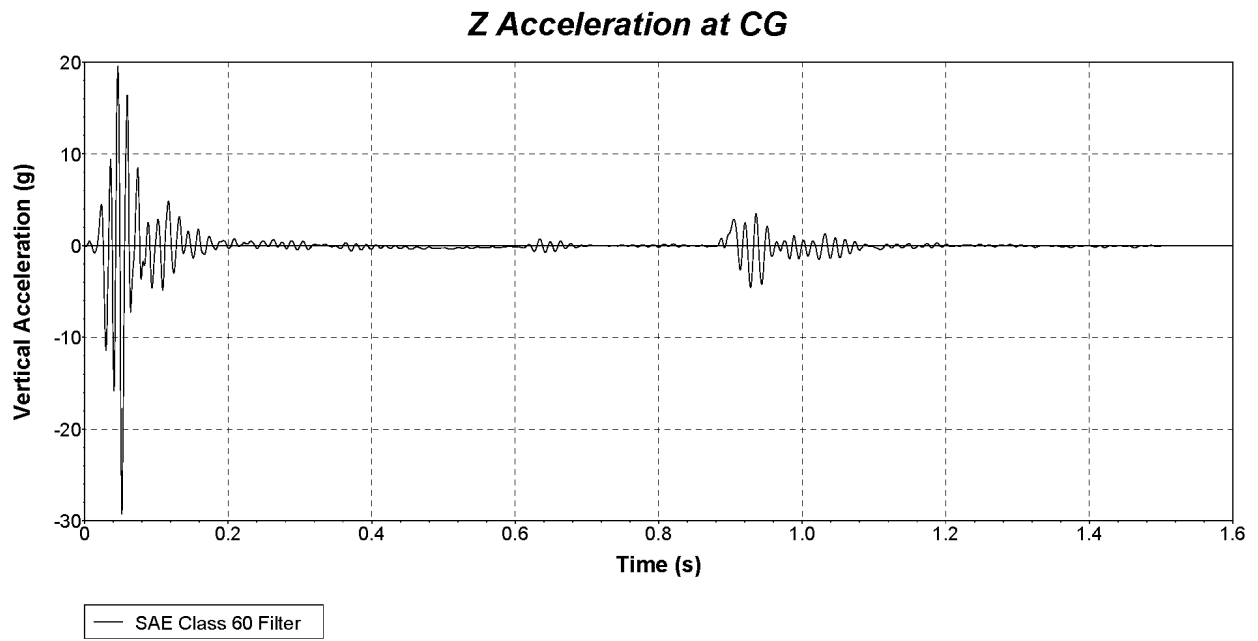
**Figure C.9. Vehicle Vertical Accelerometer Trace for Test No. 616161-01-1
(Accelerometer Located at Center of Gravity).**
