Roadside Safety Pooled Fund

**Texas A&M
Transportation
Institute**
Proving Ground

Test Report No. 610211-01, REV 1
Test Report Date: October 2021
REV 1: March 2023

MASH CRASH TESTING AND EVALUATION OF THE MGS WITH REDUCED POST SPACING

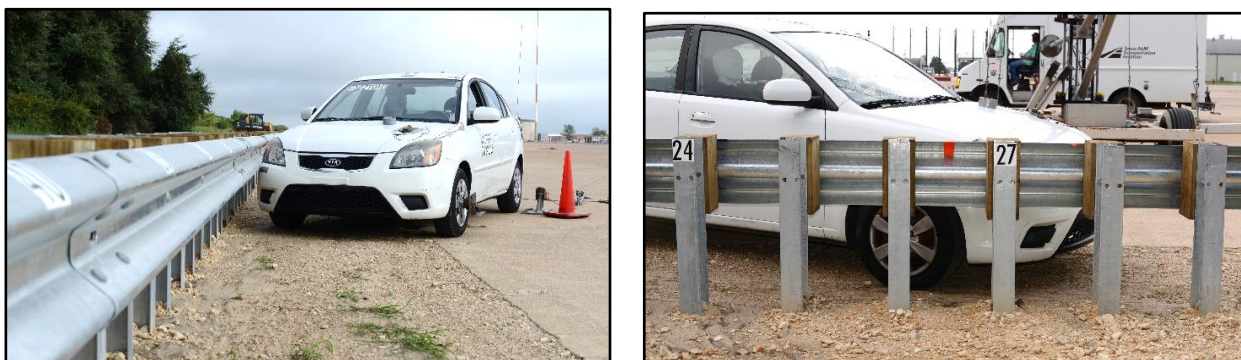
Figure 4.3. Guardrail/Test Vehicle Geometrics for Test No. 610211-01-1.

MASH Test 3-10 involves an 1100C vehicle weighing 2420 lb \pm 55 lb impacting the CIP of the guardrail at an impact speed of 62 mi/h \pm 2.5 mi/h and an angle of 25 degrees \pm 1.5 degrees. The CIP for *MASH* Test 3-10 on the MGS with quarter post spacing was 73 inches \pm 12 inches upstream of post 31 (see Figure 2.1 and Figure 4.3).

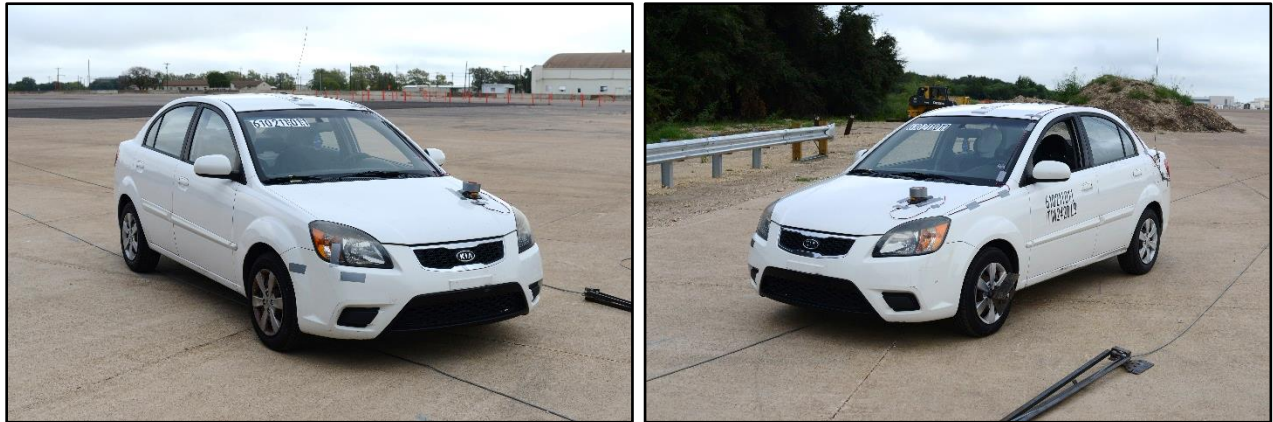
Figure 4.4. Test Vehicle before Test No. 610211-01-1.

Figures 4.3 and 4.4 show the 2010 Kia Rio* used for the crash test. The vehicle's test inertia weight was 2453 lb, and its gross static weight was 2618 lb. The height to the lower edge of the vehicle bumper was 7.75 inches, and the height to the upper edge of the bumper was 21.5 inches. Table D.1 in Appendix D gives additional dimensions and information on the vehicle. The vehicle was directed into the installation using the cable reverse tow and guidance system. It was released to be freewheeling and unrestrained just prior to impact.

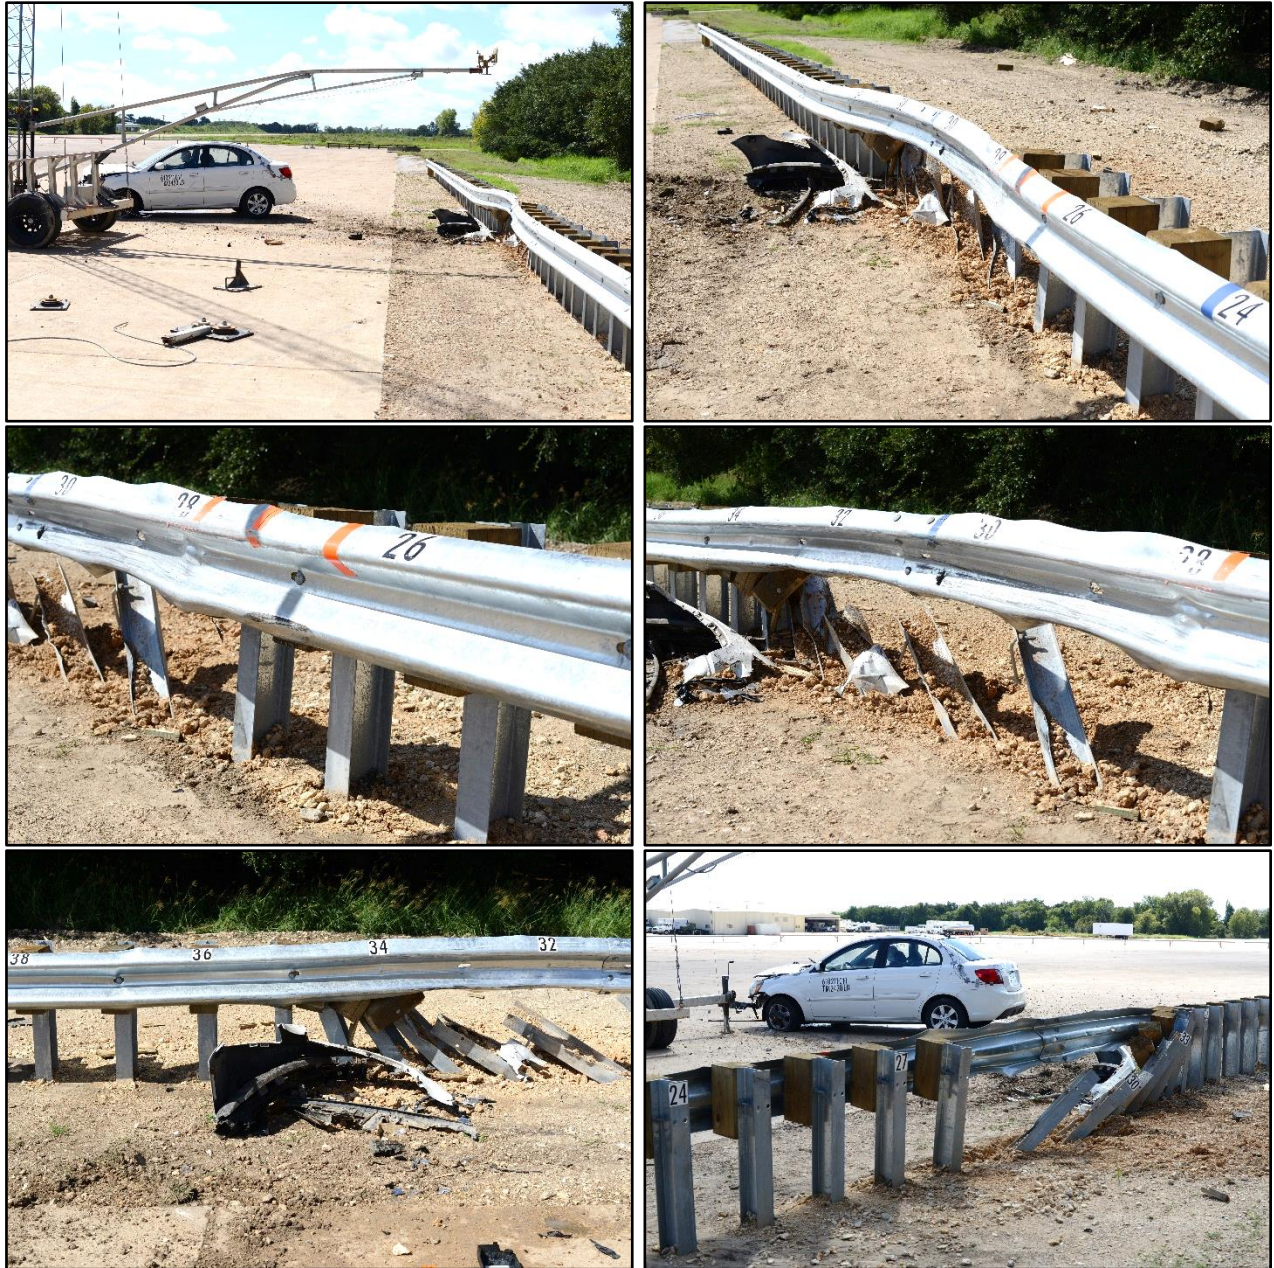
Figure 4.5. MGS with Quarter Post Spacing after Test No. 610211-01-1.

Figure 4.5 shows the damage to the MGS with quarter post spacing. No visible movement was noted at posts 1 through 24. Posts 29-34 were all deformed and leaning downstream. The soil around post 37 was disturbed, and there was no movement noted at posts 38 to the end. Table 4.2 provides additional measurements regarding the posts movement through the soil. Working width was 16.4 inches, and height of working width was 29.0 inches. Maximum dynamic deflection during the test was 16.4 inches, and maximum permanent deformation of the W-beam rail was 7.5 inches.

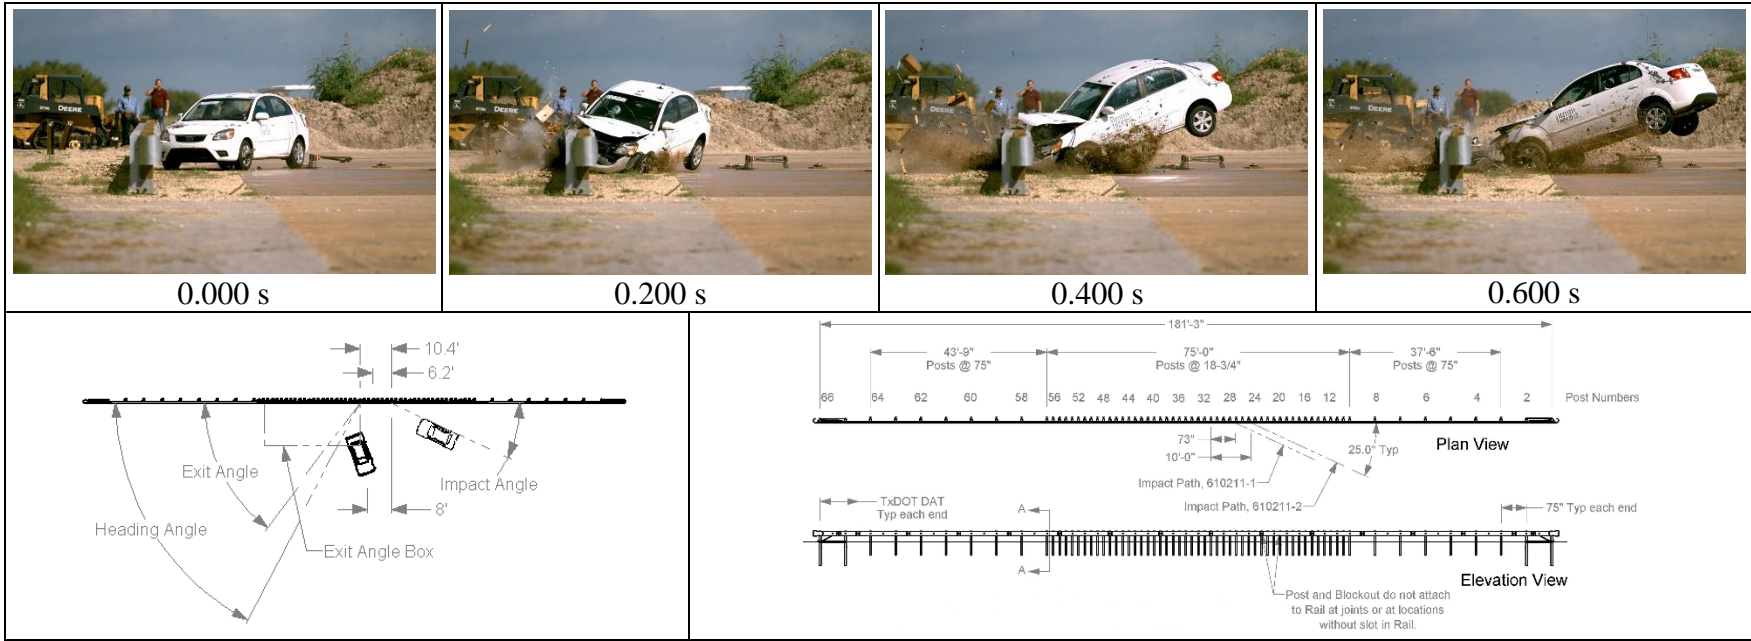
Test Agency..... Texas A&M Transportation Institute (TTI)
 Test Standard Test No..... MASH Test 3-10
 TTI Test No. 610211-01-1
 Test Date 2018-10-04

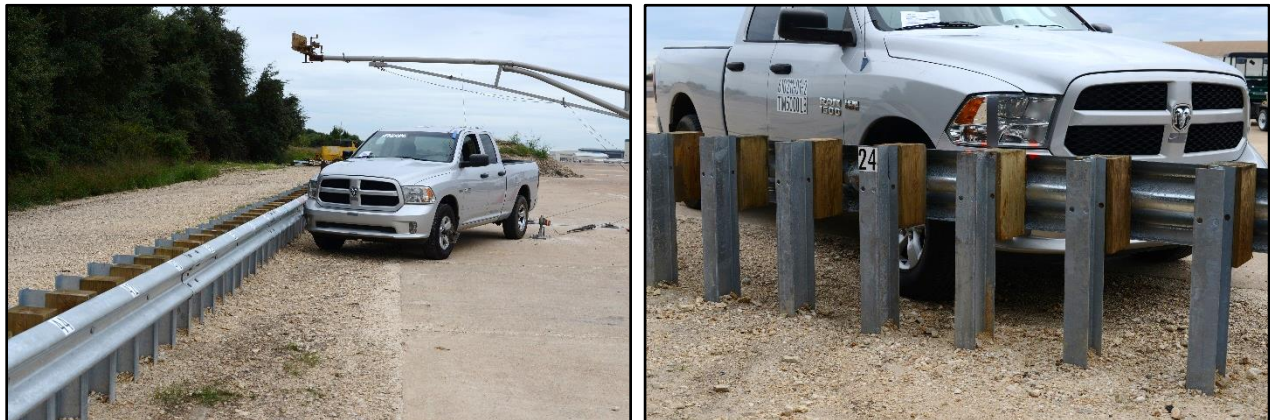
Figure 4.9. Guardrail/Test Vehicle Geometrics for Test No. 610211-01-2.

MASH Test 3-11 involves a 2270P vehicle weighing 5000 lb \pm 110 lb impacting the CIP of the guardrail at an impact speed of 62 mi/h \pm 2.5 mi/h and an angle of 25 degrees \pm 1.5 degrees. The CIP for MASH Test 3-11 on the MGS with quarter post spacing was 120 inches \pm 12 inches upstream of post 31 (see Figure 2.1 and Figure 4.9).

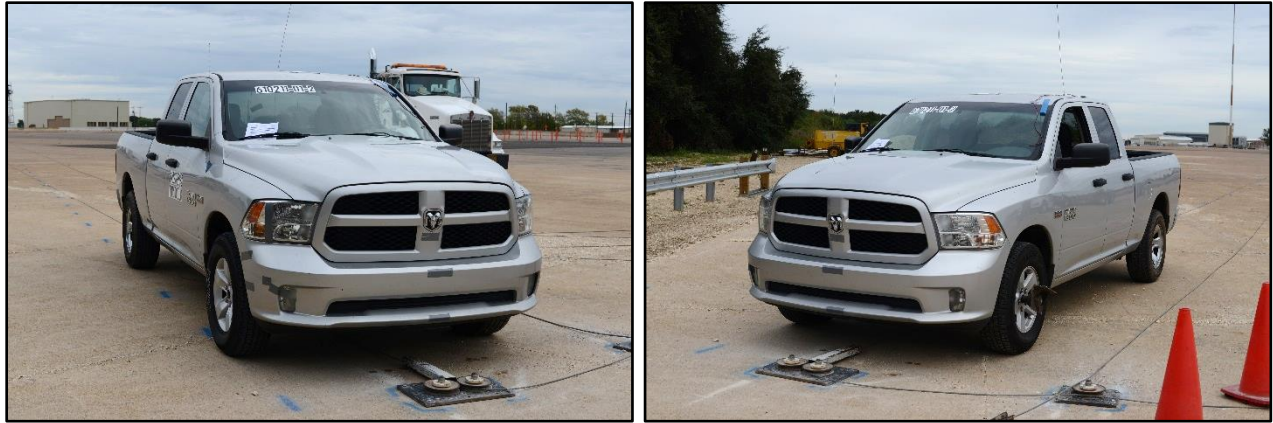
Figure 4.10. Test Vehicle before Test No. 610211-01-2.

Figures 4.9 and 4.10 show the 2014 RAM 1500 pickup truck used for the crash test. The vehicle's test inertia weight was 5007 lb, and its gross static weight was 5007 lb. The height to the lower edge of the vehicle bumper was 11.75 inches, and the height to the upper edge of the bumper was 27 inches. The height to the center of gravity of the vehicle was 28.3 inches. Tables E.1 and E.2 in Appendix E1 give additional dimensions and information on the vehicle. The vehicle was directed into the installation using the cable reverse tow and guidance system. It was released to be freewheeling and unrestrained just prior to impact.

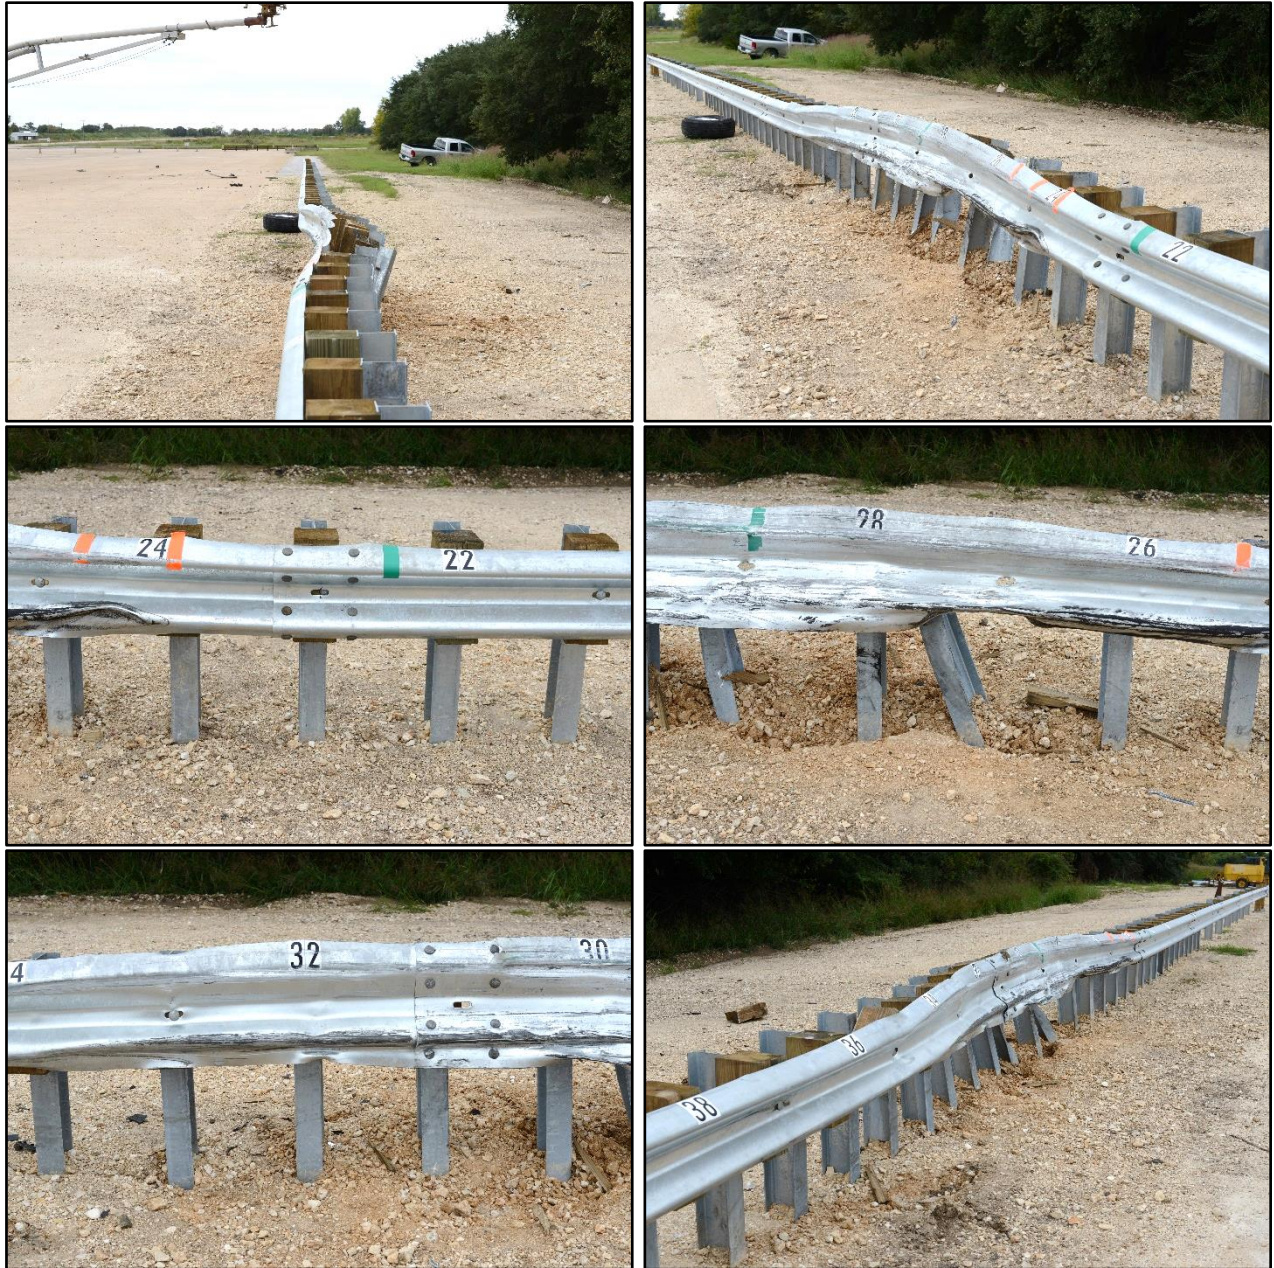
Figure 4.11. MGS System with Quarter Post Spacing after Test No. 610211-01-2.

Figure 4.11 shows the damage to the MGS with quarter post spacing. The soil around post 1 was disturbed, and the rail released from the blockouts at posts 27, 29, and 31. The soil around posts 21 and 22 was disturbed, and posts 26 through 31 were pushed downstream and toward the field side. Table 4.5 provides additional measurements. Working width was 37.1 inches, and height of working width was 27.9 inches. Maximum dynamic deflection during the test was 19.5 inches, and maximum permanent deformation of the W-beam rail was 11.0 inches.

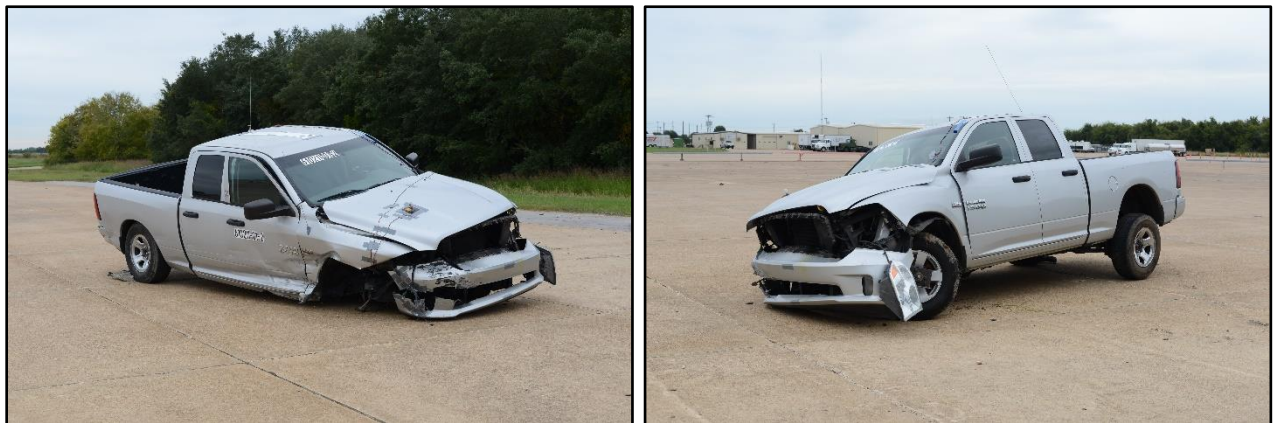
Figure 4.12. Test Vehicle after Test No. 610211-01-2.

Figure 4.12 shows the damage sustained by the vehicle. The front bumper, radiator and support, grill, right head light, right front fender, right front upper and lower A arms, right front tire and rim, right frame rail, right front door (4-inch gap at top of door), right front floor pan, right rear door, right rear fender, right rear rim, and right bumper were damaged. No damage to the fuel tank was observed. Maximum exterior crush to the vehicle was 15 inches in the front plane on the right side above the front bumper. Maximum occupant compartment deformation was 2 inches in the right front firewall area. Figure 4.13 shows the interior of the vehicle. Tables E.3 and E.4 in Appendix E1 provide exterior crush and occupant compartment measurements.

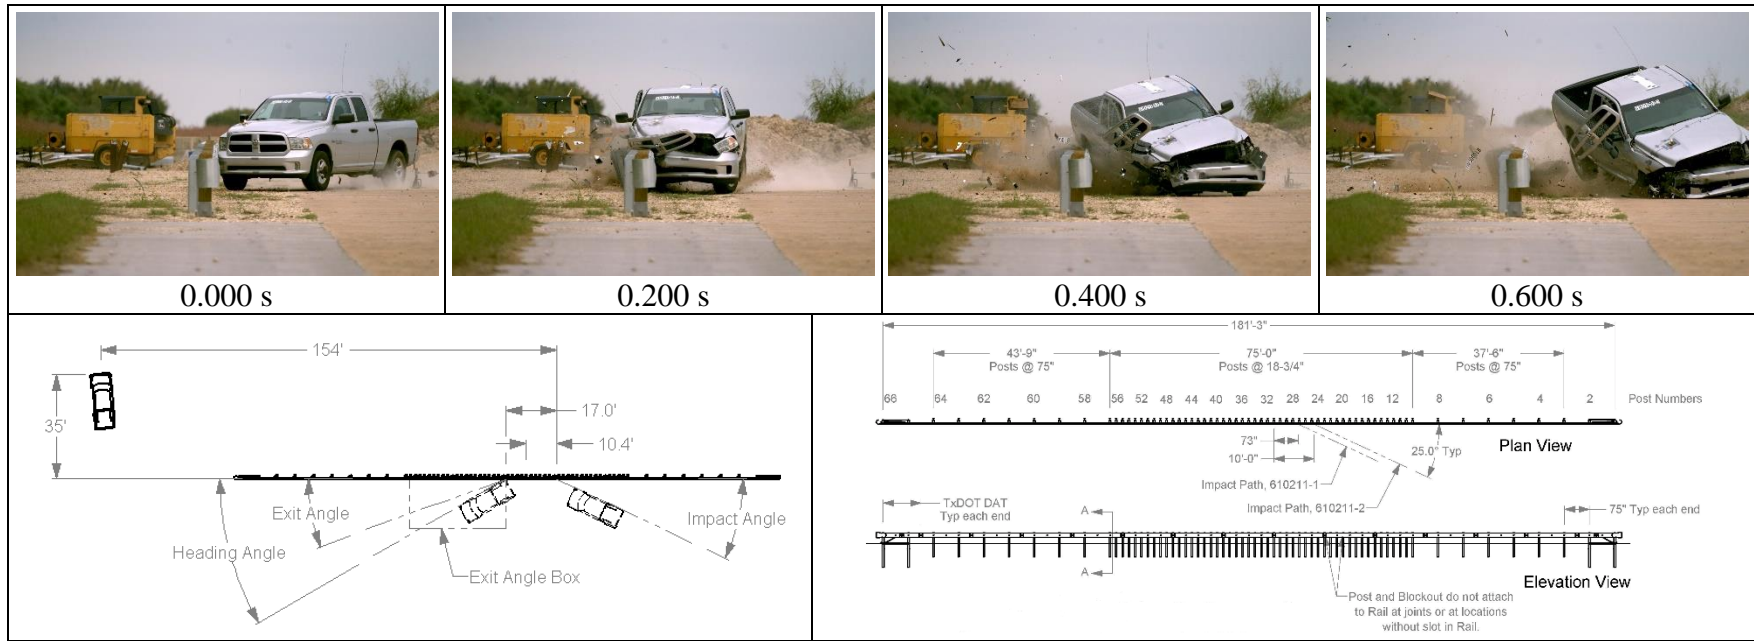
Test Agency..... Texas A&M Transportation Institute (TTI)
 Test Standard Test No. MASH Test 3-11
 TTI Test No. 610211-01-2
 Test Date 2018-10-22

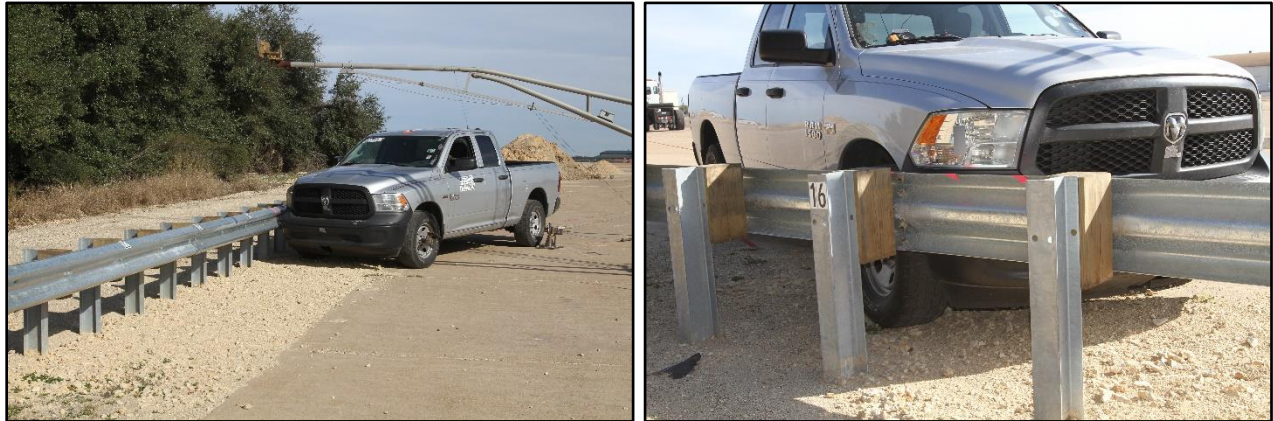
Figure 5.3. MGS with Half Post Spacing/Test Vehicle Geometrics for Test No. 610211-01-3.

MASH Test 3-11 involves a 2270P vehicle weighing 5000 lb \pm 110 lb impacting the CIP of the guardrail at an impact speed of 62 mi/h \pm 2.5 mi/h and an angle of 25 degrees \pm 1.5 degrees. The CIP for MASH Test 3-11 on the MGS with half post spacing was 136 inches \pm 12 inches upstream of post 20 (see Figure 2.2 and Figure 5.3).

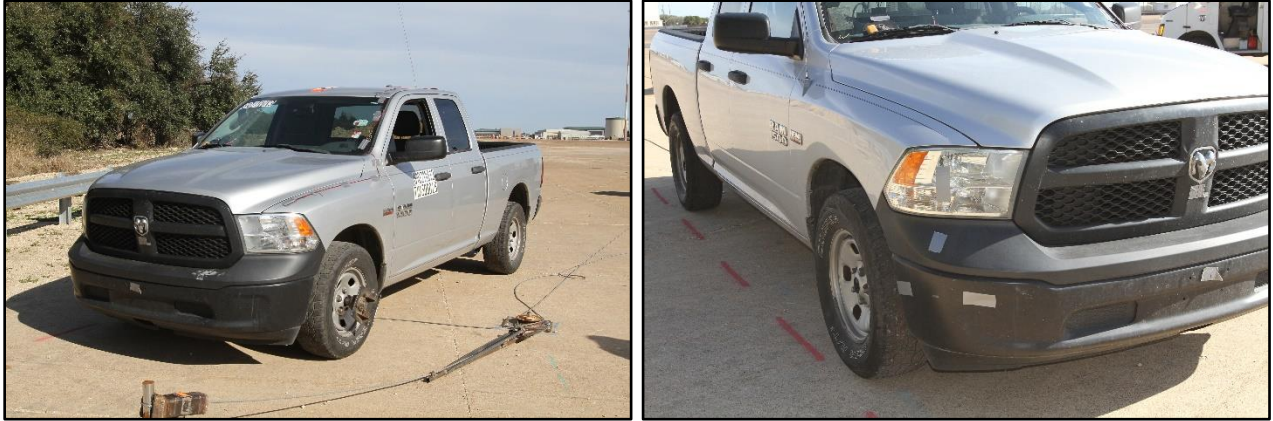
Figure 5.4. Test Vehicle before Test No. 610211-01-3.

Figures 5.3 and 5.4 shows the 2013 RAM 1500 pickup truck used for the crash test. The vehicle's test inertia weight was 5018 lb, and its gross static weight was 5018 lb. The height to the lower edge of the vehicle bumper was 11.75 inches, and the height to the upper edge of the bumper was 27.0 inches. The height to the vehicle's center of gravity was 28.0 inches. Tables G.1 and G.2 in Appendix G1 give additional dimensions and information on the vehicle. The vehicle was directed into the installation using the cable reverse tow and guidance system. It was released to be freewheeling and unrestrained just prior to impact.

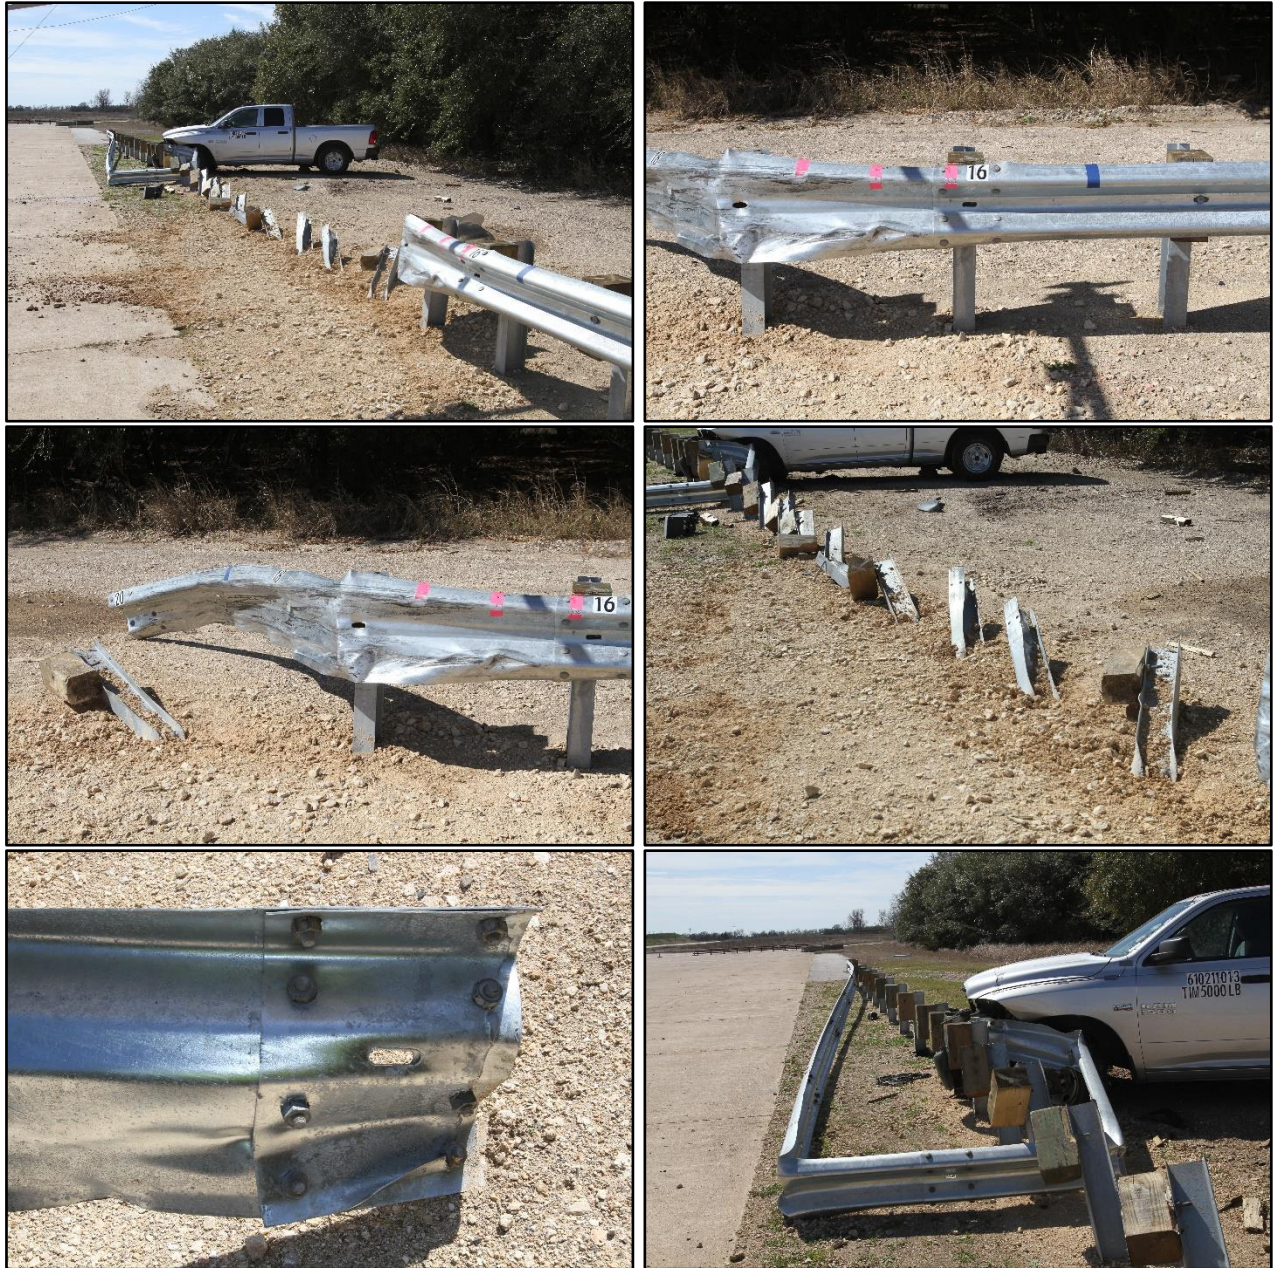
Figure 5.5. MGS with Half Post Spacing after Test No. 610211-01-3.

Figure 5.5 shows the damage to the MGS with half post spacing. The W-beam guardrail ruptured at post 20 and released from post 16 through post 39. The soil was disturbed at post 1. Table 5.2 provides additional measurements.

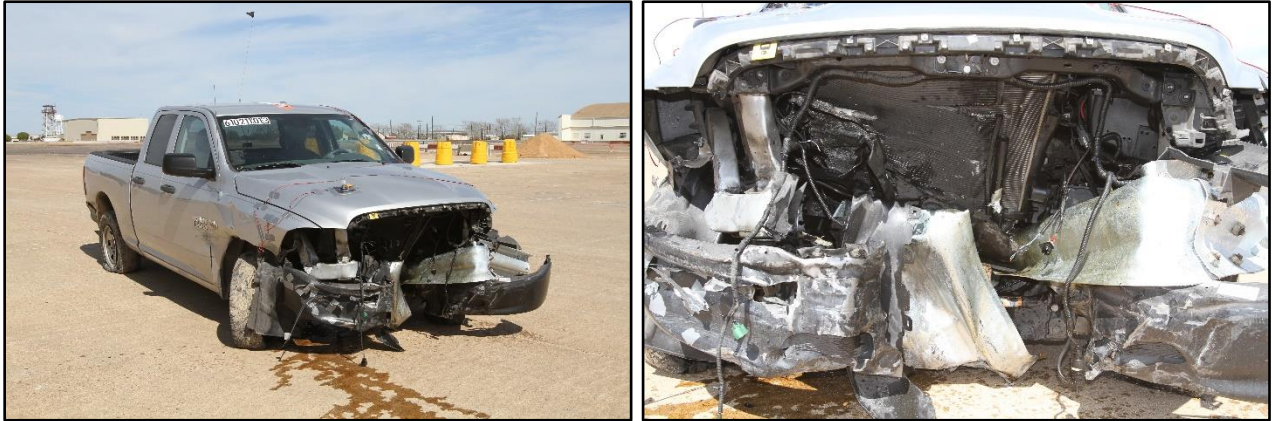
Figure 5.6. Test Vehicle after Test No. 610211-01-3.

Figure 5.6 shows the damage sustained by the vehicle. The front bumper, hood, grill, radiator and support, right and left front fenders, right front and rear doors, rear exterior bed, rear bumper, right front and rear tires and rims, and left front tire were damaged. No damage to the fuel tank was observed. Maximum exterior crush to the vehicle was 22.0 inches in the front plane at the center at bumper height. Maximum occupant compartment deformation was 0.5 inch in the right floorpan. Figure 5.7 shows the interior of the vehicle. Tables G.3 and G.4 in Appendix G1 provide exterior crush and occupant compartment measurements.

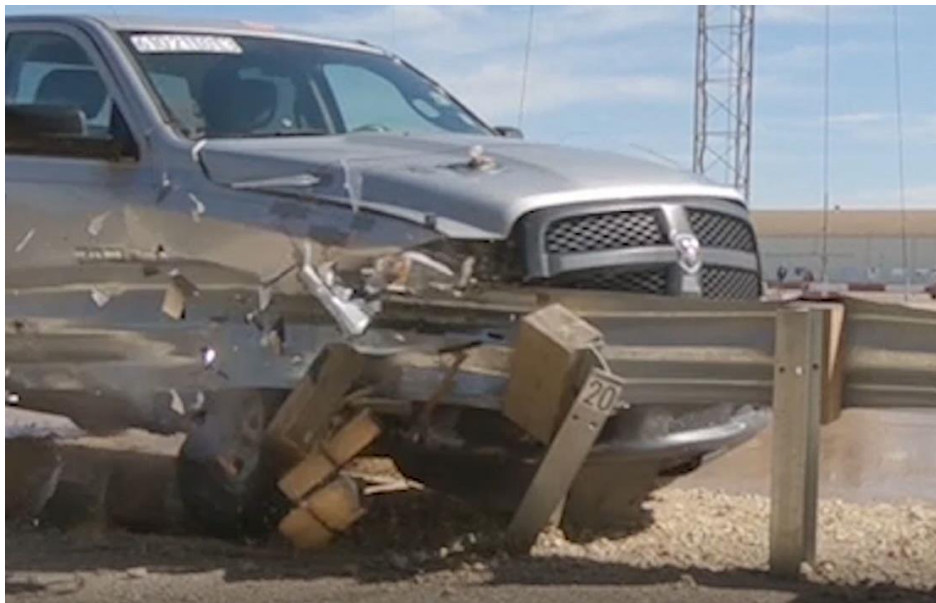
Figure 5.9. Rear View of Rail Rupture.

Following the failed *MASH* test 3-11, the research team investigated the cause of the rail rupture. After a thorough analysis of the damaged installation and the crash test video, the research team determined the rail rupture was caused by a localized interaction between the W-beam rail and the wood blockout. Figure 5.9 shows a rear view of the test installation at the approximate time of rail rupture. As the rail deflected laterally rearward and flattened with the impact of the test vehicle, the edge of the W-beam became intertwined with the wood blockout. As the wood blockout deflected and twisted, the edge of the rail deformed. This deformation caused a tear to initiate in the rail, and the continuing impact event propagated the tear through the rest of the rail cross-section.

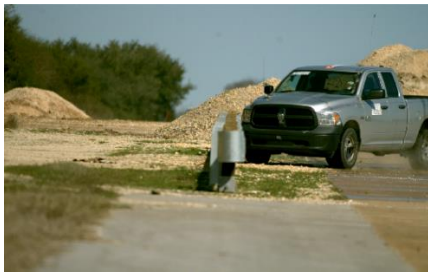
Figure 5.11. Gut View Comparison of Failed *MASH* Test 3-11 Simulation.

The research team first developed the model of the original half post spacing system with 14-inch tall blockouts. The research team had a level of confidence with this model because it was developed with components from previous projects whose models were confirmed to be accurately predicting impact behavior. To further gain confidence in the model, the research team compared the results of the failed crash test and the corresponding computer simulation. Because the model lacked the ability to replicate the rail rupture, the research team confirmed the behavior of the model until the time of rail rupture in the failed test. Figure 5.11 through Figure 5.13 show the comparison between the failed test and the simulation. After comparing the simulation to the failed test, the research team accepted the validity of the model and proceeded with further computer simulation.

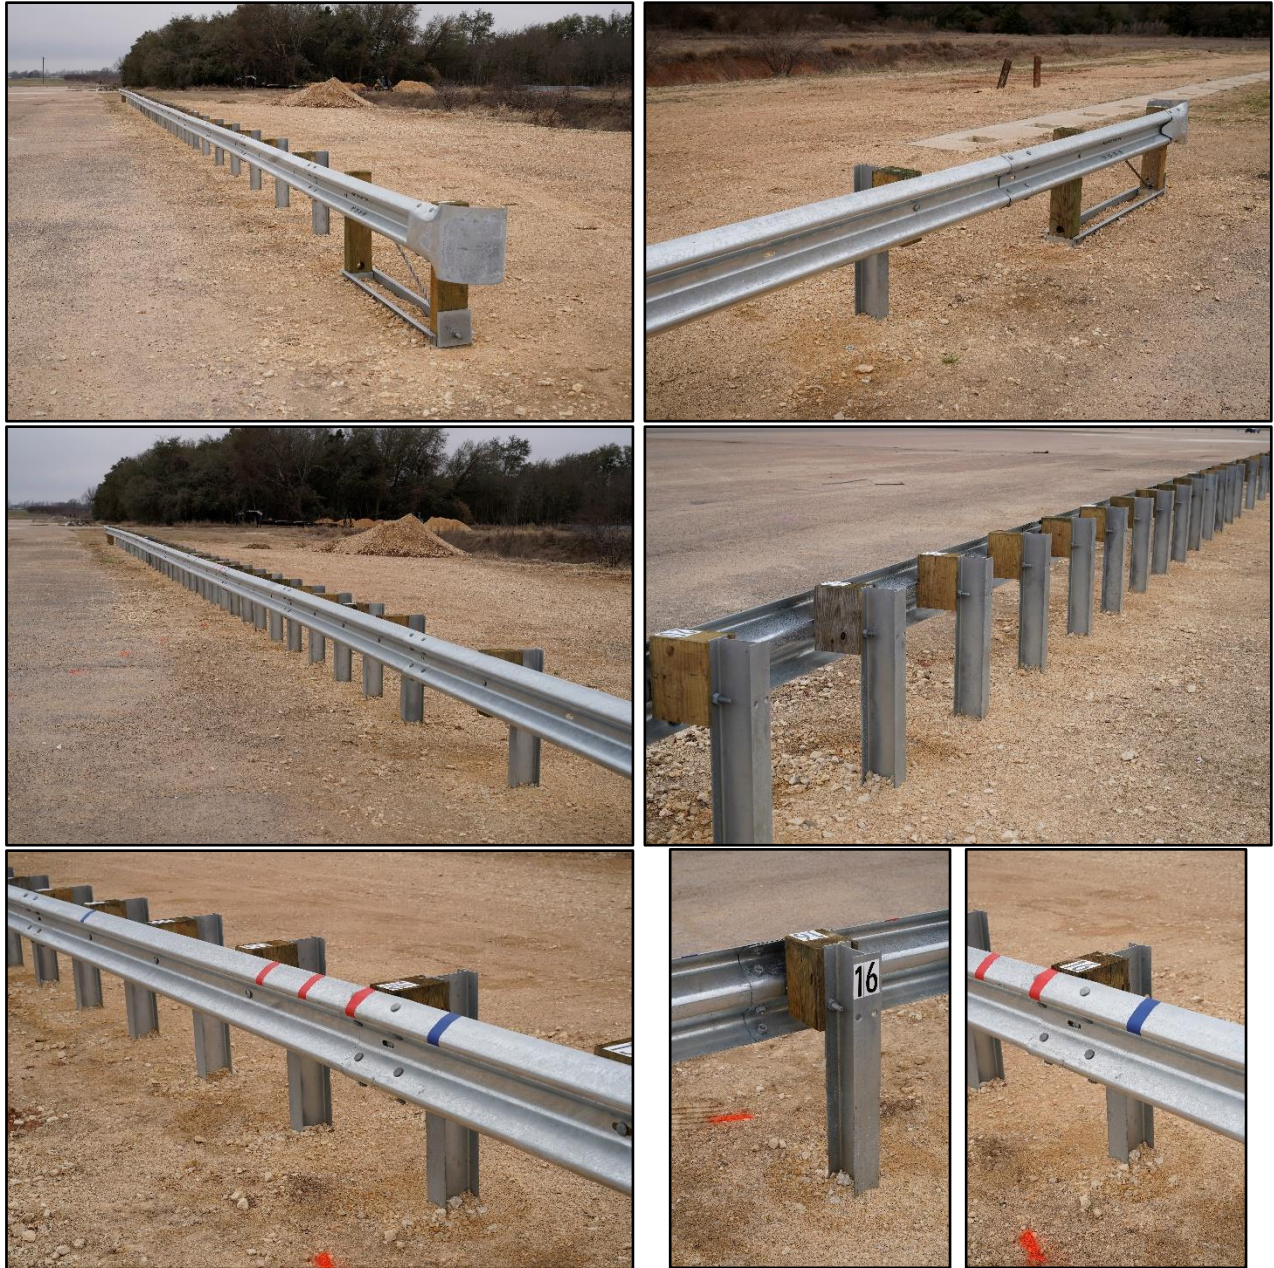
Figure 5.18. MGS with Half Post Spacing and Shortened Blockouts prior to Testing.

Figure 5.17 presents overall information on the MGS with half post spacing and shortened blockouts, and Figure 5.18 provides photographs of the installation. Appendix H provides further details of the MGS with half post spacing and shortened blockouts.

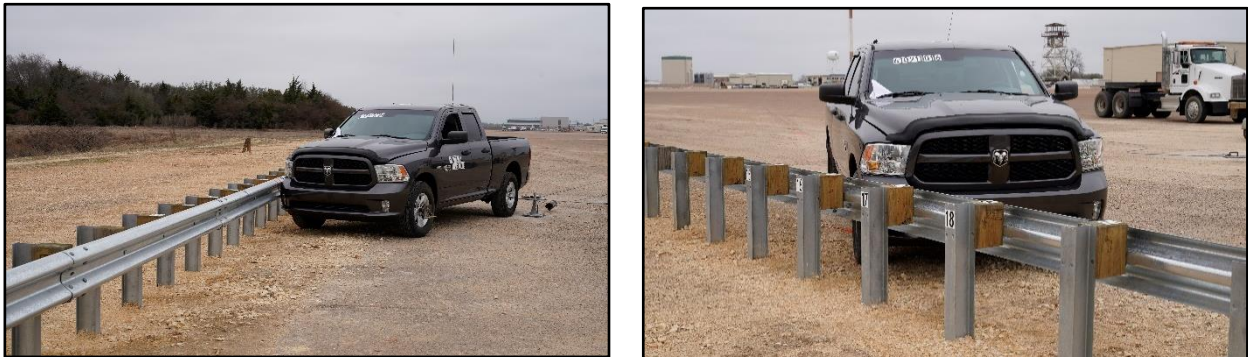
Figure 5.19. Guardrail/Test Vehicle Geometrics for Test No. 610211-01-6.

MASH Test 3-11 involves a 2270P vehicle weighing 5000 lb \pm 110 lb impacting the CIP of the guardrail at an impact speed of 62 mi/h \pm 2.5 mi/h and an angle of 25 degrees \pm 1.5 degrees. The CIP for *MASH* Test 3-11 on the MGS with half post spacing and shortened blockouts was 136 inches \pm 12 inches upstream of post 20 (see Figure 2.3 and Figure 5.19).

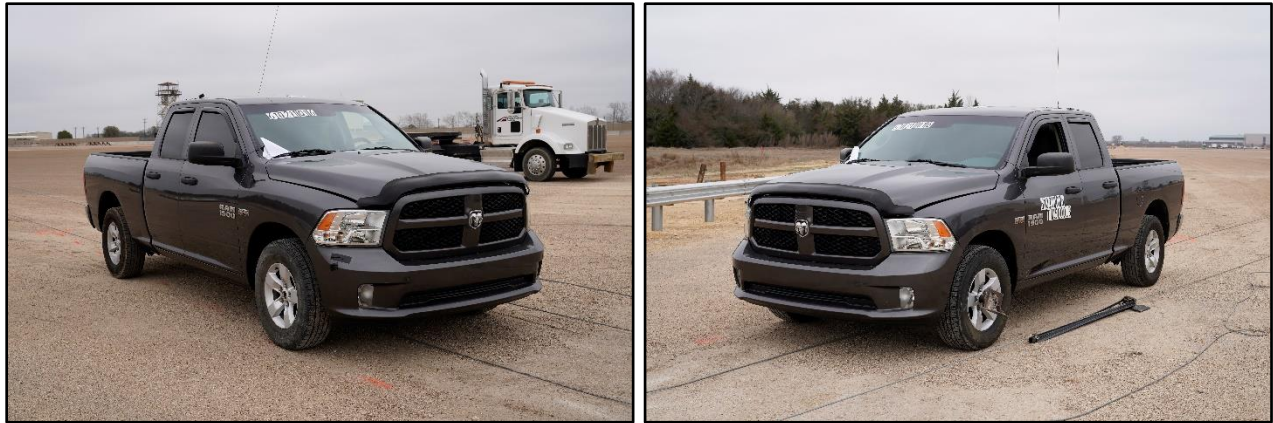
Figure 5.20. Test Vehicle before Test No. 610211-01-6.

Figure 5.20 shows the 2016 RAM 1500 pickup truck used for the crash test. The vehicle's test inertia weight was 5039 lb, and its gross static weight was 5039 lb. The height to the lower edge of the vehicle bumper was 11.75 inches, and the height to the upper edge of the bumper was 27.0 inches. The height to the vehicle's center of gravity was 28.6 inches. Tables I.1 and I.2 in Appendix I1 give additional dimensions and information on the vehicle. The vehicle was directed into the installation using the cable reverse tow and guidance system. It was released to be freewheeling and unrestrained just prior to impact.

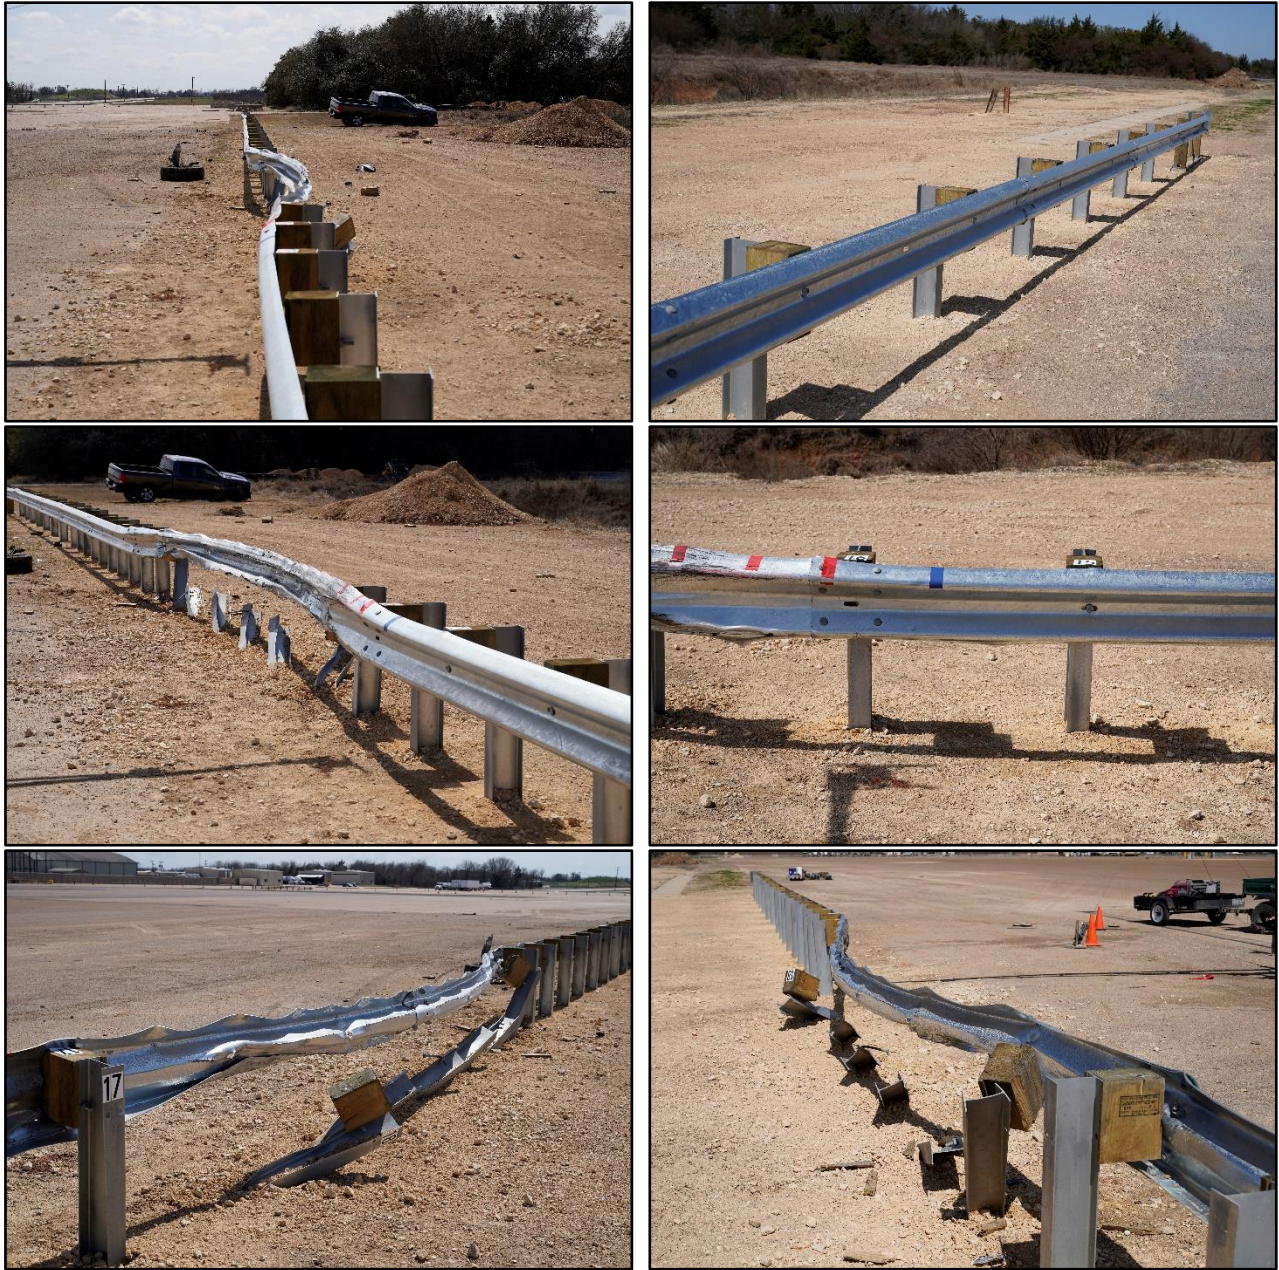
Figure 5.21. MGS with half Post Spacing and Shortened Blockouts after Test No. 610211-01-6.

Post #	Soil Gap (inches)			Post Lean from Vertical
	D/S	T/S	F/S	
1	1/8	-	-	-
2	1/8	-	-	-
15	-	1/8	-	-
16	-	5/8	1/4	1°
17	-	-	1 1/4	3°
23	-	7/8	-	37°
38	-	1/8	-	-
39	-	1/2	-	-

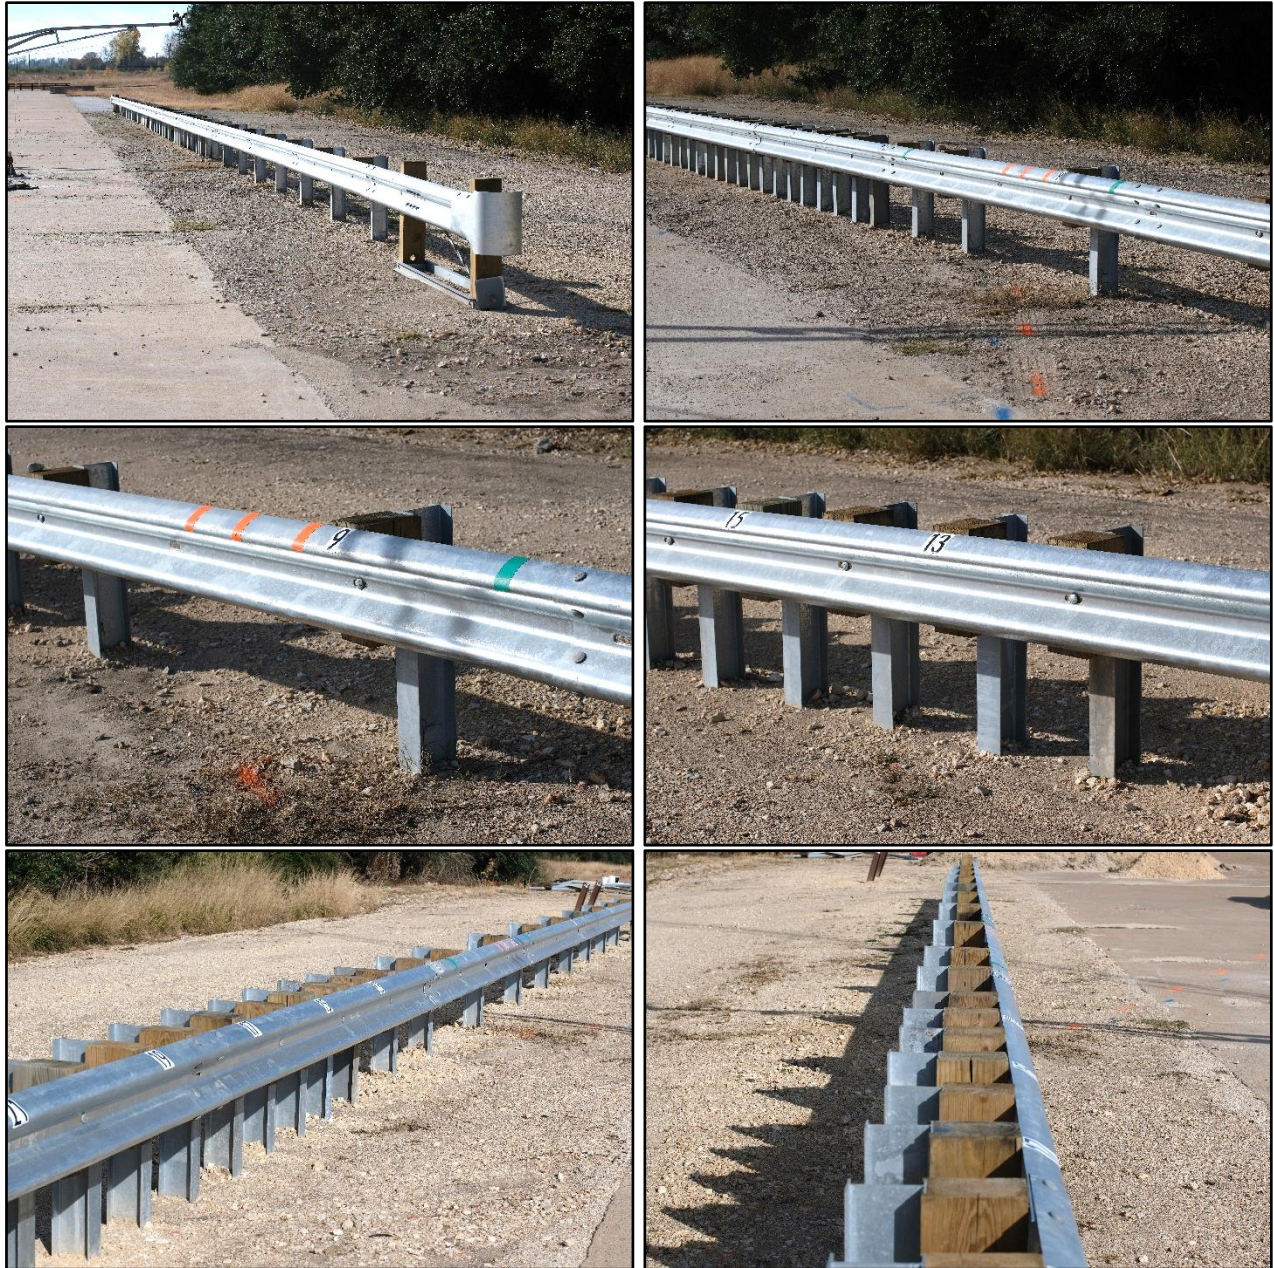
Figure 6.2. Transition from Full to Quarter Post Spacing prior to Testing.

Figure 6.1 presents overall information on the transition from full to quarter post spacing, and Figure 6.2 provides photographs of the installation. Appendix J provides further details of the transition from full to quarter post spacing.

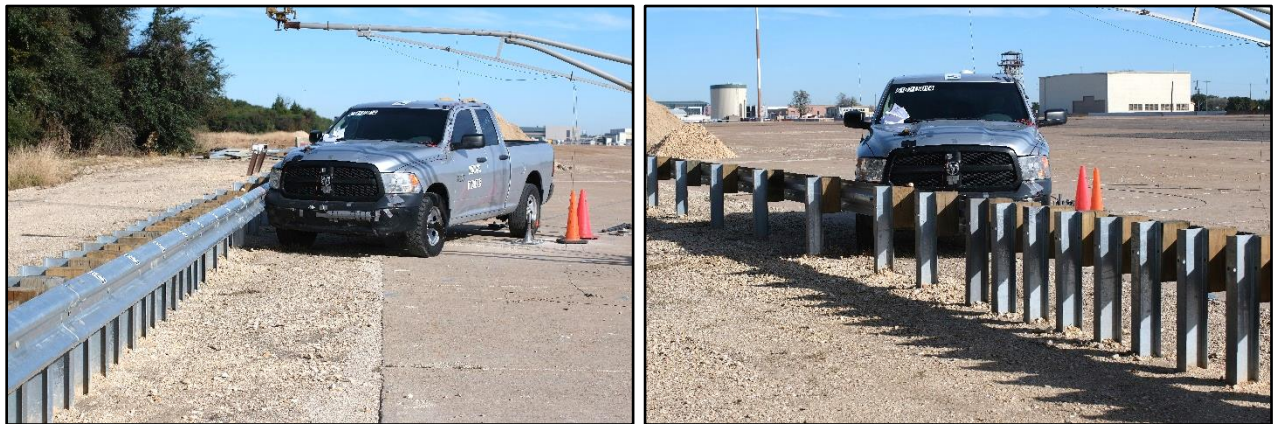
Figure 6.3. Transition/Test Vehicle Geometrics for Test No. 610211-01-4.

MASH Test 3-21 involves a 2270P vehicle weighing 5000 lb \pm 110 lb impacting the CIP of the transition at an impact speed of 62 mi/h \pm 2.5 mi/h and an angle of 25 degrees \pm 1.5 degrees. The CIP for *MASH* Test 3-21 on the standard transition from full to quarter post spacing was 132 inches \pm 12 inches upstream of post 13 (see Figure 2.4 and Figure 6.3).

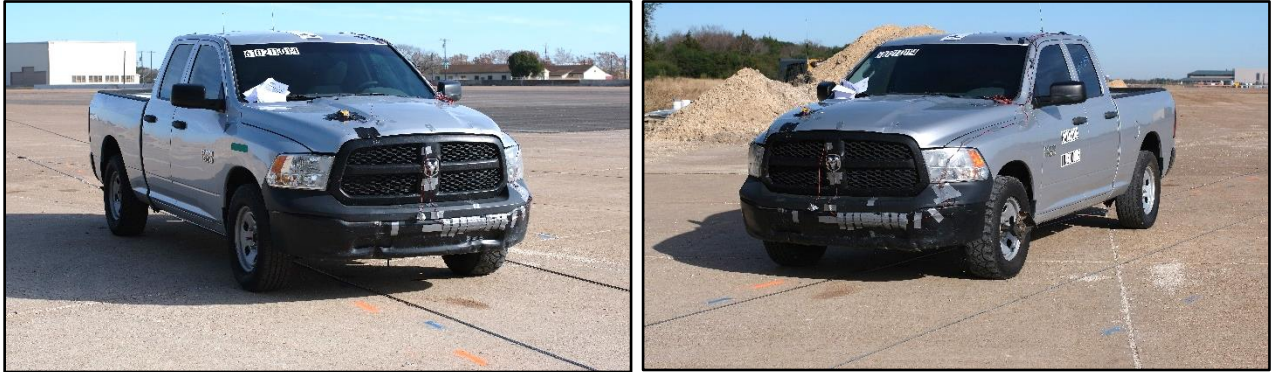
Figure 6.4. Test Vehicle before Test No. 610211-01-4.

Figure 6.4 shows the 2013 RAM 1500 pickup truck used for the crash test. The vehicle’s test inertia weight was 5060 lb, and its gross static weight was 5060 lb. The height to the lower edge of the vehicle bumper was 11.75 inches, and height to the upper edge of the bumper was 27.0 inches. The height to the vehicle’s center of gravity was 28.0 inches. Tables K.1 and K.2 in Appendix K1 give additional dimensions and information on the vehicle. The vehicle was directed into the installation using the cable reverse tow and guidance system. It was released to be freewheeling and unrestrained just prior to impact.
