Roadside Safety Pooled Fund

**Texas A&M
Transportation
Institute**
Proving Ground

Test Report No. 610211-01, REV 1
Test Report Date: October 2021
REV 1: March 2023

MASH CRASH TESTING AND EVALUATION OF THE MGS WITH REDUCED POST SPACING

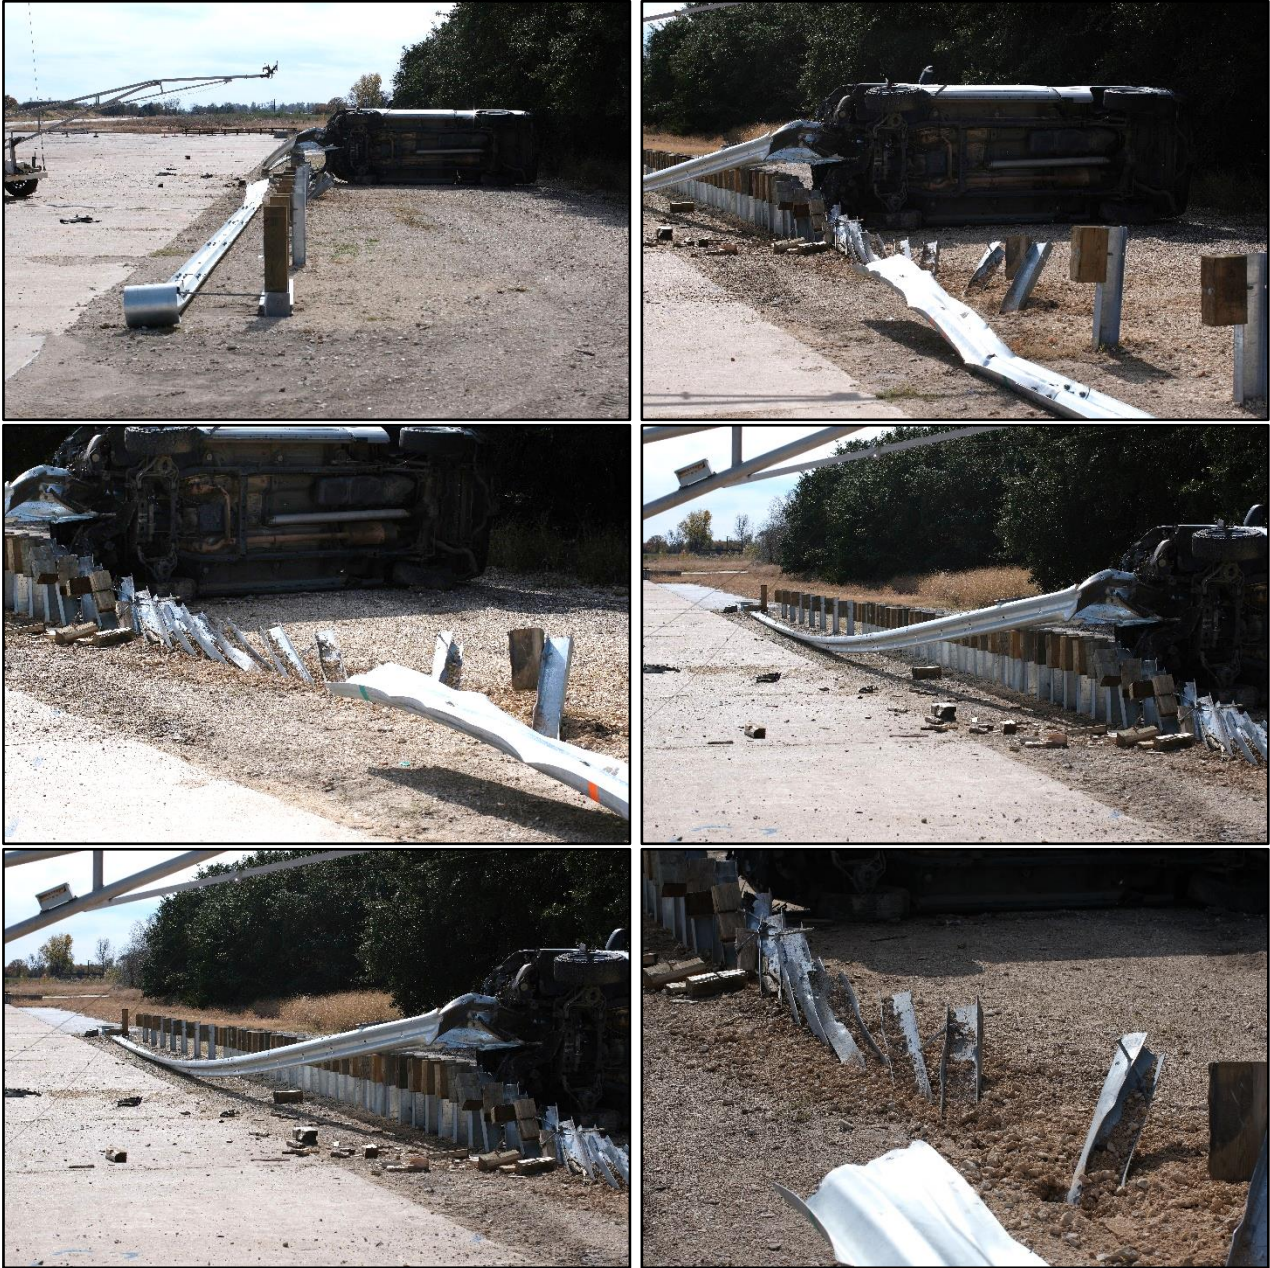
Figure 6.5. Transition from Full to Quarter Post Spacing after Test No. 610211-01-4.

showed no movement. The blockouts separated from posts 11-16, and the rail element ruptured at the splice at post 11. Table 6.2 provides additional measurements.

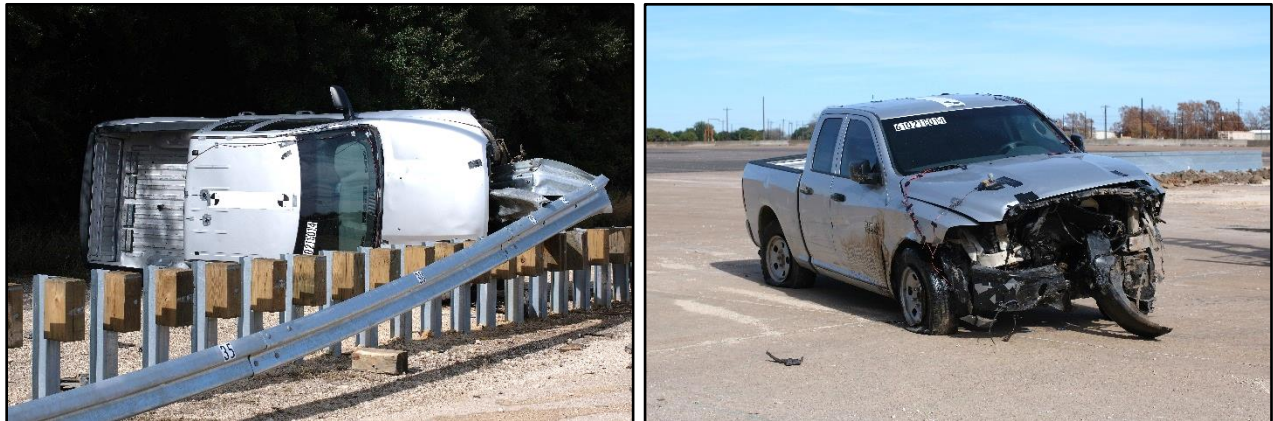
Figure 6.6. Test Vehicle after Test No. 610211-01-4.

Figure 6.6 shows the damage sustained by the vehicle. The front bumper, grill, hood, radiator and support, right front fender, right front tire and rim, right front and rear doors, right rear exterior bed, and right rear tire and rim were damaged. No damage to the fuel tank was observed. Maximum exterior crush to the vehicle was 18.0 inches in the front plane near the center at bumper height. No occupant compartment deformation or intrusion occurred. Figure 6.7 shows the interior of the vehicle. Tables K.3 and K.4 in Appendix K1 provide exterior crush and occupant compartment measurements.

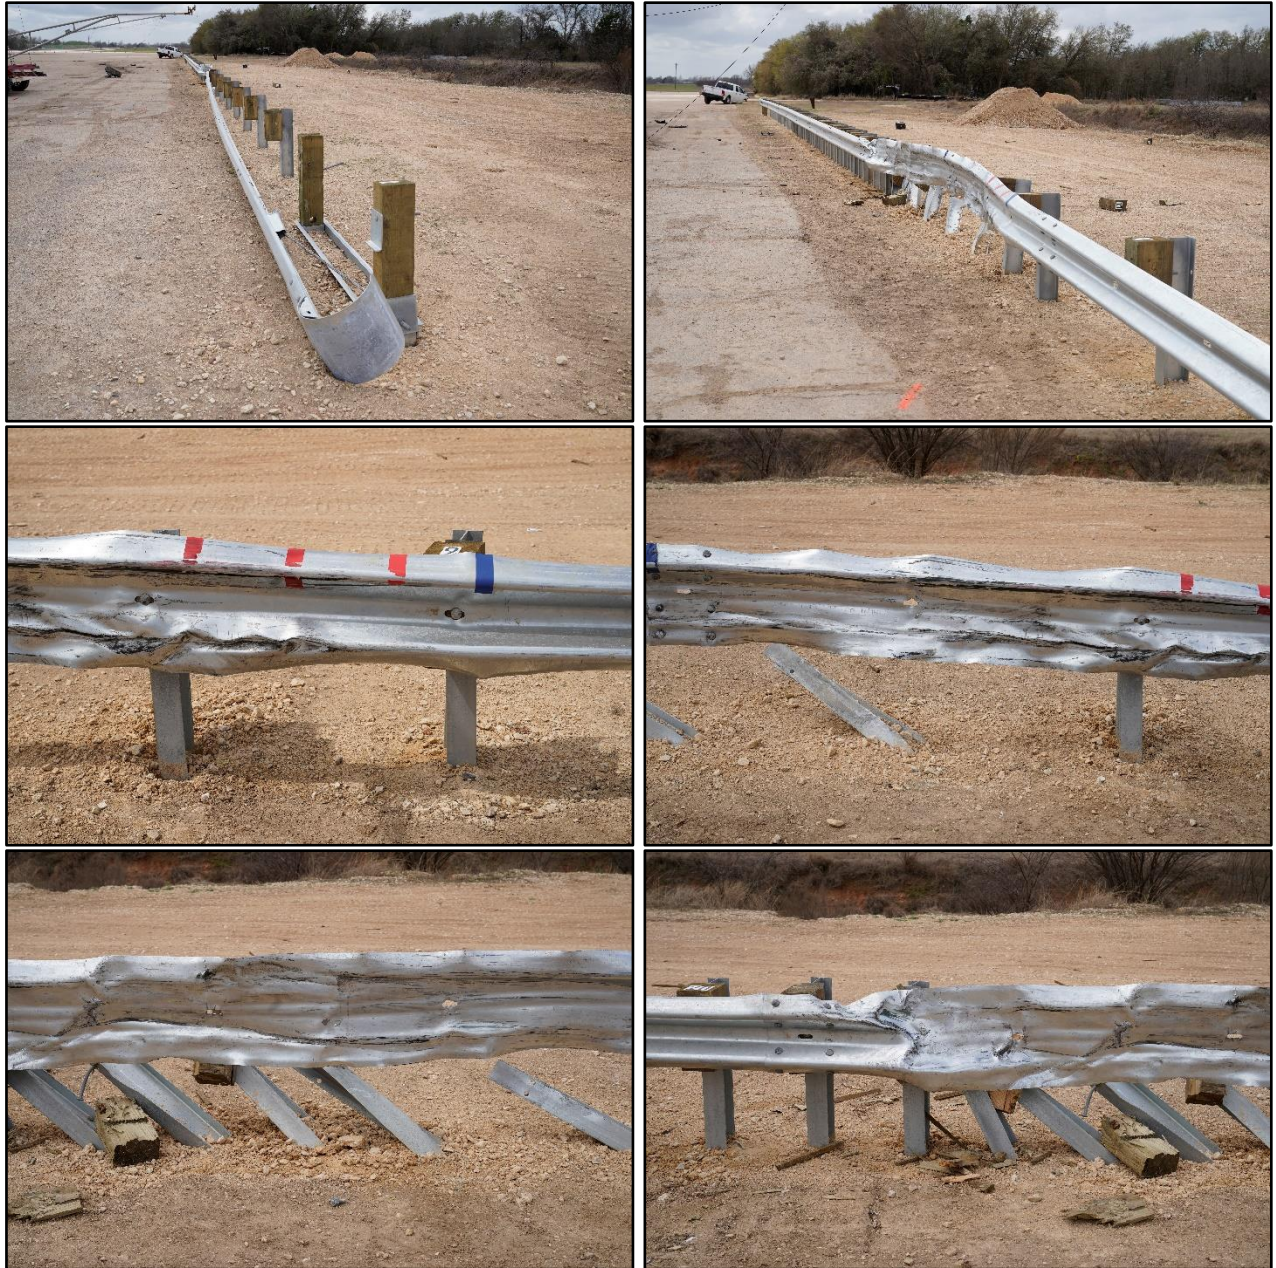
Figure 6.20. Longer Transition from Full to Quarter Post Spacing after Test No. 610211-01-5.

Figure 6.19 through Figure 6.21 show the damage to the installation. The rail released from posts 1 through 8, 11 through 16, and post 18. Post 2 was split in half vertically. Posts 11 through 13 and post 15 were missing their blockouts, and post 16 had only a partial blockout remaining. The debris field of the blockouts extended 58 ft downstream and 35 ft towards the field side. The soil was disturbed at posts 2 through 8 and 19 through 21. Table 6.5 provides additional measurements. Working width was 36.9 inches, and height of working width was 60.7 inches. Maximum dynamic deflection during the test was 23.9 inches, and maximum permanent deformation was 15.0 inches.

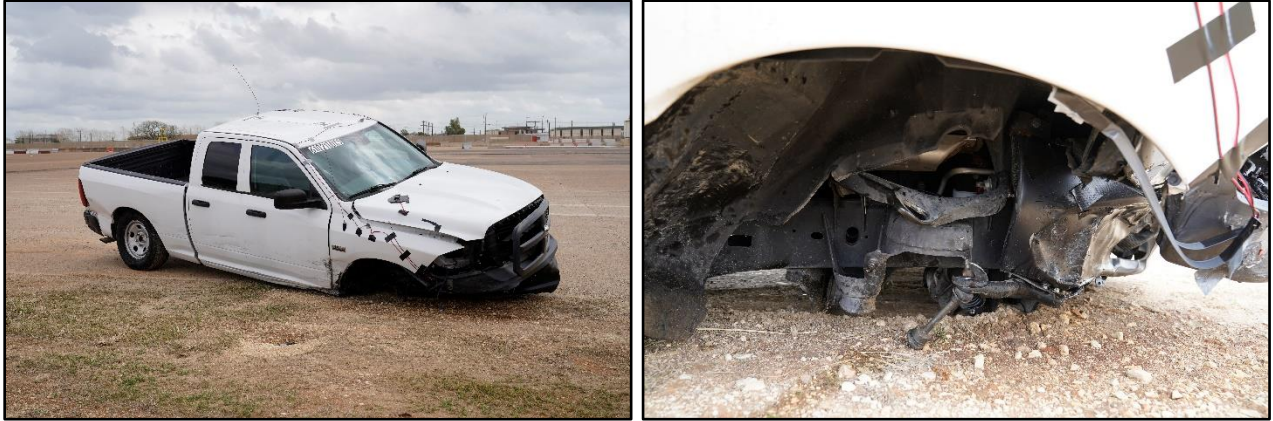
Figure 6.22. Test Vehicle after Test No. 610211-01-5.

Figure 6.22 shows the damage sustained by the vehicle. The front bumper, grill, radiator and support, right front fender, right front tire and rim, right frame rail, right upper and lower control arms, right front and rear doors, right rear exterior bed, and rear bumper were damaged. No damage to the fuel tank was observed. Maximum exterior crush to the vehicle was 16.0 inches in the front plane at the right front corner at bumper height. No occupant compartment deformation or intrusion occurred. Figure 6.23 shows the interior of the vehicle. Tables M.3 and M.4 in Appendix M1 provide exterior crush and occupant compartment measurements.

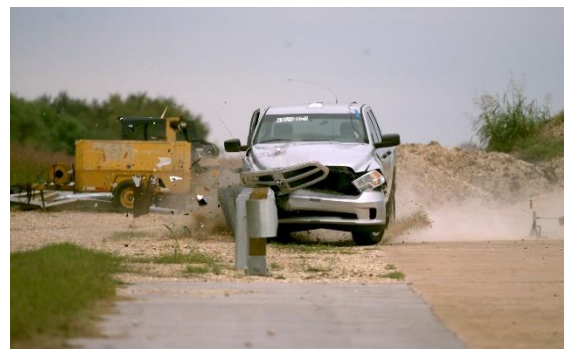
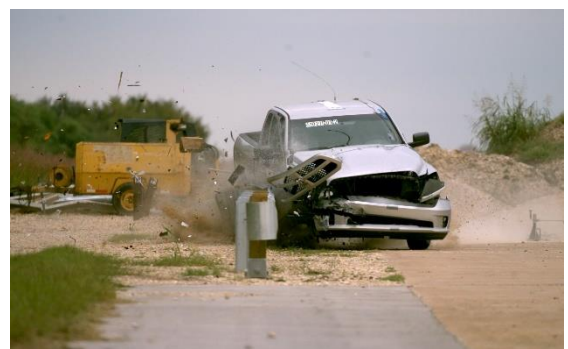
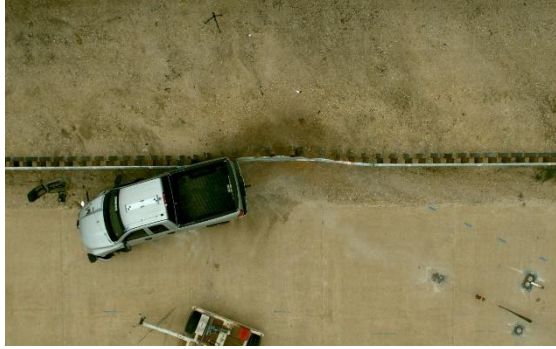
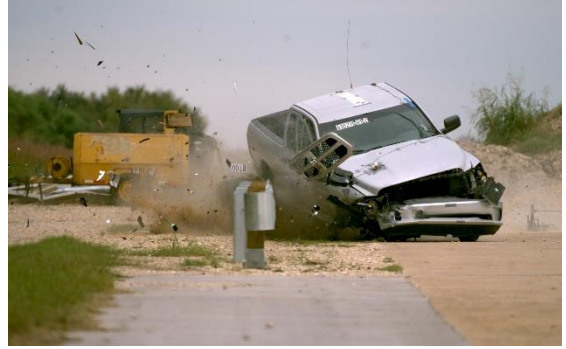
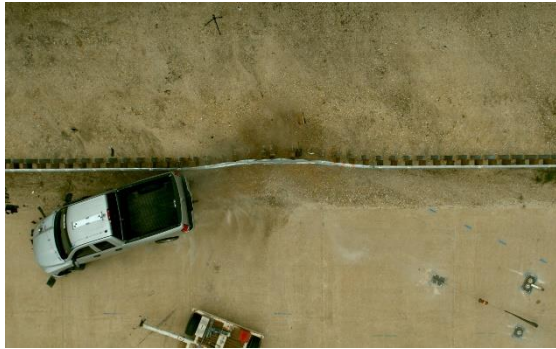
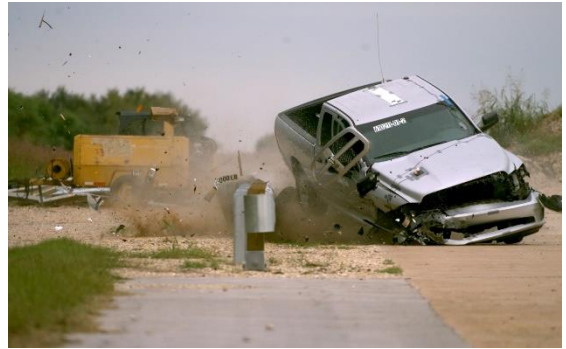
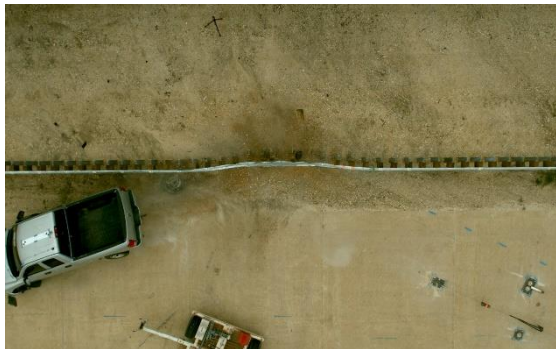
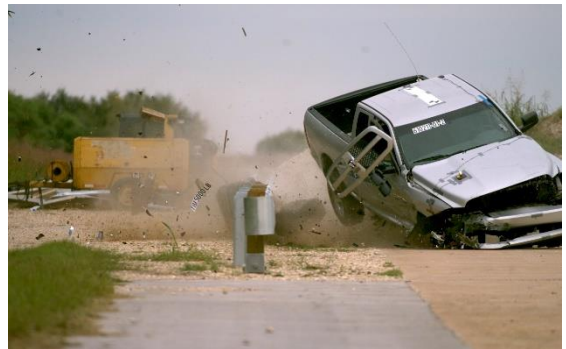
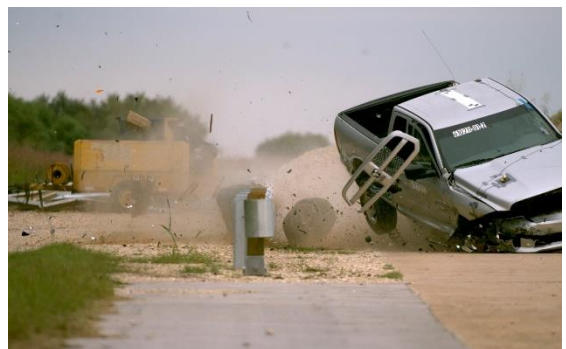
Figure E.1. Sequential Photographs for Test No. 610211-01-2 (Overhead and Frontal Views).

Figure E.1. Sequential Photographs for Test No. 610211-01-2 (Overhead and Frontal Views) (Continued).

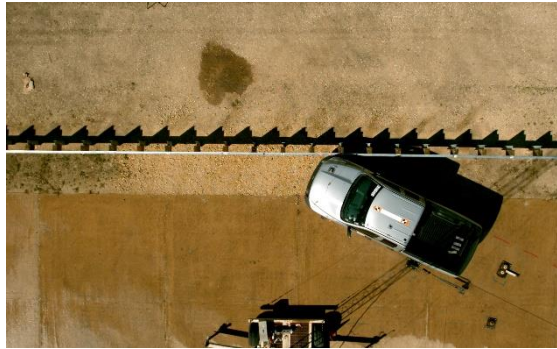
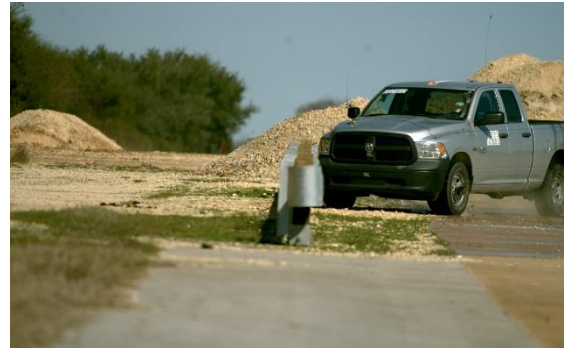
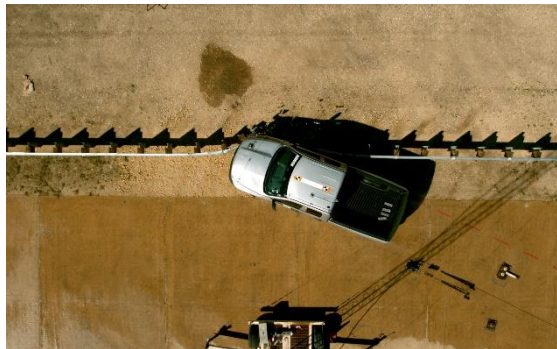
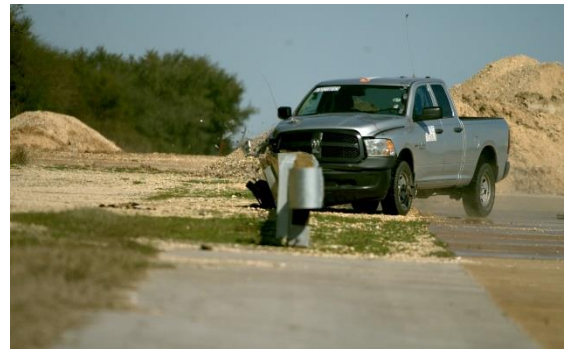
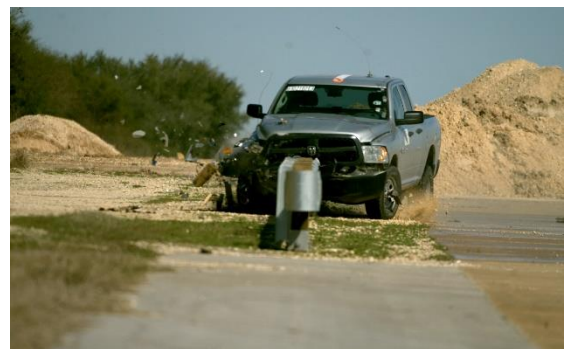
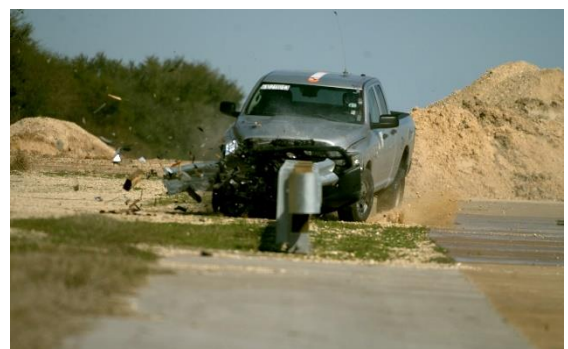
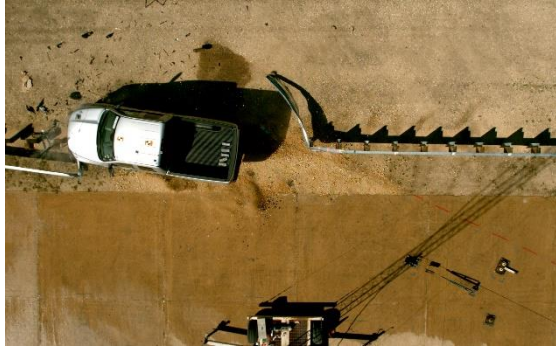
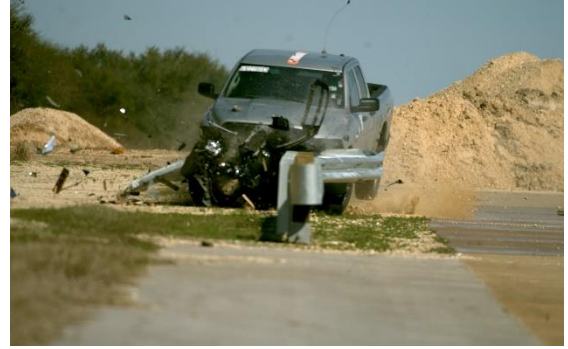
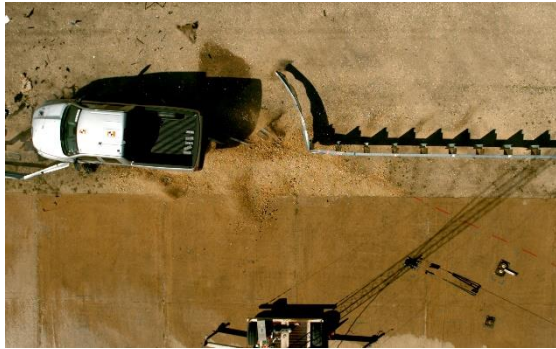
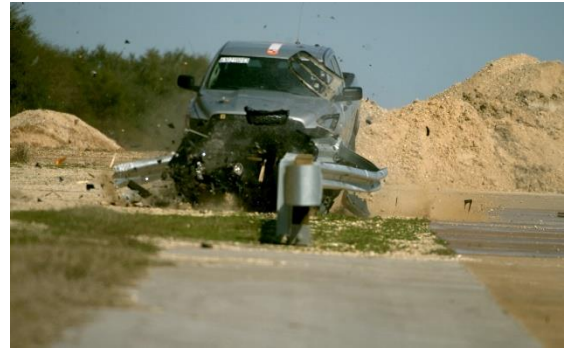
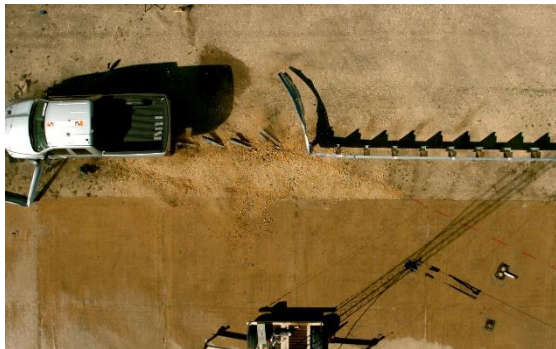
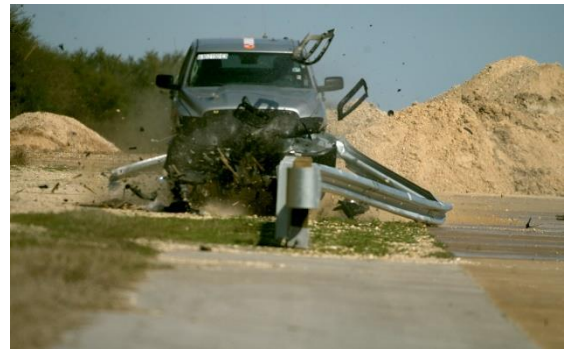
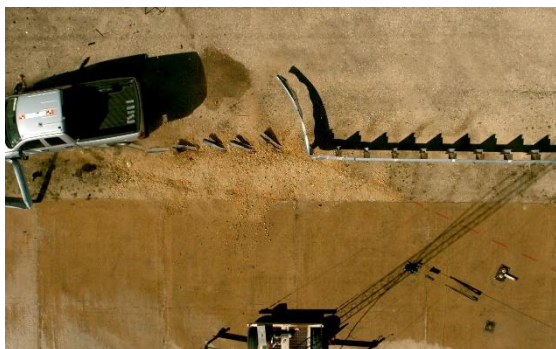
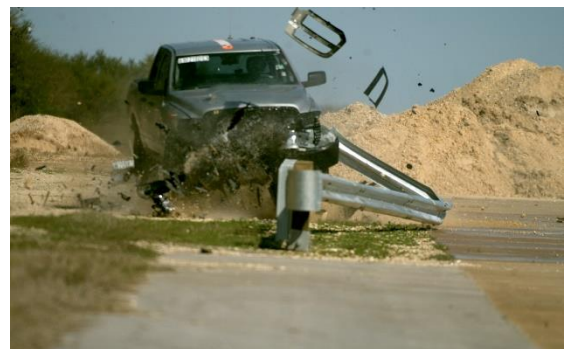
Figure G.1. Sequential Photographs for Test No. 610211-01-3 (Overhead and Frontal Views).

Figure G.1. Sequential Photographs for Test No. 610211-01-3 (Overhead and Frontal Views) (Continued).
