<p><b>Project Title:</b></p>	<p>MASH TL-3 Design, Testing and Evaluation of a Flared Guardrail System - Phase 2</p>

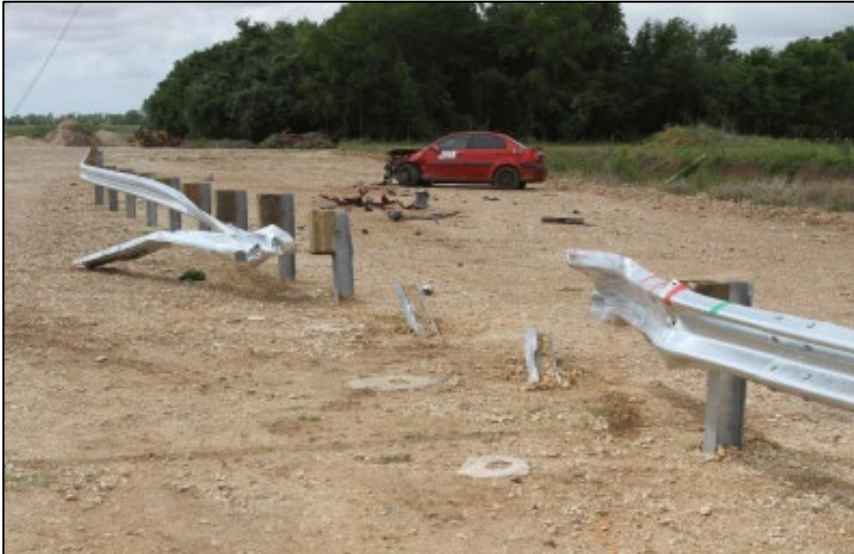
<p><b>Project Background:</b></p>	<p>The recently completed pooled fund project 609971-01 "Testing and Evaluation of the MGS System with Critical Flare at MASH Test Level 3 Conditions" developed design details but unsuccessfully MASH crash tested an MGS guardrail system under the following flared installations:</p> <ul style="list-style-type: none"> <li>• 7:1 flared MGS system with small car – failed, ruptured rail</li> </ul> <div data-bbox="279 1161 1526 1465" data-label="Diagram"> <p><b>Test Installation</b></p> <p>Plan View</p> <p>Post Numbers</p> </div>

- 11:1 flared MGS system with pickup truck – failed, containment problem due to failed anchor

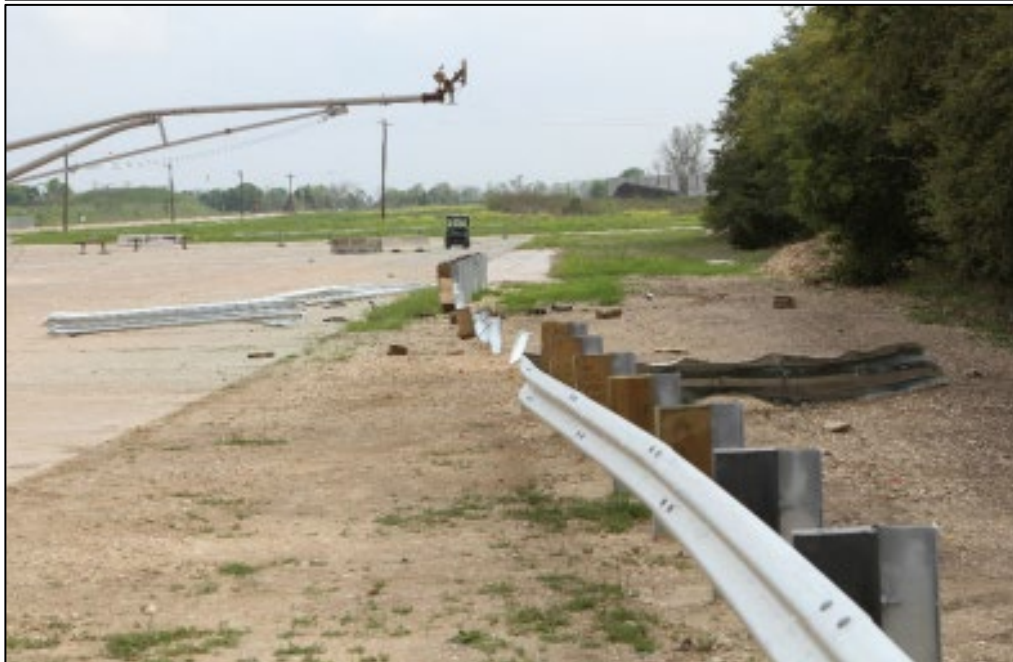
- 11:1 flared MGS section with non-flared MGS sections at the end of the system (shortened flared section) with a pickup truck – failed, ruptured rail
