TRNo. 618851-01-1

EVALUATION OF A MEDIAN GUARDRAIL TRANSITION TO MEDIAN F-SHAPE CONCRETE BARRIER

Sponsored by
Roadside Safety Pooled Fund

TEXAS A&M TRANSPORTATION INSTITUTE PROVING GROUND

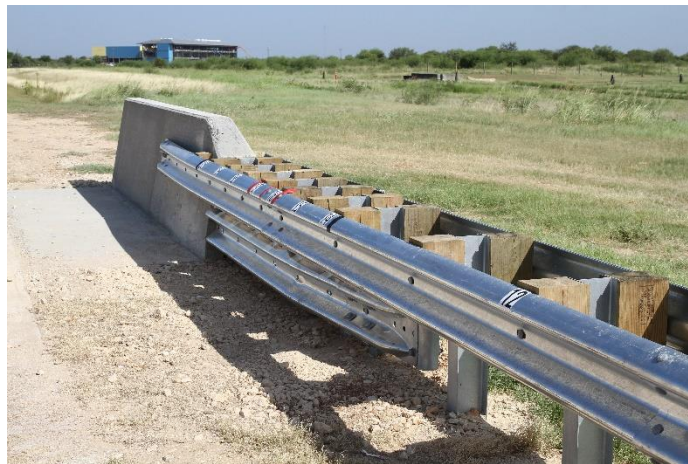
Figure 1.1. MASH TL-3 Median Guardrail Transition to Median Single Slope Barrier. (2)

Previous testing was conducted on a median guardrail transition to a median single slope concrete barrier (2). Figure 1.1 shows the transition system. A total of four full-scale crash tests were performed to evaluate the MASH compliance of the system. The system was evaluated at three different transition locations. First, the transition from the median single slope concrete barrier to the median guardrail with quarter post spacing and w-beam rub rail was evaluated with MASH Test 3-21. Second, the transition from the median guardrail with quarter post spacing and w-beam rub rail to the median guardrail with half post spacing was evaluated with MASH Tests 3-20 and 3-21. Third, the transition from the median guardrail with half post spacing to the standard length of need median guardrail was evaluated with MASH Test 3-20. The transition system was found to be compliant for MASH TL-3.

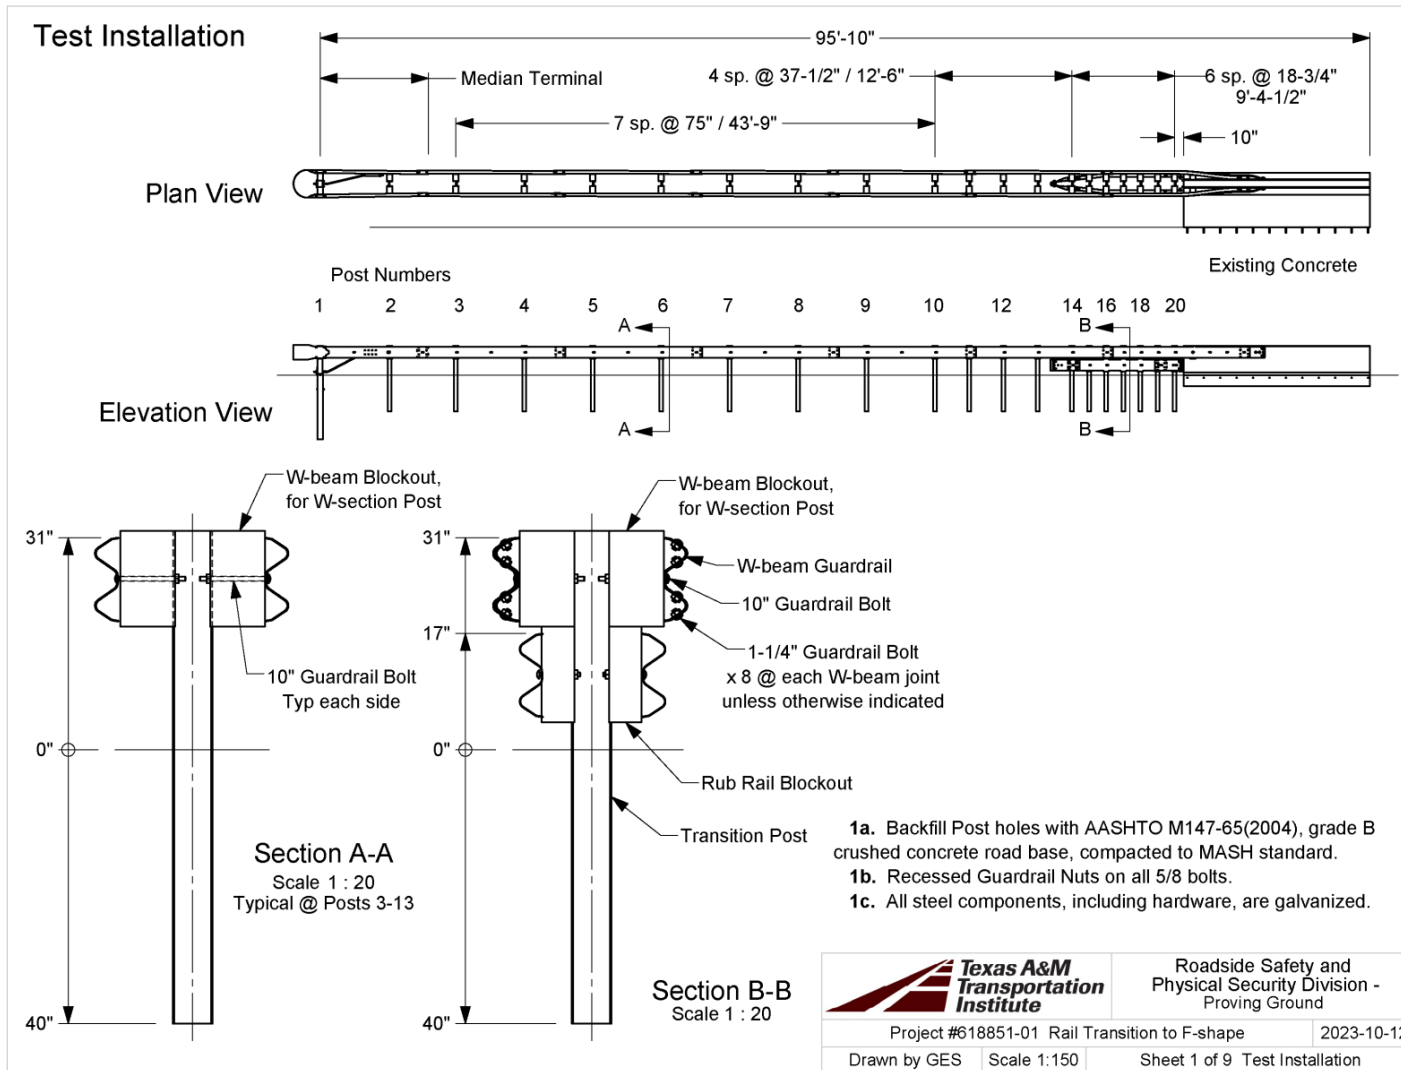
Figure 3.1. Details of Median Guardrail Transition to Median F-Shape Barrier.

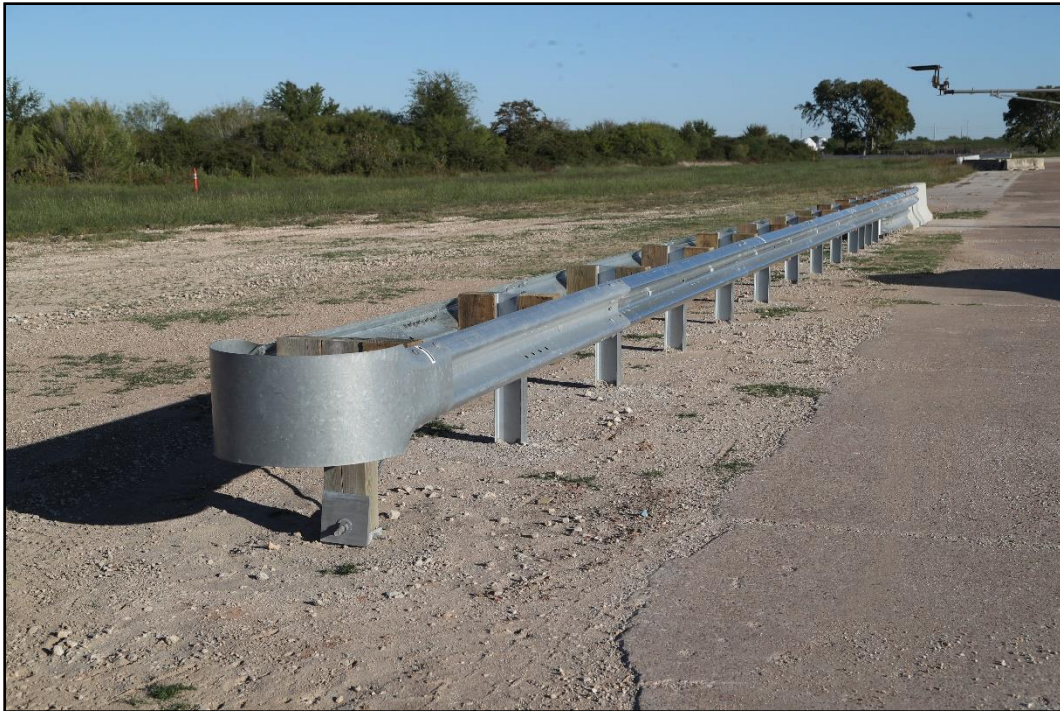
Figure 3.2. Median Guardrail Transition to Median F-Shape Barrier prior to Testing.

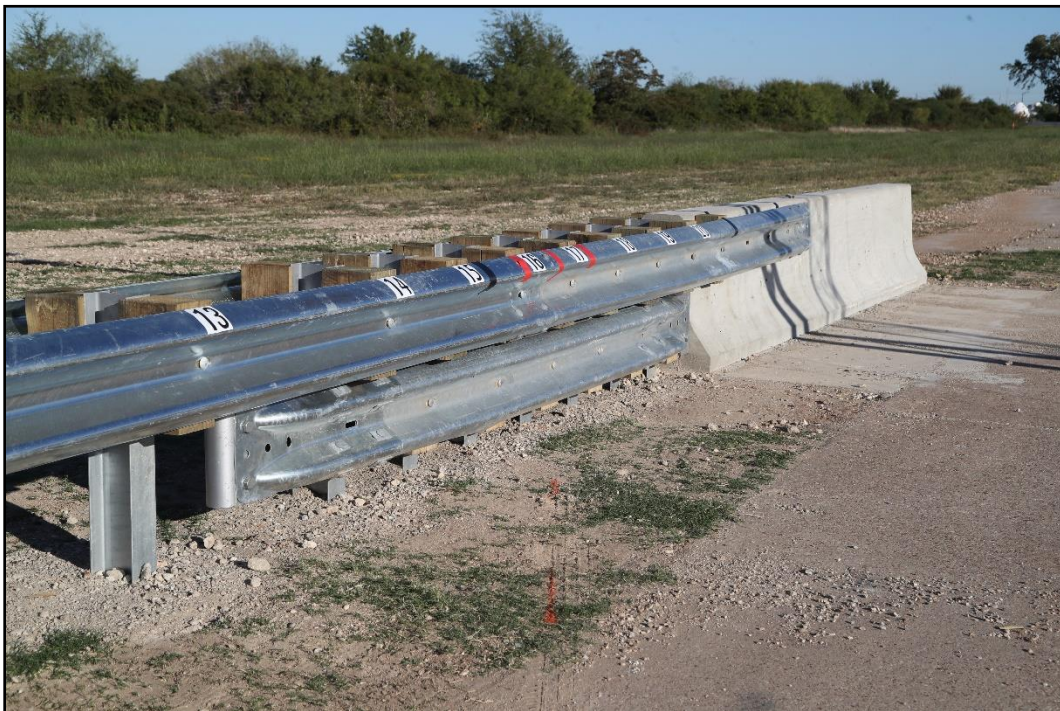
Figure 3.3. Median Guardrail Transition to Median F-Shape Barrier at Impact prior to Testing.

Figure 3.1 presents the overall information on the Median Guardrail Transition to Median F-Shape Barrier, and Figure 3.2 thru Figure 3.7 provide photographs of the installation. Appendix A provides further details on the Median Guardrail Transition to Median F-Shape Barrier. Drawings were provided by the Texas A&M Transportation Institute (TTI) Proving Ground, and construction was performed by DMA Contractors and TTI Proving Ground personnel.

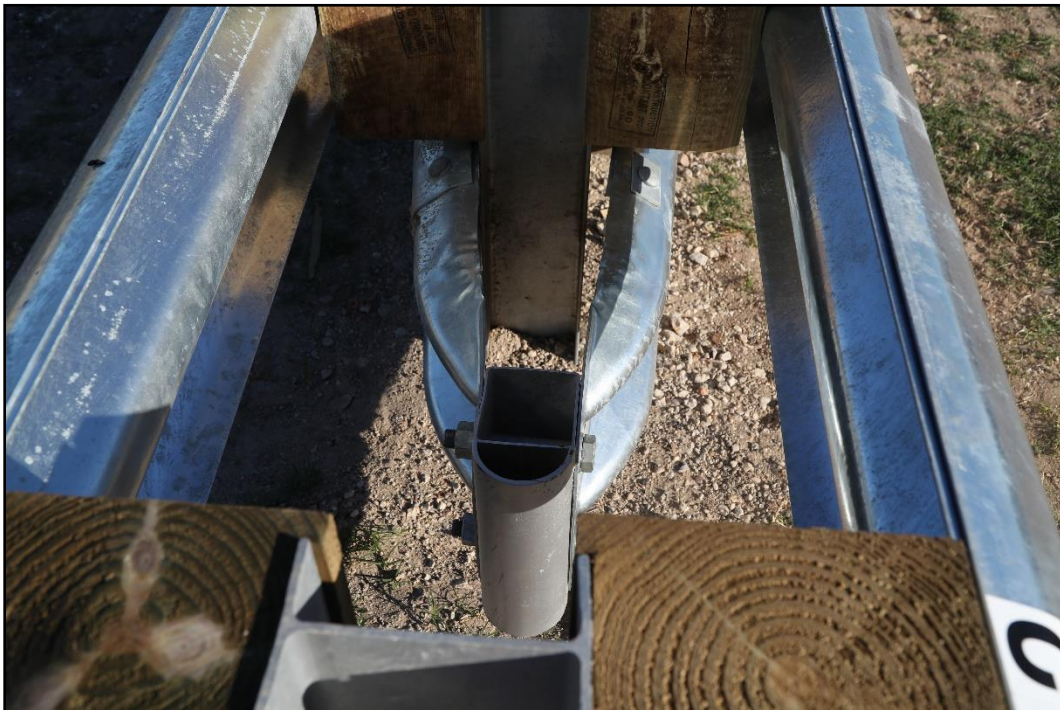
Figure 3.5. Median Guardrail Transition to Median F-Shape Barrier Upstream Rub Rail Termination prior to Testing.

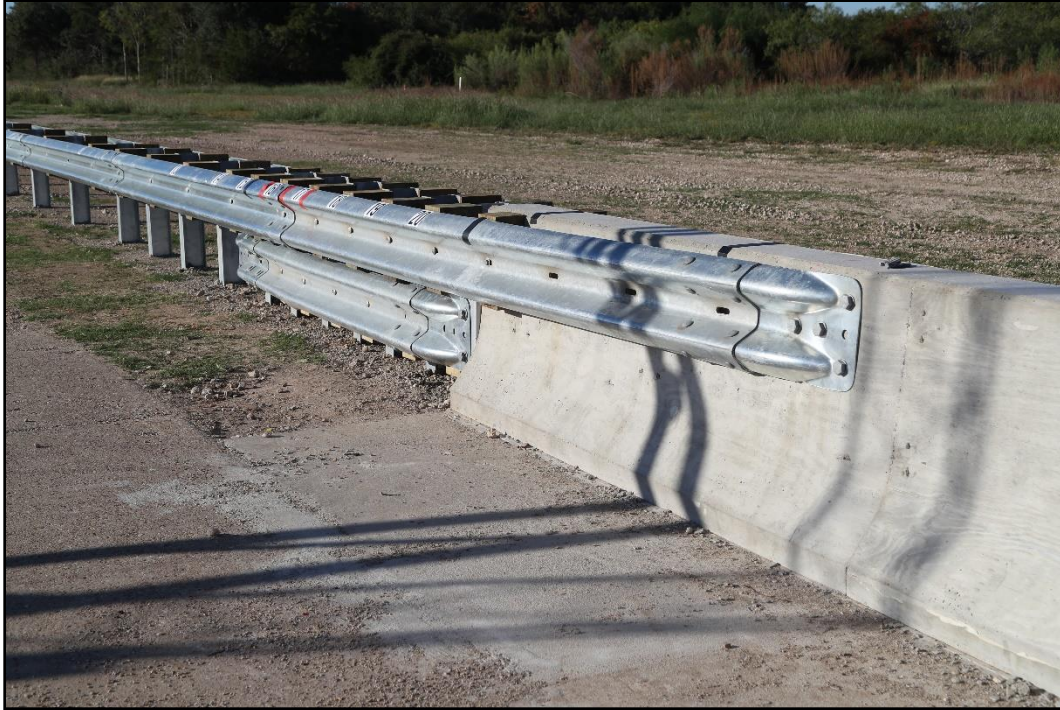
Figure 3.6. Downstream View of the Median Guardrail Transition to Median F-Shape Barrier prior to Testing.

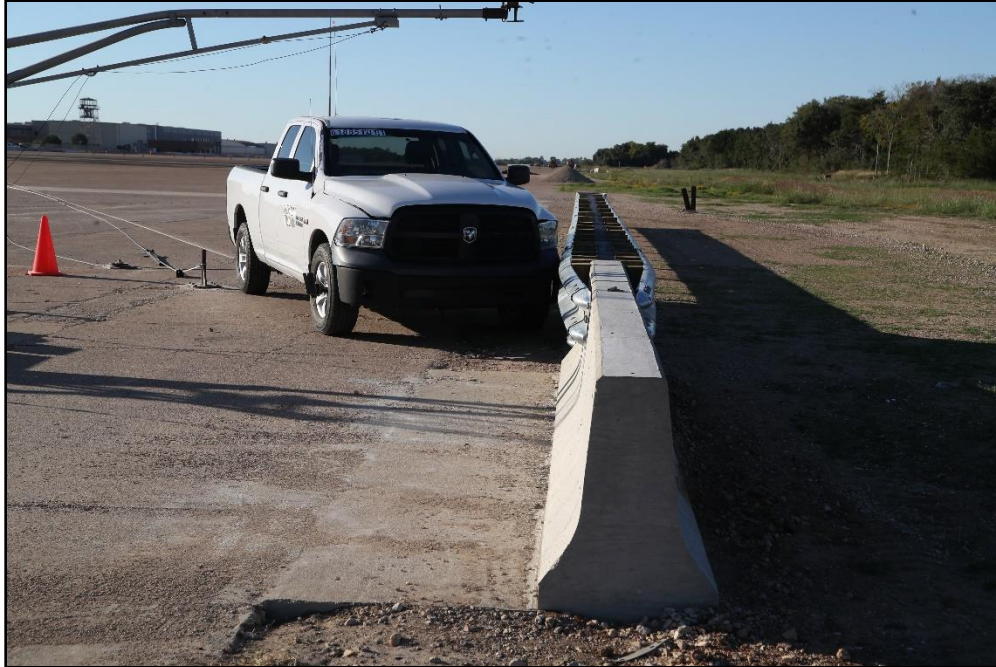
Figure 6.1. Median Guardrail Transition to Median F-Shape Barrier/Test Vehicle Geometrics for Test 618851-01-1.

See Table 6.1 for details of *MASH* impact conditions for this test and Table 6.2 for the exit parameters. Figure 6.1 and Figure 6.2 depict the target impact setup.

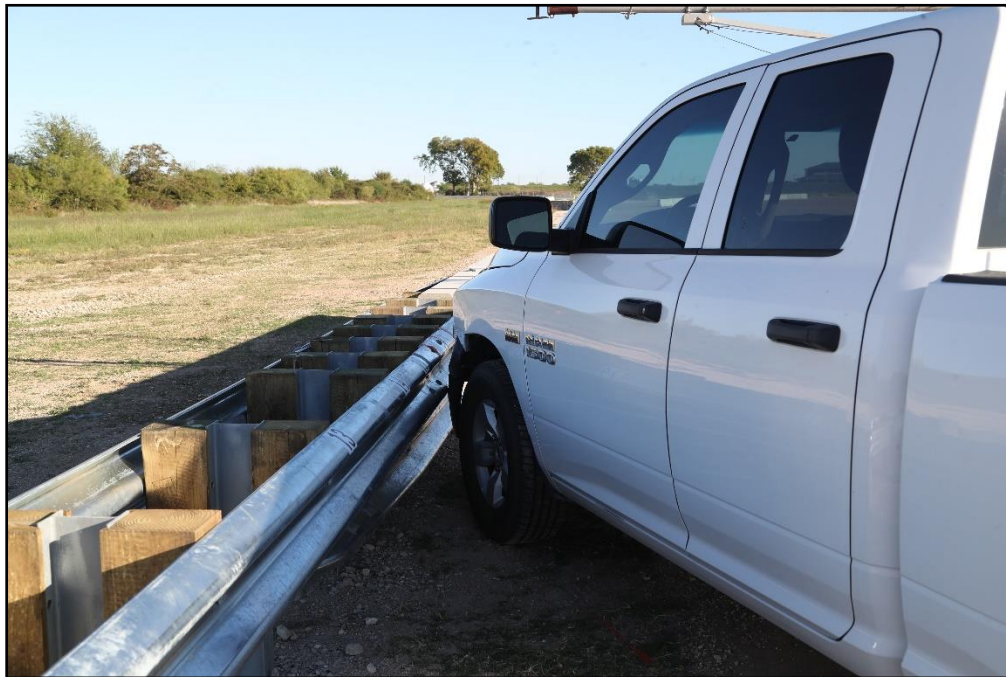
Figure 6.2. Median Guardrail Transition to Median F-Shape Barrier/Test Vehicle Impact Location for Test 618851-01-1.

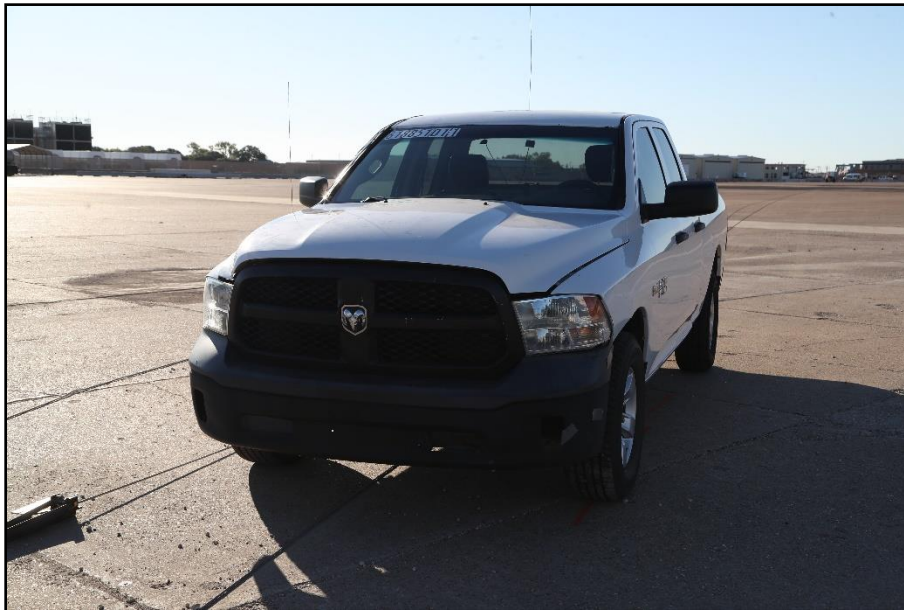
Figure 6.3. Impact Side of Test Vehicle before Test 618851-01-1.

Figure 6.3 and Figure 6.4 show the 2018 RAM 1500 used for the crash test. Table 6.4 shows the vehicle measurements. Figure C.1 in Appendix C.1 gives additional dimensions and information on the vehicle.

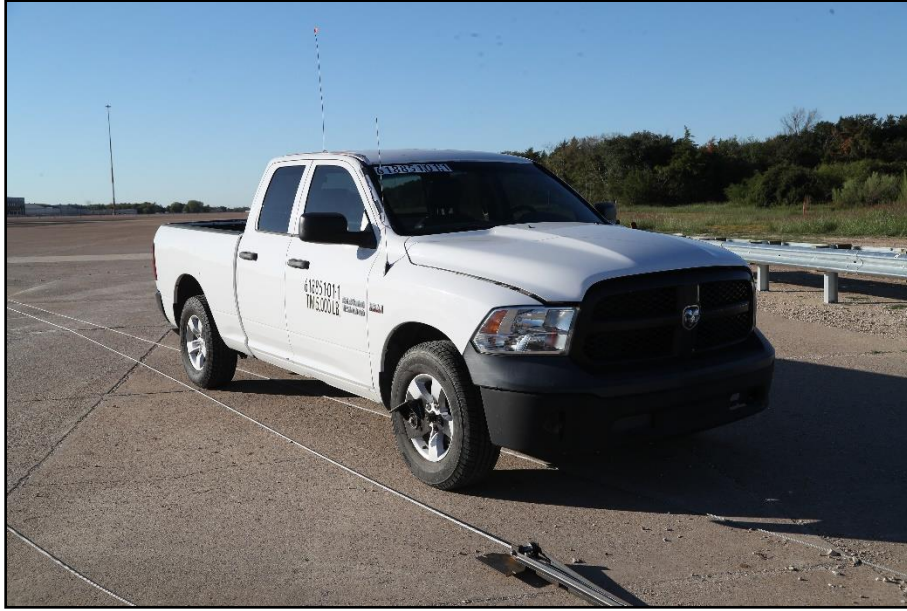
Figure 6.4. Opposite Impact Side of Test Vehicle before Test 618851-01-1.

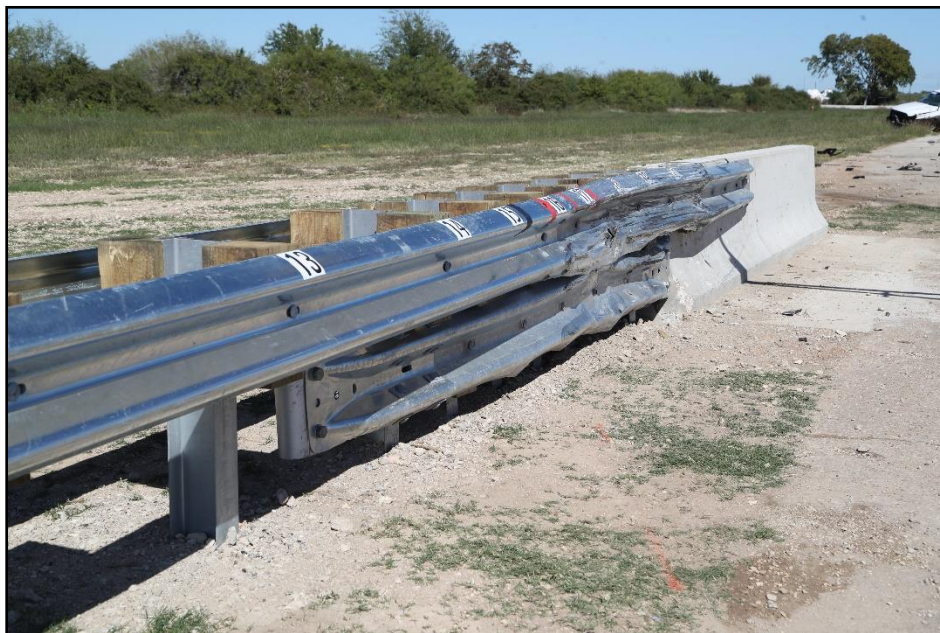
Figure 6.5. Median Guardrail Transition to Median F-Shape Barrier at Impact Location after Test 618851-01-1.

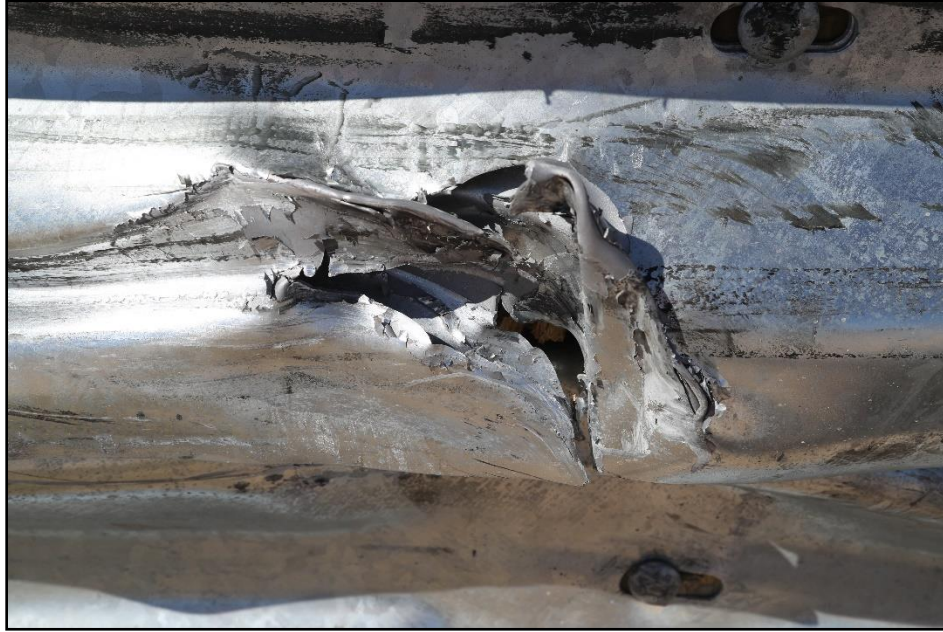
Figure 6.6. Vehicle Snag at Post 18 on the Median Guardrail Transition to Median F-Shape Barrier after Test 618851-01-1.

The median guardrail to median f-shape concrete barrier transition system was evaluated through full-scale crash testing. *MASH* Test 3-21 was conducted on the system. The crash test was considered a failure due to the vehicle occupant compartment deformation exceeding the *MASH* limit. The vehicle had a deformation of 11.5 inches in the foot well/toe pan region, which exceeds the *MASH* limit of 9 inches. Thus, the transition system was considered unsatisfactory for *MASH* TL-3 evaluation criteria.

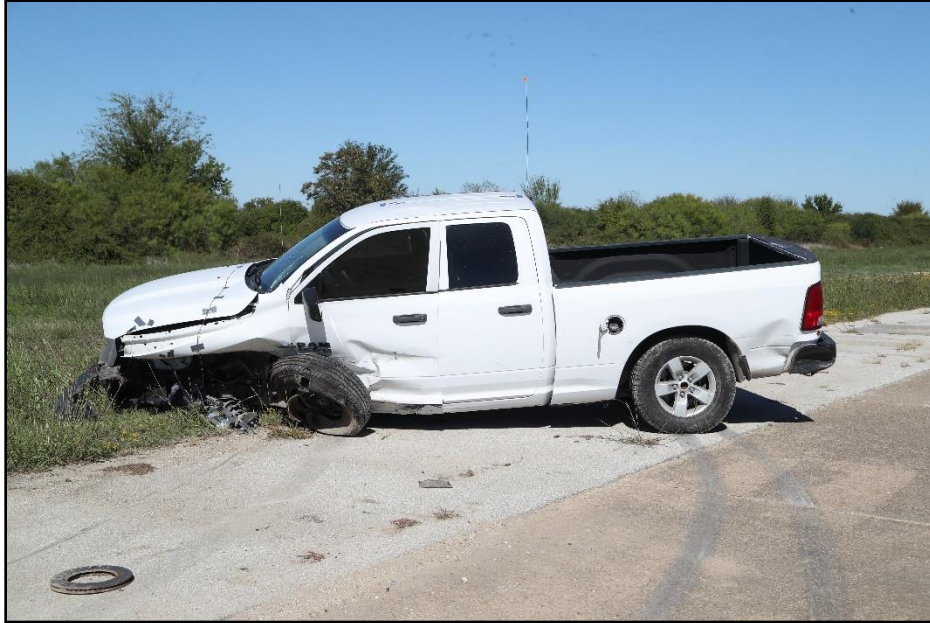
Figure 6.7. Impact Side of Test Vehicle after Test 618851-01-1.

Side Windows	The side windows remained intact
Maximum Exterior Deformation	19 inches in the front plane at the left front corner at bumper height
VDS	11LFQ5
CDC	11FLEW3
Fuel Tank Damage	None
Description of Damage to Vehicle:	The left front bumper, fender, and door were dented. There were cracks in the windshield due to the flexing of the vehicle and not due to penetration by the test article. The grill, radiator, and support were damaged. The left headlight broke off. The left front tire blew out and the wheel broke. The left control arm was ripped off, the spring popped out, and the shock was bent on the left side. The A pillar was bent and the left front door had a 9.5-inch gap at the top. There was a buckle in the roof measuring 9 inches long, 7 inches wide, and 0.8 inches deep. The left rear cab corner, rear quarter fender, and rear bumper were dented. The left side foot well had some separating at the seam. The maximum deformation was 11.5 inches at the foot well/toe pan.

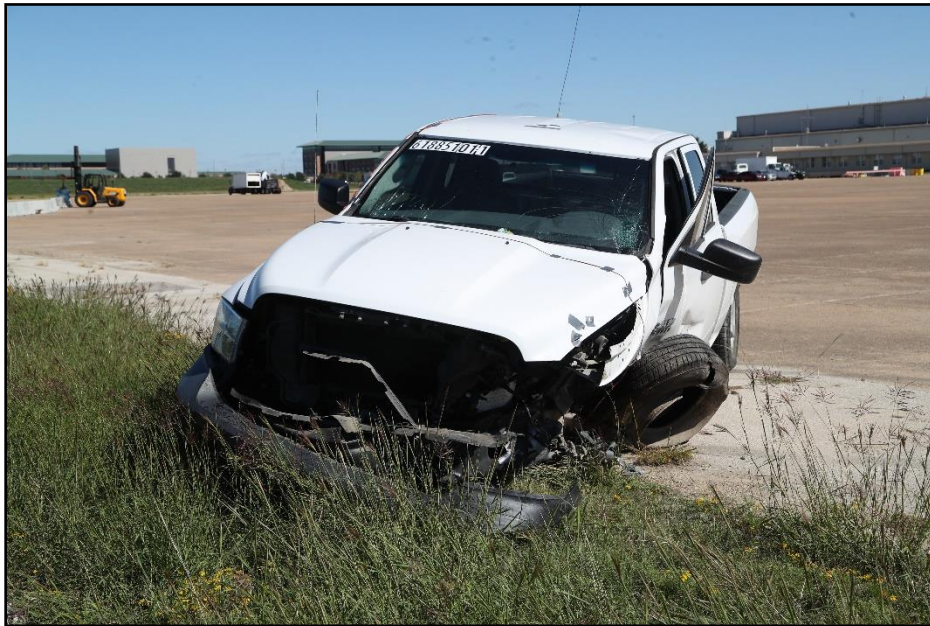
Figure 6.8. Front Impact Side of Test Vehicle after Test 618851-01-1.

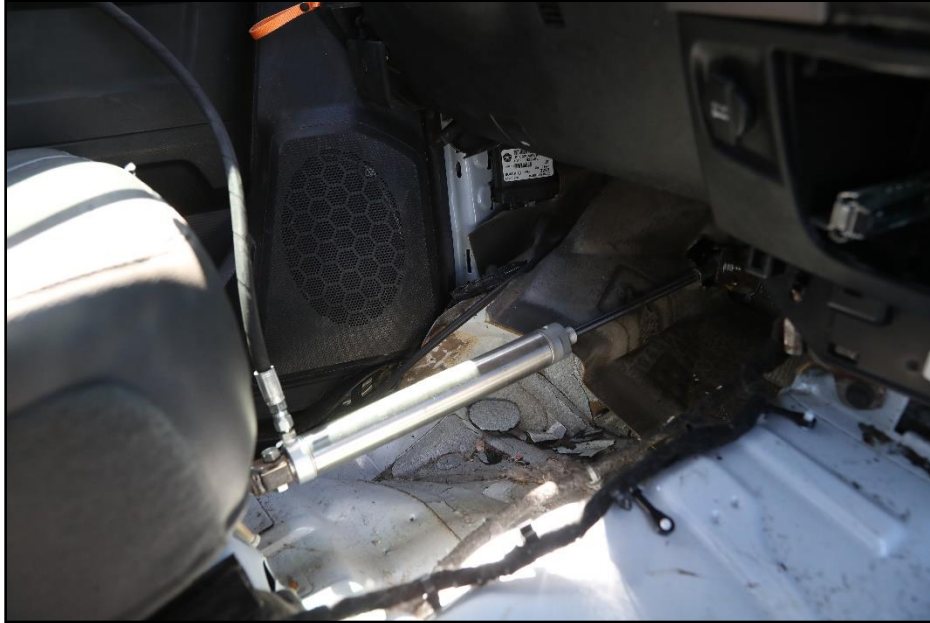
Figure 6.9. Interior of Test Vehicle on Impact Side after Test 618851-01-1.

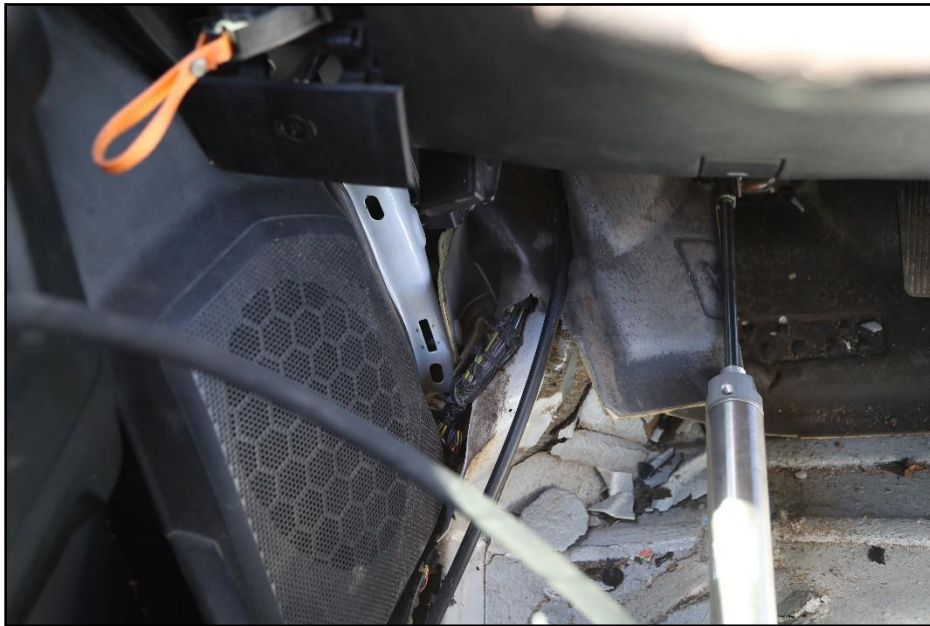
Figure 6.10. Seam Separation on Impact Side after Test 618851-01-1.

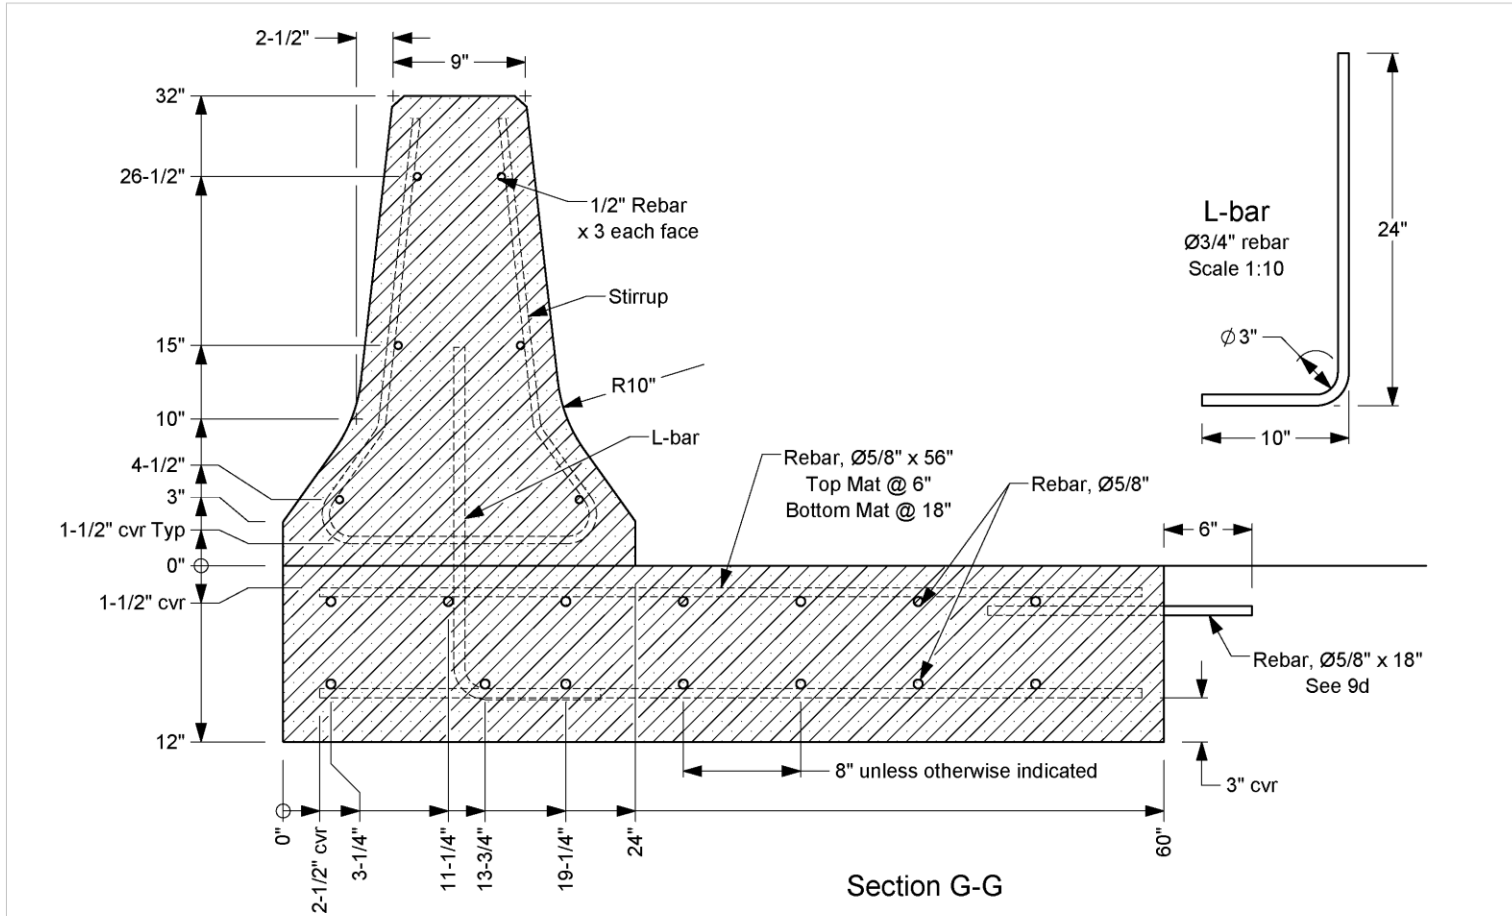
Roadside Safety and Physical Security Division - Proving Ground	
Project #618851-01 Rail Transition to F-shape		2023-10-12	
Drawn by GES	Scale 1:10	Sheet 9 of 9 Concrete Cross Section

- 9a. Concrete is TxDOT Class C (3,600 psi).
- 9b. 1" Chamfer (3/4" each way) top edges of parapet.
- 9c. All rebar dimensions are to center of bar unless otherwise indicated by "cvr" (cover). All rebar is grade 60.
- 9d. Secure in existing concrete with Hilti HIT-RE 500 V3 epoxy according to manufacturer's instructions, at 18" spacing with 6" embedment.

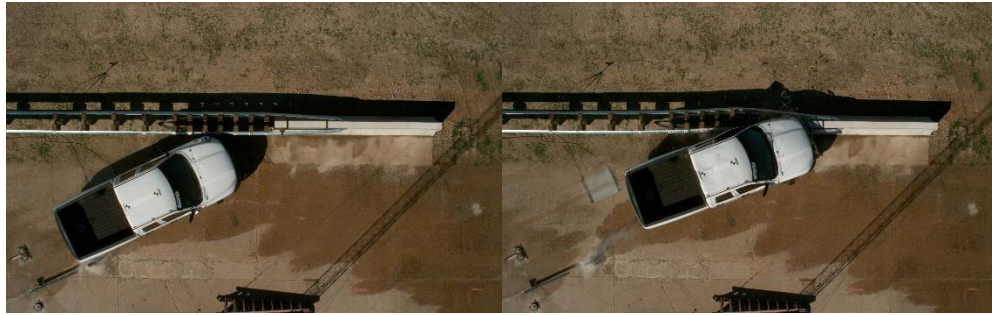
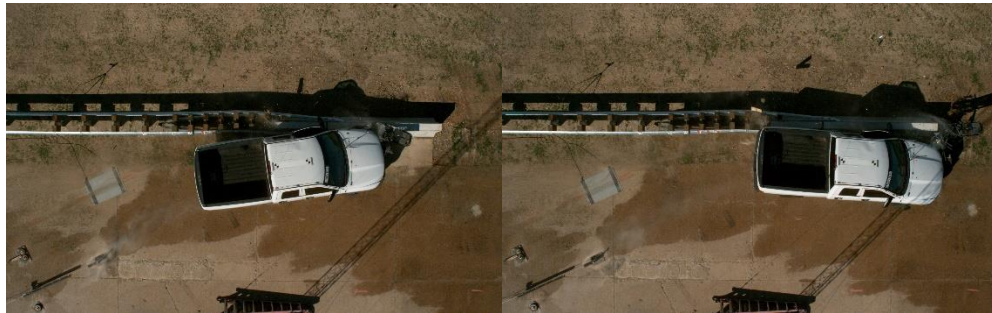
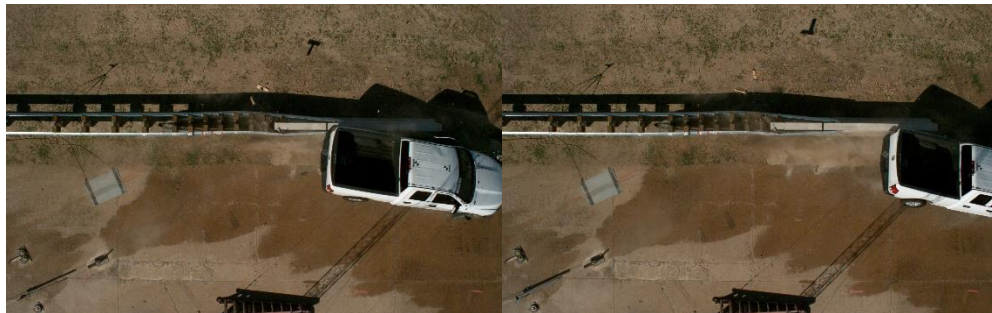
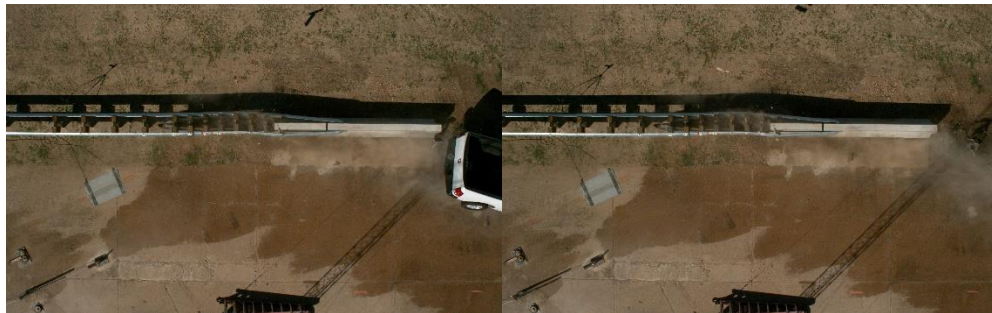
Figure C.4. Sequential Photographs for Test 618851-01-1 (Overhead Views).

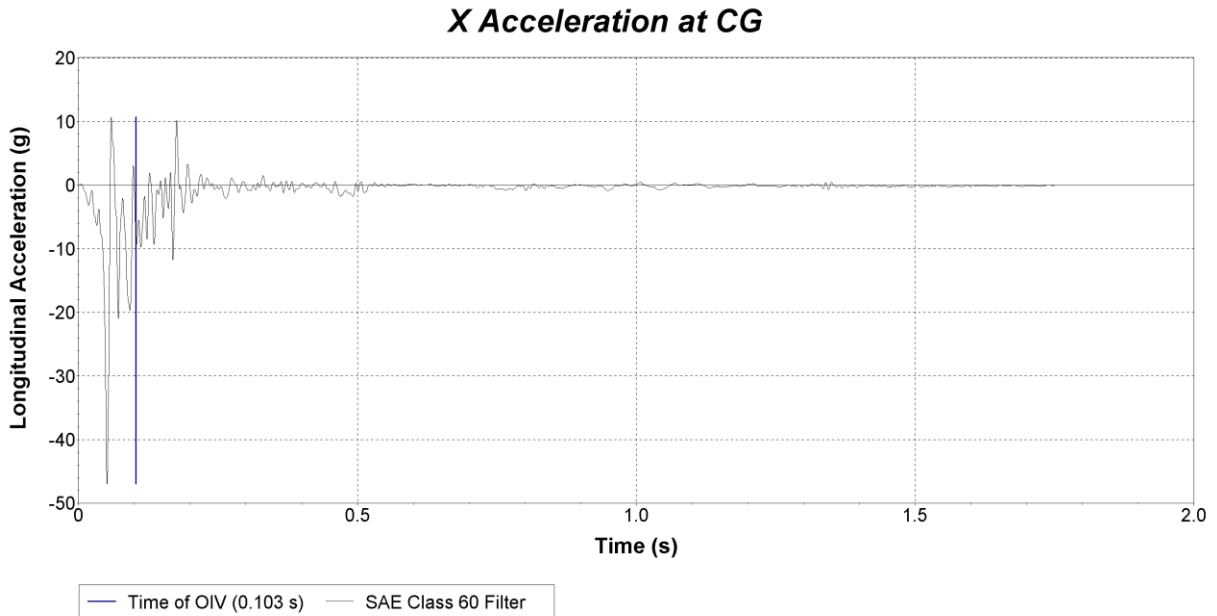
Figure C.7. Vehicle Longitudinal Accelerometer Trace for Test 618851-01-1 (Accelerometer Located at Center of Gravity).
