Test Report No. 619551-01

**EVALUATION OF *MASH* TL-3 TRANSITION DESIGN WITH A
STORM DRAIN – CRASH TEST OF 1100C VEHICLE (SMALL CAR)**

Sponsored by
Roadside Safety Pooled Fund

TEXAS A&M TRANSPORTATION INSTITUTE PROVING GROUND

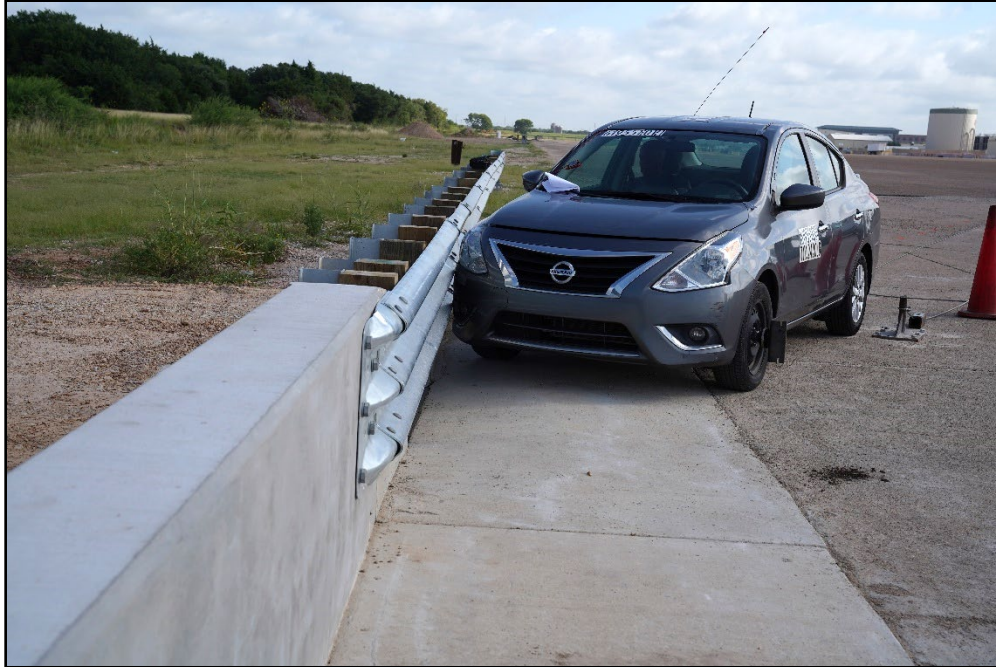
Figure 5.1. TL-3 Transition with a Storm Drain Inlet/Test Vehicle Geometrics for Test 619551-01-1.

See Table 5.1 for details of *MASH* impact conditions for this test and Table 5.2 for the exit parameters. Figure 5.1 and Figure 5.2 depict the target impact setup.

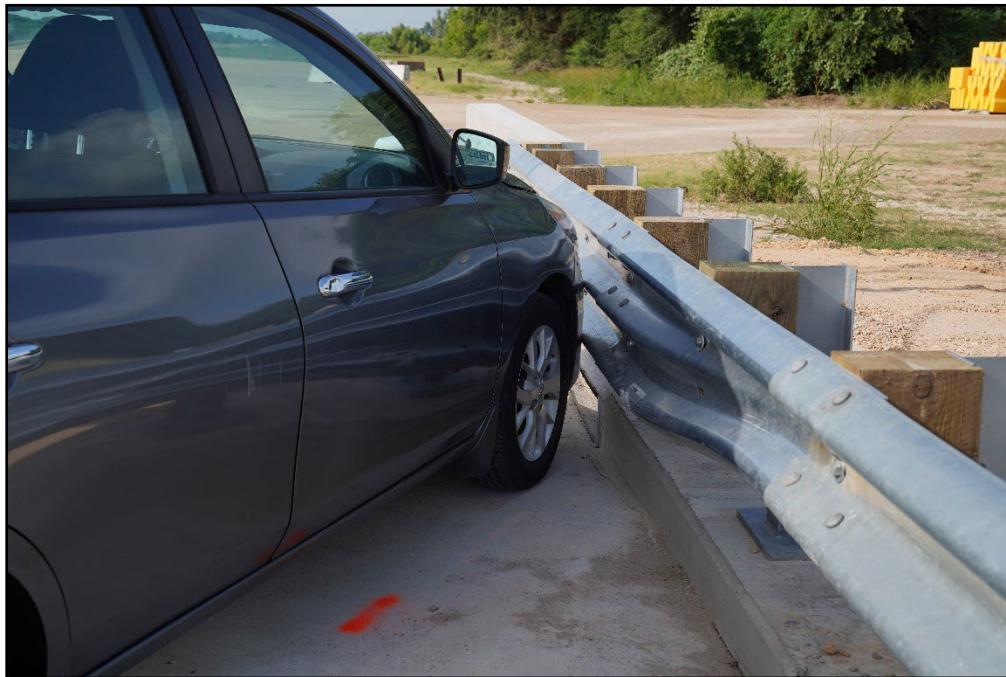
Figure 5.2. TL-3 Transition with a Storm Drain Inlet/Test Vehicle Impact Location 619551-01-1.

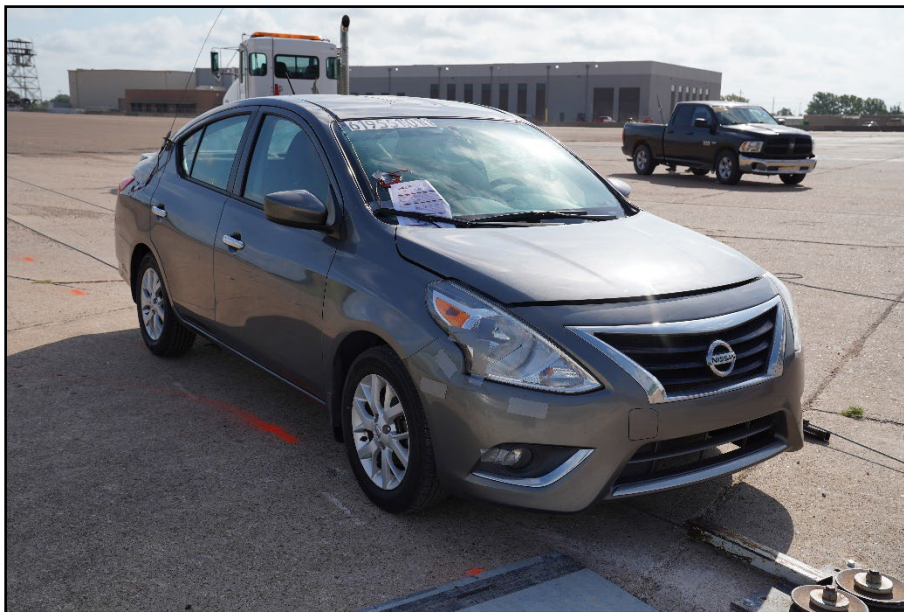
Figure 5.3. Impact Side of Test Vehicle before Test 619551-01-1.

Figure 5.3 and Figure 5.4 show the 2017 Nissan Versa used for the crash test. Table 5.4 shows the vehicle measurements. Figure C.1 in Appendix C.1 gives additional dimensions and information on the vehicle.

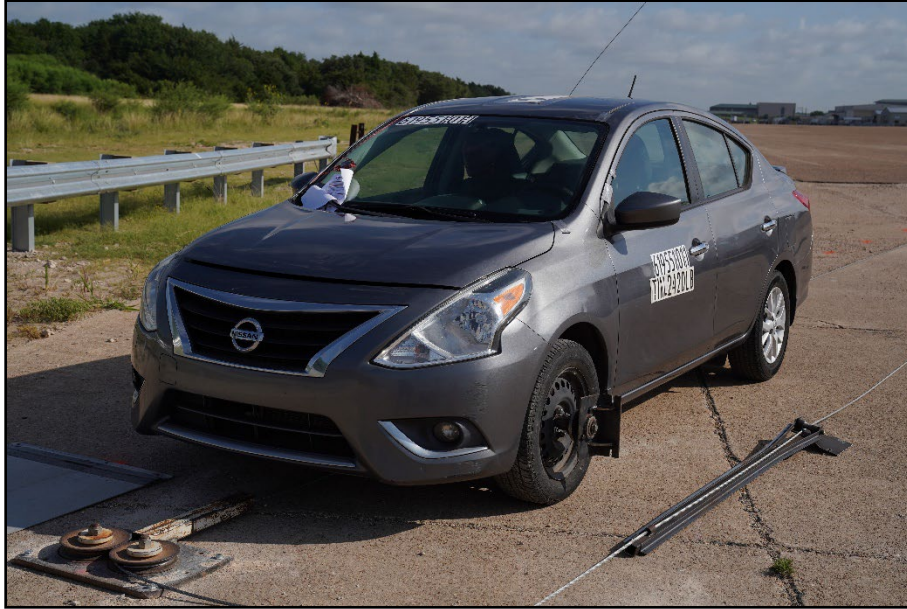
Figure 5.4. Opposite Impact Side of Test Vehicle before Test 619551-01-1.

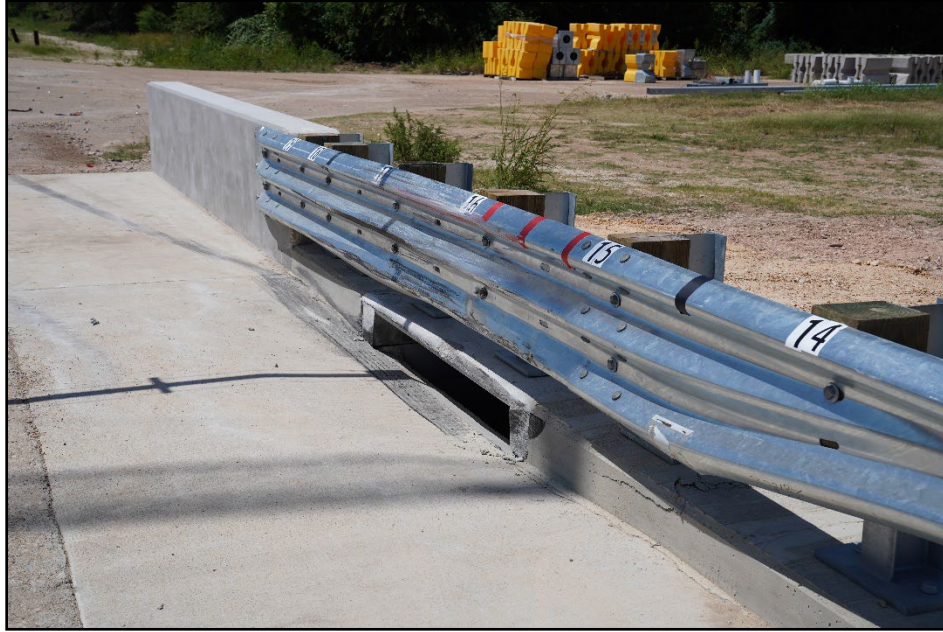
Figure 5.5. Traffic Side of the TL-3 Transition with a Storm Drain Inlet at Impact Location after Test 619551-01-1.

The concrete was damaged at post 15, and the rail was scuffed and deformed between posts 15 and 18. The drop inlet top was pushed back 0.5-inch. Post 15 was leaning 1 degree to the field side, and posts 16 and 17 were leaning 2 degrees. Table 5.6 describes the deflection and working width of the TL-3 Transition with a Storm Drain Inlet. Figure 5.5 and Figure 5.6 show the damage to the TL-3 Transition with a Storm Drain Inlet.

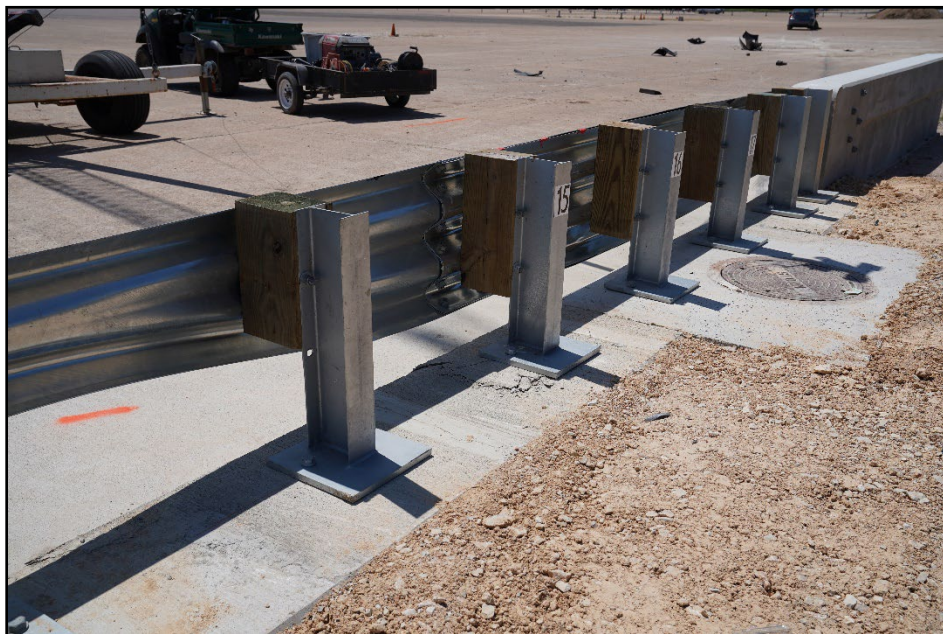
Figure 5.6. Field Side of the TL-3 Transition with a Storm Drain Inlet at Impact Location after Test 619551-01-1.

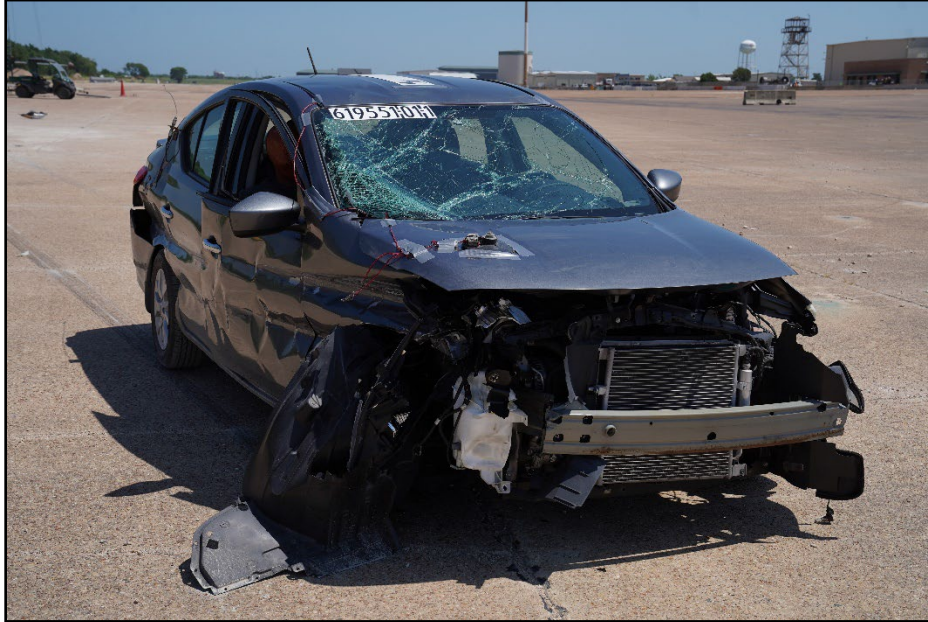
Figure 5.7. Impact Side of Test Vehicle after Test 619551-01-1.

Figure 5.7 and Figure 5.8 show the damage sustained by the vehicle. Figure 5.9 and Figure 5.10 show the interior of the test vehicle. Table 5.7 and Table 5.8 provide details on the occupant compartment deformation and exterior vehicle damage. Figures C.2 and C.3 in Appendix C.1 provide exterior crush and occupant compartment measurements.

Side Windows	The front right side window shattered, but it was not caused by penetration by the test article.
Maximum Exterior Deformation	9 inches in the front plane at the right corner at bumper height
VDS	01RFQ5
CDC	01FREW3
Fuel Tank Damage	None
Description of Damage to Vehicle:	The bumper, grill, right front fender, right front wheel, right front control arm, frame rail, headlights, windshield, right front a-pillar, right doors, right quarter fender, right tail light, and right front side window were damaged. The top of the right front door had a 2.75-inch gap. The windshield had extensive cracking due to flexing of the body, but there were no holes and no tearing in the laminate.

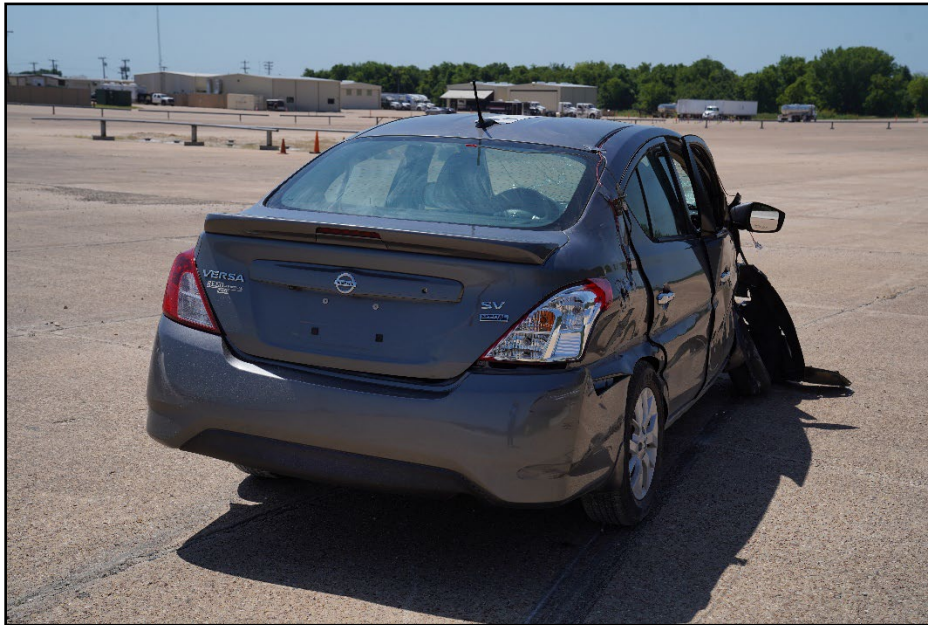
Figure 5.8. Rear Impact Side of Test Vehicle after Test 619551-01-1.

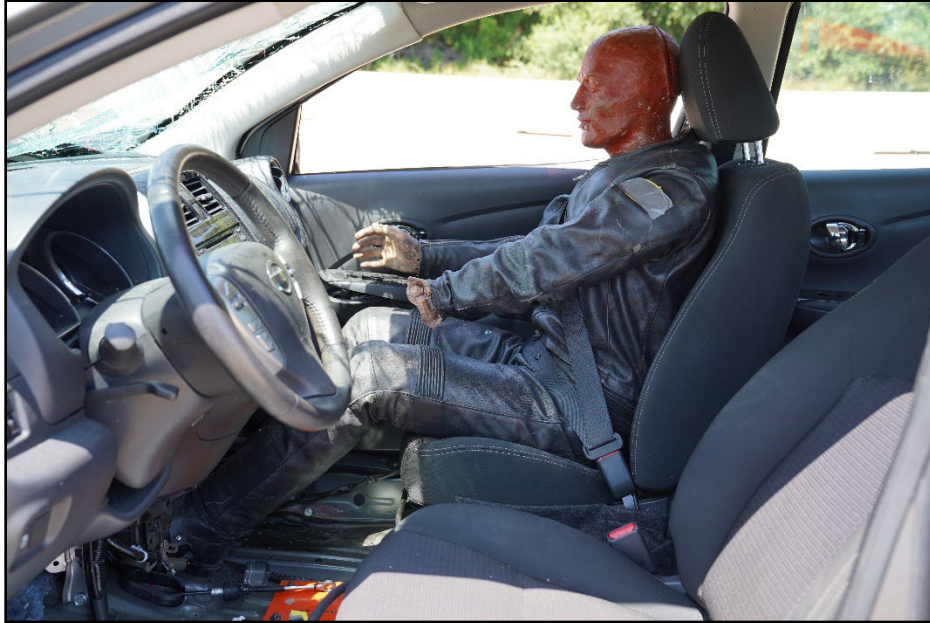
Figure 5.9. Overall Interior of Test Vehicle after Test 619551-01-1.

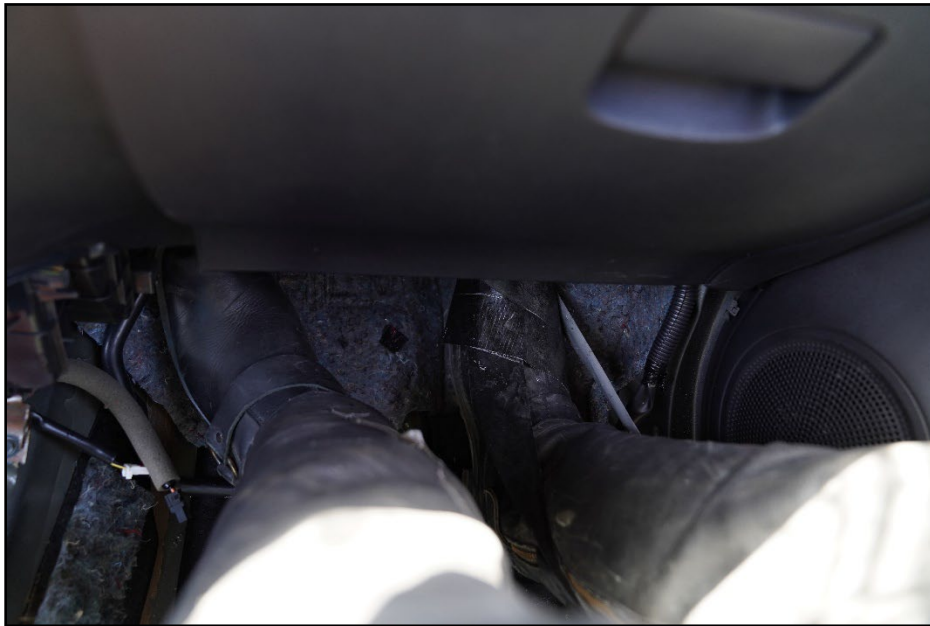
Figure 5.10. Interior of Test Vehicle on Impact Side after Test 619551-01-1.

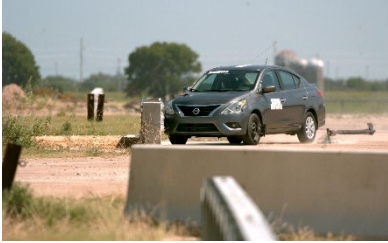
Figure 5.11. Summary of Results for MASH Test 3-20 on TL-3 Transition with a Storm Drain Inlet.

Figure 5.11 summarizes the results of MASH Test 619551-01-1.

<p style="text-align: center;">0.000 s</p>	Test Agency	Texas A&M Transportation Institute (TTI)					
	Test Standard/Test No.	MASH 2016, Test 3-20					
	TTI Project No.	619551-01-1					
	Test Date	2023-06-27

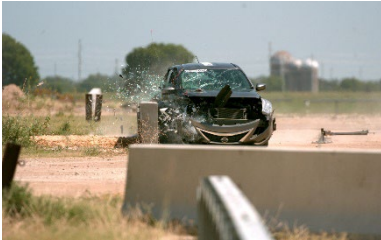
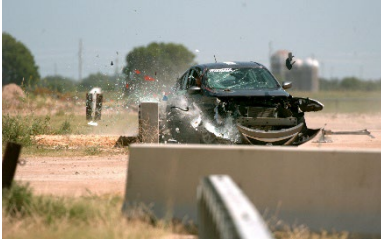
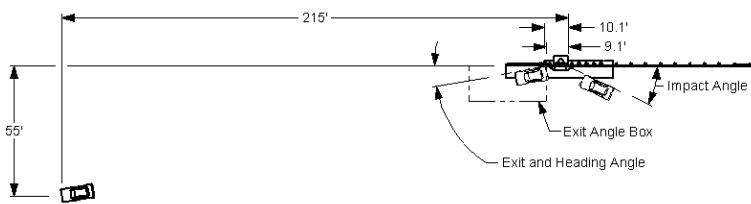
<p style="text-align: center;">0.100 s</p>	TEST ARTICLE						
	Type	Longitudinal Barrier					
	Name	TL-3 Transition with a Storm Drain Inlet					
	Length	102 feet 10 inches

<p style="text-align: center;">0.200 s</p>	Key Materials	Thrie-beam & W-beam rail, 72-inch wide-flange guardrail post, wingwall post, pre-cast drop inlet, Concrete parapet					
	Soil Type and Condition	Type D Grade 1 crushed concrete, damp					
	TEST VEHICLE						
	Type/Designation	1100C

<p style="text-align: center;">0.300 s</p>	Year, Make and Model	2017 Nissan Versa					
	Inertial Weight (lb)	2437					
	Dummy (lb)	165					
	Gross Static (lb)	2602					
IMPACT CONDITIONS							
Impact Speed (mi/h)	62.6

Impact Angle (deg)	25.3						
Impact Location	121.3 inches upstream from the downstream edge of the concrete						
Impact Severity (kip-ft)	58.3						
EXIT CONDITIONS							
Exit Speed (mi/h)	49.1						
Trajectory/Heading Angle (deg)	10.8 / 10.3						
Exit Box Criteria	Vehicle crossed the exit box a 42 ft downstream from loss of contact.						
Stopping Distance	215 ft downstream 55 ft to the traffic side						
TEST ARTICLE DEFLECTIONS							
Dynamic (inches)	1.9						
Permanent (inches)	1						
Working Width / Height (inches)	52.3 / 0.0						
VEHICLE DAMAGE							
VDS	01RFQ5						
CDC	01FREW3						
Max. Ext. Deformation (inches)	9						
Max Occupant Compartment Deformation	2.75 inches in the windshield						
OCCUPANT RISK VALUES							
Long. OIV (ft/s)	20	Long. Ridedown (g)	4.9	Max 50-ms Long. (g)	-11.3	Max Roll (deg)	3.9
Lat. OIV (ft/s)	33.7	Lat. Ridedown (g)	10.5	Max 50-ms Lat. (g)	-19.7	Max Pitch (deg)	2.9

THIV (m/s)	11.9	ASI	2.63	Max 50-ms Vert. (g)	2.4	Max Yaw (deg)	39.9

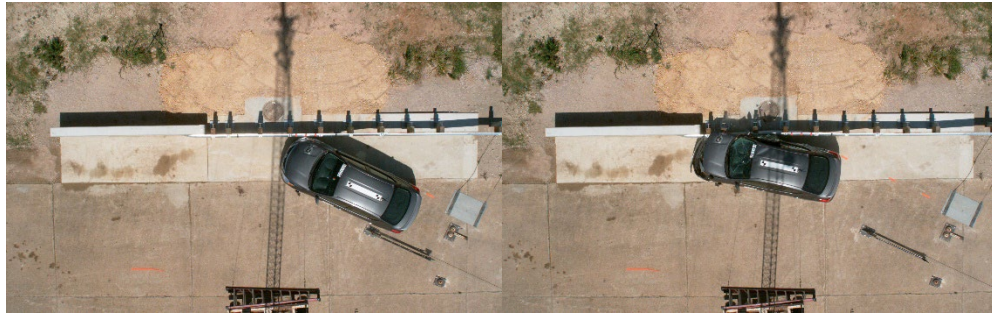
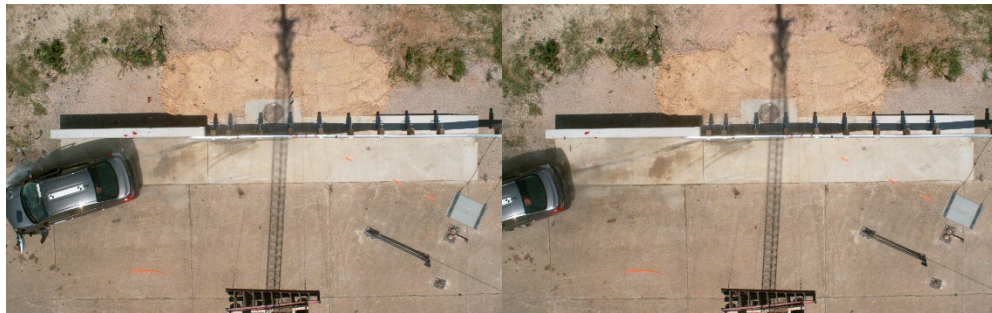
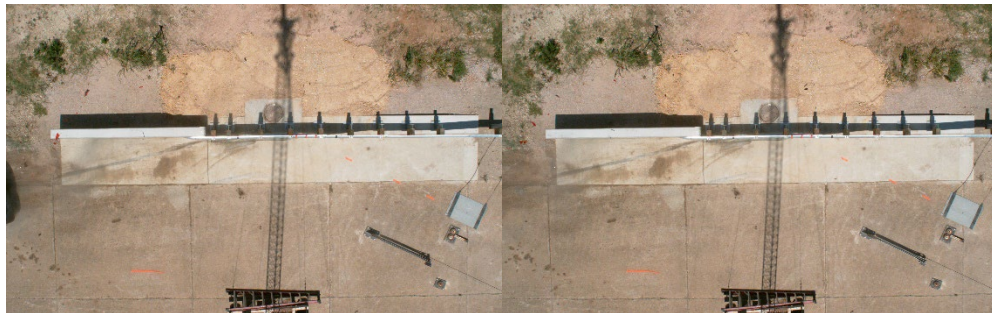
Figure C.4. Sequential Photographs for Test 619551-01-1 (Overhead Views).

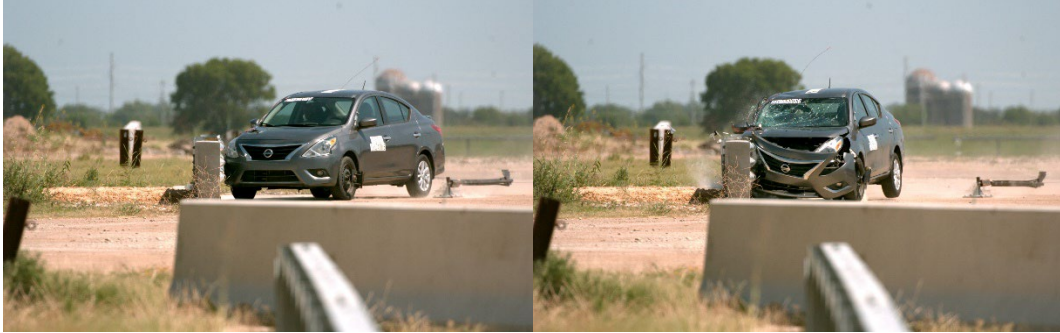
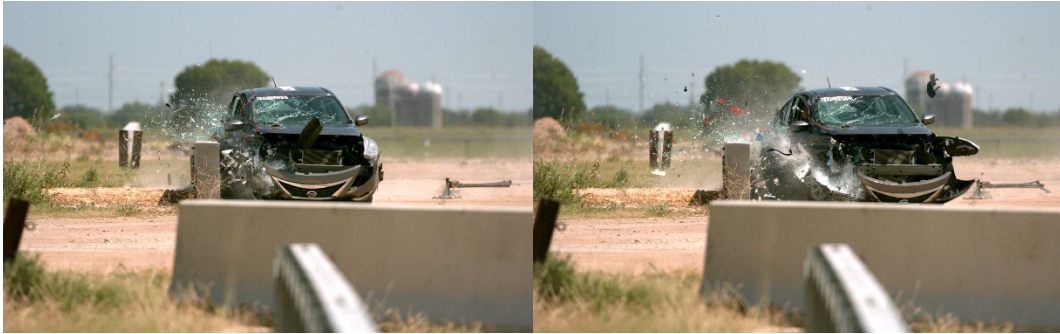
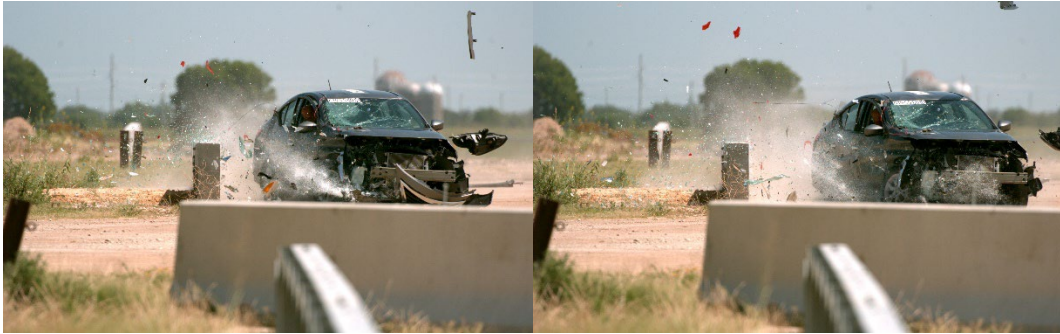
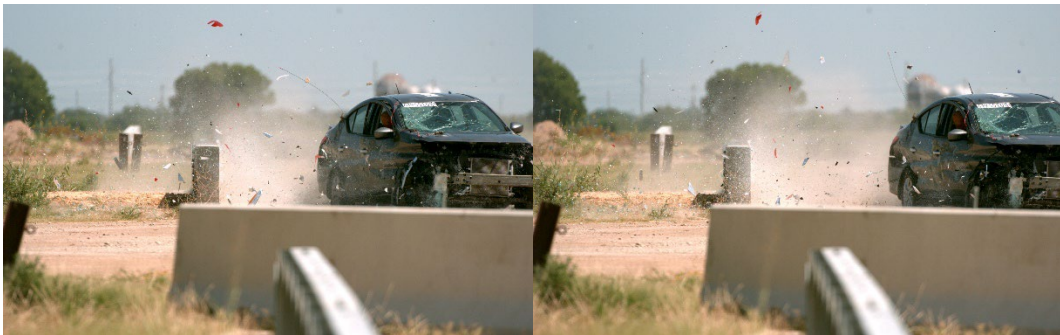
Figure C.5. Sequential Photographs for Test 619551-01-1 (Frontal Views).

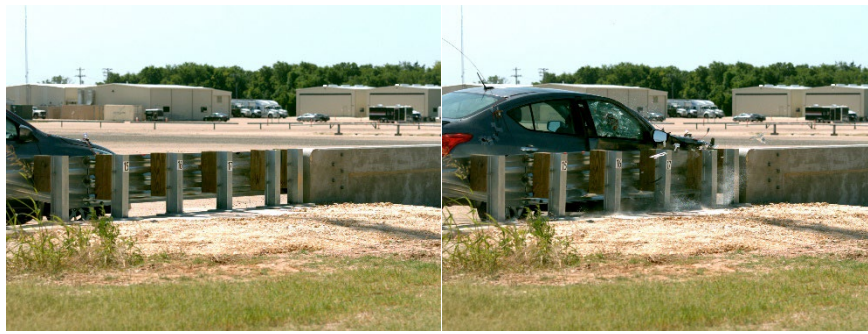
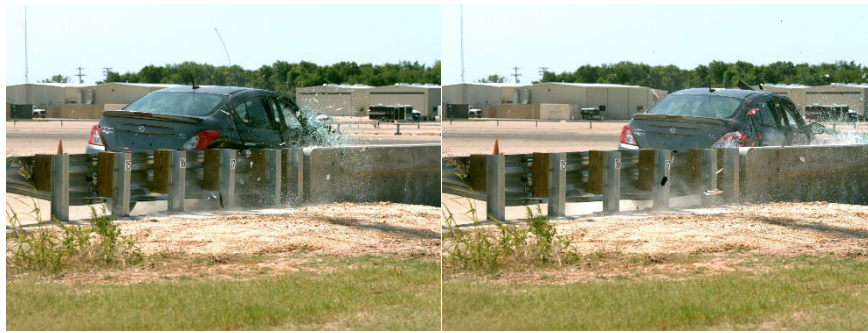
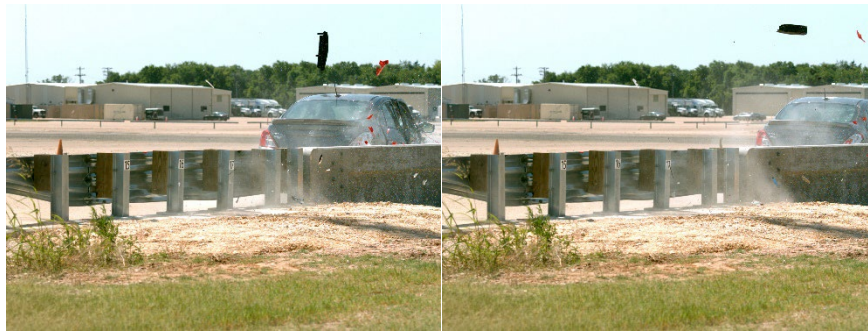
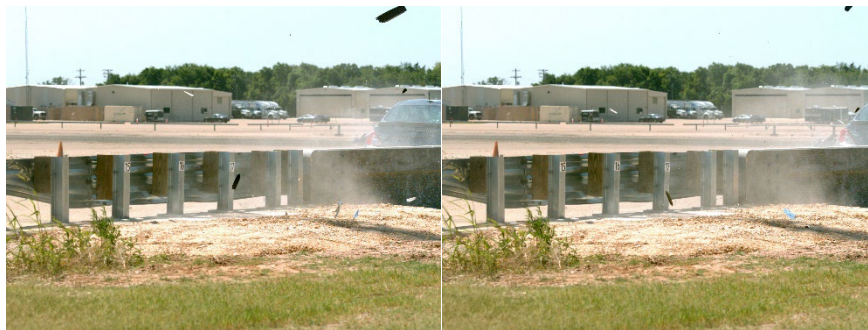
(a) 0.000 s

(b) 0.100 s

(c) 0.200 s

(d) 0.300 s

(e) 0.400 s

(f) 0.500 s

(g) 0.600 s

(h) 0.700 s

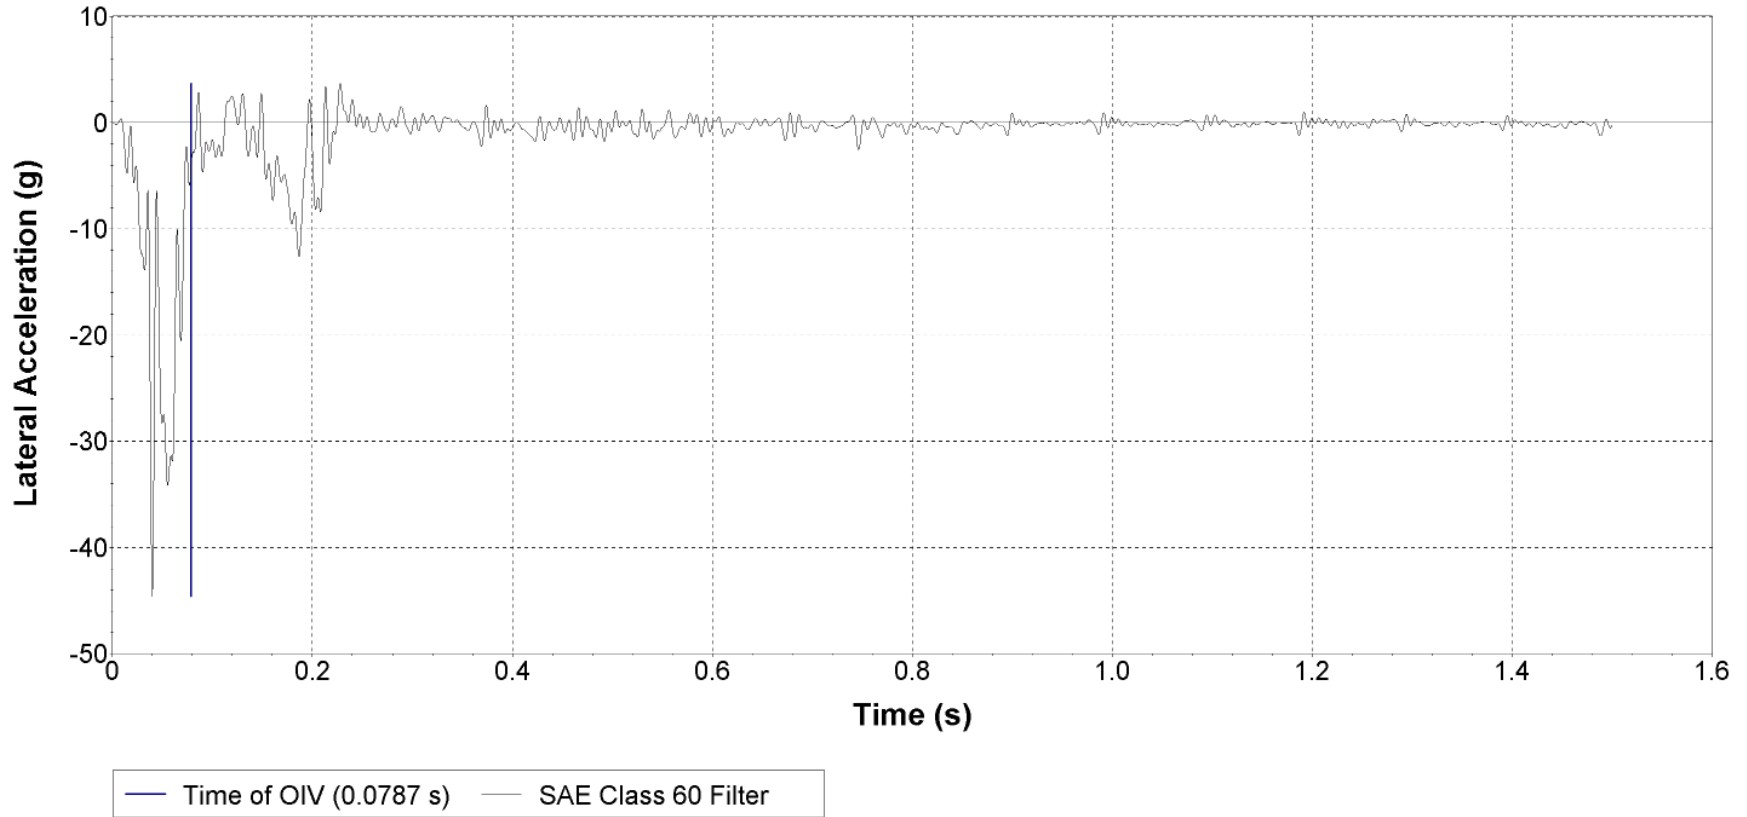
Y Acceleration at CG

Figure C.9. Vehicle Lateral Accelerometer Trace for Test 619551-01-1 (Accelerometer Located at Center of Gravity).
