Test Report No. 618981-01-1

**MASH TEST LEVEL 3 EVALUATION OF A SHORTER THRIE-BEAM  
APPROACH TRANSITION**

Sponsored by  
**Washington State Department of Transportation**

TRNo. 618981-01-1  
Contract No.: T 4541

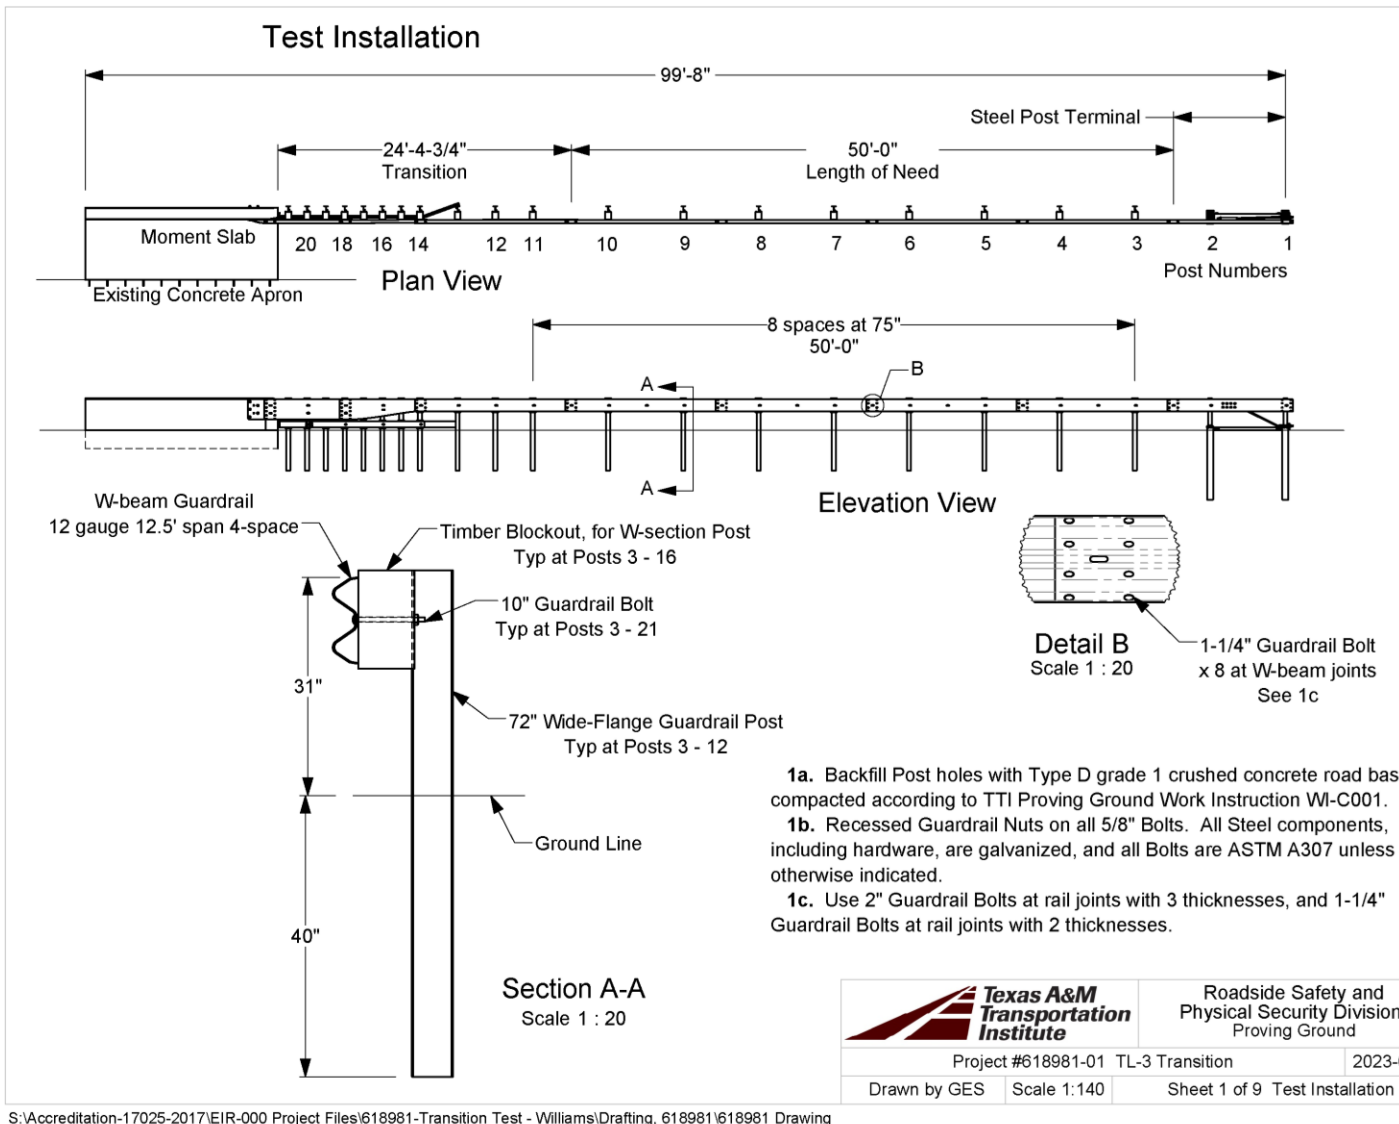
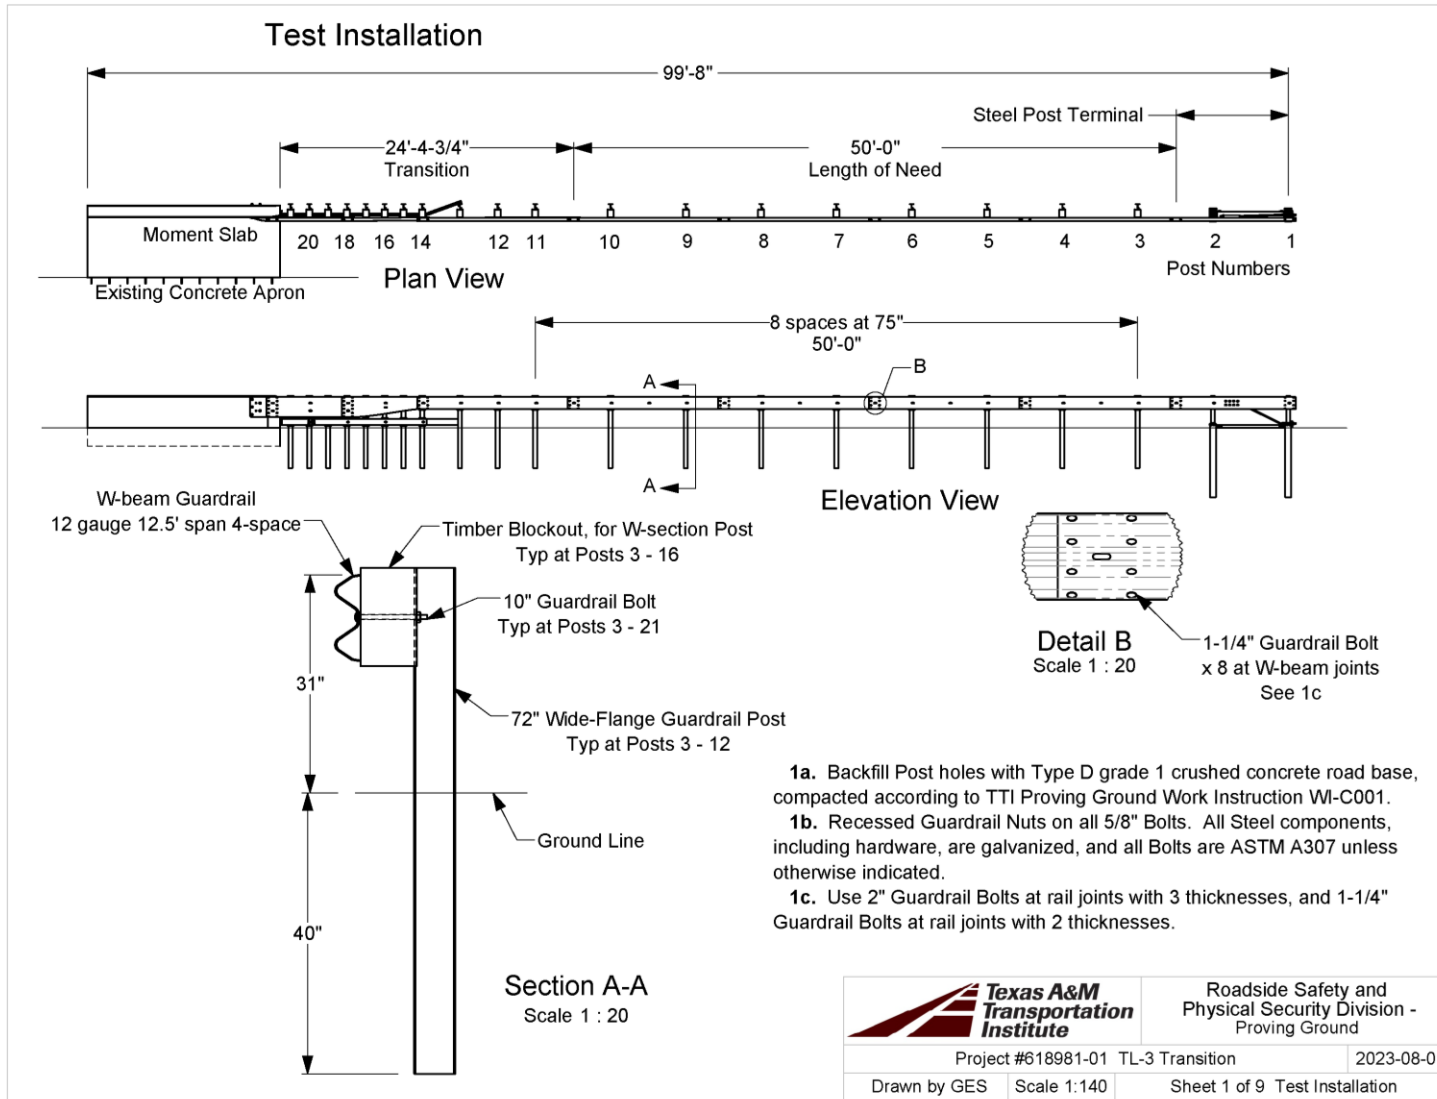
**Figure 3.1. Details of Shortened Transition.**

Figure 3.1 presents the overall information on the Shortened Transition, and Figure 3.2 thru Figure 3.7 provide photographs of the installation. Appendix A provides further details on the Shortened Transition. Drawings were provided by the Texas A&M Transportation Institute (TTI) Proving Ground, and construction was performed by TTI Proving Ground personnel.

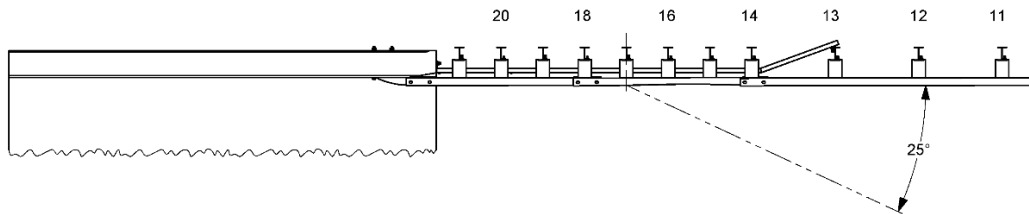
**Figure 4.1. Target CIP for *MASH* TL-3 Tests on Shortened Transition.**

Table 4.1 shows the test conditions and evaluation criteria for *MASH* TL-3 for Longitudinal Barrier. The target critical impact point (CIPs) for the test was determined using the information provided in *MASH* Section 2.2.1 and Section 2.3.2 Figure 4.1 shows the target CIP for the *MASH* TL-3 test on the Shortened Transition.

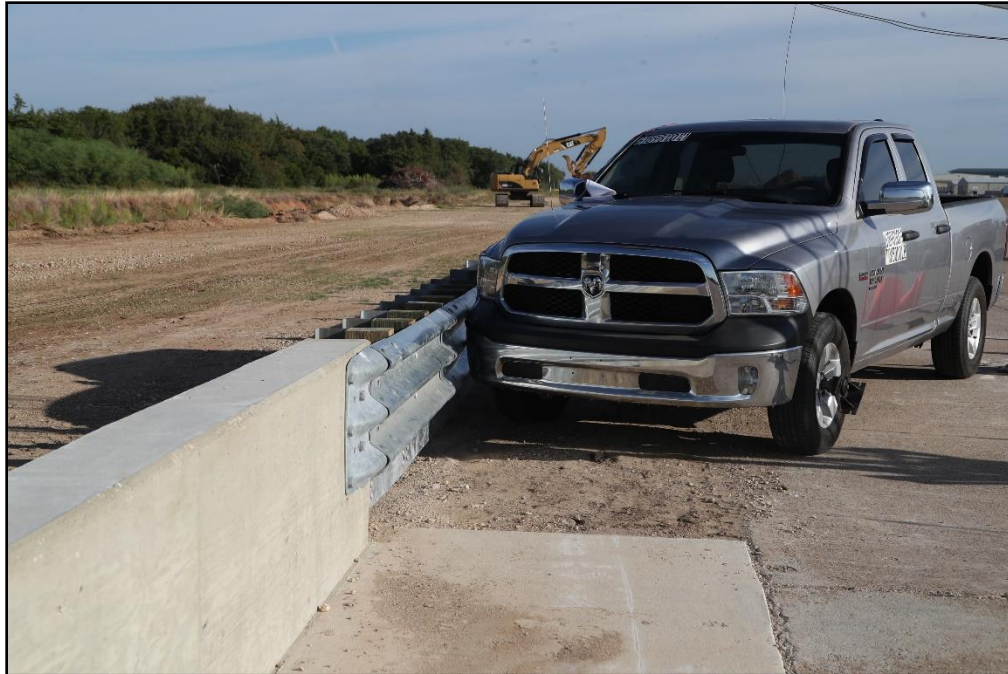
**Figure 6.1. Shortened Transition Test Vehicle Geometrics for Test 618981-01-1.**

See Table 6.1 for details of *MASH* impact conditions for this test and Table 6.2 for the exit parameters. Figure 6.1 and Figure 6.2 depict the target impact setup.

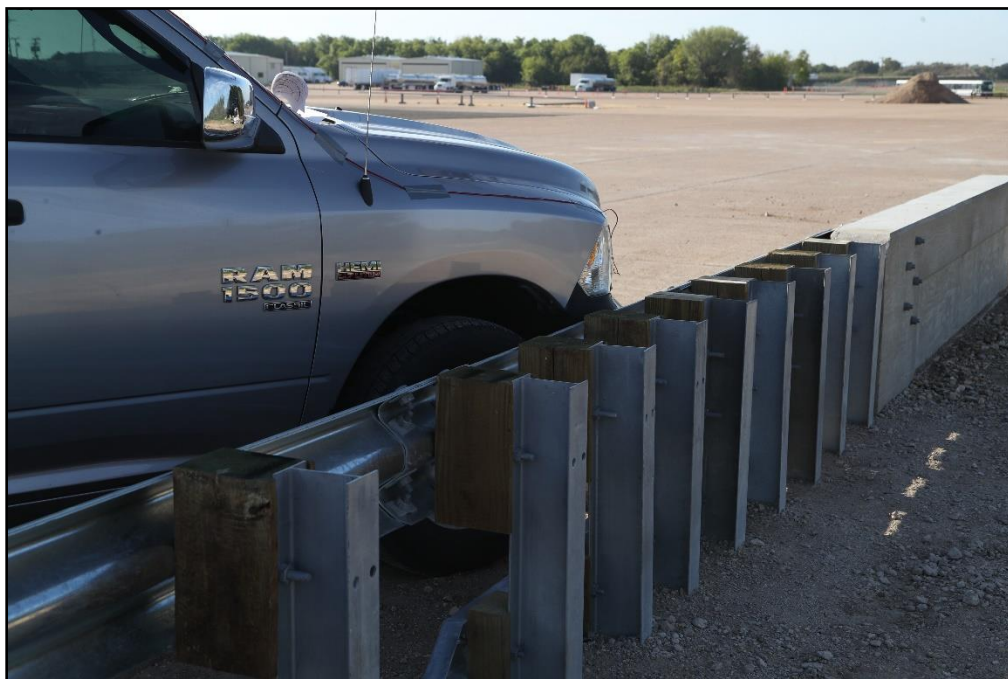
**Figure 6.2. Shortened Transition/Test Vehicle Impact Location 618981-01-1.**

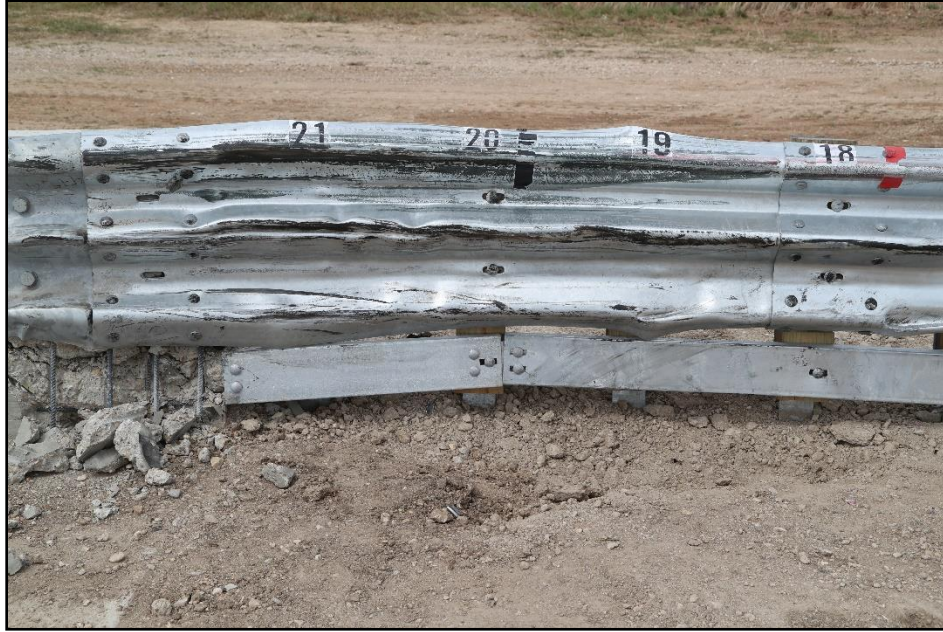
**Figure 6.5. Shortened Transition at Impact Location after Test 618981-01-1.**

Table 6.6 describes the deflection and working width of the Shortened Transition. Figure 6.5 and Figure 6.6 show the damage to the Shortened Transition.

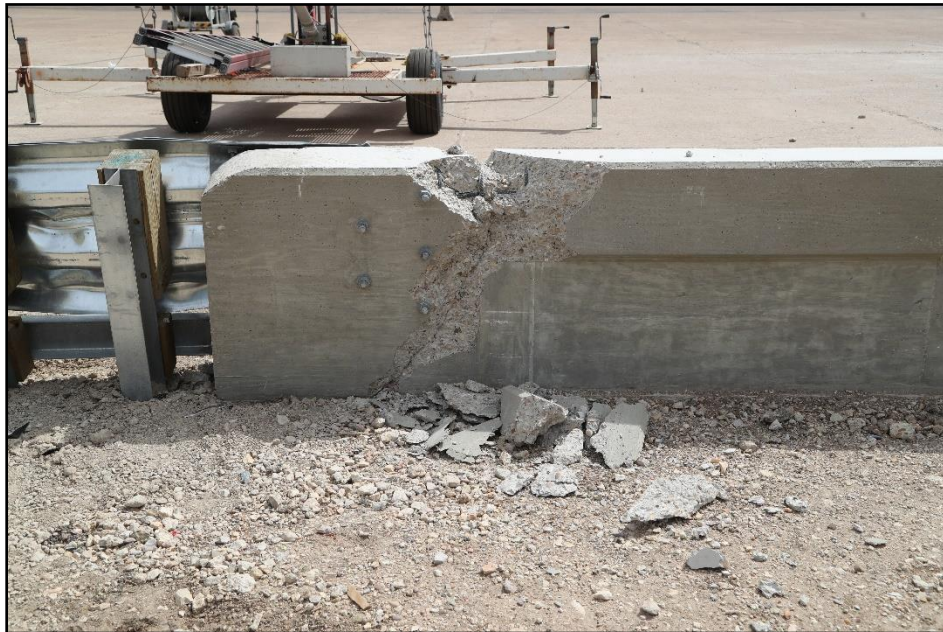
**Figure 6.6. Field Side View of Shortened Transition of Concrete Parapet after Test 618981-01-1.**

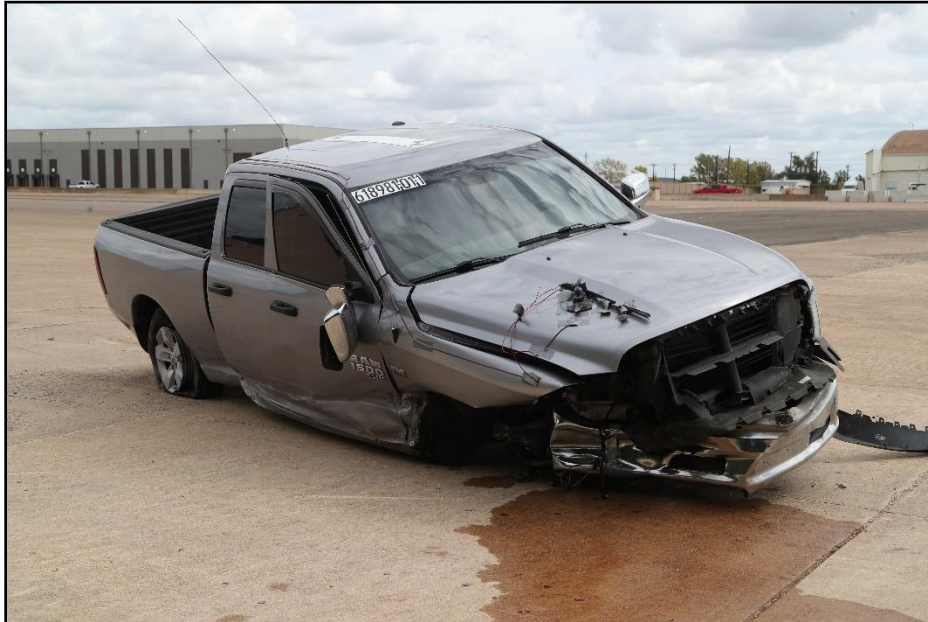
**Figure 6.7. Impact Side of Test Vehicle after Test 618981-01-1.**

Figure 6.7 and Figure 6.8 show the damage sustained by the vehicle. Figure 6.9 and Figure 6.10 show the interior of the test vehicle. Table 6.7 and Table 6.8 provide details on the occupant compartment deformation and exterior vehicle damage. Figures C.2 and C.3 in Appendix C.1 provide exterior crush and occupant compartment measurements.

Side Windows	Side windows remained intact
Maximum Exterior Deformation	24 inches of the front bumper
VDS	01FRQ5
CDC	01FREW8
Fuel Tank Damage	None
Description of Damage to Vehicle:	The bumper, grill, radiator, and support were severely deformed. The right headlight was broken and the right front fender was dented. There were dents and scratches all down the lower portion of the right hand side. The right rear wheel busted and the right rear tire was blown out. There was a 4-inch gap at the top of the right front door and a .5-inch gap at the top of the right rear door. The right rear bumper was dented.

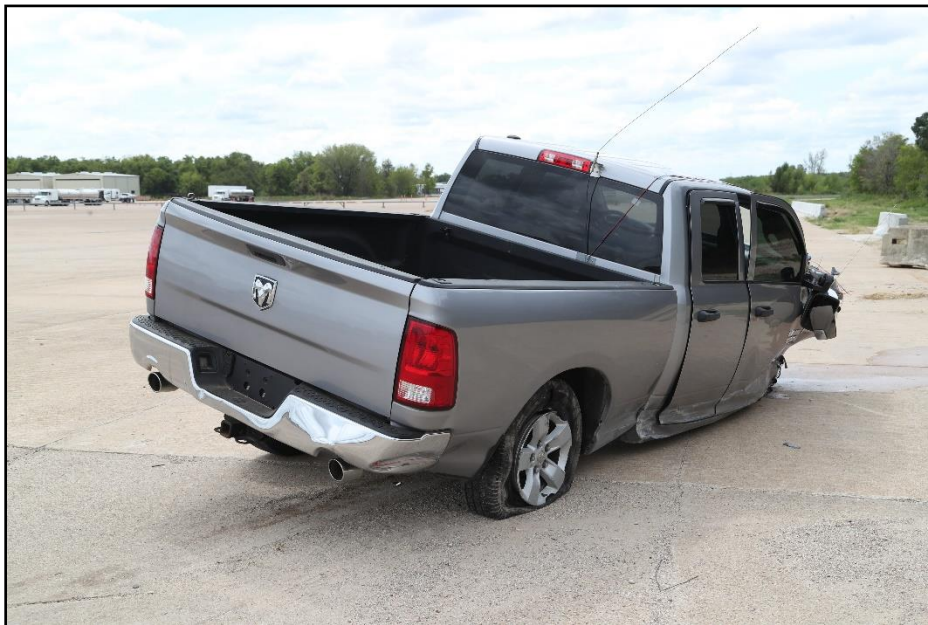
**Figure 6.8. Rear Impact Side of Test Vehicle after Test 618981-01-1.**

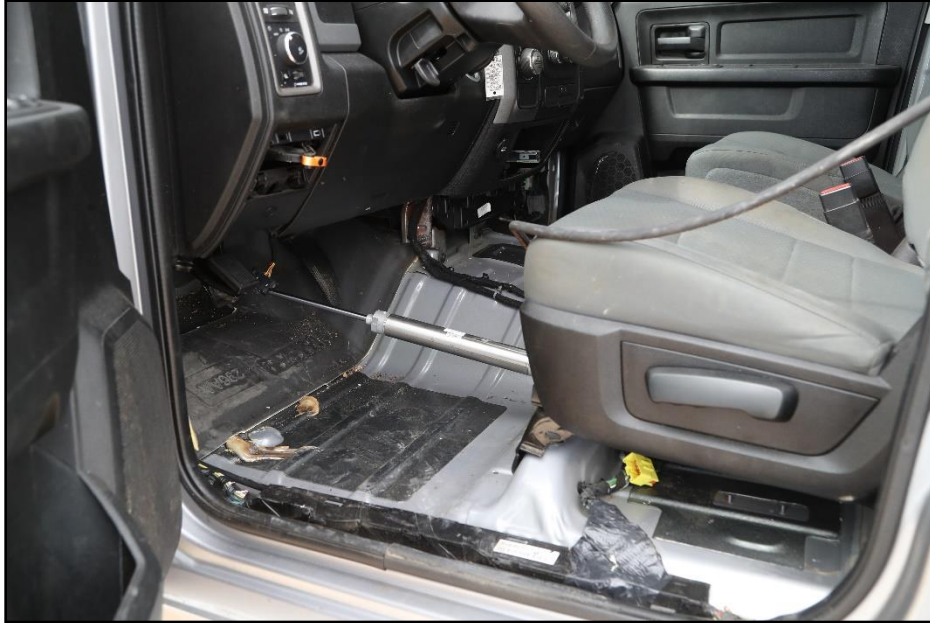
**Figure 6.9. Overall Interior of Test Vehicle after Test 618981-01-1.**

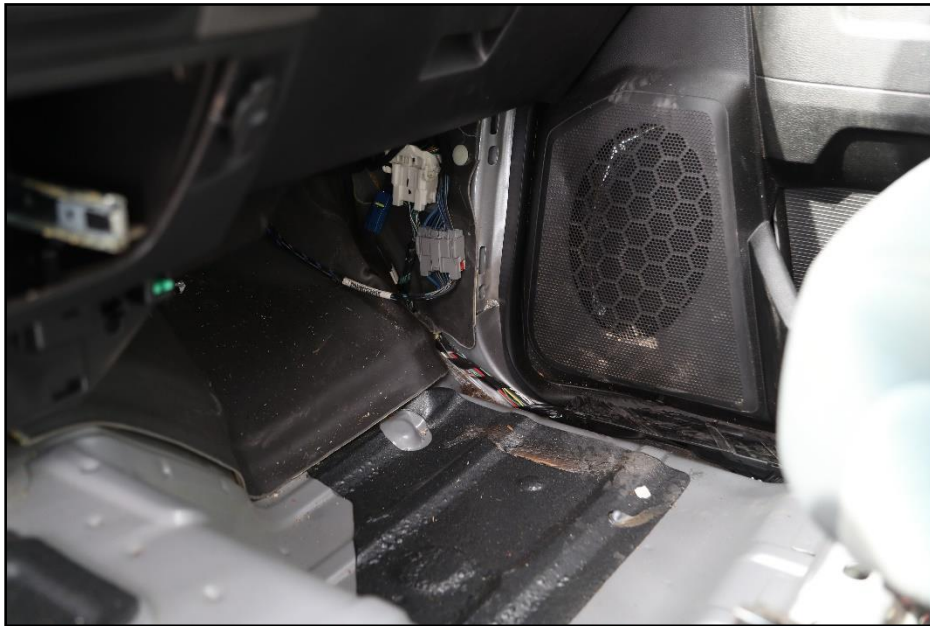
**Figure 6.10. Interior of Test Vehicle on Impact Side after Test 618981-01-1.**

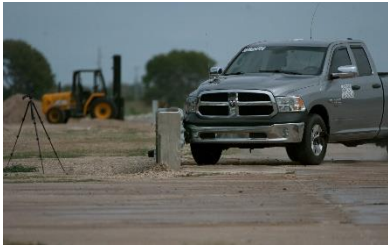
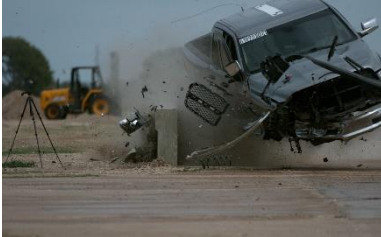
Figure 6.11 summarizes the results of MASH Test 618981-01-1.

<p style="text-align: center;"><b>0.000 s</b></p>	Test Agency		Texas A&M Transportation Institute (TTI)					
	Test Standard/Test No.		MASH 2016, Test 3-21					
	TTI Project No.		618981-01-1					
	Test Date		2023-09-21					
<b>TEST ARTICLE</b>								
		Type	Longitudinal Barrier					
		Name	Shortened Transition					
		Length	99 feet and 8 inches					
		Key Materials	Galvanized steel rubrail, timber blockouts, concrete parapet, Hilti HT-RE 500 V3 epoxy					
		Soil Type and Condition	concrete, crushed concrete, wet

<p style="text-align: center;"><b>0.200 s</b></p>	<b>TEST VEHICLE</b>							
			Type/Designation	2270P				
			Year, Make and Model	2019 RAM 1500				
			Inertial Weight (lb)	5031				
		Dummy (lb)	N/A					
		Gross Static (lb)	5031					
<b>IMPACT CONDITIONS</b>								
		Impact Speed (mi/h)	63.2					
		Impact Angle (deg)	25.1					
		Impact Location	1.5 inches upstream of centerline of post 17

Impact Severity (kip-ft)	120.9					
<b>EXIT CONDITIONS</b>								
		Exit Speed (mi/h)	48.2					
		Trajectory/Heading Angle (deg)	6.3 / 10.7					
		Exit Box Criteria	Vehicle crossed the exit box 55 ft downstream from loss of contact.					
		Stopping Distance	246 ft downstream 12 ft to the traffic side

<p style="text-align: center;"><b>0.400 s</b></p>	<b>TEST ARTICLE DEFLECTIONS</b>							
			Dynamic (inches)	12.2				
			Permanent (inches)	11.9				
			Working Width / Height (inches)	31.3 / 31				
<b>VEHICLE DAMAGE</b>								
		VDS	01FRQ5					
		CDC	01FREW8					
		Max. Ext. Deformation (inches)	24					
		Max Occupant Compartment Deformation	1 inch into the floorpan					
<b>OCCUPANT RISK VALUES</b>								
Long. OIV (ft/s)	22.8	Long. Ridedown (g)	11.7	Max 50-ms Long. (g)	-9.6	Max Roll (deg)	59.5	
Lat. OIV (ft/s)	26.4	Lat. Ridedown (g)	12.5	Max 50-ms Lat. (g)	-12.1	Max Pitch (deg)	14.4	
THIV (m/s)	10.1	ASI	1.6	Max 50-ms Vert. (g)	-3.9	Max Yaw (deg)	39.0

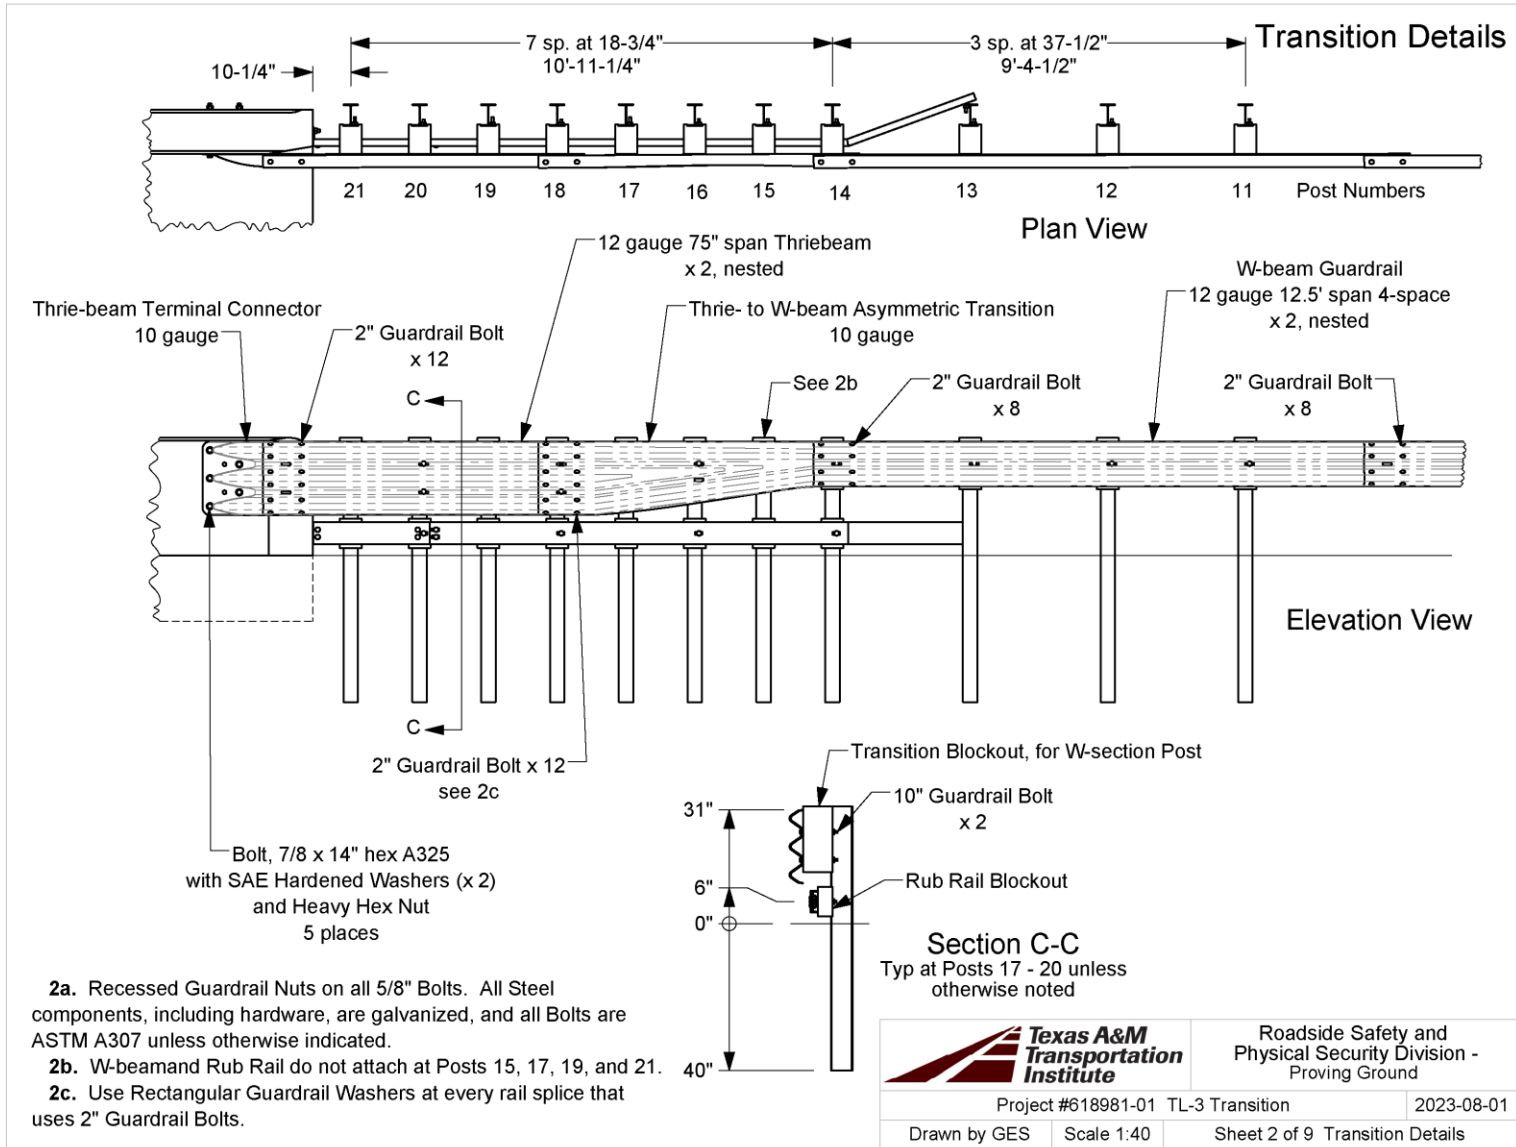
Project #618981-01 TL-3 Transition		2023-08-01
Drawn by GES	Scale 1:40	Sheet 2 of 9 Transition Details

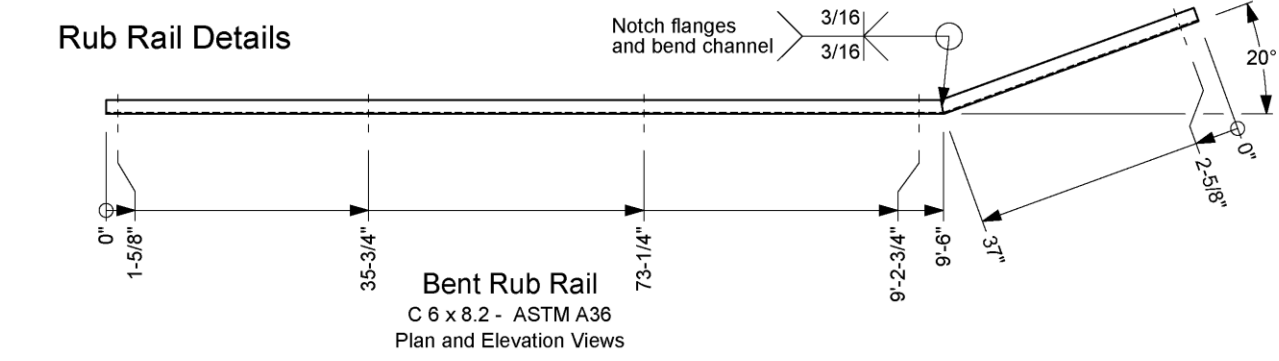
Roadside Safety and Physical Security Division - Proving Ground	
Project #618981-01 TL-3 Transition		2023-08-01	
Drawn by GES	Scale 1:20	Sheet 6 of 9 Rub Rail Details

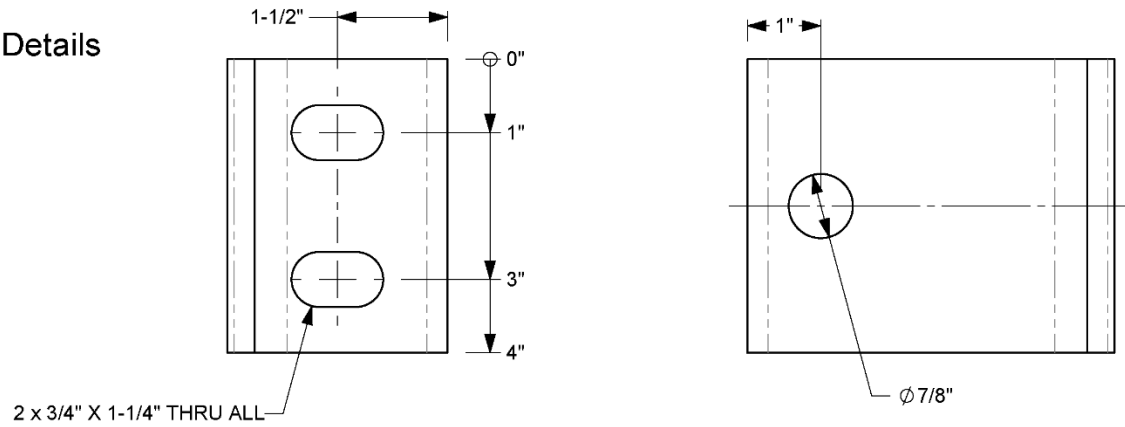
**Rub Rail Bracket**  
L 5" x 3" x 3/8" - ASTM A36

Roadside Safety and Physical Security Division - Proving Ground	
Project #618981-01 TL-3 Transition	2023-08-01	
Drawn by GES	Scale 1:2	Sheet 7 of 9 Bracket Details

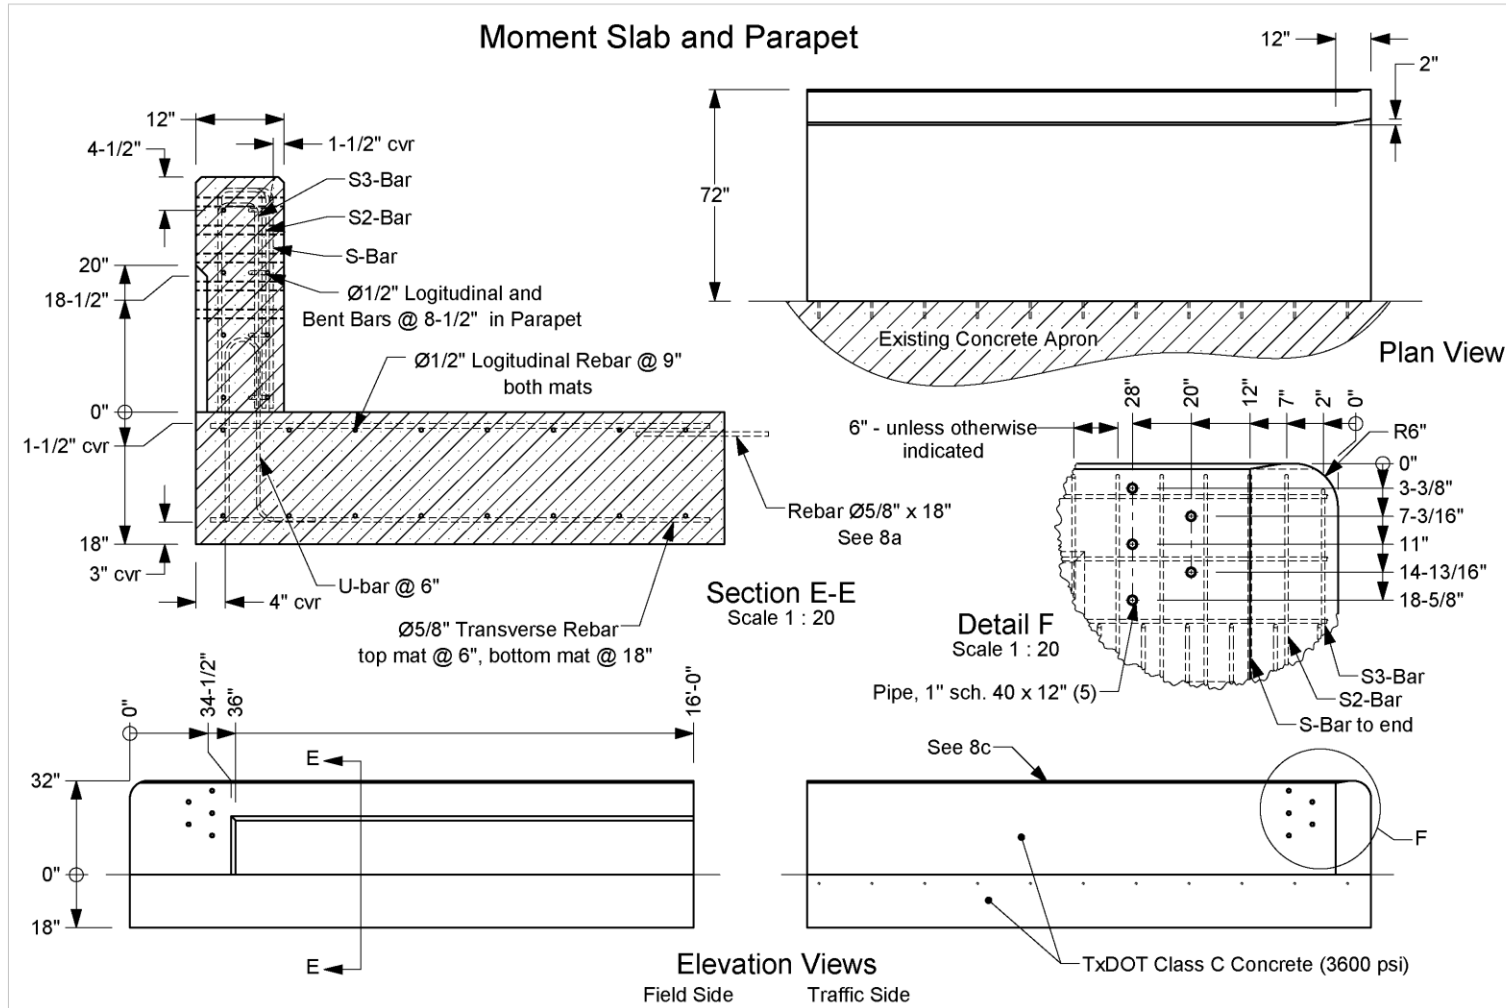
- 8a.** Secure in existing concrete apron with Hilti HIT-RE 500 V3 epoxy according to manufacturer's instructions, with 6" embedment at 18" spacing.
- 8b.** All rebar dimensions are to center unless otherwise indicated by "cvr" (cover).
- 8c.** 1" chamfer (3/4" each way) exposed edges of parapet as shown.

Roadside Safety and Physical Security Division - Proving Ground	
		Project #618981-01 TL-3 Transition	2023-08-01
Drawn by GES	Scale 1:50	Sheet 8 of 9 Moment Slab and Parapet

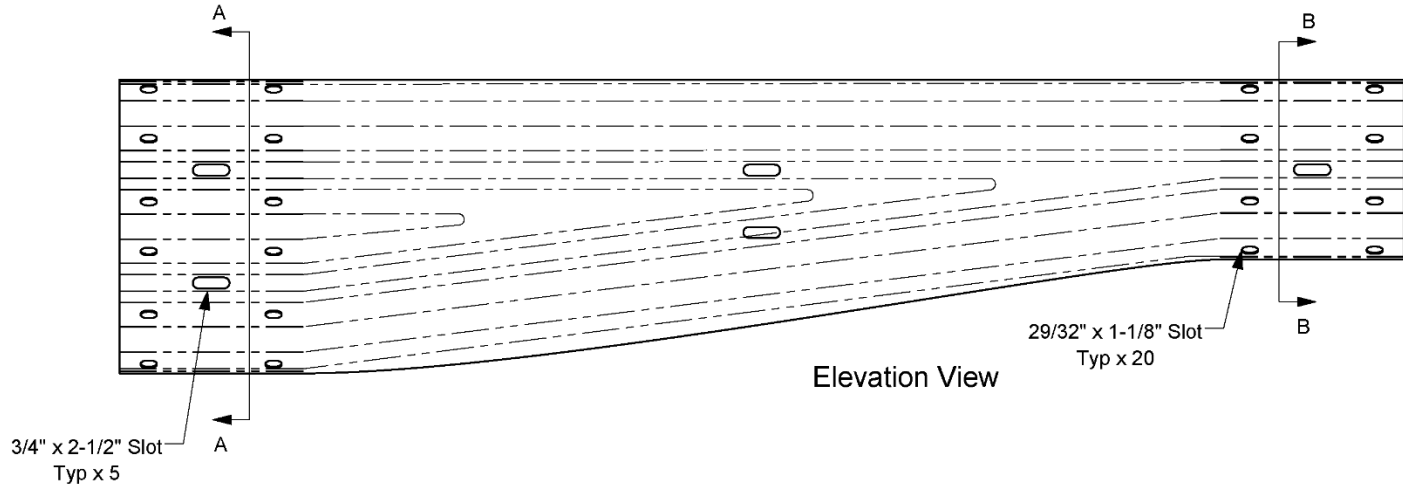
### Thrie to W-Beam, asymmetric 10 gauge

Roadside Safety and Physical Security Division - Proving Ground	
Thrie- to W-beam Asymmetric Transition		2022-07-18	
Drawn by GES	Scale 1:10	Sheet 1 of 1

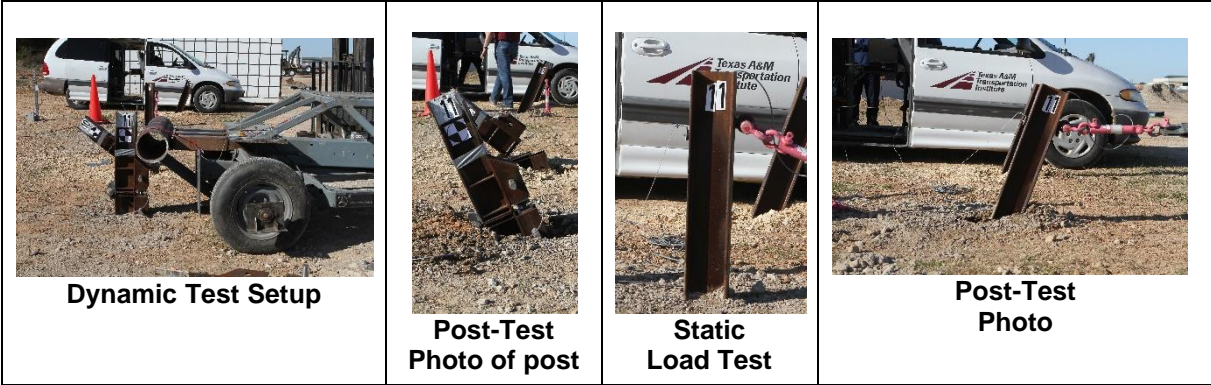
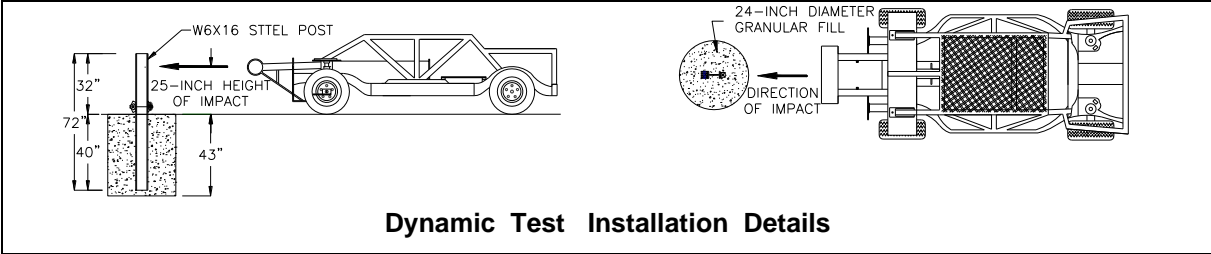
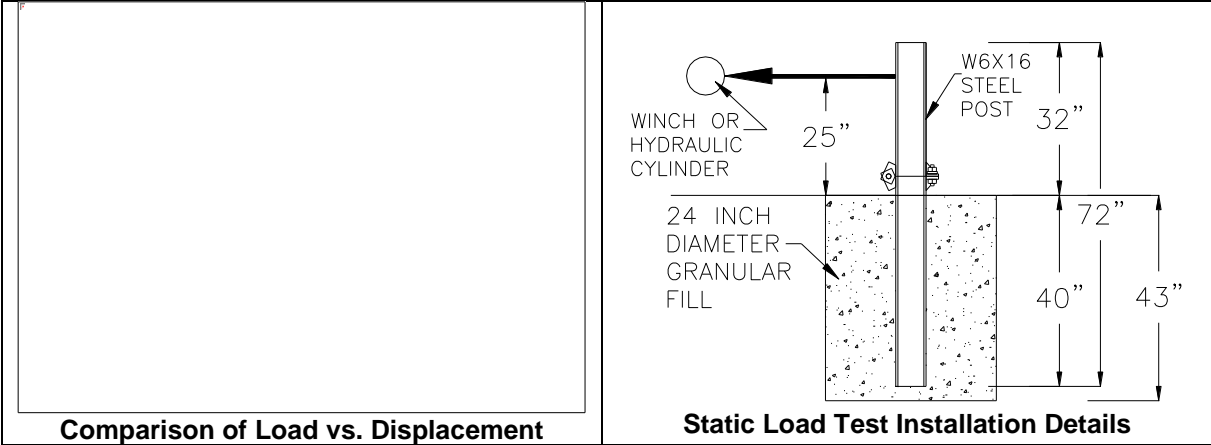
Comparison of Load vs. Displacement	
Date	2020-02-02
Test Facility and Site Location	TTI Proving Ground, 3100 SH 47, Bryan, TX 77807
In Situ Soil Description (ASTM D2487)	Sandy gravel with silty fines
Fill Material Description (ASTM D2487) and sieve analysis	Type 1 Grade D Crushed Concrete Road Base
Description of Fill Placement Procedure	12-inch lifts tamped with a pneumatic compactor for 20 sec
Bogie Weight	2020 lb
Impact Velocity	19.2 mph

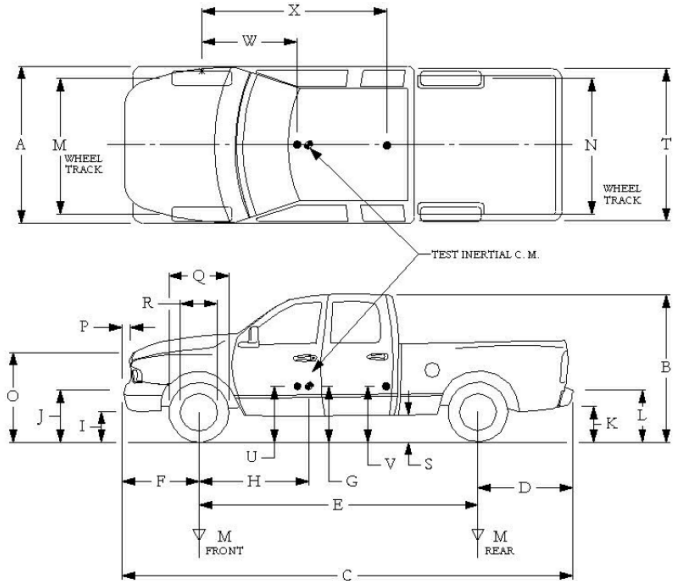
Geometry:		inches	
A	78.50	F	40.00
B	74.00	G	28.62
C	227.50	H	61.49
D	44.00	I	11.75
E	140.50	J	27.00
		K	20.00
		L	30.00
		M	68.50
		N	68.00
		O	46.00
		P	3.00
		Q	30.50
		R	18.00
		S	13.00
		T	77.00
		U	26.75
		V	30.25
		W	61.50
		X	79.00
Wheel Center Height Front	14.75	Wheel Well Clearance (Front)	6.00
Wheel Center Height Rear	14.75	Wheel Well Clearance (Rear)	9.25
		Bottom Frame Height - Front	12.50
		Bottom Frame Height - Rear	22.50

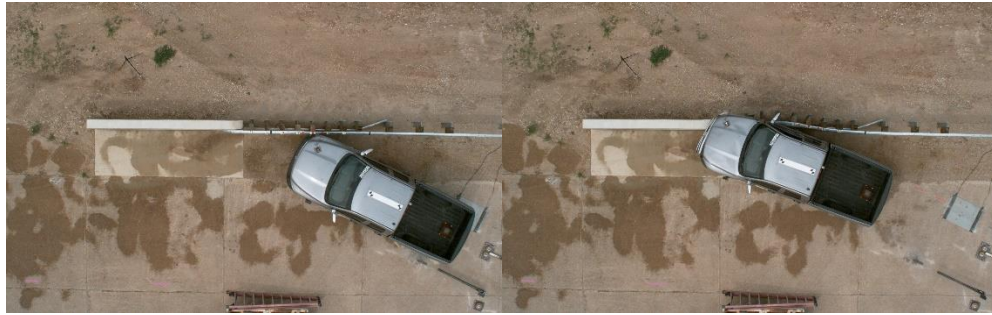
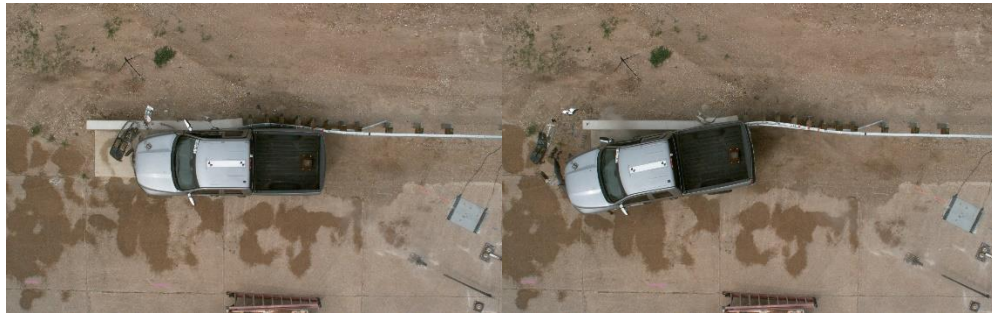
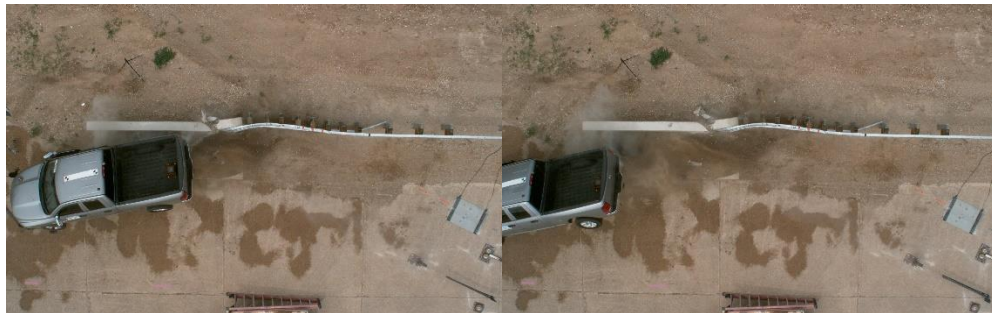
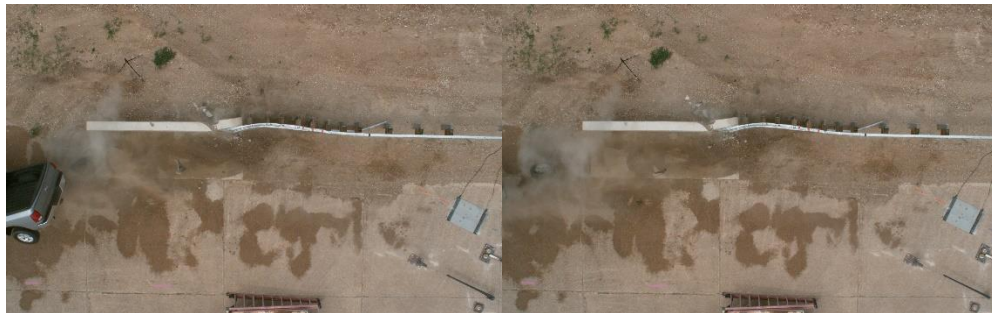
**Figure C.4. Sequential Photographs for Test 618981-01-1 (Overhead Views).**

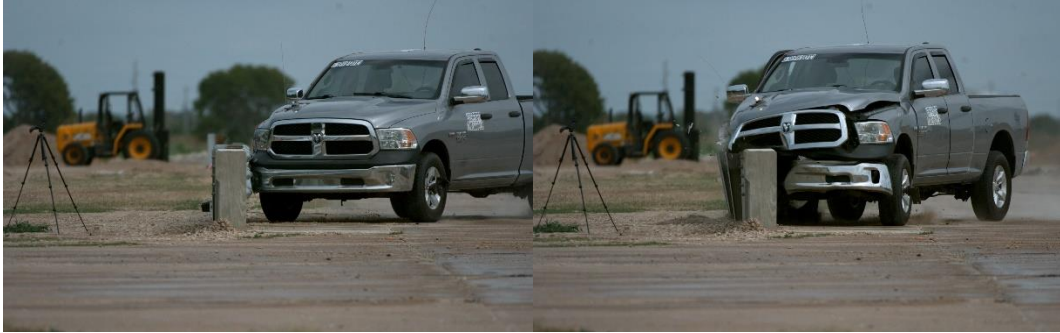
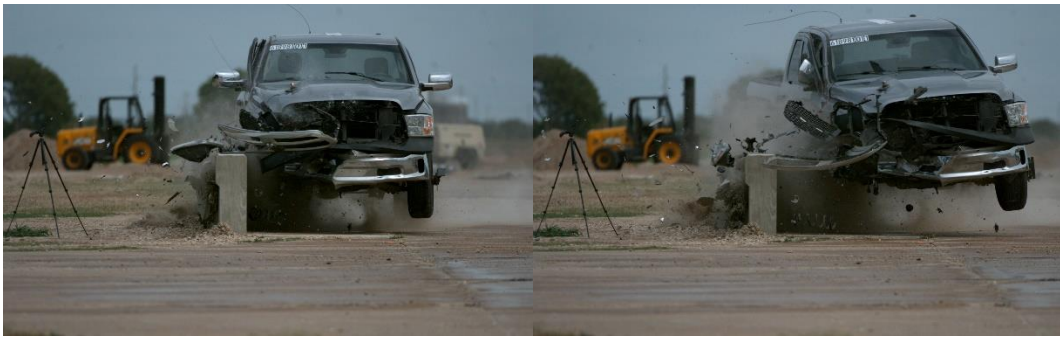
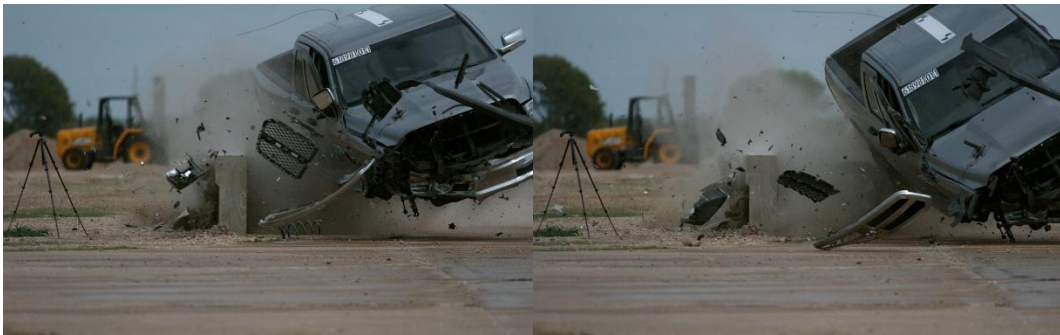
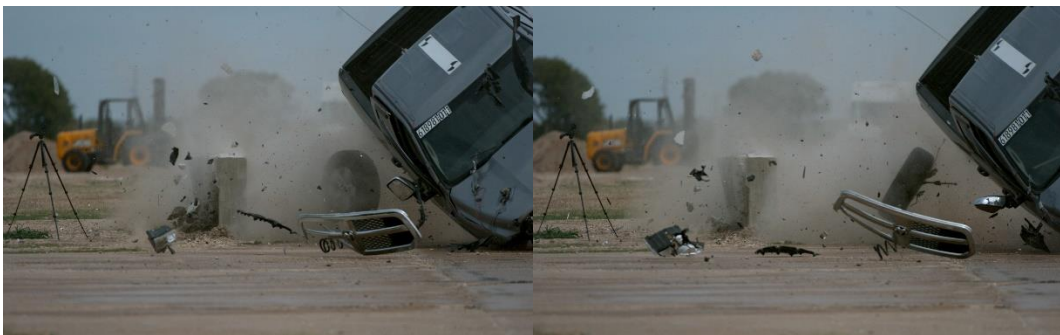
**Figure C.5. Sequential Photographs for Test 618981-01-1 (Frontal Views).**

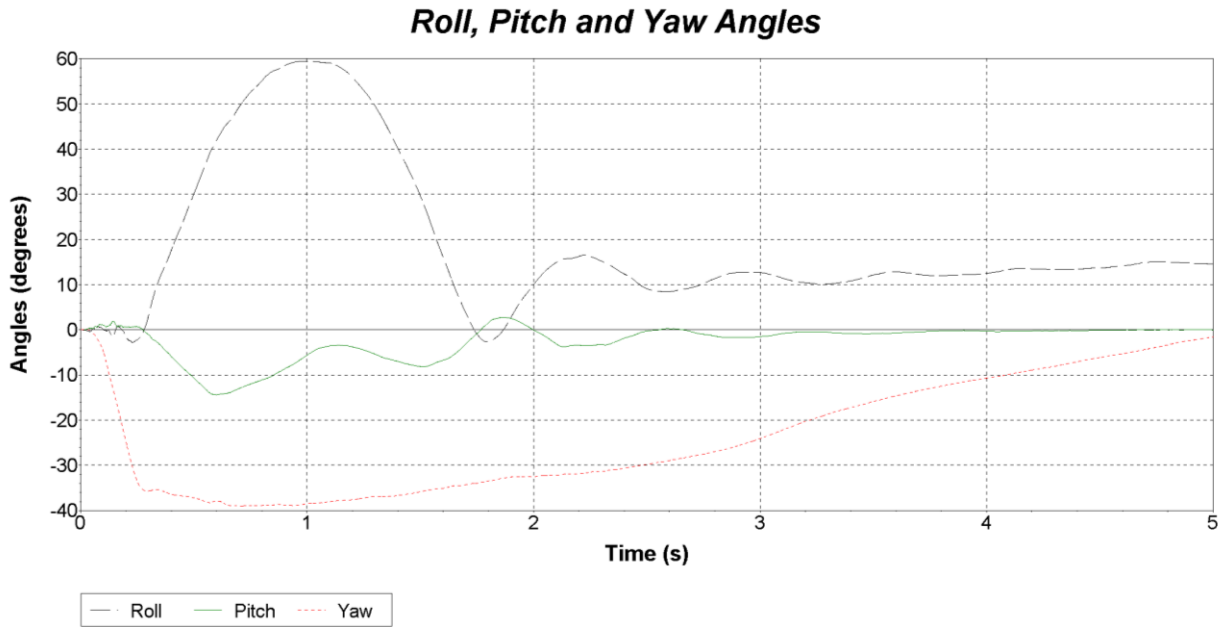
Axes are vehicle-fixed.  
Sequence for determining orientation:

1. Yaw.
2. Pitch.
3. Roll.

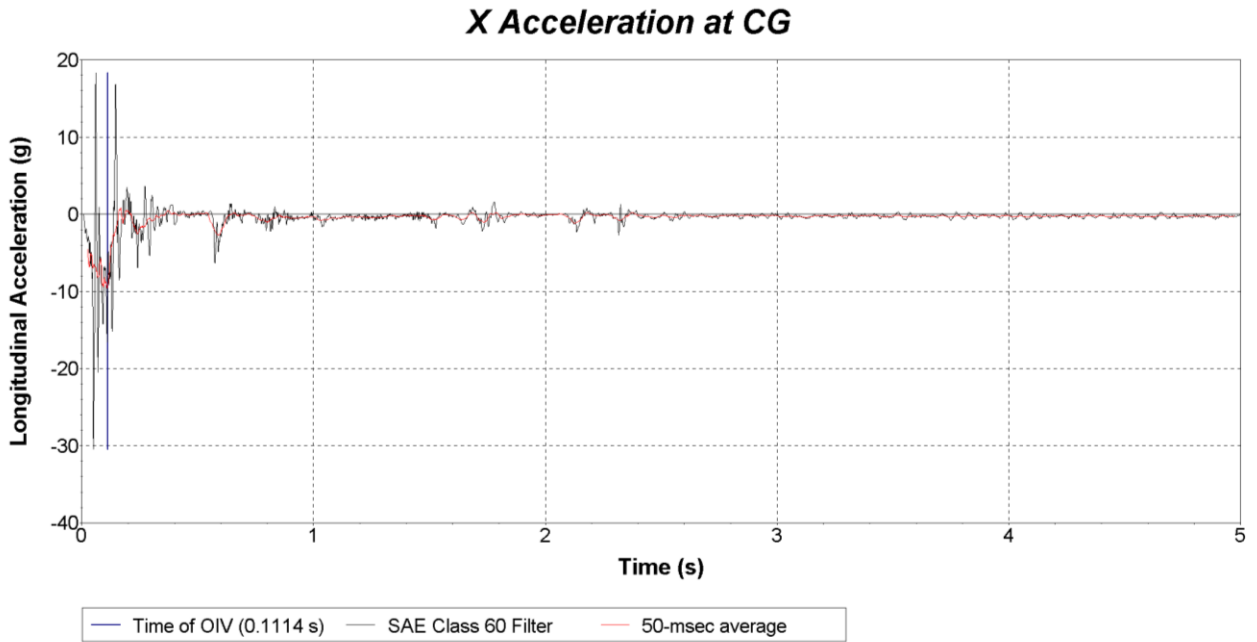
**Figure C.8. Vehicle Longitudinal Accelerometer Trace for Test 618981-01-1 (Accelerometer Located at Center of Gravity).**

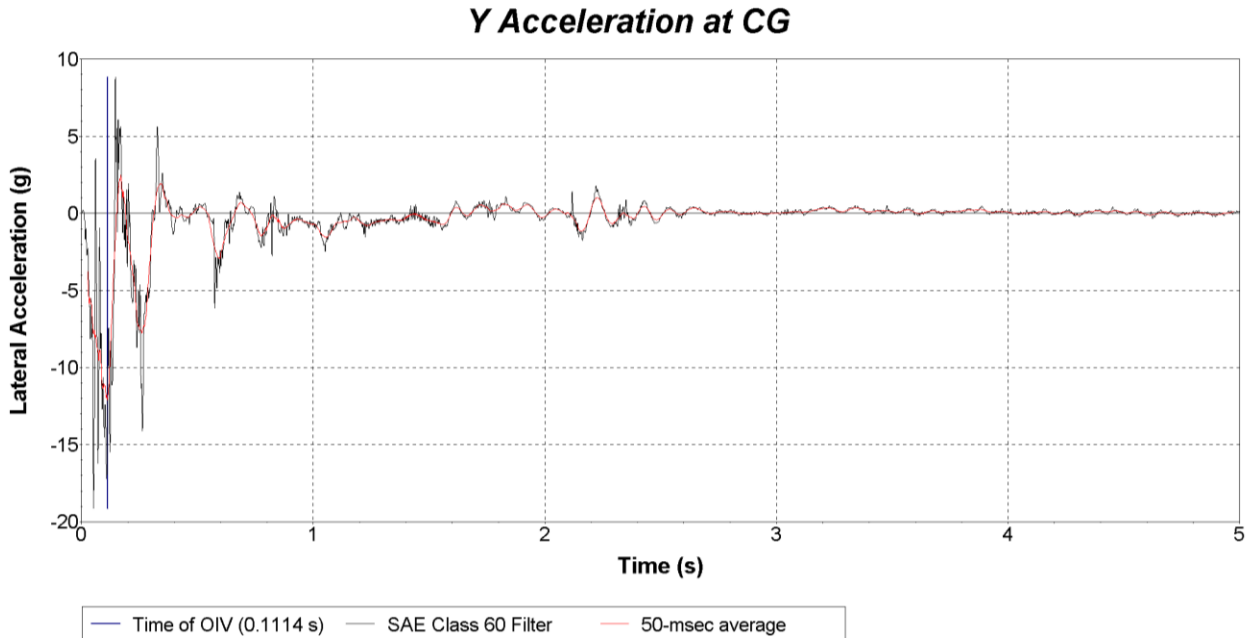
**Figure C.9. Vehicle Lateral Accelerometer Trace for Test 618981-01-1 (Accelerometer Located at Center of Gravity).**

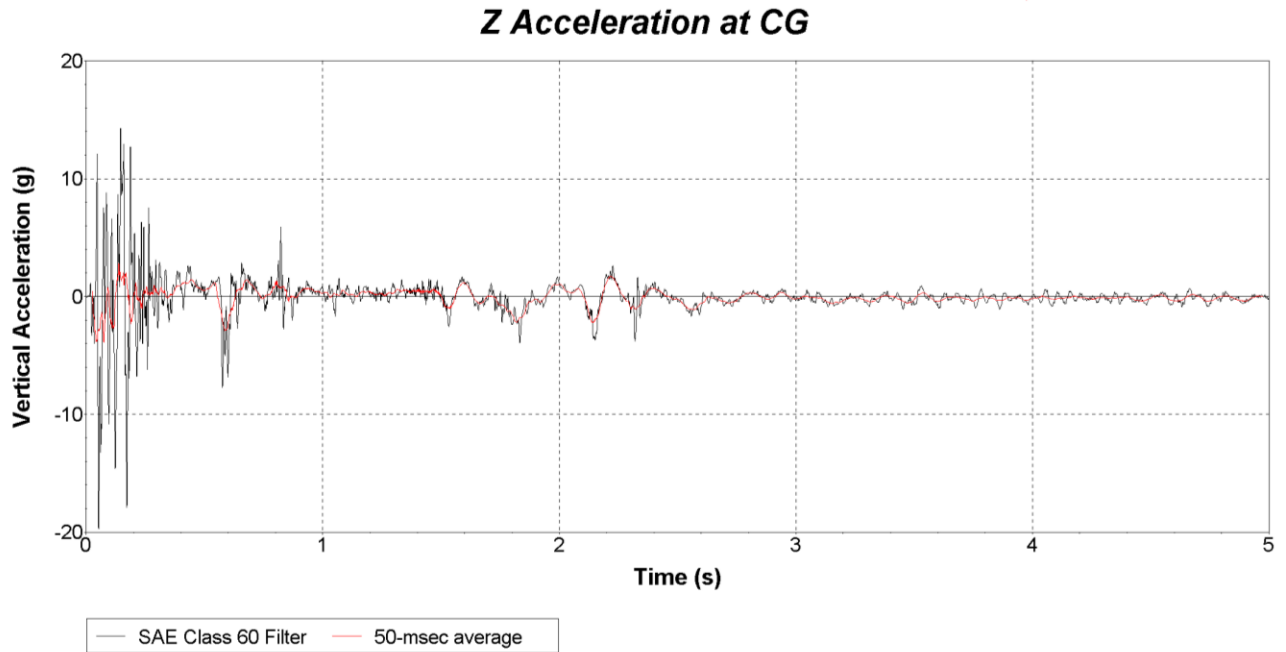
**Figure C.10. Vehicle Vertical Accelerometer Trace for Test 618981-01-1  
(Accelerometer Located at Center of Gravity)**
