Research Project Number TPF-5(193) Supplement #128

CRASH TESTING AND EVALUATION OF THE NEW YORK STATE BOX BEAM TO WEAK-POST W-BEAM TRANSITION

MIDWEST ROADSIDE SAFETY FACILITY

MwRSF Research Report No. TRP-03-414-24

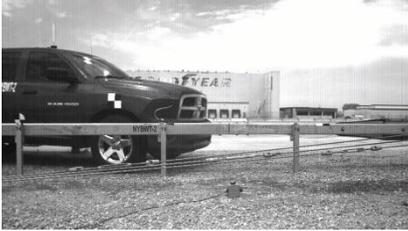
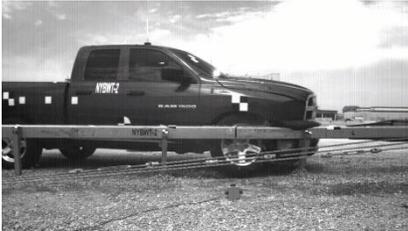
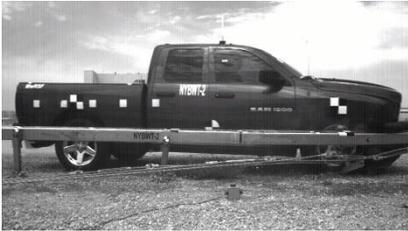
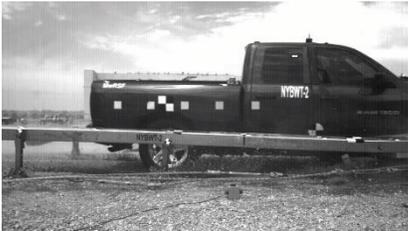
Figure 55. Sequential Photographs, Test No. NYBWT-2

0.000 sec

0.062 sec

0.106 sec

0.156 sec

A detailed description of the sequential impact events is contained in Table 4, with movement definitions provided in Appendix E. Sequential photographs are shown in Figures 55 and 56. Documentary photographs of the crash test are shown in Figures 57 through 63. The vehicle trajectory and final position are shown in Figure 64.

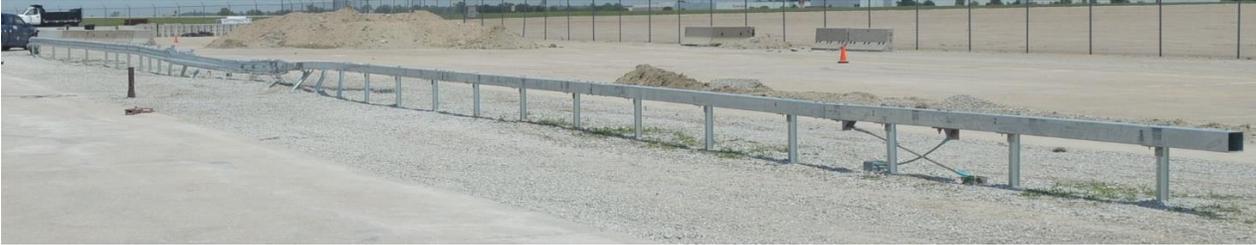
Figure 65. Overall System Damage, Test No. NYBWT-2

Damage to the barrier was moderate, as shown in Figures 65 through 74. Barrier damage consisted of rail deformation, deformed posts, and contact marks on the front faces of the box beam and W-beam rail.

Contact marks were found along the barrier beginning 7 in. (178 mm) upstream from the targeted impact point and ending 6½ in. (165 mm) downstream from the centerline of post no. 22. An outward bend 10 in. (254 mm) long by 4 in. (102 mm) high by 1 in. (25 mm) deep was located 24 in. (610 mm) upstream from post no. 17 on the bottom of the transition plate. A bend 12 in. (305 mm) long by 2 in. (51 mm) deep was found 16 in. upstream from post no. 17 on the bottom of the transition plate. Two smaller bends were found on the bottom and top edges of the rail. One smaller bend was found at the transition plate bolt hole near post no. 17. A 3½-in. (89-mm) long by ½-in. (13-mm) deep kink was found 18 in. (457 mm) upstream from post no. 17 on the top of the transition plate. A 4-in. (102-mm) long by 1½-in. (38-mm) high kink was found 2 in. (51 mm) downstream from post no. 21 on the top edge of the rail. Four other smaller kinks were found on the top and bottom edges of the rail. A 12-in. (305-mm) long tear was found starting 34 in. (864 mm) upstream from post no. 17 on the bottom edge of the transition plate. A 3-in. (76-mm) by ½-in. (13-mm) wide by ½-in. (13-mm) deep tear was found 14 in. (356 mm) upstream from post no. 17 on the front face of the transition plate. Flattening measuring 16 in. (406 mm) long by 6 in. (152 mm) high was found 10 in. (254 mm) upstream from post no. 22 on the top part of the rail.

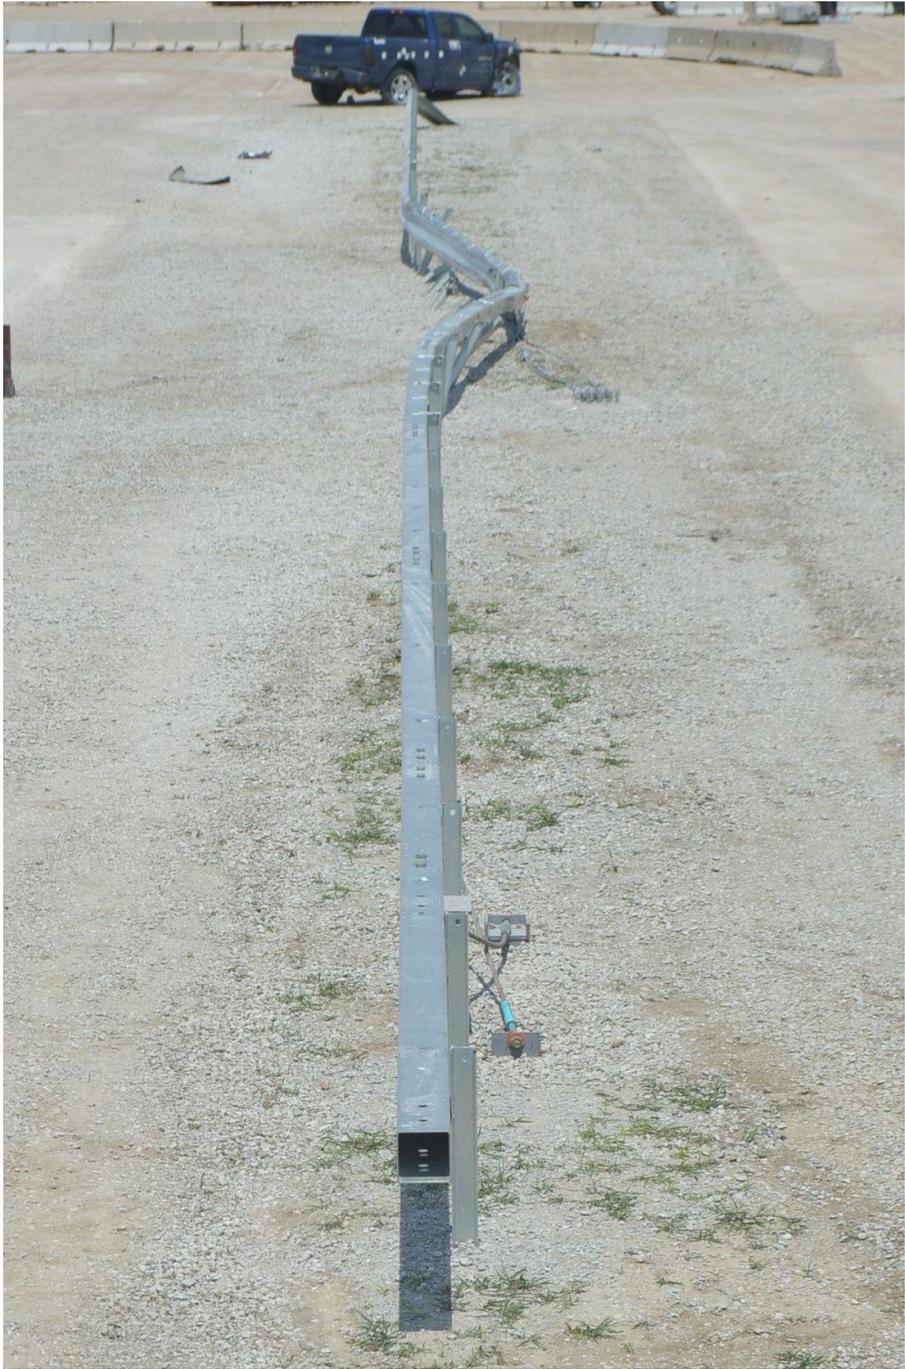
Post nos. 3, 4, 12, and 13 rotated downstream. Post nos. 12 and 13 also rotated backward. Post nos. 1, 2 and 5 through 15 twisted clockwise. Post nos. 17, 18, 21, 22 twisted counterclockwise. Post nos. 14 through 22 were bent backward. Post nos. 16 through 20 were bent downstream. Post no. 33 bent upstream. The rail-to-bracket bolt pulled out from post nos. 15 through 18. The post-to-rail bolt pulled out from post nos. 19 and 22.

Small soil gaps were found at post nos. 11 through 15, 21, and 22. A 21-in. (533-mm) diameter by 1-in. (25-mm) high soil heave was found at post no. 14. A 19-in. (483-mm) diameter by 1-in. (25-mm) high soil heave was found at post no. 15. A 27-in. (686-mm) diameter by ¾-in. (19-mm) deep soil crater was found at post no. 16. Soil craters 18 in. (457 mm) diameter by 2 in. (51 mm) deep were found at post nos. 17 and 18. A 14-in. (356-mm) diameter by 1½-in. (38-mm) deep soil crater was found at post no. 19. A 16-in. (406-mm) diameter by 1-in. (25-mm) deep soil crater was found at post no. 20.

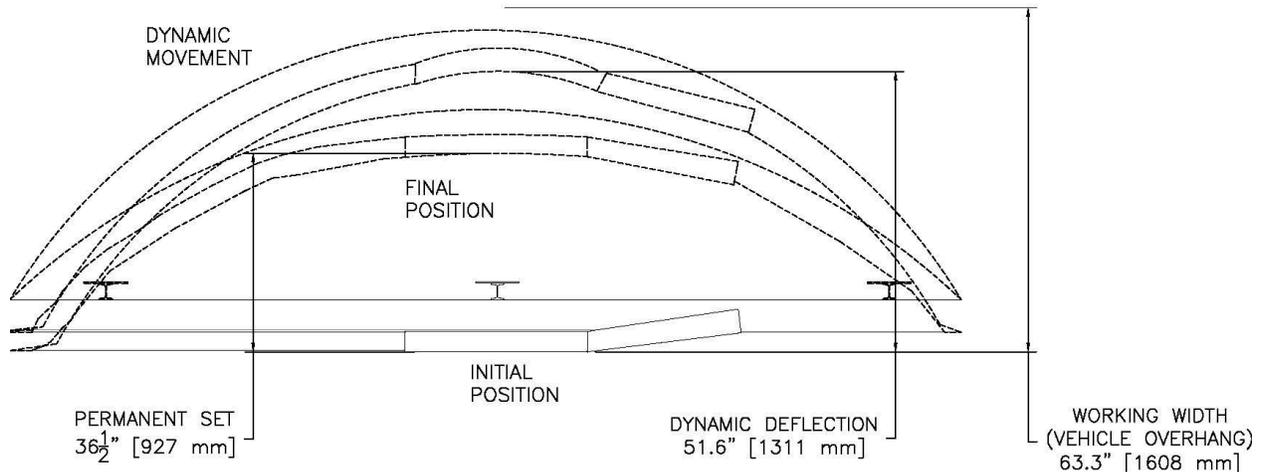
Figure 75. Permanent Set, Dynamic Deflection, and Working Width, Test No. NYBWT-2

The maximum lateral rail and post permanent set was 36½ in. (927 mm) at the rail at post no. 17 and 22⅞ in. (581 mm) at the centerline of post no. 15, as measured in the field, respectively. The maximum lateral dynamic rail and post deflections were 51.6 in. (1,311 mm) at the rail at post no. 17 and 29.0 in. (737 mm) at the centerline post no. 18, respectively. The maximum lateral dynamic deflection values were determined from high-speed digital video analysis. The working width of the system was found to be 63.3 in. (1,608 mm) due to vehicle protrusion over the top of the system, also determined from high-speed video analysis. A schematic of the permanent set, dynamic deflection, and working width is shown in Figure 75.

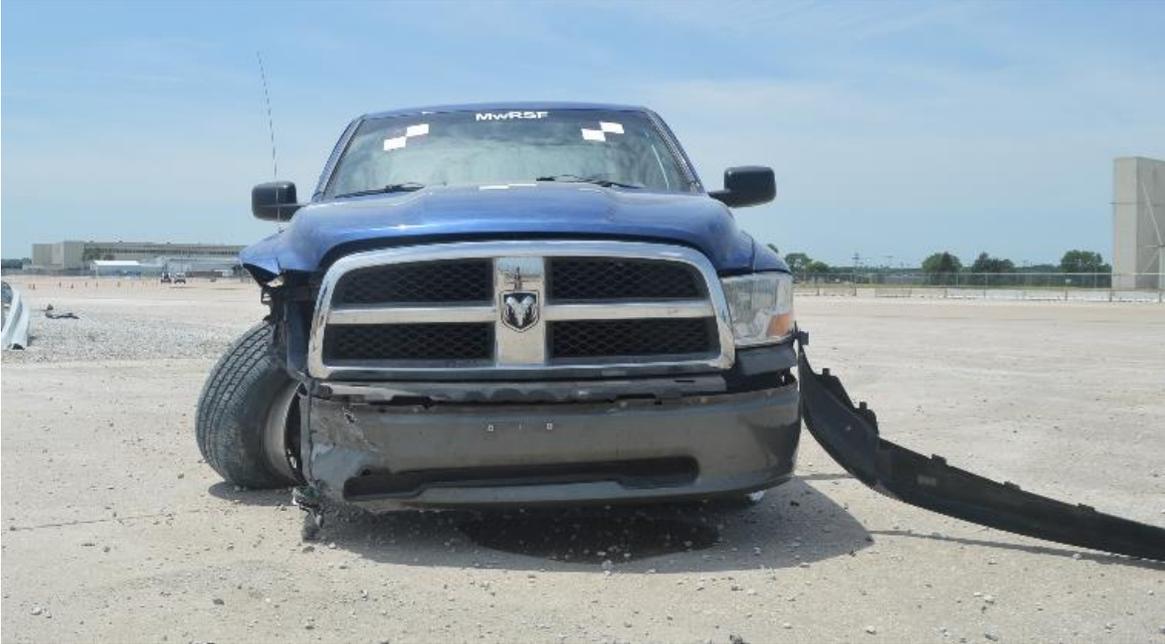
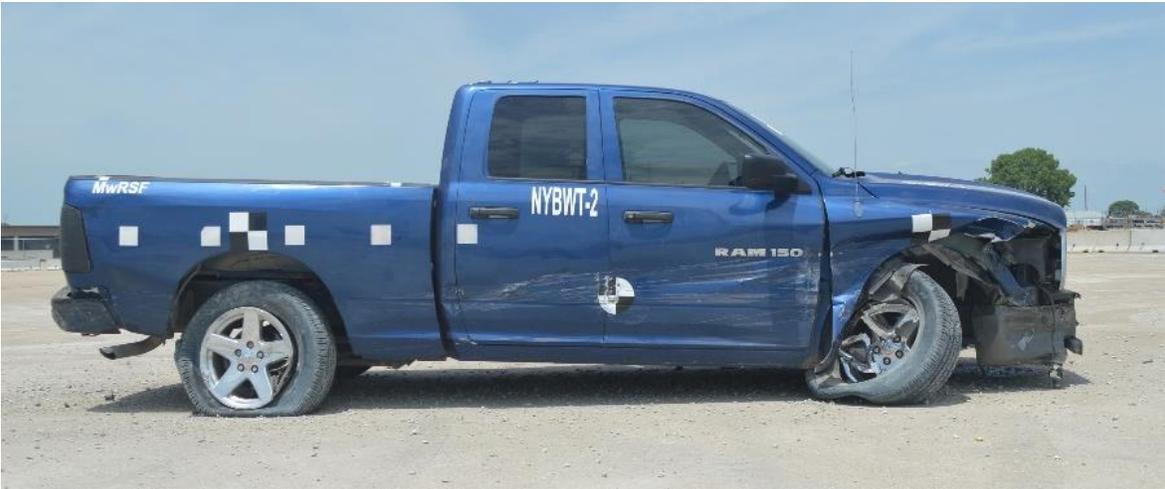
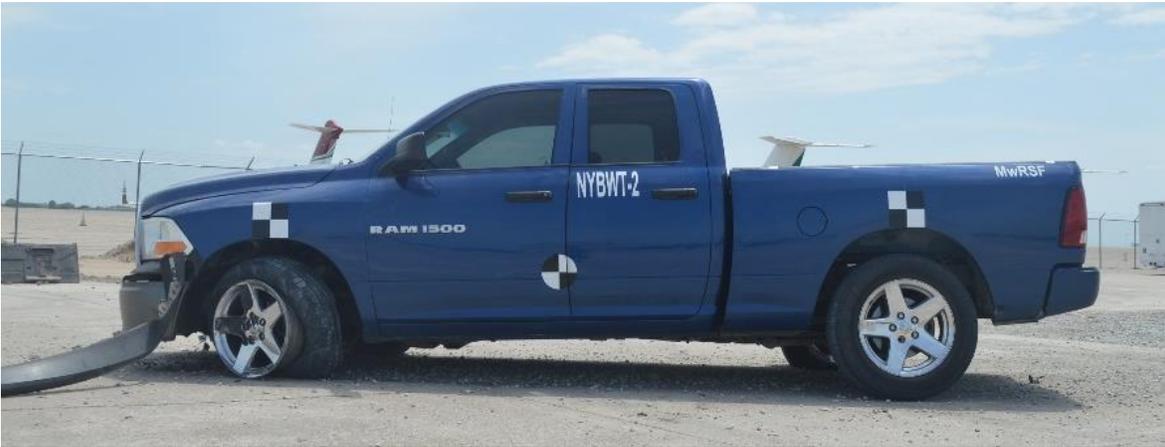
Figure 76. Vehicle Damage, Test No. NYBWT-2

The damage to the vehicle was moderate, as shown in Figures 76 through 79. The maximum occupant compartment intrusion values are listed in Table 7 along with the intrusion limits established in MASH 2016 for various areas of the occupant compartment. Complete occupant compartment and vehicle deformations and the corresponding locations are provided in Appendix F. MASH 2016 defines intrusion or deformation as the occupant compartment being deformed and reduced in size with no observed penetration. There were no penetrations into the occupant compartment, and none of the established MASH 2016 deformation limits were violated. Outward deformations, which are denoted as negative numbers in Appendix F, are not considered crush toward the occupant, and are not evaluated by MASH 2016 criteria.

Majority of the damage was concentrated on the right-front corner and right side where the impact occurred. The right-side front bumper was bent inward and backward. The right-front quarter panel was bent up to the hood in front of the tire. Behind the tire, the right-front quarter panel was pushed backward and outward and contacted the tire. Scrapes were found along both the right-side doors and the right-rear quarter panel. A 1½-in. (38-mm) long puncture was found 1 in. (25 mm) from the front of the right-rear door. The right-rear quarter panel was peeled backward toward the bumper. The right-rear bumper was deformed outward and buckled upward due to contact with the right-rear quarter panel. The right-rear caliper and right-side headlight were disengaged. The right-side lower control arm bushings and the right-side tie rods were bent. The roof, windows, and left side remained undamaged.

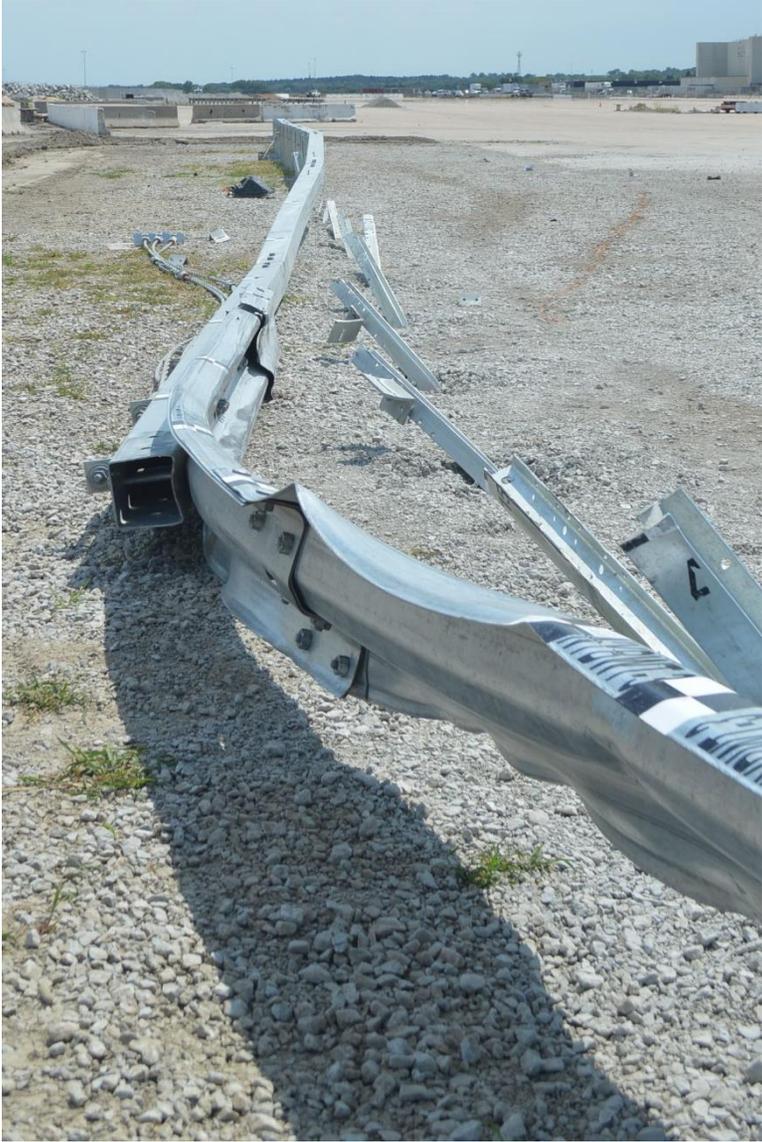
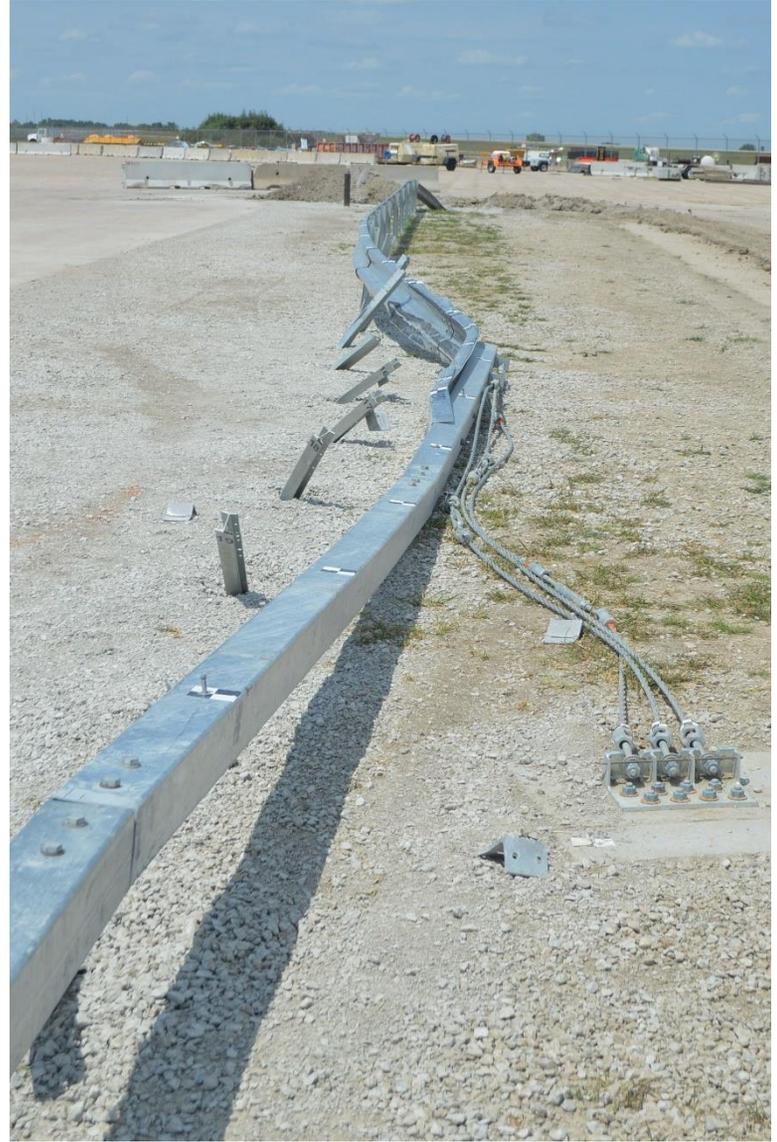
Figure 89. Overview of Damage to System, Test No. NYBWT-3

Damage to the barrier was moderate, as shown in Figures 89 through 95. Barrier damage consisted of rail deformation, deformed posts, and contact marks on rail sections. The length of contact along the barrier was approximately 95 ft – 11 in. (29.2 m) which spanned from post no. 14 to post no. 30.

Contact marks were found covering large portions of the barrier. A total of 14 kinks were found along the rail. These included an 18-in. (457-mm) long by 1½-in. (38-mm) high kink was found 1 in. (25 mm) downstream from post no. 13 on the bottom of the rail. An 8-in. (203-mm) long by ¼-in. (32-mm) high kink was found 1 in. (25 mm) downstream from the centerline of post no. 13 on the top of the rail. A 7-in. (178-mm) long by ½-in. (13-mm) deep kink was found 30 in. (762 mm) downstream from the centerline of post no. 14 on the bottom of the rail. A 12-in. (305-mm) long by ¼-in. (6-mm) high kink was found 43½ in. (1,105 mm) downstream of the centerline of post no. 15 on the top of the rail. Another kink measuring 8 in. (203 mm) long and ¼ in. (6 mm) high was found 29½ in. (749 mm) upstream from post no. 12 on the top of the rail. A 2½-in. (64-mm) long by ¼-in. (6-mm) high kink was found 5⅝ in. (143 mm) downstream from post no. 12 on the top of the rail. Another kink was found 35 in. (889 mm) downstream from post no. 14 at the top of the rail. Measuring 24 in. (610 mm) long by 2½ in. (64 mm) high. A kink measuring 9½ in. (241 mm) long by 1 in. (25 mm) high was found 18 in. (457 mm) downstream from post no. 14 at the bottom of the rail. A kink was found 9 in. (229 mm) upstream from post no. 16 at the top of the rail measuring 11 in. (279 mm) long by ¼ in. (6 mm) high.

Rail flattening was found 10 in. (254 mm) upstream from post no. 14 extending 52 in. (1,321 mm) downstream. Rail flattening measuring 20 in. (508 mm) long by 3 in. (76 mm) high was found 33 in. (838 mm) downstream from post no. 15. Bending measuring 12 in. (305 mm) long by ½ in. (13 mm) deep was found 32 in. (813 mm) downstream from post no. 14. A ¼-in. (6-mm) long by ⅛-in. (3mm) wide gouge was found 1⅞ in. (29 mm) from the top of the transition at the start of the upstream edge. The rail was deformed starting 42 in. (1,067 mm) downstream from post no. 15 extending downstream for 162½ in. (4,128 mm).

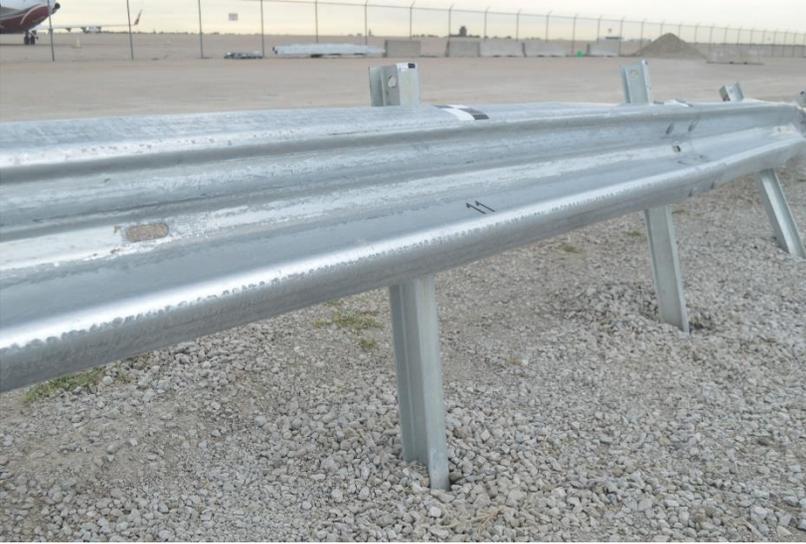
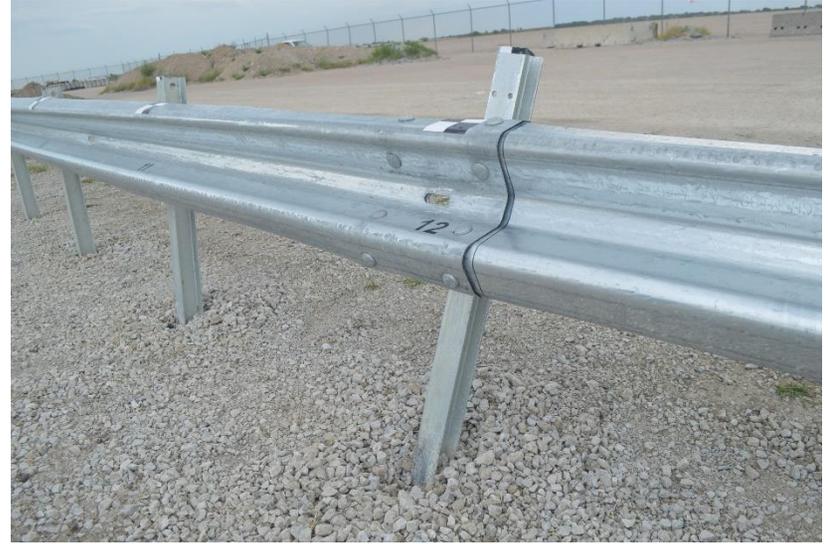
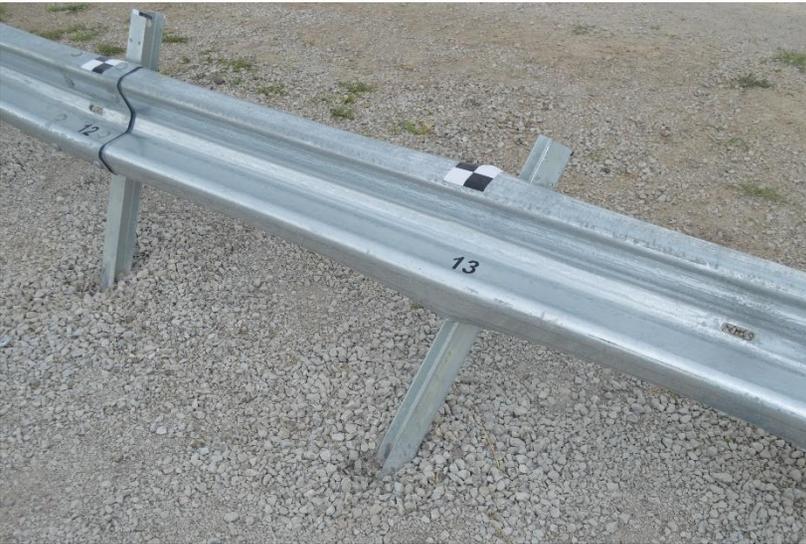
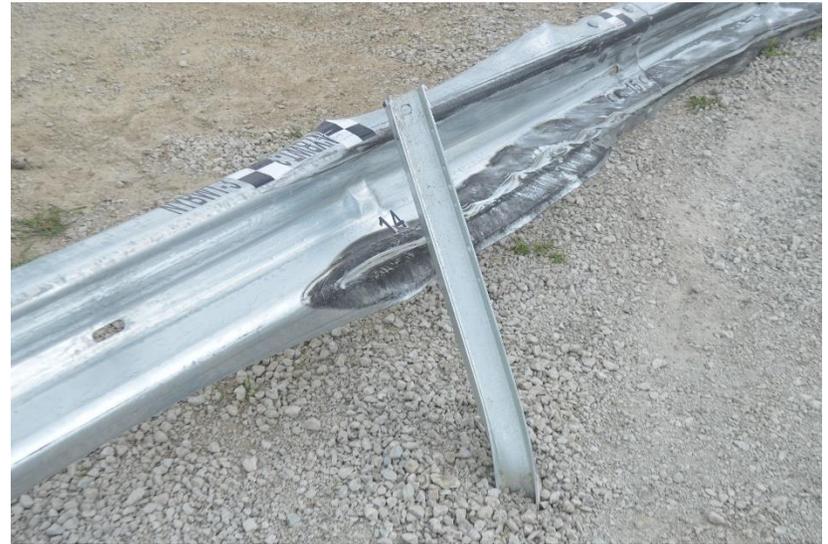
Figure 91. Damage to Post Nos. 11 through 14, Test No. NYBWT-3

Post nos. 1 through 3, 5, 6, and 25 through 29 rotated clockwise. Post nos. 1, 10, 11, and 24 rotated backward. Post no. 1 deflected downstream and rotated backward and clockwise. Post nos. 30 and 31 rotated upstream. Post nos. 12 through 23 bent backward. Post nos. 13 through 23 bent downstream. Post nos. 13, 14, and 23 twisted counterclockwise. Post nos. 16 through 21 twisted clockwise. Post-to-rail bolts pulled out of post nos. 12 and 15 through 23. Soil gaps were found at post nos. 10 through 13, 29, 31, and 32. Soil heaves were found at post nos. 11 through 21 and 23. Soil craters were found at post nos. 13 and 15 through 23.

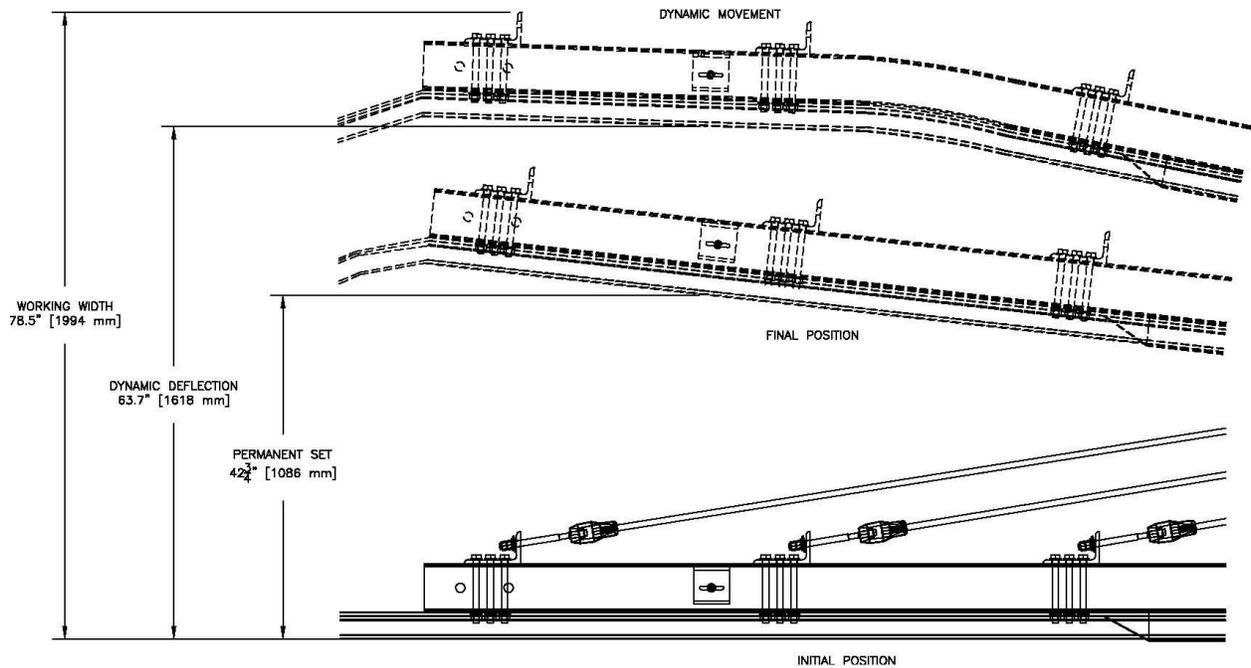
Figure 96. Permanent Set, Dynamic Deflection, and Working Width, Test No. NYBWT-3

The maximum lateral rail and post permanent set were 42¾ in. (1,086 mm) at post no.16, and 19½ in. (495 mm) at post no. 13, as measured in the field. The maximum lateral dynamic rail and post deflections were 63.7 in. (1,618 mm) at post no. 16 and 23.3 in. (592 mm) at post no. 14, respectively, as determined from high-speed digital video analysis. The working width of the system was found to be 78.5 in. (1,994 mm), also determined from high-speed digital video analysis. A schematic of the permanent set, dynamic deflection, and working width is shown in Figure 96.

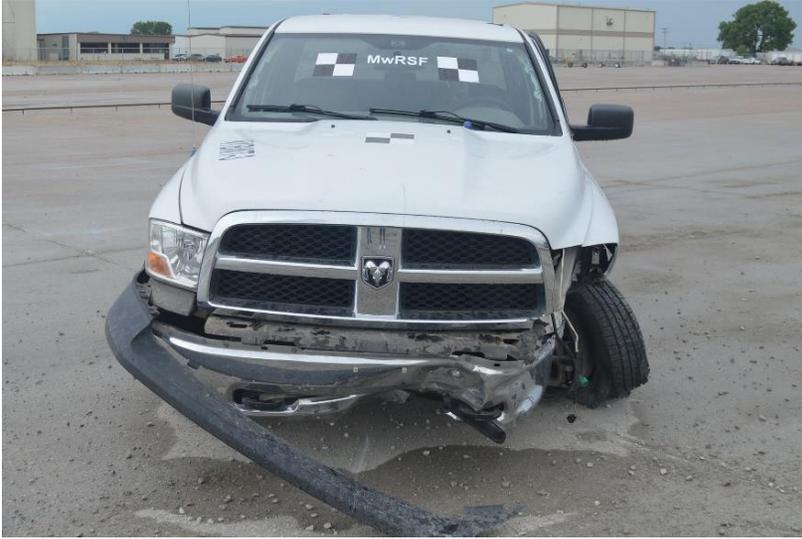
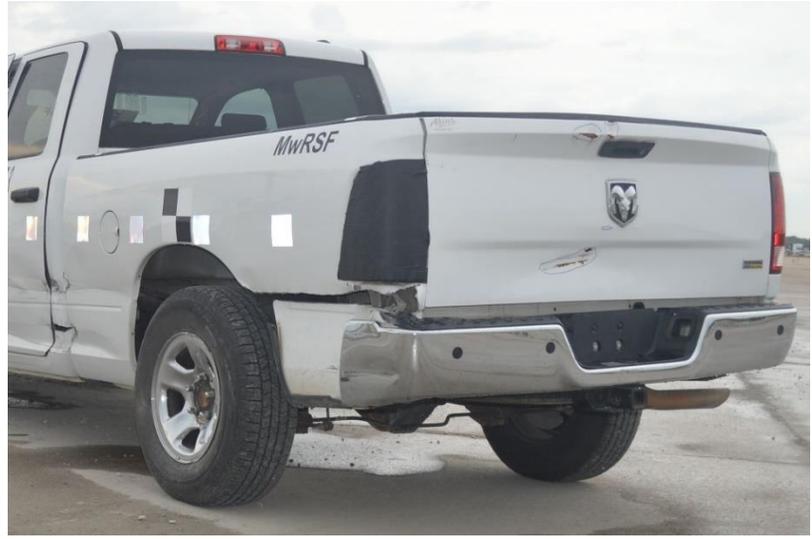
Figure 97. Vehicle Damage, Test No. NYBWT-3

The damage to the vehicle was moderate, as shown in Figures 97 through 100. The maximum occupant compartment intrusion values are listed in Table 13 along with the intrusion limits established in MASH 2016 for various areas of the occupant compartment. Complete occupant compartment and vehicle deformations and the corresponding locations are provided in Appendix F. MASH 2016 defines intrusion or deformation as the occupant compartment being deformed and reduced in size with no observed penetration. There were no penetrations into the occupant compartment and none of the established MASH 2016 deformation limits were violated. Outward deformations, which are denoted as negative numbers in Appendix F, are not considered crush toward the occupant, and are not evaluated by MASH 2016 criteria.

Majority of the damage was concentrated on the left-front corner and left side of the vehicle where the impact occurred. The left-front quarter panel was deformed inward by the by the door. The left-front door was also dented inward along the bottom of the door. A gouge was found on the bottom-front corner of the door. The front bumper was dented just to the left of center and was deformed into the engine compartment on the left-side, thus bending the body frame. The bottom-left side of the grill was deformed and was partially disengaged. Scrapes and dents were found along the bottom of the left-rear door. The scrapes become tears on the bottom rear corner of the door frame. A dent was found on the left-rear quarter panel in front of the wheel well. A tear was found beginning at the back of the wheel well and extending to the back of the left-rear quarter panel just above the rear bumper. The rear bumper was also dented on the left side.

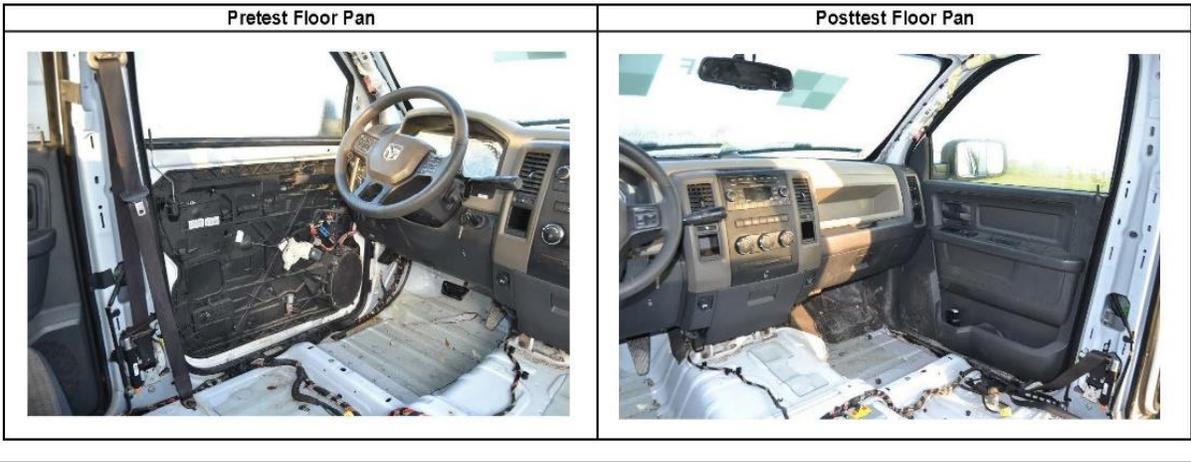
Figure F-7. Floor Pan Deformation Data – Set 1, Test No. NYBWT-3

^B Crush calculations that use multiple directional components will disregard components that are negative and only include positive values where the component is deforming inward toward the occupant compartment.

^C Direction for Crush column denotes which directions are included in the crush calculations. If "NA" then no intrusion is recorded, and Crush will be 0.
