MASH EVALUATION OF PEDESTRIAN TRAFFIC SIGNALS

Sponsored by
Roadside Safety Pooled Fund

TEXAS A&M TRANSPORTATION INSTITUTE PROVING GROUND

7. Author(s) Sofokli Cakalli, Nathan D. Schulz, Roger P. Bligh, William J. L. Schroeder and Maysam Kiani		8. Performing Organization Report No. TRNo. 617891-01 1-4

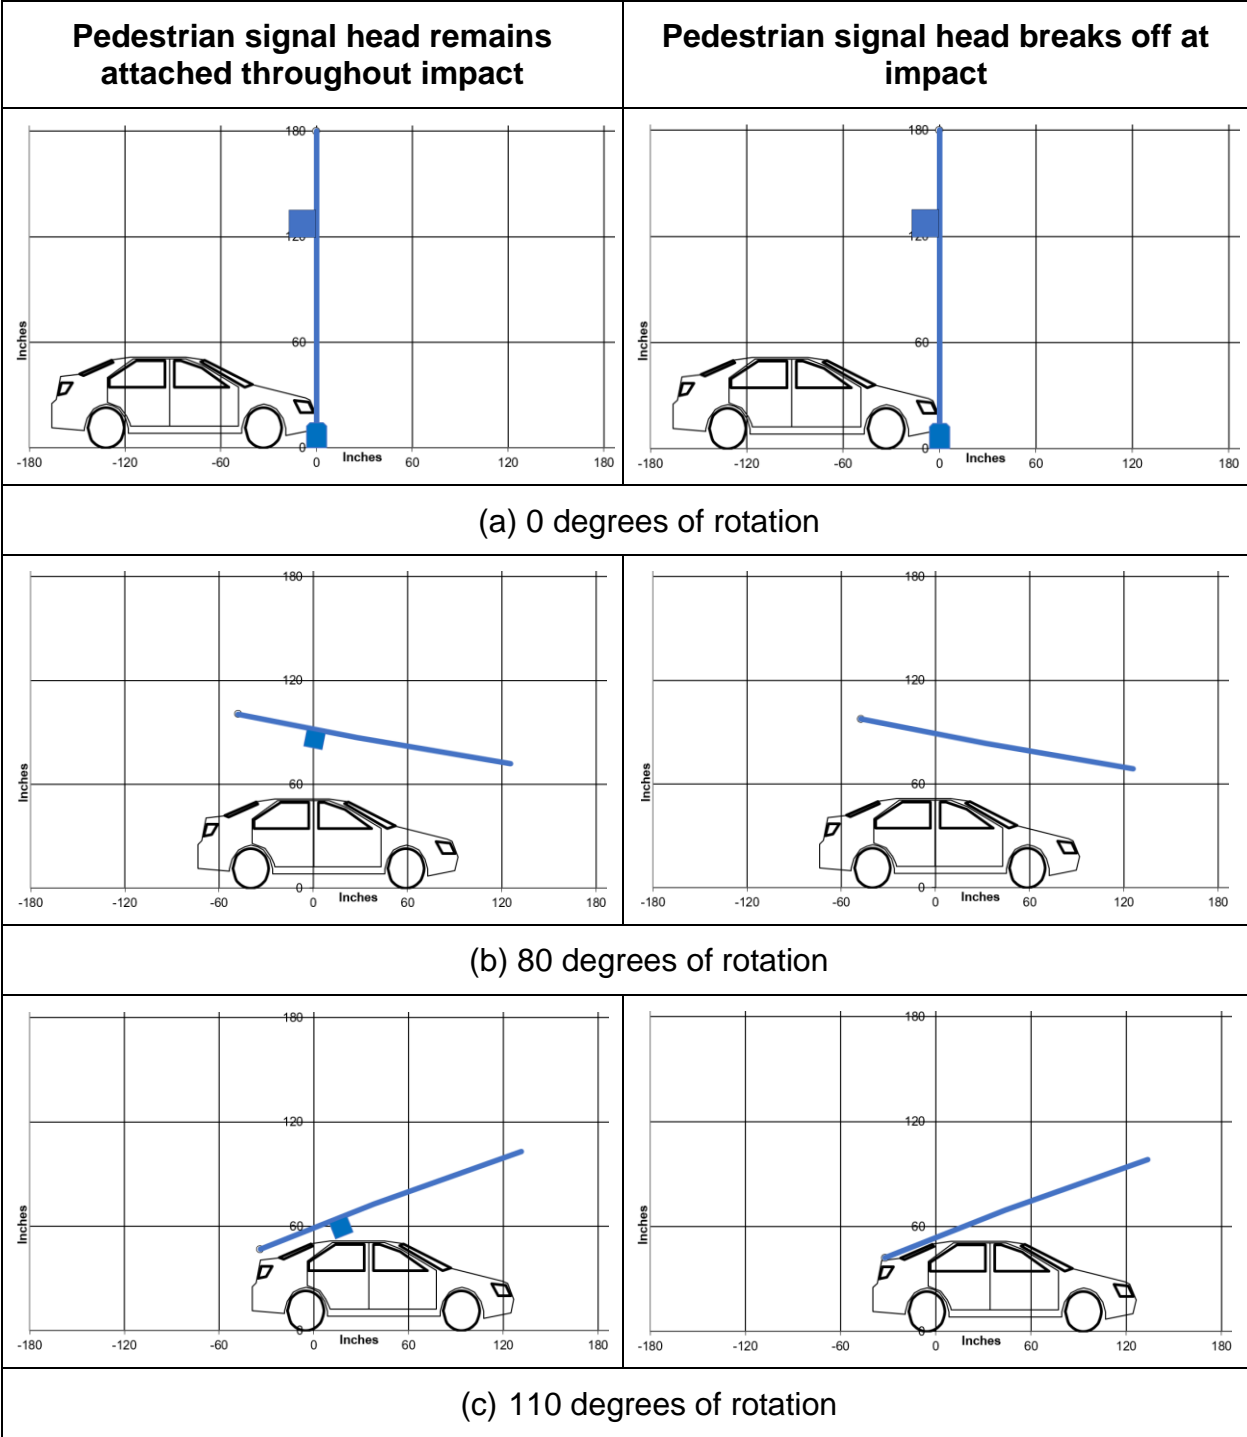
Figure 3.4. Implicit Engineering Crashworthiness Evaluation of Configuration 2 for MASH Test 3-61

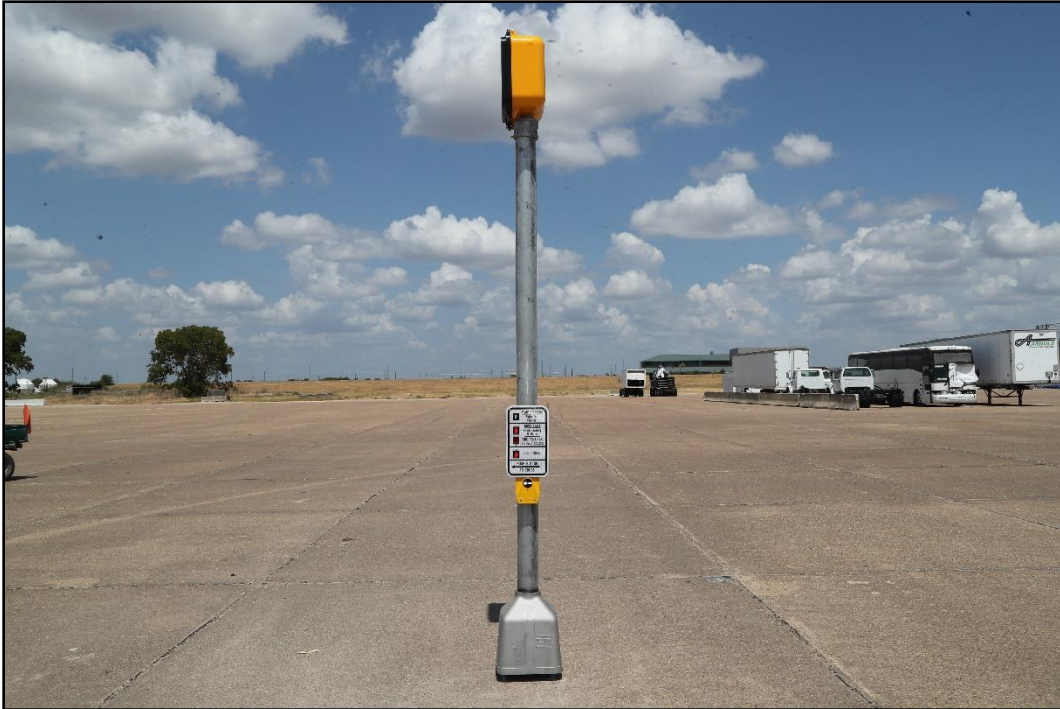
Figure 4.2. 90 Degree View of the MUTCD Standard Pedestrian Signal Prior to Crash Test 617891-01-1.

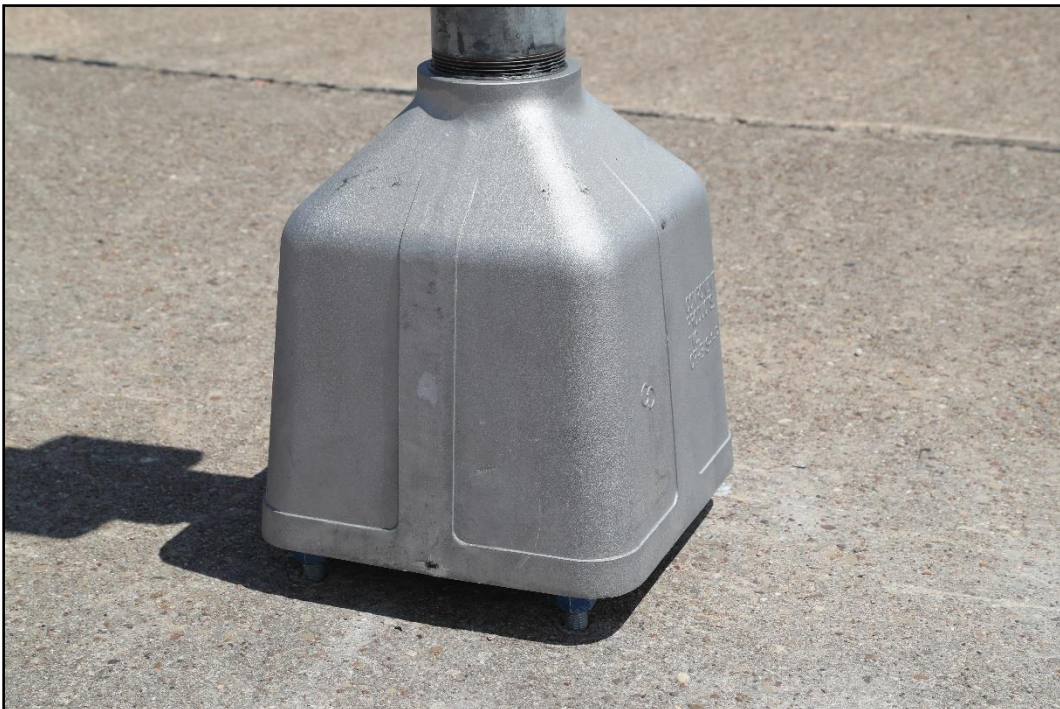
Figure 4.3. MUTCD Standard Pedestrian Signal Base Prior to Crash Test 617891-01-1.

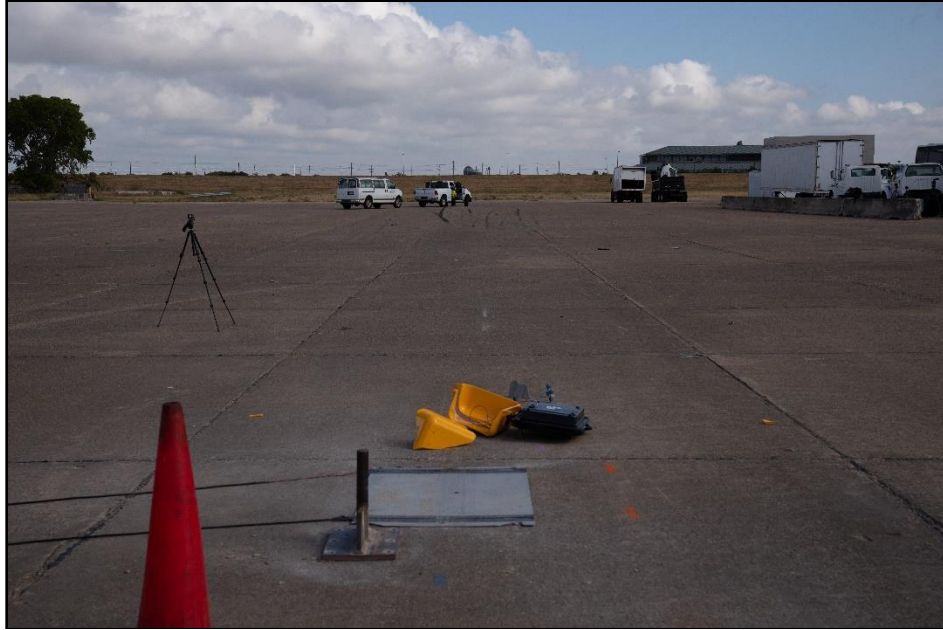
The base fractured, and the remainder of the base was trapped under the vehicle. The anchor bolts on the impact side were bent downstream. The pedestrian signal head fell three feet upstream and broke. The signal pole landed 510 feet downstream and 15 feet to the left of the point of impact. The threads at the end of the pole were damaged and the end of the pole was dented. There was scuffing on the pole and the push buttons on the sign, and the top of the sign bracket was gouged. Figure 7.5 and Figure 7.6 show the damage to the MUTCD standard pedestrian signal assembly.

Figure 7.5. MUTCD Standard Pedestrian Signal at Impact Location after Test 617891-01-1.

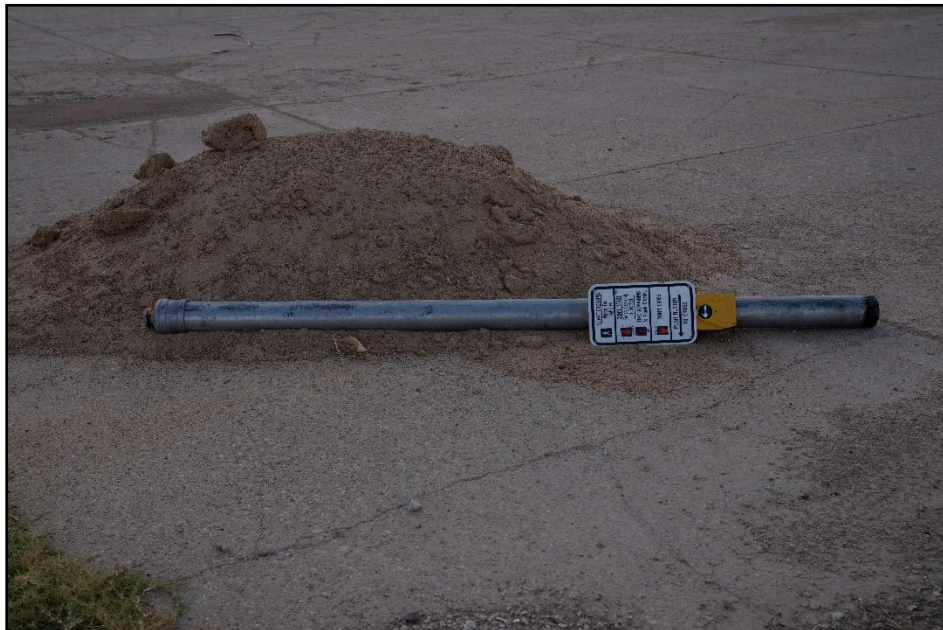
Figure 7.6. MUTCD Standard Pedestrian Signal at its Landing Location after Test 617891-01-1.

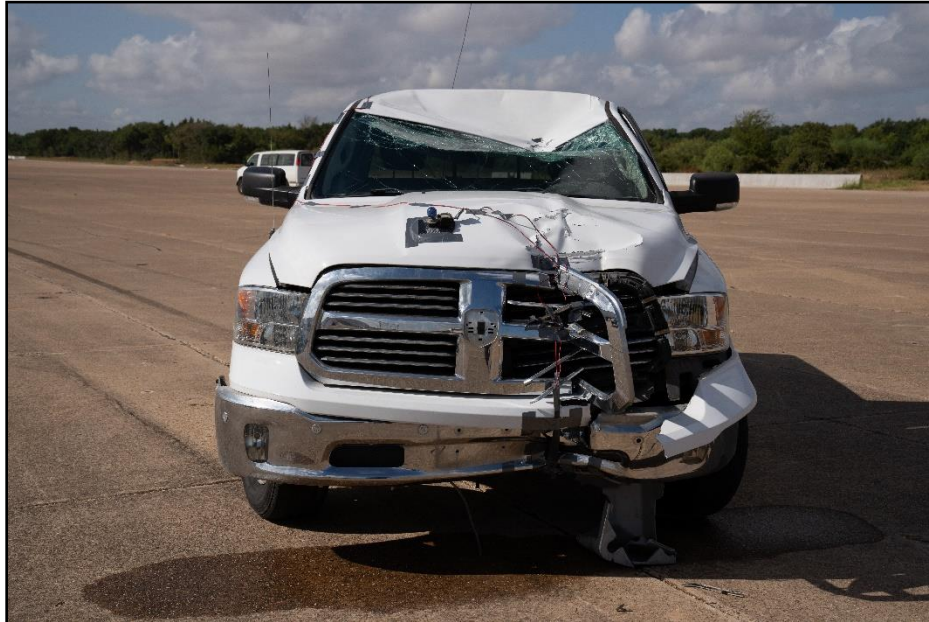
Figure 7.7. Front of the Test Vehicle after Test 617891-01-1.

Figure 7.7 and Figure 7.8 show the damage sustained by the vehicle. Figure 7.9 and Figure 7.10 show the interior of the test vehicle. Table 7.6 and Table 7.7 provide details on the occupant compartment deformation and exterior vehicle damage. Figures C.2 and C.3 in Appendix C.1 provide exterior crush and occupant compartment measurements.

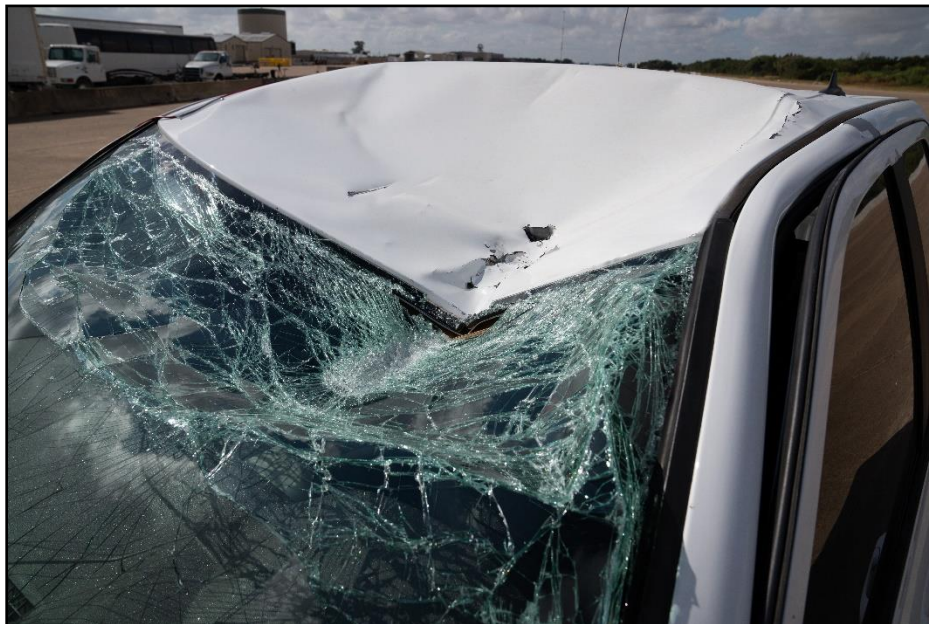
Figure 7.8. Roof and Windshield of the Test Vehicle after Test 617891-01-1.

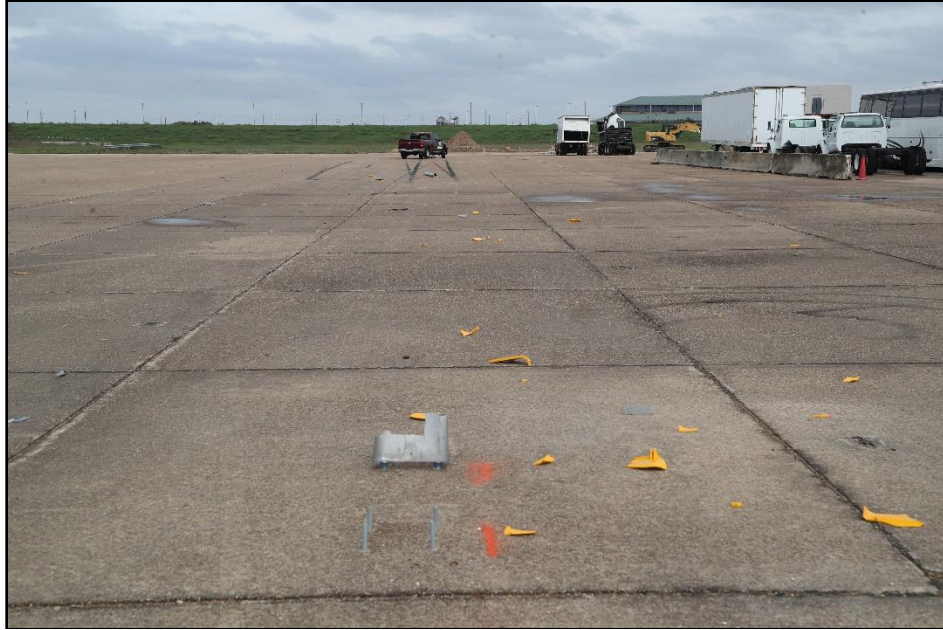
The signal pole landed 166 feet downstream and in-line with the impact path. The debris field extended 47 feet to the left of impact, 24 feet to the right, and 188 feet downstream of the point of impact. A piece of the signal head support was stuck in the roof of the vehicle. Figure 8.5 and Figure 8.6 show the damage to the MUTCD standard pedestrian signal assembly.

Figure 8.5. MUTCD Standard Pedestrian Signal at Impact Location after Test 617891-01-2.

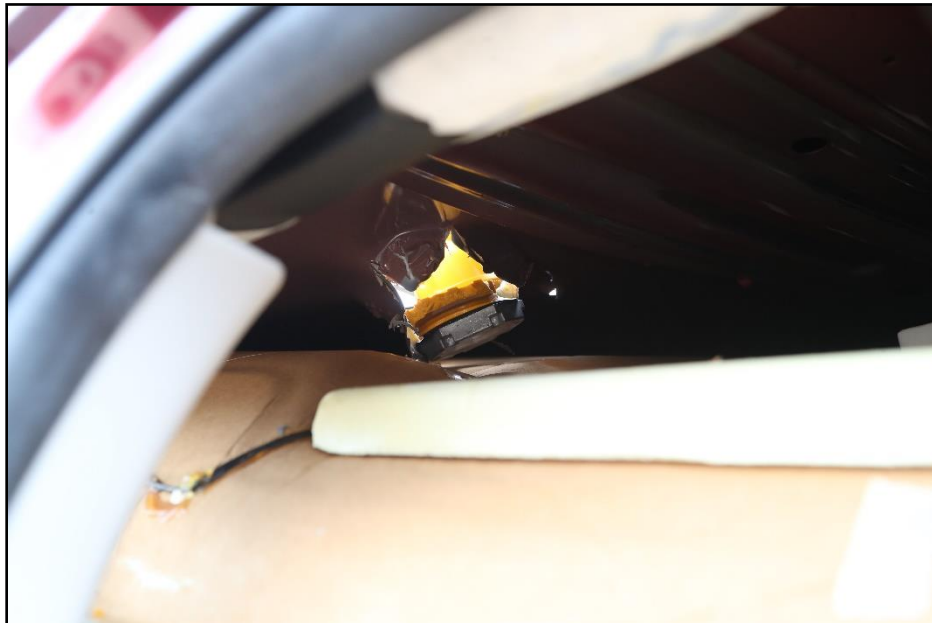
Figure 8.10. Test Article Penetration into the Test Vehicle after Test 617891-01-2.

Figure 8.11 summarizes the results of *MASH* Test 617891-01-2. Due to penetration of the test article into the occupant compartment through the roof, the test did not meet *MASH* evaluation criteria D.

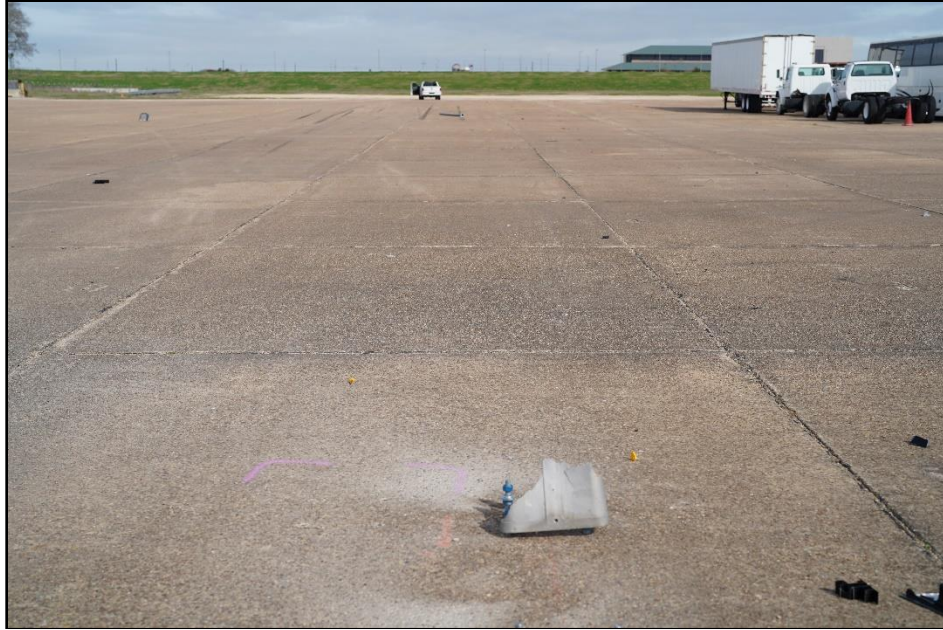
The signal pole landed 180 feet downstream and in-line with the installation. The signal head broke off. Figure 9.5 and Figure 9.6 show the damage to the MUTCD standard pedestrian signal assembly.

Figure 9.5. MUTCD Standard Pedestrian Signal at Impact Location after Test 617891-01-3.

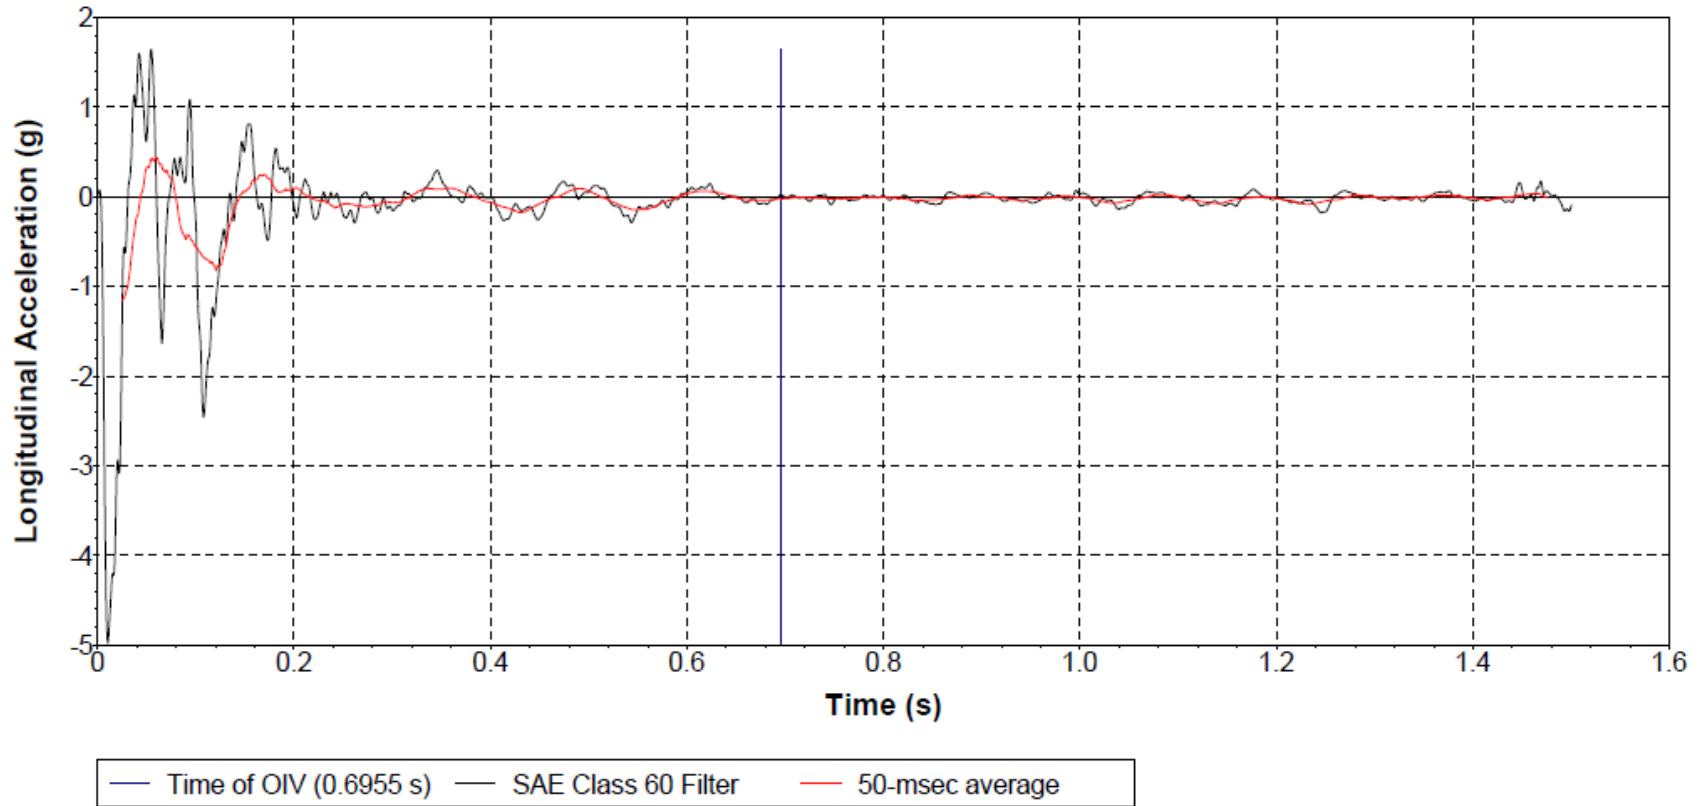
Figure C.8. Vehicle Longitudinal Accelerometer Trace for Test 617891-01-1 (Accelerometer Located at Center of Gravity).
