Test Report No. 612281-02
Test Report Date: October 2019

MASH TL-3 EVALUATION OF W-BEAM GUIDERAIL OVER UNDERGROUND STRUCTURE

Sponsored by
Pennsylvania Department of Transportation

TEXAS A&M TRANSPORTATION INSTITUTE PROVING GROUND

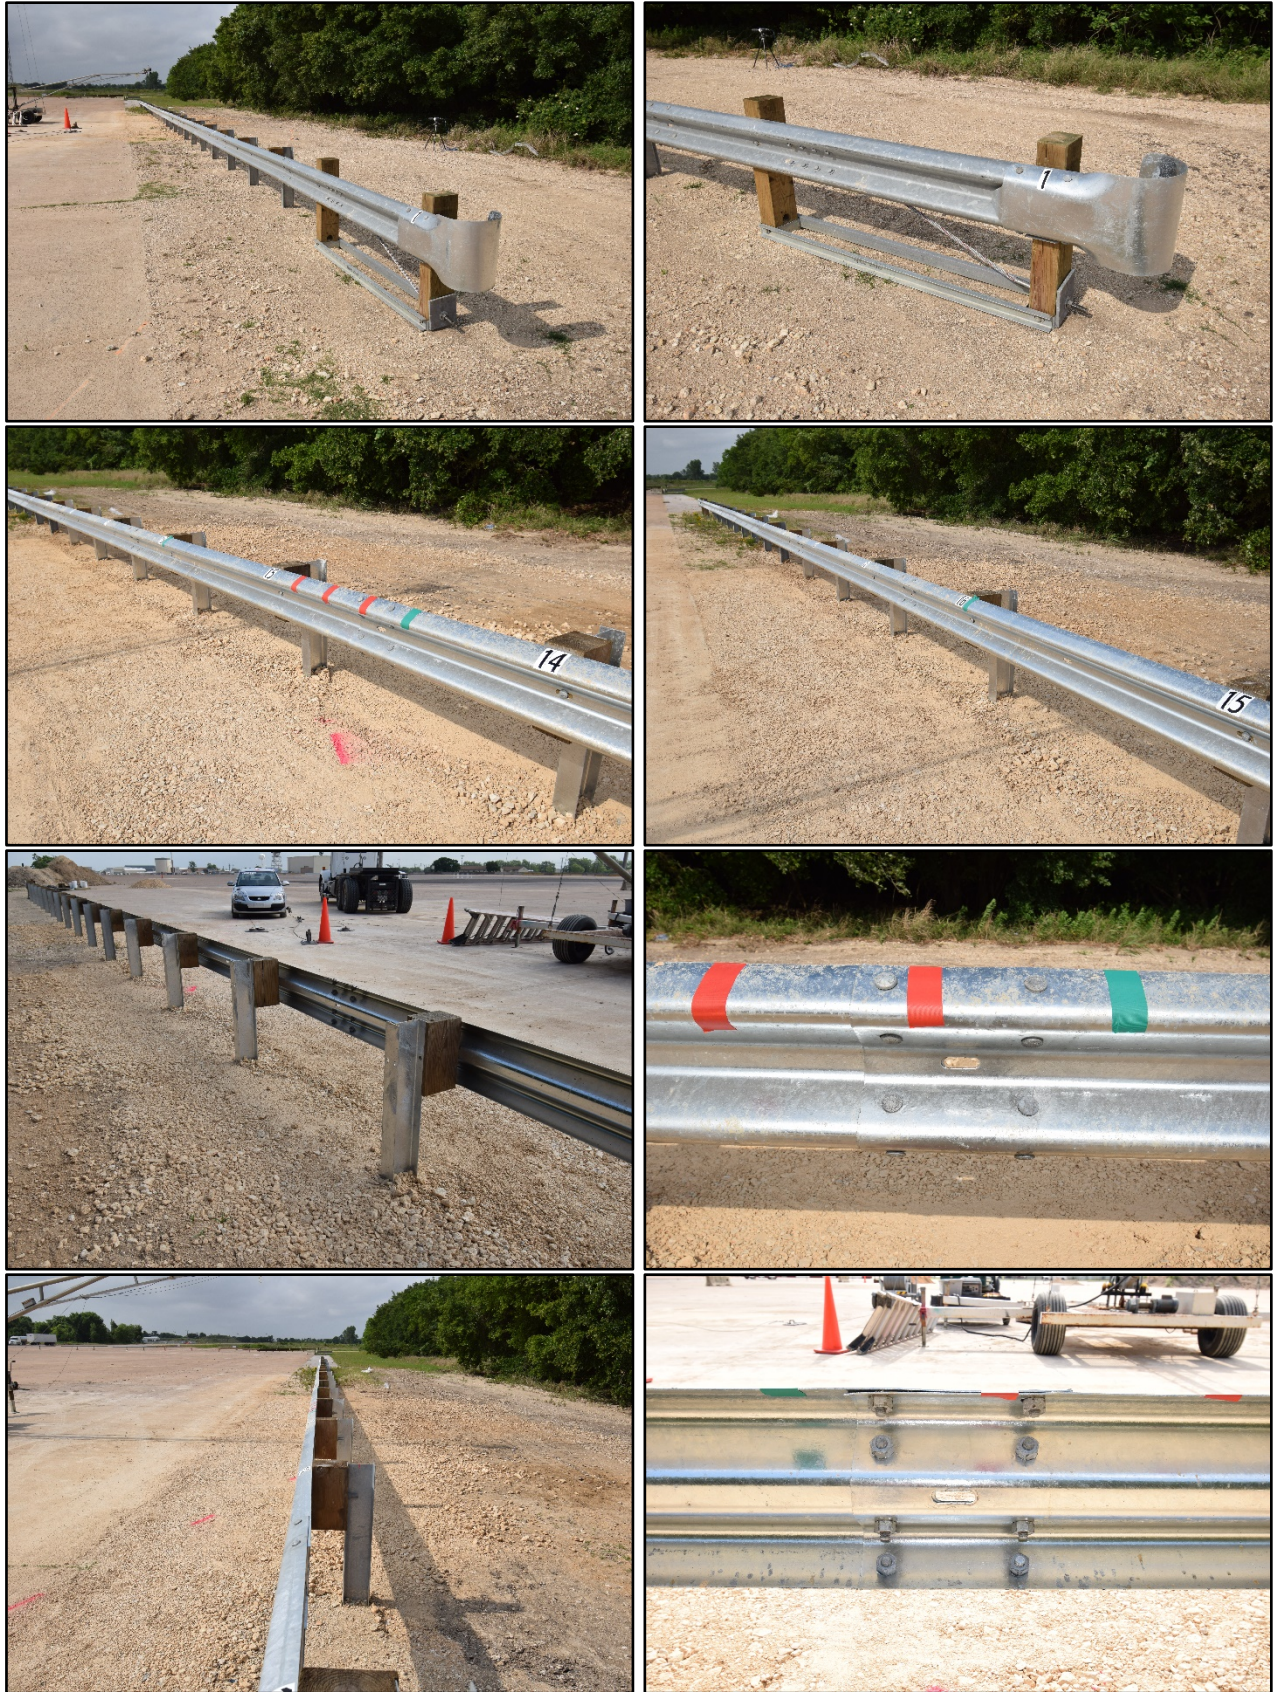
Figure 2.2. W-Beam Guiderail over Underground Structure prior to Testing.

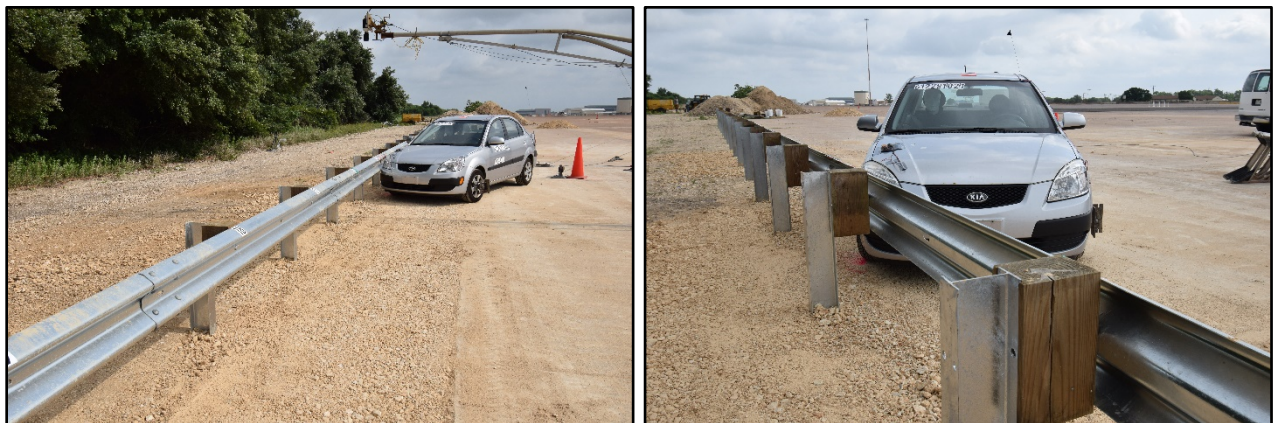
Figures 5.1 and 5.2 show the 2009 Kia Rio used for the crash test. The vehicle's test inertia weight was 2420 lb, and its gross static weight was 2585 lb. The height to the lower edge of the vehicle front bumper was 7.75 inches, and height to the upper edge of the bumper was 21.5 inches. Table D.1 in Appendix D1 gives additional dimensions and information on the vehicle. The vehicle was directed into the installation using the cable reverse tow and guidance system, and was released to be freewheeling and unrestrained just prior to impact.

Figure 5.1. Guiderail/Test Vehicle Geometrics for Test No. 612281-02-1.

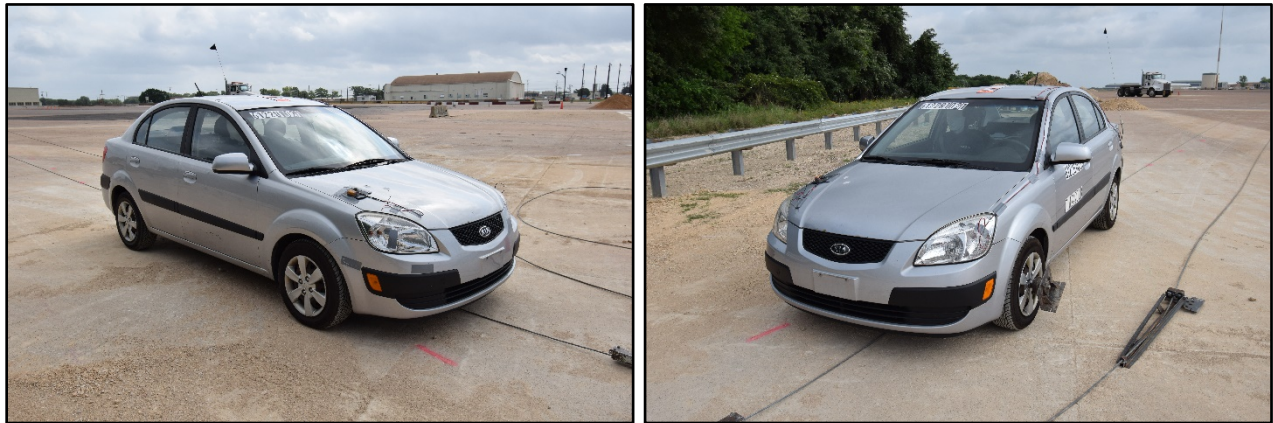
Figure 5.2. Test Vehicle before Test No. 612281-02-1.

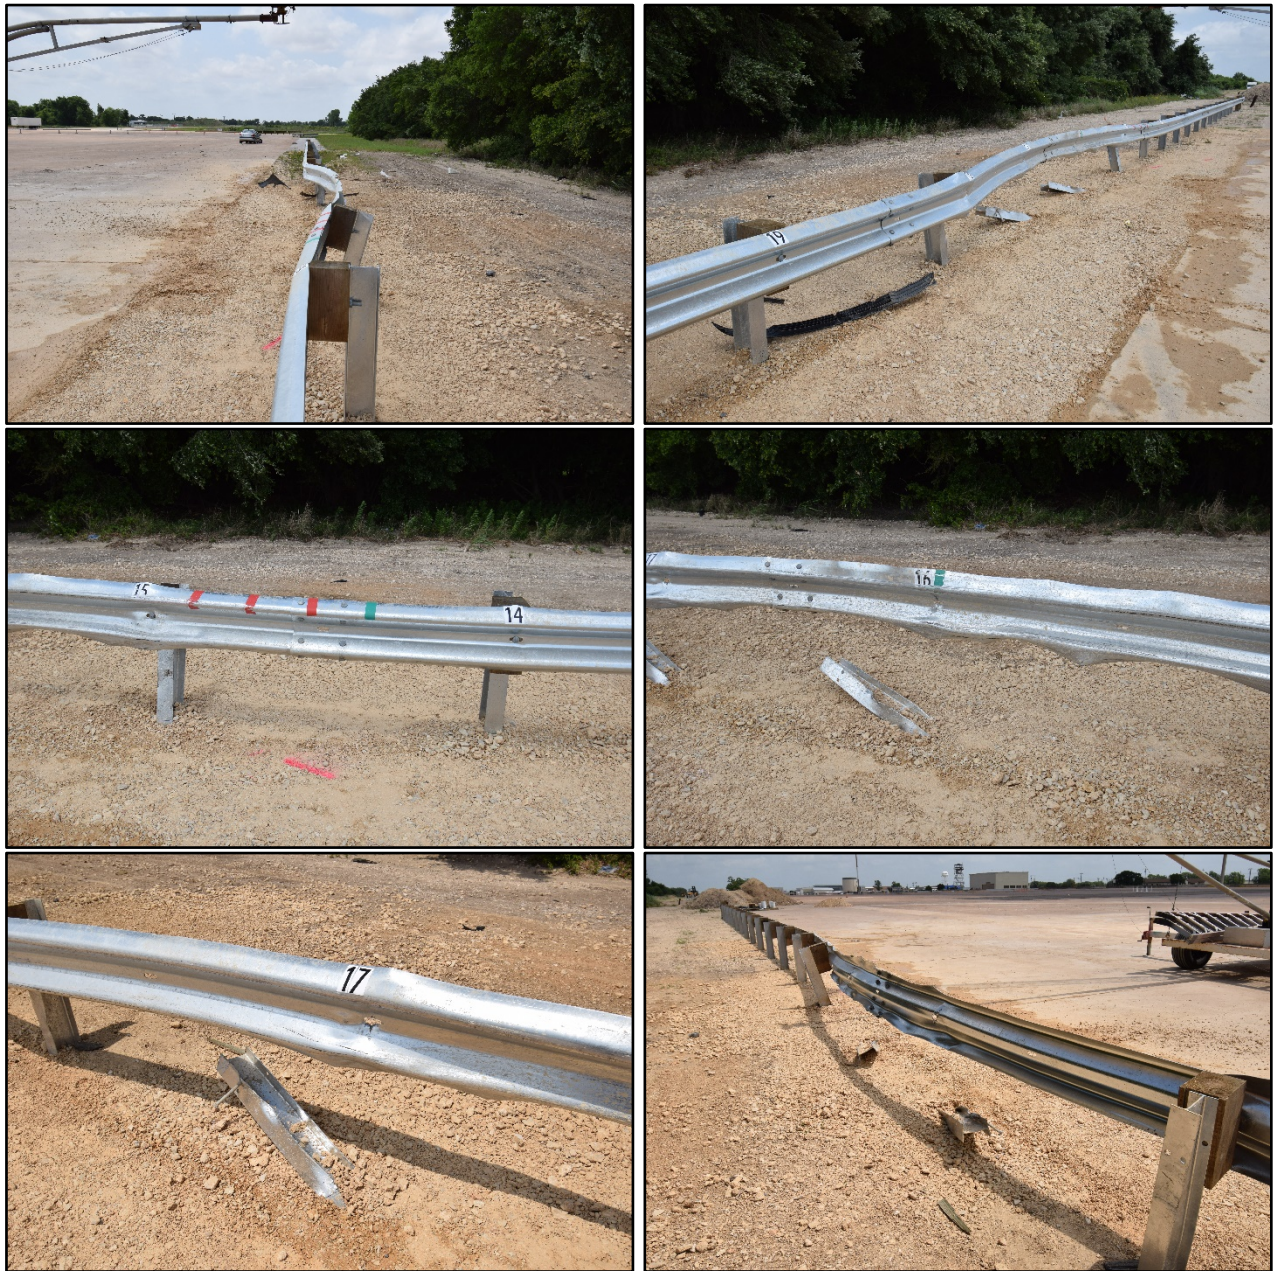
Figure 5.3 shows the damage to the W-Beam Guiderail over Underground Structure. The soil was disturbed around post 1, and it was pulled downstream 0.13 inch at ground level. The W-beam rail element released from posts 16 through 18, and the blockouts released from posts 16 and 17. Post 15 was leaning toward the field side at 77°, posts 16 and 17 were leaning toward the field side at approximately 5° and downstream approximately 45°, and post 18 was leaning toward the field side at 87°. No movement or damage was observed at posts 2-14 and 19-30.

Working width[†] was 30.5 inches, and height of working width was 39.8 inches. Maximum dynamic deflection during the test was 27.0 inches, and maximum permanent deformation was 20.5 inches.

Figure 5.3. Guideway after Test No. 612281-02-1.

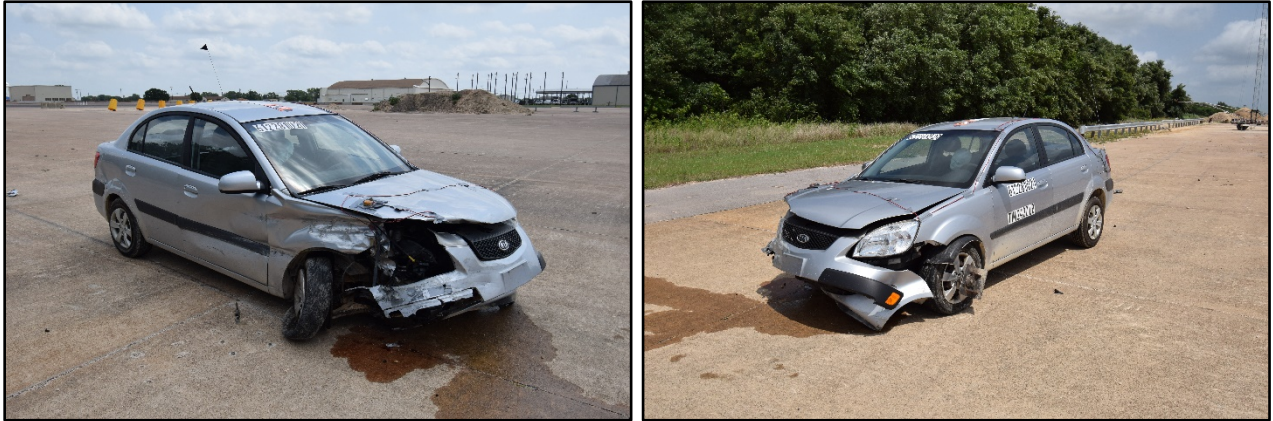
Figure 5.4 shows the damage sustained by the vehicle. The front bumper, hood, radiator and support, right front fender, right front tire and rim, right front strut and tower, right front and rear doors, right rear quarter panel, and rear bumper were damaged. Maximum exterior crush to the vehicle was 8.0 inches in the side plane at the right front corner at bumper height. No occupant compartment deformation or intrusion was observed. Figure 5.5 shows the interior of the vehicle. Tables D.2 and D.3 in Appendix D1 provide exterior crush and occupant compartment measurements.

Figure 5.4. Test Vehicle after Test No. 612281-02-1.

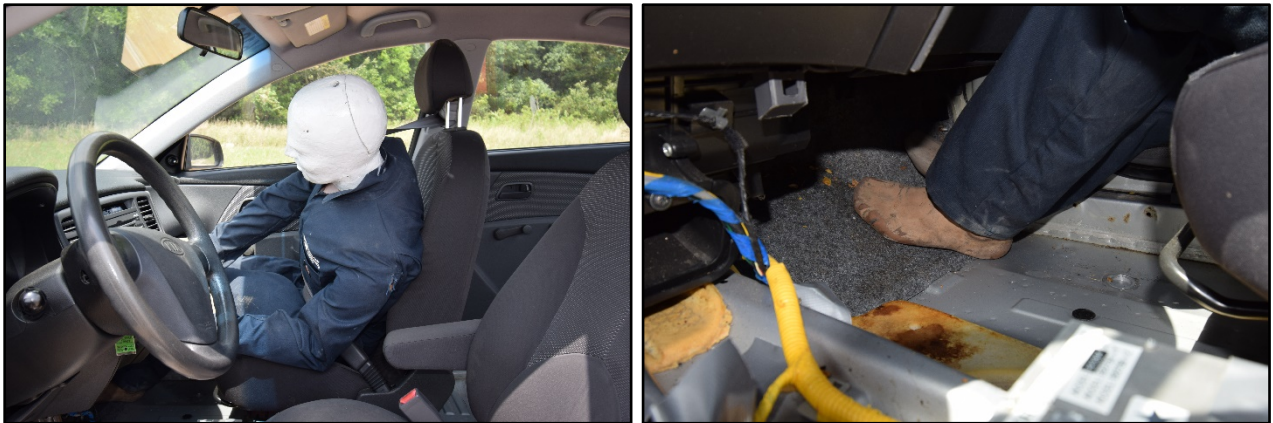
Figure 5.5. Interior of Test Vehicle after Test No. 612281-02-1.

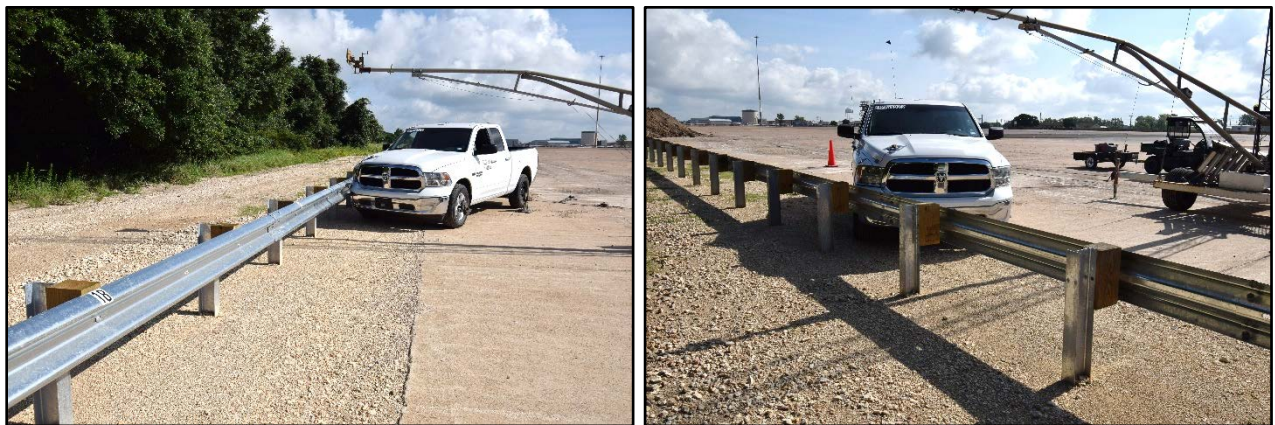
Figures 6.1 and 6.2 show the 2014 RAM 1500 pickup truck used for the crash test. The vehicle's test inertia weight was 5042 lb, and its gross static weight was 5042 lb. The height to the lower edge of the vehicle front bumper was 11.75 inches, and height to the upper edge of the bumper was 27.0 inches. The height to the vehicle's center of gravity was 29.0 inches. Tables E.1 and E.2 in Appendix E1 give additional dimensions and information on the vehicle. The vehicle was directed into the installation using the cable reverse tow and guidance system, and was released to be freewheeling and unrestrained just prior to impact.

Figure 6.1. Guiderail/Test Vehicle Geometrics for Test No. 612281-02-2.

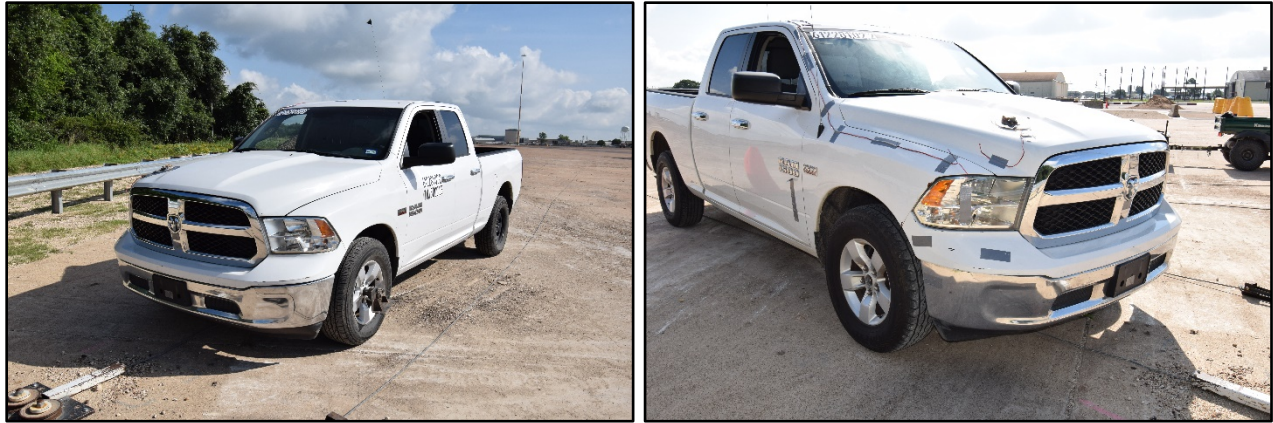
Figure 6.2. Test Vehicle before Test No. 612281-02-2.

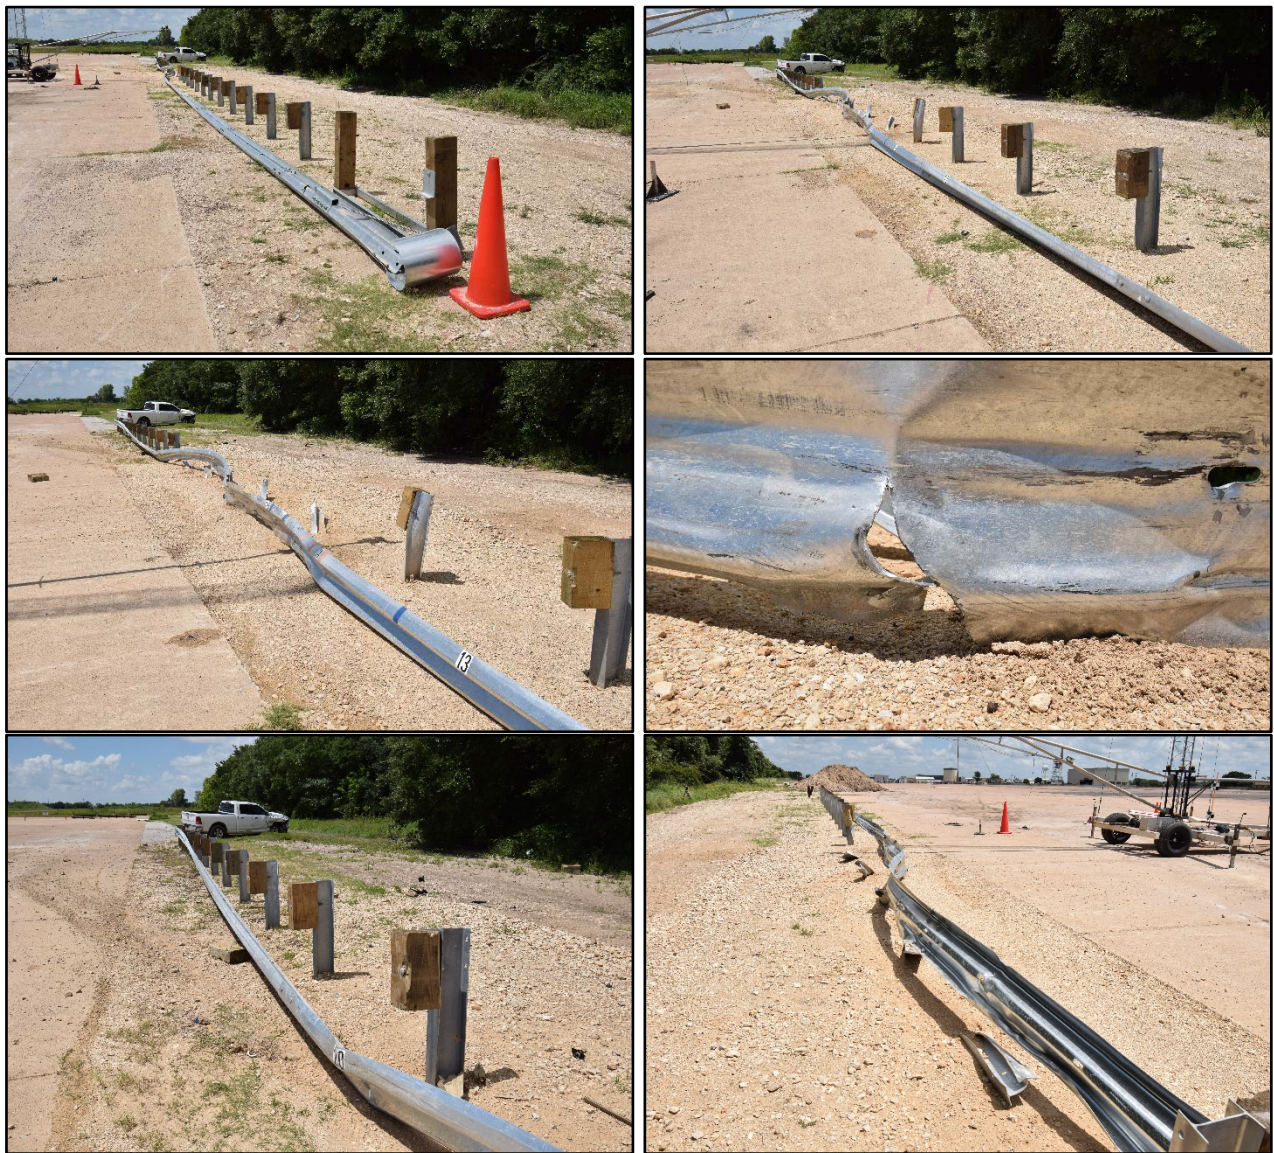
Figure 6.3 shows the damage to the W-Beam Guiderail over Underground Structure. The soil was disturbed around post 1, and it was pulled downstream 1.25 inches at ground level. The rail element released from posts 1 through 27, and the blockouts released from posts 15 through 19. Post 13 rotated 30° clockwise, post 14 was rotated 90° clockwise, posts 15 through 19 were leaning downstream at approximately 5° (all about the vertical centerline), and post 20 was leaning downstream at 84° and had a 0.5-inch gap at grade on the traffic side. Post 30 had a 0.5-inch gap on the downstream side. The rail element was partially torn just downstream of post 16. Working width was 62.4 inches, and height of working width was 54.3 inches. Maximum dynamic deflection during the test was 53.1 inches, and maximum permanent deformation was 17.1 inches.

Figure 6.3. Guiderail after Test No. 612281-02-2.

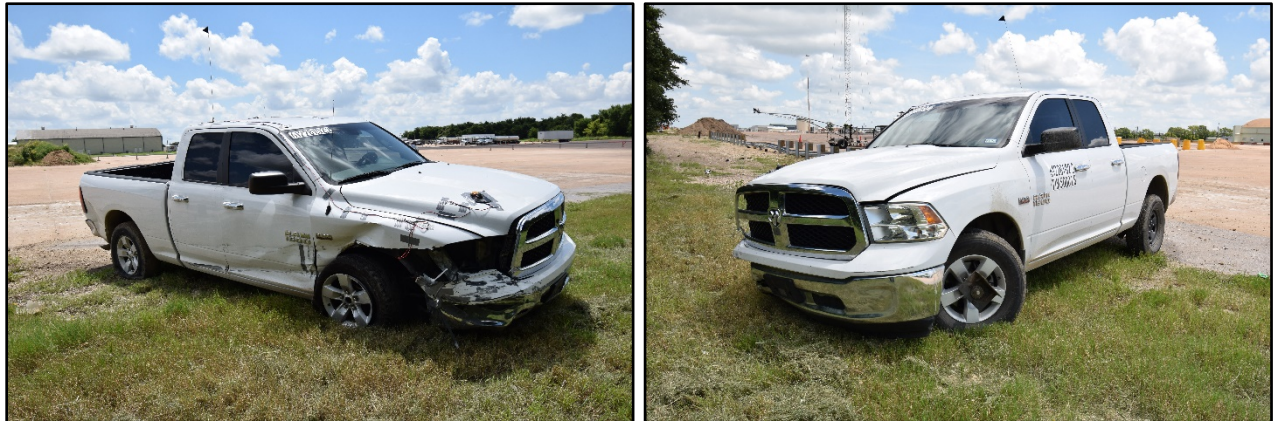
Figure 6.4 shows the damage sustained by the vehicle. The front bumper, grill, right front fender, right front tire and rim, right lower A-arm, right front and rear doors, right rear tire and rim, right rear exterior bed, and rear bumper were damaged. Maximum exterior crush to the vehicle was 11.0 inches in the side plane at the right front corner at bumper height. No occupant compartment deformation or intrusion was observed. Figure 6.5 shows the interior of the vehicle. Tables E.3 and E.4 in Appendix E1 provide exterior crush and occupant compartment measurements.

Figure 6.4. Test Vehicle after Test No. 612281-02-2.

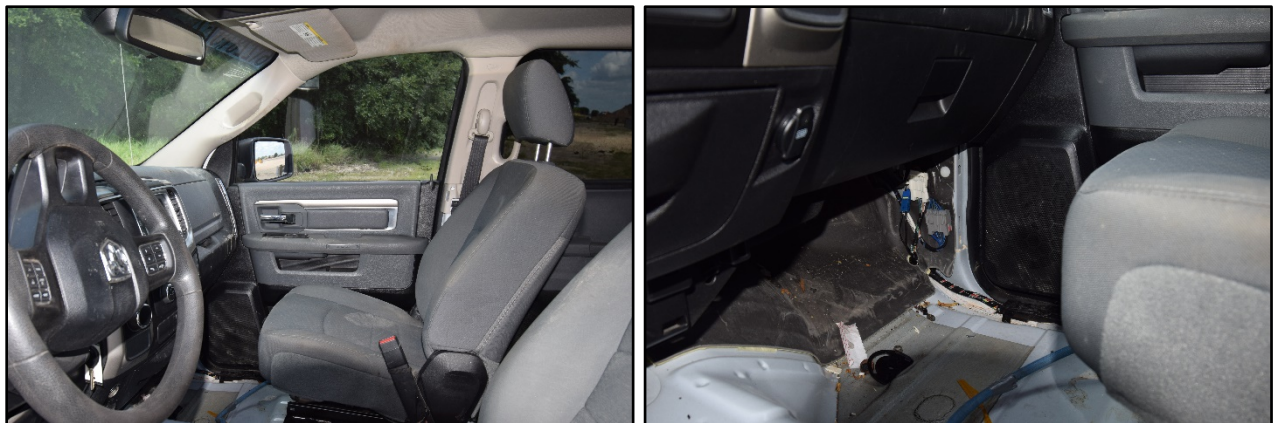
Figure 6.5. Interior of Test Vehicle after Test No. 612281-02-2.

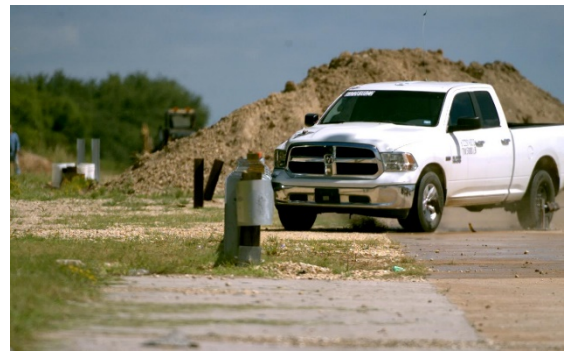
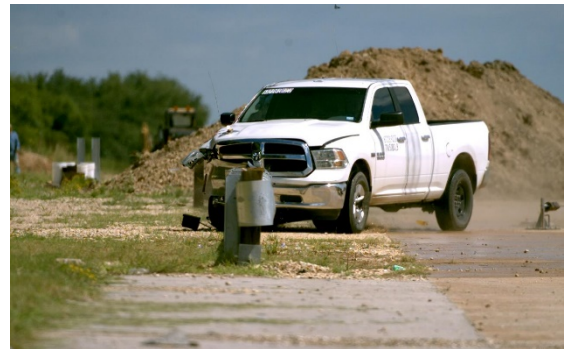
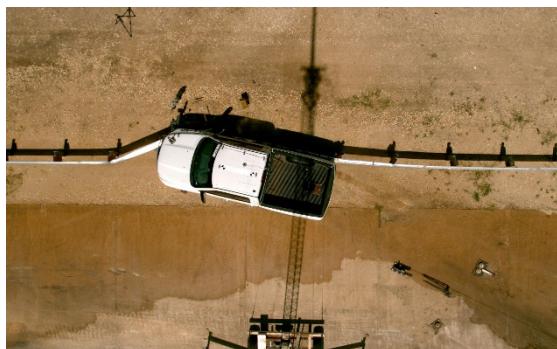
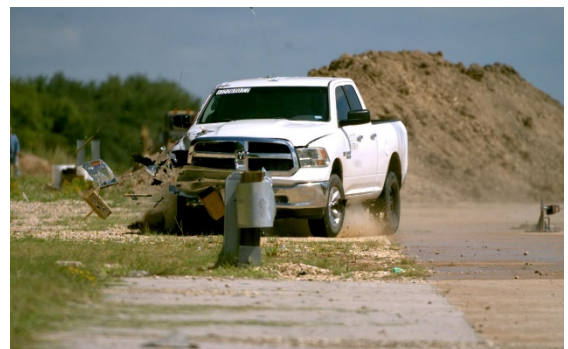
Figure E.1. Sequential Photographs for Test No. 612281-02-2 (Overhead and Frontal Views).

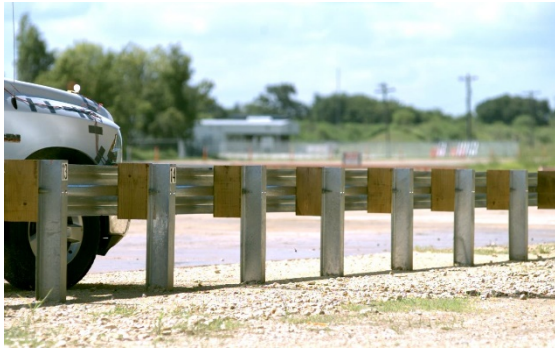
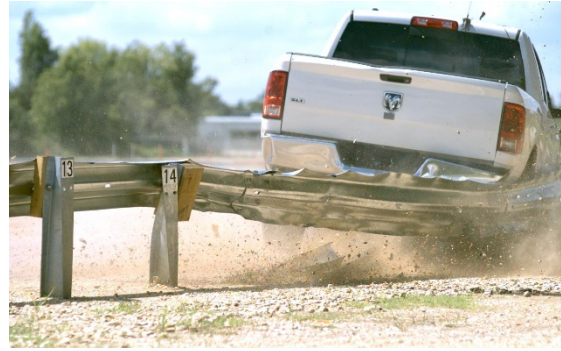
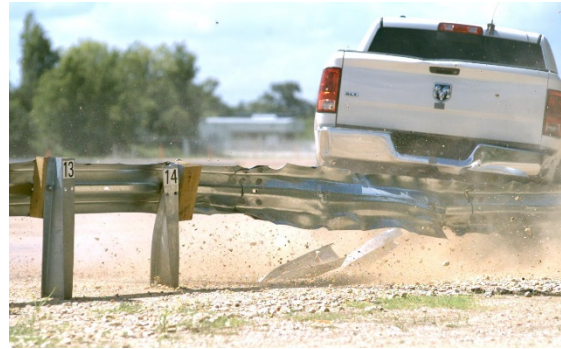
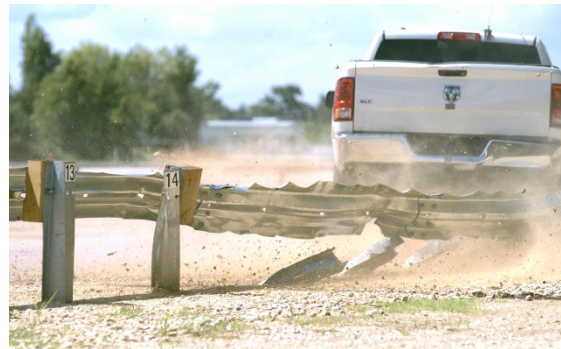
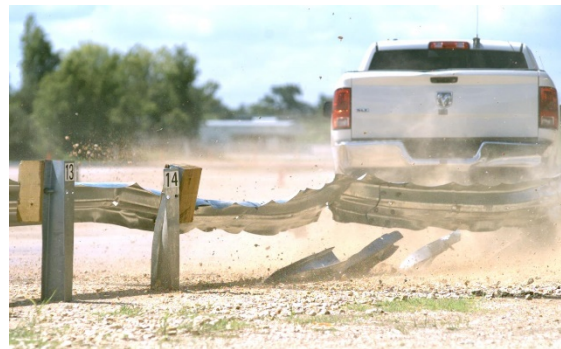
Figure E.2. Sequential Photographs for Test No. 612281-02-2 (Rear View).
