Test Report No. 611971-01
Test Report Date: July 2023

MASH TEST 2-11 ON W-BEAM GUARDRAIL WITH MODIFIED SPECIAL STEEL POSTS FOR CONCRETE STRUCTURE MOUNT

Contract No.: T4541-DH
Test No.: 611971-01-1
Test Date: 2021-04-22

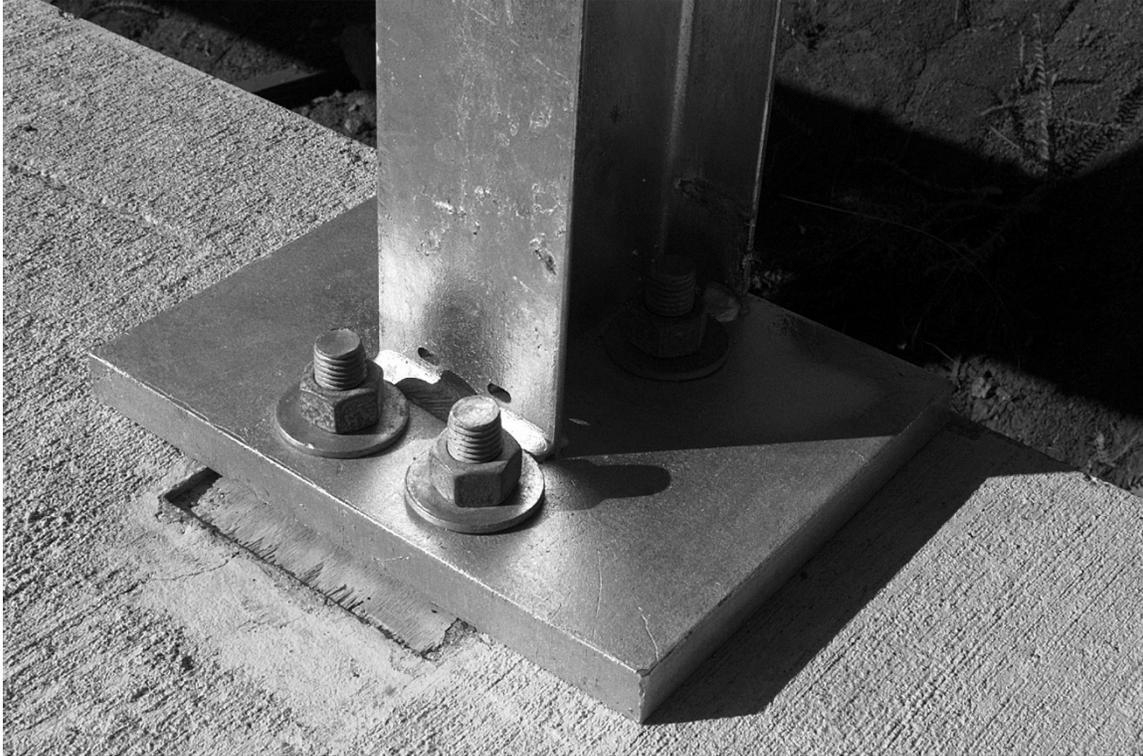
Figure 2.4. TxDOT T6 Steel Post Welded Connection.

Another evaluated concept was utilizing a similar failure mechanism as designed with the TxDOT T6 post (5). In this design, a steel post is welded to a baseplate using a specific weld pattern. Upon impact, the welds are designed to fail, and therefore, the post is allowed to rotate away from impact. Figure 2.4 shows the welded connection which was designed to fail upon impact of the T6 post.

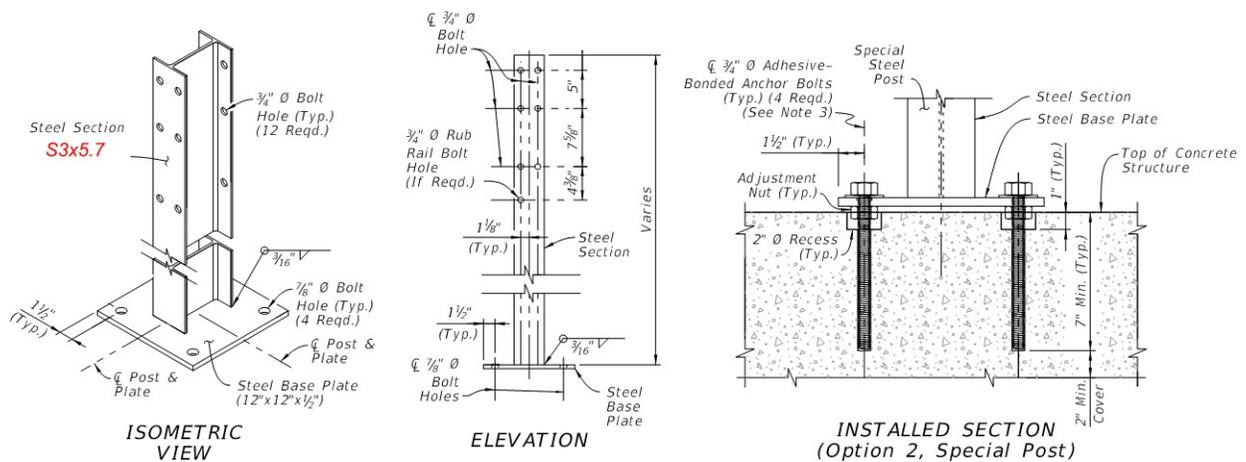
Figure 2.7. Modified FDOT Modified Special Steel Posts for Concrete Structure Mount (Florida Department of Transportation, 2017-2018)

This design option is a modification of the FDOT Modified Special Steel Posts for Concrete Structure Mount detail for W-beam guardrail design. The difference between this design option and the FDOT Modified Special Steel Posts for Concrete Structure Mount design is that an S3x5.7 post is used instead of a W6x8.5 post. Again, this change in post size is due to the desire for the posts to yield during an impact. Figure 2.7 shows a sketch of the proposed Modified FDOT Modified Special Steel Posts for Concrete Structure Mount. Table 2.3 lists a few advantages and disadvantages of this option when compared to the other design options.

Advantages	Disadvantages
Easy retrofit in the field (same bolt and baseplate configuration as existing design)	Time consuming to replace after vehicle impact if anchors are damaged
Weak post to minimize pocketing and snagging potential	Different post than current FDOT standard

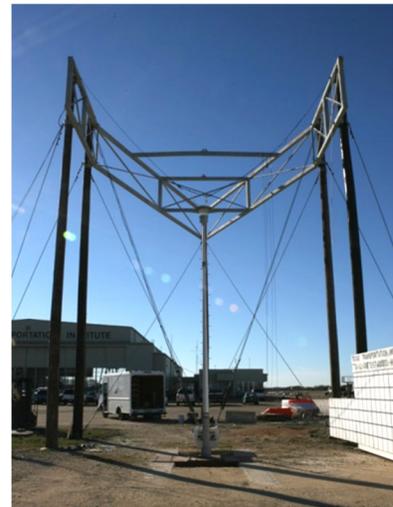
Figure 3.1. TTI Proving Ground's Pendulum Testing Facility.

The special baseplate posts were tested at the Texas A&M Transportation Institute (TTI) outdoor pendulum testing facility. The utilized pendulum bogie, which was built according to the specifications of the Federal Outdoor Impact Laboratory's (FOIL) pendulum, and the testing area, are shown in Figure 3.1. Frontal crush of the aluminum honeycomb nose of the bogie simulates the crush of an actual vehicle. The crushable nose configuration is the FOIL ten stage bogie nose. Cartridges of expendable aluminum honeycomb material of differing densities are placed in a sliding nose. The pendulum impacts special baseplate posts at a target speed and height above the ground as determined for each test. After a test, the honeycomb material is replaced, and the bogie is reused. A sketch of the honeycomb configuration used for the pendulum bogie is shown in Appendix A. A brief description of the procedures used is presented in Appendix B.

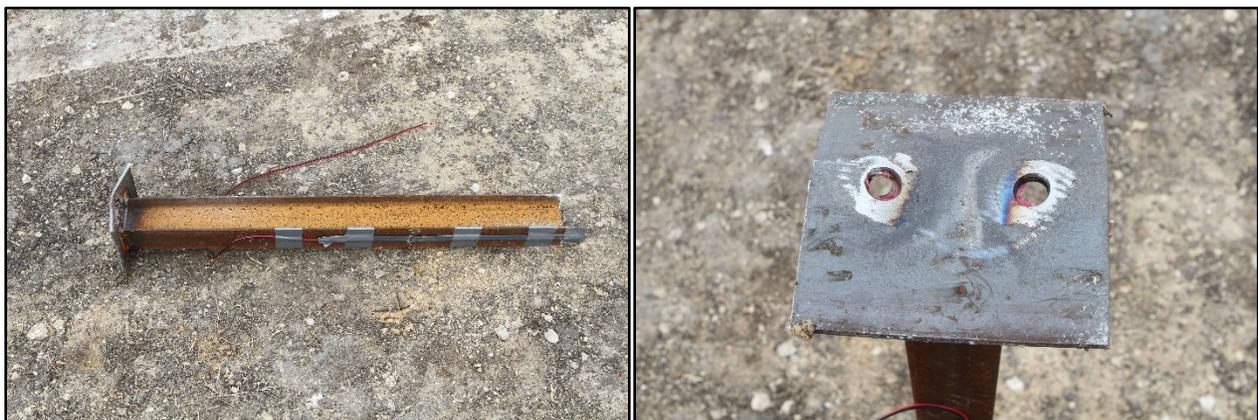
Figure 3.6. Post after Test No. 611971-01 P1.

The baseplate deformed and released from anchor bolts. The nuts and threaded ends released from the anchors. The post slightly deformed at the base plate. The anchor bolts sheared and released the baseplate.

Tests P1 (Option 4), P4, (Option 4) and P6 (Option 5) exhibited bolts shearing near grade, which would cause repair or replacement to be more difficult. In test P7 (Option 2), the Hilti HDI SS 303 Flush Anchors were removed from the concrete structure during the impact. Furthermore, significant damage was found on the concrete structure.

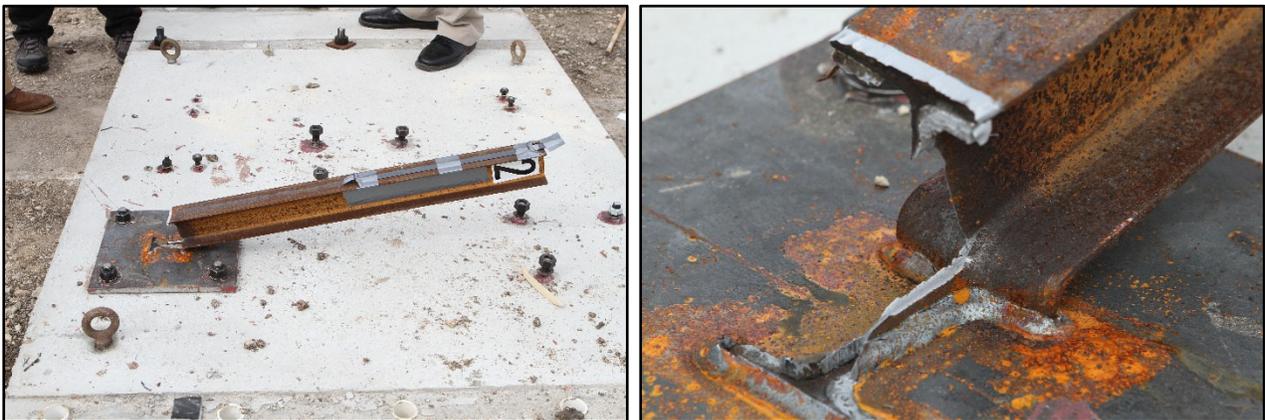
Figure 3.9. Post after Test No. 611971-01 P2.

The front flange released from welds, the web partially tore, and the post leaned toward the field side.

Tests P2 and P3 (both Option 3) exhibited the ideal behavior which the research team desired. The posts fractured near the baseplate weld location, and the anchors remained intact. Test P2 was repeated in Test P5 to ensure repeatability of the release mechanism. Test P5 was also successful with the posts fracturing near the baseplate weld location, and the anchors remaining intact.

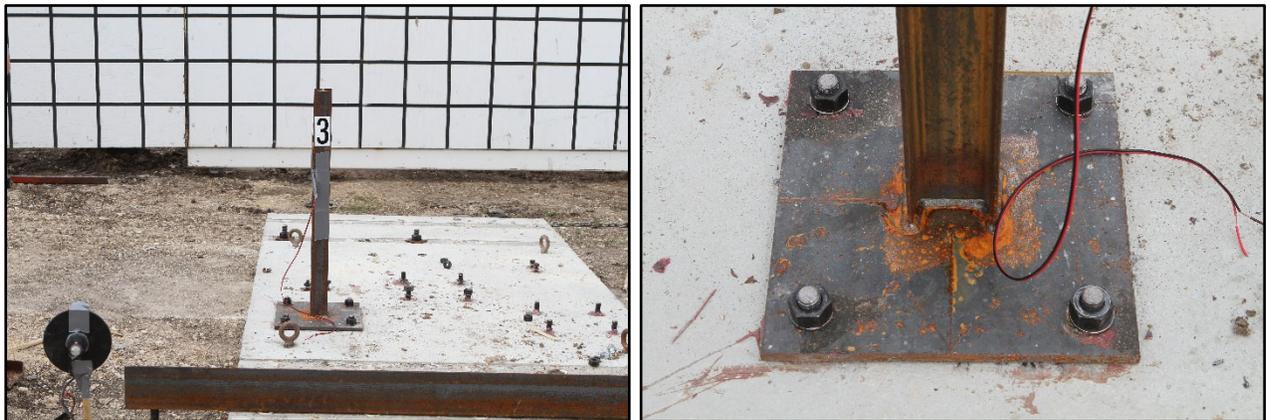
Figure 3.10. Post before Test No. 611971-01 P3.

The pendulum surrogate vehicle (bogie) impacted the post at 0 degrees (post loaded in weak axis) and at 21.9 mi/h. The center of the crushable bogie nose was aligned at 28.25 inches above grade.

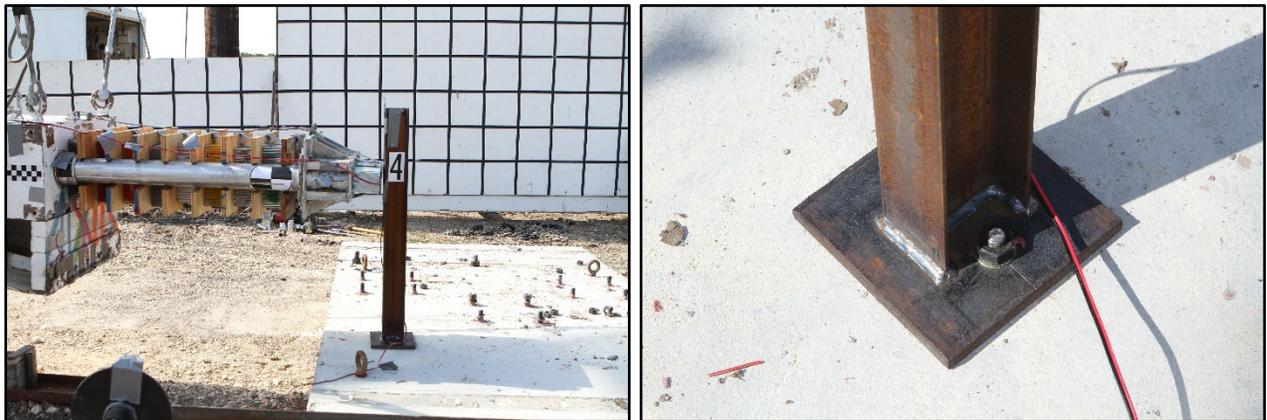
Figure 3.12. Post before Test No. 611971-01 P4.

The pendulum surrogate vehicle (bogie) impacted the post at 90 degrees (post loaded in strong axis) and at a speed of 22.3 mi/h. The center of the crushable bogie nose was aligned at 26.25 inches above grade.

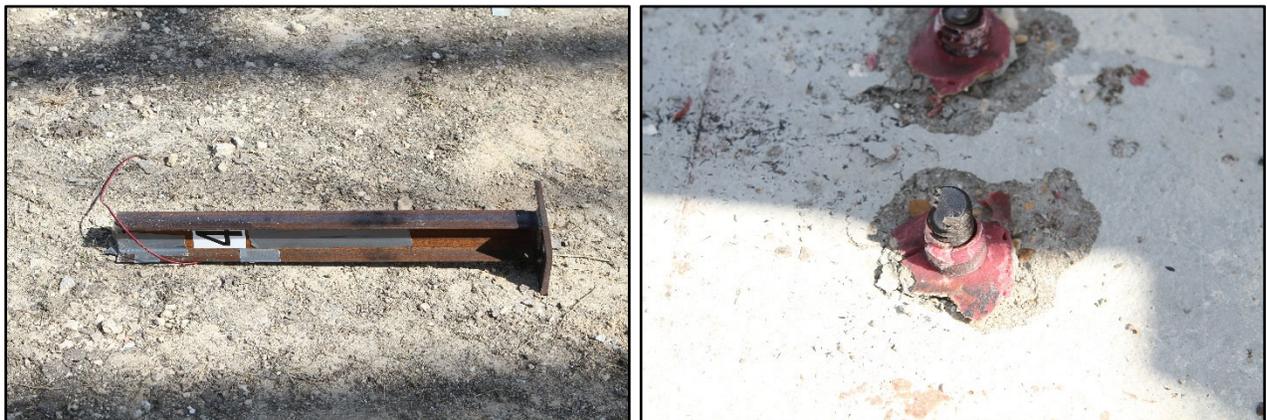
Figure 3.13. Post after Test No. 611971-01 P4.

The baseplate deformed, the post leaned away from the impact side, and the anchors sheared.

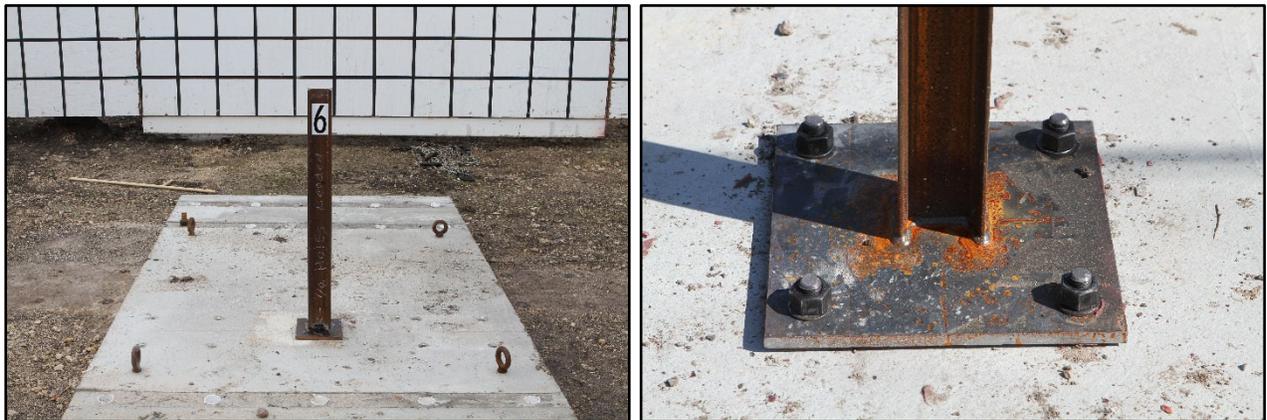
Figure 3.14. Post before Test No. 611971-01 P5.

The pendulum surrogate vehicle (bogie) impacted the post at 0 degrees (post loaded in strong axis) and at 21.9 mi/h. The center of the crushable bogie nose was aligned at 30.0 inches above grade.

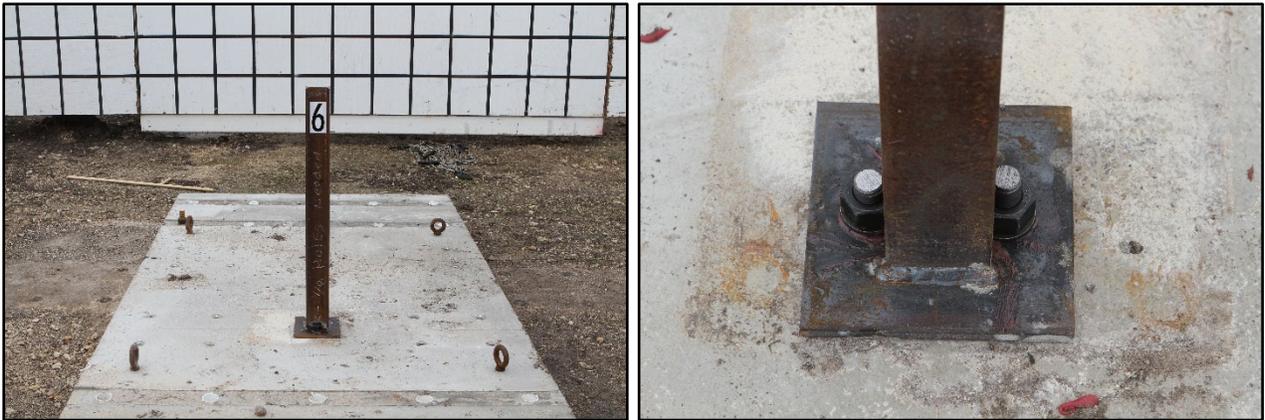
Figure 3.16. Post before Test No. 611971-01 P6.

The pendulum surrogate vehicle (bogie) impacted the post at 90 degrees (post loaded in strong axis) and 21.8 mi/h. The center of the crushable bogie nose was aligned at 26.25 inches above grade.

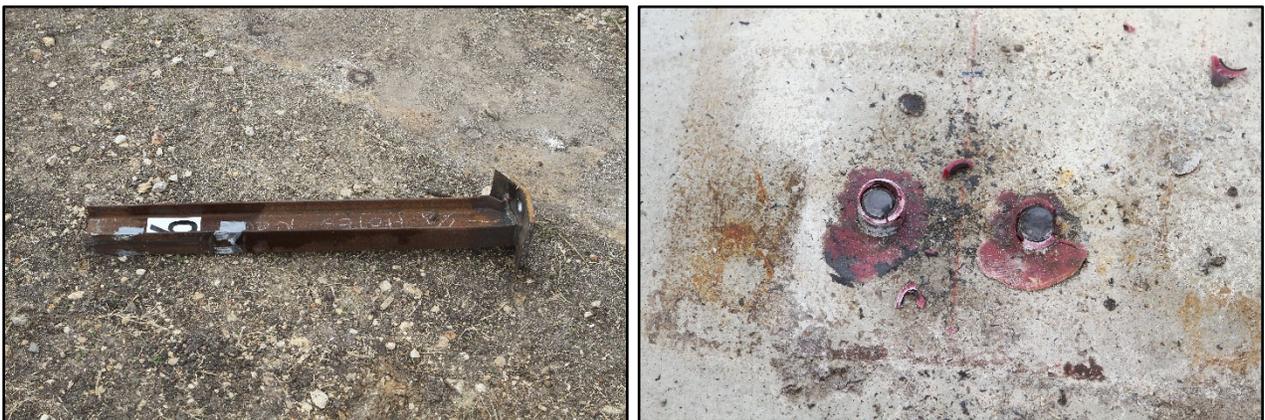
Figure 3.17. Post after Test No. 611971-01 P6.

The baseplate deformed and released. The post remained attached to the baseplate. The anchors were sheared.

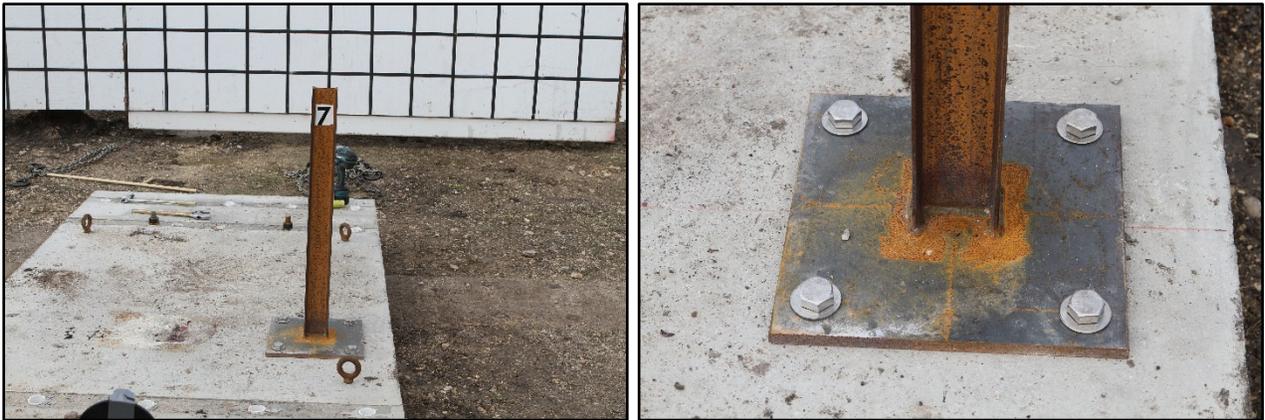
Figure 3.18. Post before Test No. 611971-01 P7.

The pendulum surrogate vehicle (bogie) impacted the post at 90 degrees (post loaded in strong axis) and 21.9 mi/h. The center of the crushable bogie nose was aligned at 28.875 inches above grade.

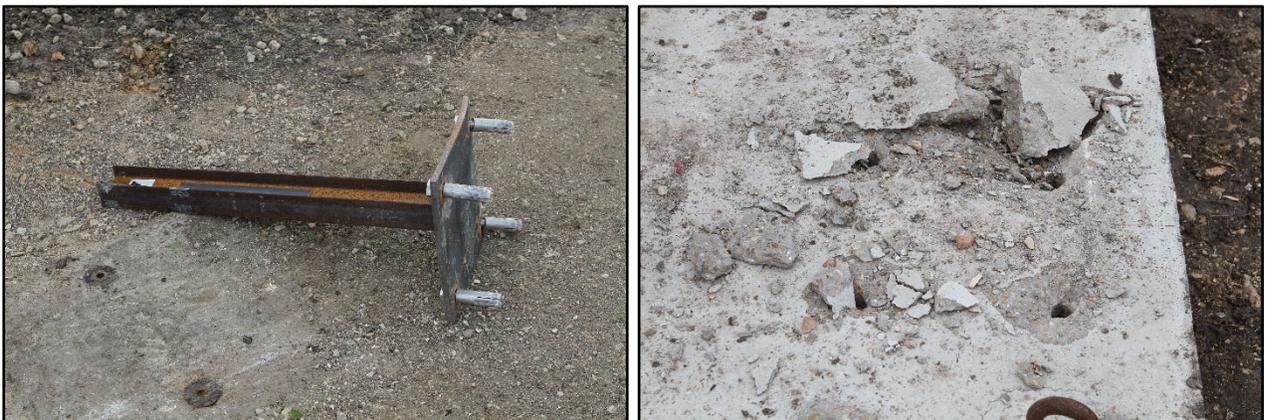
Figure 3.19. Post after Test No. 611971-01 P7.

The baseplate deformed the impact, the two impact side bolts released from concrete, and the concrete was damaged in the rear bolt mounting area

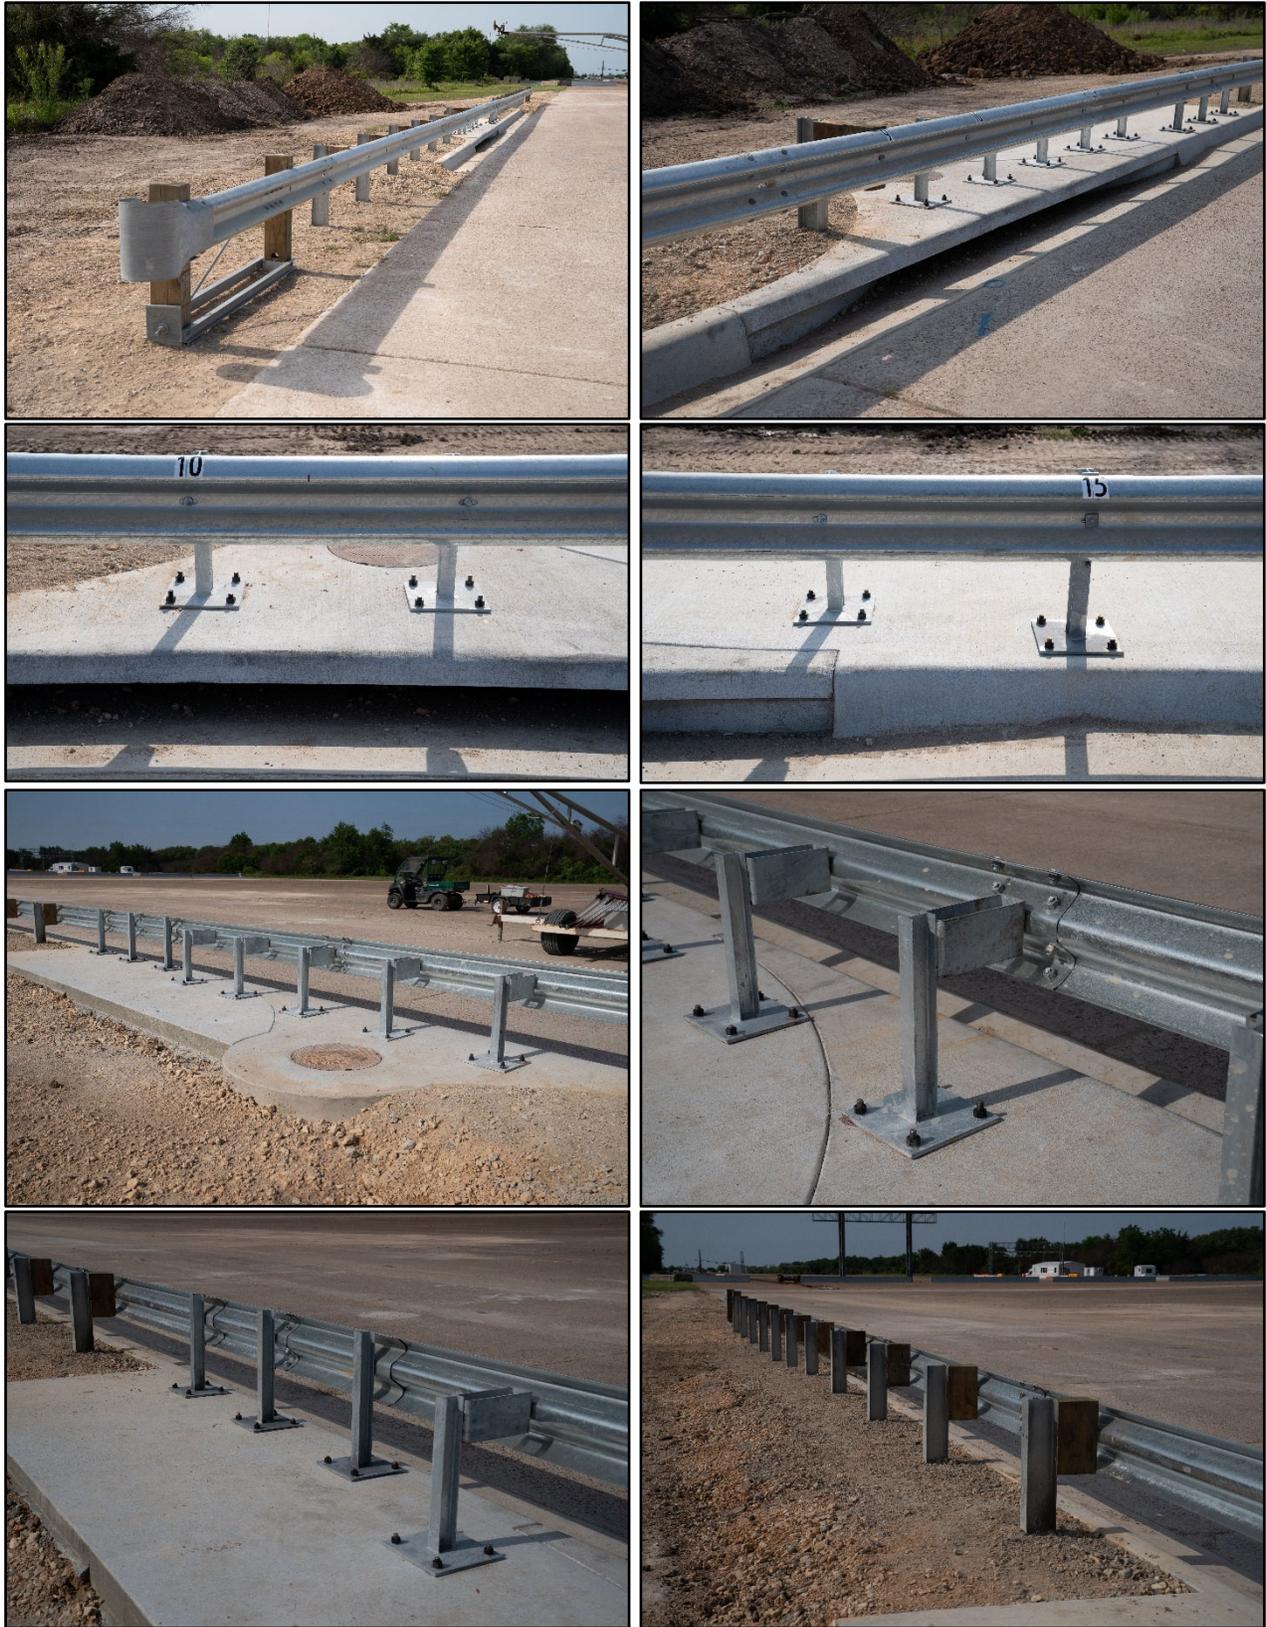
Figure 4.2. W-Beam Guardrail with Modified Special Steel Posts for Concrete Structure Mount prior to Testing.

Figure 4.1 presents the overall information on the W-Beam Guardrail with Modified Special Steel Posts for Concrete Structure Mount, and Figure 4.2 provides photographs of the installation. Appendix D provides further details on the W-Beam Guardrail with Modified Special Steel Posts for Concrete Structure Mount. Drawings were provided by the Texas A&M Transportation Institute (TTI) Proving Ground. Construction was subcontracted, but supervised by TTI Proving Ground personnel.

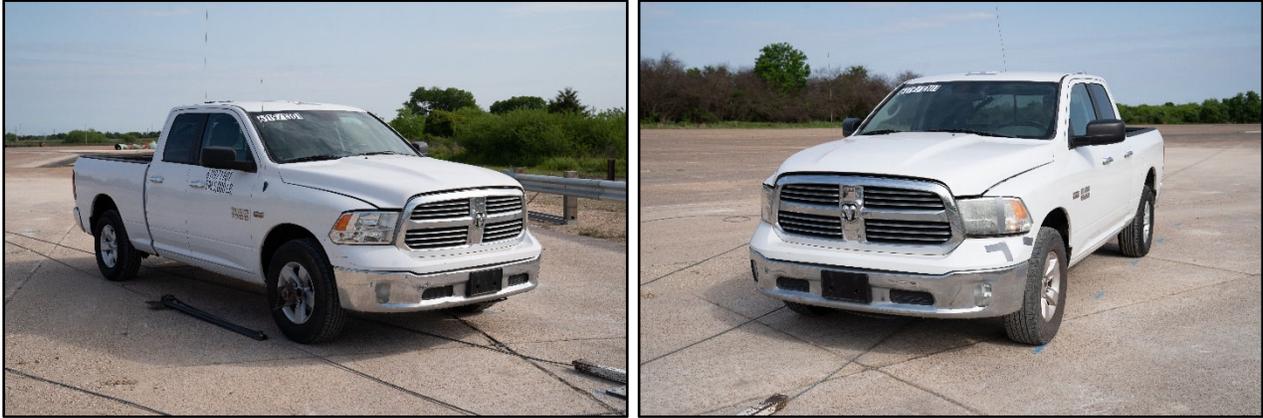
Figure 7.2. Test Vehicle before Test No. 611971-01-1.

Figure 7.2 shows the 2015 RAM 1500 pickup truck used for the crash test. The vehicle's test inertia weight was 5032 lb, and its gross static weight was 5032 lb. The height to the lower edge of the vehicle bumper was 11.75 inches, and height to the upper edge of the bumper was 27.0 inches. The height to the vehicle's center of gravity was 28.25 inches. Tables D.1 and D.2 in Appendix D.1 give additional dimensions and information on the vehicle. The vehicle was directed into the installation using a cable reverse tow and guidance system, and was released to be freewheeling and unrestrained just prior to impact.

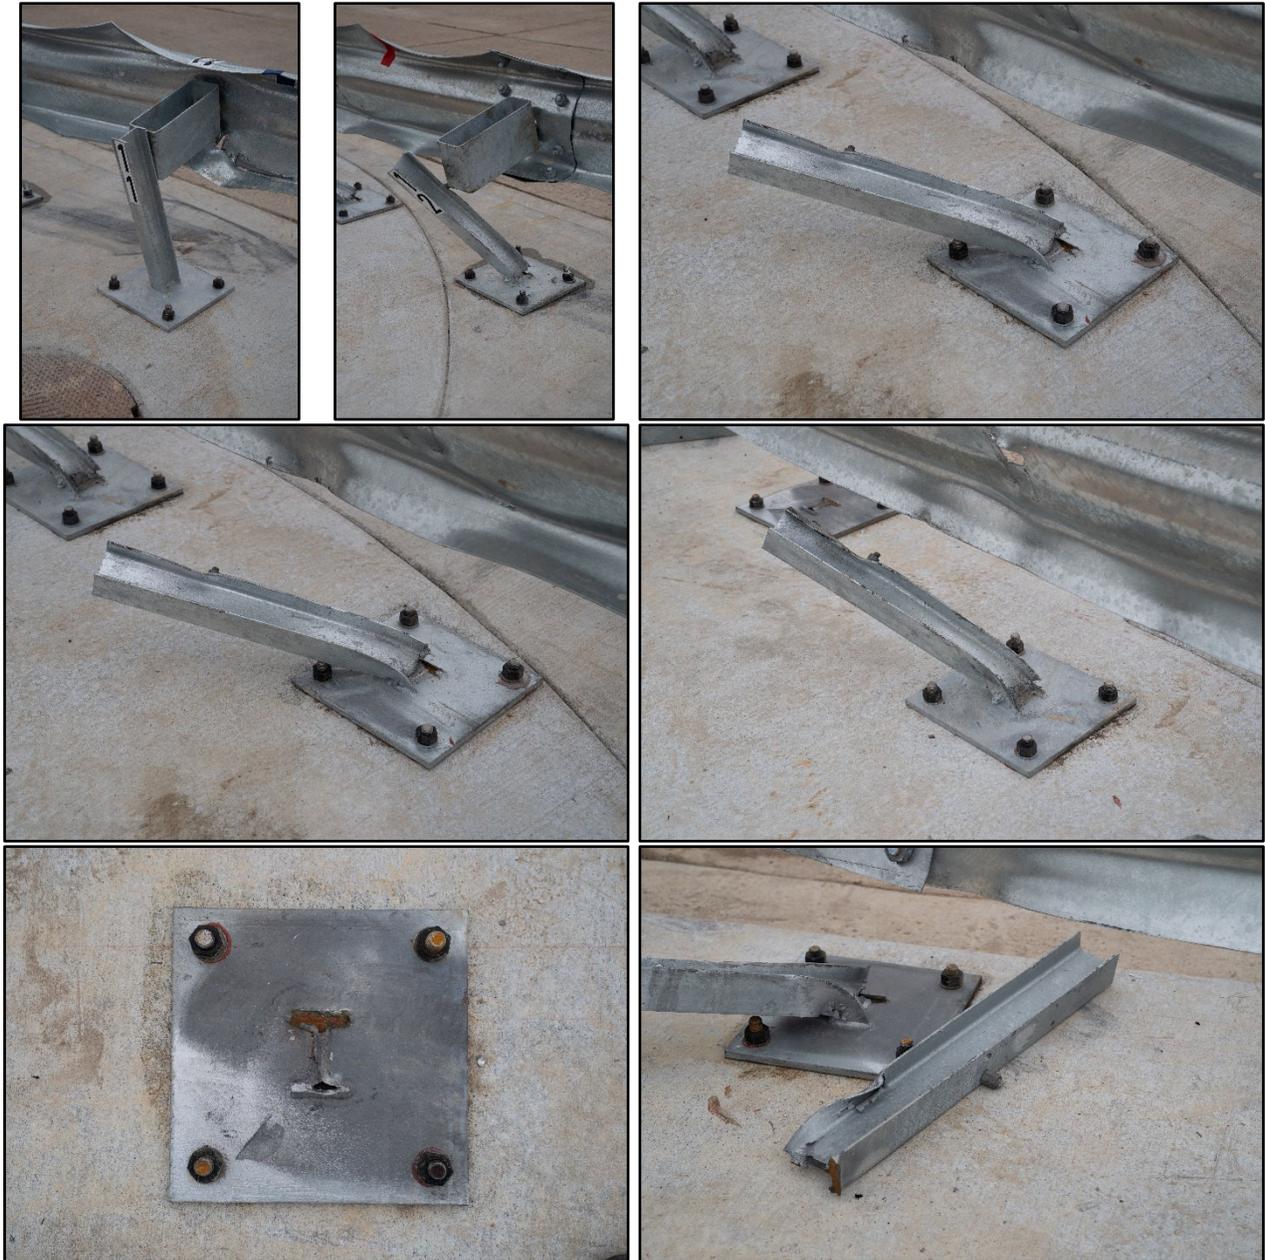
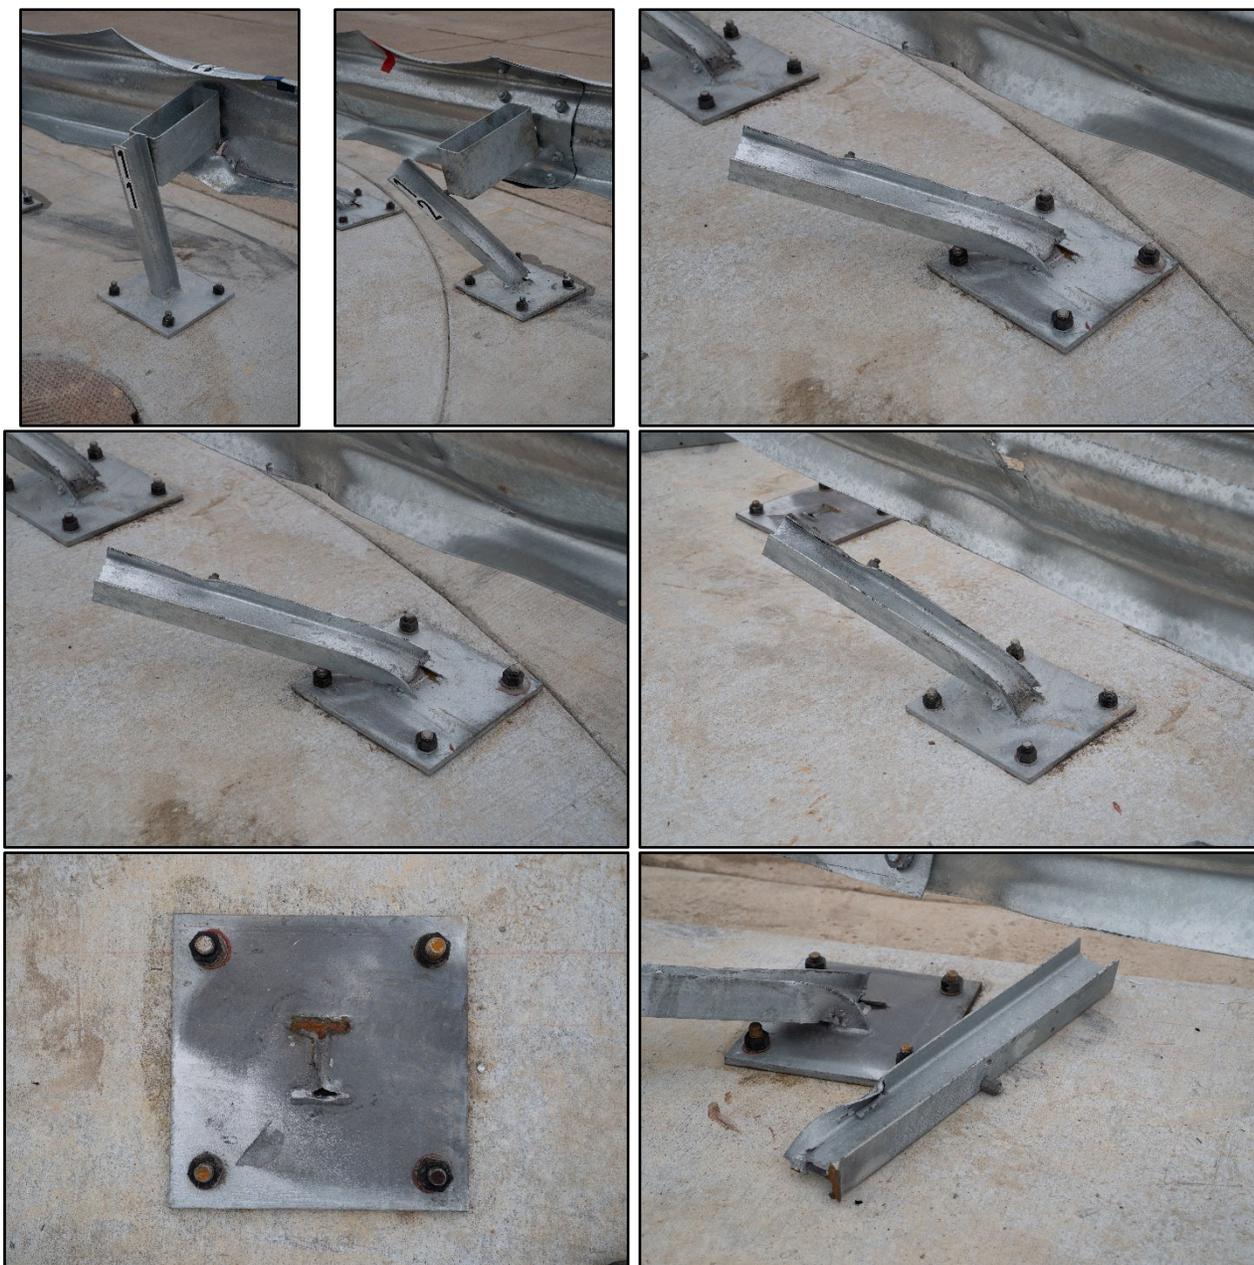
Figure 7.4. Posts 11 through 18 after Test No. 611971-01-1.

Figure 7.3 and Figure 7.4 shows the damage to the guardrail. The vehicle had a secondary impact with the rail just before coming to rest 2 ft downstream of post 26. There was some concrete spalling on the traffic side face of the inlet at post 10. The rail had tears in two different locations. There were two tears located at post 11 measuring 2 and 3 inches, respectively. The

other tear was approximately 3 inches long and was located downstream of the splice at post 17. The rail did not fully tear and maintained continuity. The dislodged blockouts and spacers created a debris field on the field side of the installation measuring 28 ft behind and 22 ft downstream from post 9. Posts 12 through 14 released from their blockouts and fractured at the base of the post. Post 15 separated from the base and landed 20 inches downstream.

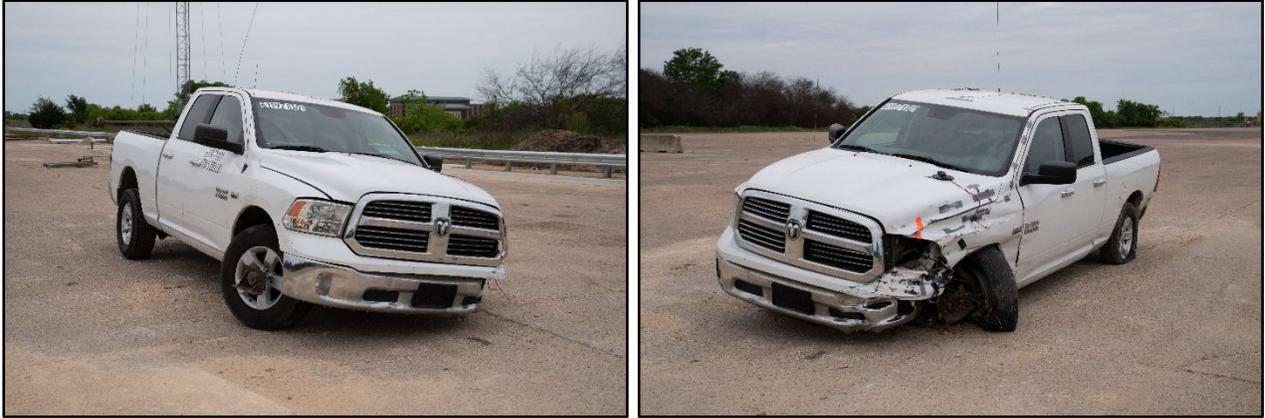
Figure 7.5. Test Vehicle after Test No. 611971-01-1.

Figure 7.5 shows the damage sustained by the vehicle. The front bumper, hood, grill, left front fender, left front tire and rim, left lower control arm, left front door, left exterior bed, left rear tire and rim, and rear bumper were damaged. No fuel tank damage was observed. Maximum exterior crush to the vehicle was 8.0 inches in the side plane at the left front corner at bumper height. No occupant compartment deformation or intrusion were observed. Figure 7.6 shows the interior of the vehicle. Tables D.3 and D.4 in Appendix D.1 provide exterior crush and occupant compartment measurements.
