TECHNICAL MEMORANDUM

Project Name: T4541 MASH Implementation Technical Support for

Washington State I-90 Snoqualmie Pass Scupper Barrier,

Subject: Phase 2 - Full Scale Crash Testing of I-90 Scupper Barrier, &

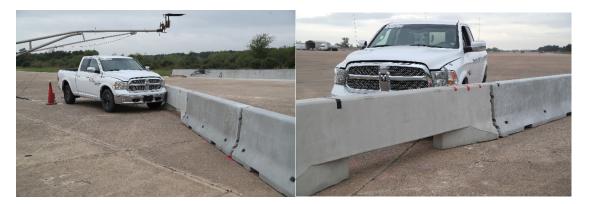
Figure 9 – Photos of MASH Test 3-11 Before Crash Test

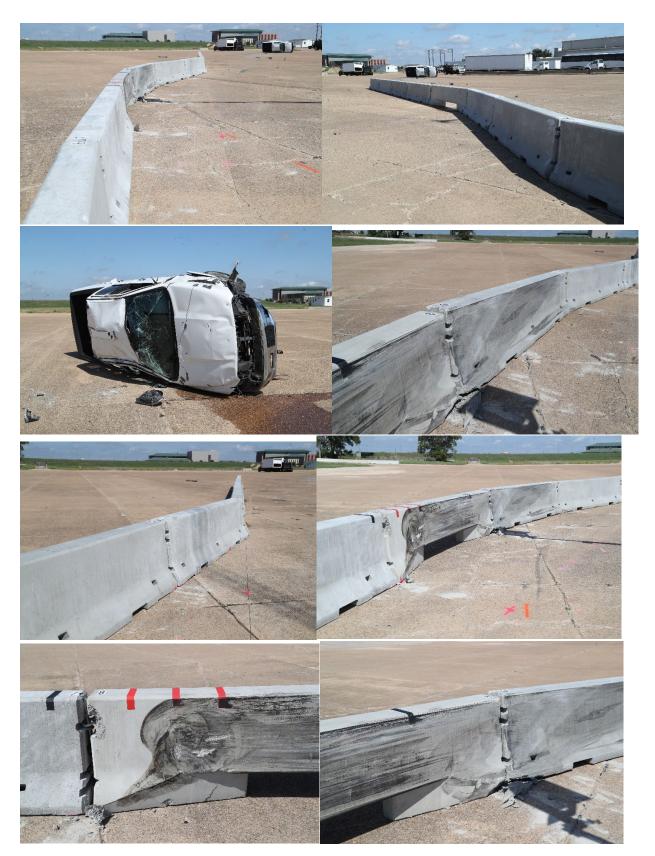
On October 13, 2023, MASH Test 3-11 was performed on the test installation shown in Figures 1 through 8 above. The critical impact point for MASH Test 3-11 was 4.3 feet upstream of the centerline of barrier Number 8 with the pickup traveling from left to right as shown in Figure 1 above. MASH Test 3-11 was not successful. Several loops in the scupper barriers were ruptured and the vehicle rolled over resulting in a failed test with respect to MASH Test 3-11 Specifications. The maximum dynamic deflection from the test was 76.0 inches (6'-4"). Pictures of the crash test installation and the vehicle before and after the crash test are provided as follows.

Figure 10 – Photos of MASH Test 3-11 After Crash Test

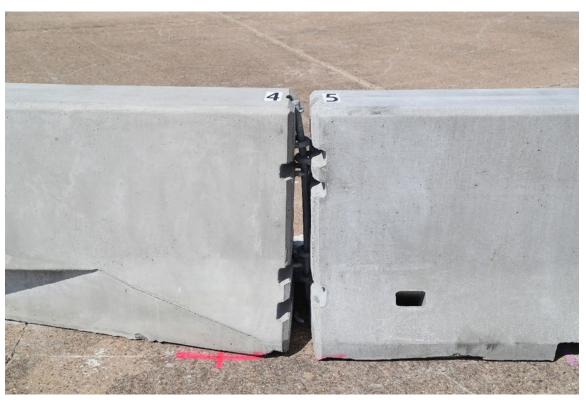
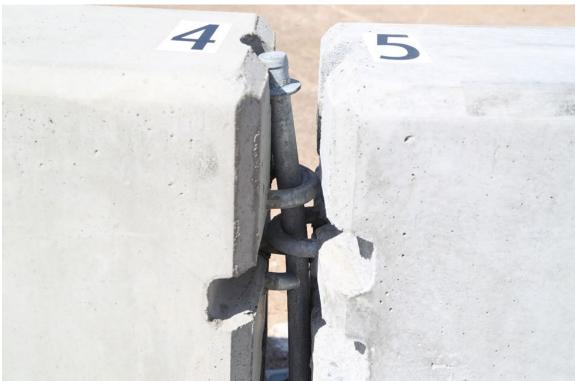
Figure 11 – Photos of Connection Between Barriers 4 & 4

The project team evaluated the test results and concluded that the failed/ruptured loops contributed to the poor performance of the barrier with respect to MASH Test 3-11 Specifications. Research work was added to Phase 2, material testing was performed on several failed loops (4B, 4M,8T) and one not ruptured (9T) from the crash test to determine if the strength of the loops were deficient with respect to ASTM A36 Material Specifications. Table 1 provides a summary of the tensile testing on the loops. The tensile testing on the loops concluded that the loops met the design strength of ASTM A36 Material. Therefore, the loop material for the scupper barriers used for this project was satisfactory. The failed loops likely contributed to the dynamic deflection of the barrier and causing instability of the pickup truck during the MASH Test 3-11. For additional information on the material testing of the loops, please refer to the testing information in Appendix A.

Based on the evaluation of the material testing results, it was recommended to improve the strength of the loops. Increasing the strength of the loops and preventing rupture will likely improve the performance of the pickup truck for the MASH Test 3-11 requirements (prevent rollover). The loops were modified using ¾" wide by 1" high bent plate. The loop material was also change to ASTM A572 Grade 50 Material. Engineering details of the new design are shown in Figures 15 to 20 below. This design is recommended for full-scale crash testing to MASH Test 3-11 Specifications as part of Phase 3 to be performed later.

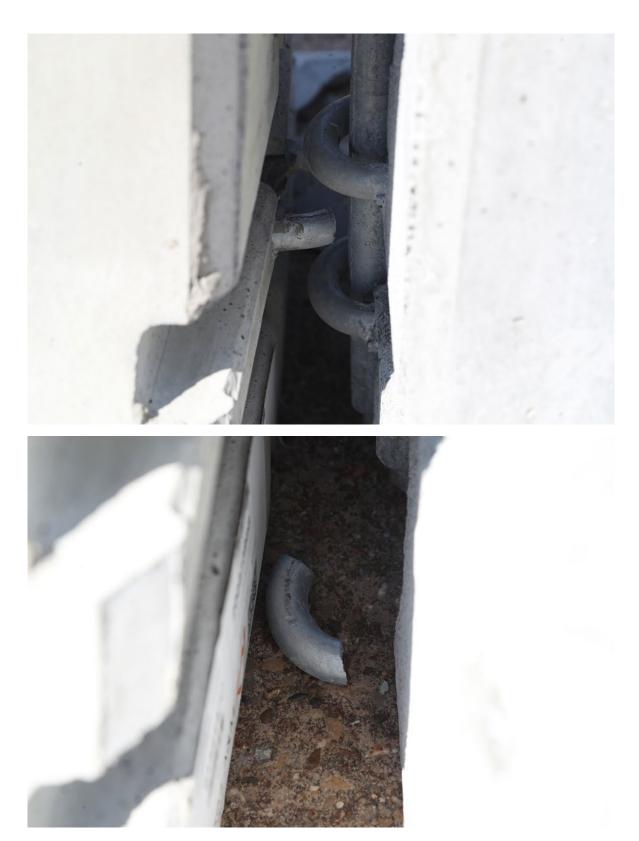
Figure 12 – Photos of Connection Between Barriers 4 & 5 Cont'd.

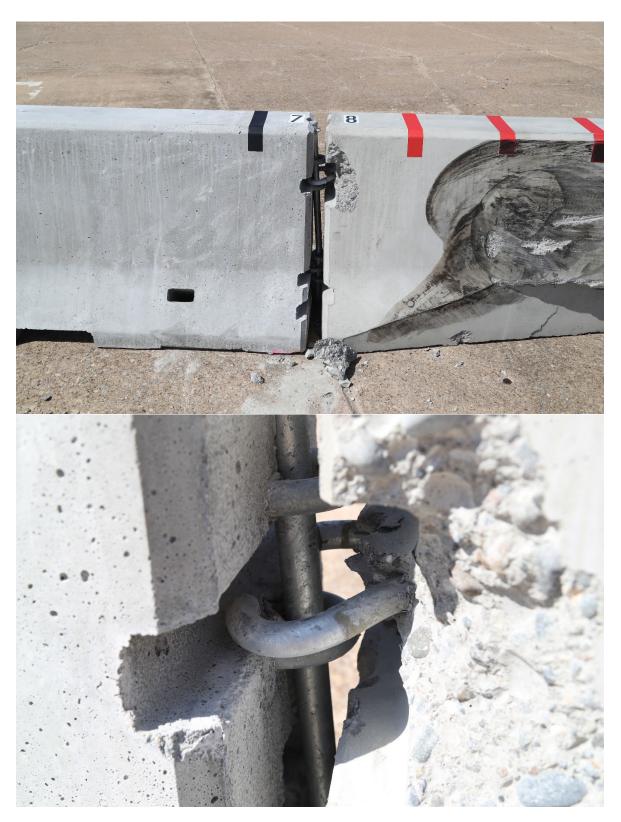
Figure 13 – Photos of Connection Between Barriers 7 & 8

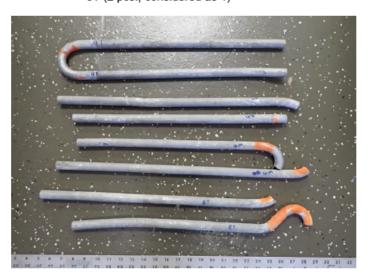
IDENTIFICATION: 4 ea. 3/4" ASTM Hot Rolled A36 Material Loops, client identified as:

4B (2 pcs., considered as 1)4M (2 pcs., considered as 1)8T (2 pcs., considered as 1)
