Test Report No. 620331-01-1

**DESIGN AND EVALUATION OF *MASH* TL-5 CONCRETE MEDIAN BARRIER WITH SHALLOW EMBEDMENT**

Sponsored by  
**Roadside Safety Pooled Fund**

**TEXAS A&M TRANSPORTATION INSTITUTE PROVING GROUND**

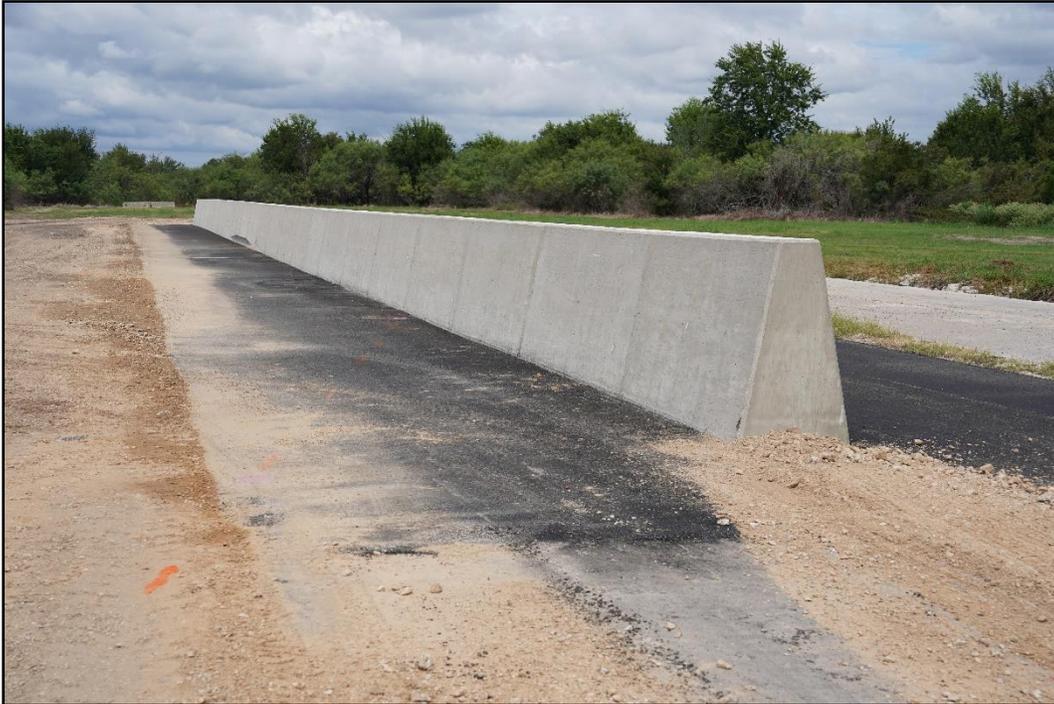
**Figure 3.2. Overall View of the TL-5 Concrete Median Barrier with Shallow Embedment Prior to Testing.**

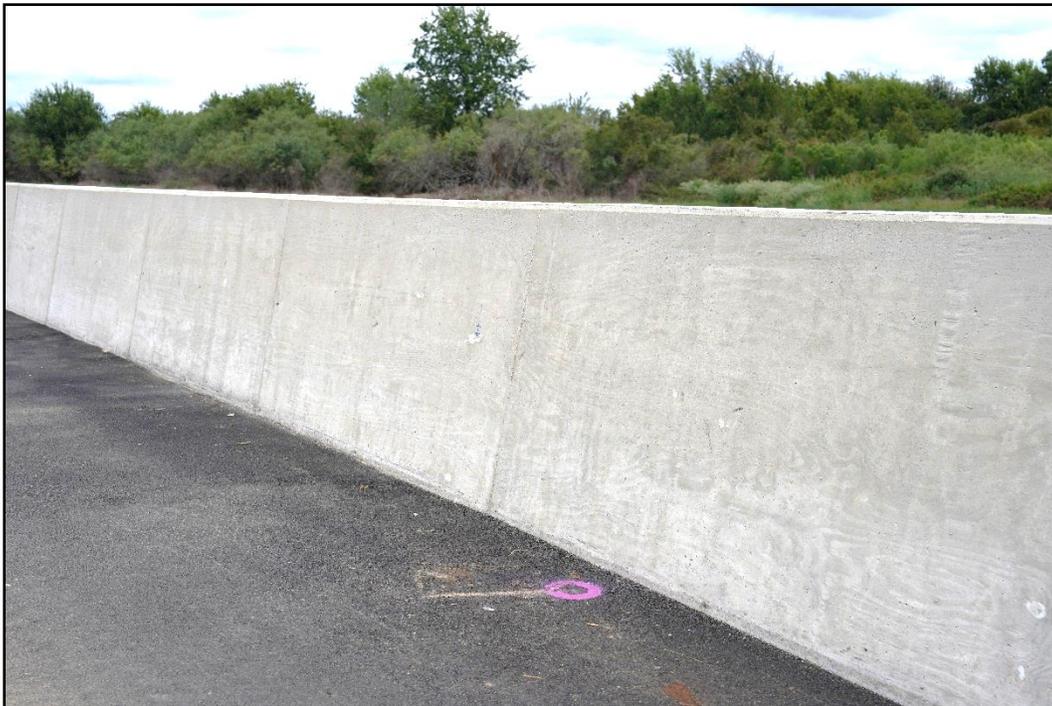
**Figure 3.3. TL-5 Concrete Median Barrier with Shallow Embedment at Impact Location Prior to Testing.**

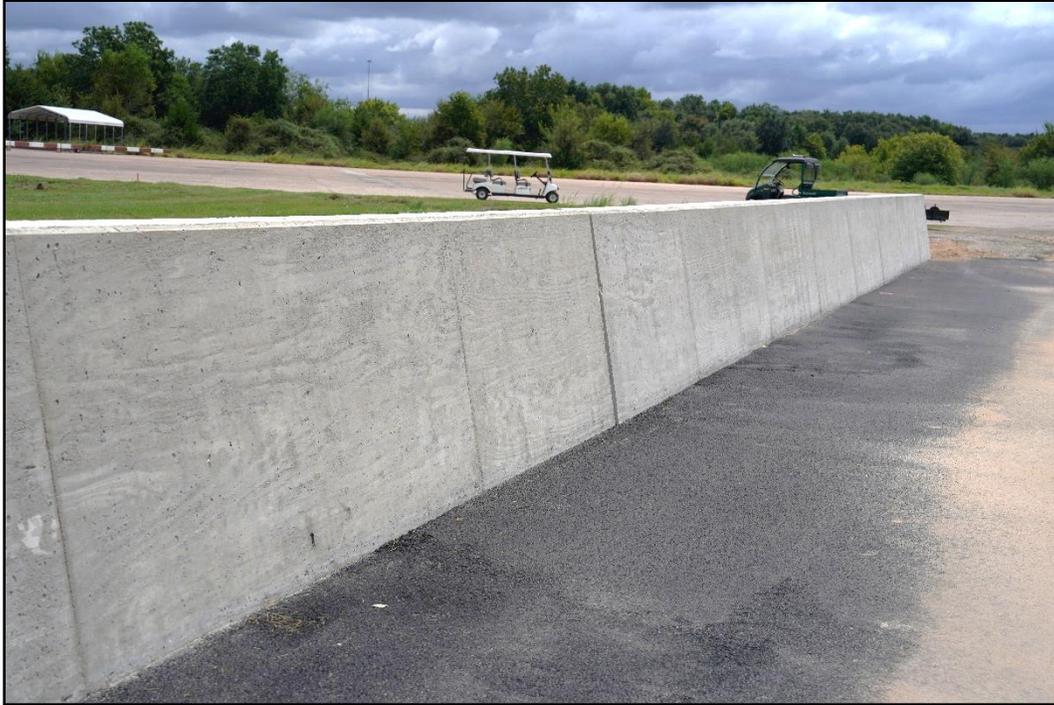
**Figure 3.4. Upstream Oblique View of the TL-5 Concrete Median Barrier with Shallow Embedment Prior to Testing.**

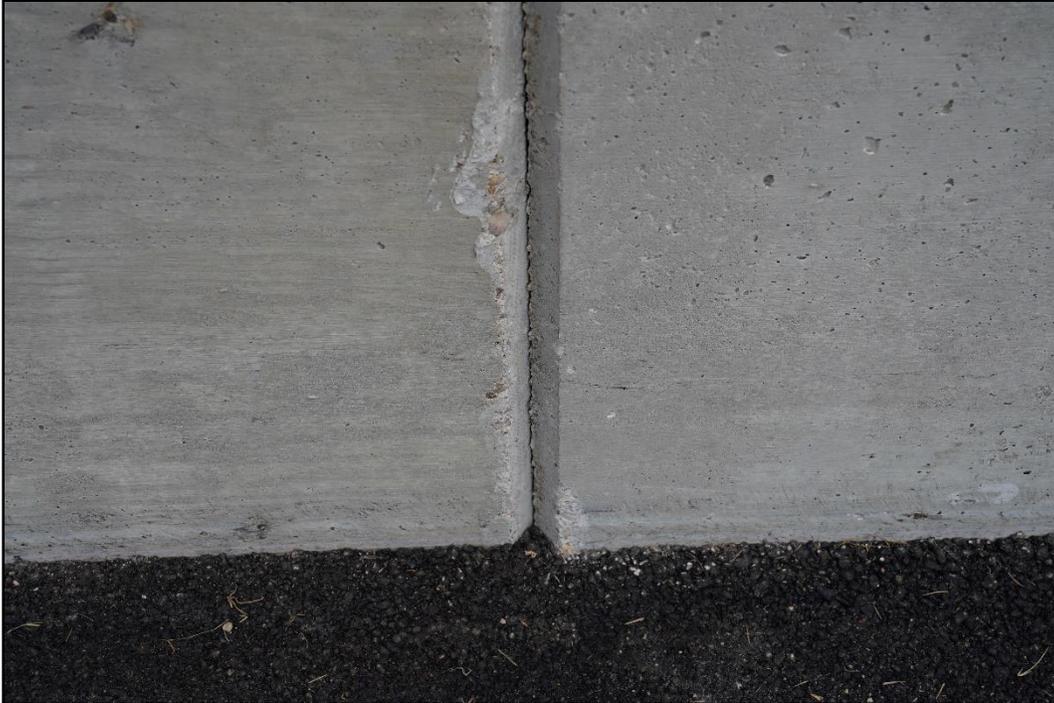
**Figure 3.6. Detail of Cold Joint at Grade of the TL-5 Concrete Median Barrier with Shallow Embedment Prior to Testing.**

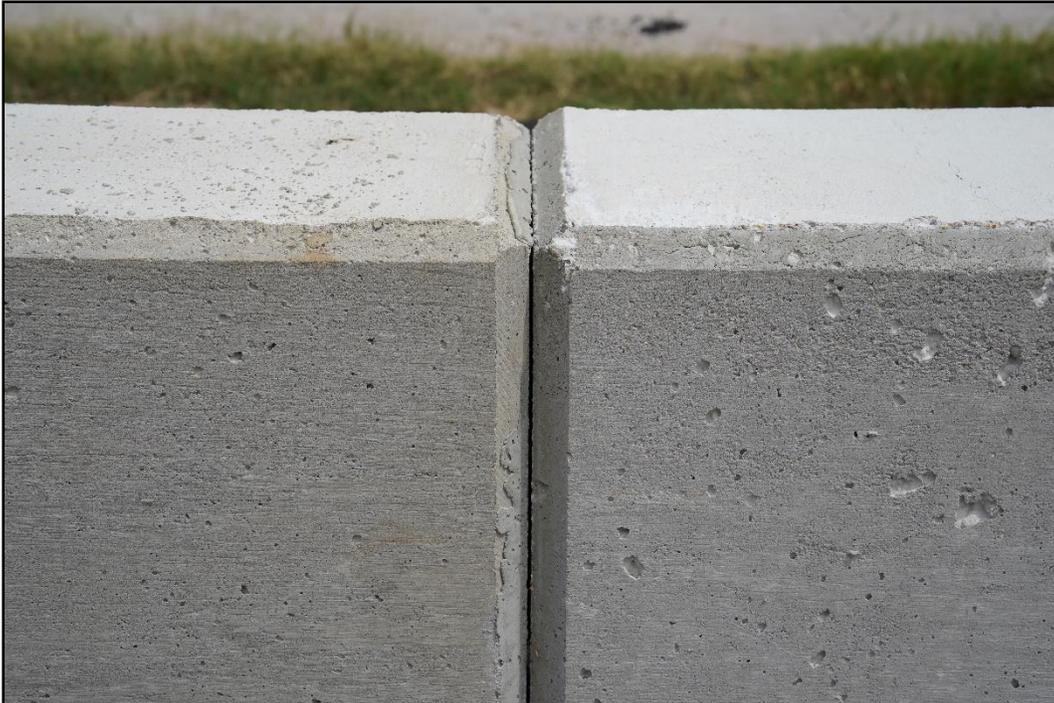
**Figure 3.7. Detail of the Top of the Cold Joint of the TL-5 Concrete Median Barrier with Shallow Embedment Prior to Testing.**

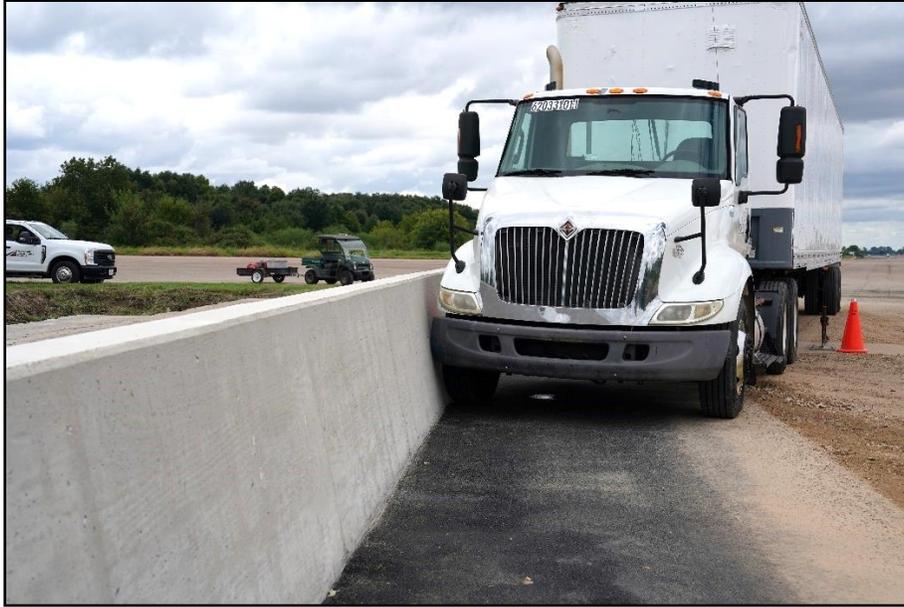
**Figure 6.1. TL-5 Concrete Median Barrier with Shallow Embedment/Test Vehicle Geometrics for Test 620331-01-1.**

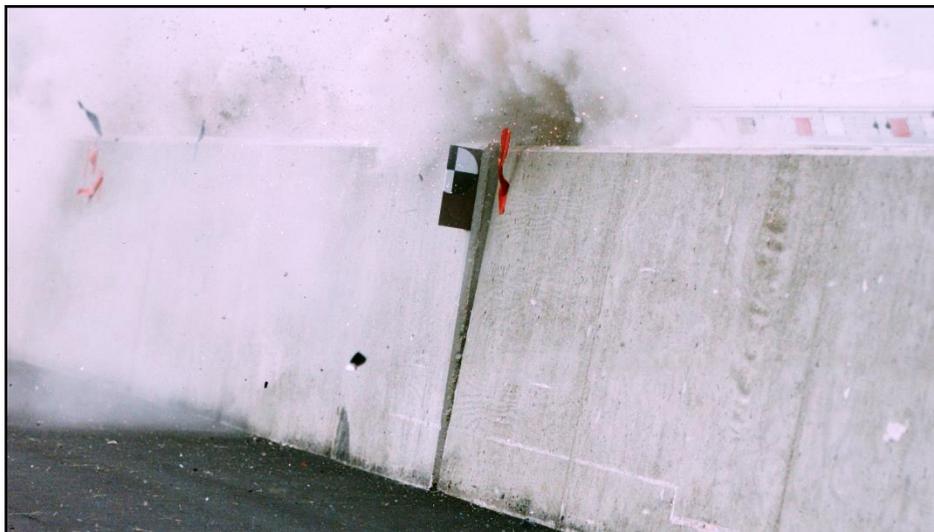
**Figure 6.6. TL-5 Concrete Median Barrier with Shallow Embedment at Maximum Deflection during Test 620331-01-1.**

Table 6.6 describes the deflection and working width of the TL-5 Concrete Median Barrier with Shallow Embedment. Figure 6.6 shows the TL-5 Concrete Median Barrier with Shallow Embedment at maximum deflection during the test. Figure 6.7 through Figure 6.12 show the damage to the barrier after the test.

Test Parameter	Measured
Permanent Deflection/Location	0.5 inches toward field side, at the joint between barrier sections 1 and 2
Dynamic Deflection	2.1 inches at the top of barrier section 1
Working Width <sup>a</sup> and Height	44.5 inches, at a height of 135.2 inches, at the top rear passenger corner of trailer

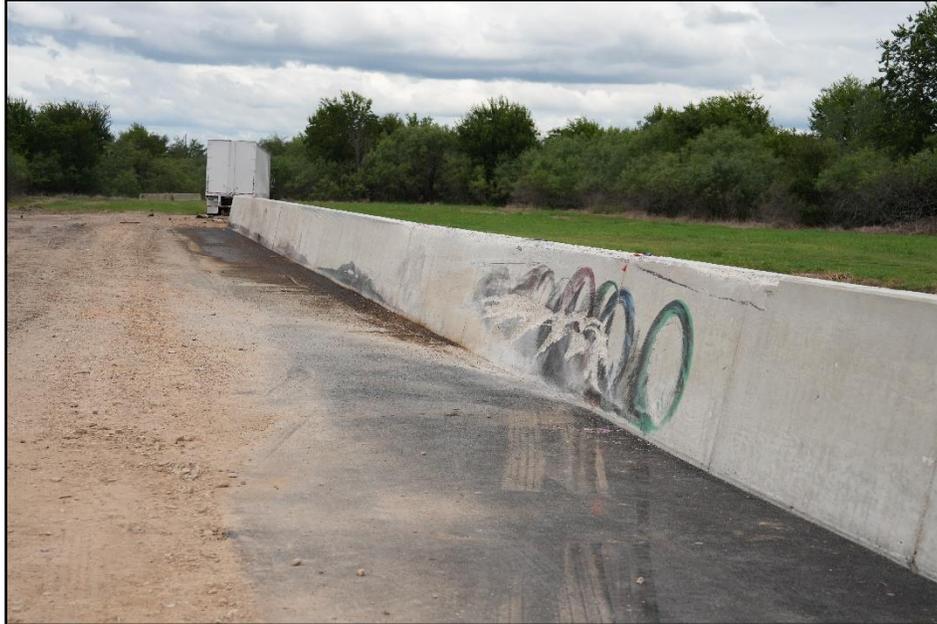
**Figure 6.7. Overall View of TL-5 Concrete Median Barrier with Shallow Embedment after Test 620331-01-1.**

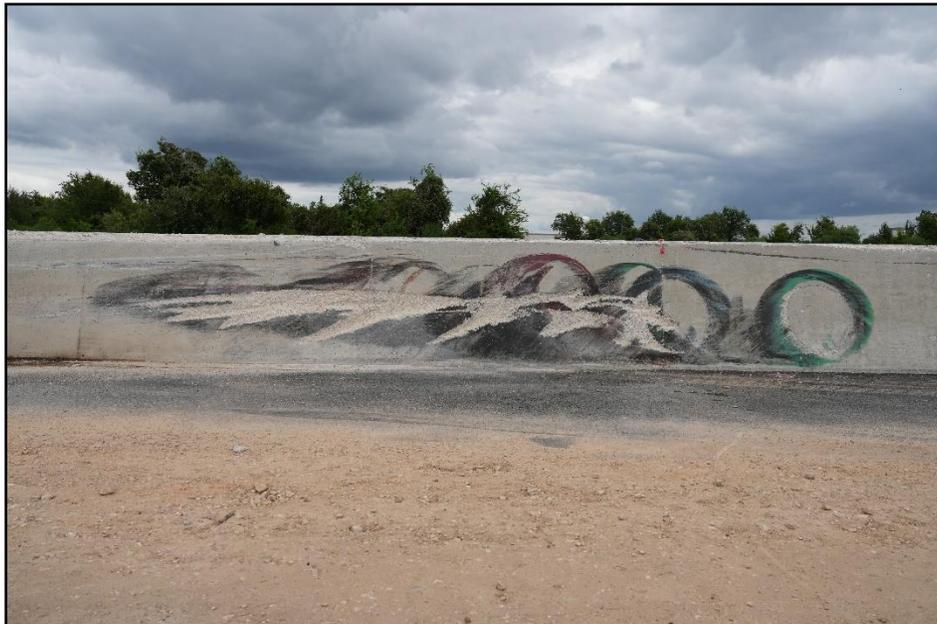
**Figure 6.8. Right Angle View of TL-5 Concrete Median Barrier with Shallow Embedment at Impact Location after Test 620331-01-1.**

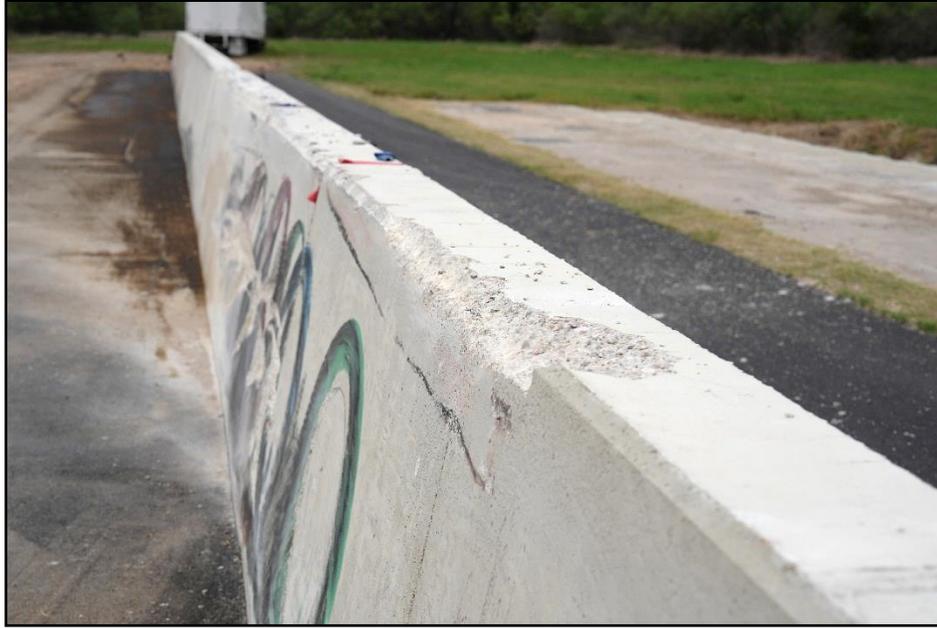
**Figure 6.9. TL-5 Concrete Median Barrier with Shallow Embedment at Impact Location after Test 620331-01-1.**

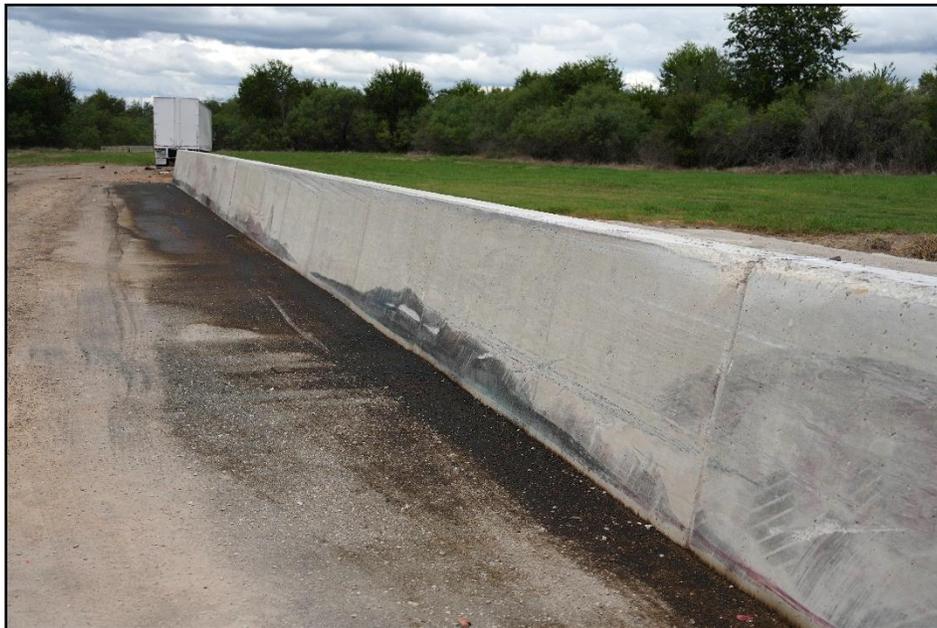
**Figure 6.10. Oblique View of Downstream Damage and Cold Joint of TL-5 Concrete Median Barrier with Shallow Embedment after Test 620331-01-1.**

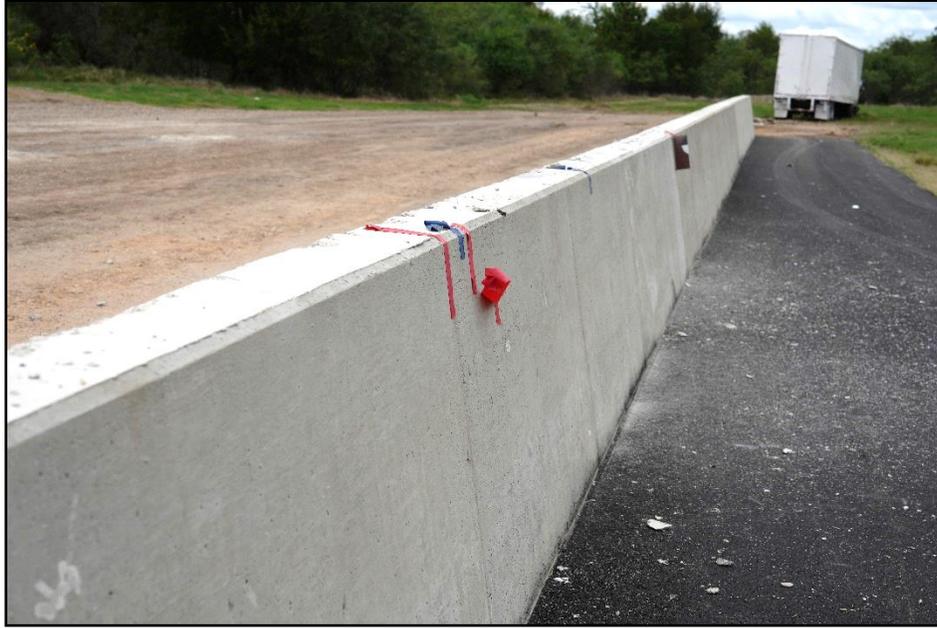
**Figure 6.11. Oblique Downstream Field Side View of TL-5 Concrete Median Barrier with Shallow Embedment at Impact Location after Test 620331-01-1.**

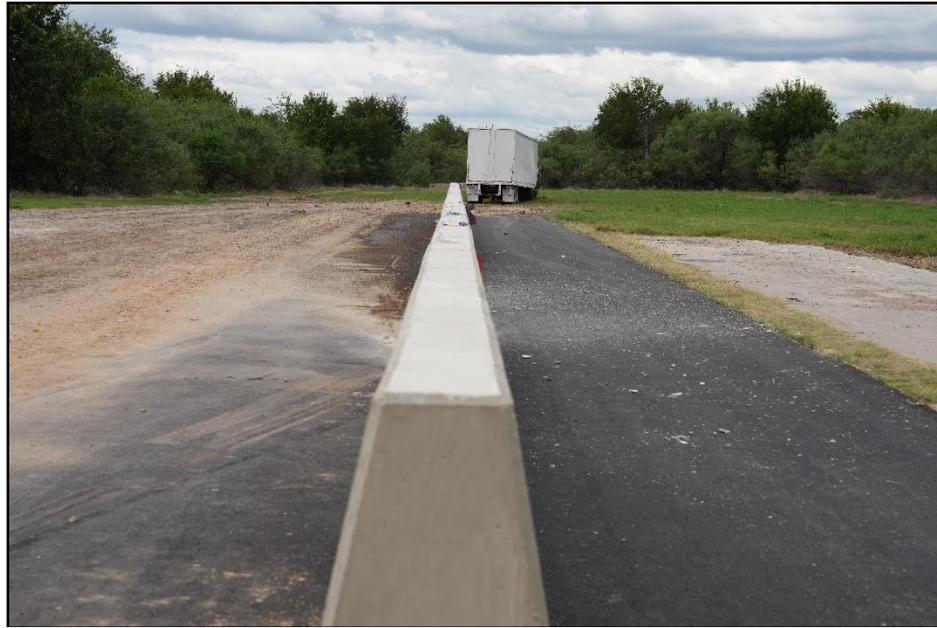
**Figure 6.12. Downstream In-line View of TL-5 Concrete Median Barrier with Shallow Embedment after Test 620331-01-1.**

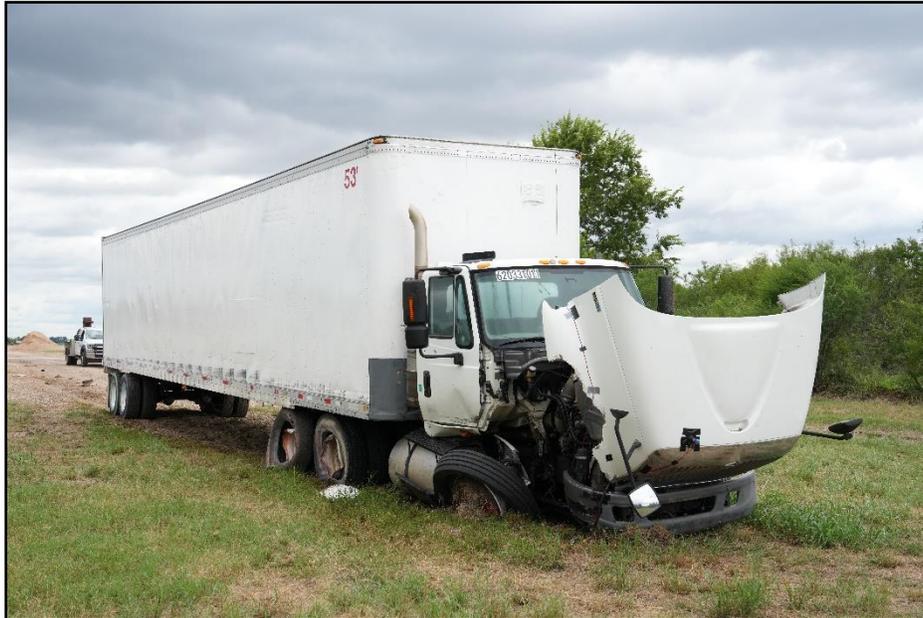
**Figure 6.13. Impact Side of Test Vehicle after Test 620331-01-1.**

Figure 6.13 through Figure 6.16 show the damage sustained by the exterior of the vehicle. Figure 6.16 shows the interior of the trailer. Table 6.7 and Table 6.8 provide details of the occupant compartment deformation and exterior vehicle damage.

Side Windows	Side windows remained intact
Maximum Exterior Deformation	16 inches at right front bumper
VDS	01FRQ6
CDC	01FRGW6
Fuel Tank Damage	Yes
Description of Damage to Vehicle:	The bumper, fender, and lower portion of the right door were deformed. The wheels on the right side of the tractor and trailer were deformed. The right tire on the tractor and the outer and inner right front tires on the trailer ruptured. The back right inner and outer tires on the trailer were deflated. The fifth wheel was dislodged, and the right fuel tank was ruptured. There were abrasions and deformations all down right side of trailer. The king pin was deformed and there was a tear in the trailer starting 19 inches from the front of the trailer that measured 12 inches wide x 20 inches high.

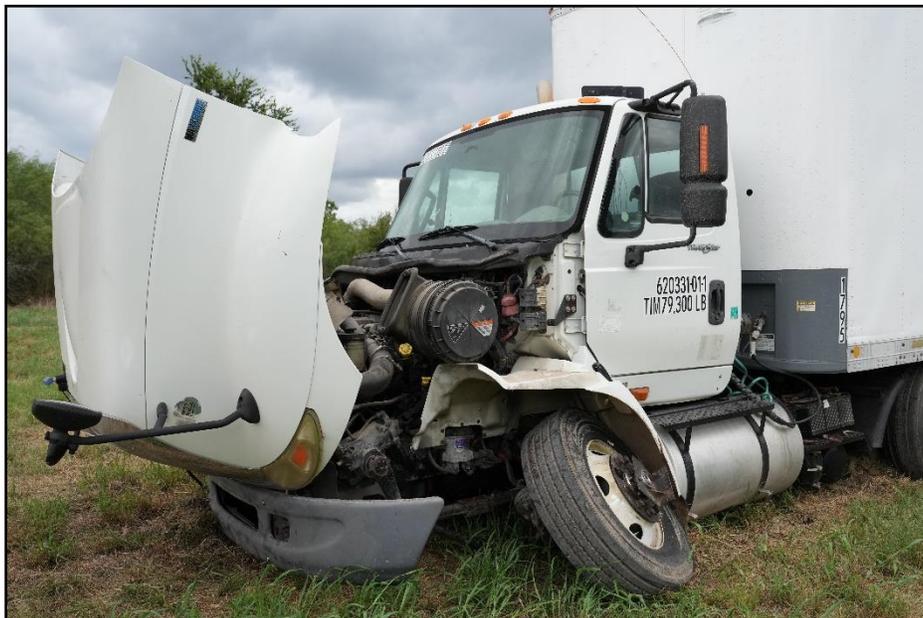
**Figure 6.14. Opposite Impact Side of Test Vehicle after Test 620331-01-1.**

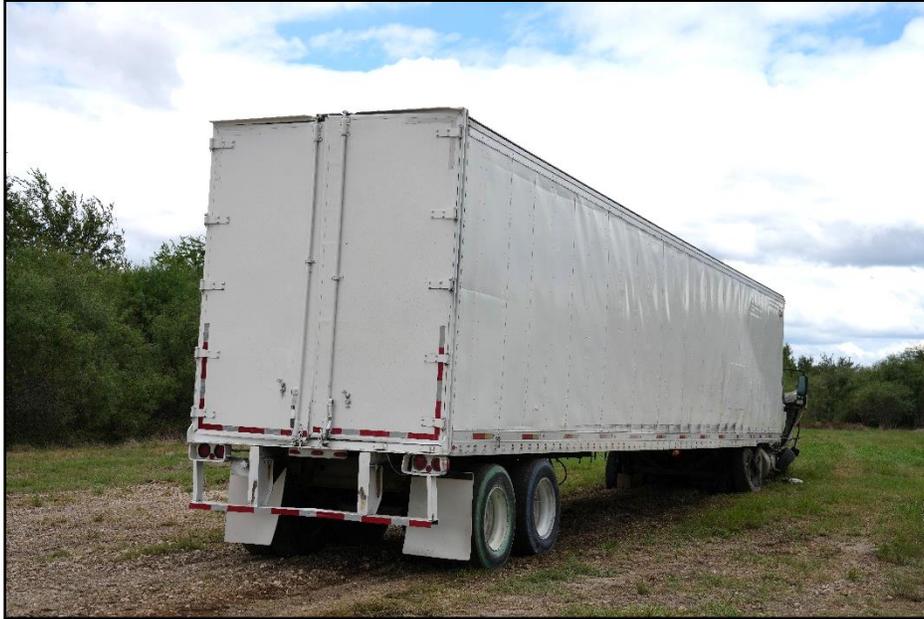
**Figure 6.15. Rear Impact of Test Vehicle after Test 620331-01-1.**

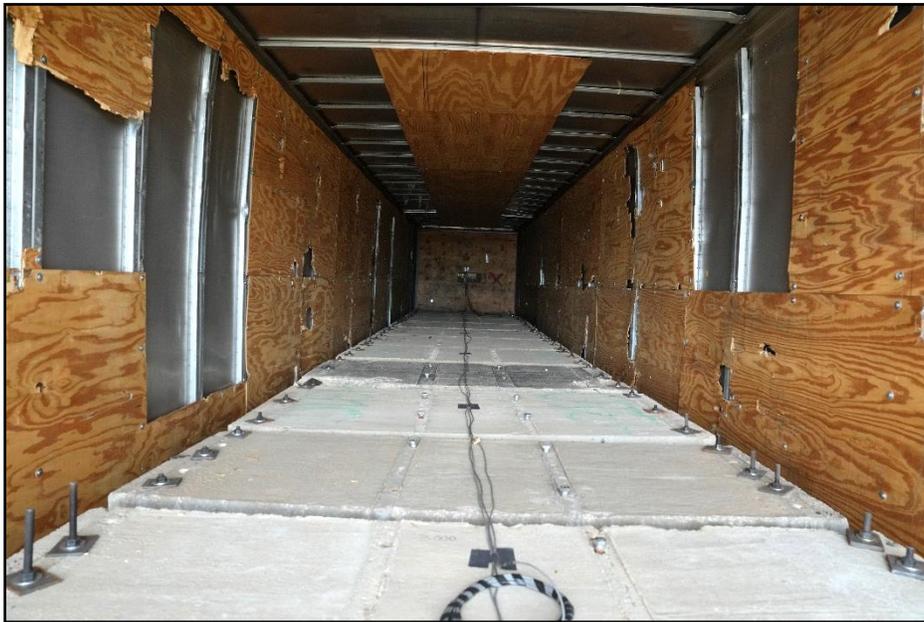
**Figure 6.16. Trailer Interior of Test Vehicle after Test 620331-01-1.**

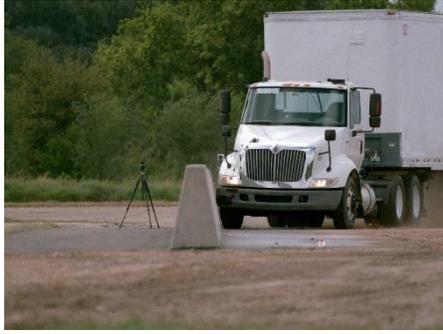
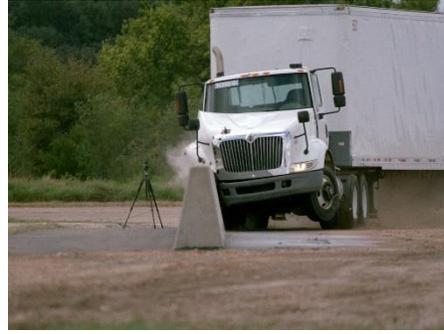
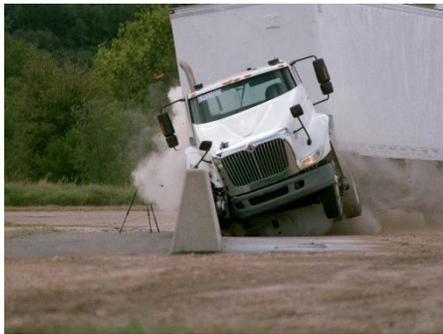
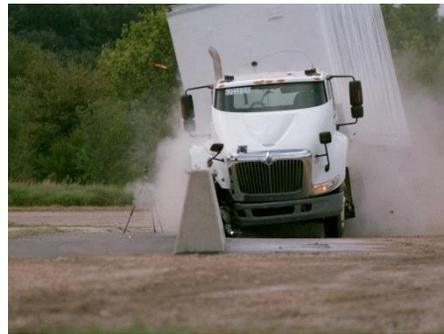
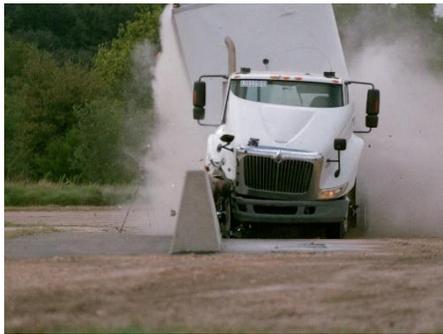
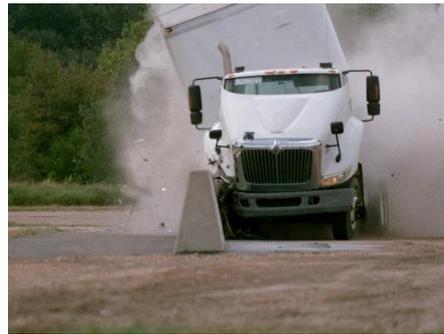
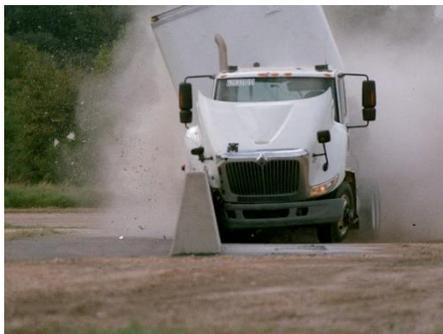
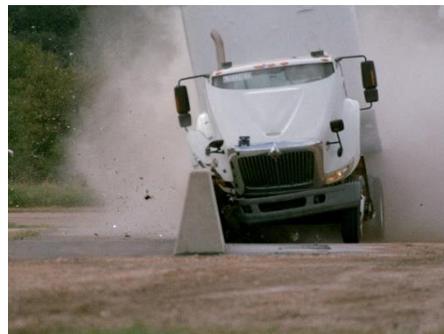
**Figure C.3. Sequential Photographs for Test 620331-01-1 (Upstream In-line Views).**

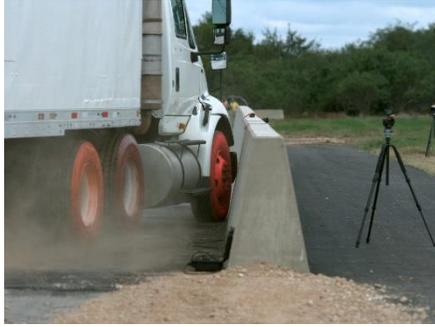
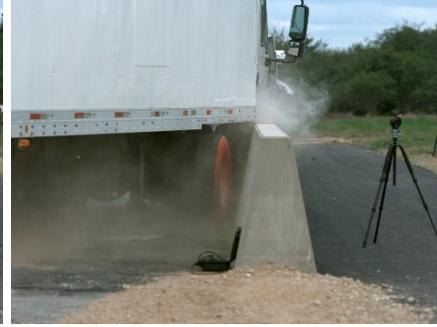
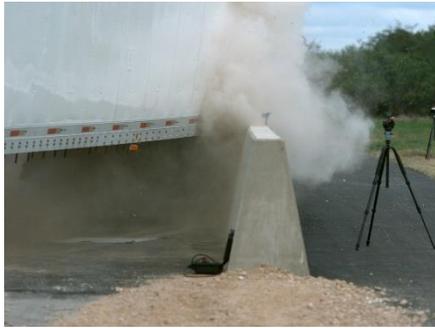
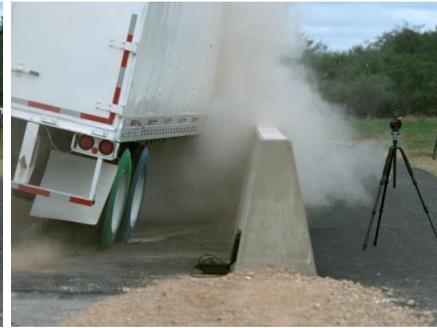
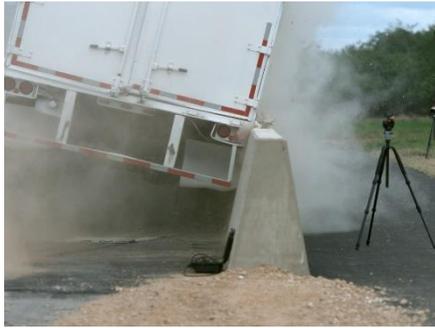
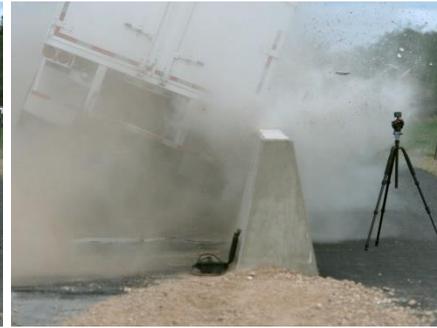
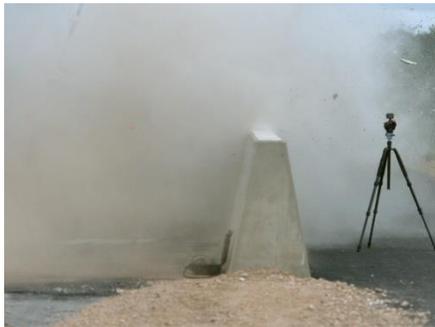
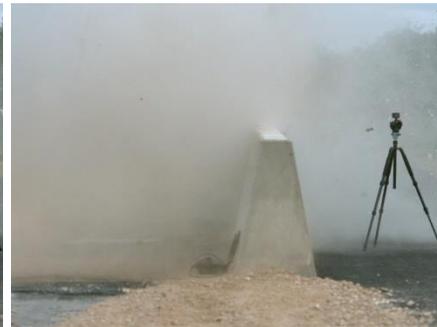
**Figure C.4. Sequential Photographs for Test 620331-01-1 (Downstream In-line Views).**
