Roadside Safety Pooled Fund

Test Report No. 610211-01, REV 2
Test Report Date: October 2021
REV 2: December 2025

***MASH* CRASH TESTING AND EVALUATION OF THE MGS WITH REDUCED POST SPACING**

Test Nos.: 610211-1 / -2 / -4 / -3 / -6 / -5

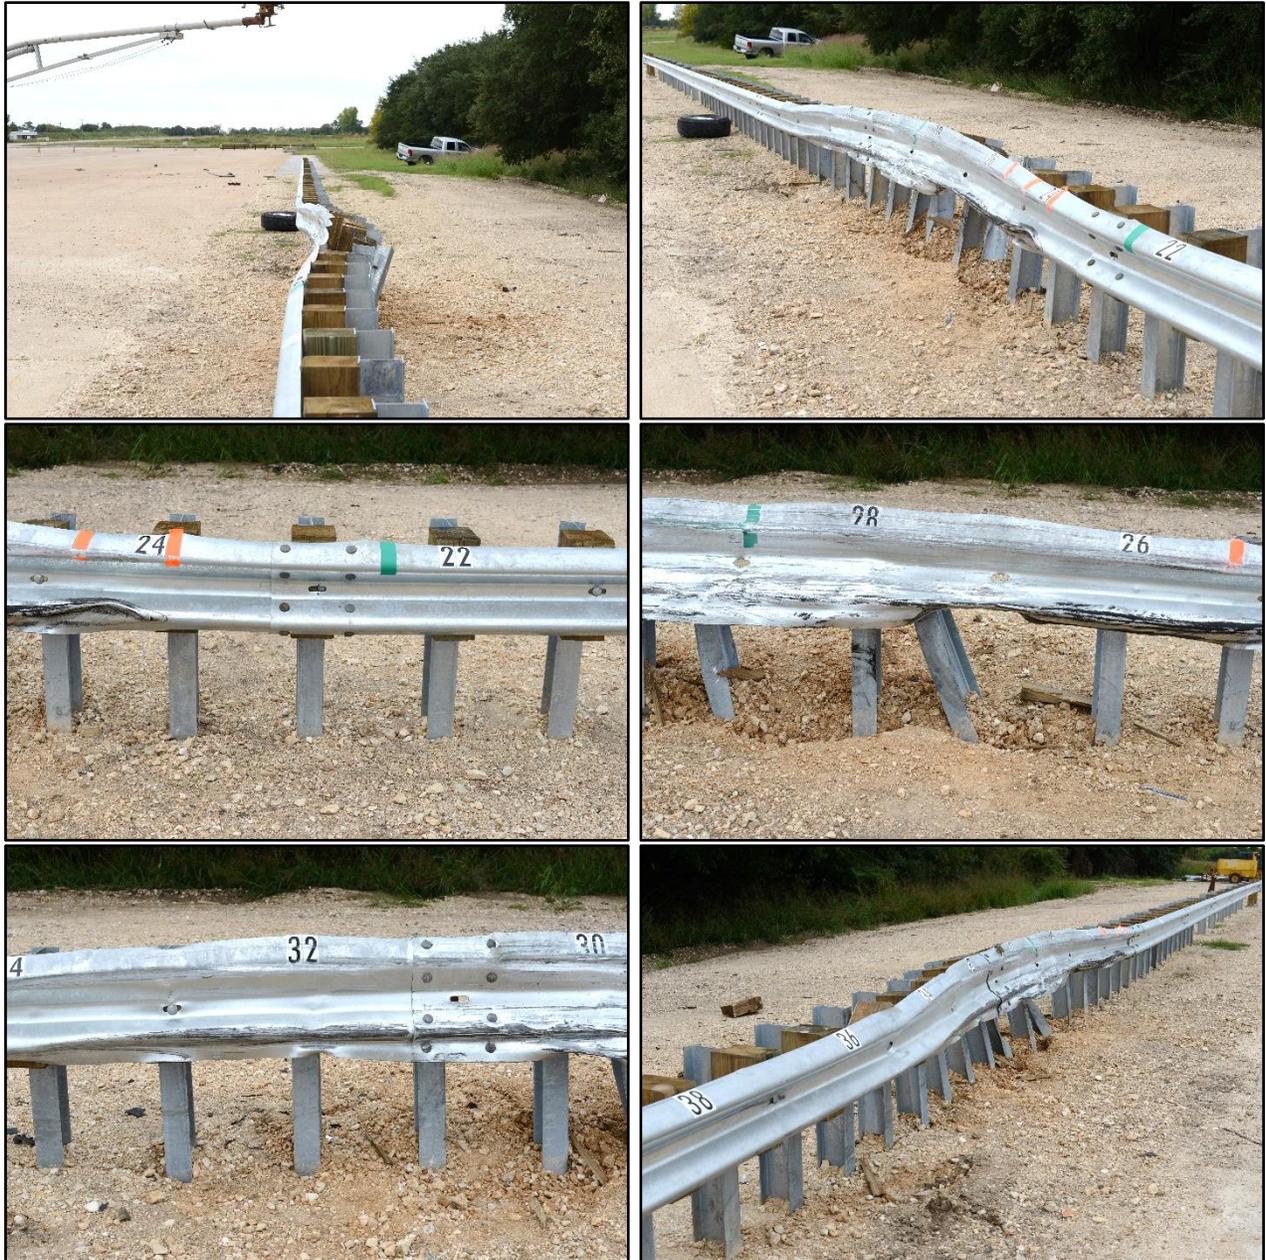
Figure 4.11. MGS System with Quarter Post Spacing after Test No. 610211-01-2.

Figure 4.11 shows the damage to the MGS with quarter post spacing. The soil around post 1 was disturbed, and the rail released from the blockouts at posts 27, 29, and 31. The soil around posts 21 and 22 was disturbed, and posts 26 through 31 were pushed downstream and toward the field side. Table 4.5 provides additional measurements. Working width was 37.1 inches, and height of working width was 27.9 inches. Maximum dynamic deflection during the test was 19.5 inches, and maximum permanent deformation of the W-beam rail was 11.0 inches.

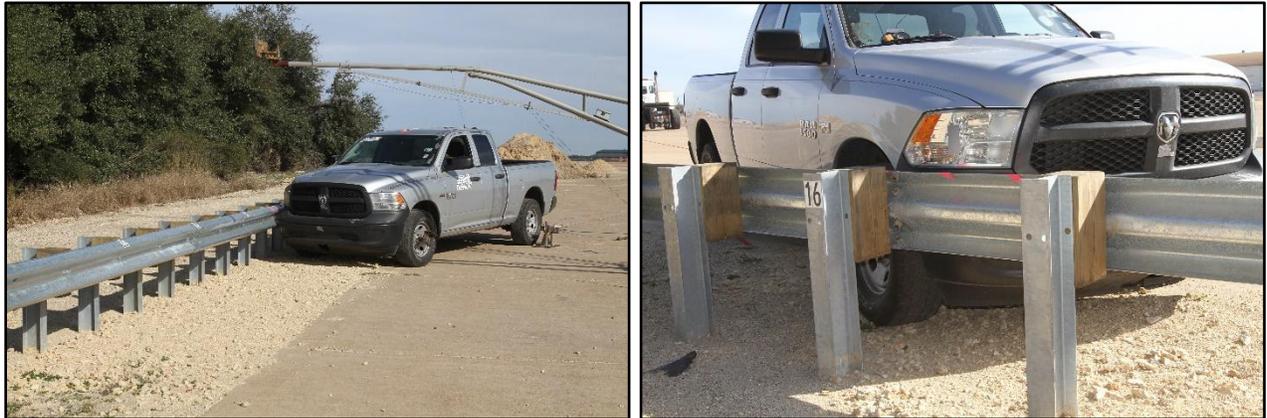
Figure 5.3. MGS with Half Post Spacing/Test Vehicle Geometrics for Test No. 610211-01-3.

MASH Test 3-11 involves a 2270P vehicle weighing 5000 lb \pm 110 lb impacting the CIP of the guardrail at an impact speed of 62 mi/h \pm 2.5 mi/h and an angle of 25 degrees \pm 1.5 degrees. The CIP for MASH Test 3-11 on the MGS with half post spacing was 136 inches \pm 12 inches upstream of post 20 (see Figure 2.2 and Figure 5.3).

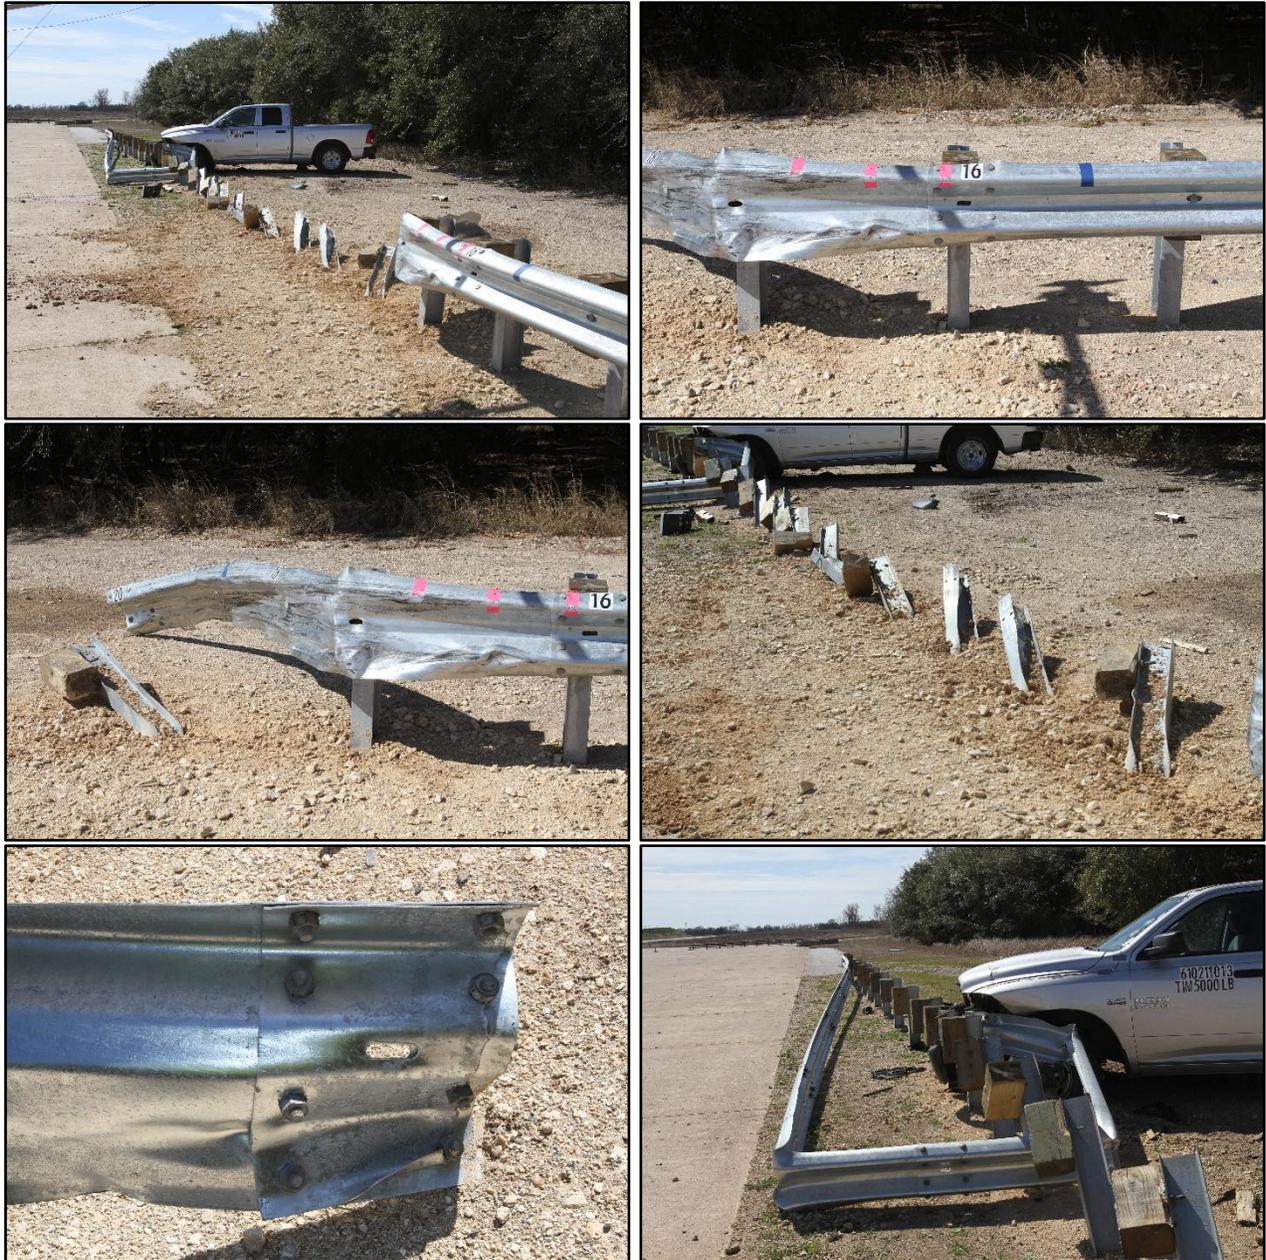
Figure 5.5. MGS with Half Post Spacing after Test No. 610211-01-3.

Figure 5.5 shows the damage to the MGS with half post spacing. The W-beam guardrail ruptured at post 20 and released from post 16 through post 39. The soil was disturbed at post 1. Table 5.2 provides additional measurements.

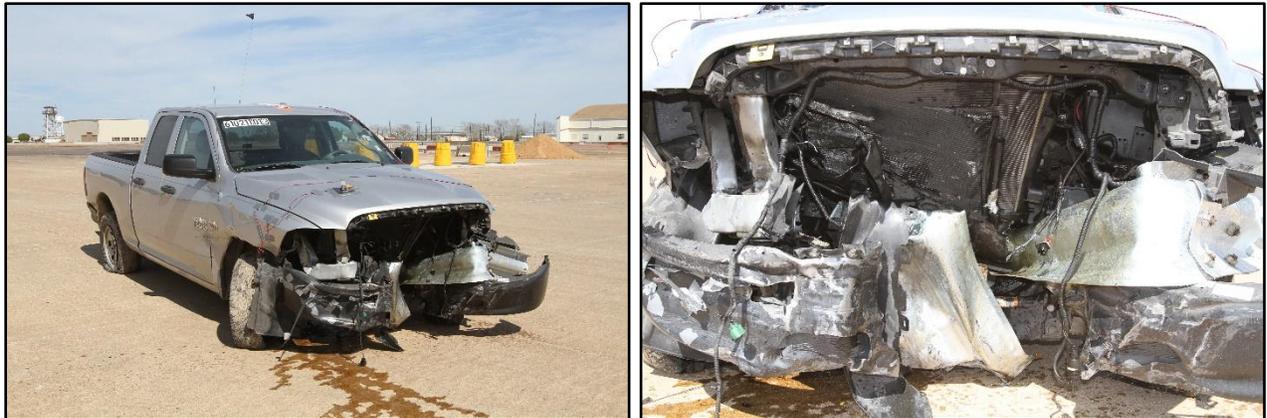
Figure 5.6. Test Vehicle after Test No. 610211-01-3.

Figure 5.6 shows the damage sustained by the vehicle. The front bumper, hood, grill, radiator and support, right and left front fenders, right front and rear doors, rear exterior bed, rear bumper, right front and rear tires and rims, and left front tire were damaged. No damage to the fuel tank was observed. Maximum exterior crush to the vehicle was 22.0 inches in the front plane at the center at bumper height. Maximum occupant compartment deformation was 0.5 inch in the right floorpan. Figure 5.7 shows the interior of the vehicle. Tables G.3 and G.4 in Appendix G1 provide exterior crush and occupant compartment measurements.

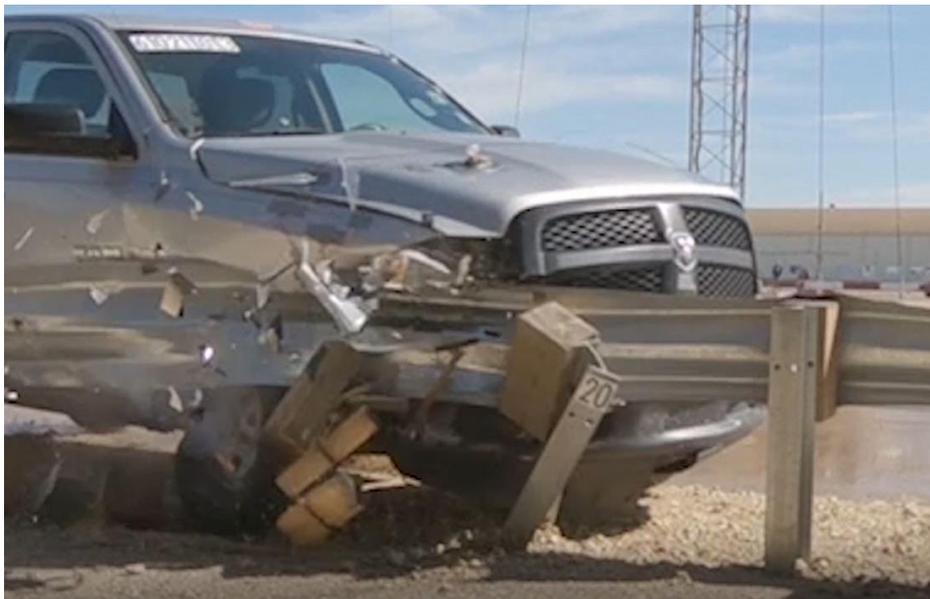
Figure 5.9. Rear View of Rail Rupture.

Following the failed *MASH* test 3-11, the research team investigated the cause of the rail rupture. After a thorough analysis of the damaged installation and the crash test video, the research team determined the rail rupture was caused by a localized interaction between the W-beam rail and the wood blockout. Figure 5.9 shows a rear view of the test installation at the approximate time of rail rupture. As the rail deflected laterally rearward and flattened with the impact of the test vehicle, the edge of the W-beam became intertwined with the wood blockout. As the wood blockout deflected and twisted, the edge of the rail deformed. This deformation caused a tear to initiate in the rail, and the continuing impact event propagated the tear through the rest of the rail cross-section.

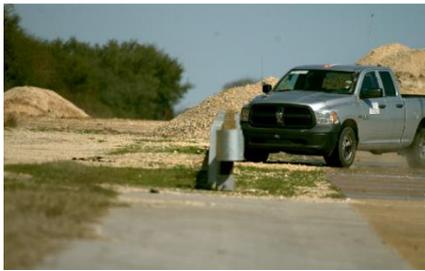
Figure 5.11. Gut View Comparison of Failed *MASH* Test 3-11 Simulation.

The research team first developed the model of the original half post spacing system with 14-inch tall blockouts. The research team had a level of confidence with this model because it was developed with components from previous projects whose models were confirmed to be accurately predicting impact behavior. To further gain confidence in the model, the research team compared the results of the failed crash test and the corresponding computer simulation. Because the model lacked the ability to replicate the rail rupture, the research team confirmed the behavior of the model until the time of rail rupture in the failed test. Figure 5.11 through Figure 5.13 show the comparison between the failed test and the simulation. After comparing the simulation to the failed test, the research team accepted the validity of the model and proceeded with further computer simulation.

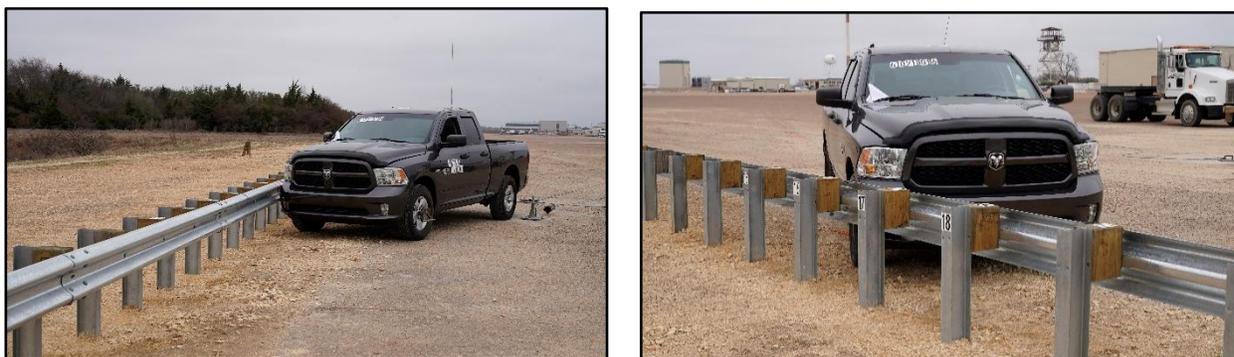
Figure 5.19. Guardrail/Test Vehicle Geometrics for Test No. 610211-01-6.

MASH Test 3-11 involves a 2270P vehicle weighing 5000 lb \pm 110 lb impacting the CIP of the guardrail at an impact speed of 62 mi/h \pm 2.5 mi/h and an angle of 25 degrees \pm 1.5 degrees. The CIP for *MASH* Test 3-11 on the MGS with half post spacing and shortened blockouts was 136 inches \pm 12 inches upstream of post 20 (see Figure 2.3 and Figure 5.19).

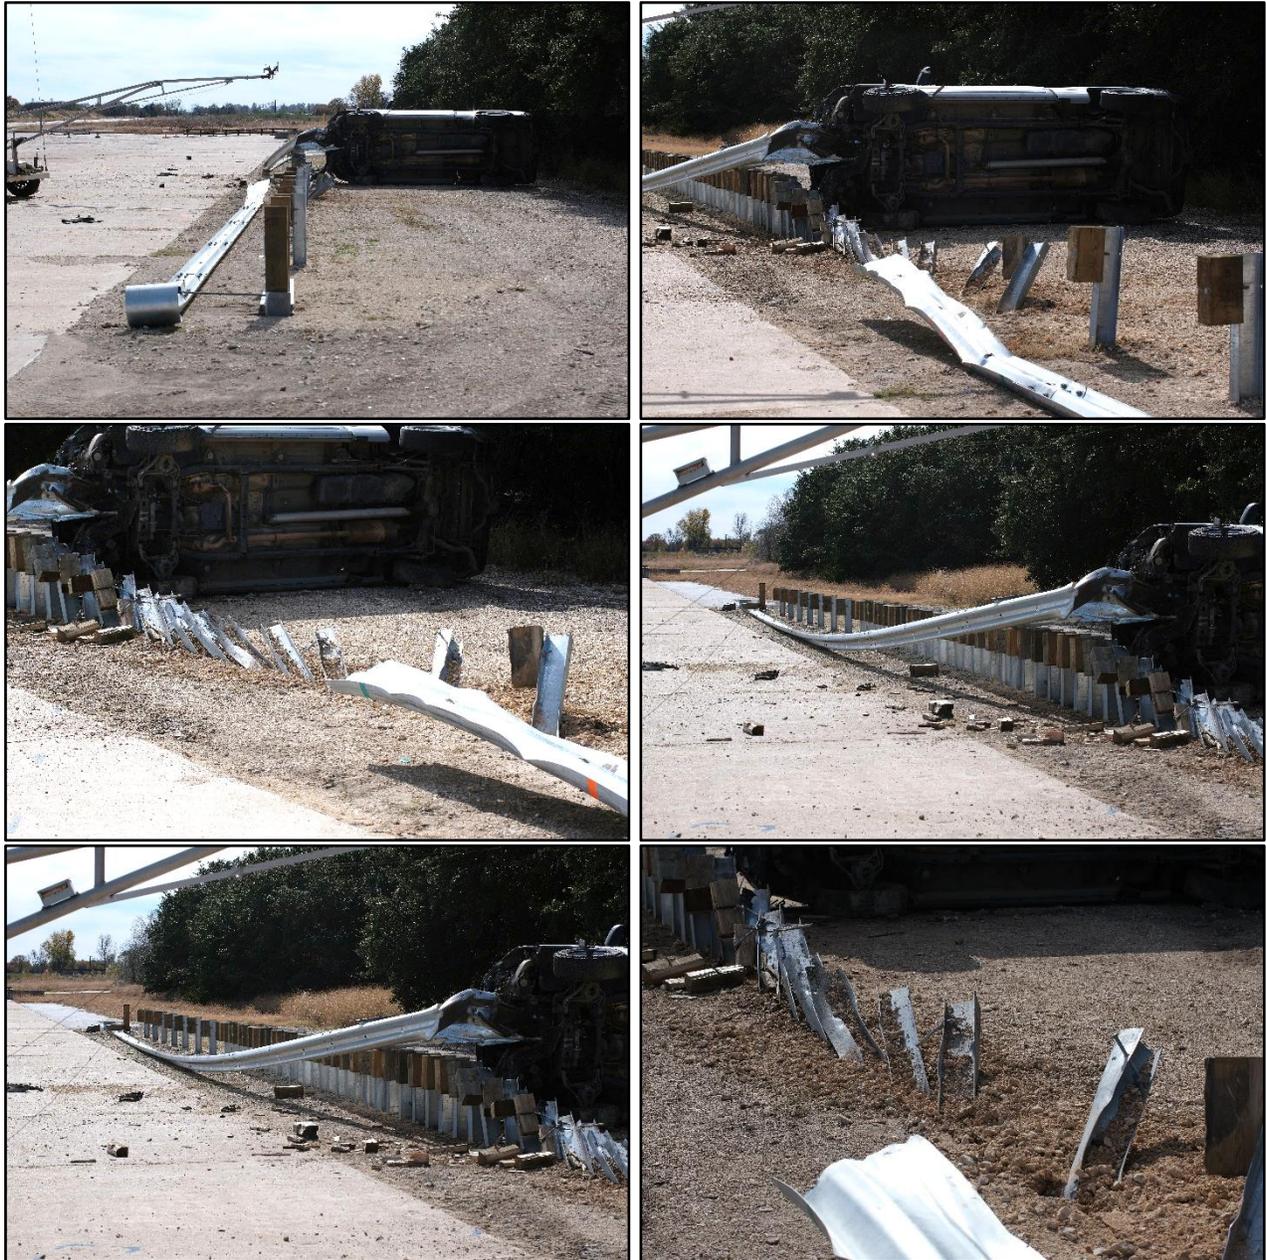
Figure 6.5. Transition from Full to Quarter Post Spacing after Test No. 610211-01-4.

showed no movement. The blockouts separated from posts 11-16, and the rail element ruptured at the splice at post 11. Table 6.2 provides additional measurements.

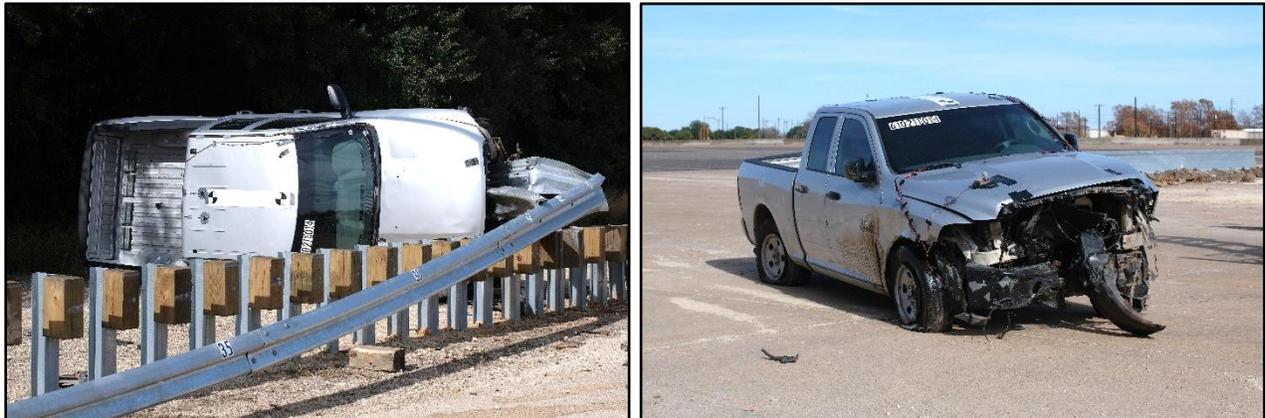
Figure 6.6. Test Vehicle after Test No. 610211-01-4.

Figure 6.6 shows the damage sustained by the vehicle. The front bumper, grill, hood, radiator and support, right front fender, right front tire and rim, right front and rear doors, right rear exterior bed, and right rear tire and rim were damaged. No damage to the fuel tank was observed. Maximum exterior crush to the vehicle was 18.0 inches in the front plane near the center at bumper height. No occupant compartment deformation or intrusion occurred. Figure 6.7 shows the interior of the vehicle. Tables K.3 and K.4 in Appendix K1 provide exterior crush and occupant compartment measurements.
