Test Report No. 621201-01-1-3

### ***MASH* EVALUATION OF SQUARE TUBE SLIP BASE SIGN SUPPORT SYSTEMS**

Sponsored by  
**Roadside Safety Pooled Fund**

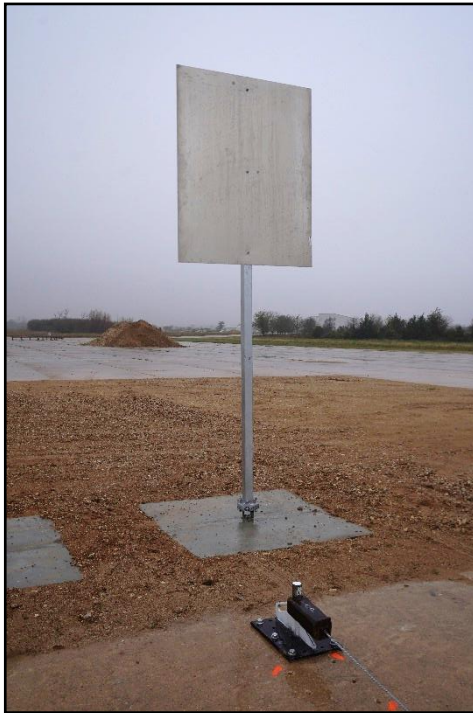
**Figure 5.2. 3 × 3 Square Tube Slip Base Sign Support System prior to Testing.**

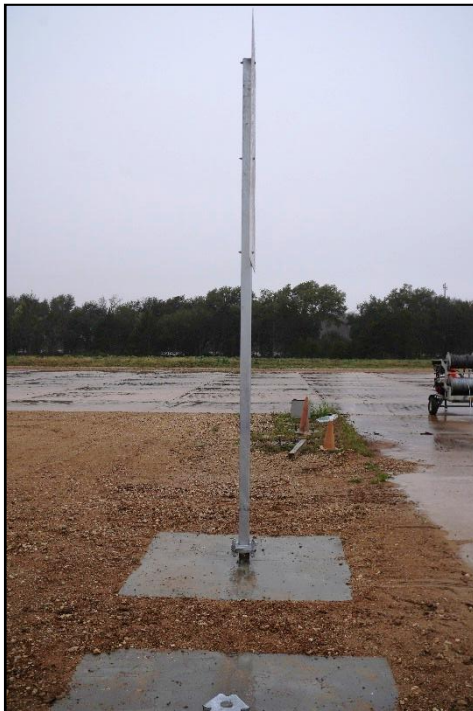
**Figure 5.3. Right Angle View of the 3 × 3 Square Tube Slip Base Sign Support System prior to Testing.**

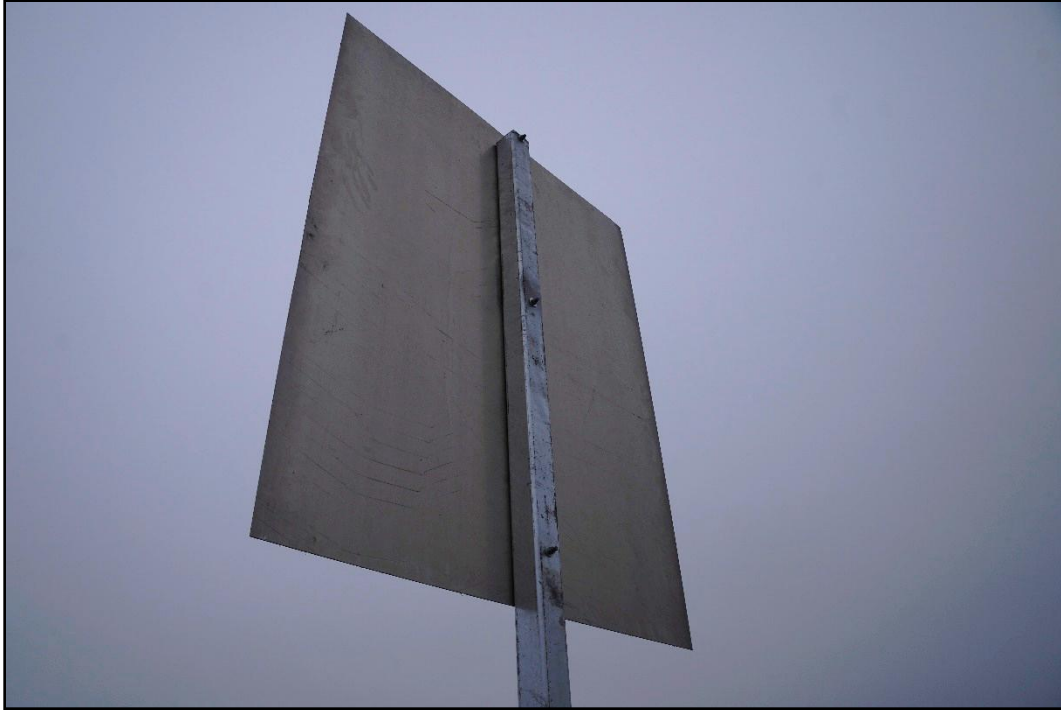
**Figure 5.4. Sign Panel Assembly prior to Testing.**

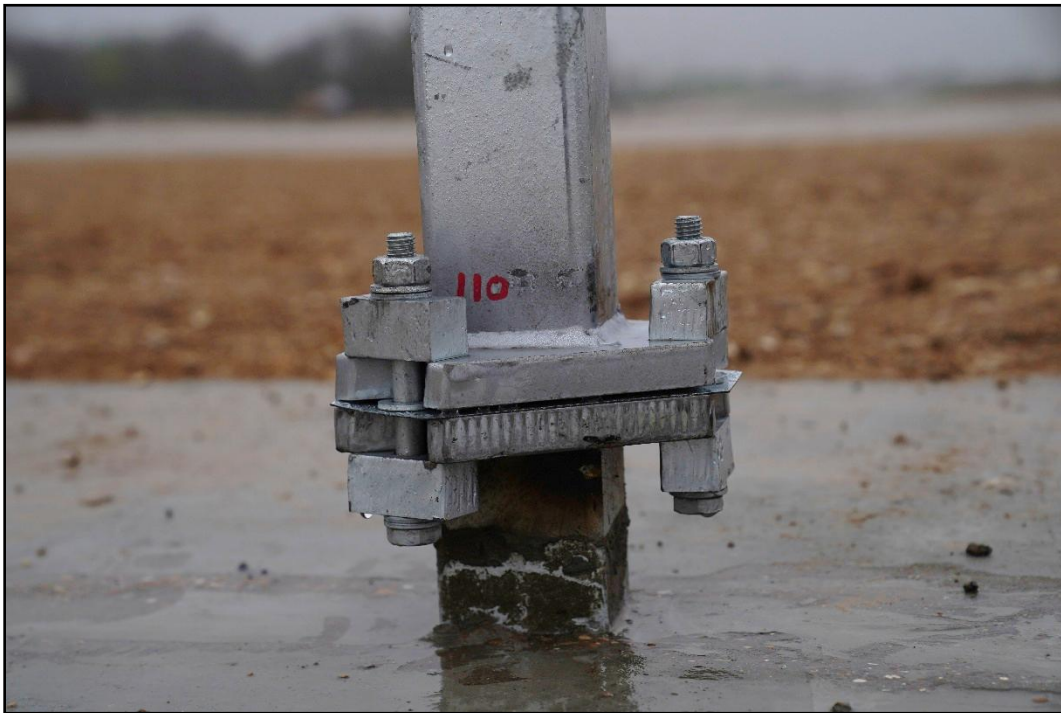
**Figure 5.5. Slip Base Assembly prior to Testing.**

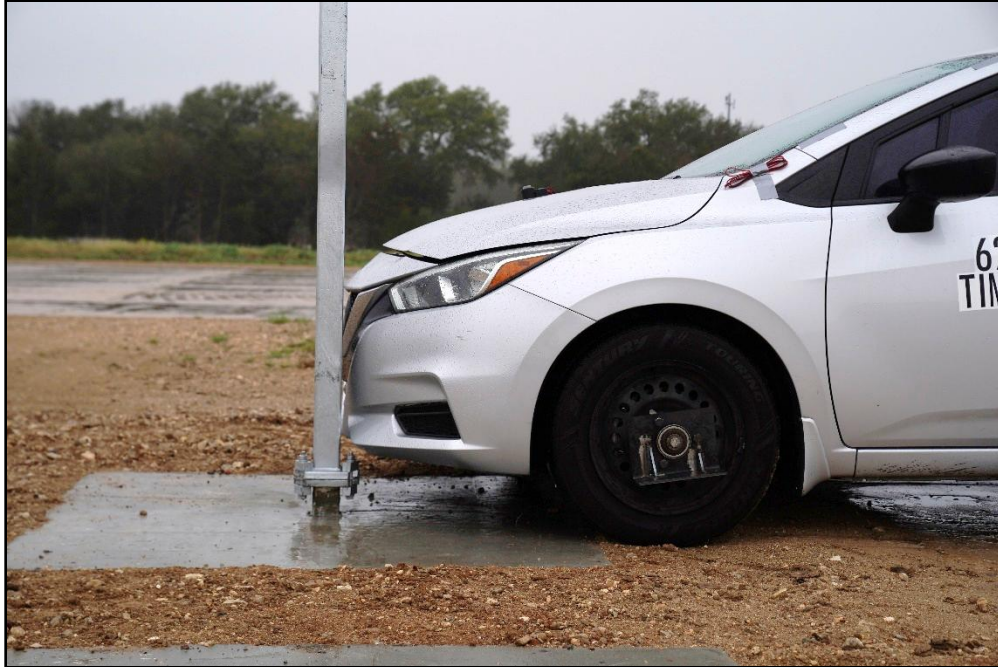
**Figure 6.2. 3 × 3 Square Tube Slip Base Sign Support System/Test Vehicle Geometrics for Test 621201-01-1.**

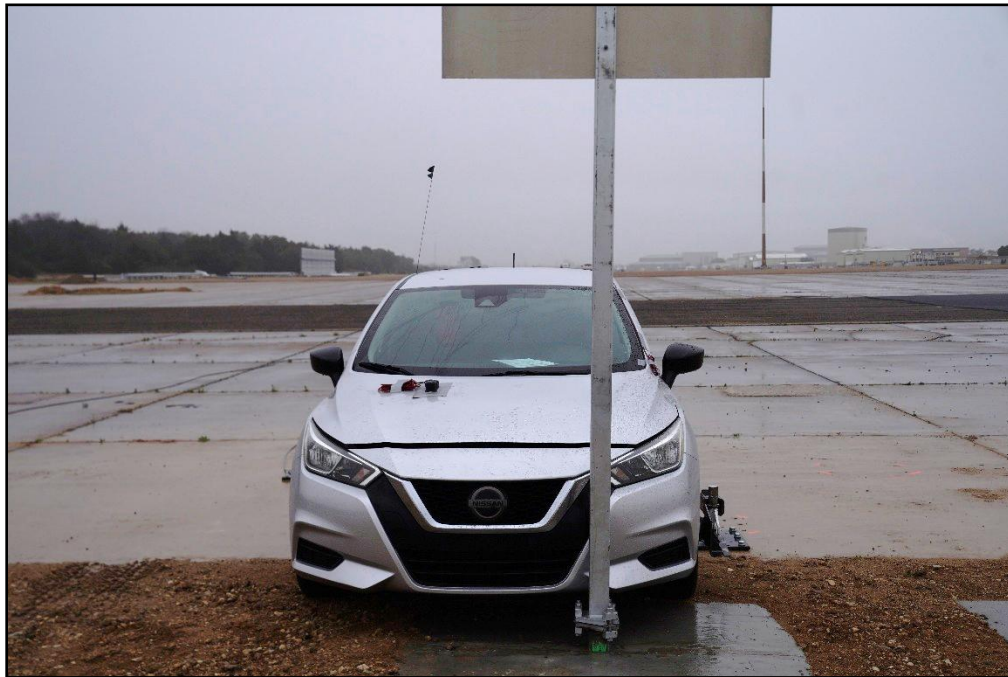
**Figure 6.3. 3 × 3 Square Tube Slip Base Sign Support System/Test Vehicle Impact Location for Test 621201-01-1.**

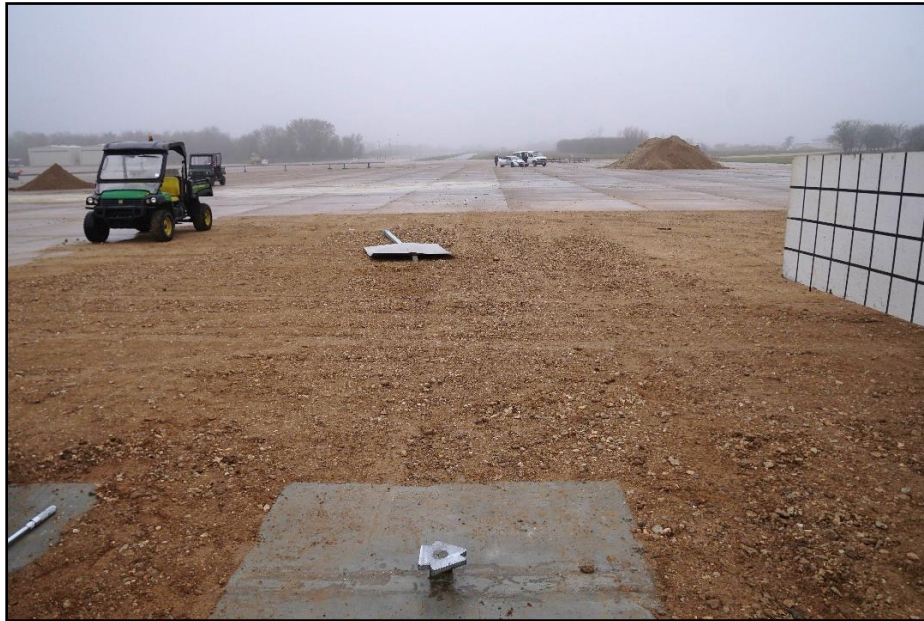
The sign support assembly released from the base and came to rest 30 feet downstream from impact. Bolts from the base landed 75 feet, 135 feet, and 450 feet downstream from impact. Figure 6.6 and Figure 6.7 show the damage to the 3 × 3 Square Tube Slip Base Sign Support System.

**Figure 6.6. 3 × 3 Square Tube Slip Base Sign Support System at Impact Location after Test 621201-01-1.**

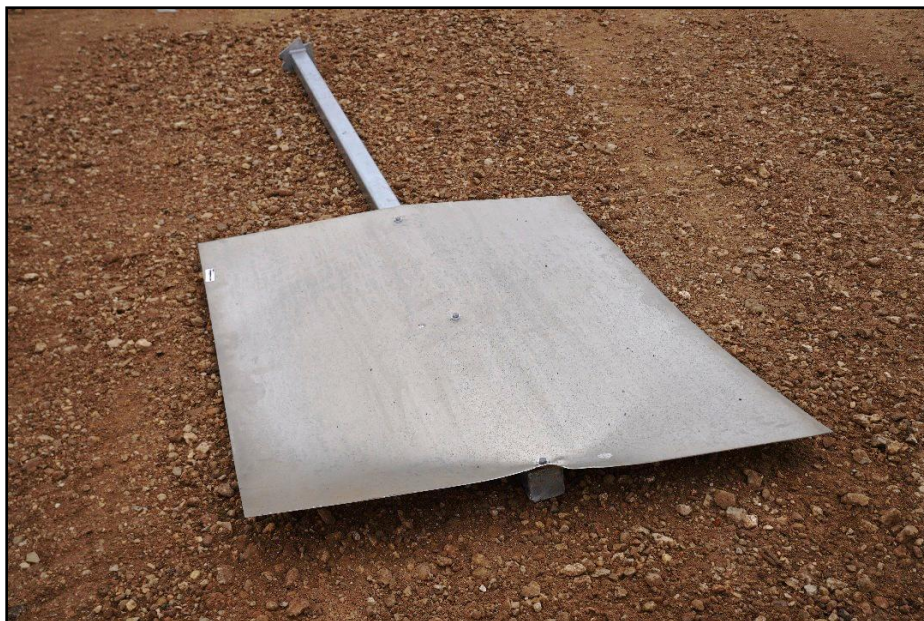
**Figure 6.7. 3 × 3 Square Tube Slip Base Sign Support System at Resting Position after Test 621201-01-1.**

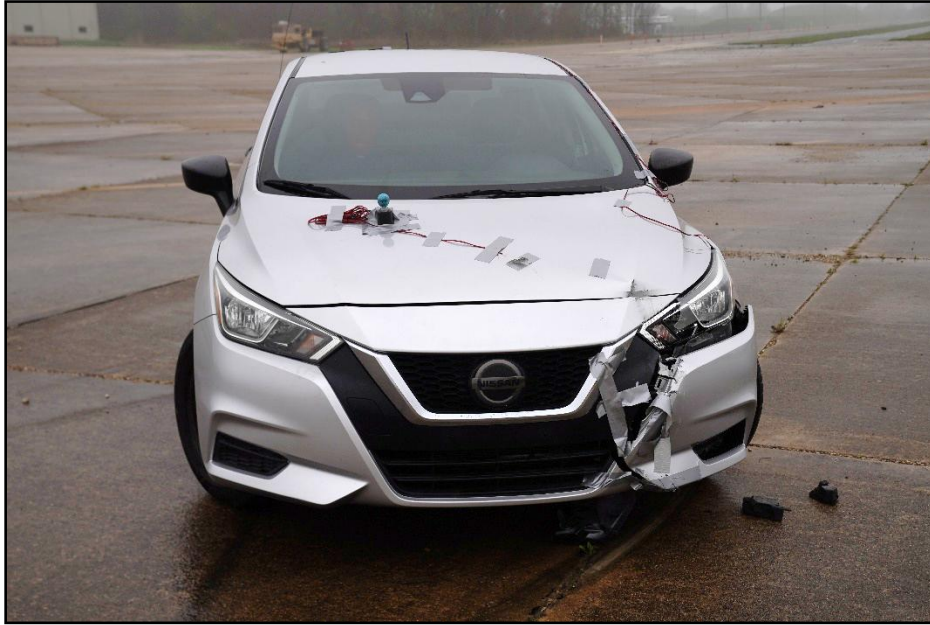
**Figure 6.8. Impact Side of Test Vehicle after Test 621201-01-1.**

| <b>Test Parameter</b> | <b>Details</b> |
|---|---|
| Description of Damage to Vehicle: | The left side of the front bumper and hood were deformed. The clips that were holding the bumper on the left side, and the left headlight both fractured. |

Figure 6.8 and Figure 6.9 show the damage sustained by the vehicle. Table 6.6 and Table 6.7 provide details on the occupant compartment deformation and exterior vehicle damage. Figure B.2 and Figure B.3 in Appendix B.1 provide exterior crush and occupant compartment measurements.

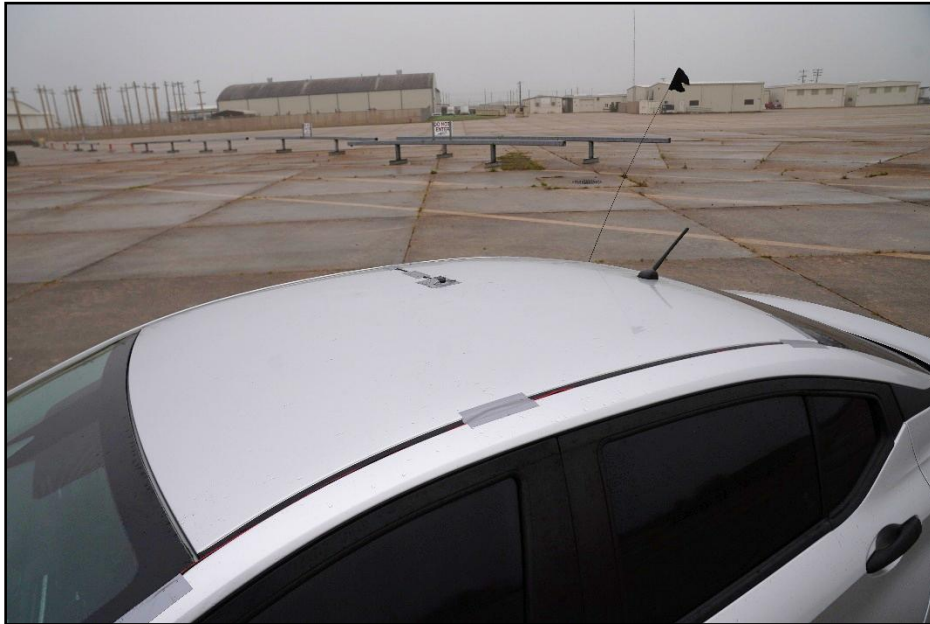
**Figure 6.9. Roof of Test Vehicle after Test 621201-01-1.**

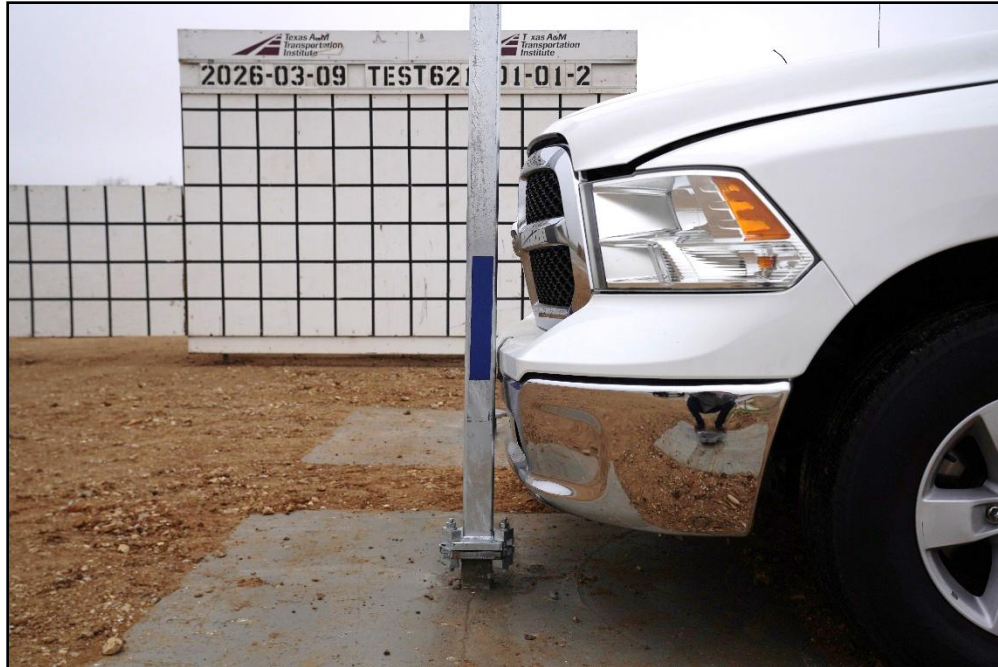
**Figure 7.2. 3 × 3 Square Tube Slip Base Sign Support System/Test Vehicle Geometrics for Test 621201-01-2.**

As shown in Figure 7.2, the initial contact point between the bumper and the post was approximately 26 inches above the ground. The remainder of the pickup truck's front profile extended vertically above this point with a small offset from the post. Following initial contact between the truck and the post, the post rotated slightly and engaged the upper portion of the vehicle's front profile near the hood (Figure 10.1). This interaction was believed to affect the trajectory of the sign support system. The increase in bumper impact height in the analysis program was intended to capture this observed behavior.

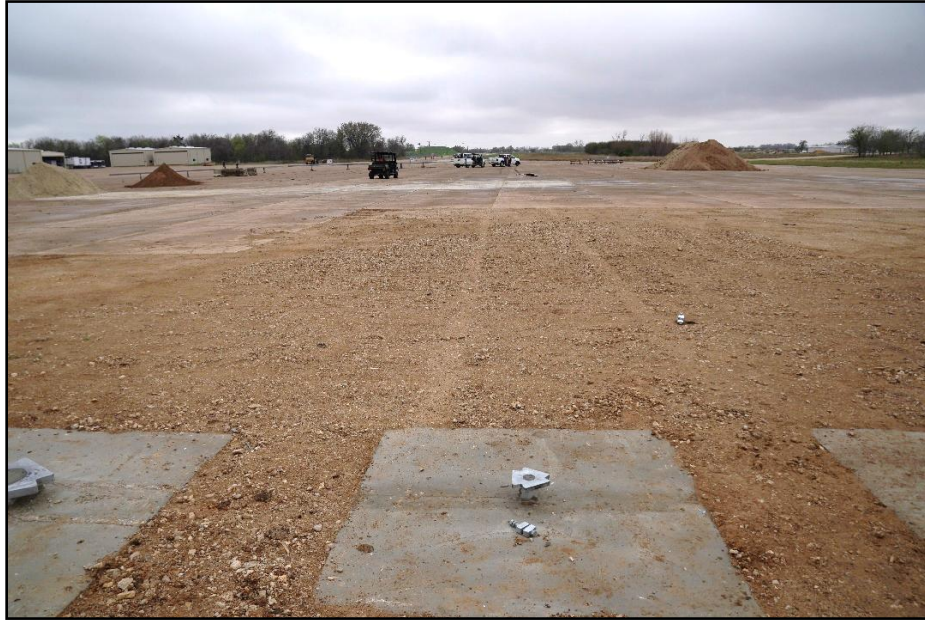
The sign support assembly released from the base and came to rest 160 feet downstream from impact. One bolt from the base stayed at impact, and the other two landed 8 and 140 feet downstream from impact. Figure 7.6 and Figure 7.7 show the damage to the 3 × 3 Square Tube Slip Base Sign Support System.

**Figure 7.6. 3 × 3 Square Tube Slip Base Sign Support System at Impact Location after Test 621201-01-2.**

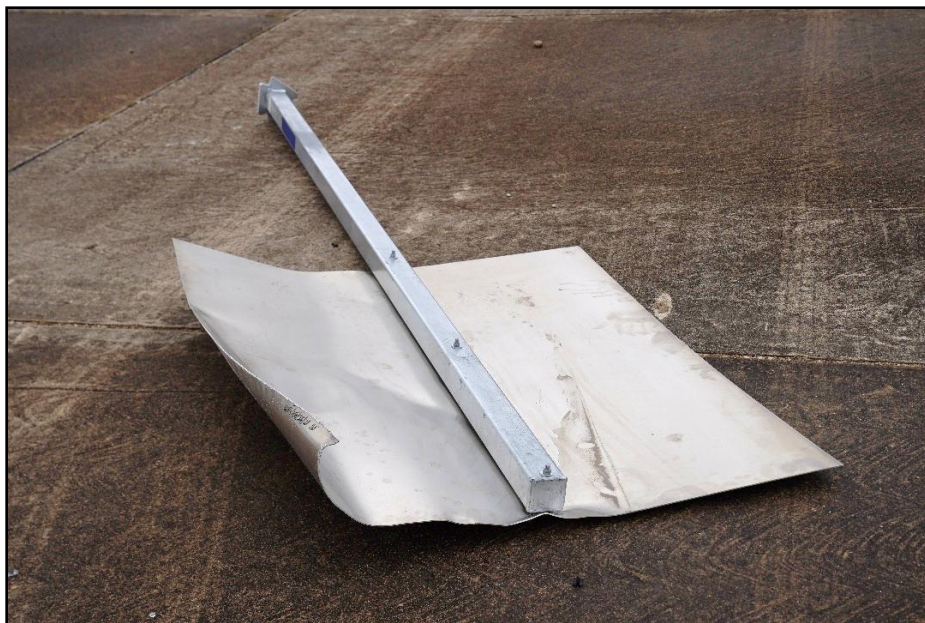
**Figure 7.7. 3 × 3 Square Tube Slip Base Sign Support System at Resting Position after Test 621201-01-2.**

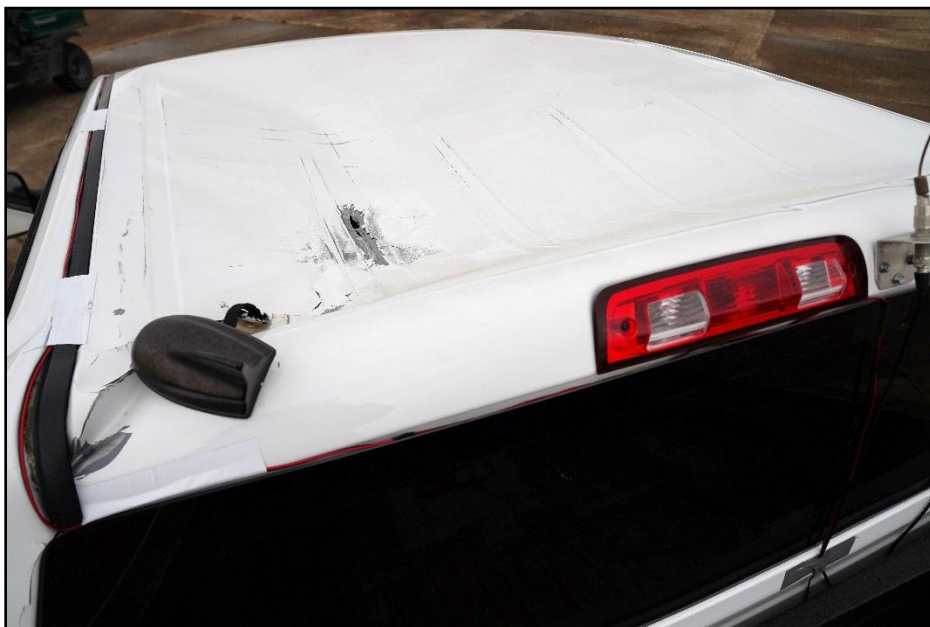
**Figure 7.9. Rear Impact Side of Test Vehicle after Test 621201-01-2.**

Figure 7.8 and Figure 7.9 show the damage sustained by the vehicle. Figure 7.10 and Figure 7.11 show the interior of the test vehicle. Table 7.6 and Table 7.7 provide details on the occupant compartment deformation and exterior vehicle damage. Figure C.2 and Figure C.3 in Appendix C.1 provide exterior crush and occupant compartment measurements.

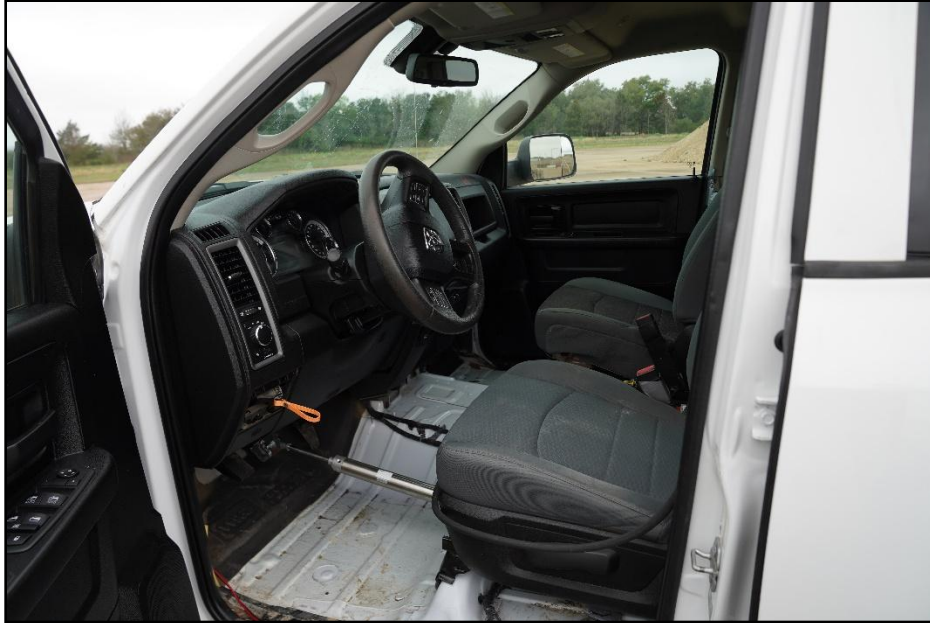
**Figure 7.10. Overall Interior of Test Vehicle after Test 621201-01-2.**

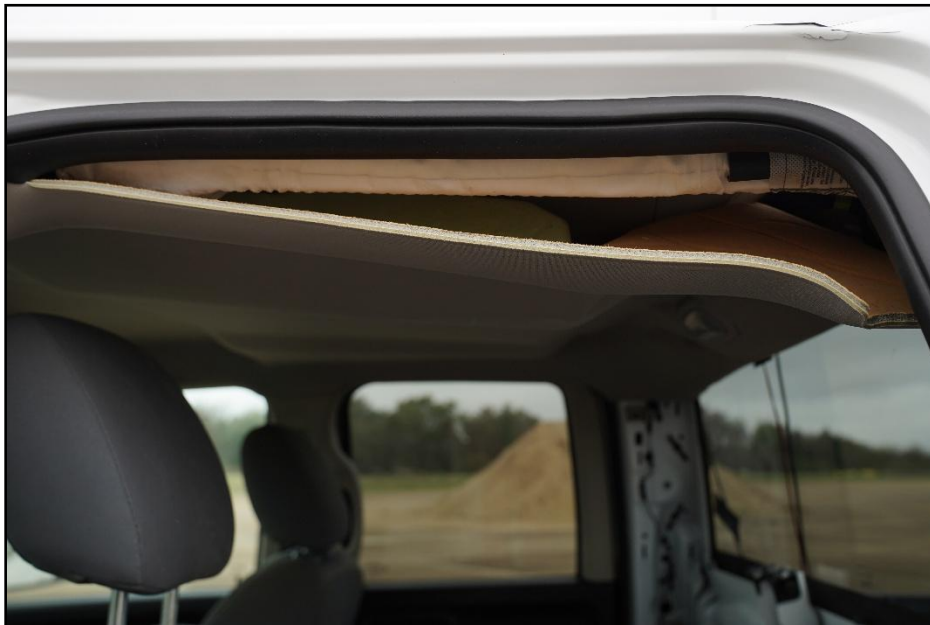
**Figure 7.11. Interior of Test Vehicle on Impact Side after Test 621201-01-2.**

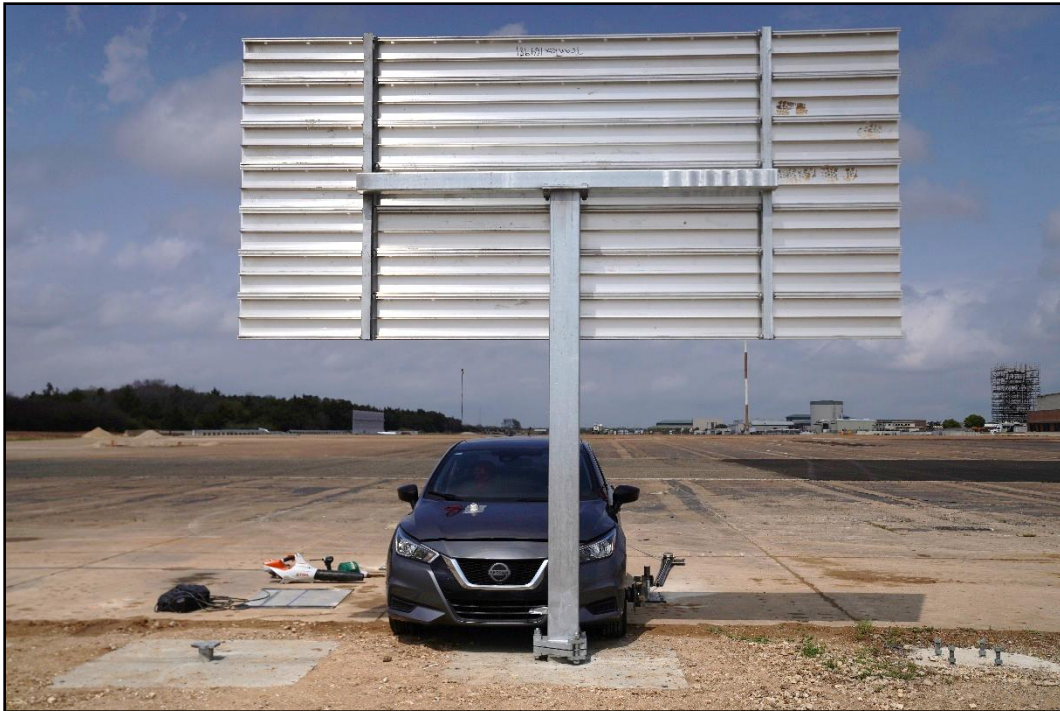
**Figure 8.2. 8 × 8 Square Tube Slip Base Sign Support System prior to Testing.**

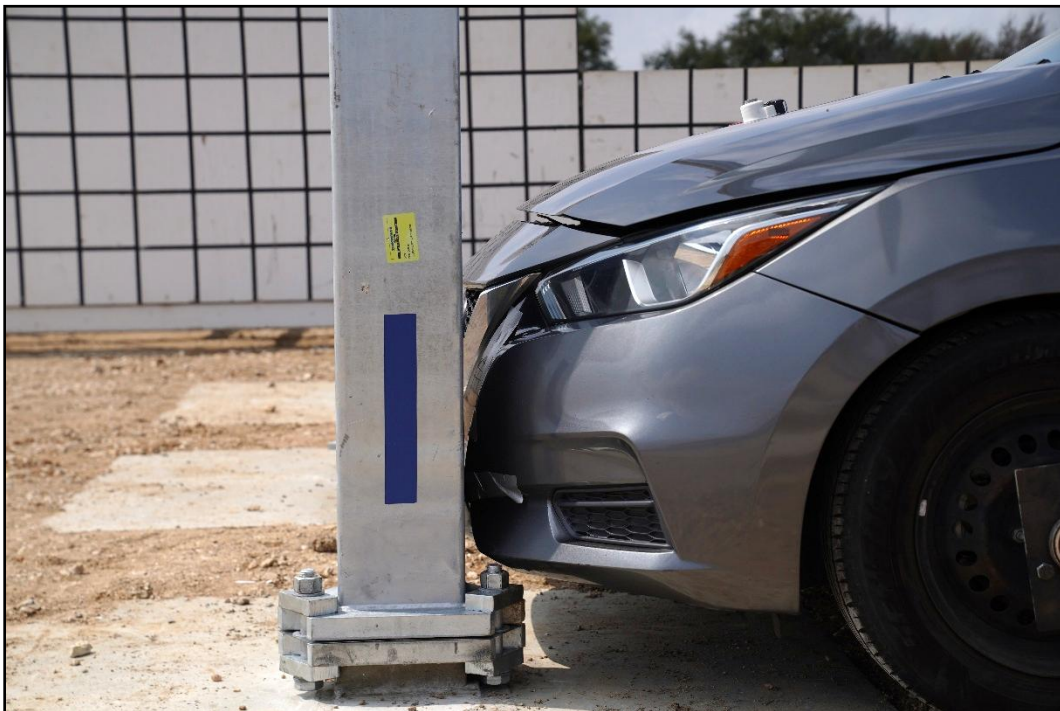
**Figure 8.3. 8 × 8 Square Tube Slip Base Sign Support System Base prior to Testing.**

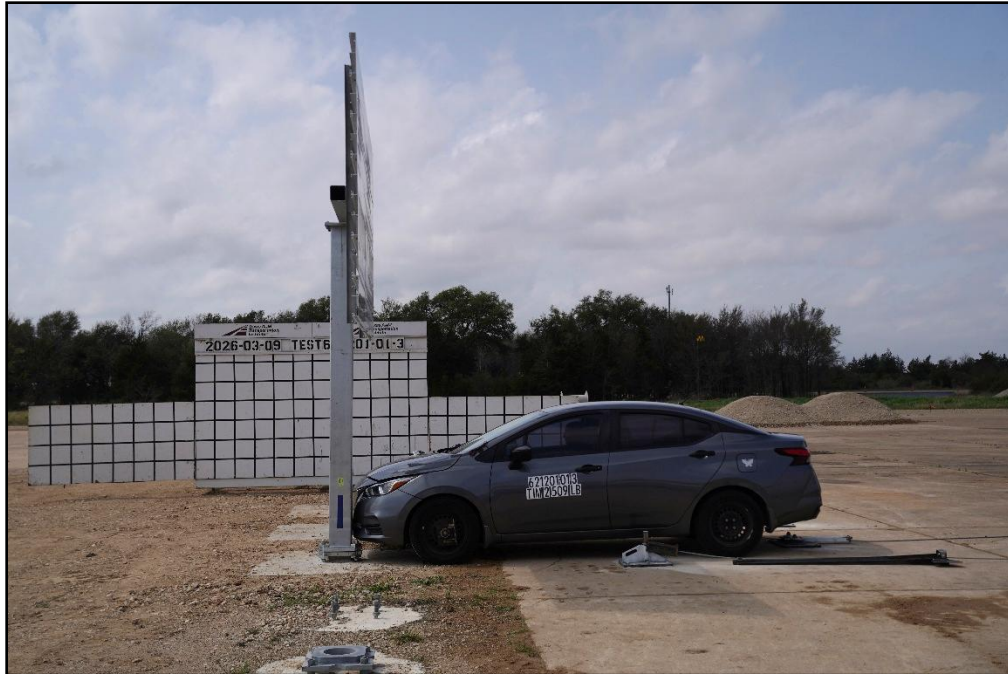
**Figure 9.2. 8 × 8 Square Tube Slip Base Sign Support System/Test Vehicle Geometrics for Test 621201-01-3.**

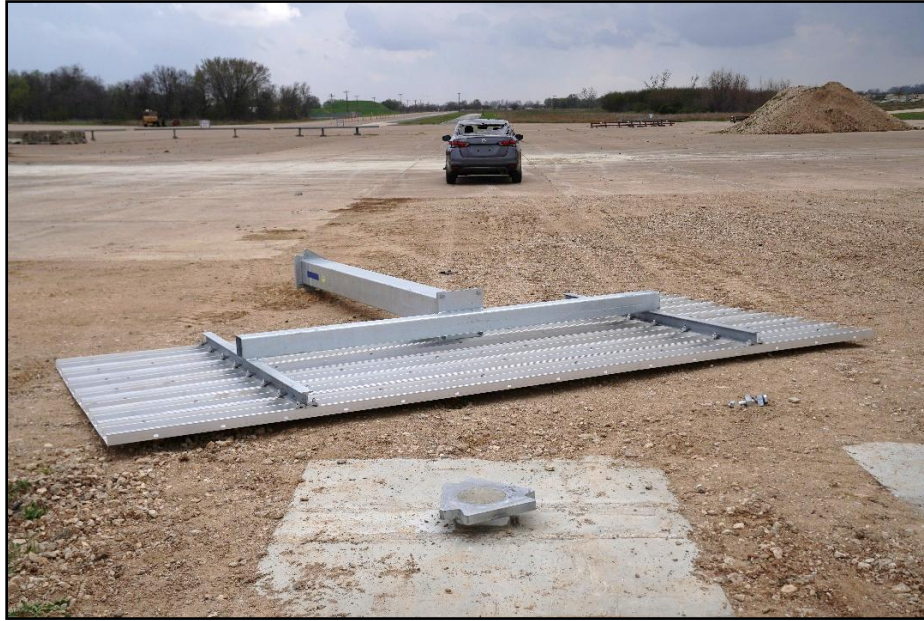
The sign support assembly released from the base and came to rest 6 feet downstream from impact. One bolt from the base was missing, and the other two landed 3 and 60 feet downstream from impact. Figure 9.6 and Figure 9.7 show the damage to the 8 × 8 Square Tube Slip Base Sign Support System.

**Figure 9.6. 8 × 8 Square Tube Slip Base Sign Support System at Impact Location after Test 621201-01-3.**

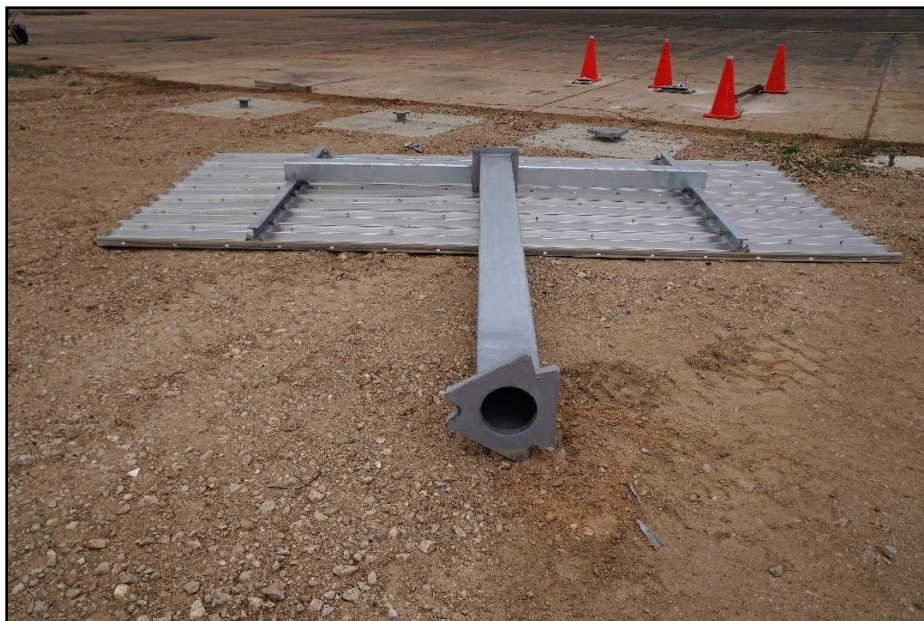
**Figure 9.7. 8 × 8 Square Tube Slip Base Sign Support System at Resting Position after Test 621201-01-3.**

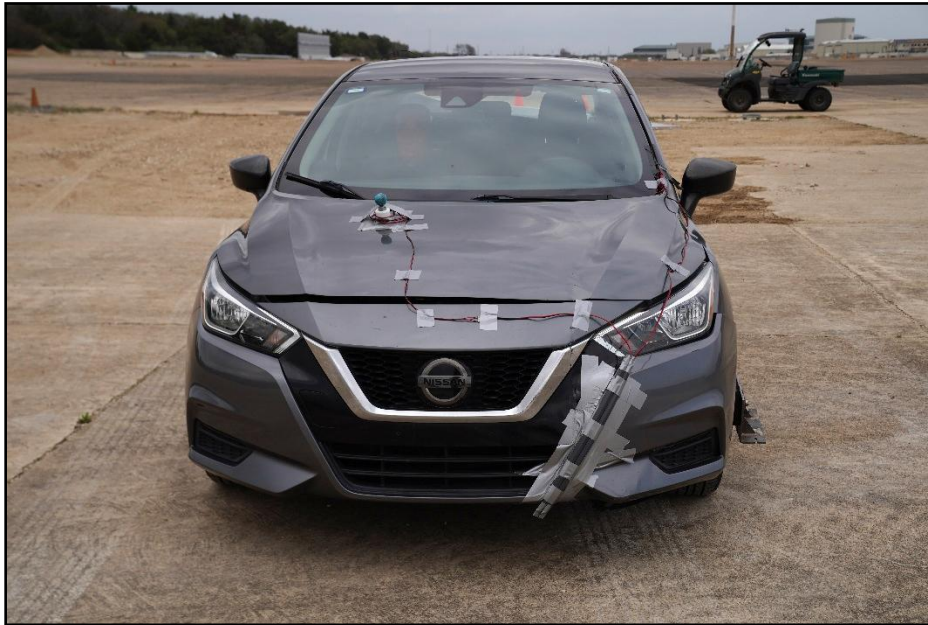
**Figure 9.8. Impact Side of Test Vehicle after Test 621201-01-3.**

| <b>Test Parameter</b> | <b>Details</b> |
|---|---|
| Description of Damage to Vehicle: | The left side of the front bumper, grill, hood, roof, and trunk were deformed. The back window was shattered by contact with the sign, but there was no penetration or potential for penetration of the test article into the occupant compartment. |

Figure 9.8 and Figure 9.9 show the damage sustained by the vehicle. Figure 9.10 and Figure 9.11 show the interior of the test vehicle. Table 9.6 and Table 9.7 provide details on the occupant compartment deformation and exterior vehicle damage. Figure E.2 and Figure E.3 in Appendix E.1 provide exterior crush and occupant compartment measurements.

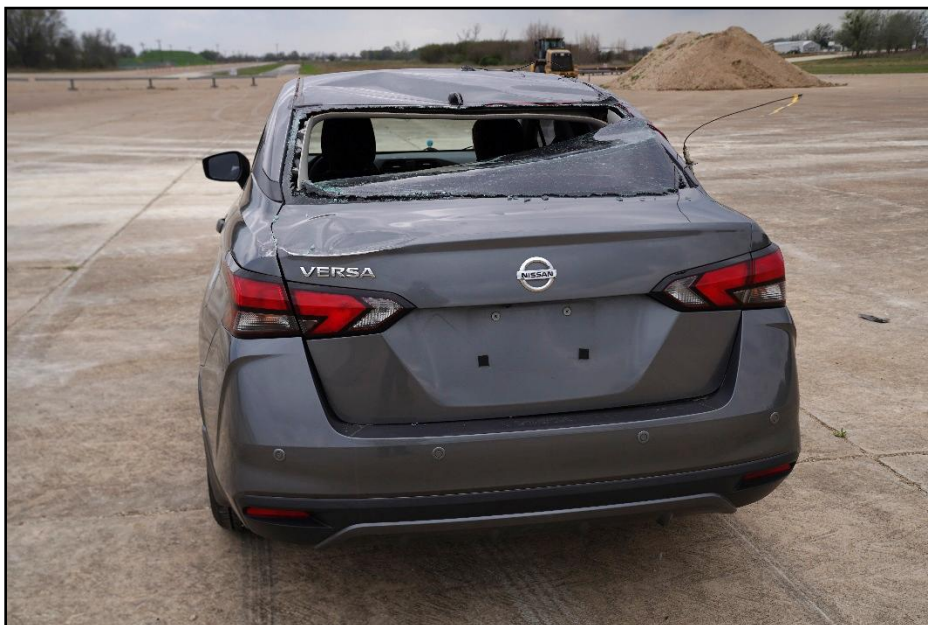
**Figure 9.9. Rear Impact Side of Test Vehicle after Test 621201-01-3.**

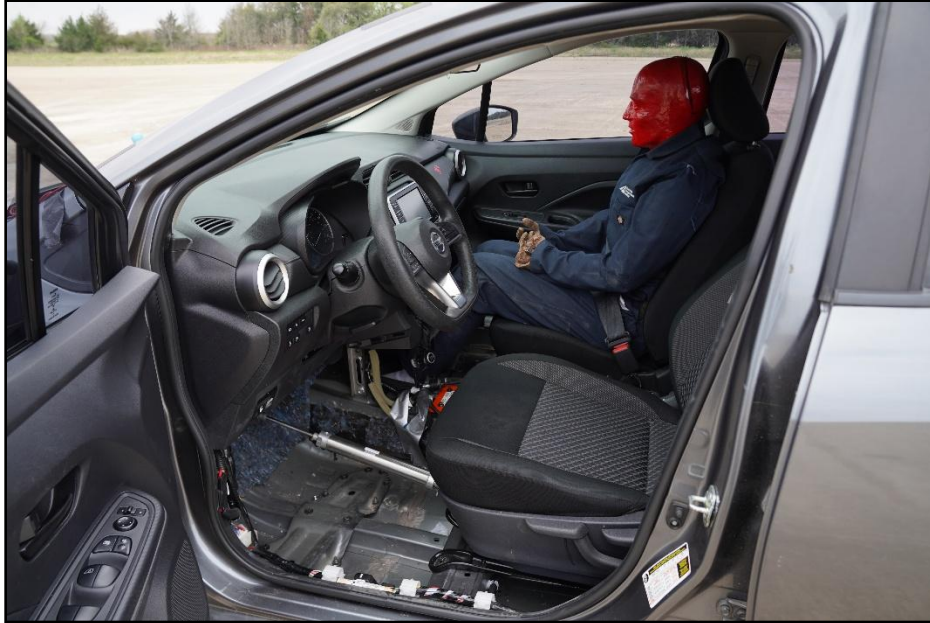
**Figure 9.10. Overall Interior of Test Vehicle after Test 621201-01-3.**

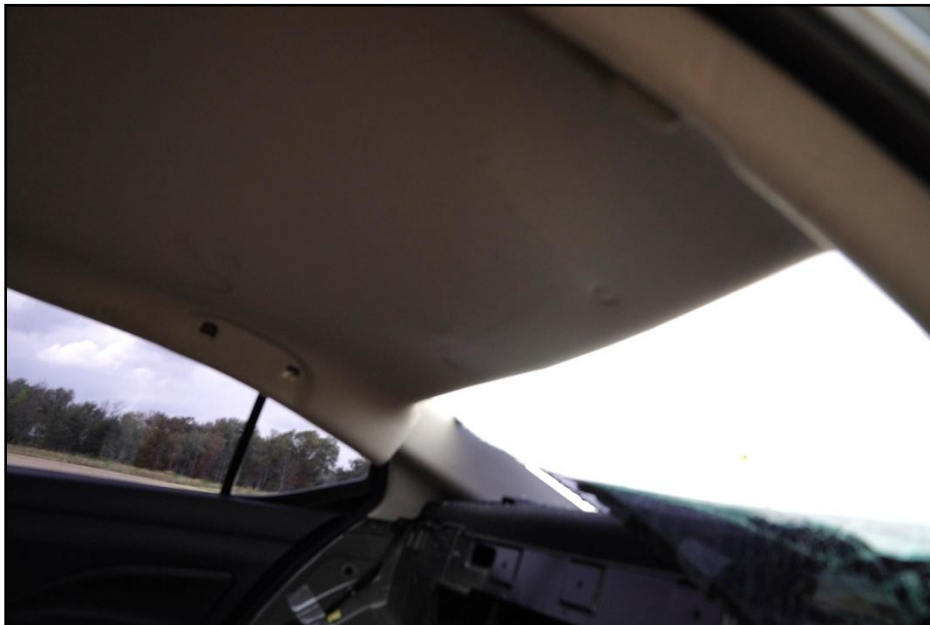
**Figure 9.11. Interior of Test Vehicle on Impact Side after Test 621201-01-3.**

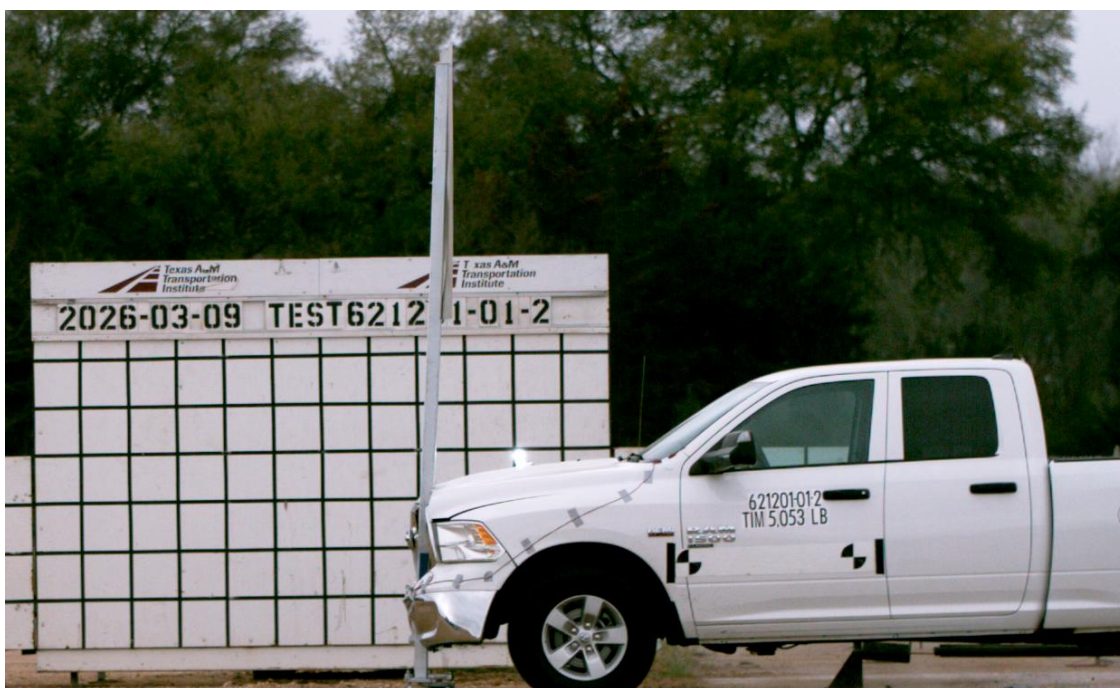
**Figure 10.1. Engagement of Pickup Truck Hood with Post.**
