**Test Report No. 405160-20**

## **MASH TL-3 TESTING AND EVALUATION OF THE W-BEAM GUARDRAIL ON SLOPE**

Test No.: 405160-20-1 and 405160-20-2

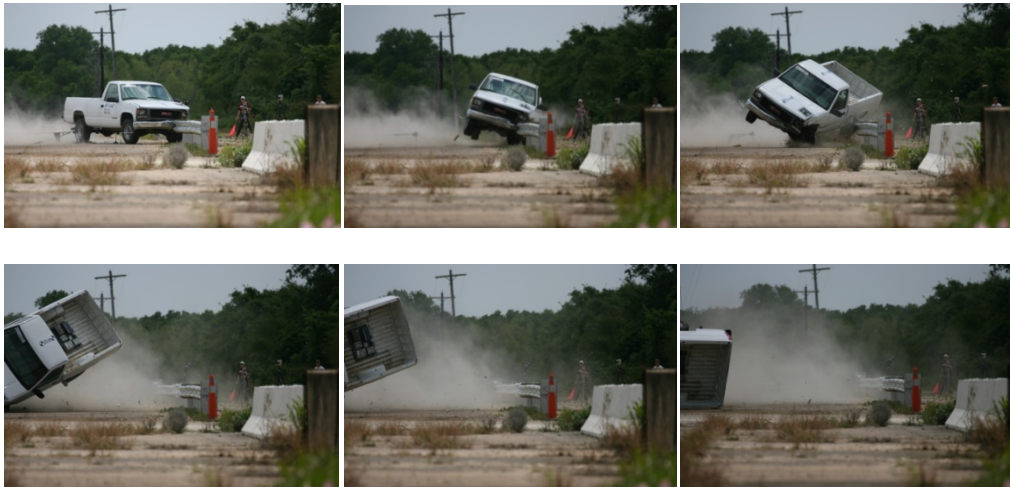
Figure 1.4. Impact sequentials for TTI test 405160-4-1.

The crash test performed was *NCHRP Report 350* test designation 3-11, which involved a 2000 kg (4409 lb) pickup truck impacting the CIP of the length of need section at a nominal speed of 100 km/h (62 mi/h) and a nominal angle of 25 degrees. The vehicle was redirected by the guardrail system; however, it rolled on its side upon exiting the guardrail system. Figure 1.4 shows sequential photos of the impact event. Figure 1.5 and figure 1.6 show damage to the guardrail and the vehicle respectively.

In the full-scale crash test, the 2000P vehicle was contained and redirected. However, after exiting the installation, the vehicle rolled onto its left side and came to rest on its left side 135 ft. downstream of impact and 34 ft. forward of the traffic face of the rail. Due to this rollover event, the guardrail on 2H:1V slope did not meet the criteria for *NCHRP Report 350* test 3-11.

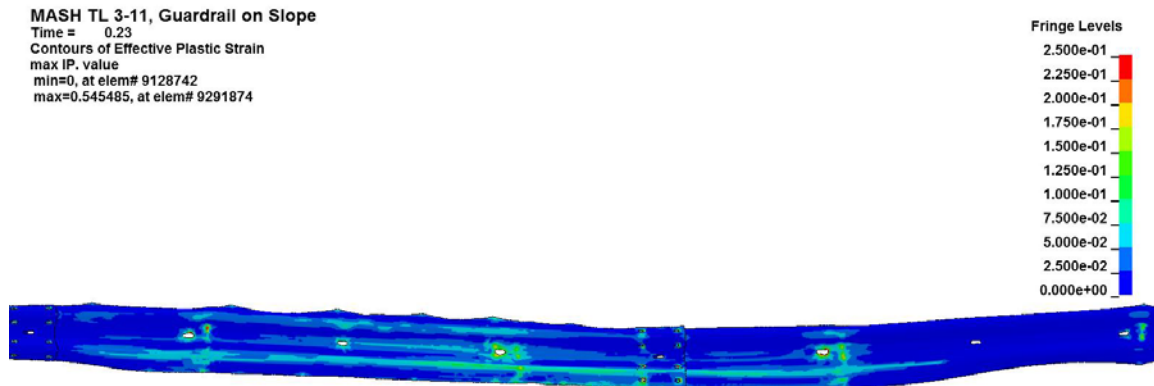
Figure 1.27. Contours of W-beam plastic strain during simulation.

Figure 1.27 shows the contours for the plastic strain within the W-beam at the time of maximum rail deflection. This indicates a low likelihood of rupture of the rail since the plastic strain values are well below rupture strain levels.

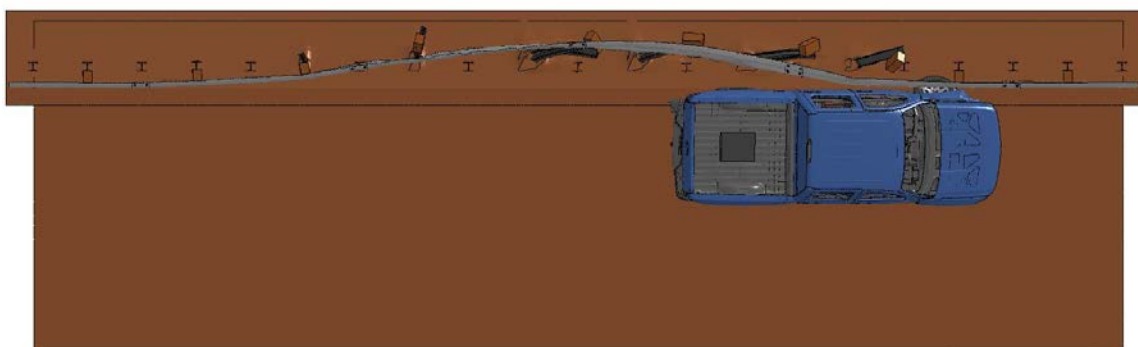
Figure 1.33. Top view of vehicle exit.

The Silverado model exited the rail system at a time of 0.63 seconds and an angle of 21 degrees, as shown in figure 1.33.

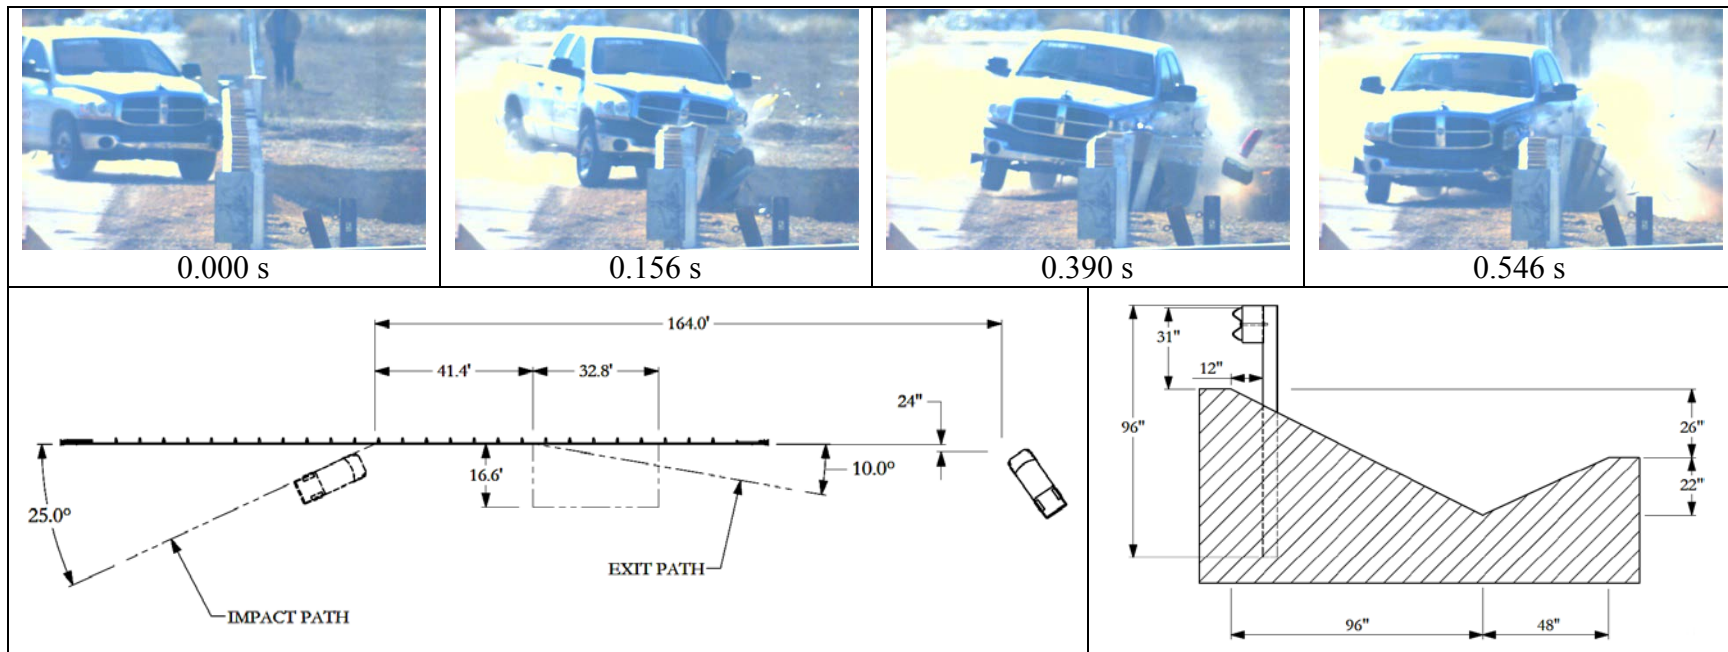
Figure 5.6. Interior of vehicle for test 405160-20-1.

Results: The rail element separated from some of the posts and one blockout separated from a post. However, these elements did not penetrate, nor show potential to penetrate the occupant compartment, nor to present undue hazard to others in the area. (PASS)  
No occupant compartment deformation occurred. (PASS)

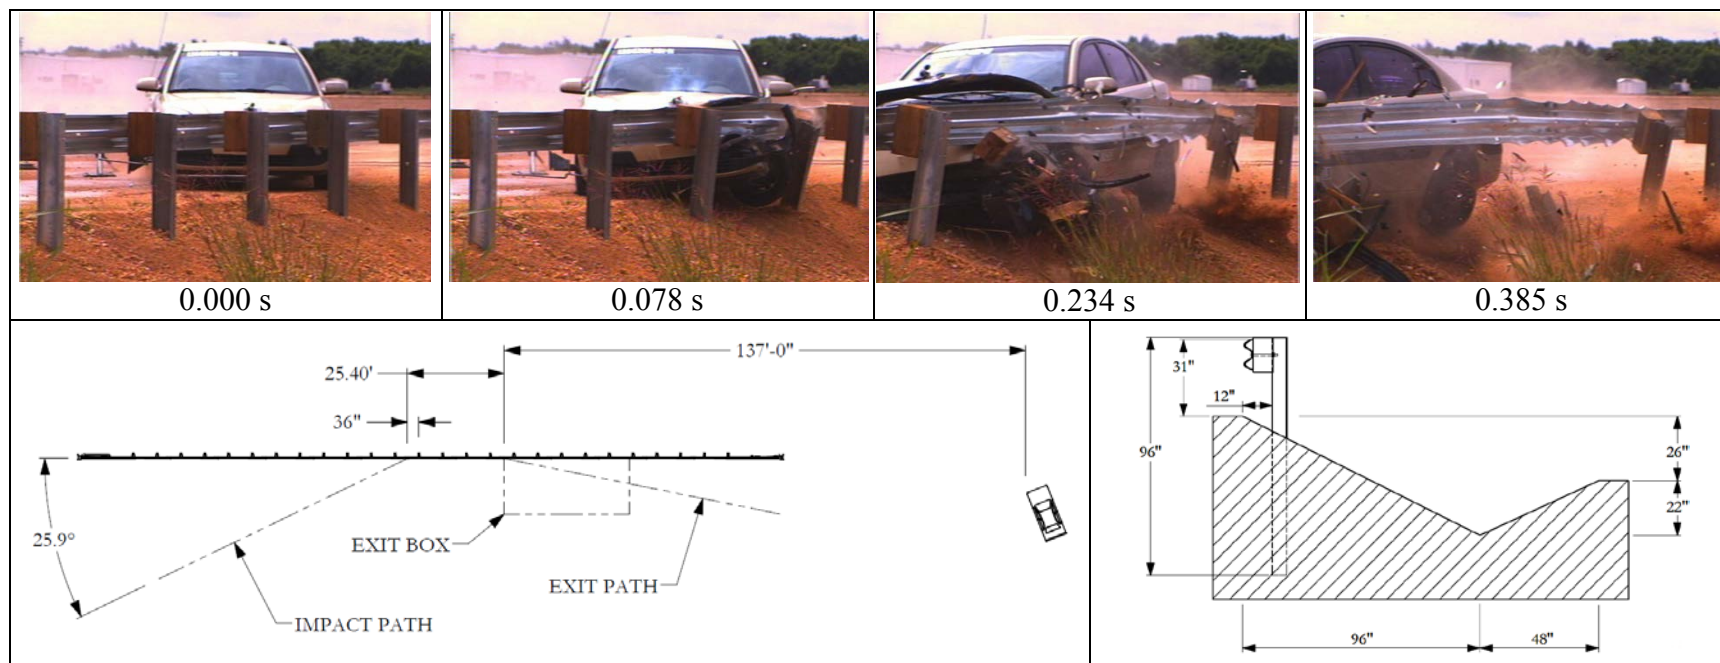
Figure 6.6. Interior of vehicle for test 405160-20-2.

Results: The rail element separated from some of the posts. However, the rail element did not penetrate, nor show potential to penetrate the occupant compartment, nor to present undue hazard to others in the area. (PASS)  
No occupant compartment deformation occurred. (PASS)
