## DEVELOPMENT GUIDANCE FOR SIGN DESIGN STANDARDS

**Test Report 0-6363-1**

TEXAS TRANSPORTATION INSTITUTE THE TEXAS A&M UNIVERSITY SYSTEM COLLEGE STATION, TEXAS

**TEXAS DEPARTMENT OF TRANSPORTATION**

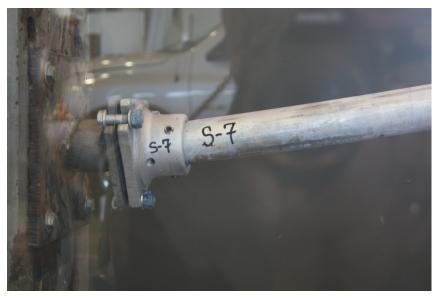
Figure 3.2 shows the test setup before load application, and Figure 3.3 shows the test setup at the point of maximum loading. Table 3.1 presents a summary of recorded loads. The testing resulted in an average failure load of 1022 lb. All three tests yielded the post support plastically at the slipbase interface. Notice that all the recorded failure loads are within 10 percent of the average failure load meeting the AASHTO requirement of a maximum allowable 681-lb wind load.

Figure 3.3. Schedule 80 Support at Maximum Load.

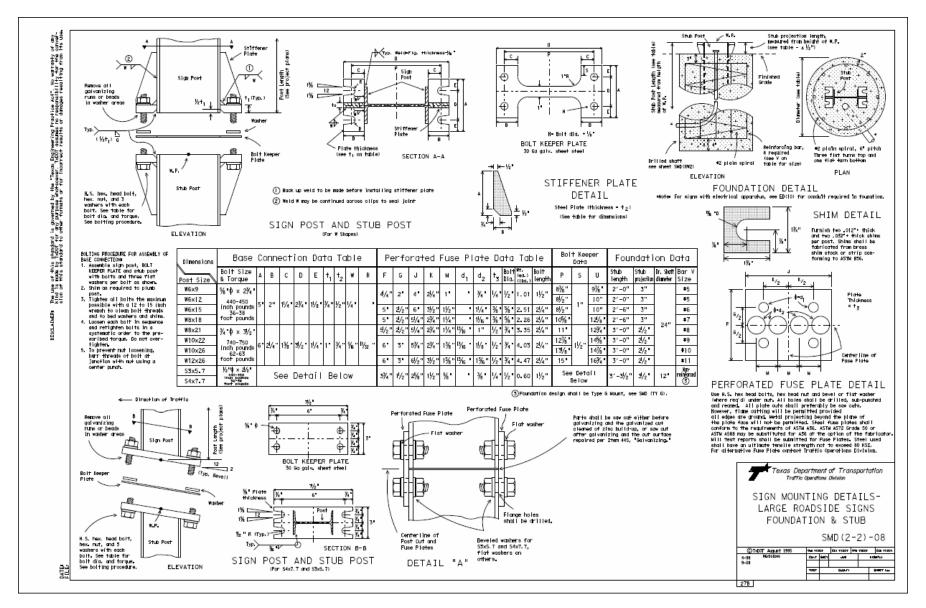
The answer lies in the fuse plate capacity. Figure 5.4 is an image of the current TxDOT standard detailing the slipbase and fuse plate connections. Table 5.1 is an enlarged image of the design table detailing the sizes of each of the components corresponding to each support section's size. Also, Figure 5.4 is the current generic fabrication diagram for all fuse plate designs; the sections that have equivalent wind load capacities share the same fuse plate details. Researchers conducted further investigation into the cause of the phenomena.

Figure 5.4. Current TxDOT Large Guide Sign Supports Slipbase and Fuse Plate Details.

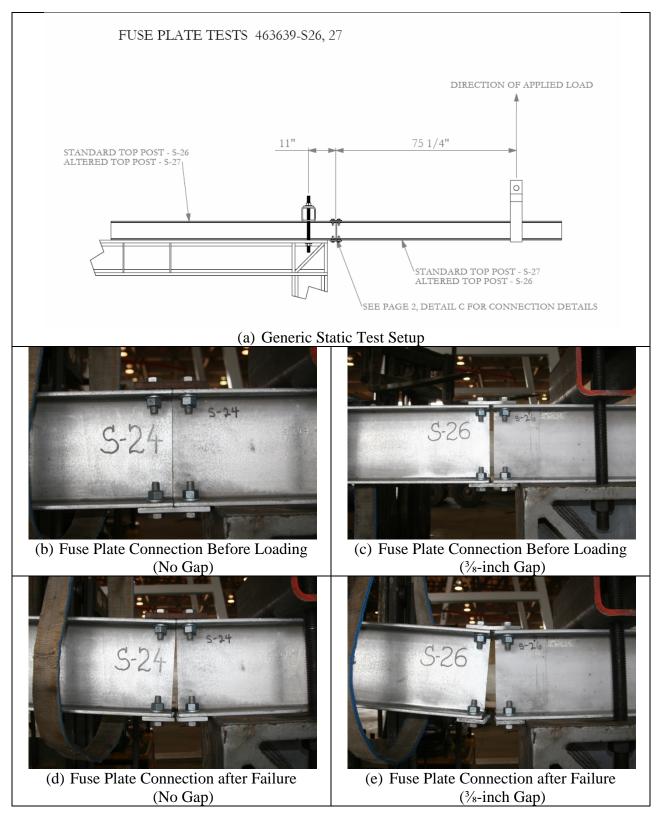
Figure 5.10 (a) details the basic test setup. The spliced beam was clamped to the rigid load frame, and then a vertical load was applied approximately 75 inches from the fuse plate connection. Appendix C gives further details of the test installation. Photos b and d in Figure 5.10 show the gapless fuse plate connection (S24 and S25) before and after failure of the fuse plate connection. Meanwhile, photos c and e in Figure 5.10 are images of the fuse plate connections with a <sup>3</sup>/<sub>8</sub>-inch gap (S26 and S27) before and after failure of the fuse plate connection.

- Test S24 tension fuse plate failed at a vertical load of 3.2 kips. This equates to a 19.2 kip\*ft fuse plate connection moment capacity.
- Test S25 tension fuse plate failed at a vertical load of 4.3 kips. This equates to a 26.6 kip\*ft fuse plate connection moment capacity.
- Test S26 tension fuse plate failed at a vertical load of 3.9 kips. This equates to a 24.7 kip\*ft fuse plate connection moment capacity.
- Test S27 tension fuse plate failed at a vertical load of 3.0 kips. This equates to a 18.7 kip\*ft fuse plate connection moment capacity.

After reviewing the results of the testing, it was determined that fuse plate connections with gaps between spliced beam sections up to 3/8-inch will provide capacities in excess of those calculated.

Figure 5.10. W8×18 Fuse Plate Fuse Plate Connection Capacity Verification (S24–S27).

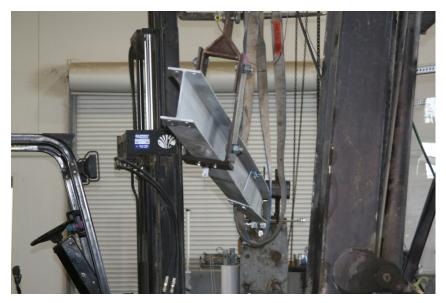
Figure 5.13. W8×18 Support at Maximum Load (S3).

Test S3 reached a maximum load of 3.5 kips. The calculated equivalent capacity of the fuse plate connection is 3.0 kips, and that of the base post section with an unbraced length of 16 ft 3 inches is 0.1 kips. This calculation includes reductions according to lateral torsional buckling (LTB) effects. Figure 5.13 shows that the beam did, in fact, fail due to LTB. The results of the static testing show the post assemblies provide capacities in excess of those calculated.

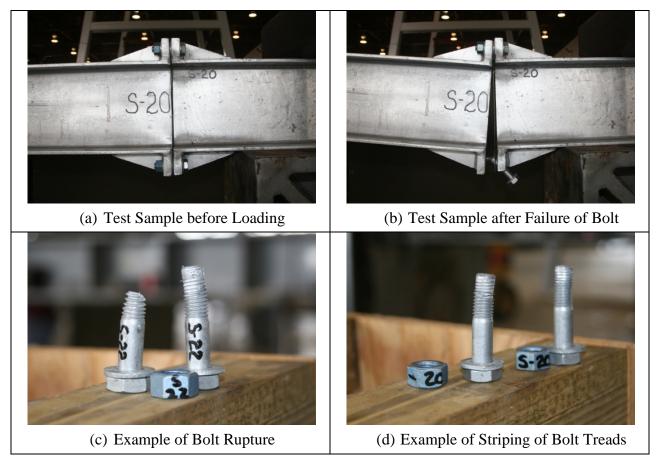
An unfactored equivalent vertical load capacity of the W8×18 post section and A325 bolted connection were calculated to be 7.9 and 6.4 kips, respectively. Therefore, it is expected that the system will fail due to bolt rupture in the slipbase connection. S20 reached a vertical load capacity of 6.4 kips, S21 reached a vertical load capacity of 6.3 kips, S22 reached a vertical load capacity of 6.4 kips, and S23 reached a vertical load capacity of 6.5 kips. These values correspond exactly with the calculated values. This also shows that the W8×18 post section may benefit in some situations from using the stronger W8×21 slipbase configuration. Photos a–d in Figure 5.16 are representative images from the static load tests.

Figure 5.16. W8×18 Slipbase Capacity Verification Test Images.

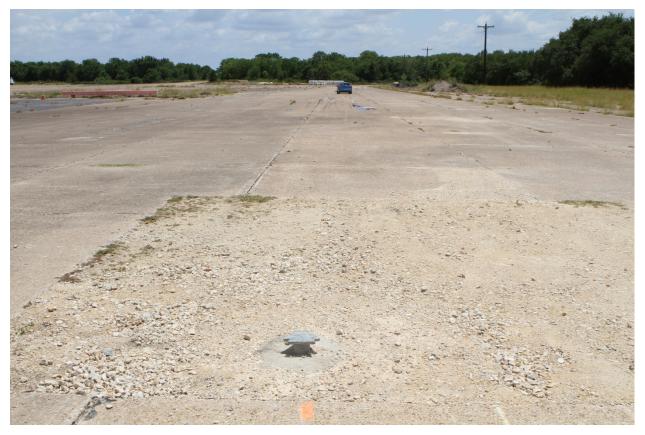
Figure 9.39. Position of Sign Support/Vehicle after Impact for Test No. 463631-2.

As shown in Figures 9.39 and 9.40, the sign support activated as designed by slipping away at the base connection. The support was slightly deformed at the insertion site with the slipbase support. The sign panel detached from the pipe support. The support and the sign panel were resting 120 ft and 111 ft downstream, 36 ft right of the impact point, respectively.

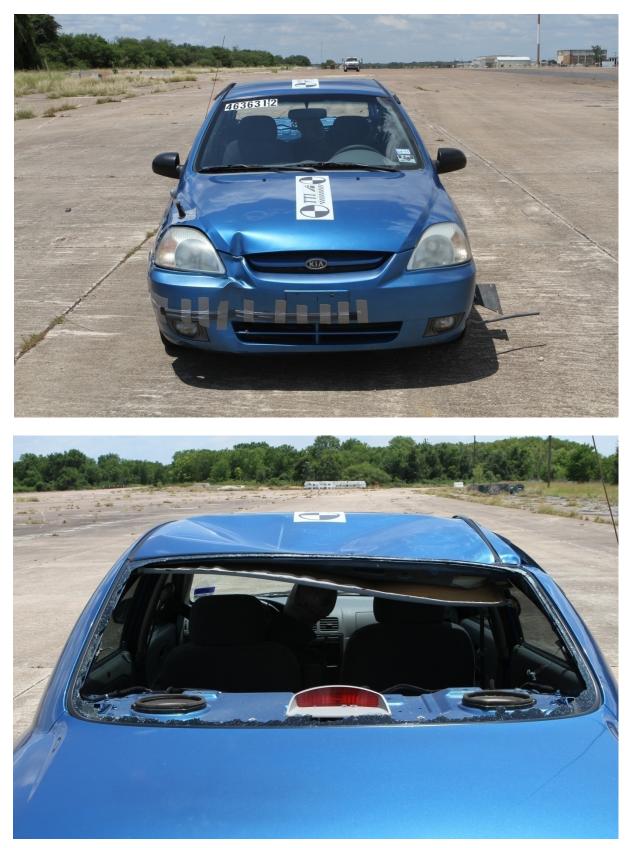
Figure 9.41. Vehicle after Test No. 463631-2.

The 1100C vehicle sustained damage to the center front (see Figures 9.41 and 7.12). The right front bumper quarter point, the hood, and the roof were deformed. Figure 7.12 shows the rear glass was completely shattered and detached from the vehicle body. The maximum exterior crush to the front plane of the vehicle was 1.5 inch at bumper height. A 30-inch  $\times$  40-inch dent in the roof with a maximum 4.75-inch depth was documented. Maximum occupant compartment deformation was 4.75 inches in the roof over the back passenger compartment with a 5-inch  $\times$  0.25-inch cut. Figures 9.42 and 7.13 show photographs of the roof and interior damage of the vehicle. Tables I2 and I3 in Appendix I show the exterior vehicle crush and occupant compartment measurements.

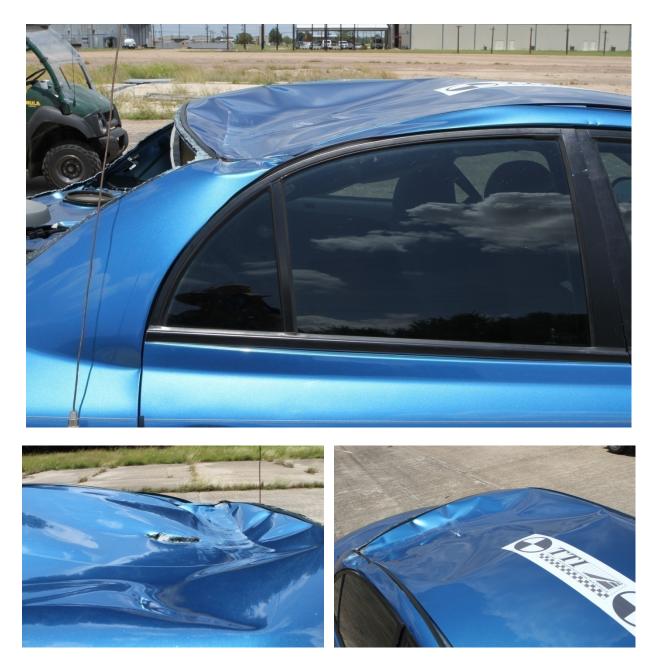
Figure 9.42. Vehicle Roof Deformation after Test No. 463631-2.

- Results:The upper support with sign panel attached slipped away at the base<br/>connection and contacted the roof of the vehicle. The rear glass was<br/>shattered and completely detached from the body of the vehicle.<br/>The roof was deformed into the occupant compartment 4.75 inches, and a<br/>5-inch  $\times$  0.25-inch cut in the roof slightly left of center over the back<br/>passenger compartment resulted from impact and interaction with a sign<br/>clamp. (FAIL)

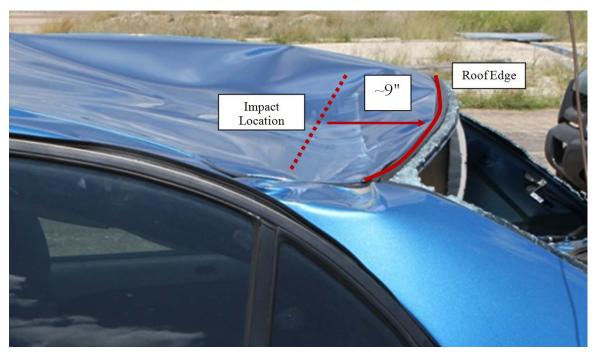
Figure 9.45. Distance of Sign Impact Location to the Roof Edge for Test No. 463631-2.

In Test no. 463631-2, the sign impacted the roof of the passenger car at around 9 inches from the edge of the vehicle's roof (see Figure 9.45). The FE simulation with the same geometry and impact conditions predicted the sign impact at the roof edge. Consequently, there was a 9 inch gap between the predicted (FE) and the resulting (test) roof impact location.

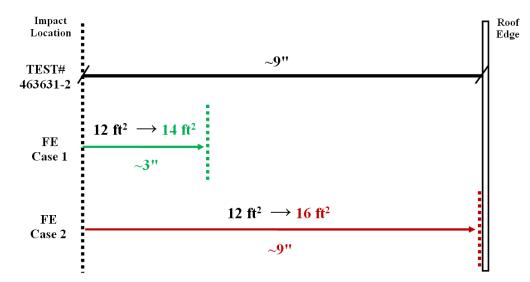
Figure 9.46. Comparison of FE Predicted Sign Impact Locations with Different Sign Areas.

According to the previously performed FE simulations for a 62-mph impact, a sign support with a 14 ft<sup>2</sup> sign area would impact the passenger car around 3 inches behind the impact location predicted with a 12 ft<sup>2</sup> sign area. On the other hand, a sign support with a 16 ft<sup>2</sup> sign area would impact the passenger car around 9 inches behind the impact location predicted with a 12 ft<sup>2</sup> sign area. Consequently, the use of a single sign support with 16 ft<sup>2</sup> sign area would fill the gap of 9 inches discussed earlier in terms of roof impact location (see Figure 9.46).

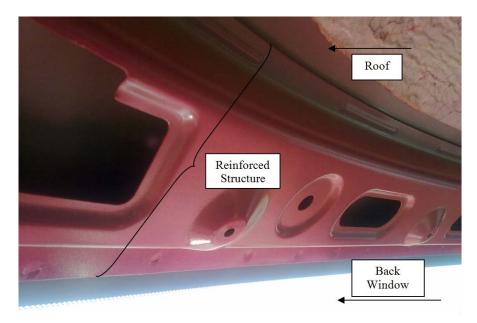
Figure 9.47. Reinforced Structure at the Small Passenger Vehicle's Roof Edge.

A closer investigation of the vehicle body, however, revealed the presence of a reinforced structure along the edge of the roof, which extends for 5 inches into the occupant compartment (see Figure 9.47).

It is believed that impacting the reinforced structure would help in containing the roof deformation caused during contact between the sign support system and the vehicle. Thus, the new goal is not necessarily to impact the edge of the roof, but a contact anywhere in the 5-inch region before the end of the roof would be considered desirable according to the consideration made above. The new gap to be filled would be now 4 inches (9 inches initial gap–5 inches of reinforced structure) (see Figure 9.48).

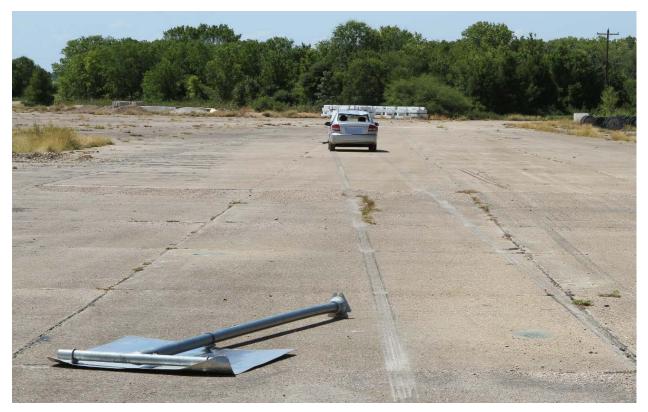
Figure 9.55. Position of Sign Support/Vehicle after Impact for Test No. 463631-3.

As shown in Figures 9.55 and 9.56, the sign support activated as designed by slipping away at the base connection. The support was very slightly deformed at bumper height. The sign panel remained attached to the pipe support. The support and the sign panel were resting 90 ft downstream and 9 ft left of the impact point.

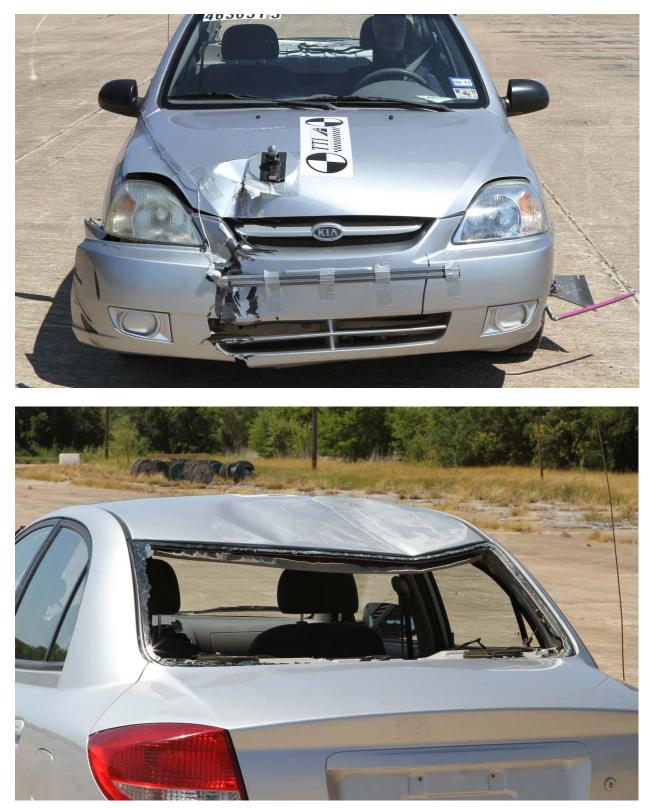
Figure 9.57. Vehicle after Test No. 463631-3.

Figures 9.57 and 9.58 show the 1100C vehicle sustained damage to the center front. The right front bumper quarter point, hood, grill, and the roof were deformed. The rear glass was completely shattered. The maximum exterior crush to the front plane of the vehicle was 2.5 inches at bumper height. A 28.5-inch  $\times$  16-inch dent in the rear roof with maximum 2.5-inch depth was documented. Maximum occupant compartment deformation was 2.5 inches in the roof over the back passenger compartment. Figures 9.58 and 9.59 show photographs of the roof and interior damage of the vehicle. Tables J2 and J3 in Appendix J show the exterior vehicle crush and occupant compartment measurements.

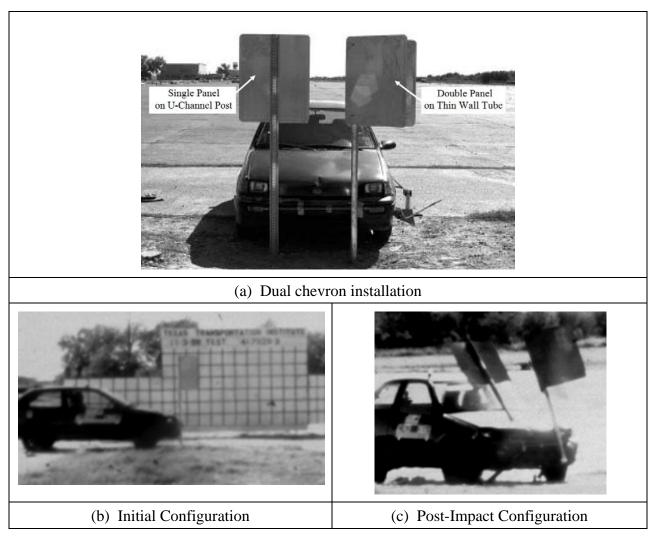
Figure 10.1. Dual Chevron Support Test No. 417929-3.

TxDOT funded a project entitled "Impact Performance Evaluation of Work Zone Traffic Control Devices" aimed at providing traffic control devices for use in work zones (in accordance with *NCHRP Report 350* guidelines) that would perform acceptably when impacted by errant vehicles. One test performed under this research project was a high-speed passenger car impact against a dual chevron installation with panels at a 4-ft mounting height on flat, level ground. Figure 10.1(a) shows that the installation had a single panel through-bolted to a U channel post, and the other installation had two panels attached to a 13 BWG pole using the standard mounting brackets. Of particular interest for the scope of this research study is the outcome of the vehicle impact with the two-panel chevron. The two-panel sign was 24 inches wide and 30 inches high. A Geo Metro passenger car impacted the sign supports head-on at a speed of 62.0 mi/h (see Figure 10.1[b]).

The U-channel chevron support failed to meet the requirements of *NCHRP Report 350*, since it contacted the windshield and cut the roof just behind the windshield frame, thereby showing potential for penetrating the occupant compartment. The thin wall chevron support performed acceptably according to the guidelines of *NCHRP Report 350*. The pole yielded at the bumper impact location and pulled out the socket system. The impacting vehicle then pushed it away, so it never had a second impact with any part of the passenger car (see Figure 10.1[c]). The sign was able to slide through the pole and leave the support impacting the windshield, but did not cause any deformation or intrusion in the occupant compartment.

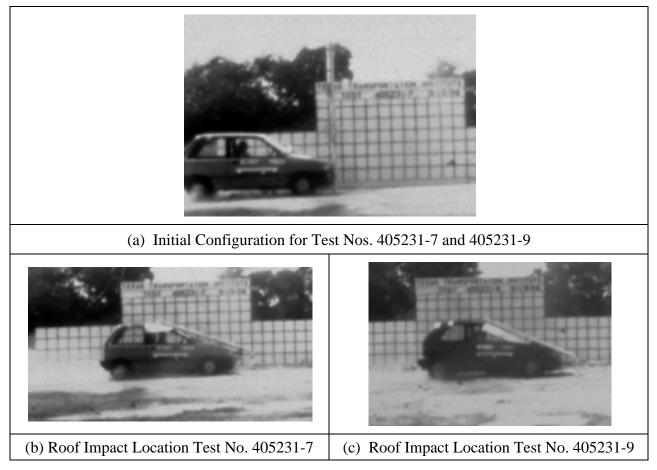
Figure 10.2. Thin-Walled Aluminum Sign Support Tests Nos. 405231-7 and 405231-9.

In Test no. 405231-7, the test article was installed in strong soil and impacted by a passenger car at 62.3 mi/h. The support was bent, pocketed around the bumper, fractured, and impacted the roof of the vehicle (see Figure 10.2[b]). Maximum roof crush was 2.4 inches. In

Test no. 405231-9, the test article was installed in weak soil and impacted by a passenger car at 63.0 mi/h. The support was bent, collapsed around the bumper, fractured and impacted the roof of the vehicle (Figure 10.2[c]). Maximum roof crush was 4.3 inches. Tests results were evaluated according to the criteria of *NCHRP Report 350*, which allows a maximum occupant compartment deformation of 5.9 inches.

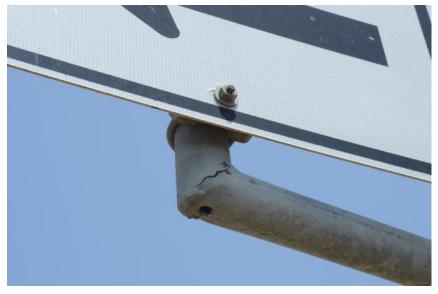
The current design bends the U-pipe to form the "U" and is fabricated from a 2<sup>3</sup>/<sub>8</sub>-inch 10BWG pipe. This discontinued design utilizes a smaller diameter U-pipe and miters the U-pipe instead of bending it to form the "U." When inspecting the failed support the cause of the failure was determined to be the weld in the left miter joint. Figure 11.2 shows the large crack that is evident of this mode of failure. A list of possible causes for this weld failure includes: wind overloading event (winds in excess of design speeds), improper fabrication (poor weld quality), cyclic fatigue, or possible corrosion. As the system is still in-service, a further inspection to determine exactly what caused the weld failure was not possible.

Figure 11.2. U-Bracket Weld Failure.

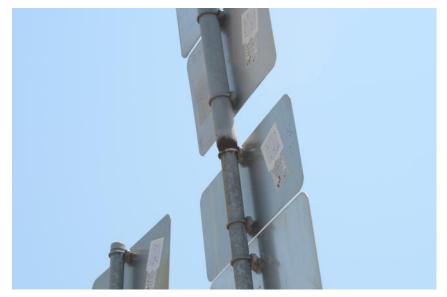
Another item to note is that the extension tube at the top of the tube was fabricated to fit the current U-bracket design. As this extension tube is much larger in diameter than the discontinued U-bracket, the extension tube was field modified to make it fit into the smaller U-pipe. However, this damaged much of the protective galvanization, leading to corrosion (see Figure 11.3).

Figure 11.3. Improper Installation of U-Bracket Extension Tube.

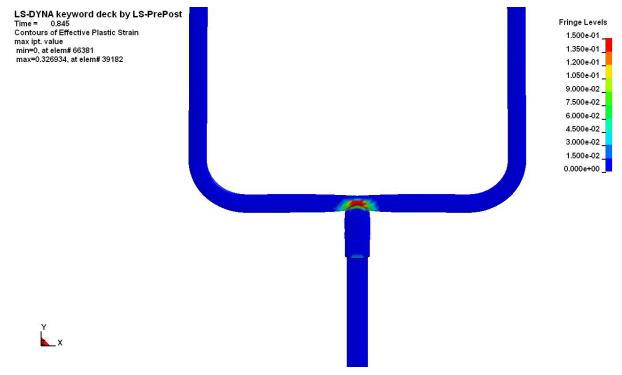
The first simulation was generated to represent the current U-bracket and support configurations. The U-pipe was simulated as a 2.375-inch 10 BWG pipe (55 ksi yield) section that had a 39-inch center to center vertical support spacing. The height of the U-bracket vertical supports was simulated to be 11 ft-9 inches The U-bracket nipple was simulated as a 3.25-inch 11 BWG pipe (55 ksi yield) support that was necked down to accept the U-pipe at one end. The geometry was a best-fit interpretation of the actual geometry since exact dimension drawings were not available. Finally, a 2.875-inch schedule 80 pipe support was simulated to support the U-bracket. A constant rate displacement was applied perpendicular to the U-bracket at 154.5 inches above the rigid fixed end support. The displacement was increased until a large yield region developed in the U-pipe near at the nipple attachment location (see Figure 11.5). This simulation predicts that the U-pipe will yield at the weld location before the schedule 80 support will yield.

Figure 11.5. Simulation of Current TxDOT Design.

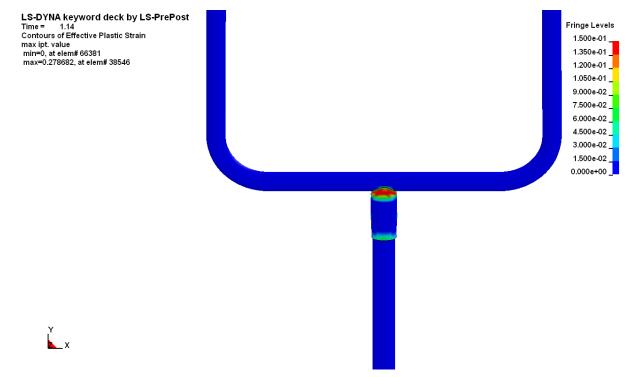
In an attempt to increase the capacity of the system, the thickness of the U-pipe section was increased to schedule 80 from BWG10. The change did prevent the yielding zone in the U-pipe, however, the nipple then became the limiting factor, evident in the large yield region shown in Figure 11.6. This simulation predicts that the nipple will yield before yielding the schedule 80 support.

Figure 11.6. Simulation of Schedule 80 U-Pipe.

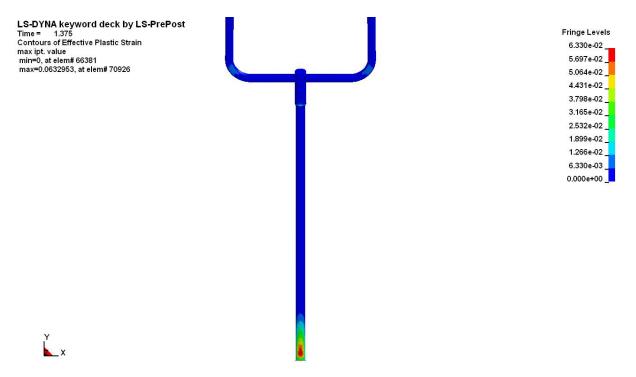
In an attempt to strengthen the connection between the nipple and the U-pipe, a new design was proposed where the nipple no longer necked down to attach to the U-pipe. Instead, the nipple was extended and a hole was drilled through it. The nipple was then threaded through the hole, and the entire assembly was welded up, giving a much larger connection area between the U-pipe and the modified nipple. This larger area helped to strengthen the connection and resulted in the schedule 80 support post yielding at the rigid fixed end condition (see Figure 11.7). Figure 11.8 shows a full detailed drawing comparing the new proposed U-bracket design to the current TxDOT design. This simulation predicted that the modified design would have a higher capacity than that of the schedule 80 pipe support.

Figure 11.7. Simulation of Modified Nipple Design.

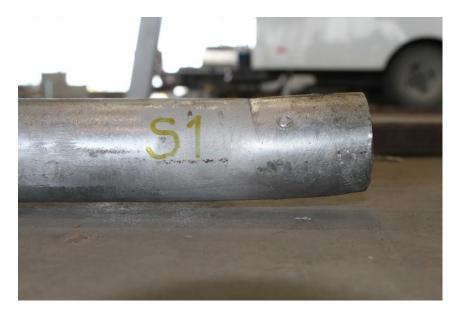
Figure 11.12(b). Image of Deformation to Schedule 80 Pipe Support.

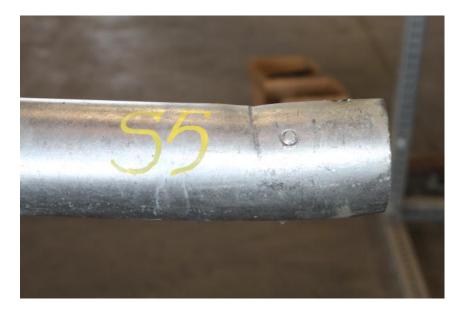
Figure 11.16. Deformation to Schedule 80 Pipe Support.

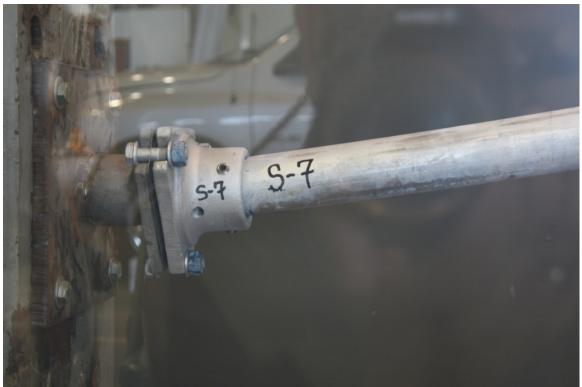
Tests S6 through S8 were performed on the schedule 80 cantilever support. Table A1 notes the maximum loads and displacements from these tests are noted. Figure A2 shows graphs of the load data. In test S8, the bottom bolt released. Figure A3 shows that the other two tests were halted after the post yielded plastically at the slipbase.

Figure A3. Test Sample S7 at Maximum Load.

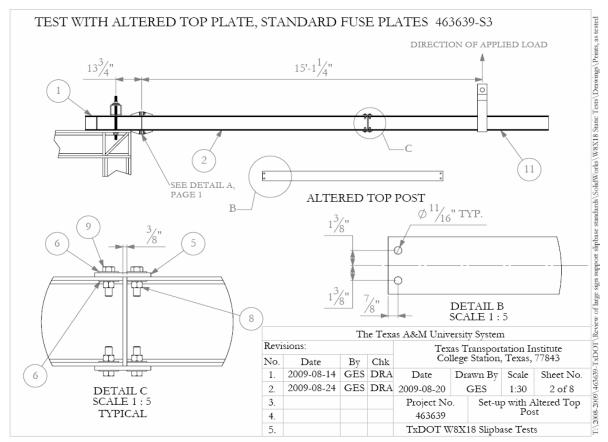
Figure C2. Test Setup for S3.

TxDOT standard fuse plates and slipbase connections were utilized to erect the W8×18 support post section (see Figure C2). The post assembly was then clamped to a load frame 13.75 inches below the slipbase connection. A vertical force was applied to the W8×18 post section in the strong axis direction 16 ft-3 inches above the clamped location. The force was measured by an in-line load cell, and deflection of the support post was measured at the point of load application using a string pot.

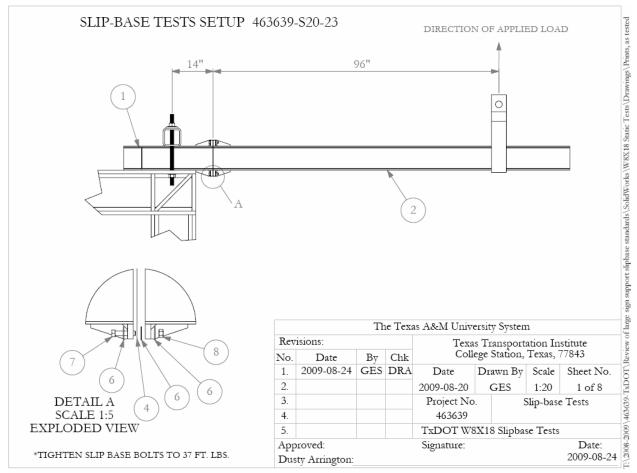
Figure C3. Test Setup for S20-23.

These tests evaluated the capacity of the standard TxDOT slipbase connection for large signs. Two W8×18 post sections were spliced together using a standard TxDOT slipbase connection (see Figure C3). The post assembly was clamped to the load frame 14 inches below the slipbase connection. A vertical load was applied in the strong axis direction of the W8×18 post section 9 -2 inches above the clamped location. An in-line load cell measured the force, and deflection of the support post was measured at the point of load application using a string pot.

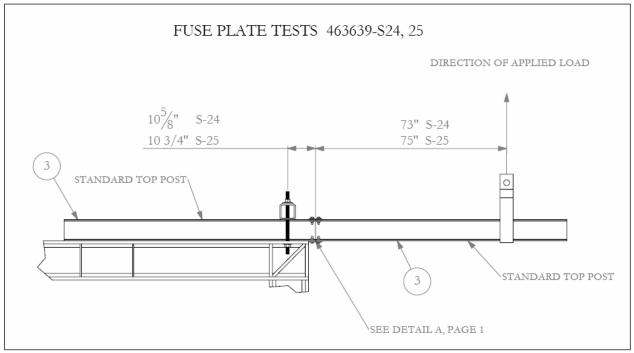
Figure C4. Test Setup for S24 and 25.

These tests evaluated the capacity of a standard splice connection. Two W8×18 post sections were spliced together using a standard TxDOT fuse plate connection (see Figure C4). The test samples were fabricated such that the gap between the spliced post sections was less than  $\frac{1}{8}$  inch. The post assembly was clamped to the load frame approximately 10.75 inches below the slipbase connection. A vertical load was applied in the strong axis direction of the W8×18 post section approximately 7 ft above the clamped location. Figure C4 has the actual distances for each test. An in-line load cell measured the force, and deflection of the support post was measured at the point of load application using a string pot.

In Tests S24 and 25, the fuse plate on the tension side of the splice connection ruptured. Figure C9 shows that a similar fuse plate failure was observed in tests S26 and S27 on the separated splice connection.

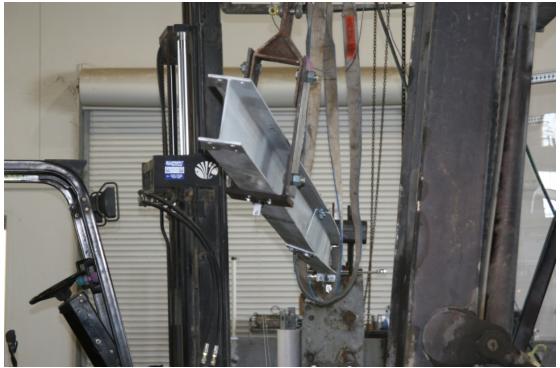
Figure C6. Test Sample S3 at Maximum Load.

In Test S3, the W8×18 support experienced significant twisting due to lateral torsional buckling (LTB), but there was no failure of the splice connection (see Figure C6). Figures C7 and C8 show that in Tests S20, S21, and S23, the nuts stripped off the threads of the slip bolts on the tension side of the slip base assembly. In Test S22, one of the bolts on the tension side of the slip base assembly ruptures and the threads stripped off the other bolt.
