PERFORMANCE EVALUATION OF THE MIDWEST GUARDRAIL SYSTEM – UPDATE TO NCHRP 350 TEST NO. 3-11 (2214MG-1)

MwRSF Research Report No. TRP-03-170-06

October 10, 2006

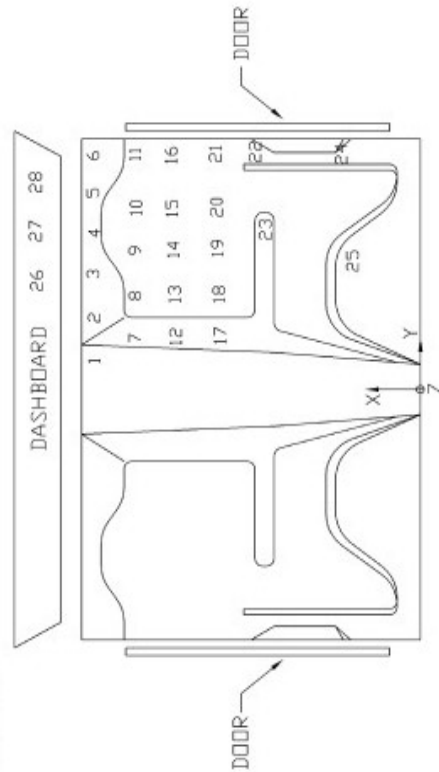
Figure C-1. Occupant Compartment Deformation Data, Test 2214MG-1

Exterior vehicle damage was moderate, as shown in Figures 29 through 32. Occupant compartment deformations to the right side and center of the floorboard, as shown in Figure 32, were judged insufficient to cause serious injury to the vehicle occupants. Maximum longitudinal deflections of 13 mm (0.5 in.) were located near the center of the right-side floor pan. Maximum lateral deflections of 25 mm (1.0 in.) were located near the center of the right-side floor pan. Maximum vertical deflections of 13 mm (0.5 in.) were located near the firewall at the right-front corner and center of the right side. Complete occupant compartment deformations and the corresponding locations are provided in Appendix C.
