**PERFORMANCE EVALUATION OF THE  
FREE-STANDING TEMPORARY BARRIER –  
UPDATE TO NCHRP 350 TEST NO. 3-11 WITH 28"  
C.G. HEIGHT (2214TB-2)**

**MIDWEST ROADSIDE SAFETY FACILITY**

MwRSF Research Report No. TRP-03-174-06

October 12, 2006

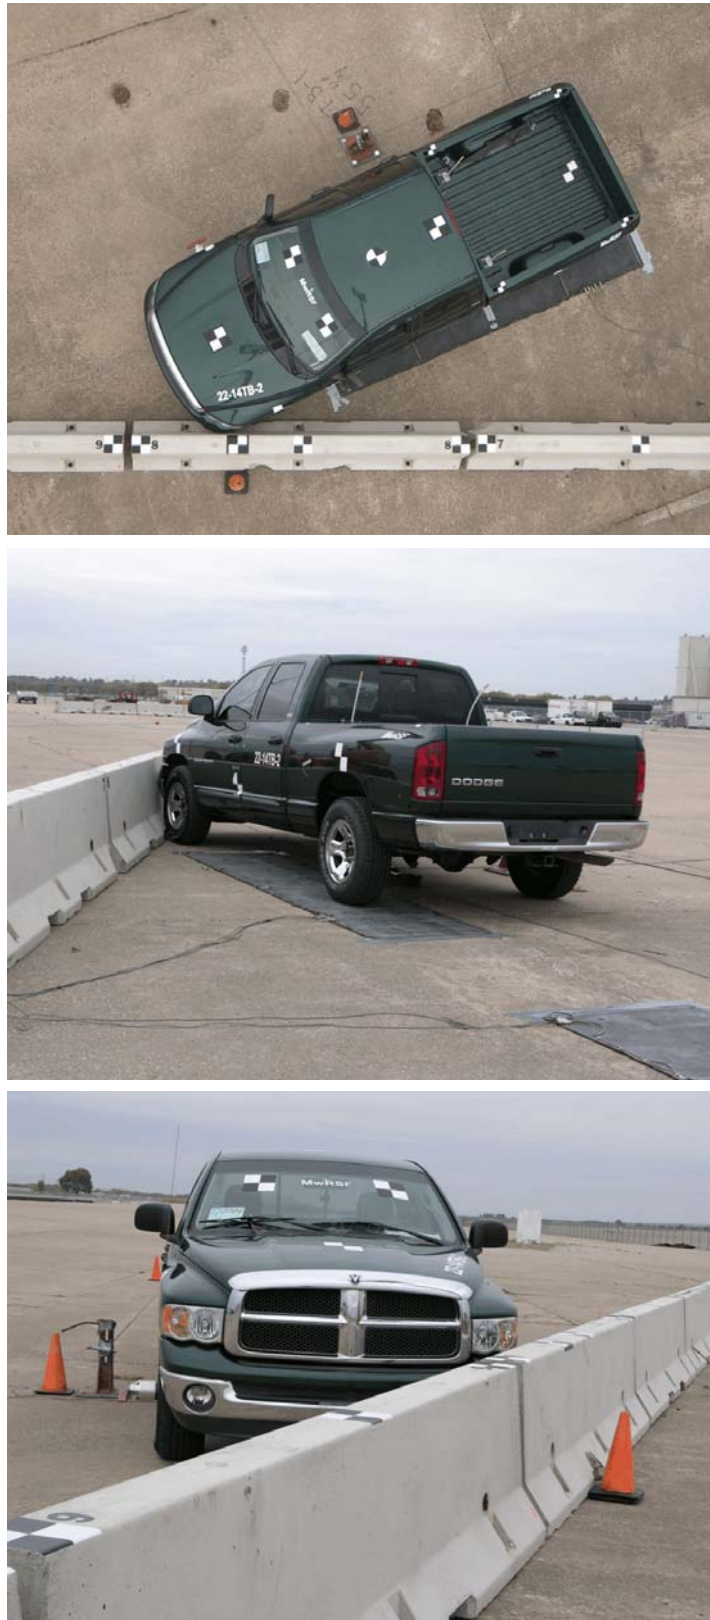
Figure 20. Impact Location, Test 2214TB-2

Initial vehicle impact was to occur 1,219 mm (48 in.) upstream from the center of the gap between barrier nos. 8 and 9, as shown in Figure 20. Actual vehicle impact occurred 1,201 mm (47.3125 in.) upstream from the center of the gap between barrier nos. 8 and 9. At 0.020 sec after impact, the left-front tire rolled up the bottom of barrier no. 8. At 0.036 sec, the left-front corner of the vehicle crushed inward as the front of the vehicle was located near the joint between barrier no. 8 and 9. At 0.056 sec, barrier nos. 8 and 9 deflected backward. At 0.070 sec, the top of the left-side door was ajar. At 0.078 sec, barrier nos. 8 and 9 continued to deflect backward and the front of the vehicle was located near the middle of barrier no. 9. At 0.122 sec, the vehicle began to redirect. At 0.126 sec, the right-front tire became airborne. At 0.156 sec, the vehicle began to redirect quickly. At 0.170 sec, the vehicle began to roll slightly CCW toward the barrier. At 0.220 sec after impact, the vehicle became parallel to the system with a resultant velocity of 75.6 km/h (47.0 mph). At 0.246 sec, the front of the vehicle pitched upward as the left-front corner rode along the top of the barrier system. At 0.282 sec, the entire left side of the vehicle was in contact with the system. At this same

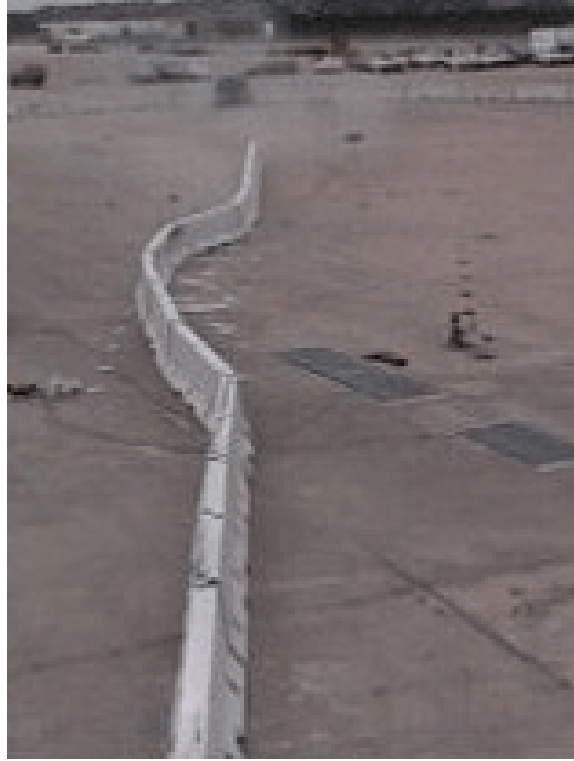
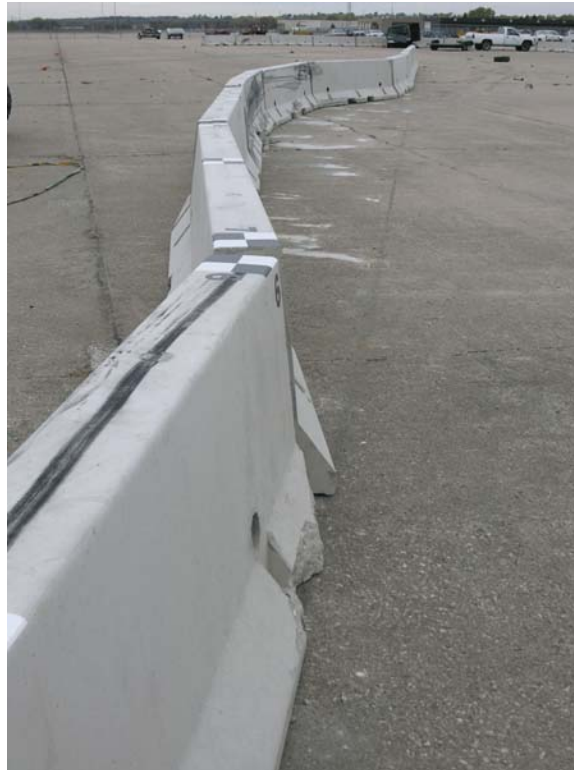
Figure 21. Vehicle Final Position and Trajectory Marks, Test 2214TB-2

time, the right-side tires were airborne. At 0.370 sec, the vehicle was completely airborne but the left side of the vehicle remained in contact with the barrier. At 0.400 sec, the vehicle rolled CCW toward the system. At 0.440 sec, the barriers slid downstream. At 0.452 sec, the front of the vehicle pitched downward as it continued to roll CCW. At 0.498 sec, the vehicle continued to roll CCW. At 0.548 sec, the vehicle encountered increased roll CCW. Prior to 0.554 sec after impact, the left-front tire disengaged from the vehicle. At 0.644 sec, the vehicle exited the system at an angle of 7.9 degrees and a resultant velocity of 72.2 km/h (44.9 mph). At this same, the left-front corner of the vehicle contacted the ground. At 0.774 sec, the vehicle recovered from CCW roll due to the ground contact. At 0.822, the right-front tire contacted the ground. At 1.214 sec, the rear tires contacted the ground. At 1.350 sec, the tailgate partially separated from the rest of the vehicle. At 1.664 sec, the vehicle yawed back toward the system. At 2.260 sec, the right-front tire deflated. The vehicle came to rest 74.63 m (244 ft - 10 in.) downstream from impact and 1.23 m (4 ft - 0.5 in.) laterally behind a line projected parallel to the traffic-side face of the temporary barrier system. The trajectory and final position of the pickup truck are shown in Figures 13 and 21.
