Test Report No. 405160-20
Test Report Date: March 2013

MASH TL-3 TESTING AND EVALUATION OF THE W-BEAM GUARDRAIL ON SLOPE

Contract No.: T4541-AT
Test No.: 405160-20-1 and 405160-20-2
Test Dates: 2012-01-18 and 2012-04-20

TEXAS A&M TRANSPORTATION INSTITUTE PROVING GROUND

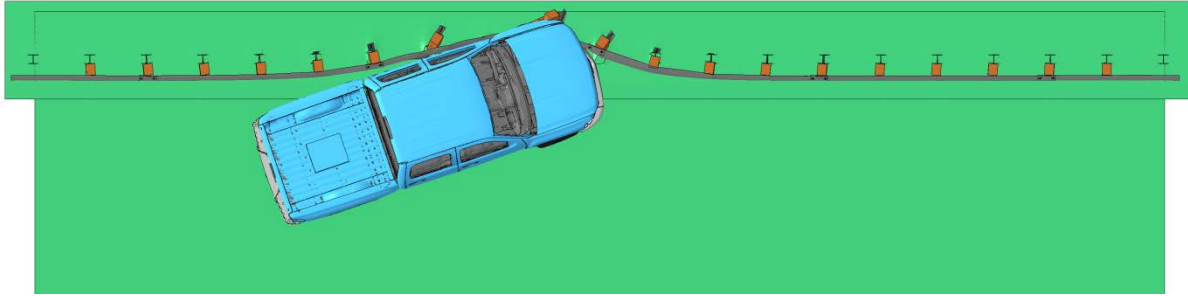
Figure 1.14. Top view of maximum deflection of system for Case 1 simulation.

Figure 1.14 shows the point of maximum deflection which occurred at approximately 0.14 seconds. The rail system reached a maximum deflection of 2.58 ft. At this point, the Silverado model had detached three posts from the rail and the driver side of the pickup truck was in contact with the rail system.

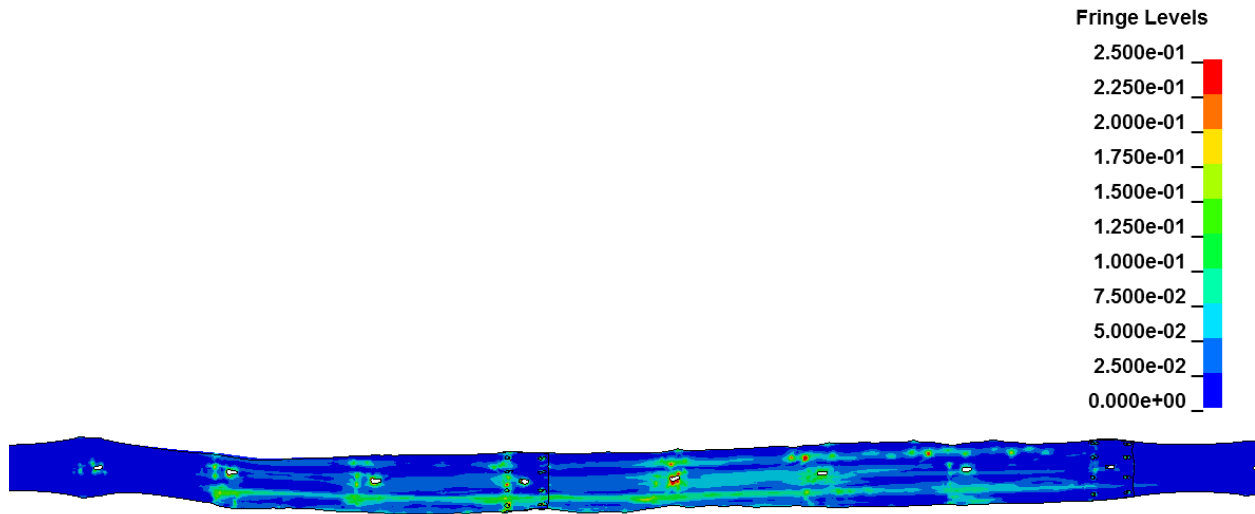
Figure 1.15. Contours of W-beam plastic strain during simulation.

Figure 1.15 shows the contours for the plastic strain within the W-beam at the time of maximum rail deflection. This indicates a low likelihood of rupture of the rail since the plastic strain values are well below rupture strain levels.

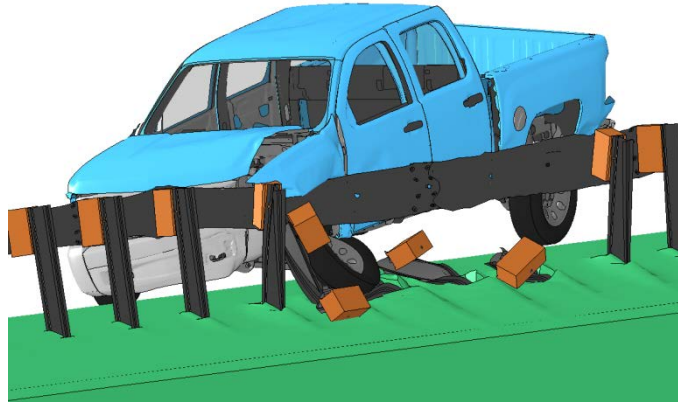
Figure 1.19. Vehicle pocketing and wheel snag upon exit.

The Silverado did not exit the system due to pocketing and wheel snag of the front left tire. The simulation became numerically unstable at this point and terminated.

In simulation Case 1, significant wheel snag and a high ridedown acceleration were observed. In simulation Case 2, with 6 ft-3 inch spacing and 8-ft posts, the 2270P vehicle was successfully redirected and contained without significant wheel snag or pocketing. The occupant risk factors were lower than those resulting from Case 1. Hence, it was recommended to test a guardrail on slope system that represents the design modeled in Case2.

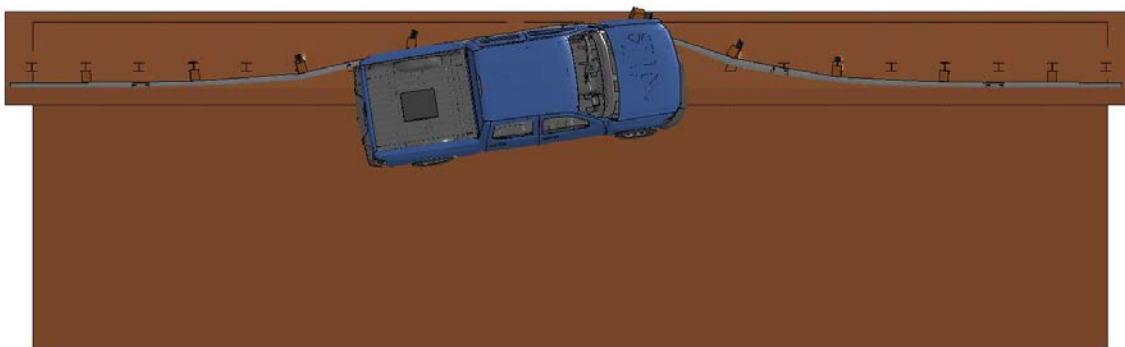
Figure 1.26. Case 2 top view of maximum deflection of system.

Figure 1.26 shows the point of maximum deflection which occurred at approximately 0.23 seconds. The rail system reached maximum deflection of 3.4 ft. At this point the Silverado model had bent five steel posts to the ground and the driver side of the pickup truck was in contact with the rail system.

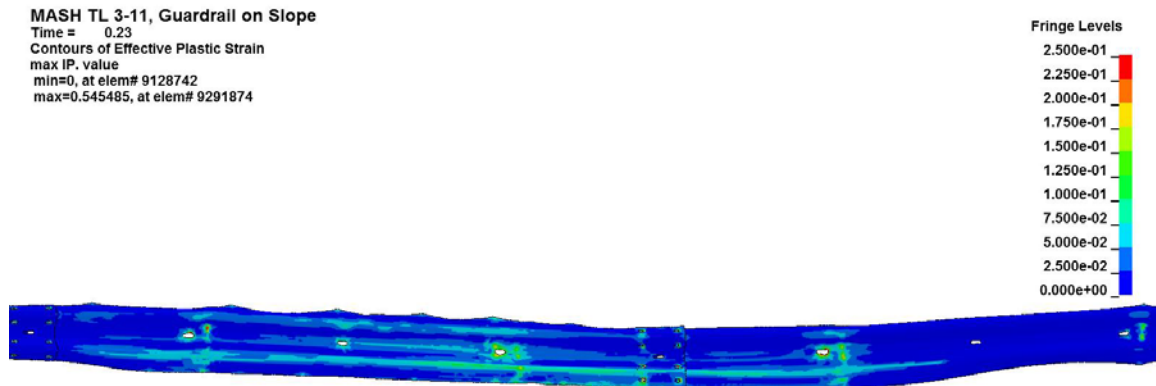
Figure 1.27. Contours of W-beam plastic strain during simulation.

Figure 1.27 shows the contours for the plastic strain within the W-beam at the time of maximum rail deflection. This indicates a low likelihood of rupture of the rail since the plastic strain values are well below rupture strain levels.

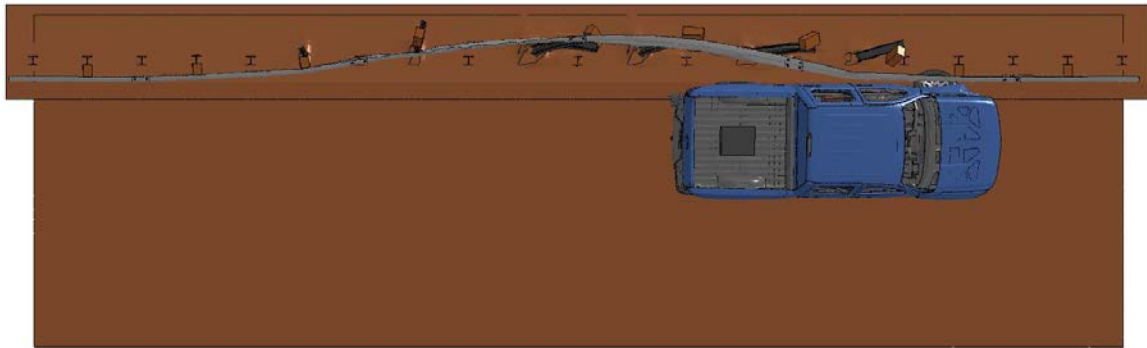
Figure 1.33. Top view of vehicle exit.

The Silverado model exited the rail system at a time of 0.63 seconds and an angle of 21 degrees, as shown in figure 1.33.

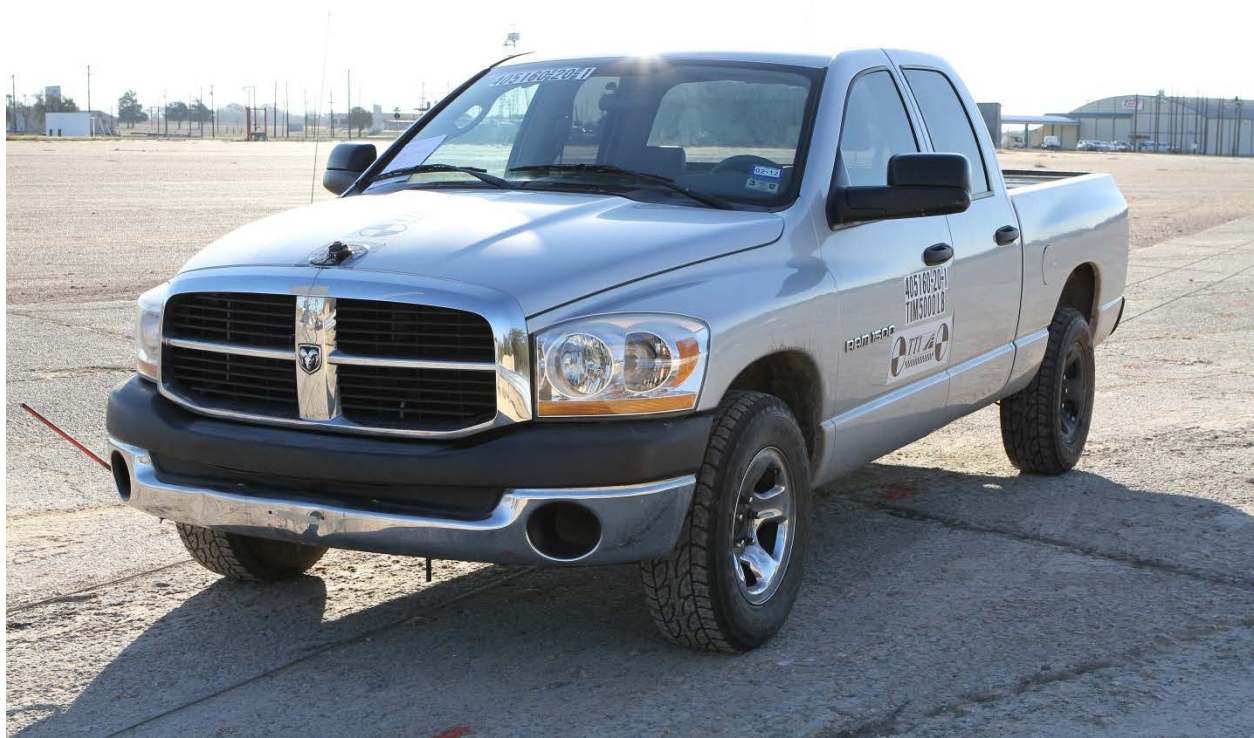
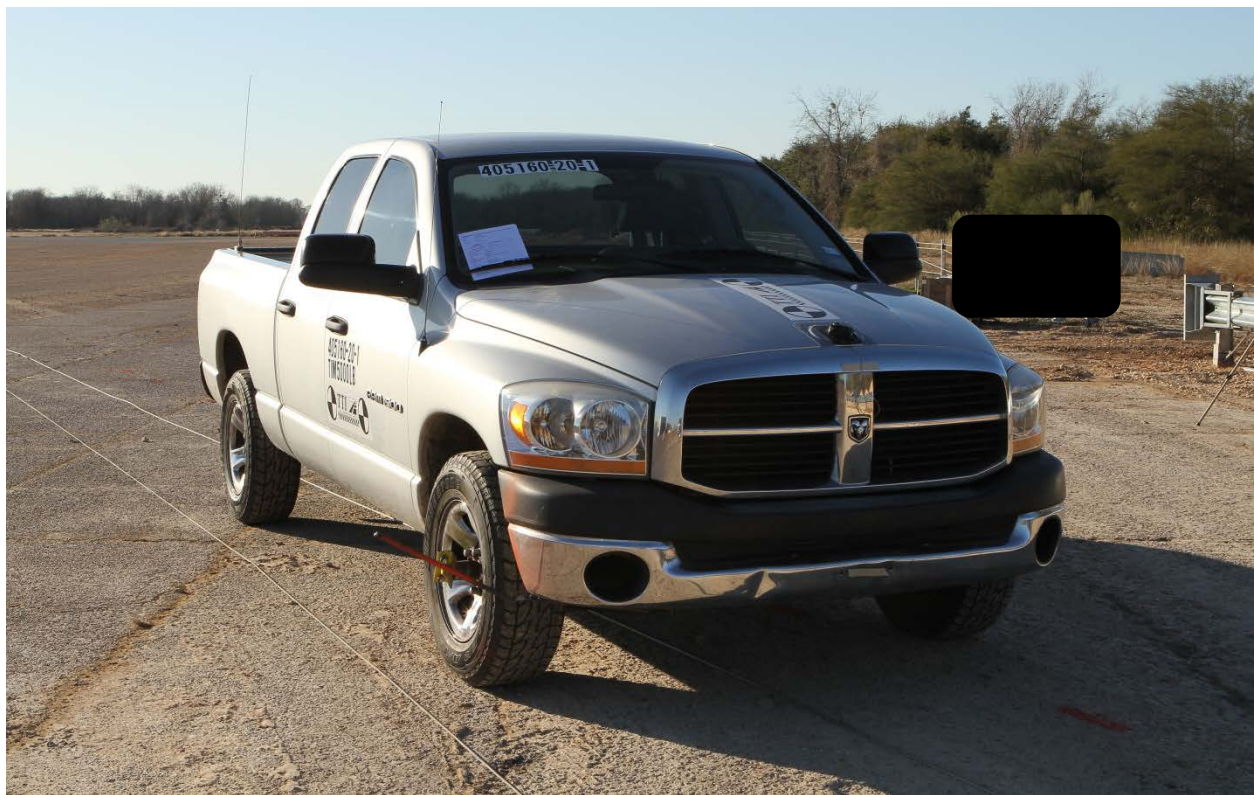
Figure 5.2. Vehicle before test 405160-20-1.

A 2006 Dodge Ram 1500 pickup truck, shown in figures 5.1 and 5.2, was used for the crash test. Test inertia weight of the vehicle was 5044 lb, and its gross static weight was 5044 lb. The height to the lower edge of the vehicle front bumper was 13.75 inches, and the height to the upper edge of the front bumper was 25.38 inches. The height to the center of gravity was 28.62 inches. Additional dimensions and information on the vehicle are given in appendix D, tables D1 and D2. The vehicle was directed into the installation using the cable reverse tow and guidance system, and was released to be free-wheeling and unrestrained just prior to impact.

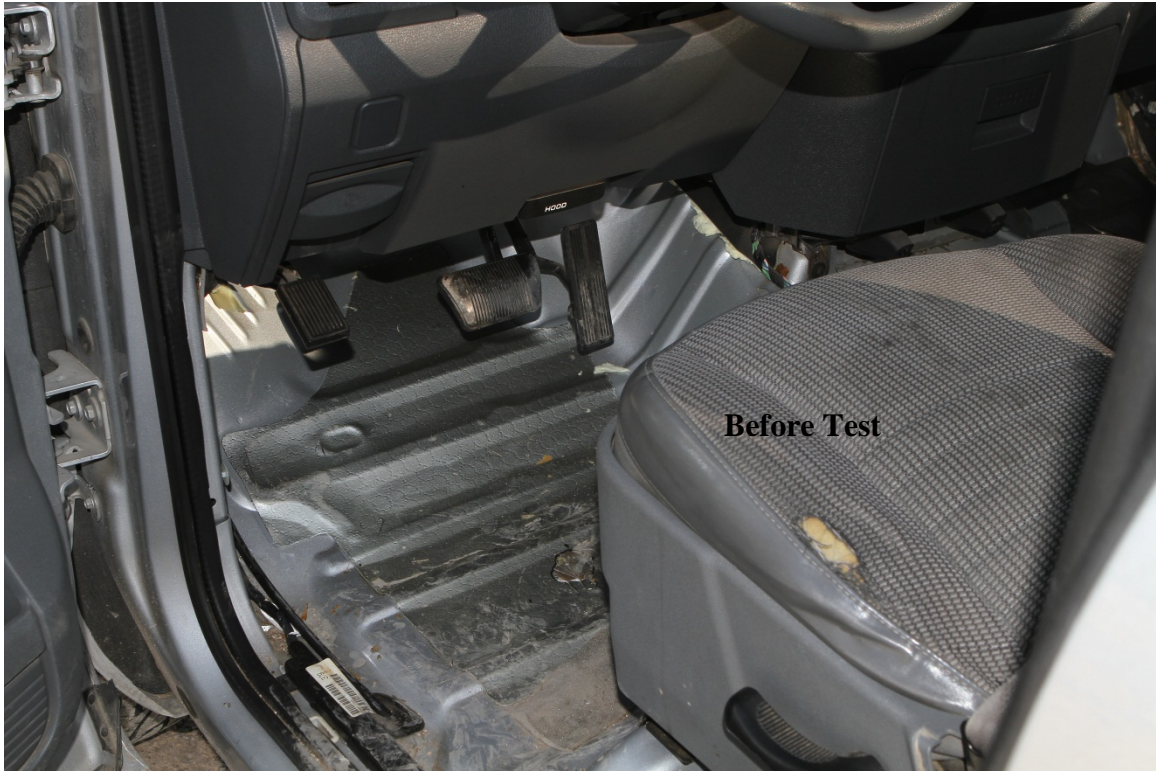
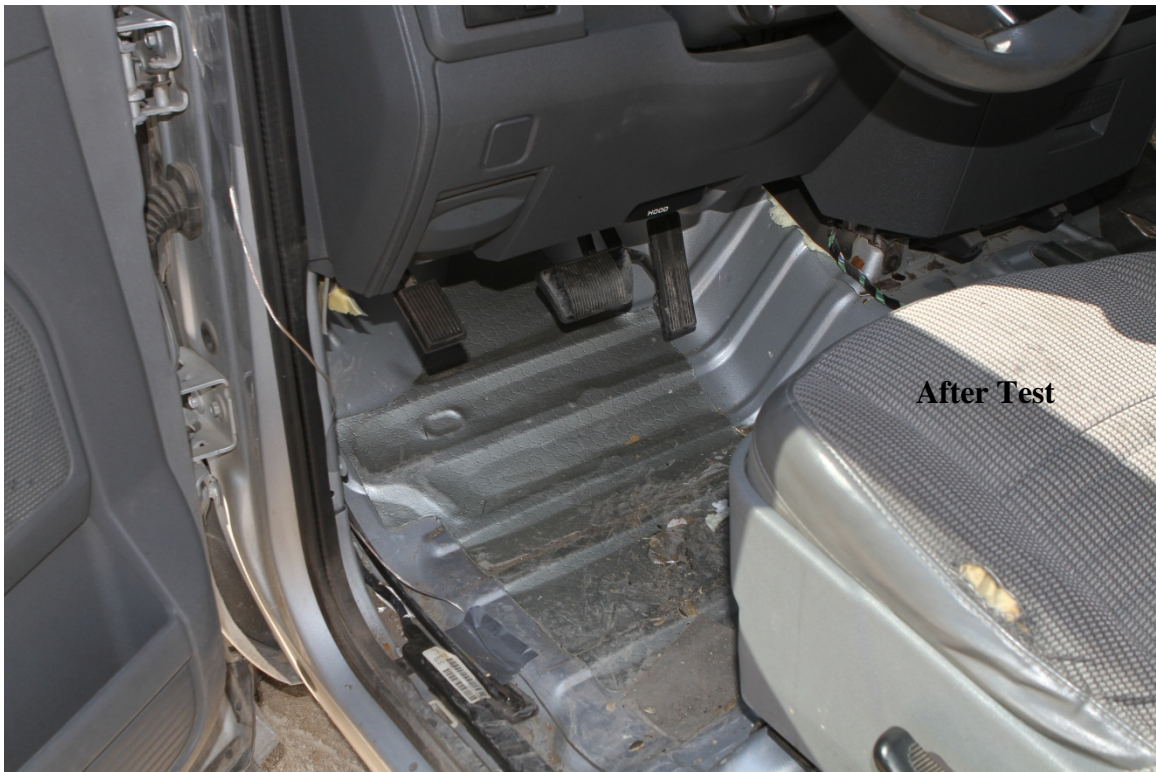
Figure 5.6. Interior of vehicle for test 405160-20-1.

Results: The rail element separated from some of the posts and one blockout separated from a post. However, these elements did not penetrate, nor show potential to penetrate the occupant compartment, nor to present undue hazard to others in the area. (PASS)
No occupant compartment deformation occurred. (PASS)

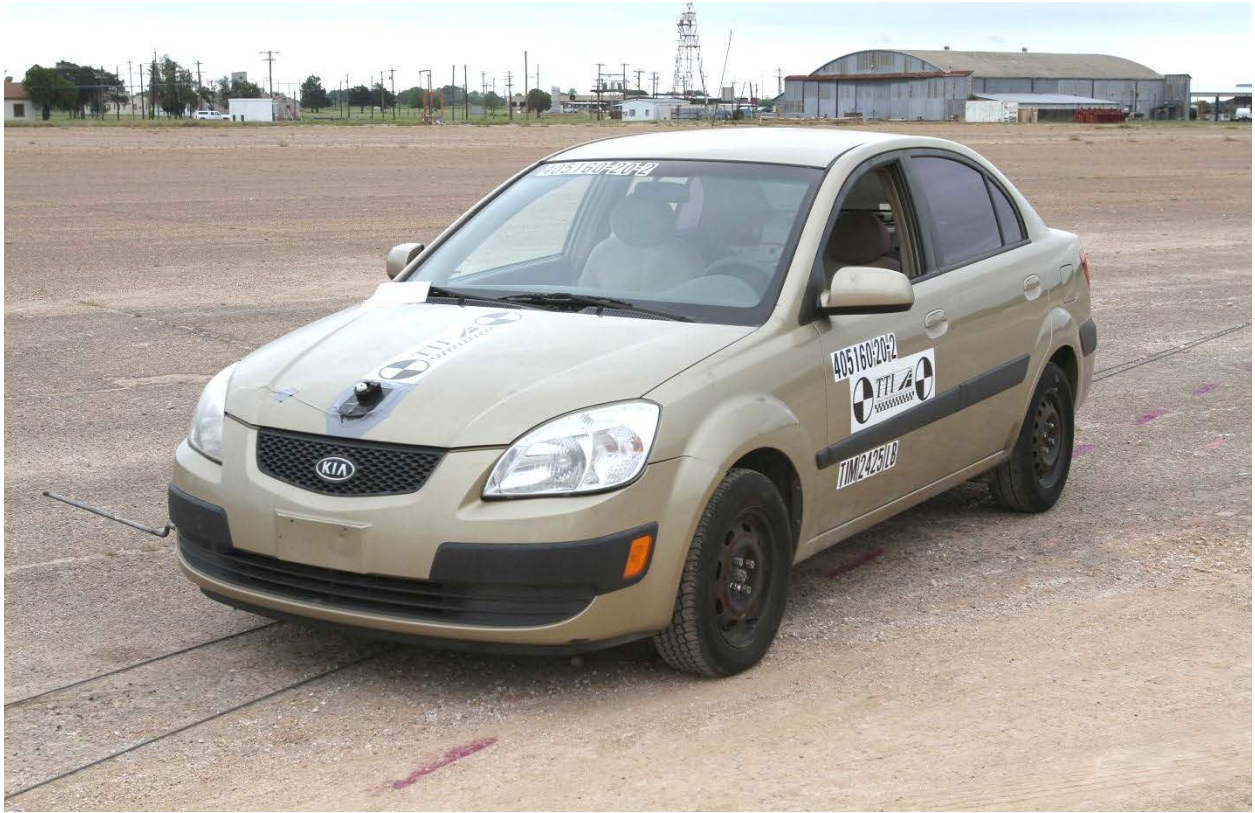
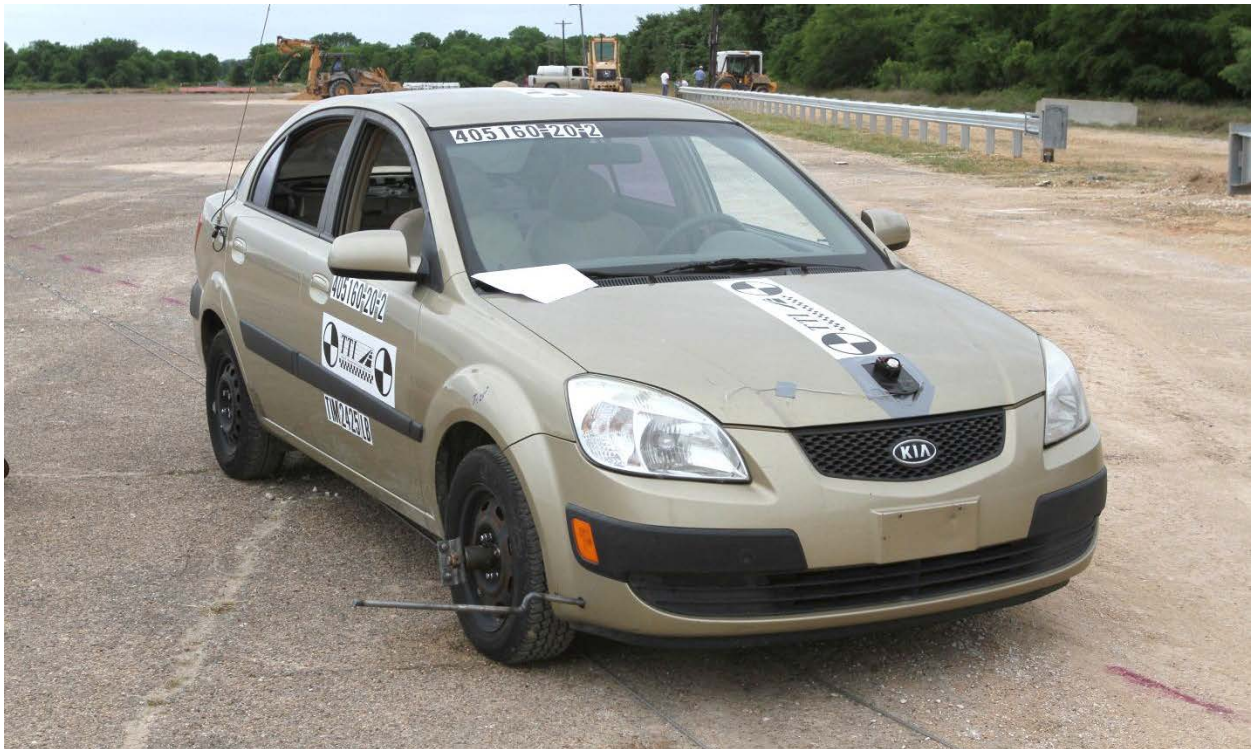
Figure 6.2. Vehicle before test 405160-20-2.

A 2006 Kia Rio, shown in figures 6.1 and 6.2, was used for the crash test. Test inertia weight of the vehicle was 2429 lb, and its gross static weight was 2593 lb. The height to the lower edge of the vehicle front bumper was 7.12 inches, and the height to the upper edge of the front bumper was 21.0 inches. Additional dimensions and information on the vehicle are given in appendix E, table E1. The vehicle was directed into the installation using the cable reverse tow and guidance system, and was released to be free-wheeling and unrestrained just prior to impact.

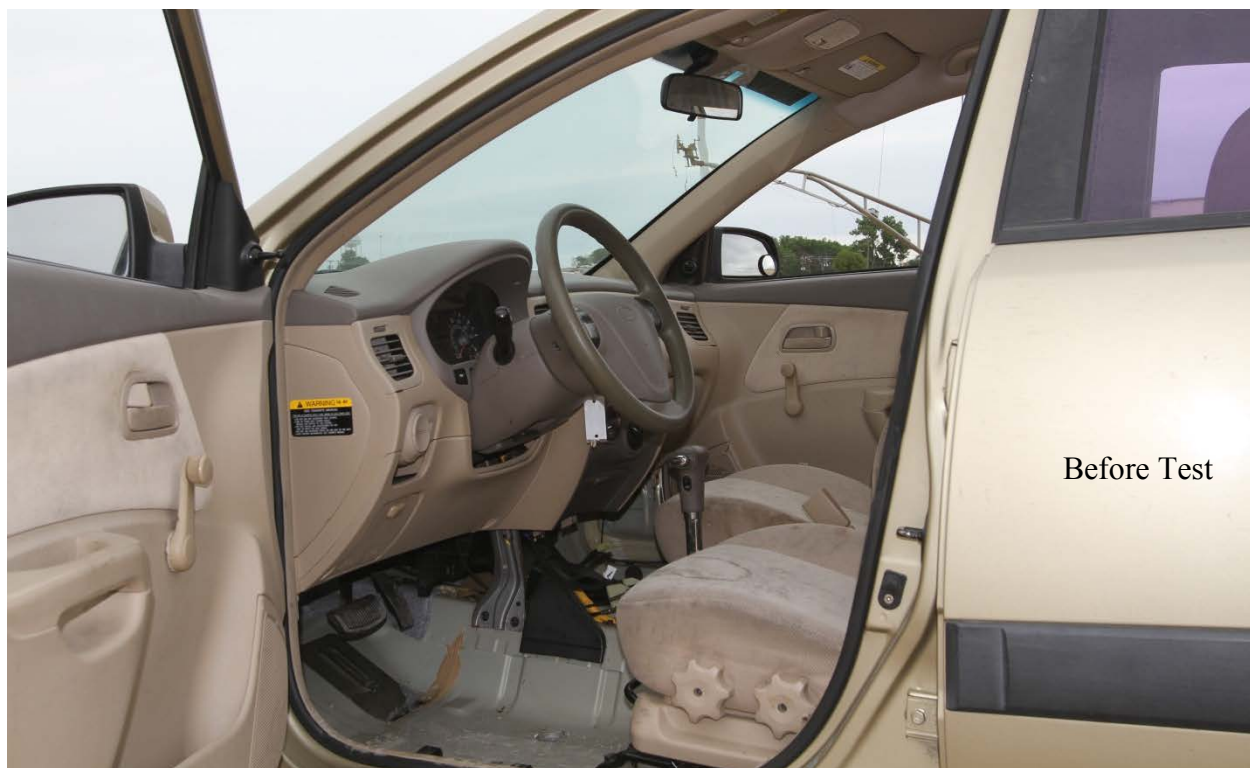
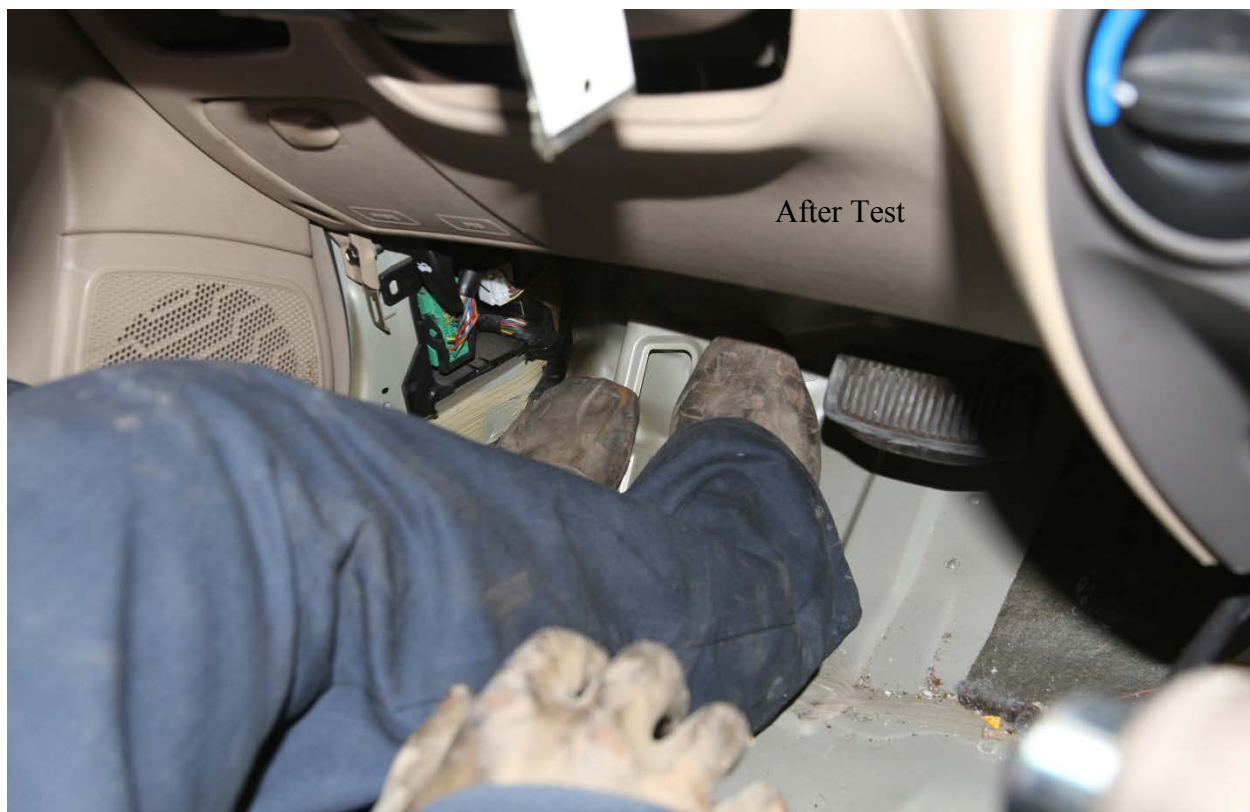
Figure 6.6. Interior of vehicle for test 405160-20-2.

Results: The rail element separated from some of the posts. However, the rail element did not penetrate, nor show potential to penetrate the occupant compartment, nor to present undue hazard to others in the area. (PASS)
No occupant compartment deformation occurred. (PASS)
