CRASH TEST AND EVALUATION OF THE TxDOT T631 BRIDGE RAIL

Test Report 9-1002-12-10

TEXAS A&M TRANSPORTATION INSTITUTE
COLLEGE STATION, TEXAS

TEXAS DEPARTMENT OF TRANSPORTATION

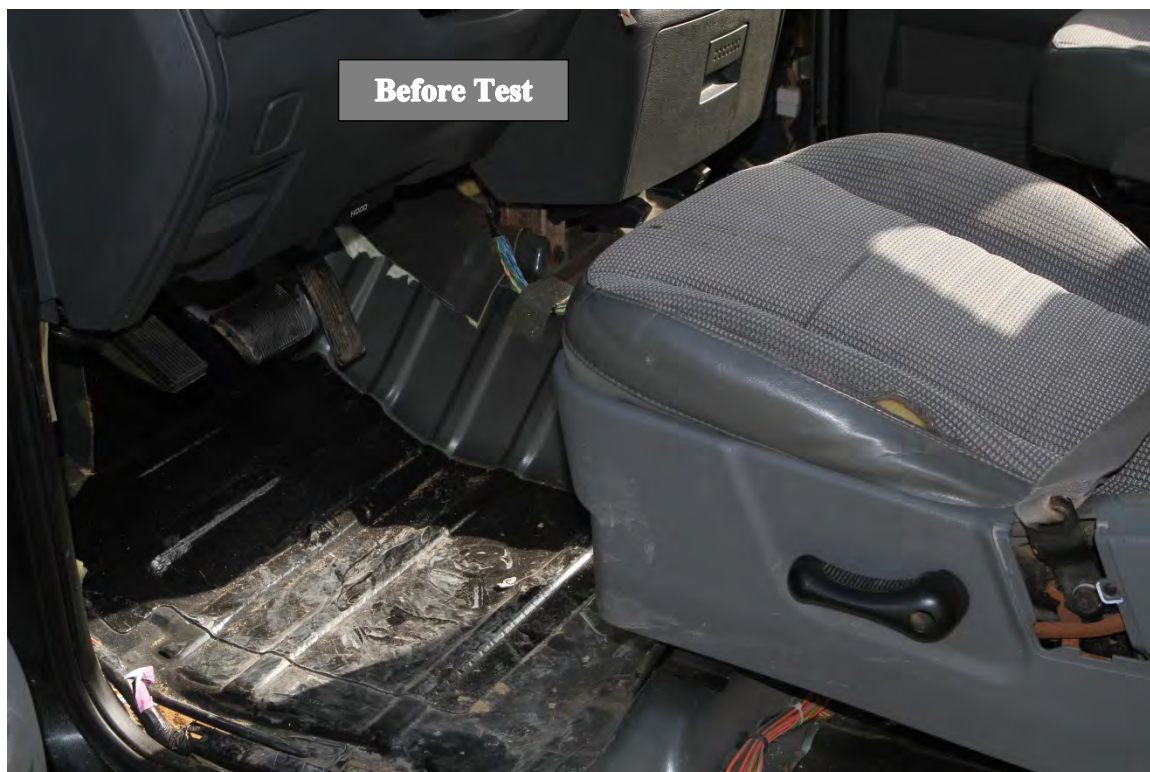
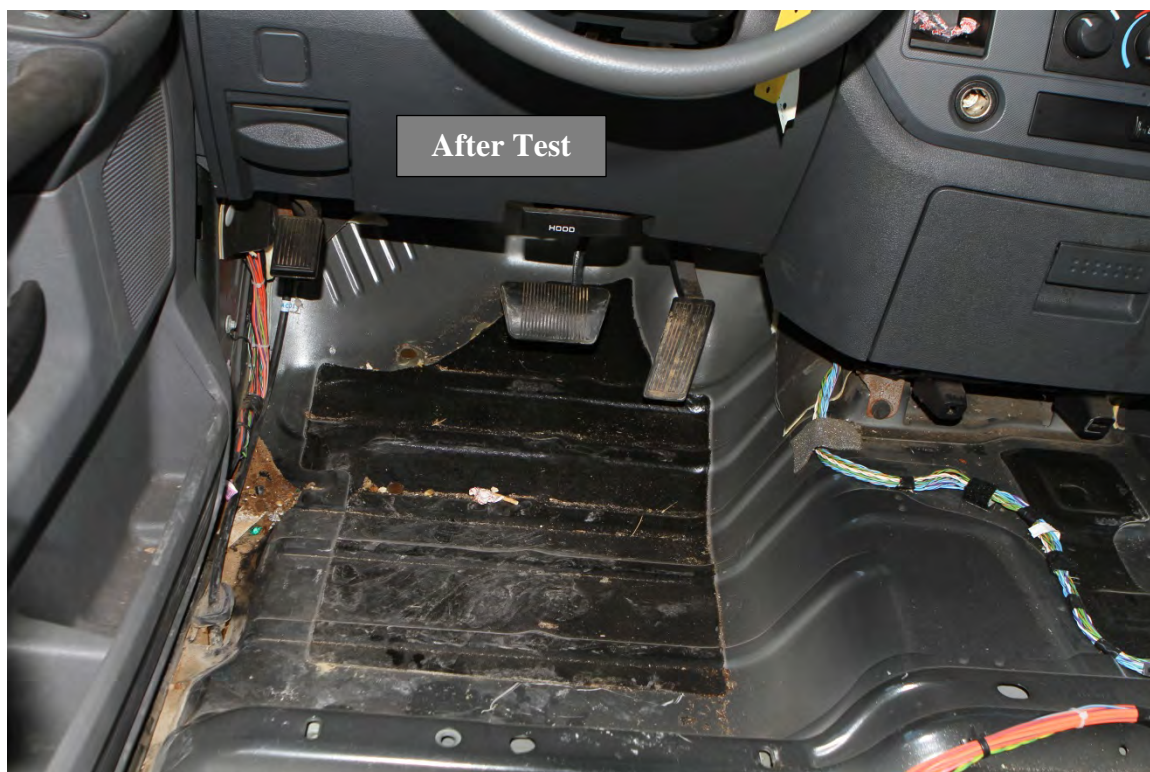
Figure 5.6. Interior of Vehicle for Test No. 490023-6-1a.

Figure 5.5 shows damage to the exterior of the vehicle. The left front wheel assembly broke from the upper and lower ball joints; the left upper and lower ball joints, A-arms, and left front tie rod end were deformed. Also damaged were the front bumper, left front fender, left front brake line, left front door, left front tire and wheel rim, left rear tire, left rear exterior bed, and the left rear bumper. Maximum exterior crush to the vehicle was 6 inches in the side plane at the left front corner at bumper height. No occupant compartment deformation or intrusion occurred. Figure 5.6 provides photographs of the interior of the vehicle. Tables C3 and C4 in Appendix C provide exterior crush and occupant compartment measurements.

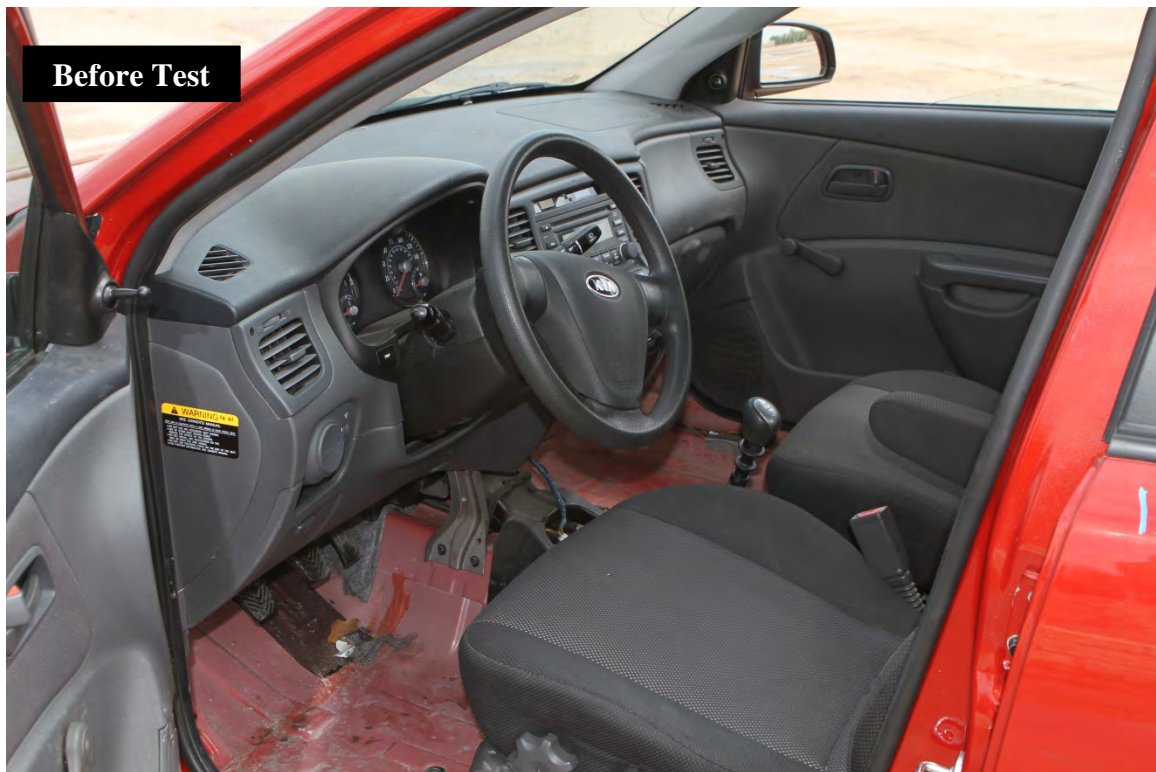
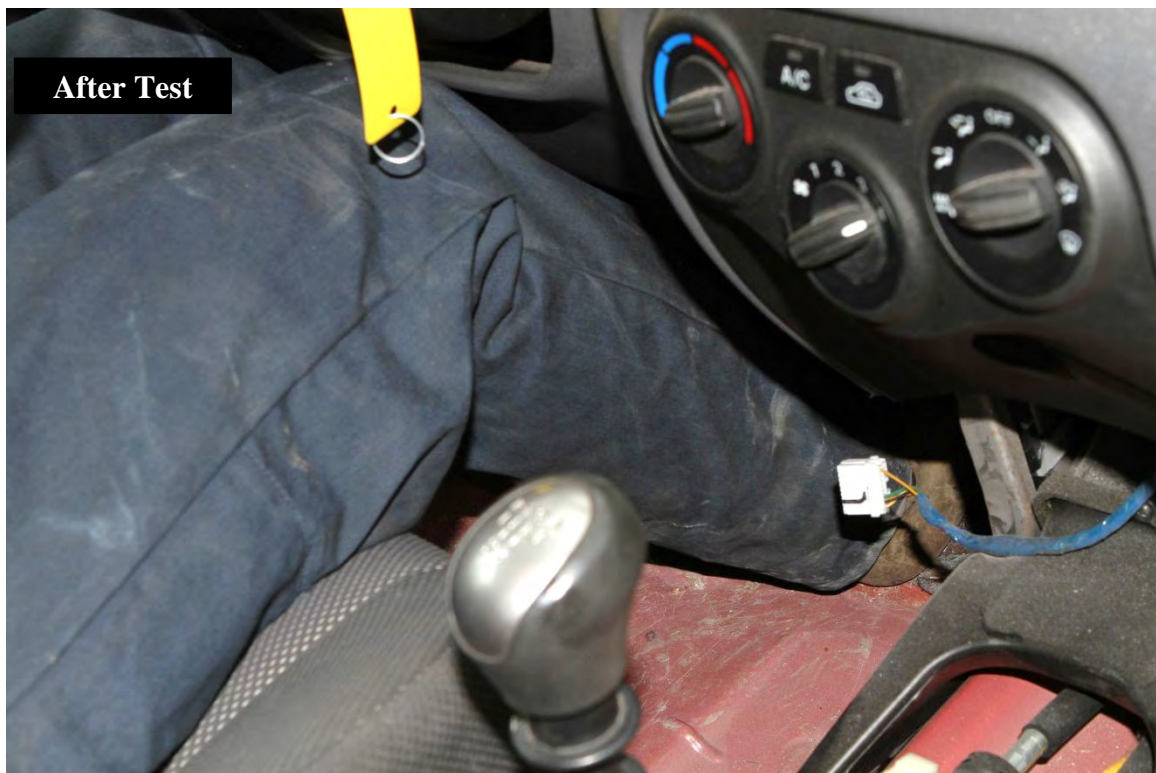
Figure 6.6. Interior of Vehicle for Test No. 490023-6-2.

Figure 6.5 shows damage to the 1100C vehicle. The left strut, strut tower, and left tie rod end were deformed. Also damaged were the front bumper, hood, left front fender, left front tire and wheel rim, and the left front door. Maximum exterior crush to the vehicle was 9.5 inches in the side plane at the left front corner at bumper height. No occupant compartment deformation or intrusion occurred. Figure 6.6 provides photographs of the interior of the vehicle. Tables D3 and D4 in Appendix D provide exterior crush and occupant compartment measurements.

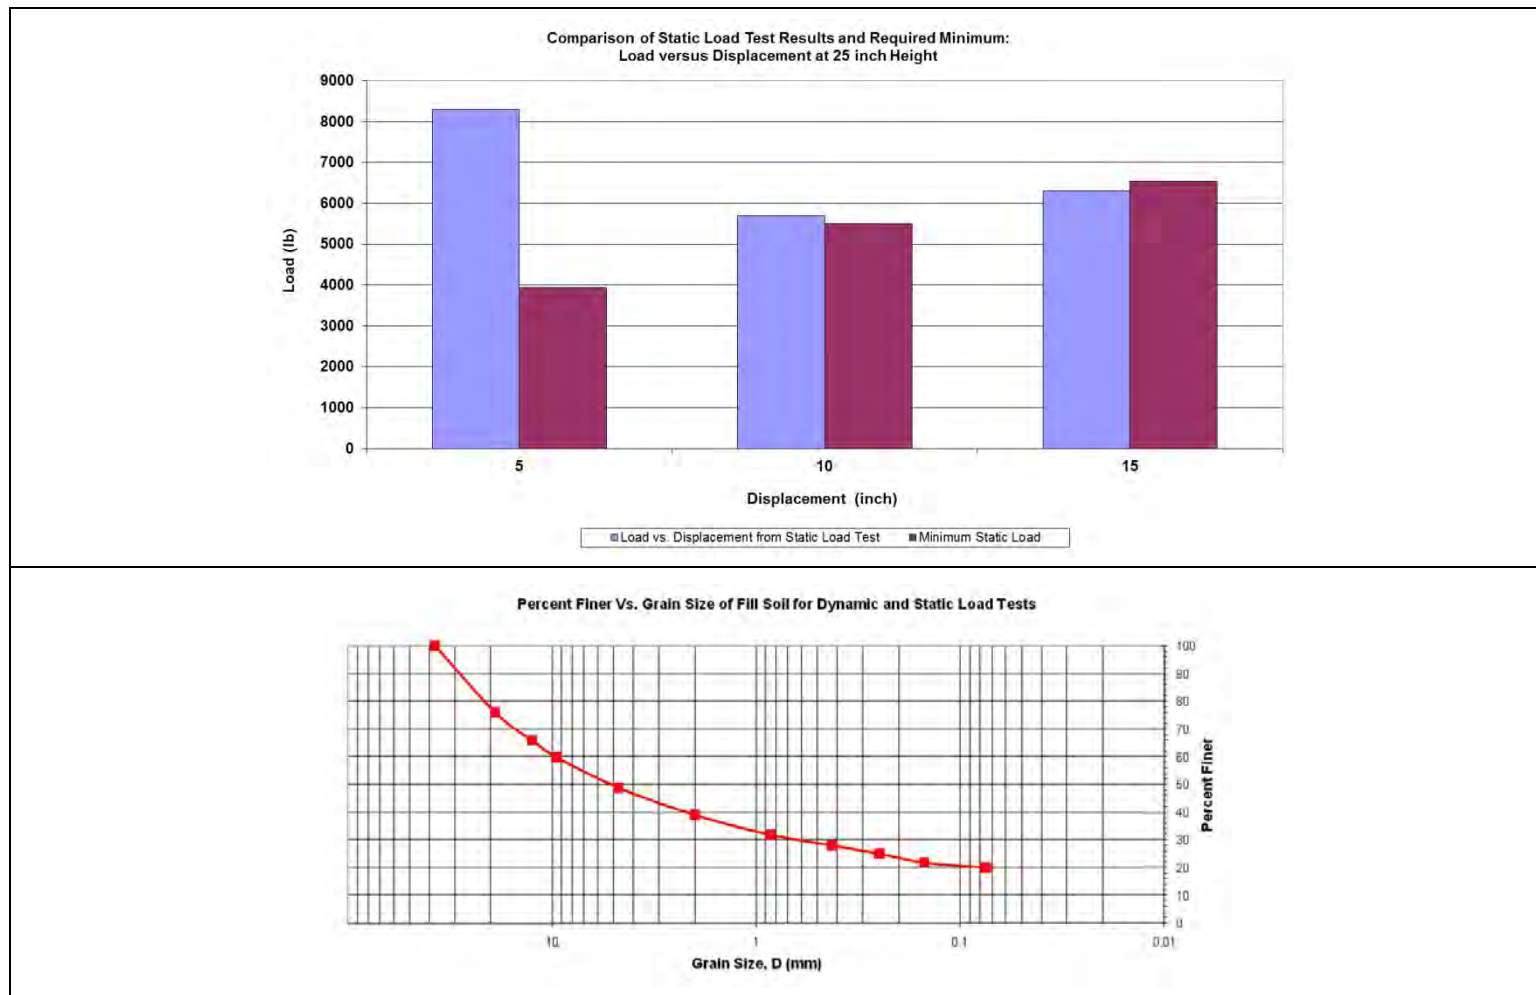
Figure C2. Test Day Static Soil Strength Documentation for Test No. 490023-6-1a.

On the day of Test No. 490023-1a, August 13, 2013, load on the post at deflections of 5 inches, 10 inches, and 15 inches was 8300 lbf, 5700 lbf, and 6300 lbf, respectively. The strength of the backfill material was slightly below minimum requirements at 15 inches (see Figure C2 in Appendix C); however, the soil was considered appropriate for testing. On the day of Test No. 490023-2, August 15, 2013, load on the post at deflections of 5 inches, 10 inches, and 15 inches was 7800 lbf, 8838 lbf, and 7926 lbf, respectively. The strength of the backfill material met minimum requirements (see Figure C3 in Appendix C).
