# CRASH TEST AND EVALUATION OF LOCKING ARCHITECTURAL MAILBOXES

**Test Report No. 9-1002-12-9**

**TEXAS A&M TRANSPORTATION INSTITUTE  
COLLEGE STATION, TEXAS**

**TEXAS DEPARTMENT OF TRANSPORTATION**

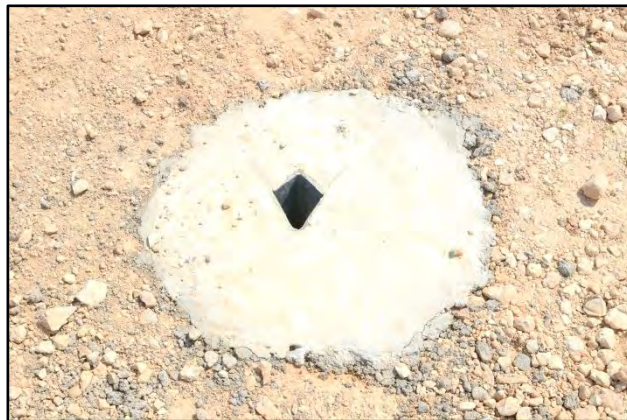
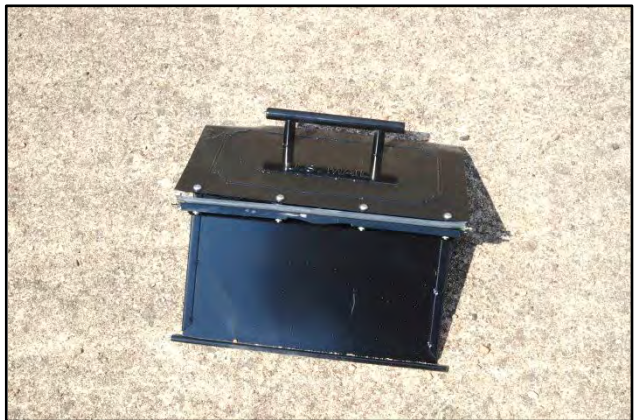
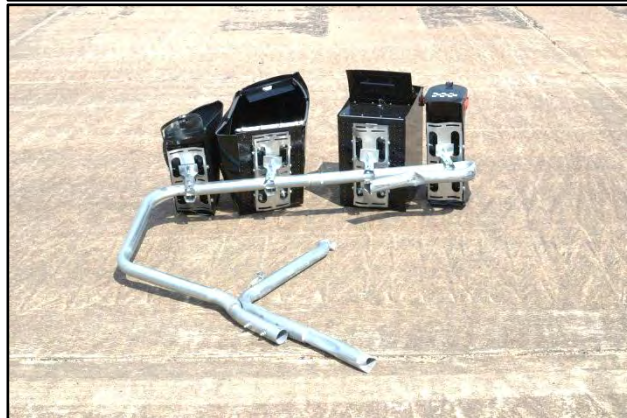
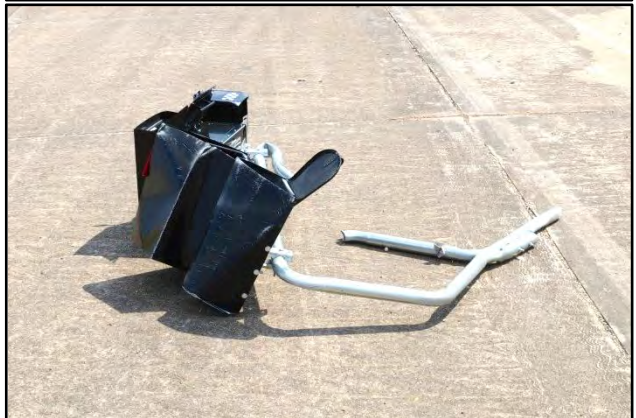
**Figure 6.21. Installation after Test No. 490023-9-6.**

Figures 6.20 and 6.21 show damage to the mailbox installation. The support pulled out of the foundation socket and was fractured on the impact side. The mailboxes remained attached

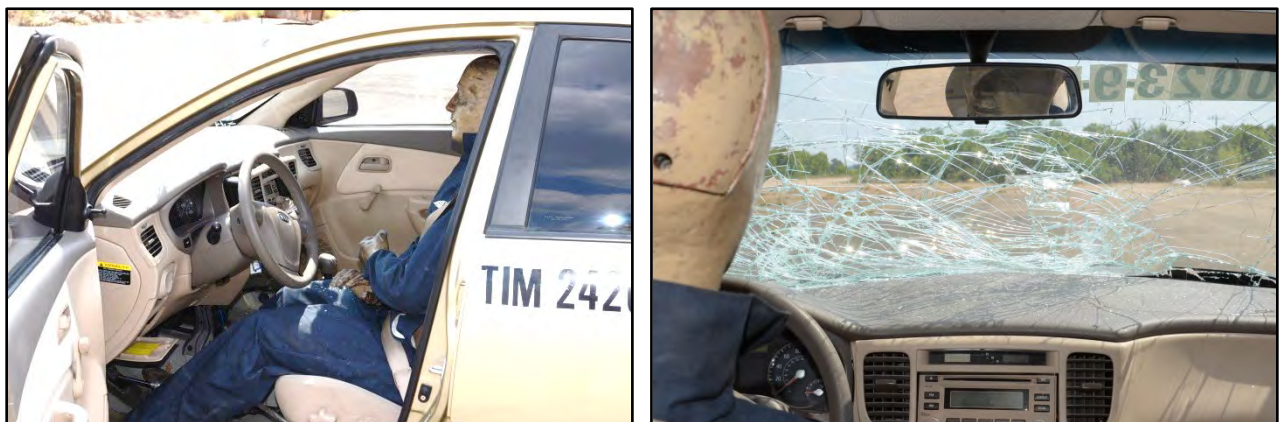
**Figure 6.23. Interior of Vehicle for Test No. 490023-9-6.**

The hood of the vehicle was dented and pushed downward. The windshield was shattered and pushed into the occupant compartment 3.5 inches and there were several small tears at the bottom edge of the windshield behind the dashboard. Figure 6.22 shows damage to the exterior of the vehicle, and Figure 6.23 shows the interior of the vehicle. Tables F2 and F3 in Appendix F provide exterior crush and occupant compartment measurements.

Results: Contact of the locking architectural mailboxes and standard mailboxes on multiple-mount support with the windshield caused several small tears at the base of the windshield. (FAIL)  
Maximum occupant compartment deformation was 3.5 inches in the windshield on the driver's side. (FAIL)
