Development and Evaluation of the Midwest Guardrail System Placed Adjacent to a 2:1 Fill Slope

*Midwest States Regional Pooled Fund Research Program
Fiscal Year 2004-2005 (Year 15)
Research Project Number SPR-3(017)
NDOR Sponsoring Agency Code RFPF-05-09*

DEVELOPMENT AND EVALUATION OF THE MIDWEST GUARDRAIL SYSTEM (MGS) PLACED ADJACENT TO A 2:1 FILL SLOPE

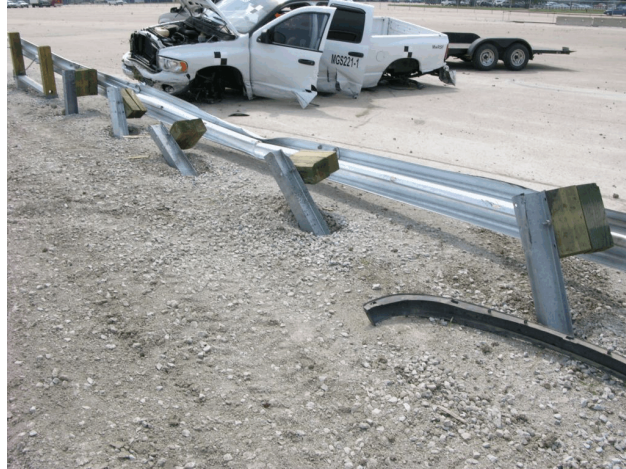
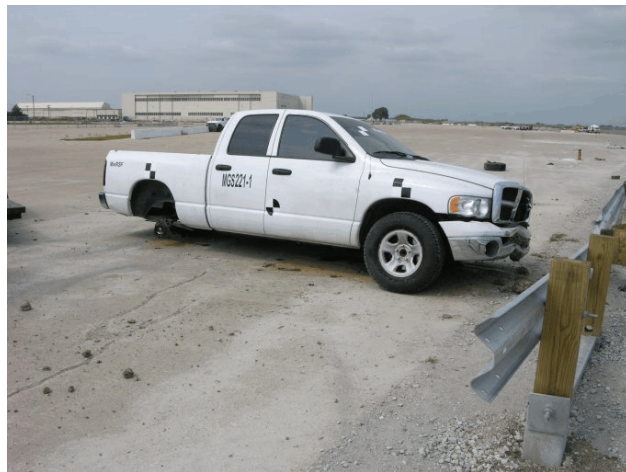
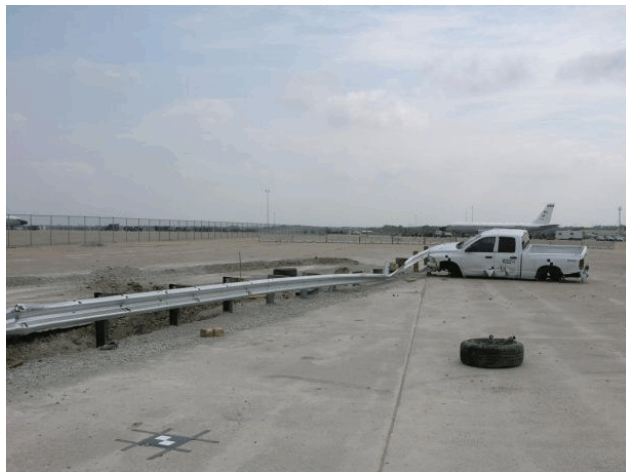
Figure 32. Vehicle Final Position and Trajectory Marks, Test No. MGS221-1

- Exit Conditions
 - Speed N/A
 - Angle N/A
 - Exit Box Criterion N/A
- Post-Impact Trajectory
 - Vehicle Stability Satisfactory
 - Stopping distance 26.3 m downstream

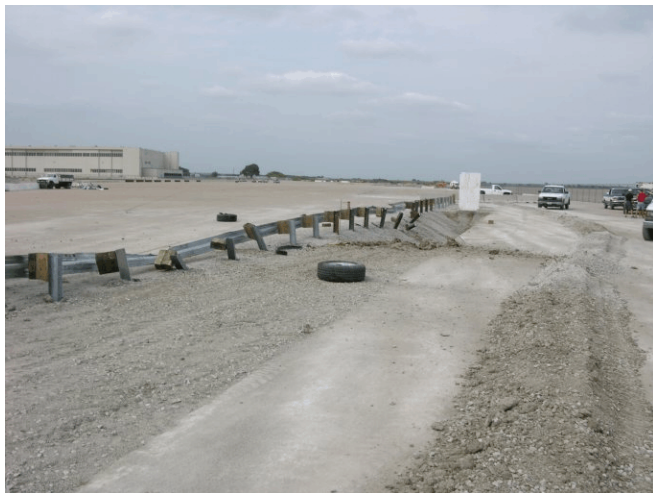
Figure 33. System Damage, Test No. MGS221-1

Damage to the barrier was moderate, as shown in Figures 33 through 41. Barrier damage consisted of deformed guardrail posts, disengaged wooden blockouts, contact marks on a guardrail section and posts, and deformed and fractured W-beam rail. The length of the vehicle contact along the MGS system was approximately 8.8 m (29 ft - 1½ in.), which spanned from 305 mm (12 in.) upstream from the centerline of post no. 13 through the midspan between post nos. 17 and 18.

The permanent set of the barrier system is shown in Figure 33. The maximum lateral permanent set rail and post deflections were 810 mm (31⁷/₈ in.) at the centerline of post no. 16 and 1,086 mm (42³/₄ in.) at post no. 15, respectively, as measured in the field. The maximum lateral dynamic rail and post deflections were 955 mm (37.6 in.) at the centerline of post no. 15 and 1,126 mm (44.3 in.) at post no. 15, respectively, as determined from high-speed digital video analysis.

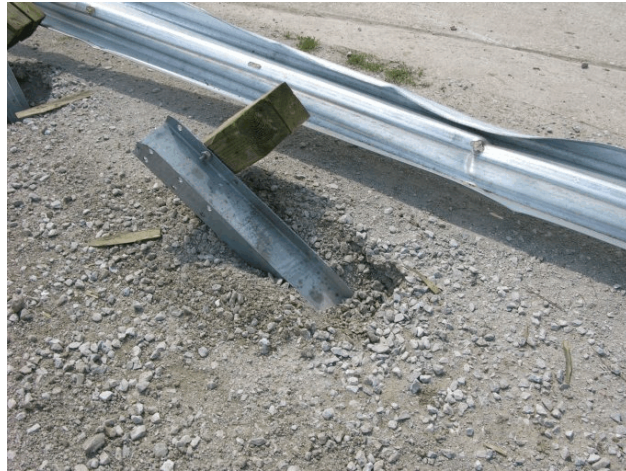
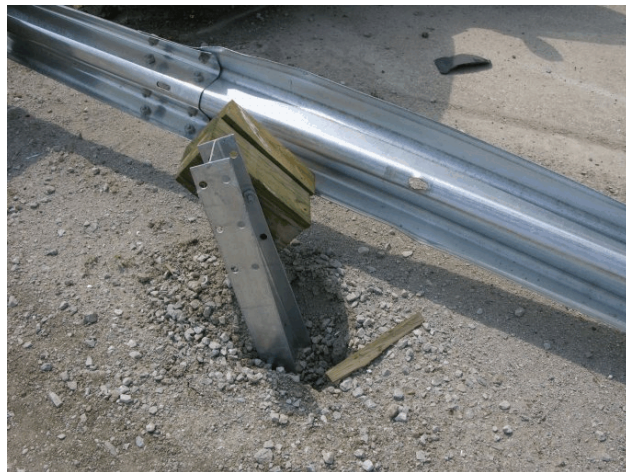
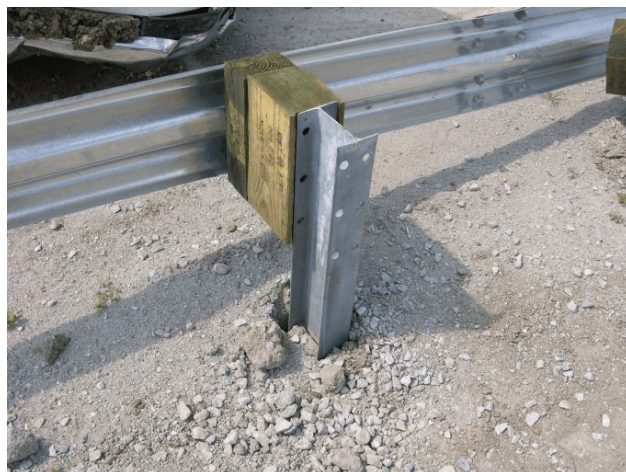
Figure 39. Post Nos. 25 through 27 Damage, Test No. MGS221-1

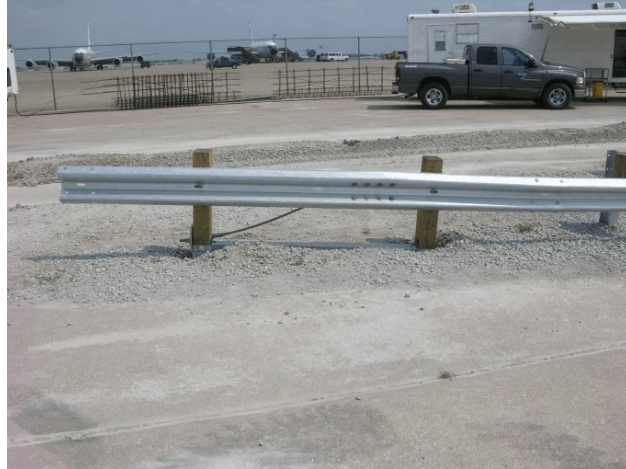
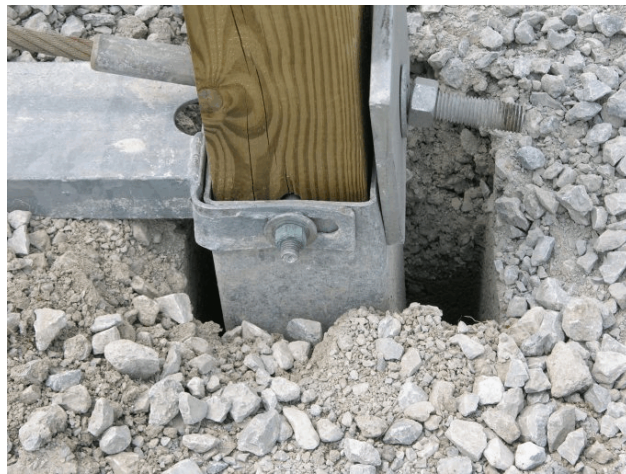
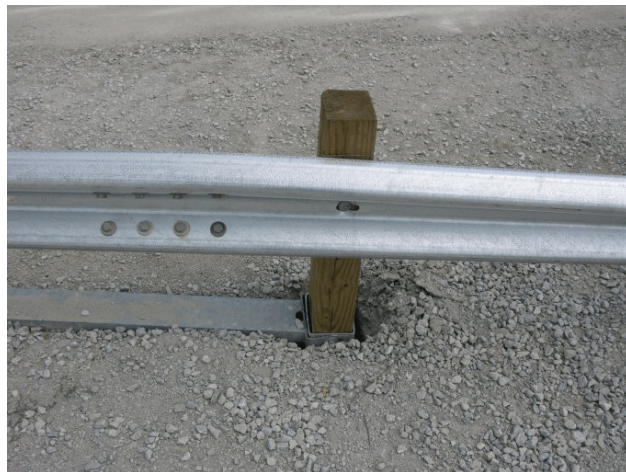
Figure 40. Upstream Anchorage Damage, Test No. MGS221-1

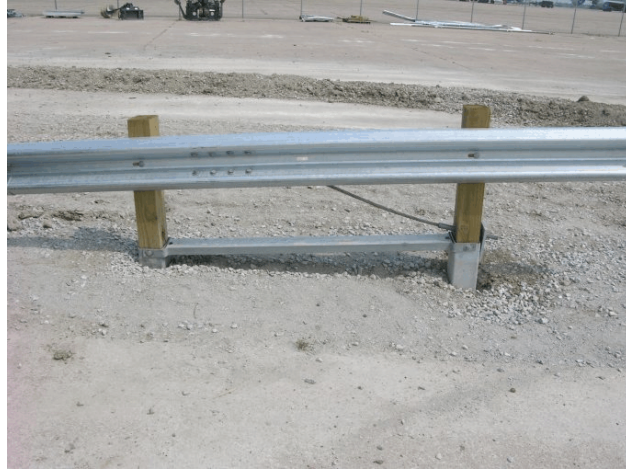
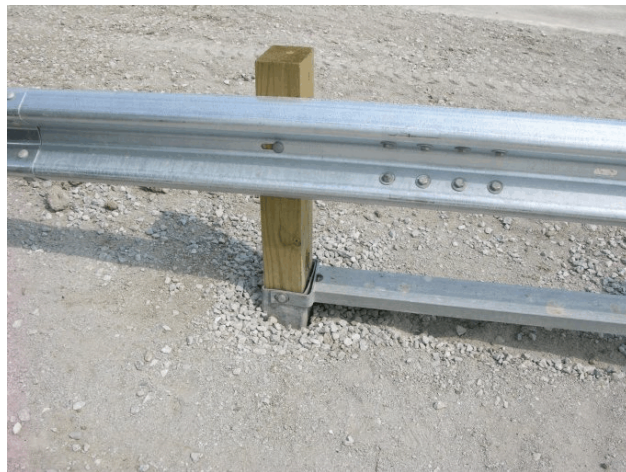
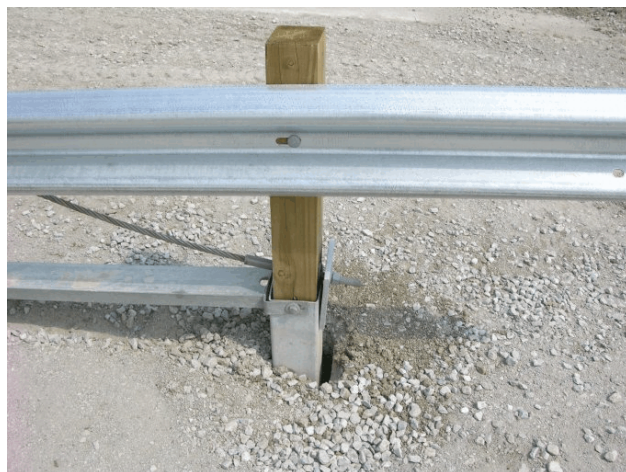
Figure 41. Downstream Anchorage Damage, Test No. MGS221-1

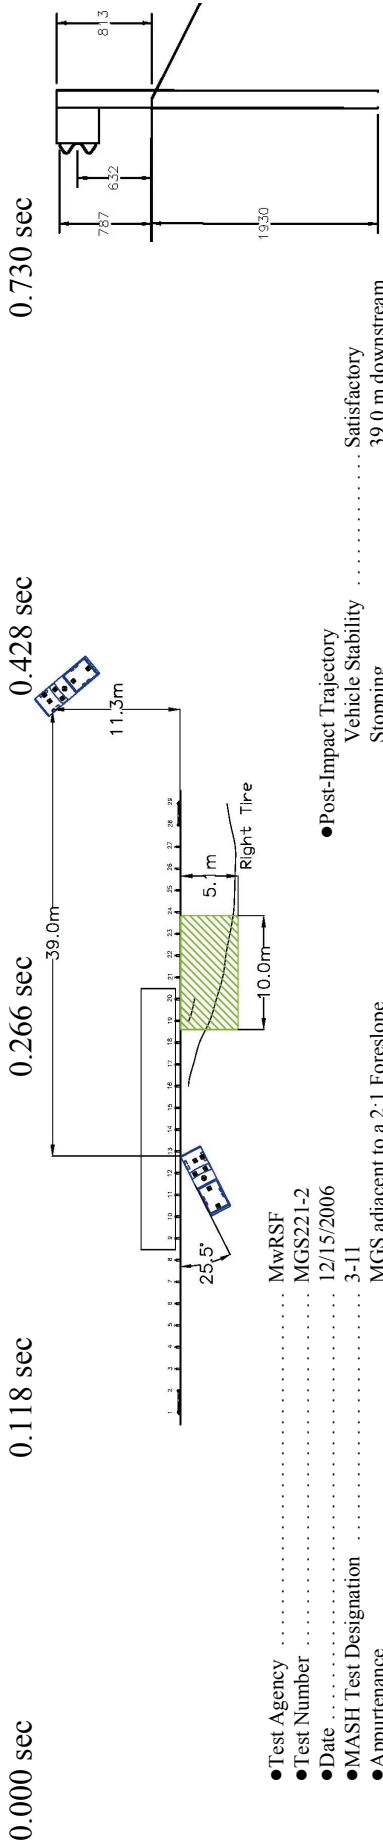
- Post-Impact Trajectory
Vehicle Stability Satisfactory
Stopping 39.0 m downstream
11.3 m laterally behind
- Occupant Impact Velocity (EDR-3)
Longitudinal -4.24 m/s < 12.2 m/s
Lateral 4.15 m/s < 12.2 m/s

- Occupant Ride Down Deceleration (EDR-3)
Longitudinal -5.36 g's < 20.49 g's
Lateral 5.28 g's < 20.49 g's
- Occupant Impact Velocity (EDR-4)
Longitudinal -4.10 m/s < 12.2 m/s
Lateral 4.06 m/s < 12.2 m/s

- Angular Displacements (Estimated from Video)
Roll 6 degrees
Pitch 5 degrees
Yaw 45 degrees

Figure 50. Summary of Test Results and Sequential Photographs, Test No. MG221-2

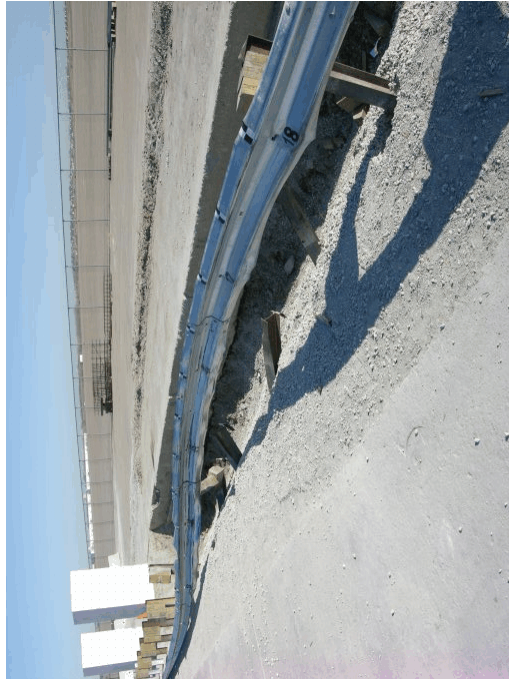
Figure 58. System Damage, Test No. MGS221-2

Damage to the barrier was moderate, as shown in Figures 58 through 64. Barrier damage consisted of deformed W-beam and guardrail posts, disengaged wooden blockouts, and contact marks on a guardrail section and posts. The length of the vehicle contact along the MGS system was approximately 12.42 m (40 ft - 9 in.), which spanned from 394 mm (15½ in.) upstream of the centerline of post no. 13 through 597 mm (23½ in.) downstream from the centerline of post no. 19.

The permanent set of the barrier system is shown in Figure 58. The maximum lateral permanent set rail and post deflections were 1,067 mm (42 in.) at the midspan between post nos. 15 and 16 and 864 mm (34 in.) at post no. 14, respectively, as measured in the field. The maximum lateral dynamic rail and post deflections were 1,463 mm (57.6 in.) at the centerline of post no. 15 and 805 mm (31.7 in.) at post no. 14, respectively, as determined from high-speed digital video analysis. The working width of the system was found to be 1,631 mm (64.2 in.).

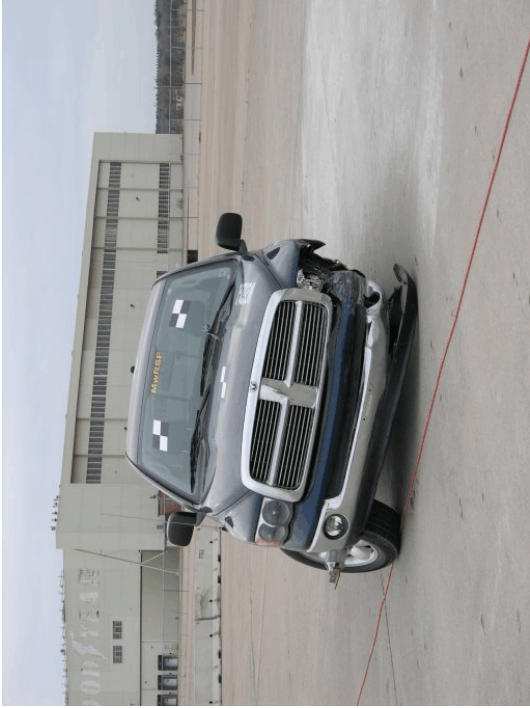
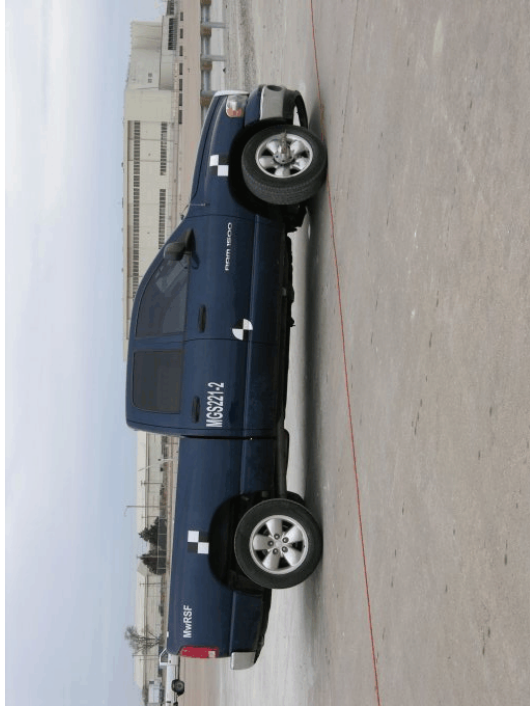
Figure 65. Vehicle Damage, Test No. MGS221-2

Exterior vehicle damage was moderate, as shown in Figures 65 and 66. Occupant compartment deformations to the left side and center of the floor pan were judged insufficient to cause serious injury to the vehicle occupants. Maximum longitudinal deflections of 6 mm (¼ in.) were located throughout the left-side floor pan. Maximum lateral deflections of 13 mm (½ in.) were
