EVALUATION OF BOX BEAM STIFFENING OF UNANCHORED TEMPORARY CONCRETE BARRIERS

MIDWEST ROADSIDE SAFETY FACILITY

MwRSF Research Report No. TRP-03-202-08

March 14, 2008

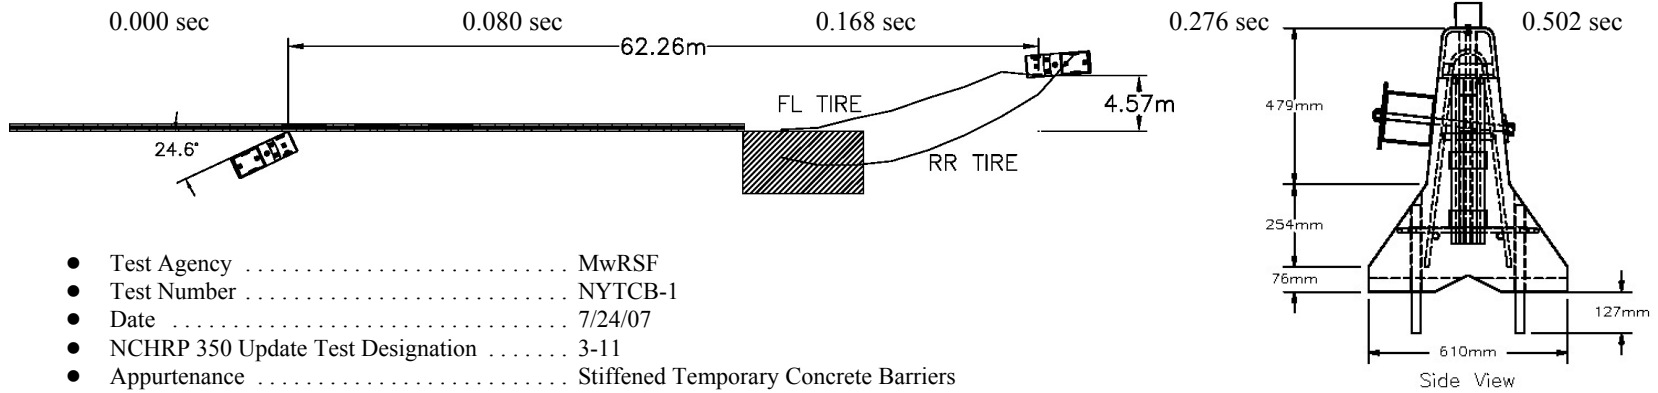
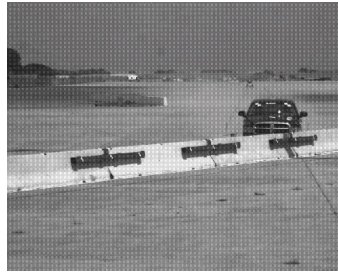
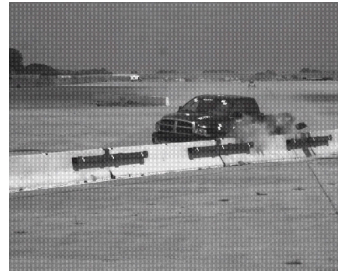
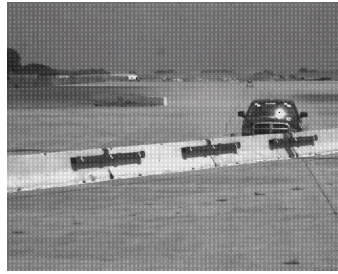
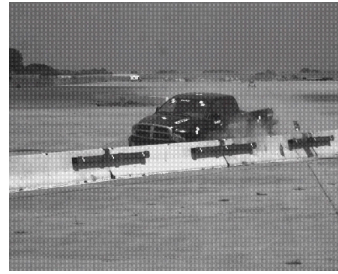
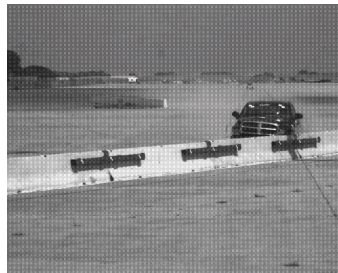
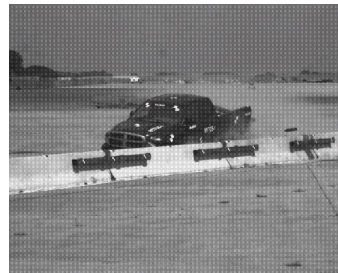
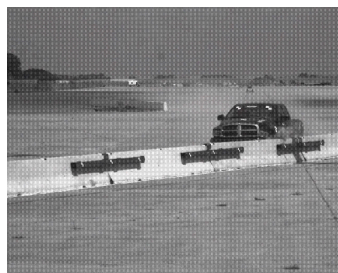
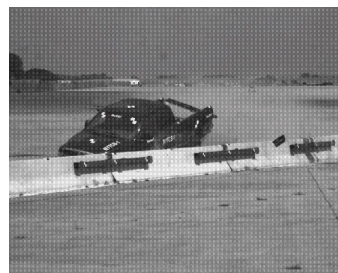
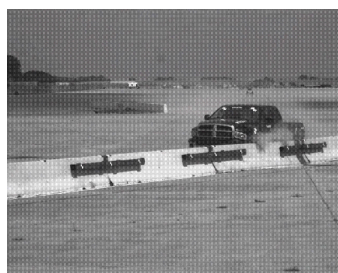
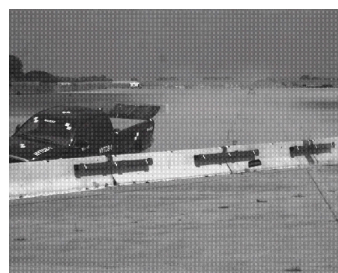
Figure 29. Summary of Test Results and Sequential Photographs, Test NYTCB-1

- Test Agency MwRSF
- Test Number NYTCB-1
- Date 7/24/07
- NCHRP 350 Update Test Designation 3-11
- Appurtenance Stiffened Temporary Concrete Barriers
- Total Length 60.96 m

- Exit Conditions
 - Speed 62.9 km/h
 - Angle 7 deg
 - Exit Box Criterion Pass
- Post-Impact Trajectory
 - Vehicle Stability Satisfactory
 - Stopping Distance 62.3 m downstream
4.6 m laterally behind
- Occupant Impact Velocity
 - Longitudinal -4.67 m/s < 12.2 m/s
 - Lateral 6.33 m/s < 12.2 m/s
- Occupant Ridedown Deceleration
 - Longitudinal 4.72 g's < 20.49 g's
 - Lateral 8.36 g's < 20.49 g's
- THIV (not required) 7.45 m/s
- PHD (not required) 8.71 g's
- Test Article Damage Moderate
- Test Article Deflections
 - Permanent Set 660 mm
 - Dynamic 700 mm
 - Working Width 1,311 mm
- Vehicle Damage Moderate
 - VDS¹³ 11-LFQ-3
 - CDC¹⁴ 11-LYEN2
 - Maximum Deformation 38 mm
- Angular Displacements
 - Roll -10.5 deg
 - Pitch -11.4 deg
 - Yaw 28.0 deg

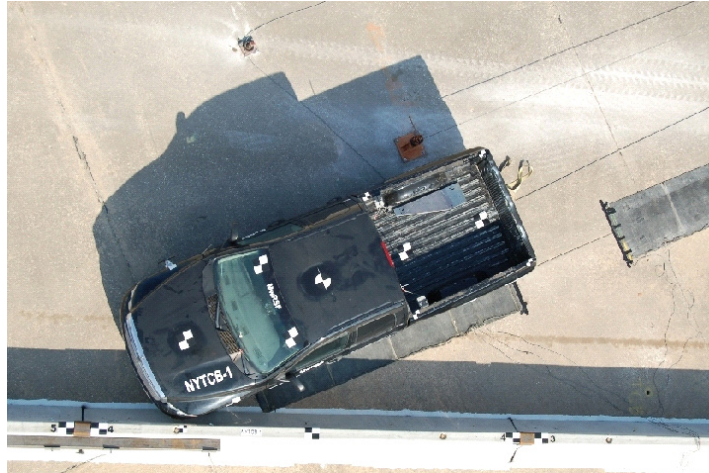
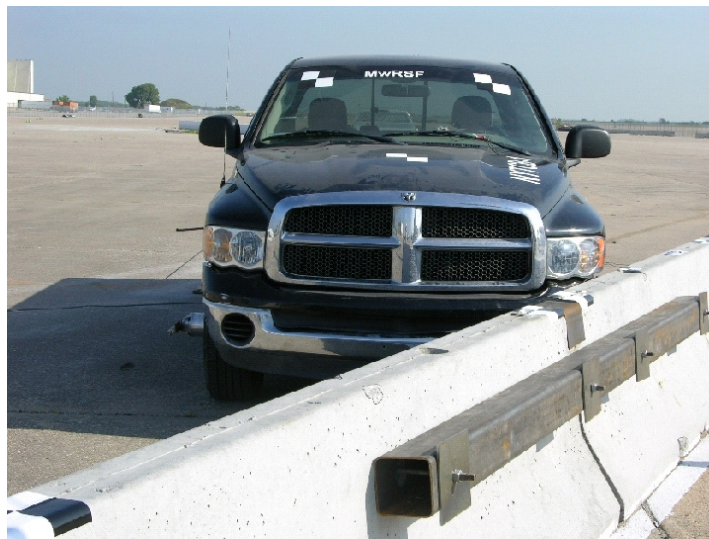
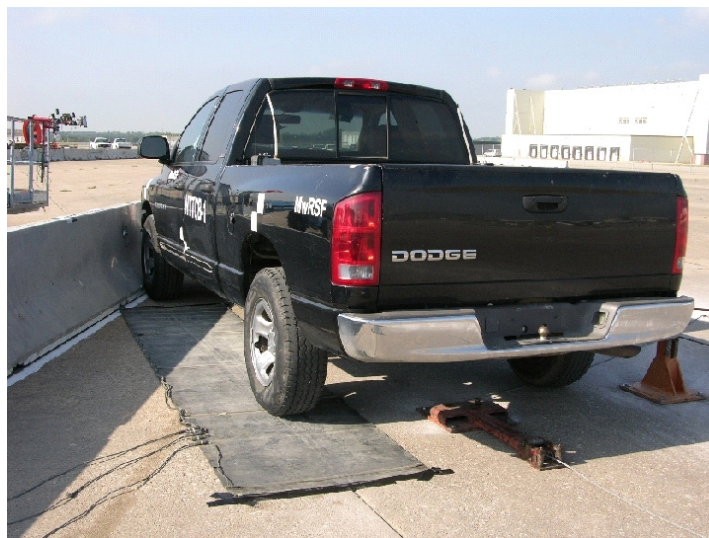
Figure 35. Impact Location, Test NYTCB-1

Initial vehicle impact was to occur 1,300 mm (51.2 in.) upstream from the downstream end of barrier no. 4, as shown in Figure 35. Actual vehicle impact occurred at the targeted impact location. At 0.004 sec, the left-front quarter panel crushed inward. At 0.010 sec, the left-front tire became airborne. At 0.018 sec, barrier no. 4 deflected backward. At 0.022 sec, barrier no. 5 deflected backward. At 0.024 sec, the left-front tire ruptured as the tire was compressed between the vehicle and barrier no. 4. At 0.034 sec, the hood became ajar. At 0.042 sec, the front of the vehicle pitched upward. At 0.054 sec, the stiffener connecting barrier nos. 4 and 5 bent significantly. At this same time, the vehicle redirected. At 0.088 sec, the stiffener between barrier nos. 5 and 6 deflected. At 0.102 sec, the right-front tire became airborne. At 0.178 sec, barrier nos. 3 and 6 deflected. At 0.216 sec, the vehicle became parallel to the system with a resultant velocity of 85.4 km/h (53.1 mph). At 0.230 sec, the left-front bumper corner scraped along the top of barrier no. 5. At 0.242 sec, the stiffener between barrier nos. 6 and 7 deflected. At 0.244 sec, the left-rear tire contacted the system. At this same time, the front of the vehicle pitched downward. At 0.300 sec, the vehicle became airborne as the right-rear tire left the ground. At 0.394 sec, the vehicle rolled away from the

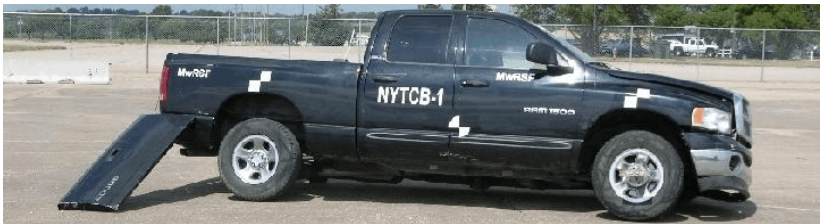
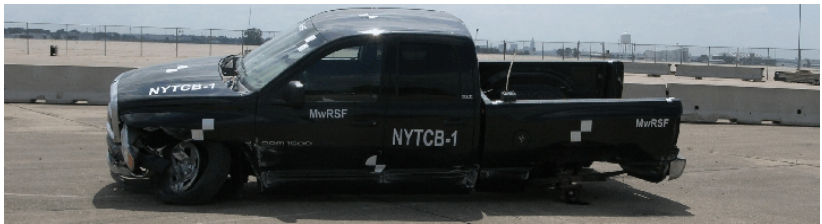
Figure 42. Vehicle Damage, Test NYTCB-1

Exterior vehicle damage was moderate, as shown in Figures 42 and 43. Occupant compartment deformations to the left side and center of the floorboard were judged insufficient to cause serious injury to the vehicle occupants. Maximum longitudinal deflections of 19 mm (0.75 in.) were located near the left-front corner of the left-side floor pan. Maximum lateral deflections of 38 mm (1.5 in.) were located near the left-front corner of the floorboard. Maximum vertical deflections of 32 mm (1.25 in.) were located near the left front of the floorboard. Complete occupant compartment deformations and the corresponding locations are provided in Appendix C.

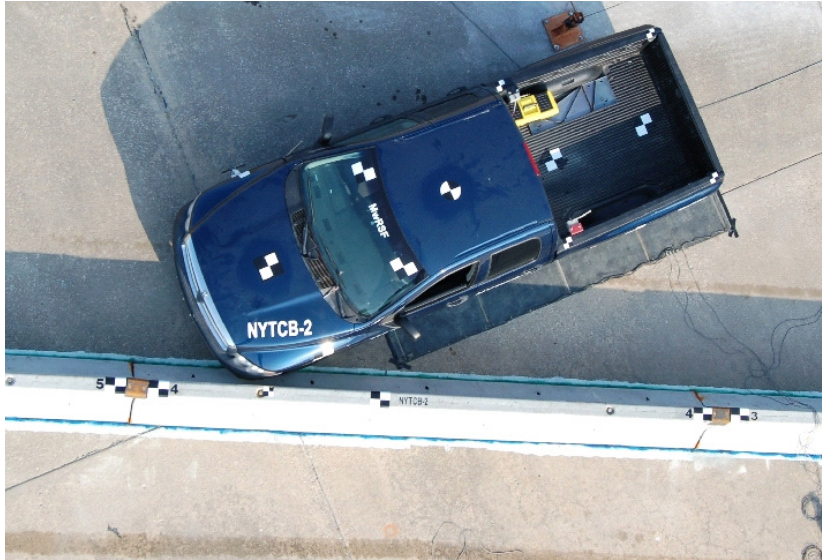
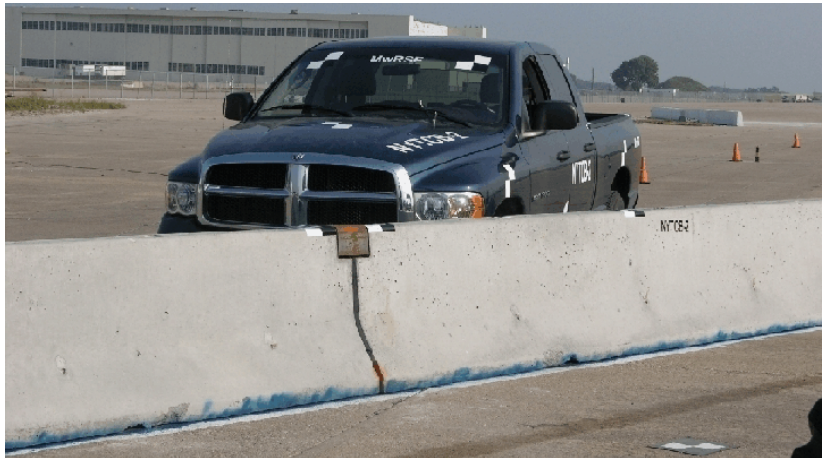
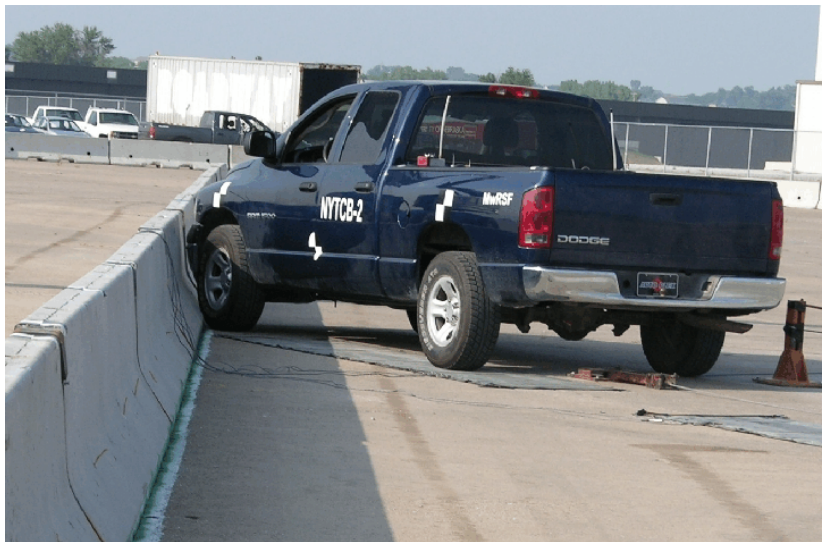
Figure 56. Impact Location, Test NYTCB-2

Initial vehicle impact was to occur 1,300 mm (51.2 in.) upstream from the downstream end of barrier no. 4, as shown in Figure 56. Actual vehicle impact occurred at the targeted impact location. Immediately after impact, the left-front quarter panel crushed inward. At 0.010 sec, barrier nos. 4 and 5 deflected away from traffic. At 0.012 sec, the left-front tire climbed the front face of barrier no. 4. At 0.032 sec, the vehicle yawed as it redirected. At 0.034 sec, the left-front quarter panel protruded over the top of the barrier. At 0.040 sec, the back side of barrier no. 4 experienced concrete spalling which disengaged from the barrier. At 0.042 sec, the vehicle climbed the front face of the system, and the vehicle's front end pitched upward. At 0.054 sec, concrete spalling occurred at the downstream end on the back side of barrier no. 3. At 0.056 sec, barrier no. 6 deflected backward due to movement of barrier no. 5. At 0.196 sec, barrier no. 7 deflected toward traffic. At 0.210 sec, barrier no. 3 moved slightly downstream. At 0.216 sec, the vehicle became parallel to the barrier with a resultant velocity of 82.7 km/h (51.4 mph). As the truck continued to redirect, it rolled toward the system. At 0.282 sec, the right-rear tire became airborne which resulted in the entire vehicle becoming airborne. At 0.296 sec, the front of the vehicle reached its maximum pitch upward

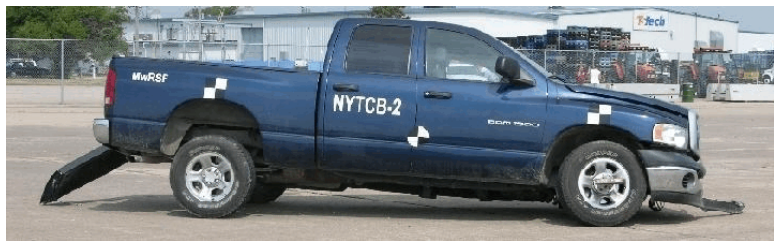
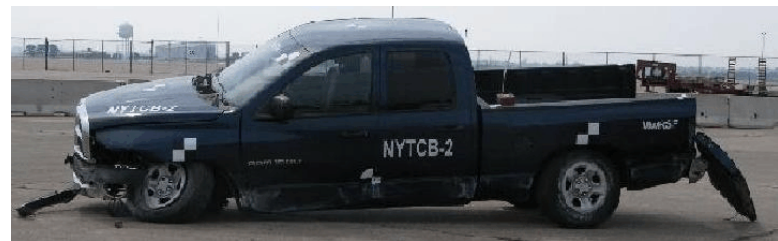
Figure 62. Vehicle Damage, Test NYTCB-2

Exterior vehicle damage was moderate, as shown in Figures 62 and 63. Occupant compartment deformations to the left side and center of the floorboard were judged insufficient to

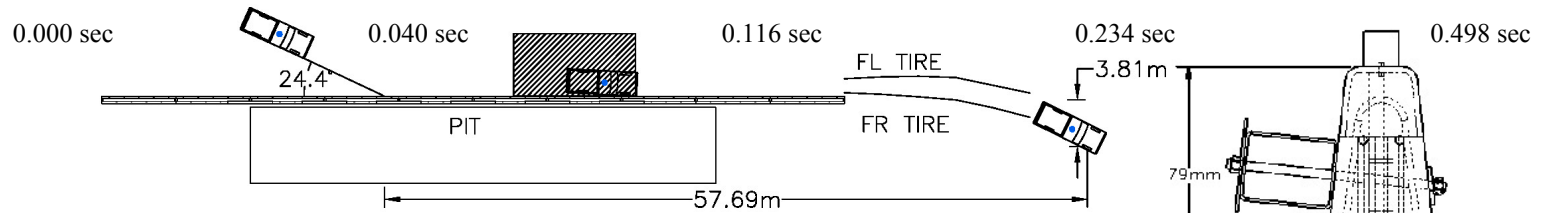
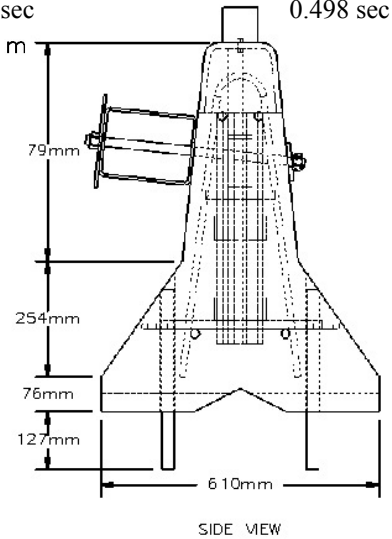
Figure 70. Summary of Test Results and Sequential Photographs, Test NYTCB-3

The analysis of the test results for test no. NYTCB-3 showed that the stiffened temporary concrete barrier system with anchored ends adequately contained and redirected the 2270P vehicle with controlled lateral displacements of the barrier system. There were no detached elements nor fragments which showed potential for penetrating the occupant compartment nor presented undue hazard to other traffic. Deformations of, or intrusion into, the occupant compartment that could have

caused serious injury did not occur. The test vehicle did not penetrate nor ride over the box beam stiffened temporary concrete barrier system and remained upright during and after the collision. Vehicle roll, pitch, and yaw angular displacements were noted, but they were deemed acceptable because they did not adversely influence occupant risk safety criteria nor cause rollover. After collision, the vehicle's trajectory revealed minimum intrusion into adjacent traffic lanes. In addition, the vehicle exited the barrier within the exit box. Therefore, test no. NYTCB-3 conducted on the stiffened temporary concrete barrier system with anchored ends was determined to be acceptable according to the TL-3 safety performance criteria of test designation no. 3-11 found in the currently proposed Update to NCHRP Report No. 350.
