Texas Transportation Institute

NCHRP REPORT 350 TEST 3-11 OF THE LONG-SPAN GUARDRAIL WITH 5.7 M CLEAR SPAN AND NESTED W-BEAMS OVER 11.4 M

Contract No. T4541-AA
Report/Test No. 405160-1-1
Test Date: May 24, 2006

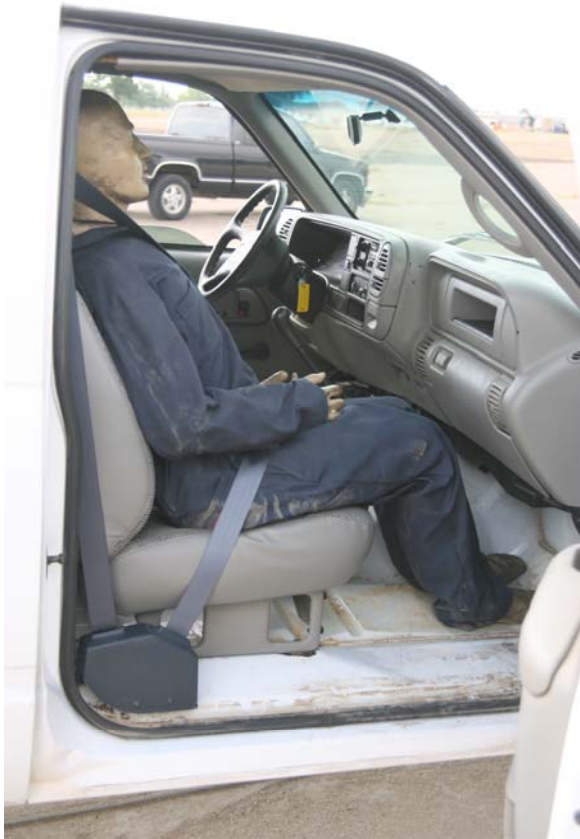
Before test

Figure 12. Interior of vehicle for test 405160-1-1.

Results: Some of the posts fractured and post 14 was resting 3.8 m on the traffic side of the rail. These debris did not penetrate nor show potential for penetrating the occupant compartment. Maximum occupant compartment deformation was 16 mm in the right floor pan to instrument panel area. (PASS)
