**CRASH TESTING AND EVALUATION OF THE
MODIFIED G4(1S) W-BEAM GUARDRAIL
ON 2:1 SLOPE**

Contract No. T4541-AC
Report/Test No. 405160-4-1
Test Date: 2008-04-16

NOVEMBER 2008

**TEXAS TRANSPORTATION INSTITUTE
THE TEXAS A&M UNIVERSITY SYSTEM
COLLEGE STATION, TEXAS 77843**

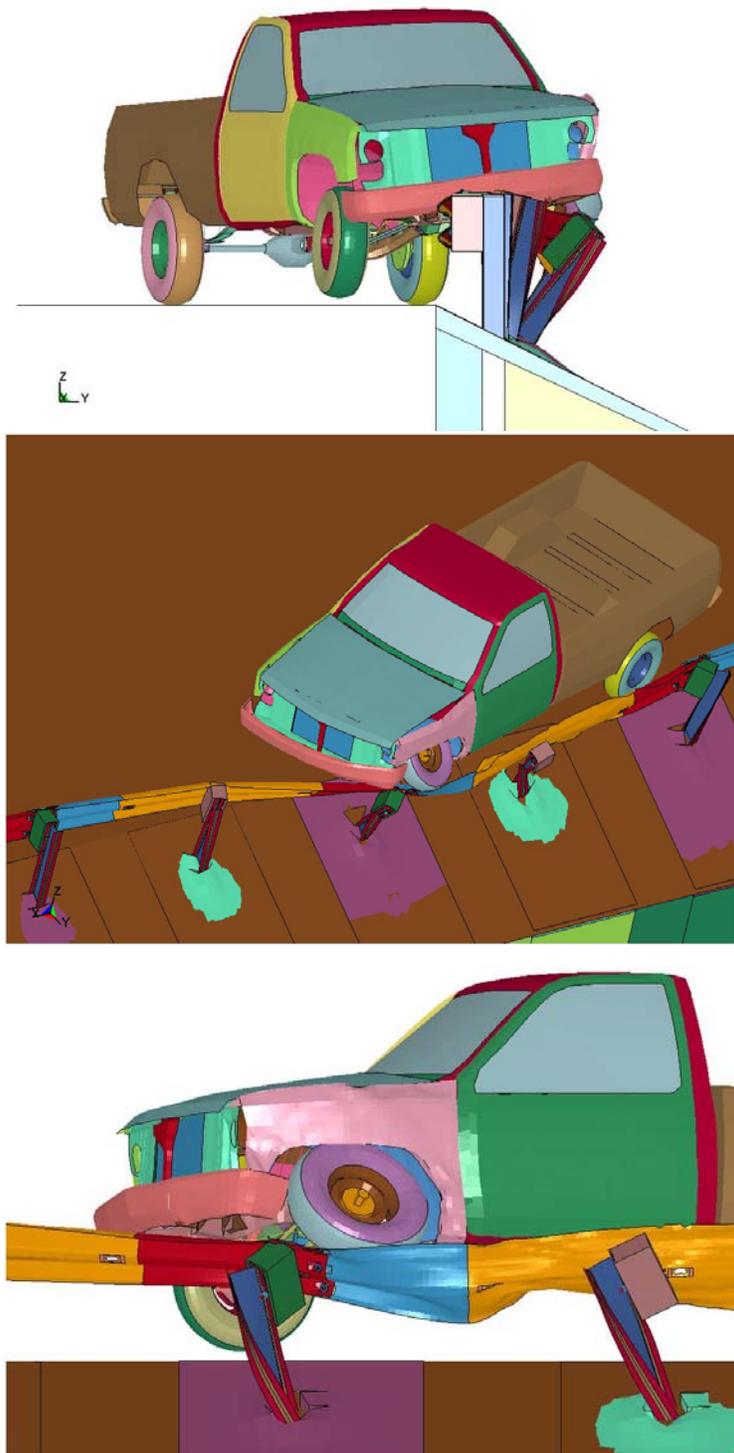
Figure 2.9. Vehicle-barrier interaction associated with test 3-11 impact of a guardrail on 2H:1V slope with 8-ft long posts spaced at 6 ft-3 inch.

Early in the simulation, the front left corner of the truck began to over-ride the rail. As the simulation progressed, the front left tire also began to over-ride the rail. The simulation stopped just as the tire passed over the rail. Figure 2.9 shows images of the truck-rail interaction during this simulation. It is evident that the truck would continue to climb and over-ride the rail, and that the system would not be effective in redirecting the truck.

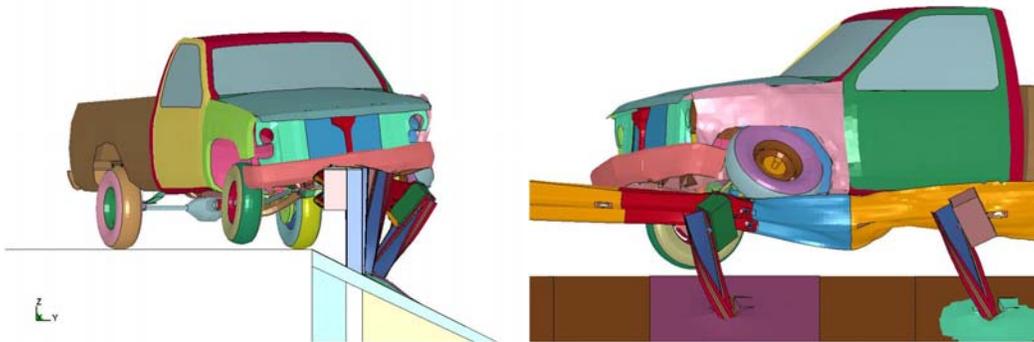
Figure 2.13. Vehicle-barrier interaction associated with test 3-11 impact of a guardrail on 2H:1V slope with 8-ft long posts spaced at 6 ft-3 inch.

Case 1: The simulation suggests that the truck would climb and over-ride the rail as shown in figure 2.13.

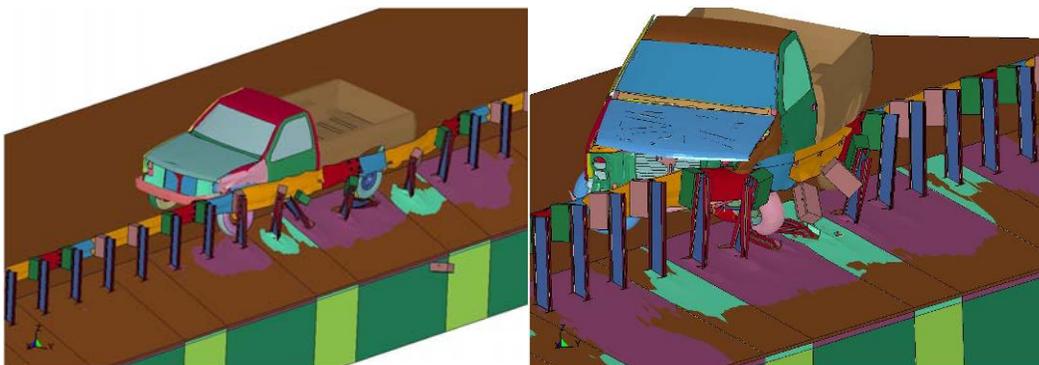
Figure 2.14. Simulation with 3 ft-1.5 inch post spacing.

Case 2: The system would most likely re-direct the vehicle without overriding, however; there is increased snagging between the front left wheel and the posts. This caused increased pitching of the vehicle and subsequently an increased roll angle. This is shown in figure 2.14.

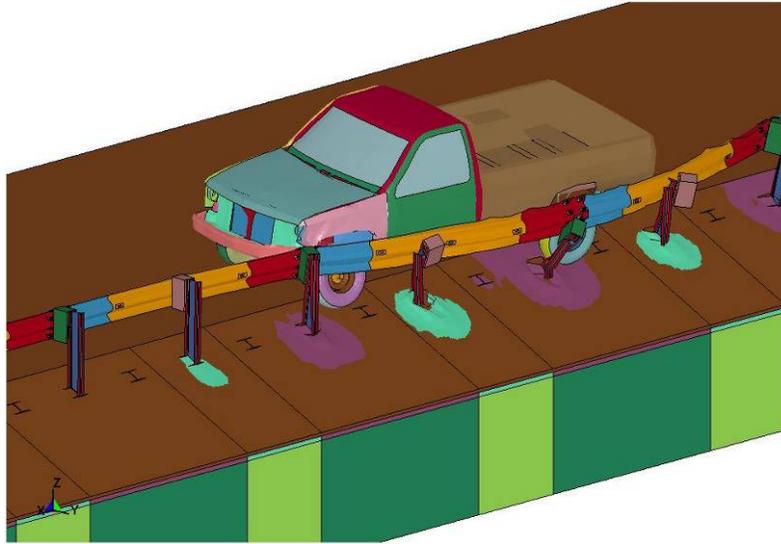
Figure 2.15. Guardrail on slope system with 6 ft-3 inch post spacing and 10-Gauge W-Beam.

Case 3: The system would most likely re-direct the vehicle without overriding. Snagging, pitching, and rolling are not as pronounced as in Case 2. A snap shot of the simulation is shown in figure 2.15.

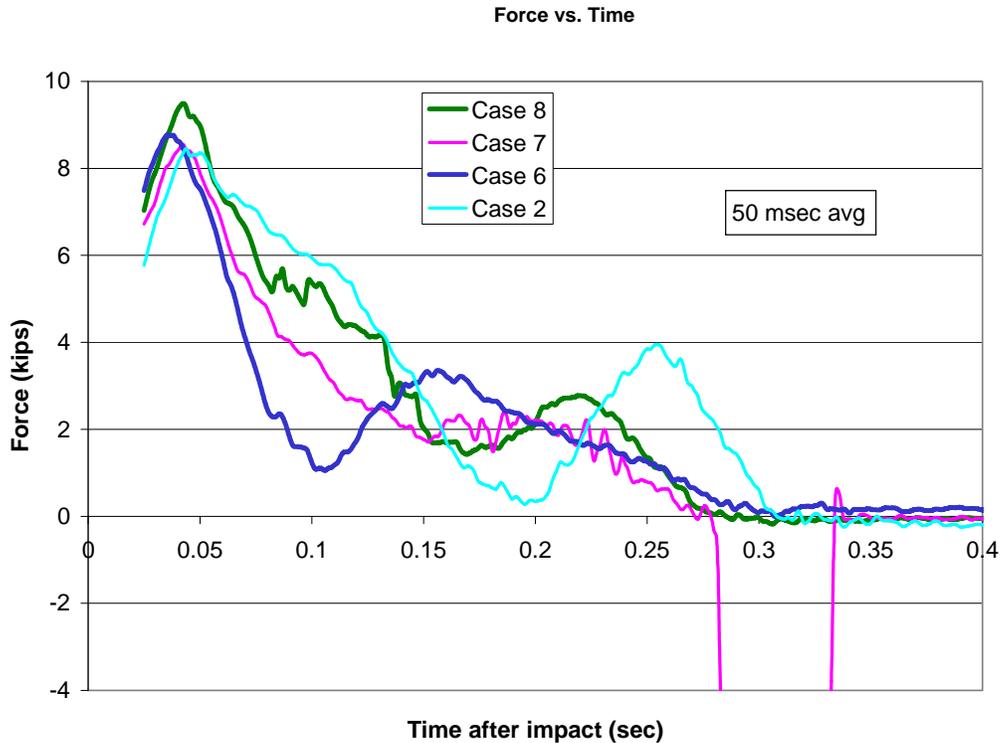
Figure 2.19. Force histories of the 7-ft long post without soil plate (case 2) and with soil plate (cases 6, 7 and 8).

The graph indicates that all tests are practically equal in terms of their maximum force capacity. This means that adding the soil plate to the post resulted in little increase of the maximum force sustained by the post upon impact.
