## CRASH TEST AND EVALUATION OF 3-FT MOUNTING HEIGHT SIGN SUPPORT SYSTEM

### Test Report 9-1002-15-1

TEXAS A&M TRANSPORTATION INSTITUTE  
COLLEGE STATION, TEXAS

TEXAS DEPARTMENT OF TRANSPORTATION

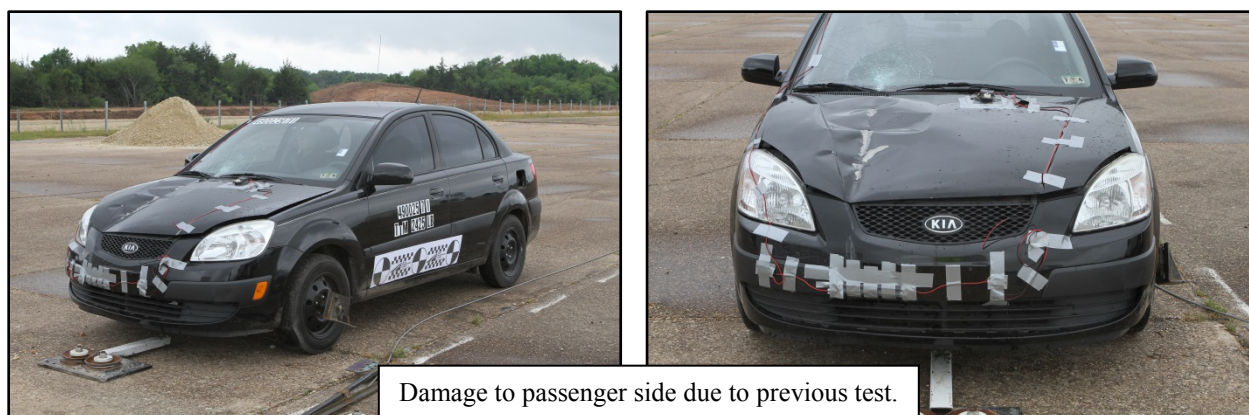
**Figure 5.2. Vehicle before Test No. 490025-7-1.**

Figures 5.1 and 5.2 show the 2009 Kia Rio used for this crash test. The right quarter point of the vehicle was damaged in the previous high-speed test (Test No. 490025-7-2) conducted that morning. However, this damage was minimal and did not affect independent assessment of the sign panel in this low-speed test. Test inertia weight of the vehicle was 2415 lb, and its gross static weight was 2580 lb. The height to the lower edge of the vehicle front bumper was 9.50 inches, and the height to the upper edge of the front bumper was 21.5 inches. Additional dimensions and information on the vehicle are given in Appendix B1, Table B.1. The vehicle was directed into the installation using a cable reverse tow and guidance system, and was released to be freewheeling and unrestrained just prior to impact.

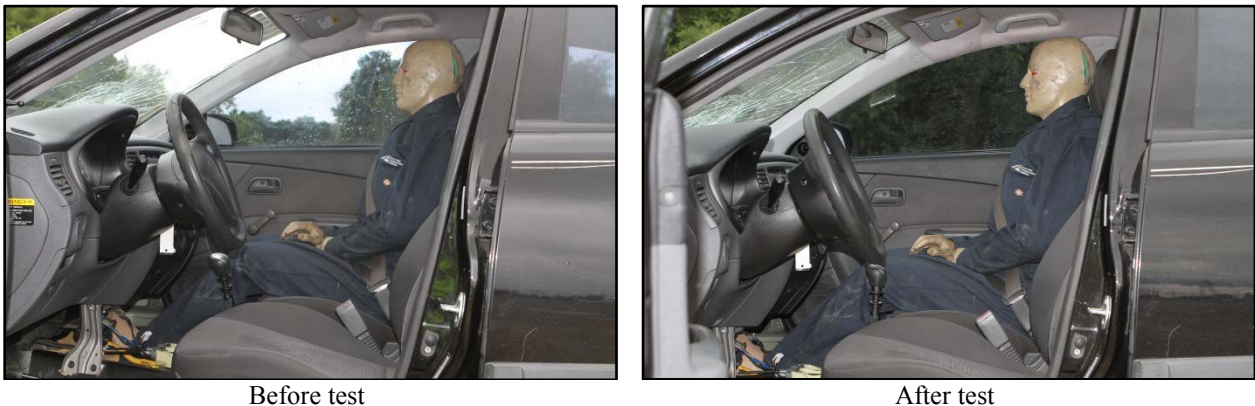
**Figure 5.5. Interior of Vehicle for Test No. 490025-7-1.**

Figure 5.4 shows minimal damage to the driver side of the vehicle after the test. The damage to the passenger side occurred during the previous high-speed test (test no. 490025-7-2), which was performed earlier that morning. Scuff marks were noted on the bumper, but no other damage was obvious. No deformation or intrusion of the occupant compartment was noted. Figure 5.5 shows the interior of the vehicle. Exterior vehicle crush and occupant compartment measurements are shown in Appendix B1, Tables B.2 and B.3, respectively.

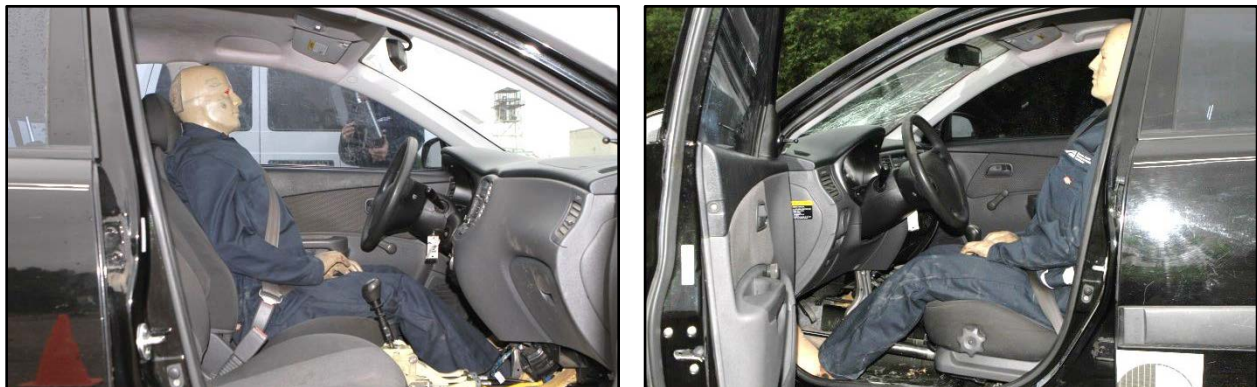
Figure 6.4 shows damage to the vehicle after the test. There was a small indentation in the right side of the hood. The windshield was fractured in the lower right corner but remained intact. No deformation or intrusion of the occupant compartment was noted. Figure 6.5 shows the interior of the vehicle. Exterior vehicle crush and occupant compartment measurements are shown in Appendix C2, Tables C.2 and C.3.
