**PERFORMANCE EVALUATION OF THE
MIDWEST GUARDRAIL SYSTEM – UPDATE TO
NCHRP 350 TEST NO. 3-11 WITH 28" C.G.
HEIGHT (2214MG-2)**

MwRSF Research Report No. TRP-03-171-06

October 11, 2006

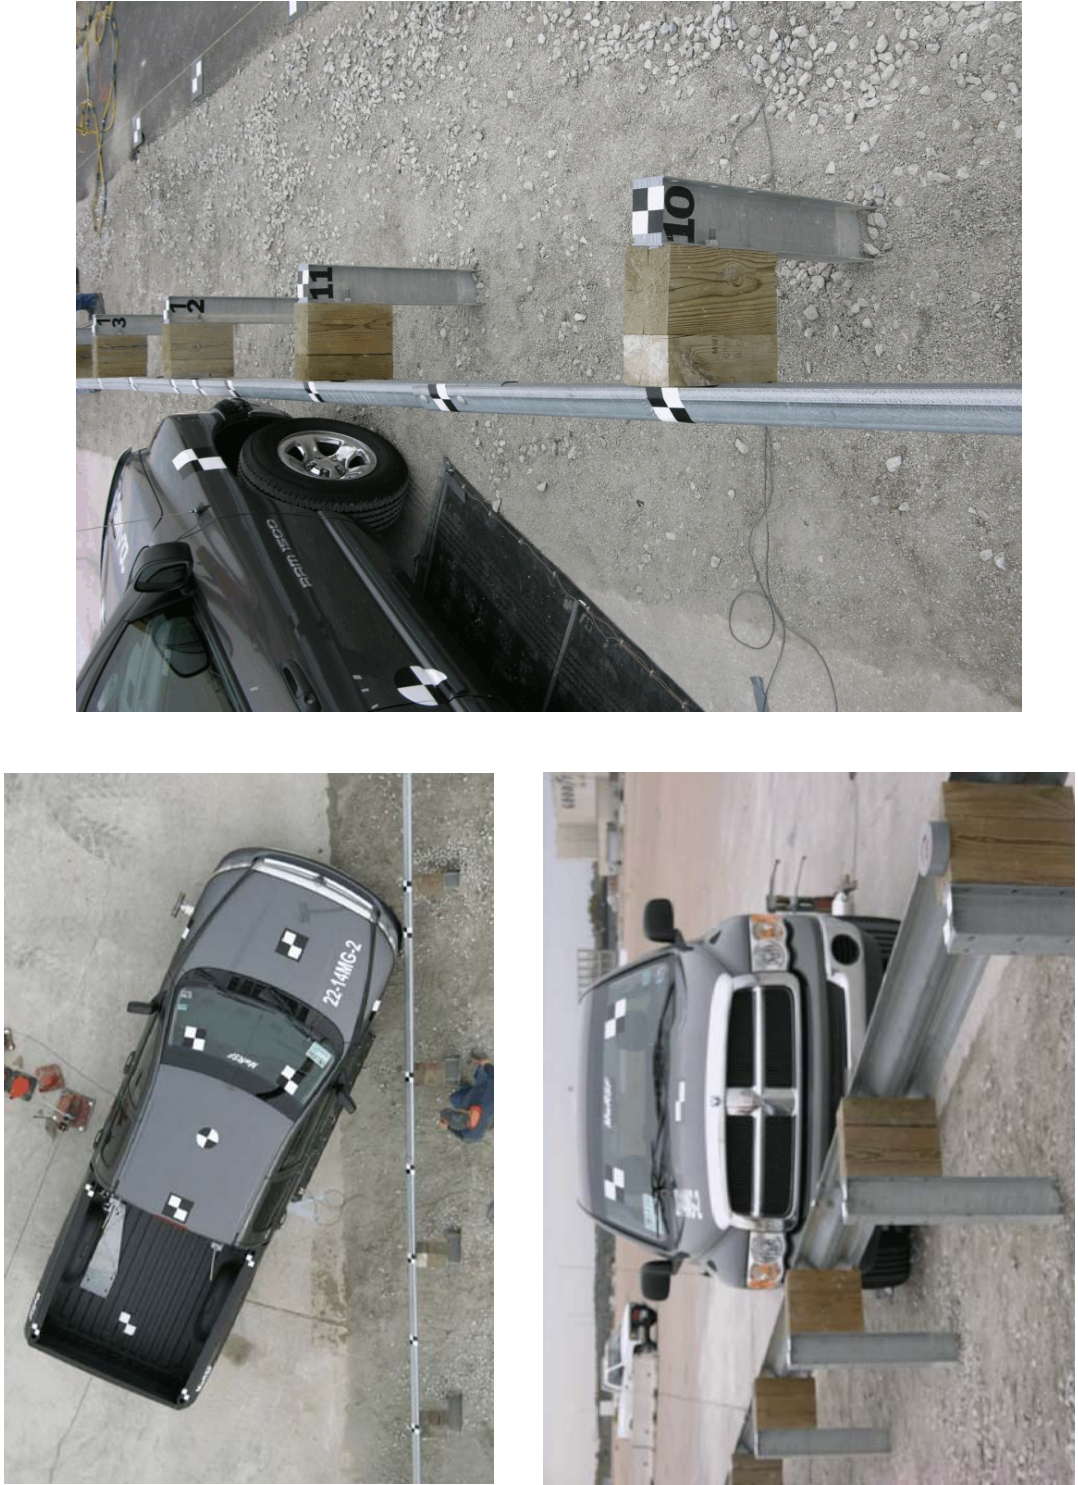
Figure 21. Impact Location, Test 2214MG-2

Initial vehicle impact was to occur between post nos. 11 and 12, or 5.21 m (17 ft - 1 in.) upstream from the center of the splice at the midspan between post nos. 14 and 15, as shown in Figure 21. Actual vehicle impact occurred 5.25 m (17 ft - 2.5 in.) upstream from the center of the splice at the midspan between post nos. 14 and 15. At 0.026 sec after impact, the rail deflected backward. At this same time, the right-front corner of the vehicle crushed inward. At 0.072 sec, the right-front corner of the vehicle was located at post no. 13. At this same time, post no. 13 deflected backward. At 0.090 sec, the guardrail disengaged from post no. 13. At this same time, the right-front corner of the vehicle protruded over the rail. At 0.102 sec, the right-front tire contact post no. 13. At 0.140 sec, the guardrail disengaged from post no. 14. At 0.162 sec, the vehicle was in contact with the rail through the right-rear wheel location. At 0.210 sec, the guardrail disengaged from post no. 15. At 0.282 sec, the vehicle became parallel to the guardrail with a resultant velocity of 73.7 km/h (45.8 mph). At this same time, the vehicle rolled slightly counter-clockwise (CCW) toward the rail. At 0.342 sec, the guardrail disengaged from post no. 16. At 0.458 sec, post no. 17 rotated

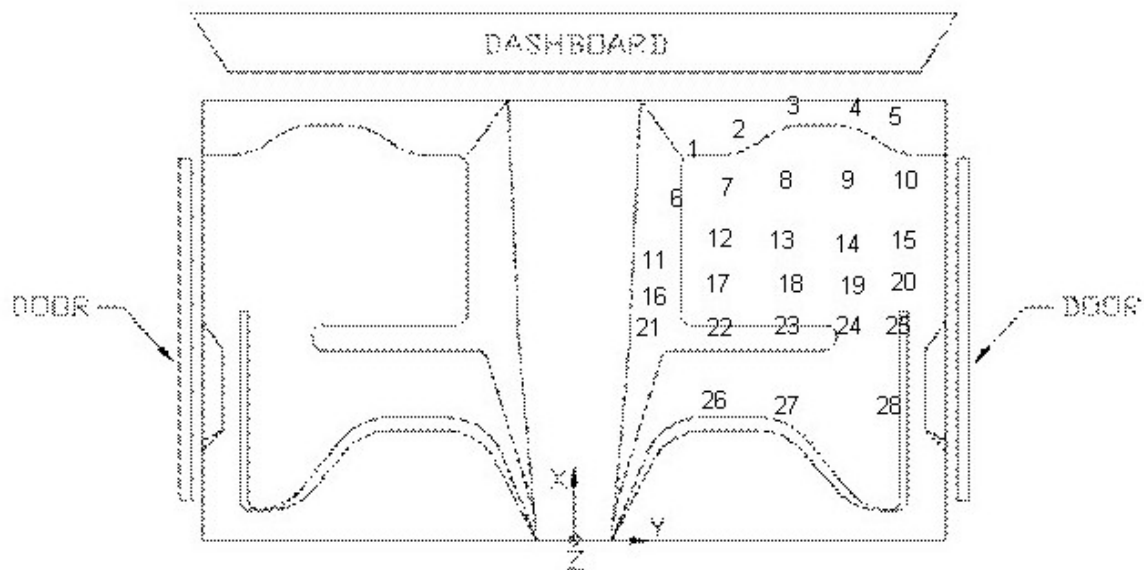
Figure C-1. Occupant Compartment Deformation Data - Set 1, Test 2214MG-2

cause serious injury to the vehicle occupants. Maximum longitudinal deflections of 19 mm (0.75 in.) were located near the center of the right-side floor pan. Maximum lateral deflections of 6 mm (0.25 in.) were located throughout the right-side floor pan. Maximum vertical deflections of 13 mm (0.5 in.) were located near the center of the right side. Complete occupant compartment deformations and the corresponding locations are provided in Appendix C.
